Effect of Roof Material on Water Quality for Rainwater Harvesting Systems

Texas Water Development Board

Texas Water Development Board Report

January 2010

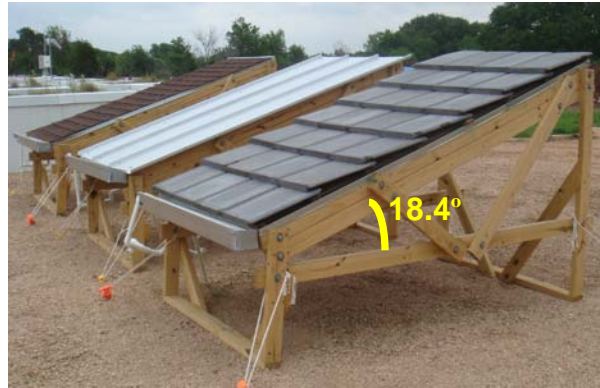
Figure 4-1. Pilot-scale roofs. (From left to right: asphalt fiberglass shingle, Galvalume®, concrete tile)

Based on the results of Task 1, three roofing materials were selected for the construction of pilot-scale roofs: GAF-Elk's asphalt fiberglass shingle, Berridge's Galvalume® standing seam metal (in which the panels are seamed together to run vertically from the roof's ridge), and MonierLifetile's concrete tile. Three wooden frames were installed at the Lady Bird Johnson Wildflower Center (Austin, Texas), with roofs (8 feet [ft] x 4 ft) at an 18.4°-angle from the horizontal (Figure 4-1). In addition, the runoff was sampled from a pilot-scale green roof and a pilot-scale cool roof that were already in place at the Lady Bird Johnson Wildflower Center. The flat green roof contained a substrate, drainage layer, and membrane root barrier as described previously by Simmons et al. (2008) for a Type E green roof. The flat cool roof consisted of a white, acrylic-surfaced, 2-ply atactic polypropylene (APP) modified bituminous membrane (Simmons et al., 2008). All of the pilot-scale roofs were exposed to the same natural environment and were therefore subject to the same atmospheric deposition, ultraviolet radiation, temperature changes, and rainfall intensity. Although all five roofs were exposed to the same environment, the lack of a slope on the green roof and the cool roof could have affected the quality of harvested rainwater because slope has previously been shown to affect harvested rainwater quality (TCEQ, 2007; Kingett Mitchell, 2003).

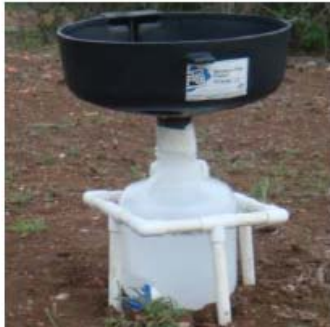
Figure 4-3. Ambient sampling device.

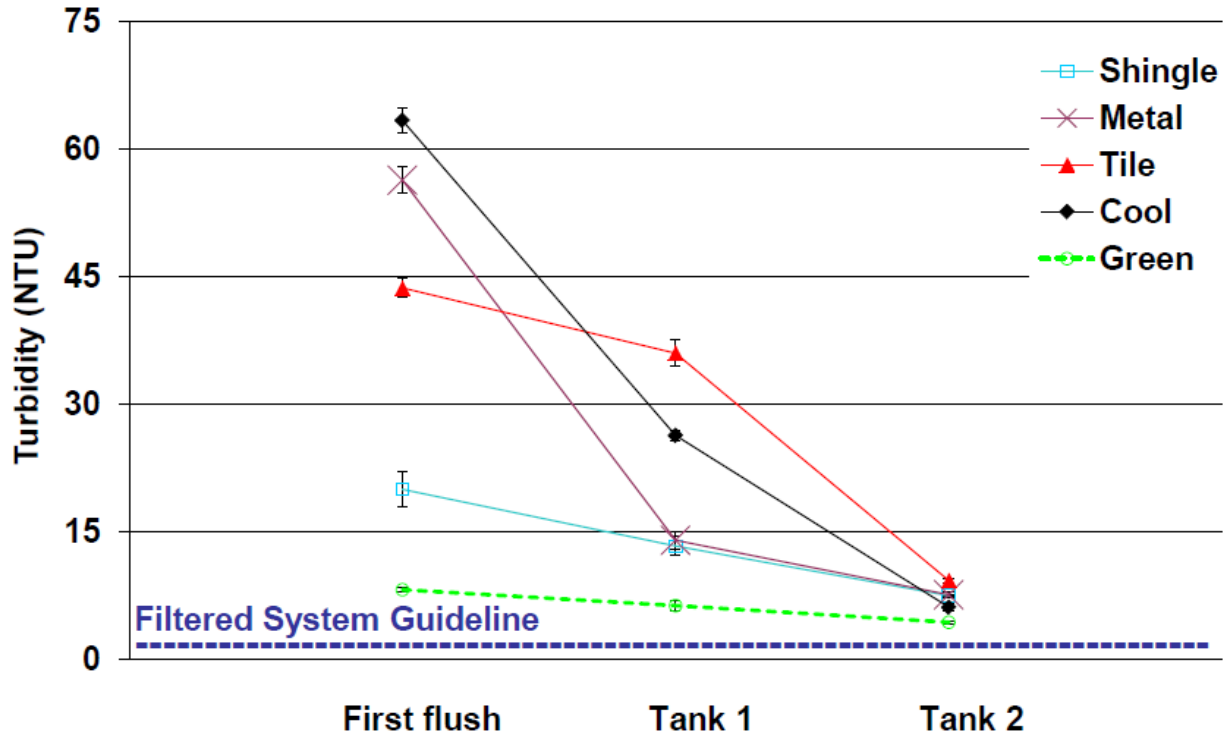
Figure 4-6. Turbidity in harvested rainwater from pilot-scale roofs for April 18, 2009 event. Ambient rainwater had average turbidity=4 NTU. Error bars represent standard deviations from triplicate analyses. Filter system guideline adapted from USEPA, 2009.

Figures 4-6 and 4-7 show turbidity and TSS of the harvested rainwater from the April 18, 2009 event, and Tables 4-6 and 4-7 summarize the median, minimum, and maximum turbidity and TSS values for the 3 rain events. Turbidity decreased dramatically from the first flush through the first and second tanks, with final values of turbidity that were on the same order as that of ambient rain. Turbidity readings in the first flush through the second tank ranged from 2 nephelometric turbidity units (NTU) to 105 NTU for all rain events, which are comparable to the 4 to 94 NTU reported in Yaziz et al. (1989). For all rain events, rainwater harvested after the first flush from the metal, tile, and cool roofs yielded higher turbidity values as compared to other roofing materials, up to 36 NTU, which might be attributed to their smoother surfaces. The lowest turbidity values were found in rainwater harvested after the first flush from the green roof, ranging from 3 NTU to 11 NTU, which is an indication that green roofs can effectively filter out particles. It is important to note, however, that all roofs yielded higher turbidity values than the 1 NTU maximum recommended for potable use of harvested rainwater (TWDB, 2006), which is the same as the USEPA’s guideline for filtered surface water (USEPA, 2009). In comparison to the turbidity values, similar trends were seen for TSS. TSS decreased dramatically from the first flush through the first and second tanks, with final values of TSS that were close to that of ambient rain. Yaziz et al. (1989) reported 53 to 276 milligram per liter (mg/L) TSS in harvested rainwater and 10 to 64 mg/L TSS in ambient rainwater. Our values were similar to these, with values of 1 to 118 mg/L TSS in the harvested rainwater after the first flush and 7 to 46 mg/L TSS in ambient rainwater. Similar to turbidity trends, the metal, tile, and cool roofs yielded higher TSS (4 to 118 mg/L) in the harvested rainwater after the first flush as compared to the other roofing materials, and green roofs yielded lower TSS (1 to 25 mg/L) in the harvested rainwater after first flush.

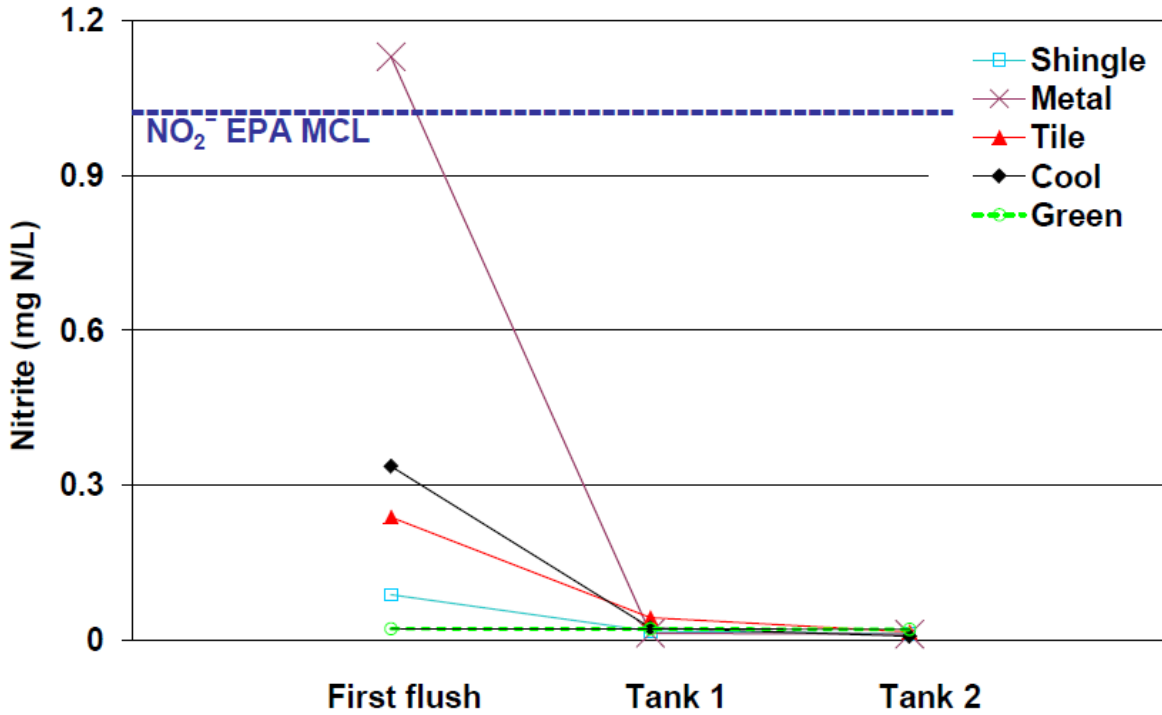
Figure 4-9. Nitrite in harvested rainwater from pilot-scale roofs for April 18, 2009 event. Ambient rainwater had nitrite=0.009 mg/L NO_2^- -N.

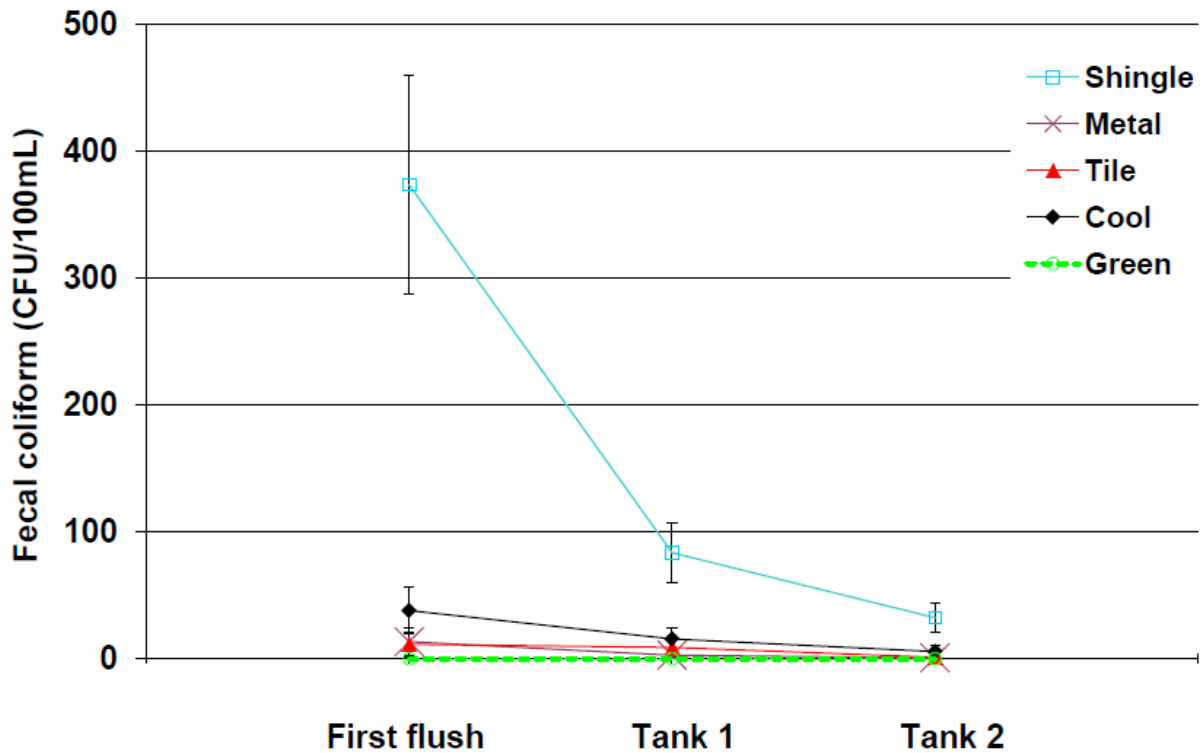
Figure 4-12. FC in harvested rainwater from pilot-scale roofs for April 18, 2009 event. Ambient rainwater had average FC=15 CFU/100mL. Error bars represent 95% confidence intervals from triplicate analyses.

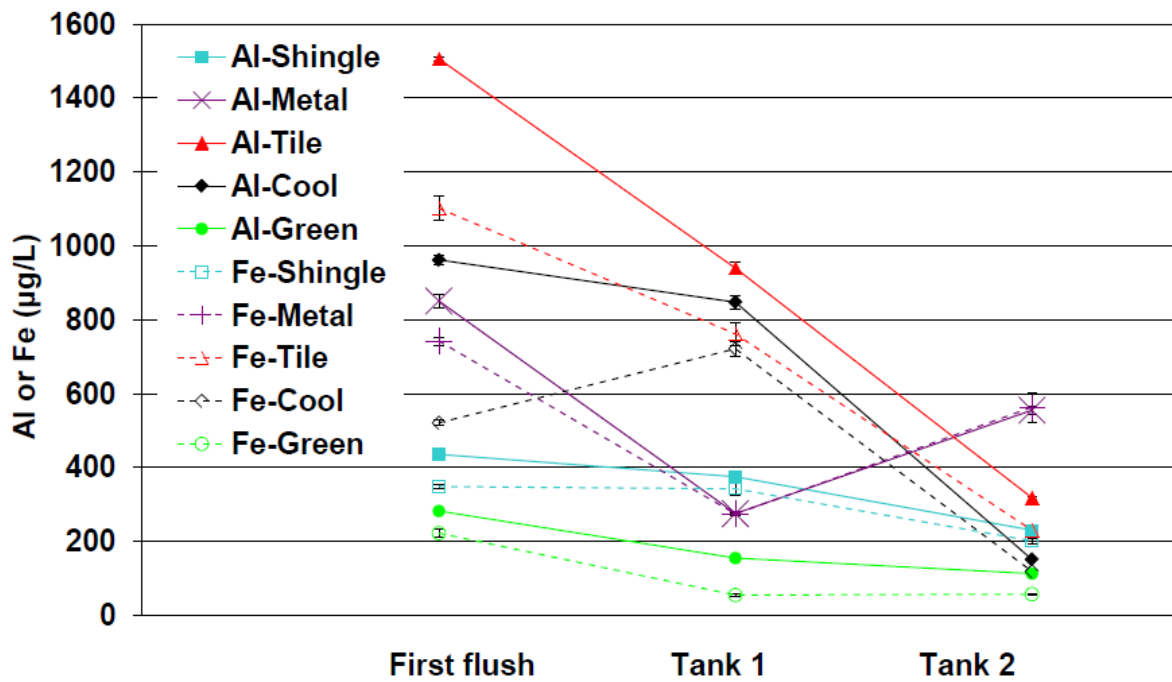
Figure 4-13. Al and Fe in harvested rainwater from pilot-scale roofs for April 18, 2009 event. Ambient rainwater had average Al=157.80 µg/L and Fe=193.70 µg/L. Error bars represent standard deviations from triplicate analyses.

after the first flush from the tile roof; this was not consistent in the other rain events, which showed the highest Al and Fe concentrations in the harvested rainwater after the first flush from the shingle and cool roofs. For all rain events, the shingle roof showed the highest Cu concentrations. The April 18, 2009 rain event showed the highest Pb concentrations in the harvested rainwater after the first flush for the green roof; this was not representative of subsequent rain events, which showed lower Pb concentrations. For the green roof, elevated Pb concentrations might have been from the solder in scupper gutter. In general, the tile and metal roofs yielded the highest Cr concentrations in the harvested rainwater after the first flush, but the levels were very low (0.16 to 2.93 µg/L); Cr was expected in the rainwater harvested from the tile and metal roofs since it is used as metallic coating and pigment for these roofs (Dofasco, 2007; MonierLifetile, 1999).

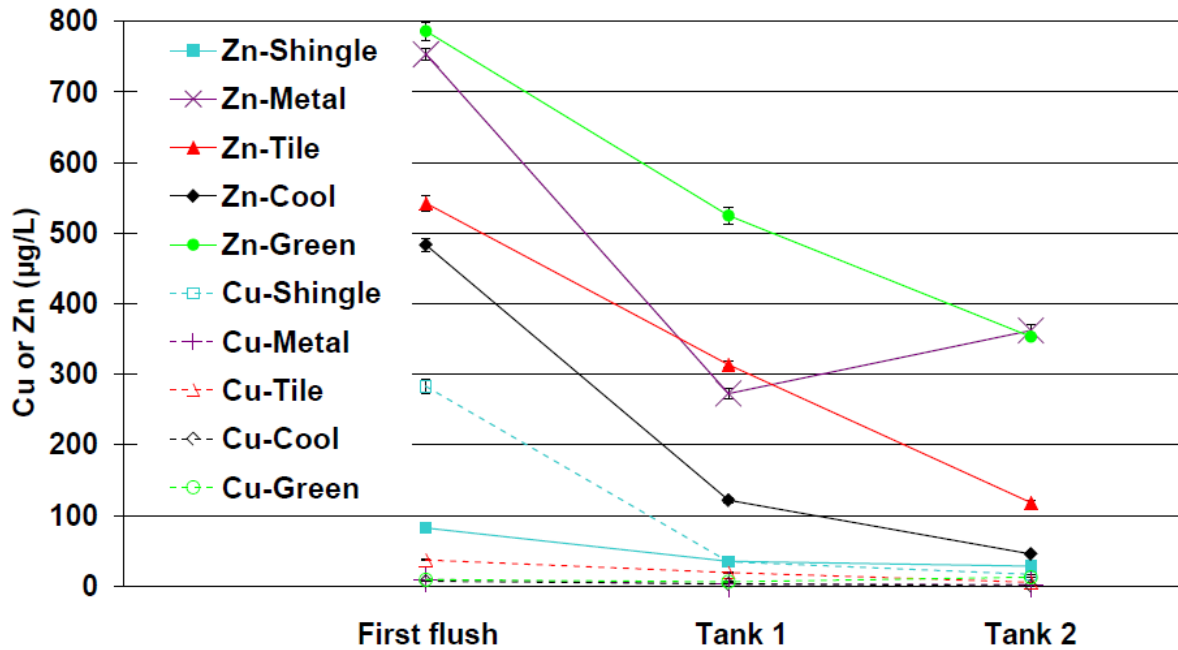
Figure 4-14. Cu and Zn in harvested rainwater from pilot-scale roofs for April 18, 2009 event. Ambient rainwater had average Cu=0.68 µg/L and Zn=21.35 µg/L. Error bars represent standard deviations from triplicate analyses.

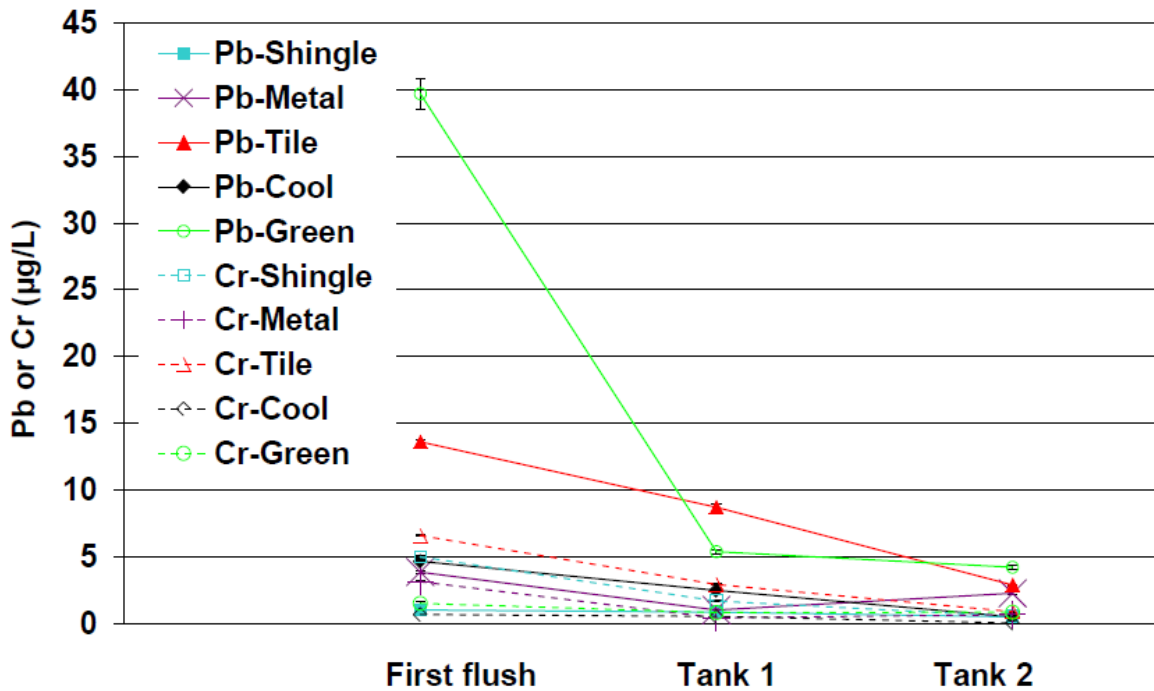
Figure 4-15. Pb and Cr in harvested rainwater from pilot-scale roofs for April 18, 2009 event. Ambient rainwater had average Pb=0.69 µg/L and Cr=0.059 µg/L. Error bars represent standard deviations from triplicate analyses.

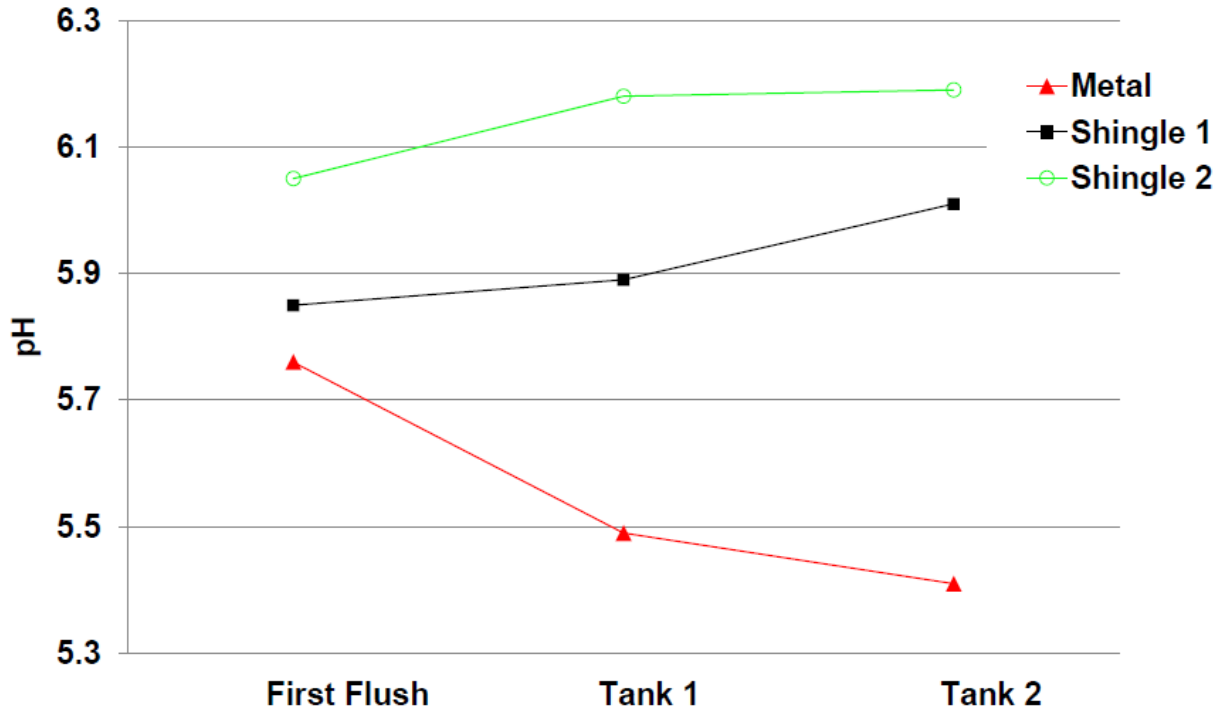
Figure 5-1. pH in harvested rainwater from full-scale roofs for February 9, 2009 event. Ambient rainwater had pH= 5.4 to 6.3 (a range is reported since different ambient samples were analyzed for each of the three locations).

studies including Yaziz et al. (1989), which reported pH values of 5.9 to 6.9 in harvested rainwater, Simmons et al. (2001), which reported pH values of 5.2 to 11.4 in harvested rainwater, and the pilot-scale roofs, which had pH values of 6.0 to 8.2 in the harvested rainwater..

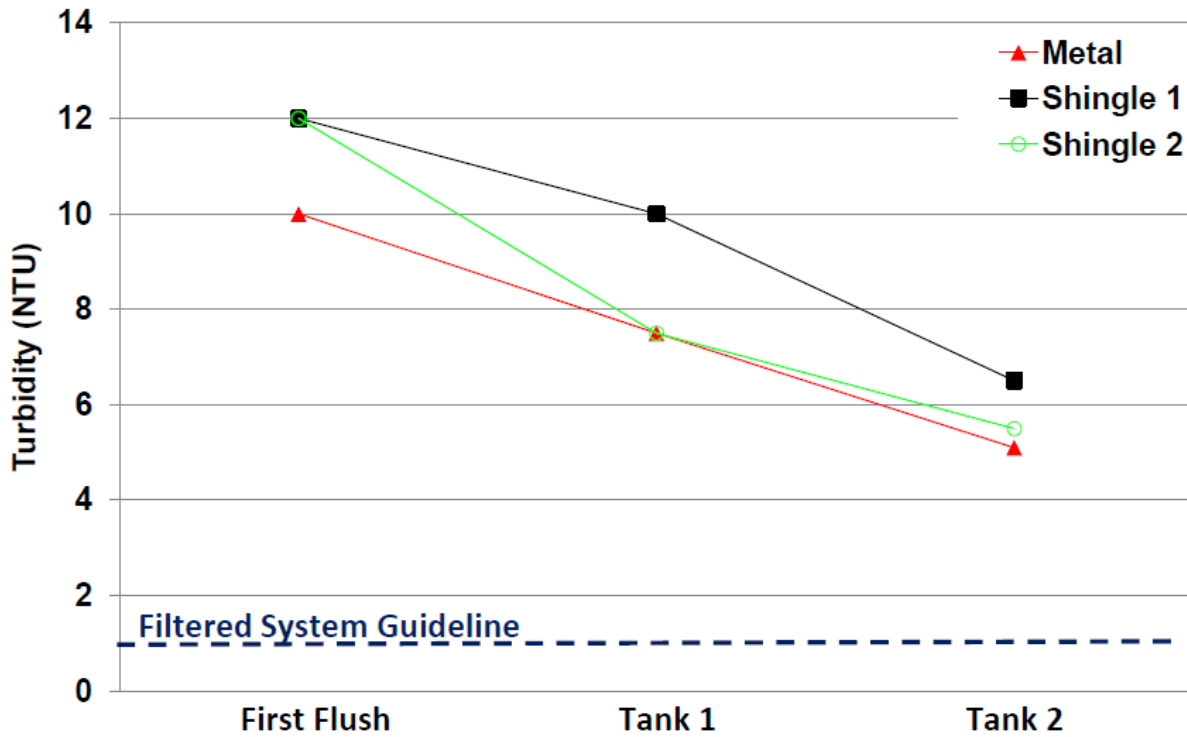
Figure 5-3. Turbidity in harvested rainwater from full-scale roofs for February 9, 2009 event. Ambient rainwater had turbidity=6 to 17 NTU (a range is reported since different ambient samples were analyzed for each of the three locations). Filtered system guideline adapted from USEPA, 2009.

the first flush from the shingle and metal roofs yielded higher turbidity values than the 1 NTU maximum recommended for potable use of harvested rainwater (TWDB, 2006), which is the same as the USEPA’s guideline for filtered surface water (USEPA, 2009). In comparison to the turbidity values, similar trends were seen for TSS. Yaziz et al. (1989) reported 53 to 276 mg/L TSS in harvested rainwater and 10 to 64 mg/L TSS in ambient rainwater; the pilot-scale roofs had values ranging from 1 to 260 mg/L TSS in harvested rainwater and 4 to 8 mg/L TSS in ambient rainwater. The values from the full-scale roofs were similar to these, with values of 10 to 760 mg/L TSS in harvested rainwater and 10 to 150 mg/L TSS in ambient rainwater.

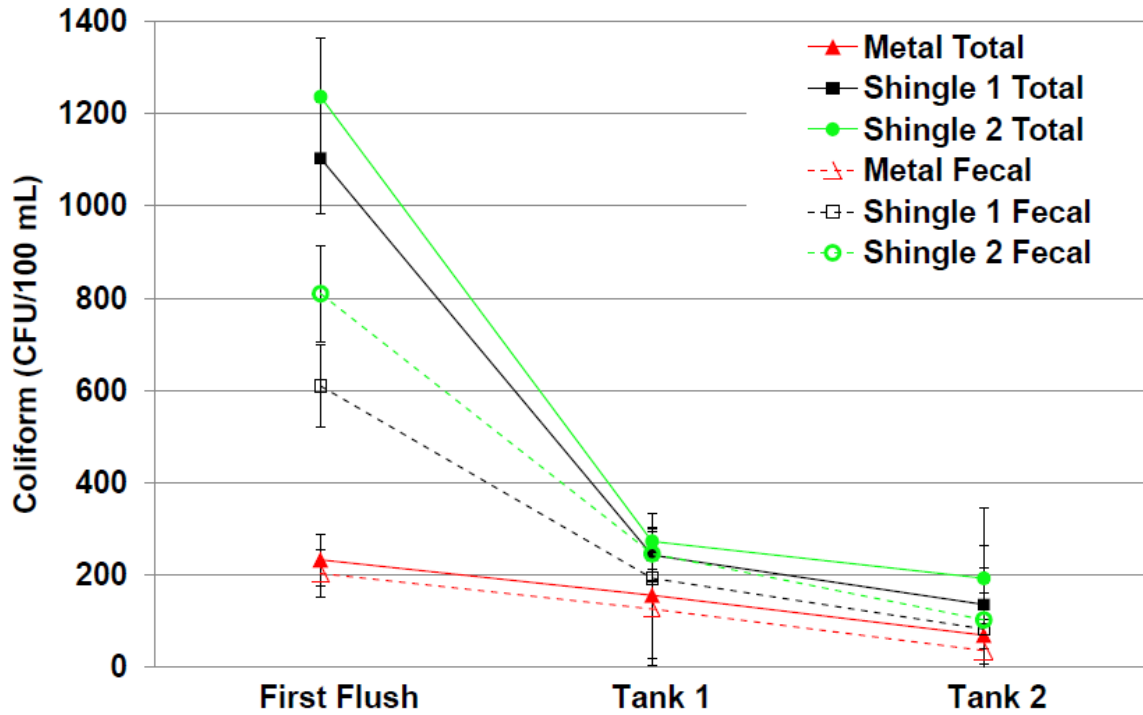
Figure 5-5. TC and FC in harvested rainwater from full-scale roofs for February 9, 2009 event. Ambient rainwater had TC=640 to 907 CFU/100mL and FC=350 to 473 CFU/100mL (a range is reported since different ambient samples were analyzed for each of the three locations) . Error bars represent 95% confidence intervals from triplicate analyses.

the ambient rainwater samples in the pilot-scale roofs (TC concentrations of 547 to 648 CFU/100mL and FC concentrations of 3 to 33 CFU/100mL). A possible explanation for the elevated TC and FC concentrations in the ambient samples at the full-scale sites is that these samplers were left open several hours longer than were the ambient samplers at the pilot-scale roof site because of the time it took to travel to the full-scale sites (all 20 miles apart). This might have led to additional deposition of TC and FC.

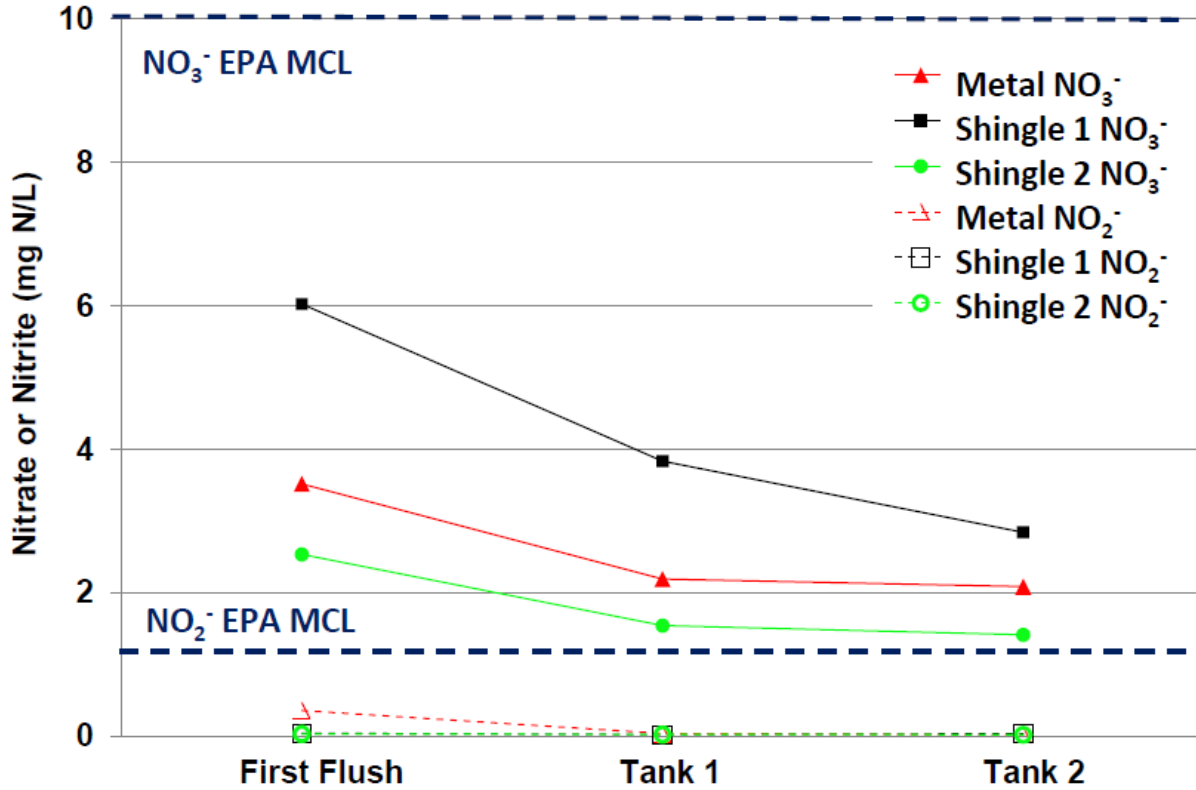
Figure 5-6. Nitrate and nitrite in harvested rainwater from full-scale roofs for February 9, 2009 event. Ambient rainwater had nitrate=1.52 to 3.17 mg/L NO₃⁻-N and nitrite=0.001 to 0.087 mg/L NO₂⁻-N (a range is reported since different ambient samples were analyzed for each of the three locations).

Figure 5-6 shows the nitrate and nitrite concentrations in the harvested rainwater from the February 9, 2009 event, and Tables 5-7 and 5-8 summarize the median, minimum, and maximum nitrate and nitrite concentrations for the 3 rain events. Nitrate concentrations decreased from the first flush to the first and second tanks. Nitrate concentrations in rainwater harvested after the first flush are below the USEPA drinking water MCL of 10 mg/L NO₃⁻-N. Other studies reported higher nitrate concentrations in harvested rainwater, including 420 mg/L NO₃⁻-N in anthropogenically influenced areas of Florida (Deng, 1998). Similar to nitrate, the nitrite concentrations also showed a decreasing trend from the first flush through the second tank, with nitrite concentrations in the first and second tanks ranging from 0.01 to 0.06 mg/L NO₂⁻-N.

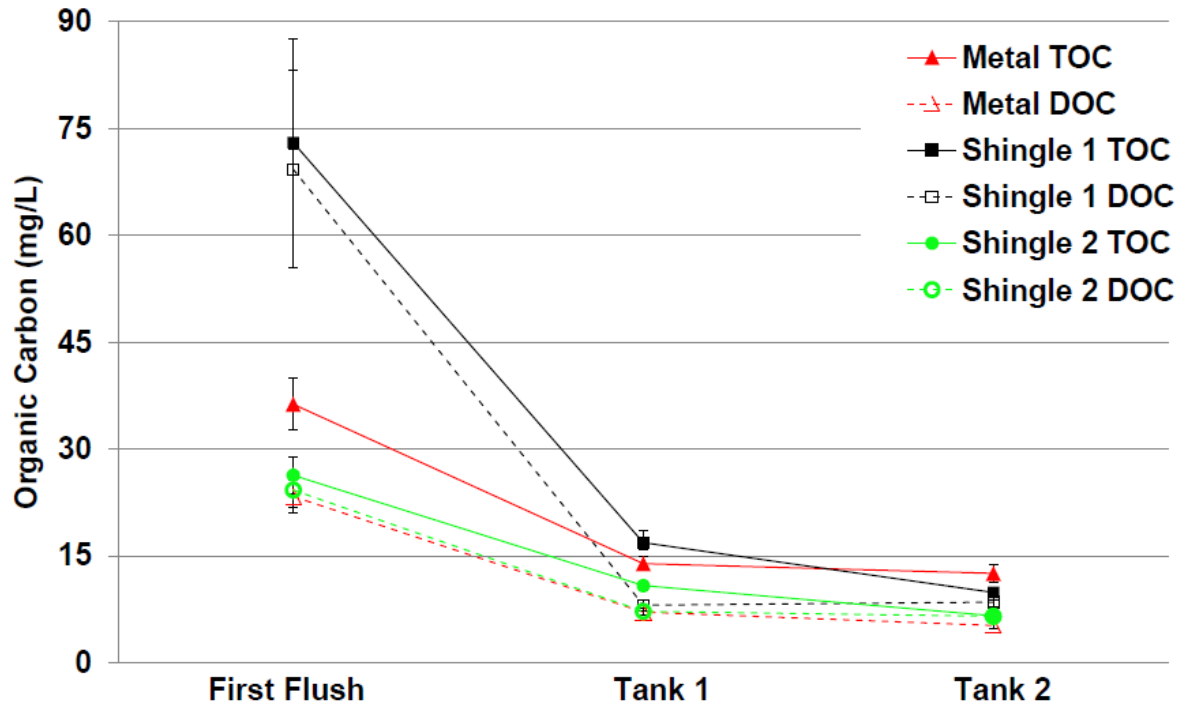
Figure 5-7. TOC and DOC in harvested rainwater from full-scale roofs for February 9, 2009 event. Ambient rainwater had TOC=8.6 to 25.6 mg/L and DOC=2.3 to 11.9 mg/L (a range is reported since different ambient samples were analyzed for each of the three locations). Error bars represent standard deviations from triplicate analyses.

Figure 5-7 shows the TOC and DOC concentrations of the harvested rainwater from the February 9, 2009 event, and Tables 5-9 and 5-10 summarize the median, minimum, and maximum TOC and DOC concentrations for the 3 rain events. TOC and DOC decreased dramatically from the first flush through the first and second tanks. TOC concentrations in the first and second tanks ranged from 6.6 to 33.8 and DOC concentrations ranged from 0.4 to 31.1 mg/L for all rain events. The rainwater harvested after the first flush for the metal and shingle full-scale roofs had DOC concentrations similar to those observed for the metal and shingle pilot-scale roofs.

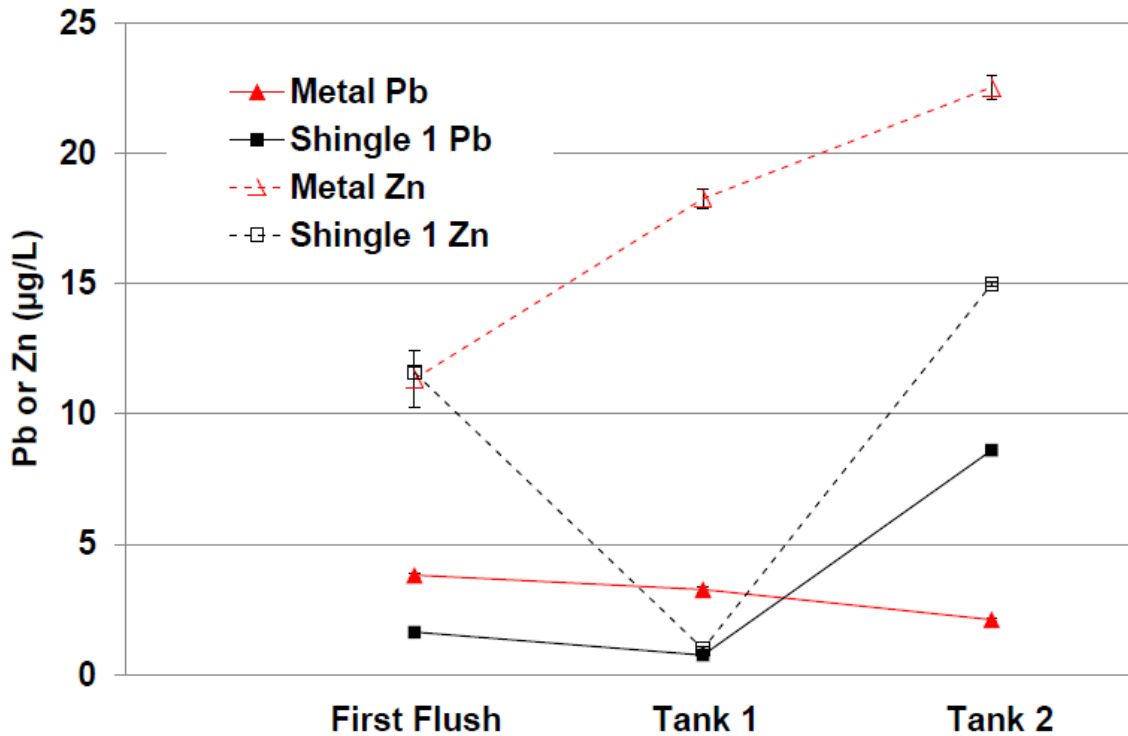
Figure 5-8. Pb and Zn in harvested rainwater from full-scale roofs for February 9, 2009 event. Ambient rainwater had Pb=3.92 $\mu\text{g/L}$ and Zn=20.52 $\mu\text{g/L}$. Error bars represent standard deviations from triplicate analyses.

to 2.27 $\mu\text{g/L}$ Pb found in the harvested rainwater after the first flush from the pilot-scale metal roof. The harvested rainwater after the first flush from the full-scale shingle roof had 1.0 to 15.0 $\mu\text{g/L}$ Zn, concentrations that were lower than those found in the harvested rainwater after the first flush from the pilot-scale shingle roof with values of 8.3 to 84.8 $\mu\text{g/L}$ Zn. The harvested rainwater after the first flush from the full-scale shingle roof had 0.7 to 8.6 $\mu\text{g/L}$ Pb, which was comparable to the <0.4 to 1.19 $\mu\text{g/L}$ Pb found in the harvested rainwater after the first flush for the pilot-scale shingle roof. Similar to the pilot-scale roofs, the harvested rainwater from the full-scale roofs had Pb concentrations below the USEPA action level of 15 $\mu\text{g/L}$ and Zn concentrations below the secondary USEPA MCL of 5000 $\mu\text{g/L}$.
