**Agricultural Water Conservation
Demonstration Initiative
2009**

Harlingen Irrigation District

Submitted by
Tom McLemore
Harlingen Irrigation District
301 E Pierce
Harlingen, TX 78550

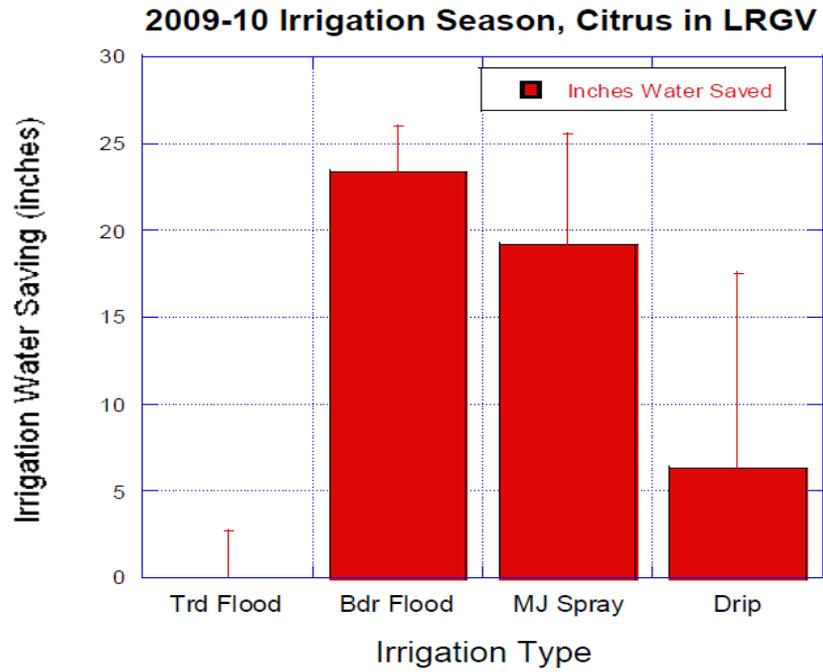
Figure 1 Water Savings Comparison

The demonstration sites continue to exhibit a savings in irrigation water compared to the Valley's traditional methods of irrigation. Below is an illustration of water savings on the Citrus sites. Notice the variability in the water saving (inches) for amount irrigated in the 2009-10 growing season for our Citrus growers. The Drip has the highest variability due to 1-line and 2-line drip systems coupled together to get the average inches irrigated. One cooperater tends to irrigate his trees a lot in both Microjet Spray and Drip Systems. Interestingly enough, the lowest variability is in the Border Flood Irrigation Systems and the highest water saving system this past year. This is more incentive to promote the Border Flood method in regards for growers in the Valley. All the original data and a graphical comparison are shown on the next page.

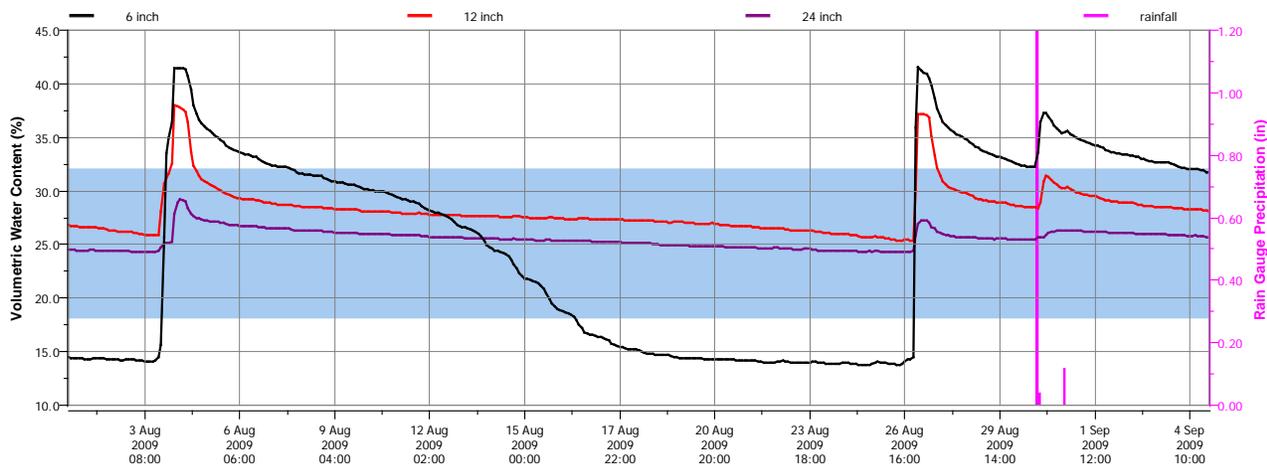
Figure 2 Decagon Soil Moisture Chart

Rain gauge equipment used in combination with soil moisture sensing equipment provides a good means of determining when rain events sufficiently impact soil water content vs. irrigation events. The most reliable rain gauge was a single tipping bucket setup in connection to a WatchDog datalogger, without soil moisture sensing equipment. The dates for precipitation and total amount of rainfall corresponded very well to rainfall data at various weather stations located in the region. Whereas rain gauges equipped to Decagon equipment provide inaccurate rainfall data, most possibly due to the tipping bucket rain gauge locate high in the air above the tree canopy affixed to 1” diameter pipe. This setup is too susceptible to erroneous reading by wind shear tipping the rain gauge.

In the chart above, where a rise in soil volumetric water content without a pink line (rainfall) suggests an irrigation event. In this way the number of precipitation and irrigation events can be determined. This procedure was used to best estimate total 2009-10 harvest year precipitation and irrigation amounts when compared to grower supplied information.

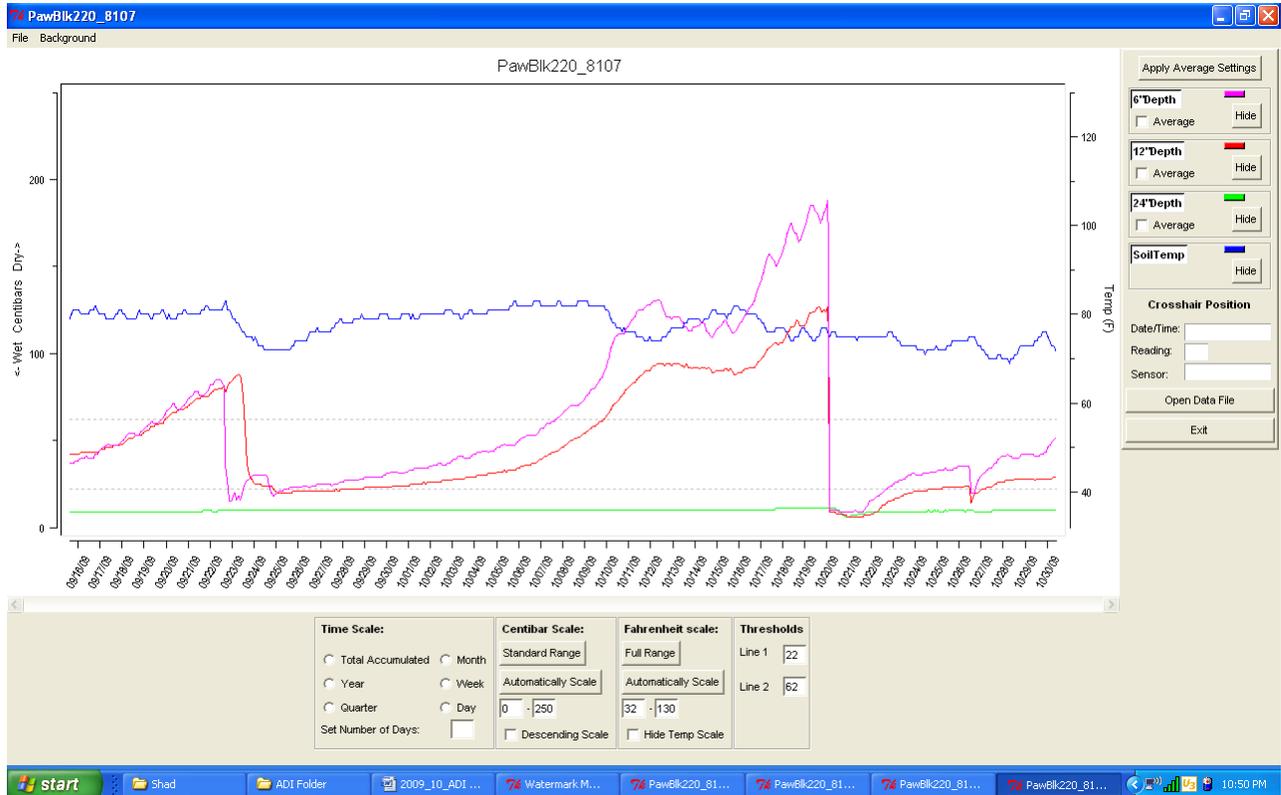
Figure 3 Water Mark Soil Moisture Chart

In the chart above, a sharp decrease in all soil moisture sensor as observed on Oct 20, 2009 indicates a flood irrigation event, whereas rainfall events generally lead to a slower, and separated decrease in soil moisture readings and not to as low a centibar reading.

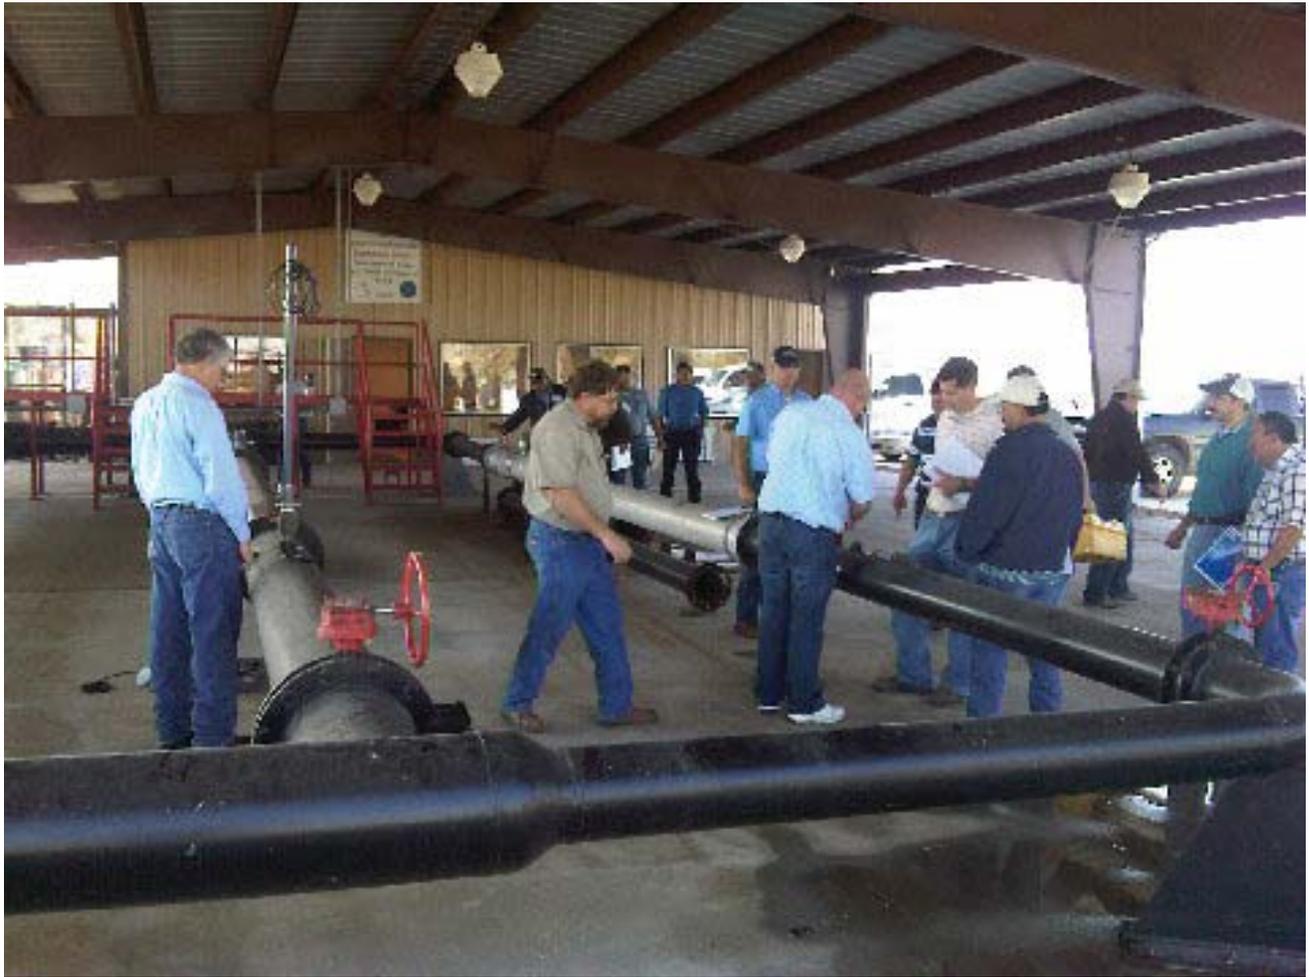
Figure 4 Closed pipe measurement at the FMC

The District conducted a three day short course on water measurement in January 2010. The course focused on flow measurement in open channel canals and closed pipe systems. The training took place at the Flow Meter Calibration Facility and was taught by Dr. Al Blair and Dr. Ian McCann. There were eighteen students from across the state in attendance. Each attendee took part in classroom lectures as well as on-hands flow measurement in open canals and closed pipe systems. Attendees also participated in real time flow measurement in the District's main

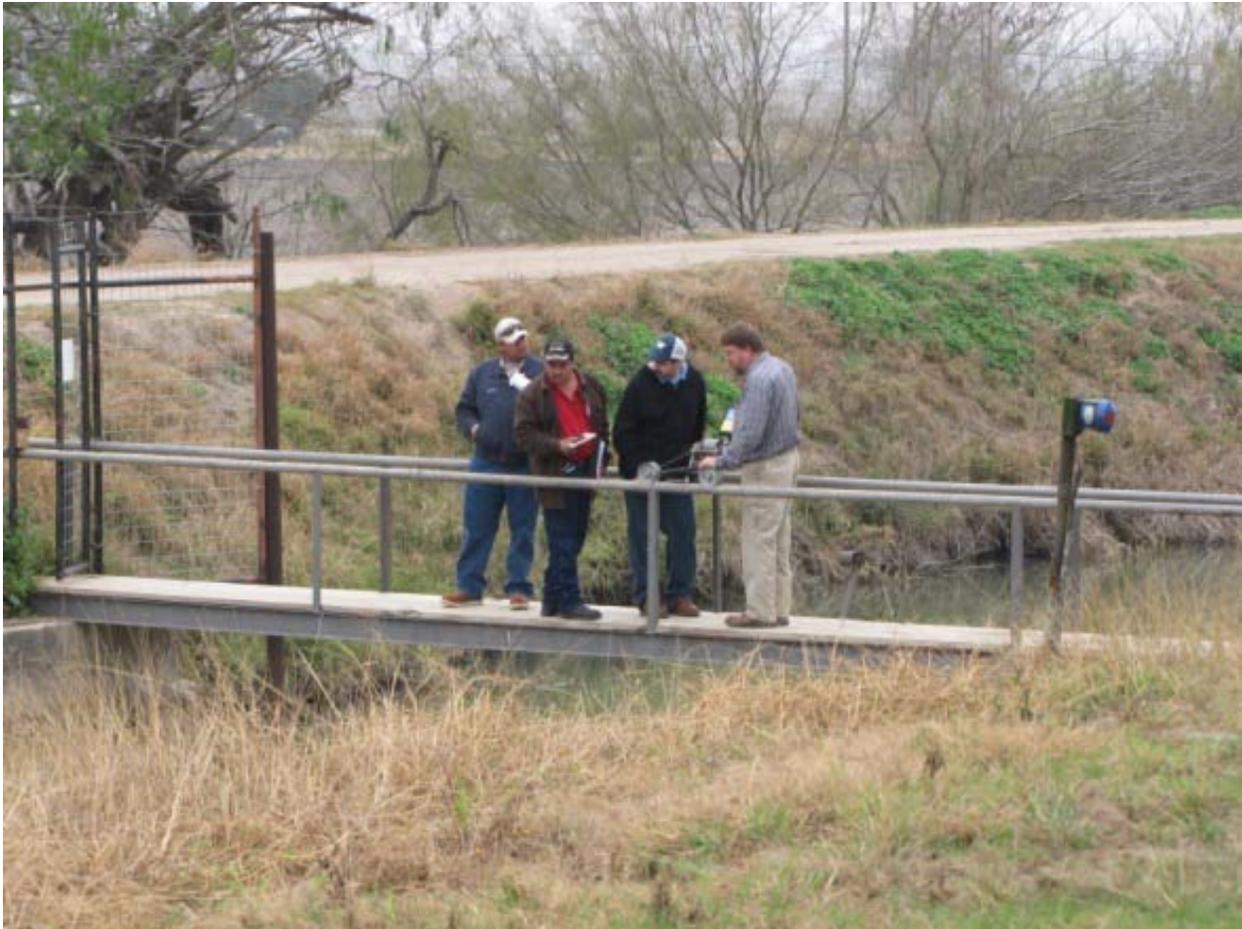
Figure 5 Flow measurement with Price AA meter

canal. District personnel along with a representative from CC Lynch inc. instructed students in the use of a Price meter and a Stream Pro acoustic-doppler open channel flow device, each one of these devices are used by the United States Geological Survey as primary flow measurement devices.

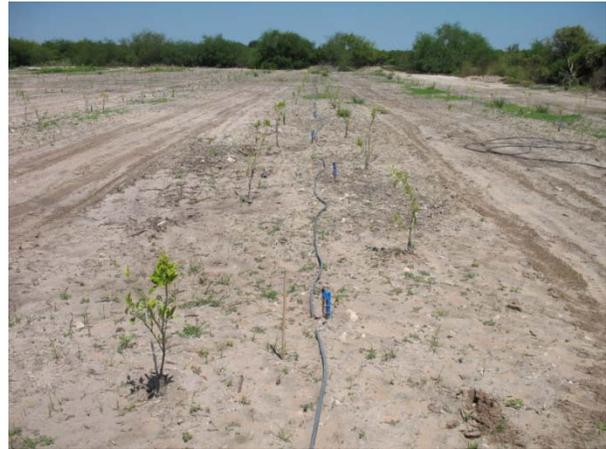
The trees at this drip site location were removed in early 2009 after the majority of trees were extremely stressed and had severe decline due to excessive water in the rooting zone following Hurricane Dolly in 2008. The site was replanted with various citrus varieties under newly established microjet irrigation. This has not been established as a new ADI site for 2009.

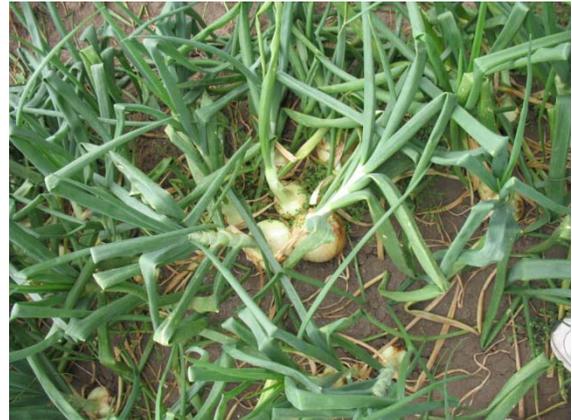
Acres: 22.0
Soil characteristics: Clay
Crop variety: White Onion
Irrigation district: Delta Lake
Irrigation system: Sub-surface drip
Field characteristics: Onions planted early Oct '09, and harvested mid Mar '08; 60 inch beds, 18" emitter spacing with 6 onion lines per bed, rows spaced 7 inches apart.

Drip tape buried center of bed, 4 to 6 inches deep, 7/8 inch tape at low flow rate of 0.24 gph. Irrigation scheduling was not based on soil moisture monitoring but by grower experience. Irrigated using a portable sand filter/ pump combination and metered each time.

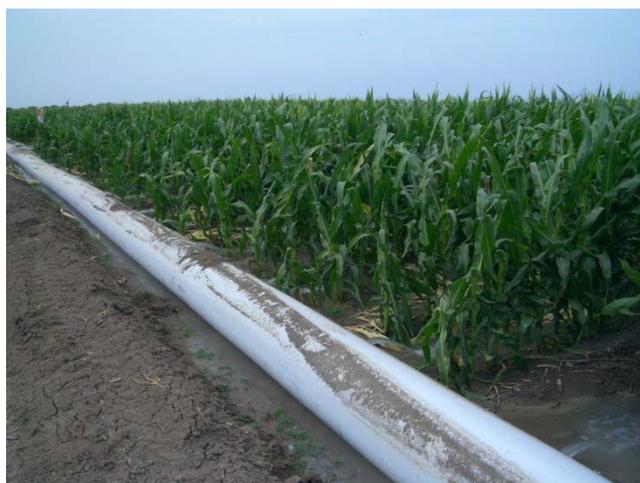
The 39 acre field was planted in seed corn and divided into three equal sections, utilizing surge irrigation in the center section of the field. The soil type is Harlingen Clay (HA). The field has a slope of .0005' to the West and the same slope to the North. The row length is 1280'.

One row located 50 rows from the North side was selected for installing a Watermark 900M monitor to record data for the furrow irrigation section. One other site 75' north of the field turnout (center) was used to collect data for the surge irrigation section. The sensor sites were located 150' inside of the east turnout. Each sensor site consisted of a soil temperature probe set at a 9" depth, and soil moisture sensors buried at 6", 12", and 24". Portable McCrometer flowmeters were used to measure the amount of water applied at the north turnout and at the center turnout.

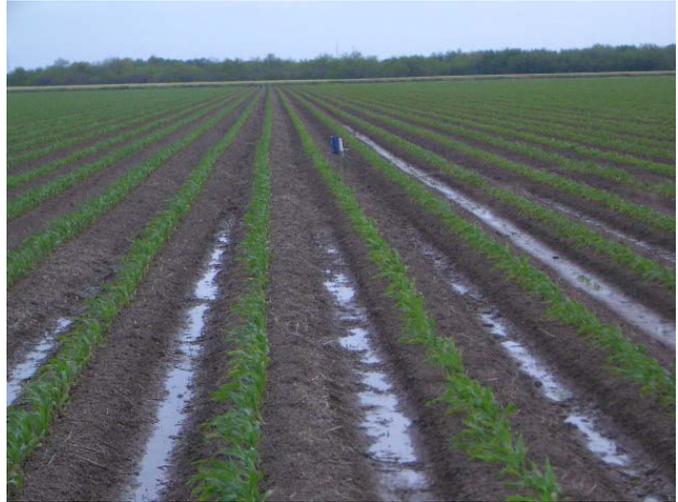
The site is a 38 acre field which was planted in grain sorghum. The irrigation method is furrow irrigation with surge valve technology and the soil type is mainly Harlingen Clay. Field slope is approximately .0005' from the North and .00025' to the East.

One furrow was selected with sensor sites 100' in from the upper end and 100' in from the lower end. Each site included a soil temperature probe and Watermark soil moisture sensors placed at depths of 6", 12", and 24". The soil moisture readings were recorded on a Watermark 900 series datalogger and radioed to a central datalogger.
