Volumetric and Sedimentation Survey of GRANGER LAKE

August 2008 Survey

The Texas Water Development Board

Brazos River Authority

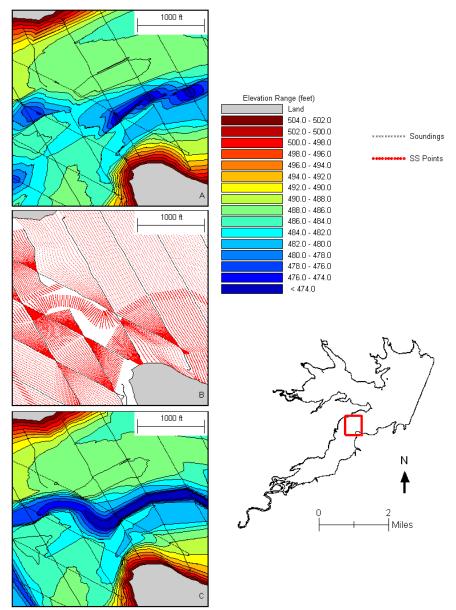
Figure 6 - Application of the Self-Similar Interpolation technique to Granger Lake sounding data -A) bathymetric contours without interpolated points, B) Sounding points (black) and interpolated points (red) with reservoir boundary shown at elevation 504.0 (black), C) bathymetric contours with the interpolated points. Note: In 6A the submerged river channel indicated by the surveyed cross sections is not represented for the areas inbetween the cross sections. This is an artifact of the TIN generation routine. Inclusion of the interpolated points (6C) corrects this and smoothes the bathymetric contours.

To ameliorate these problems, a Self-Similar Interpolation routine (developed by the TWDB) was used to interpolate the bathymetry in between many survey lines. The Self-Similar Interpolation technique effectively increases the density of points input into the TIN model, and directs the TIN interpolation to better represent the reservoir topography.¹² In the case of Granger Lake, the application of Self-Similar Interpolation helped represent the lake morphology near the banks and improved the representation of the submerged river channel (Figure 6). In areas where obvious geomorphic features indicate a high-probability of cross-section shape changes (e.g. incoming tributaries, significant widening/narrowing of channel, etc.), the assumptions used in applying the

Self-Similar Interpolation technique are not likely to be valid. Self-Similar Interpolation was not used in areas of Granger Lake where a high probability of change between cross-sections exists.¹² Figure 6 illustrates typical results of the application of the Self-Similar Interpolation routine in Granger Lake, and the bathymetry shown in Figure 6C was used in computing reservoir capacity and area tables (Appendix A, B).

As presented in Table 2, revision of the 1995 and 2002 survey data using current TWDB data processing methods resulted in an increase in reservoir capacity of approximately 1.1% and 0.7%, respectively. Such increases are typical for lakes of similar size and shape as Granger Lake, and are due to the improved representation of the lake bathymetry between adjacent cross sections that is obtained when interpolation is used (see Figure 6 and the section entitled "Self-Similar Interpolation").

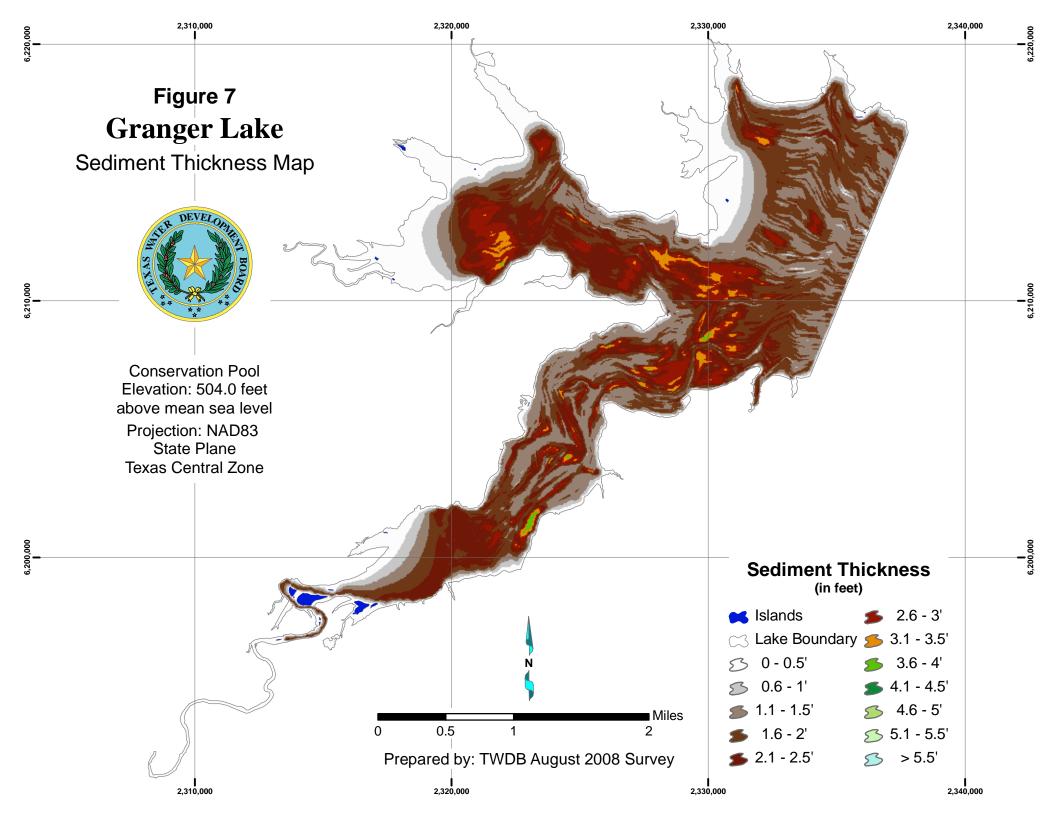
The 200 kHz, 50 kHz, and 24 kHz frequency data were used to interpret sediment distribution and accumulation throughout Granger Lake. Figure 7 shows the thickness of sediment throughout the reservoir. To assist in the interpretation of post-impoundment sediment accumulation, ancillary data was collected in the form of three core samples. All three cores were collected on January 6, 2009 with a custom-coring boat and SDI VibraCore system.

The results of the TWDB 2008 Sedimentation Survey indicate Granger Lake has accumulated 6,182 acre-feet of sediment since impoundment in 1980. The thickest sediment deposits are located within the main body of the lake near the submerged confluence of the San Gabriel River with Willis Creek. The maximum sediment thickness observed in Granger Lake was 5.7 feet. A complete description of the sediment measurement methodology and sample results is presented in Appendix D.

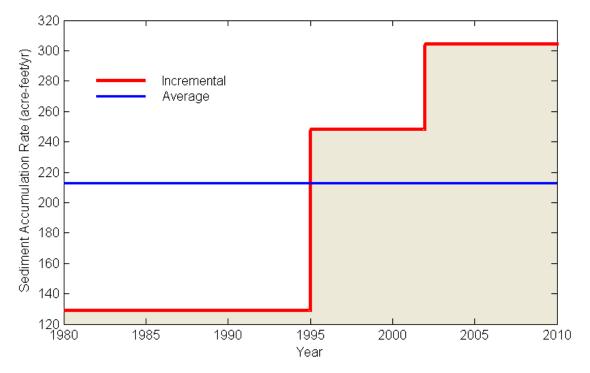
Figure 8 – *Trends in Sediment Accumulation Rates for Granger Lake. Trends are based on volumetric calculations from surveys performed in 1995, 2002, and 2008.*

Comparisons of the capacities (at conservation pool elevation) from pre-1980, 1995, 2002, and 2008 (Table 3) suggest Granger Lake looses between 129 acre-feet per year and 304 acre-feet per year, with an average loss rate of 213 acre-feet per year. Analysis of the repeated volumetric surveys suggest that the capacity loss rate for Granger Lake is increasing with time (Figure 8), which may be the result of increased development within the Granger Lake watershed.¹⁷ Verification of this assertion was not performed for this report. The TWDB notes that the lake areas at conservation pool elevation are different for each of the compared surveys (Table 2), and that some of the reported volume differences are directly attributable to the area differences. The capacity loss rates presented in Table 3 should be considered "best possible estimates."

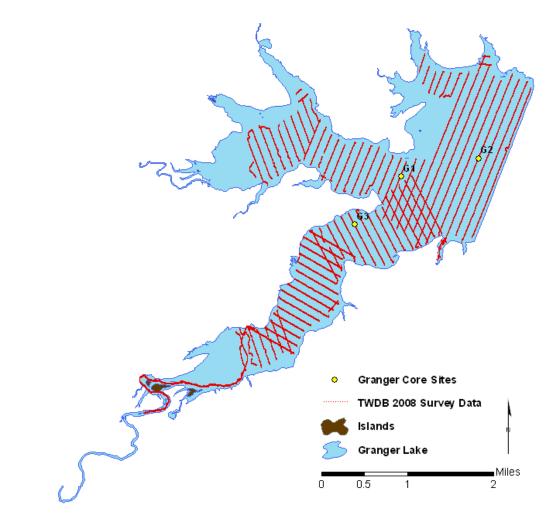
Figure D1 – TWDB 2008 survey data points for Granger Lake

Core samples collected by TWDB were collected at locations near where sounding data had been previously collected (Figure D1). The coordinates and a description of each core sample are provided in Table D1. All cores were collected with a custom-coring boat and SDI VibraCore system. Cores were analyzed by TWDB, and both the sediment thickness and the distance the core penetrated the pre-impoundment boundary were recorded.

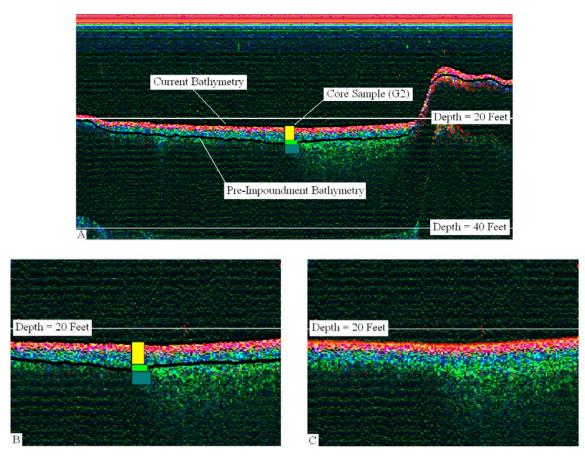
Figure D2 – DepthPic and core sample use in identifying the pre-impoundment bathymetry.

All sounding data is processed using the DepthPic software, within which both the pre-impoundment and current bathymetric surfaces are identified and manually digitized. These surfaces are first identified along cross-sections for which core samples have been collected, thereby allowing the user to identify color bands in the DepthPic display that correspond to the sediment layer(s) observed in the core samples. This process is illustrated in Figure D2 where core sample G2 is shown with its corresponding sounding data. Core sample G2 contained 42 inches of sediment above the preimpoundment bathymetry, as indicated by the yellow and green boxes. The different box colors indicate changes in soil characteristics and the blue box depicts the preimpoundment soil identified within the core sample. The pre-impoundment surface is usually identified within the core sample by one of the following methods: (1) a visual examination of the core for in-place terrestrial materials, such as leaf litter, tree bark, twigs, intact roots, etc., concentrations of which tend to occur on or just below the preimpoundment surface, (2) changes in texture from well sorted, relatively fine-grained sediment to poorly sorted mixtures of coarse and fine-grained materials, and (3) variations in the physical properties of the sediment, particularly sediment water content and penetration resistance with depth.

Within DepthPic, the current surface is automatically determined based on the signal returns from the 200 kHz transducer. The pre-impoundment surface must be determined visually based on the pixel color display and any available core sample data. Based on core sample G2, it is clear that the pre-impoundment bathymetric surface for this cross-section may be identified as the base of the blue and teal pixels in the DepthPic display. The pre-impoundment sediment layer is also clearly identifiable as the green pixels (Figure D2).

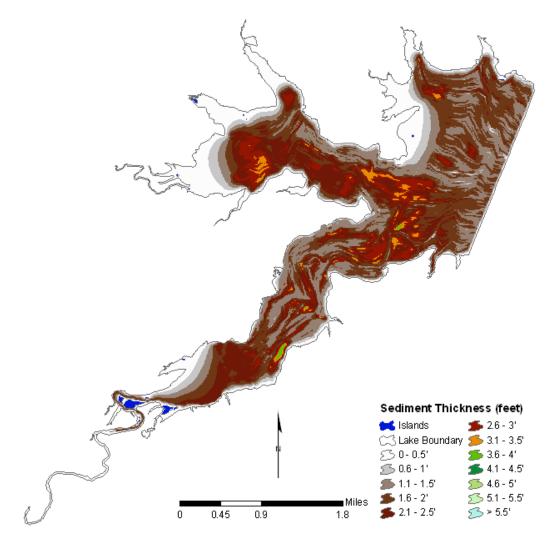
Figure D3 - Sediment thicknesses in Granger Lake derived from multi-frequency sounding data.

The accumulated sediment volume for Granger Lake was calculated from a sediment thickness TIN model created in ArcGIS. Sediment thicknesses were computed as the difference in elevations between the current and pre-impoundment bathymetric surfaces as determined with the DepthPic software. Sediment thicknesses were interpolated for locations between surveyed cross-sections using the TWDB Self-Similar interpolation technique². For the purposes of the TIN model creation, TWDB assumed 0-foot sediment thicknesses at the model boundaries (defined as the 504.00 foot NGVD29 elevation contour). Figure D3 depicts the sediment thickness in Granger Lake.

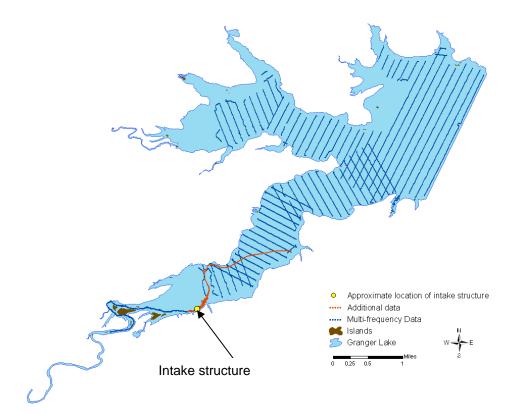
Figure F1 – Data points collected on Granger Lake during TWDB 2008 Survey.

Engineering Ltd. dual-frequency (200 kHz and 50 kHz) depth sounder integrated with Differential Global Positioning System (DGPS) equipment. Figure 1 shows the data points collected on Granger Lake.

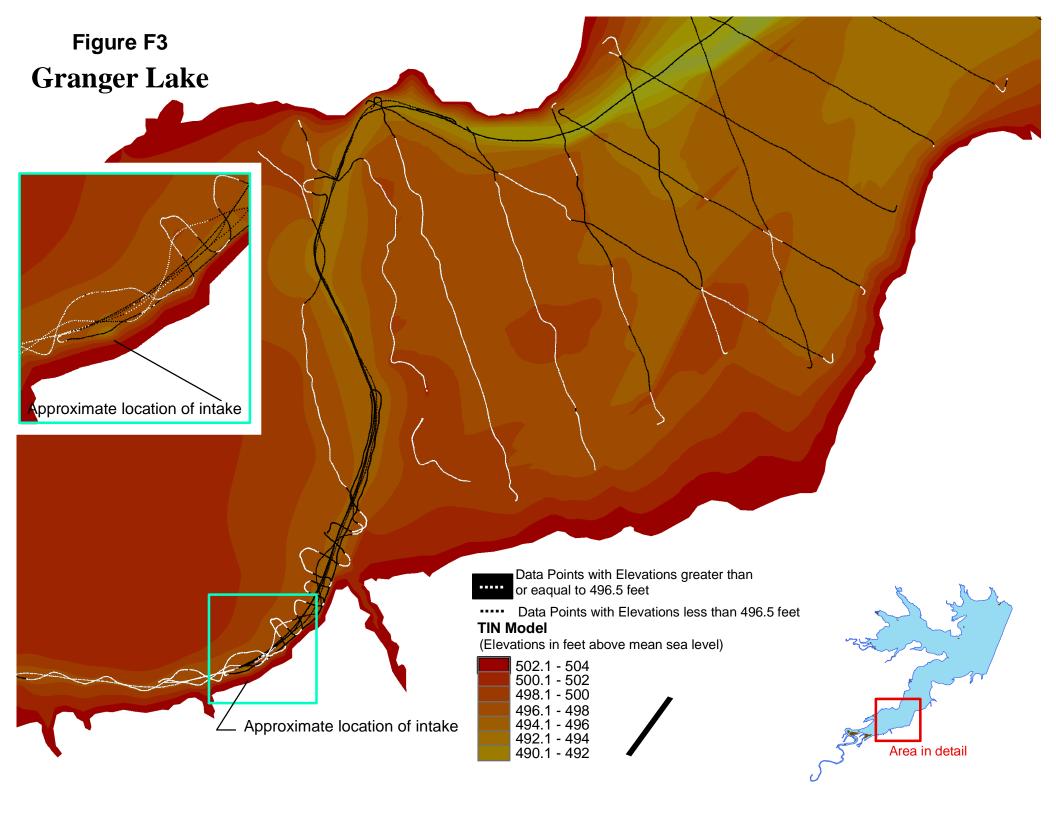
Figure F2 Granger Lake

Data Points with Elevations greater than or eaqual to 497.0 feet

502.1 - 504 500.1 - 502 498.1 - 500 496.1 - 498 494.1 - 496 492.1 - 494 490.1 - 492 Area in detail

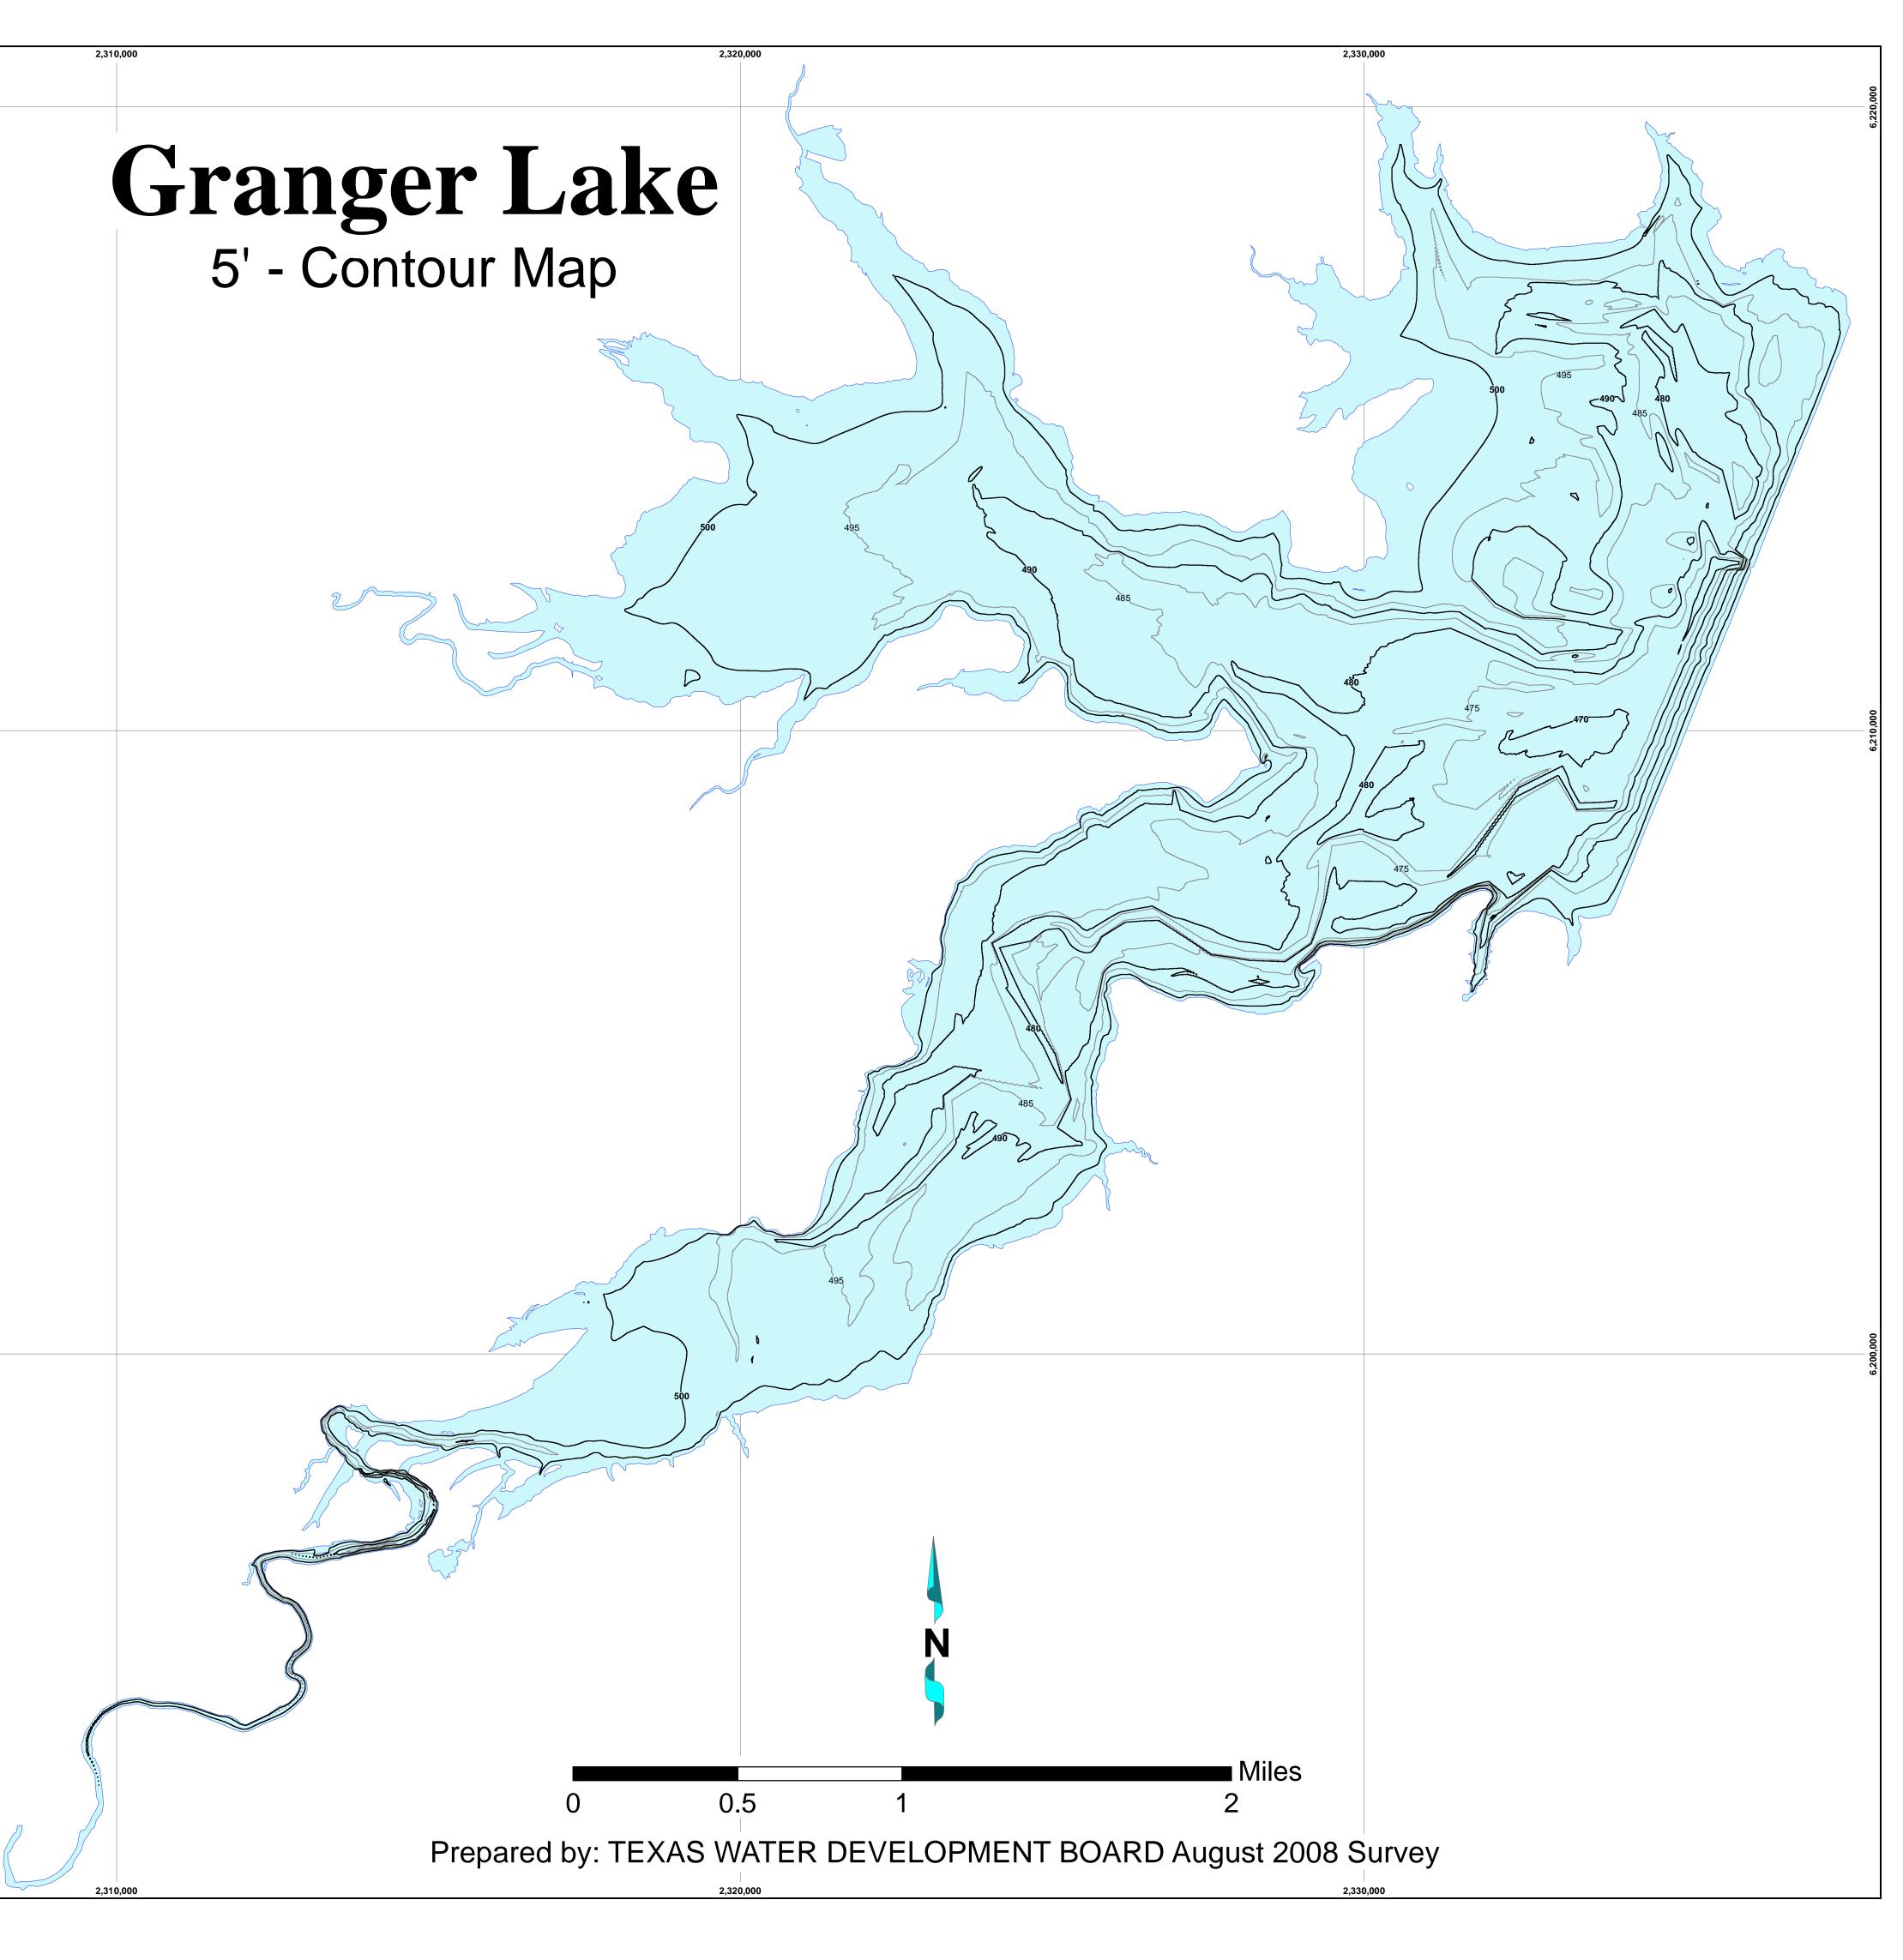
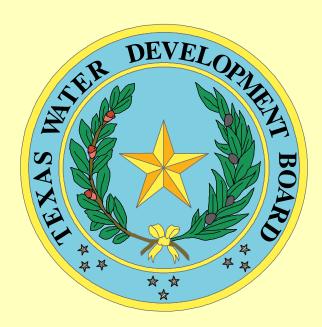
Figure 5

Contours

Conservation Pool Elevation 504.0 feet above mean sea level

The TIN model was interpolated and averaged using a cell size of 1 foot by 1 foot and converted to a raster. The raster was used to produce an Elevation Relief Map, representing the topography of the reservoir bottom (Figure 3), a map showing shaded depth ranges for Granger Lake (Figure 4), and a 5-foot contour map (Figure 5, attached).
