**Volumetric and
Sedimentation Survey
of
INKS LAKE**

August 2021

Texas Water Development Board

Prepared for:

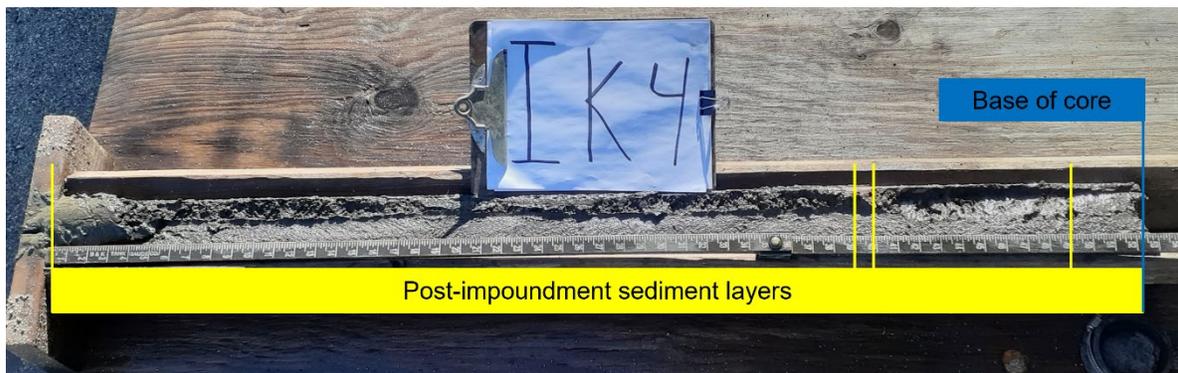
Figure 7. Sediment core IK-4 from Inks Lake. Post-impoundment sediment layers occur throughout the entire 53.0 inches of this sediment core (identified by the yellow box). The base of the core is denoted by the blue line.

A photograph of sediment core IK-4 (for location, refer to Figure 2) is shown in Figure 7. The base, or deepest part of the sample is denoted by the blue line. The pre-impoundment boundary was not identified in this core sample. The pre-impoundment surface is identified by a change in color, texture, moisture, porosity, and structure. Identification of the pre-impoundment surface for each sediment core followed a similar procedure.
