**Volumetric and
Sedimentation Survey
of
LAKE LIVINGSTON**

September 2018 – November 2019 Survey

September 2022

Texas Water Development Board

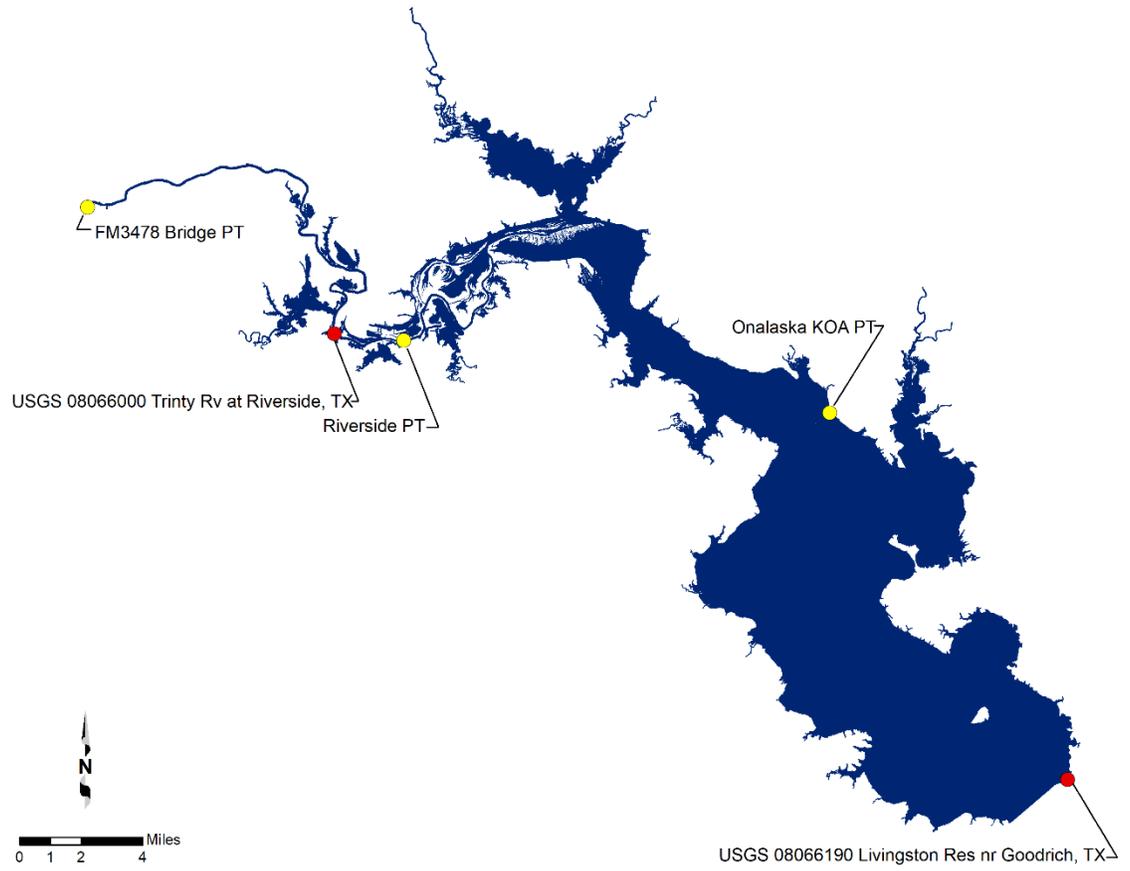
Figure 2. Locations of USGS gages and TWDB pressure transducers used to measure water surface elevations.

The vertical datum used during this survey is the National Geodetic Vertical Datum 1929 (NGVD29). This datum is utilized by the United States Geological Survey (USGS) for the reservoir elevation gage *USGS 08066190 Livingston Res nr Goodrich, TX* (U.S. Geological Survey, 2020a). The vertical datum of USGS gage *USGS 08066000 Trinity Rv at Riverside, TX* is North American Vertical Datum of 1988 (NAVD88). This datum is 0.43 feet below the NGVD29 datum (U.S. Geological Survey, 2020b). Therefore, 0.43 feet was added to the gage measurements to convert to NGVD29. Elevations herein are reported in feet relative to the NGVD29 datum. Volume and area calculations in this report are referenced to water levels developed by modeling the surface slope of the reservoir as measured by USGS gage *USGS 08066190 Livingston Res nr Goodrich, TX*, USGS gage *USGS 08066000 Trinity Rv at Riverside, TX*, and three pressure transducers deployed by the TWDB. Figure 2 shows the location of the two USGS gages and three TWDB pressure transducers. Two pressure transducers located at the FM3478 Bridge and Onalaska KOA Holiday Campground were deployed on January 29, 2019, while the Riverside location was deployed on April 2, 2019. A fourth pressure transducer was installed on land at the Riverside location on January 28, 2019, for the purpose of measuring atmospheric pressure, a dataset required for accurate calibration of the submerged pressure transducers.

During times of low inflow into the reservoir, water levels in the reservoir had little to no slope as evidenced by the correlation between the two USGS gage readings at the dam and upstream in the Trinity River. The TWDB pressure transducer data was calibrated by bringing measurements into agreement during times of low inflow. Figure 3 shows all water level measurements plotted together with shaded blocks indicating the days during which data collection occurred. Using the respective relationships between adjacent USGS gages and TWDB pressure transducers, water surface elevations were modeled prior to January 30, 2019.

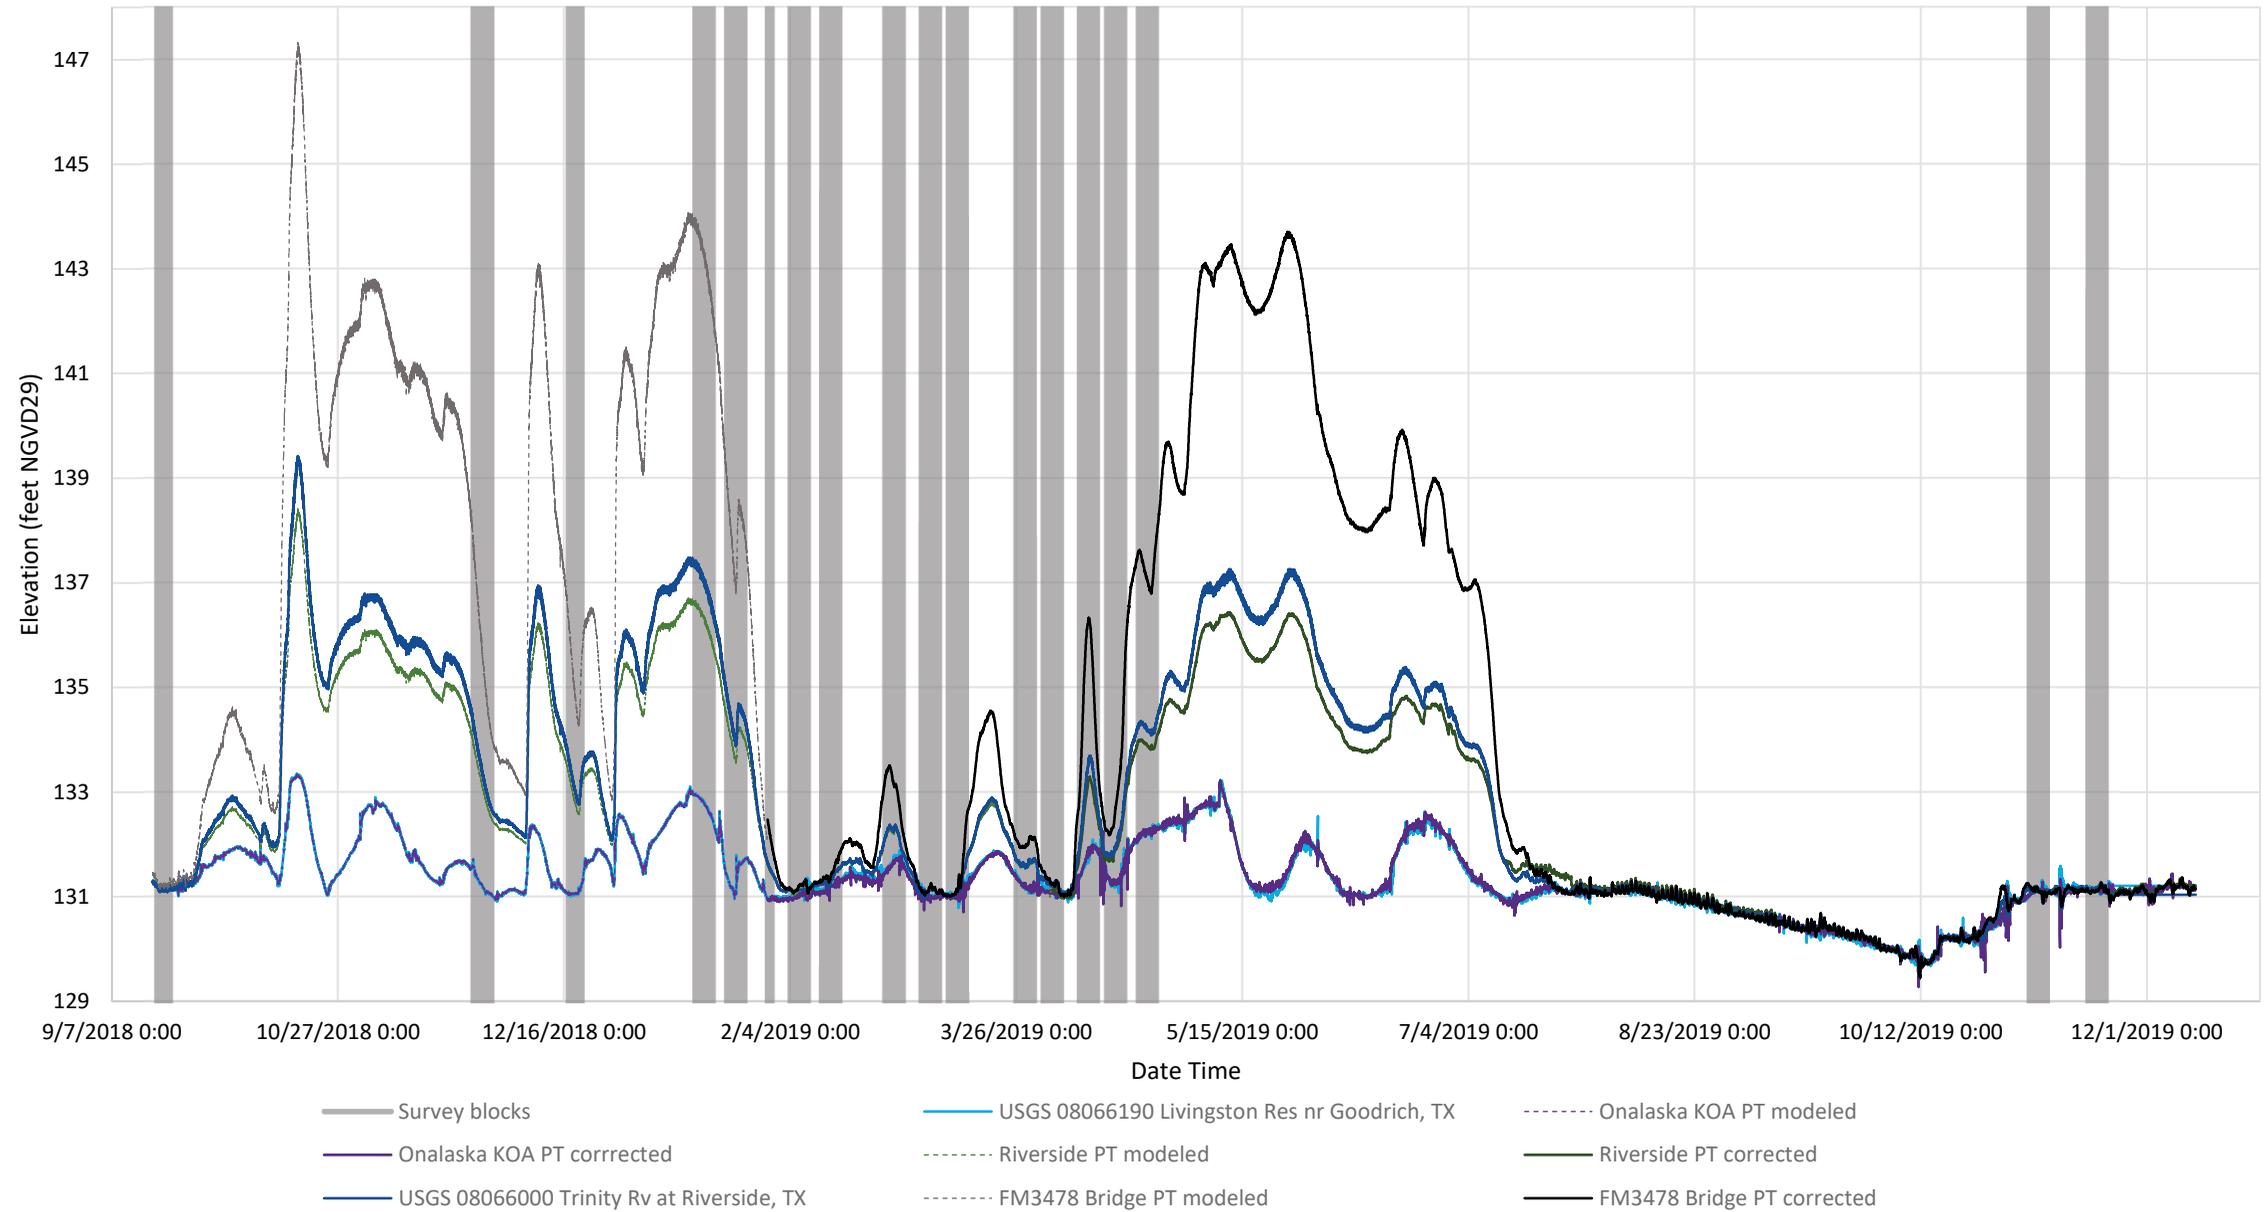
Figure 3. Plot of water level measurements for each USGS gage and TWDB pressure transducer with shaded blocks indicating the days during which data collection occurred

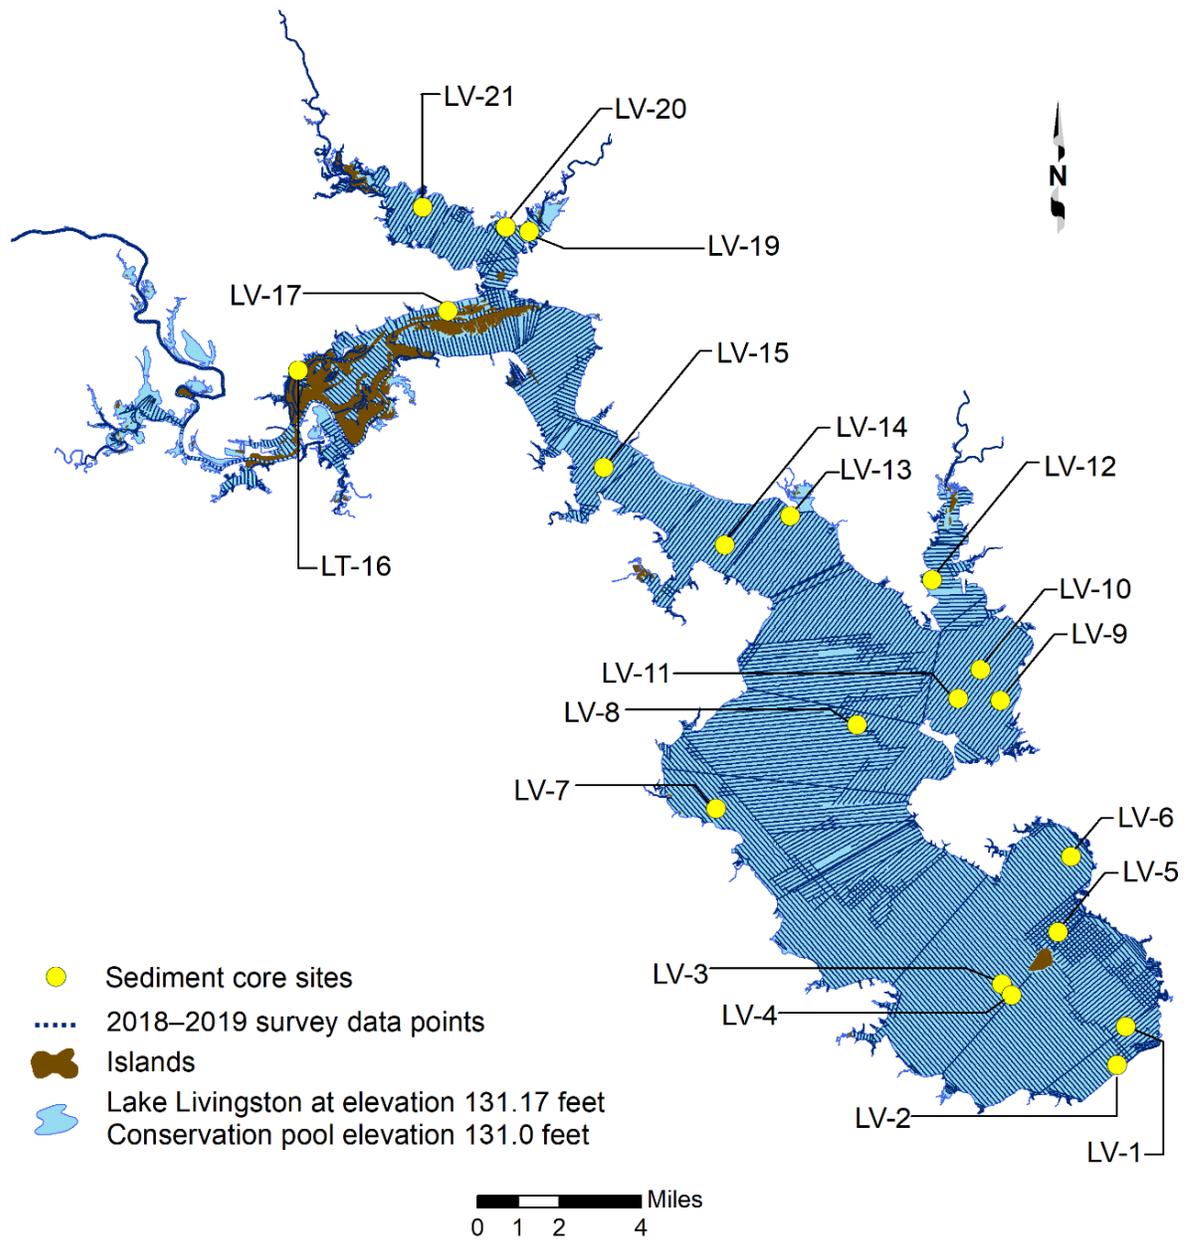
Figure 4. 2019 TWDB sounding data (blue dots), and sediment coring locations (yellow circles).

The TWDB collected bathymetric data for Lake Livingston between September 17, 2018, and November 21, 2019, while daily average water surface elevations measured between 130.97 and 132.93 feet above mean sea level (NGVD29). For data collection, the TWDB used a Specialty Devices, Inc. (SDI), single-beam, multi-frequency (208 kHz, 50 kHz, and 12 kHz) sub-bottom profiling depth sounder integrated with differential global positioning system (DGPS) equipment. Data was collected along pre-planned survey lines oriented perpendicular to the assumed location of the original river channels and spaced approximately 500 feet apart. The depth sounder was calibrated daily using a velocity profiler to measure the speed of sound in the water column and a weighted tape or stadia rod for depth reading verification. Each speed of sound profile, or velocity cast, is saved for further data processing. Figure 4 shows the data collection locations for the 2019 TWDB survey.

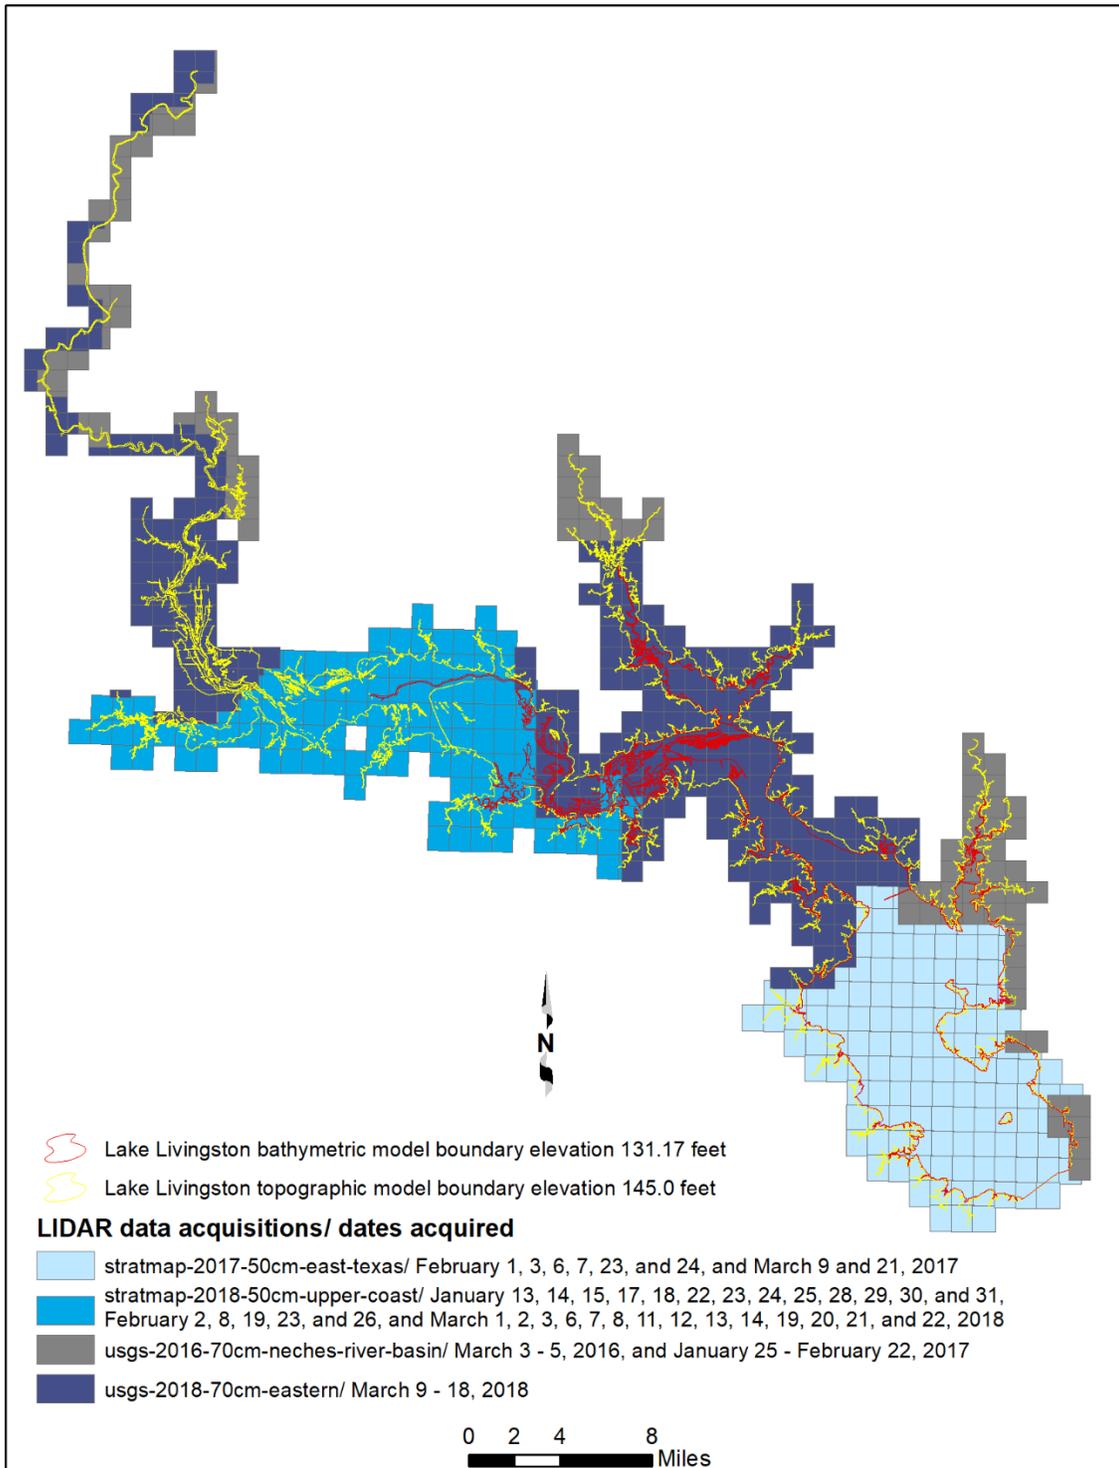
Figure 5. LIDAR data areas of acquisition for topographic model

The reservoir's topographic model boundary was generated with Light Detection and Ranging (LIDAR) Data available from the Texas Natural Resource Information System (TNRIS). Four different acquisitions of LIDAR data collected from 2016 to 2018 were referenced. The datasets were acquired between March 9-22, 2018, January 12 and March 22, 2018, February 1 and March 21, 2017, and March 3-5, 2016, and January 25 and February 22, 2017, while the daily average water surface elevation of the reservoir measured between 131.08 feet and 131.38 feet, 131.03 feet and 132.17 feet, 131.07 feet and 131.86 feet, and 131.07 feet and 131.89 feet, respectively (Figure 5). The LIDAR data .las files were imported into an LAS Dataset and the dataset was converted to a raster using a

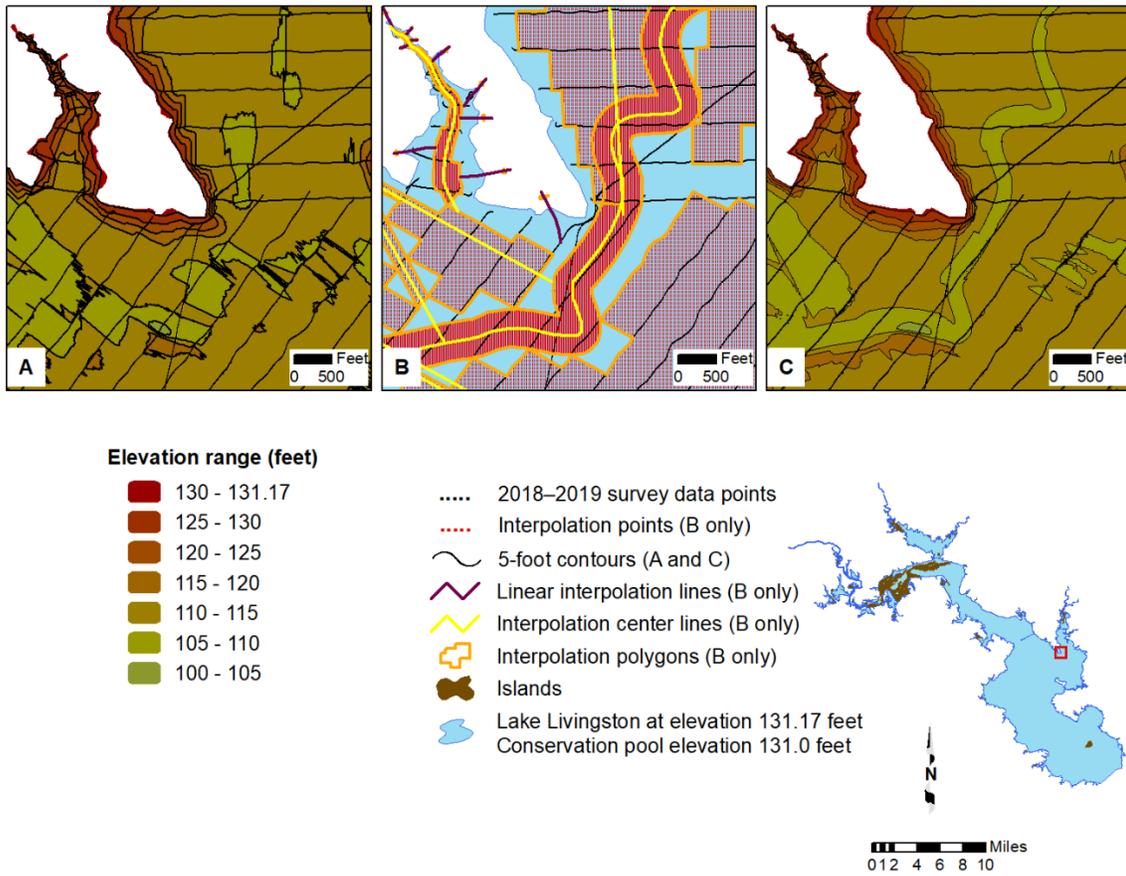
Figure 6. Anisotropic spatial interpolation and linear interpolation as applied to Lake Livingston sounding data; A) bathymetric contours without interpolated points, B) sounding points (*black*) and interpolated points (*red*), C) bathymetric contours with interpolated points.

Figure 6 illustrates typical results from application of the anisotropic interpolation and linear interpolation as applied to Lake Livingston. In Figure 6A, deeper channels and steep slopes indicated by surveyed cross-sections are not continuously represented in areas between survey cross-sections. This is an artifact of the TIN generation routine rather than an accurate representation of the physical bathymetric surface. Inclusion of interpolation points in creation of the volumetric TIN model, represented in Figure 6B, directs Delaunay triangulation to better represent the reservoir bathymetry between survey cross-sections.

The bathymetry shown in Figure 6C was used in computing reservoir elevation-capacity (Appendix A) and elevation-area (Appendix B) tables.

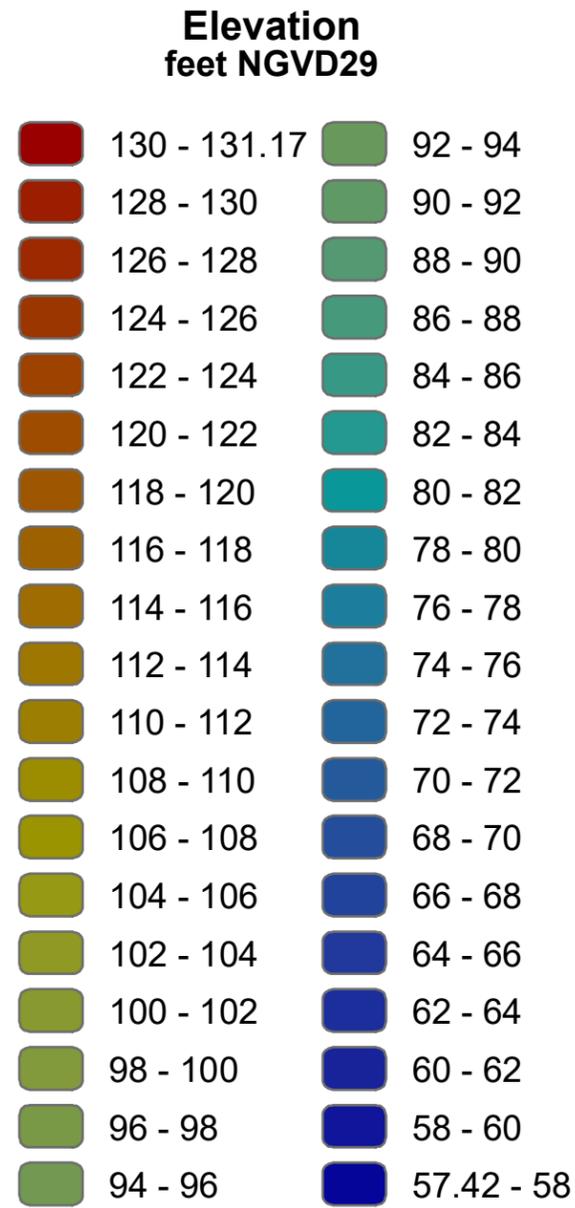
Figure 7
Lake Livingston
 Elevation relief map

~ 10-foot contours

The bathymetric volumetric TIN model was converted to a raster representation using a cell size of 2 feet by 2 feet. The resulting raster data was used to produce three figures: (1) an elevation relief map representing the topography of the reservoir bottom (Figure 7); (2) a depth range map showing depth ranges for Lake Livingston (Figure 8); and (3) a 5-foot contour map (Figure 9).

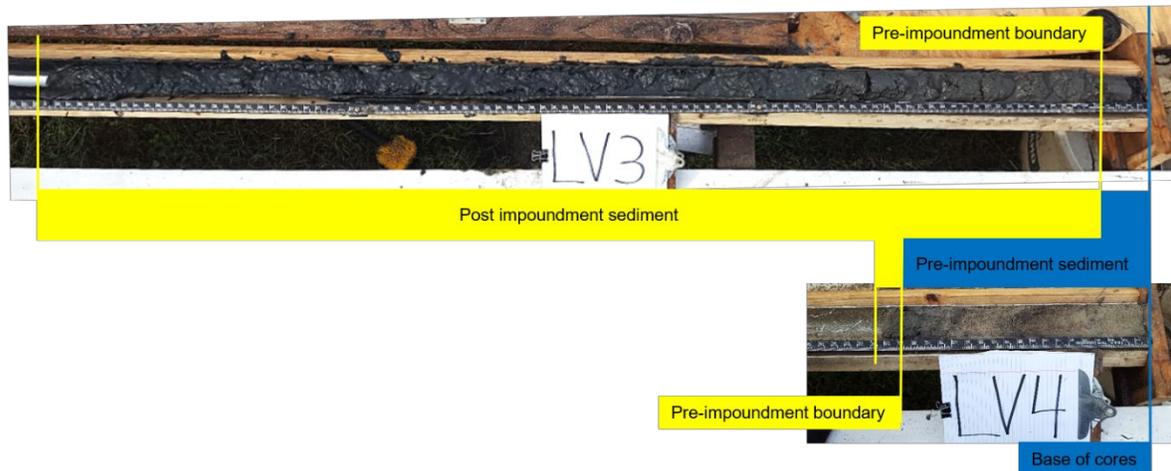
Figure 10. Sediment cores LV-3 and LV-4. Post-impoundment sediment layers are identified by yellow boxes. Pre-impoundment sediment layers are identified by blue boxes.

Photographs of sediment cores LV-3 and LV-4 (for location, refer to Figure 4) are shown in Figure 10 and are representative of sediment cores sampled from Lake Livingston. The base, or deepest part of the sample is denoted by the blue line. The pre-impoundment boundary (yellow line closest to the base) was evident within sediment core sample LV-3 at 84.0 inches and LV-4 at 2.0 inches. Pre-impoundment boundaries are identified by the change in color, texture, moisture, porosity, and structure. Identification of the pre-impoundment surface for each sediment core followed a similar procedure.

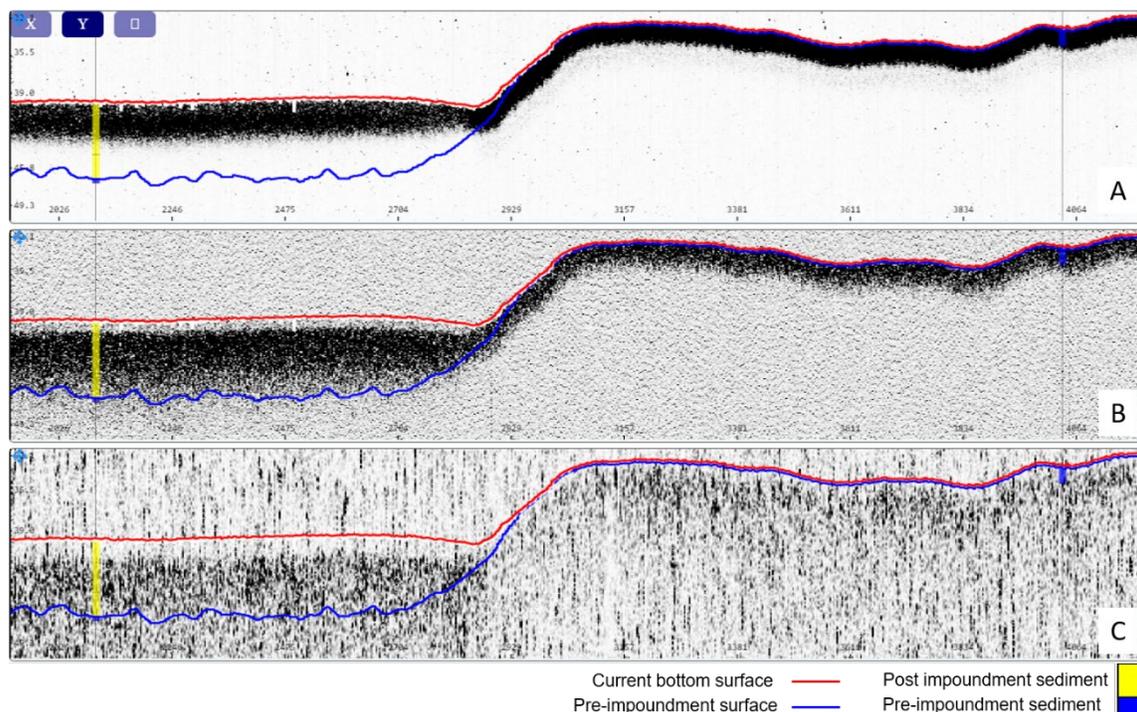
Figure 11. Sediment core samples LV-3 and LV-4 compared with acoustic signal returns. A) 208 kHz frequency, B) 50 kHz frequency, and C) 12 kHz frequency.

Figure 11 illustrates the relationships between acoustic signal returns and the layering seen in sediment cores. In this example, sediment cores LV-3 and LV-4 are shown correlated with each frequency: 208 kHz, 50 kHz, and 12 kHz. The current bathymetric surface is determined by signal returns from the 208 kHz transducer as represented by the top red line in Figure 11. The pre-impoundment surface is identified by comparing boundaries observed in the 208 kHz, 50 kHz, and 12 kHz signals to the location of the pre-impoundment surface of the sediment core sample. Many layers of sediment were identified during analysis based on changes in observed characteristics such as water content, organic matter content, and sediment particle size, and each layer is classified as either post-impoundment or pre-impoundment. Yellow boxes represent post-impoundment sediments identified in the sediment core. Blue boxes indicate pre-impoundment sediments.

The pre-impoundment boundary in sediment cores LV-3 and LV-4 most closely aligned with the different layers picked up by the 50 kHz; therefore, the 50 kHz signal was used to locate the pre-impoundment surface (Figure 11). The pre-impoundment surface is first identified along cross-sections where sediment core samples were collected. This information is used as a guide for identifying the pre-impoundment surface along cross-sections where sediment core samples were not collected.

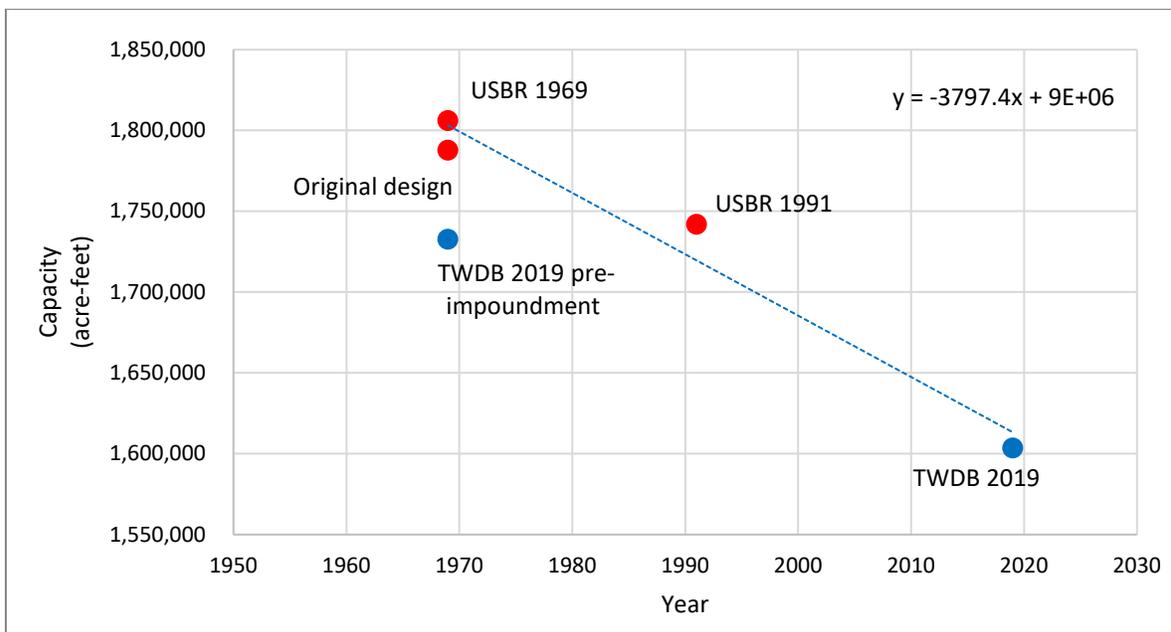
Figure 15. Plot of current and previous capacity estimates (acre-feet) at elevation 131.0 feet. Capacity estimates for each TWDB survey plotted as blue dots and other surveys as red dots. The blue trend line illustrates the total average loss of capacity through 2019.

methodologies are provided in Table 4 for sedimentation rate calculation. The 2019 TWDB sedimentation survey indicates Lake Livingston has lost capacity at an average of 2,583 acre-feet per year since impoundment due to sedimentation below conservation pool elevation (131.0 feet NGVD29). Previous capacity estimates and comparison with historical cross sections (see section below titled “Sediment range lines”) suggest the TWDB sedimentation survey results are an underestimate of the total sediment volume in Lake Livingston. For instance, island formation in the upper reaches is reflected in the loss of area and capacity but is not captured in sediment estimates. Comparison with historical area curves suggest significant sedimentation has occurred in the upper reaches above approximately the 120.5-foot contour (Figures 13 and 14). Additionally, compressive stresses on the sediments may increase sediment density, inhibiting the measurement of the original, pre-impoundment surface. Density stratification in the sediment layers can scatter and attenuate acoustic return signals of the multi-frequency depth sounder (U.S. Army Corps of Engineers, 2013). Long-term trends indicate Lake Livingston loses capacity at an average of 3,797 acre-feet per year since impoundment due to sedimentation below conservation pool elevation (131.0 feet NGVD29) (Figure 15). Differences in methodology developing capacity estimates may also contribute to differences between these surveys.

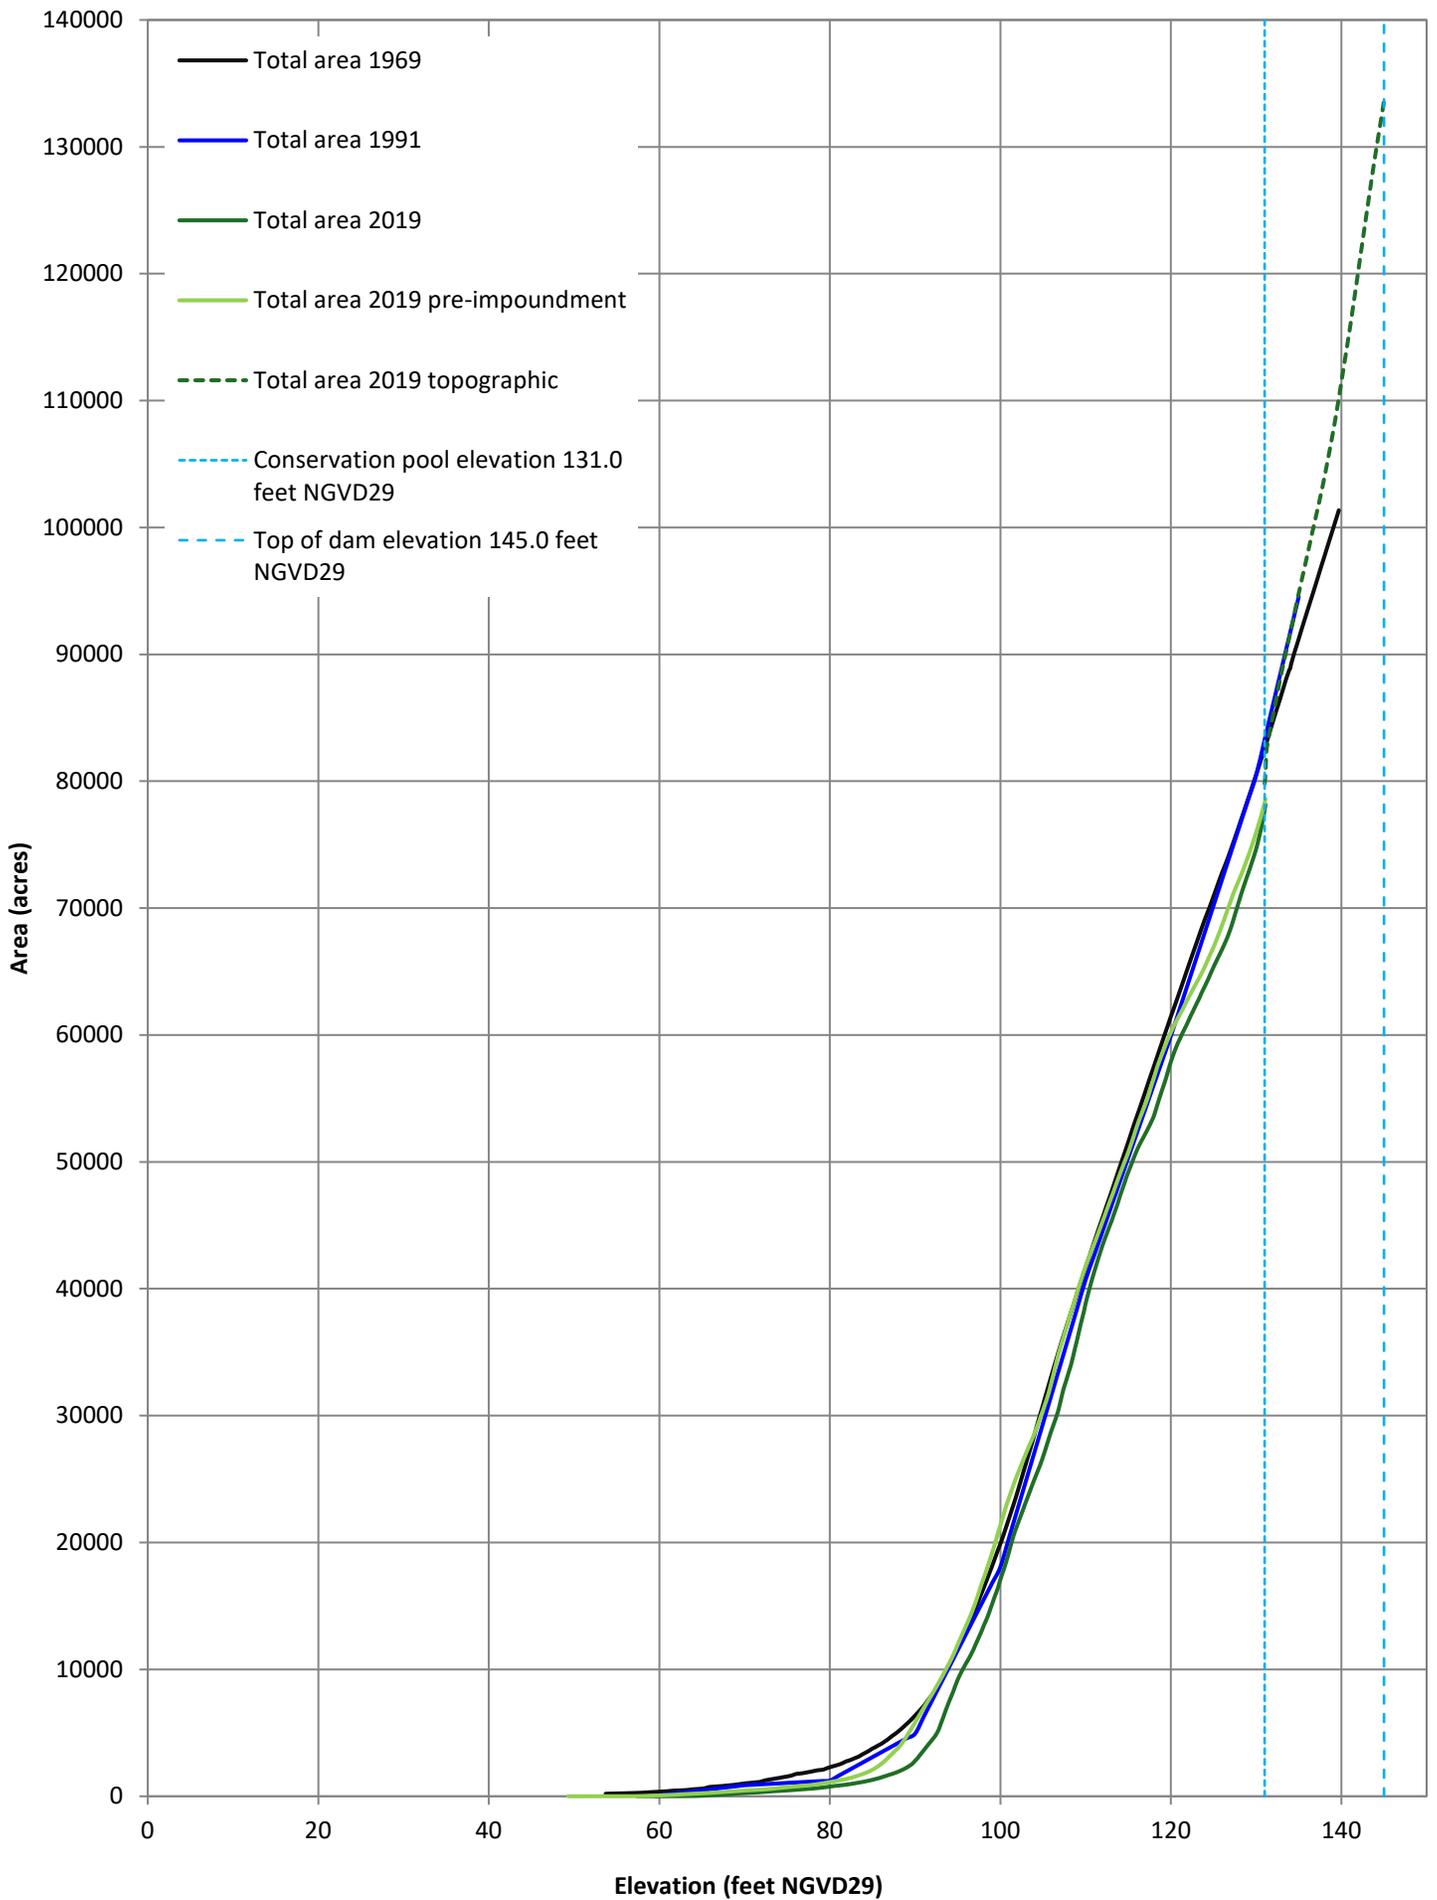
Figure 13. Comparison of current and previous area curves

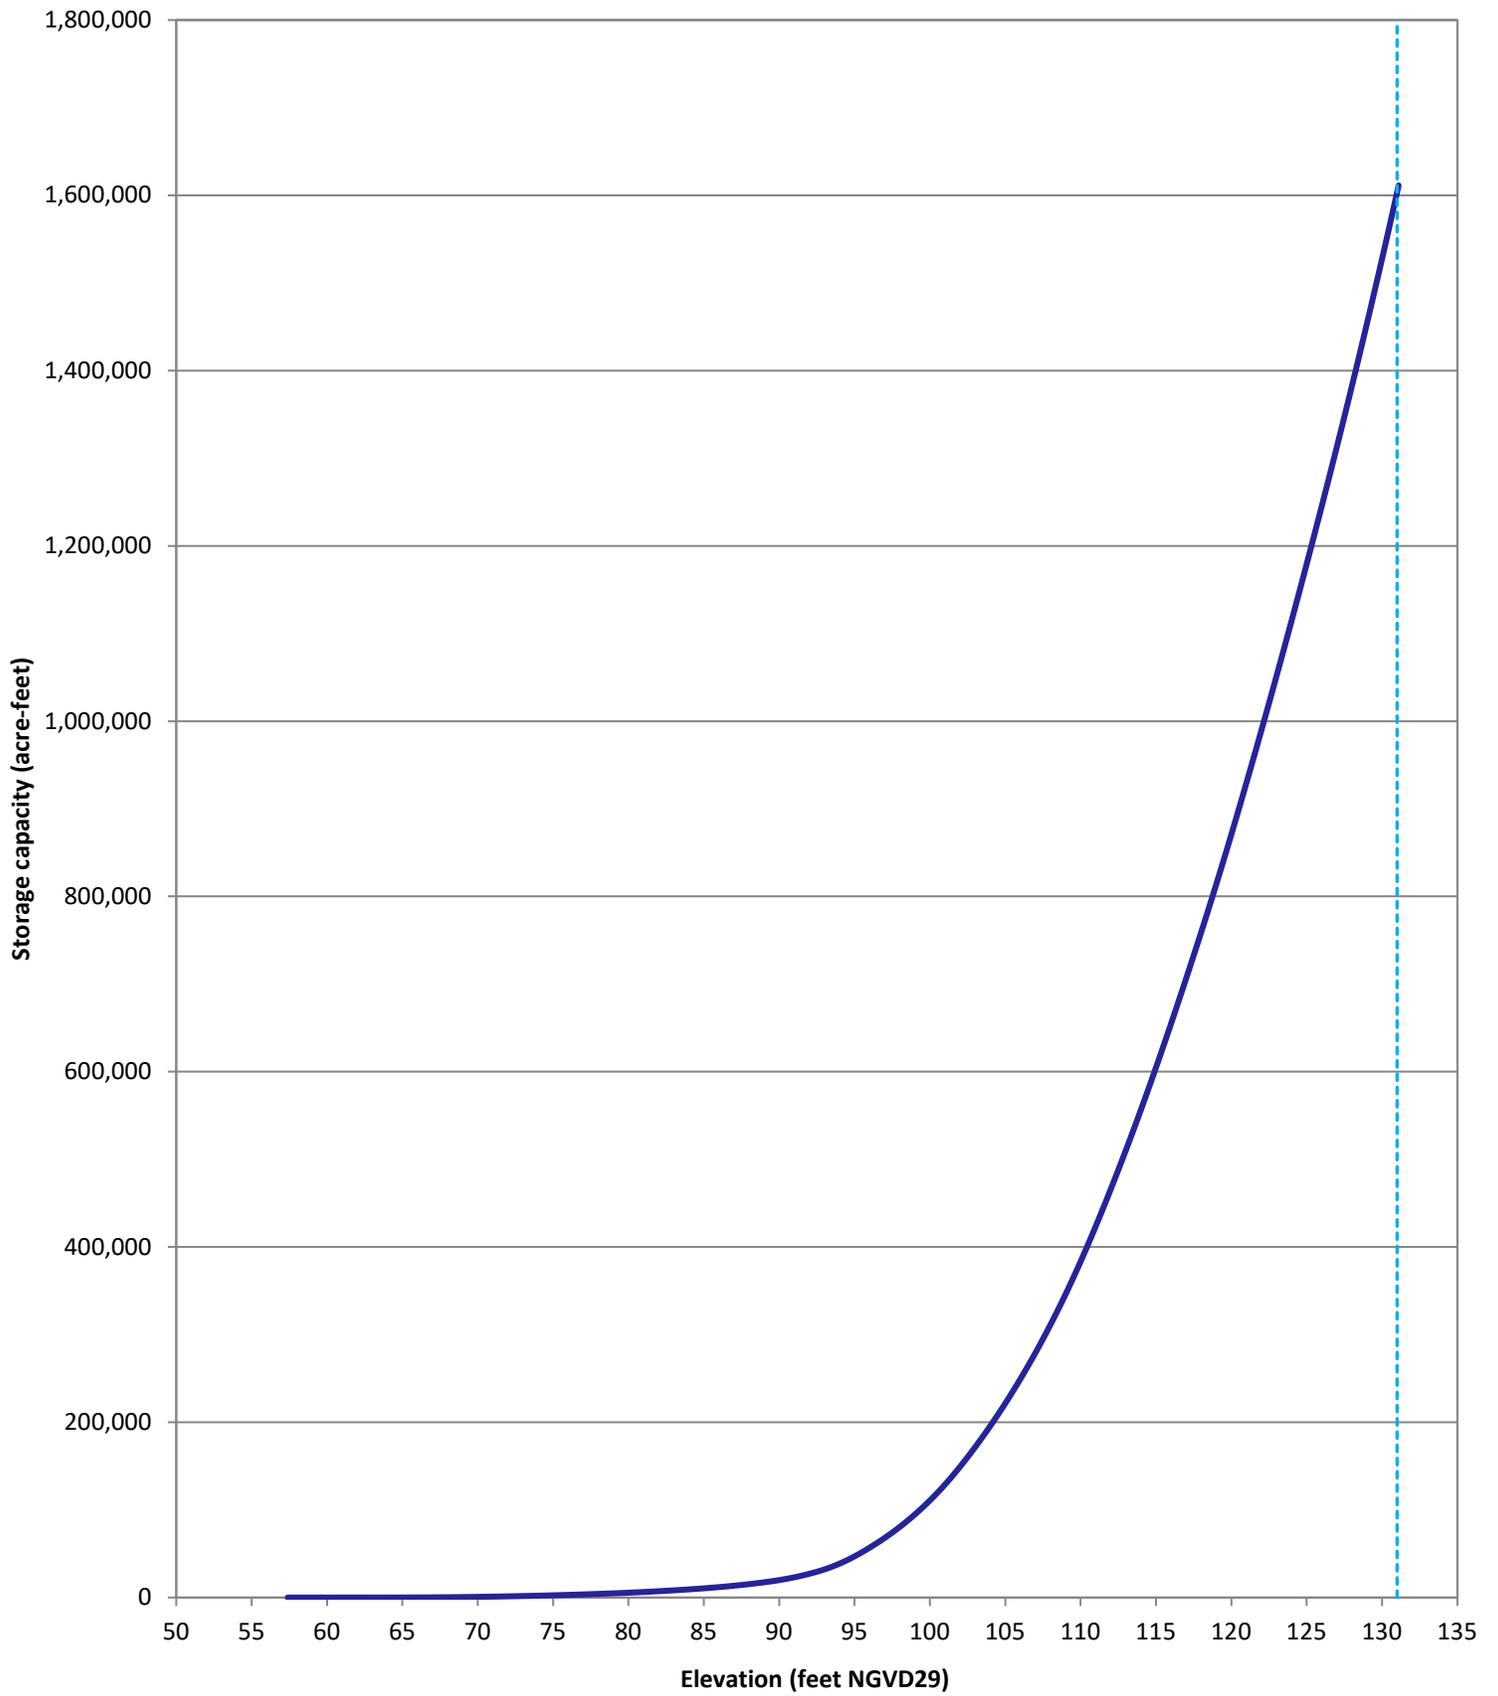
— Total capacity 2019
 - - - Conservation pool elevation 131.0 feet NGVD29

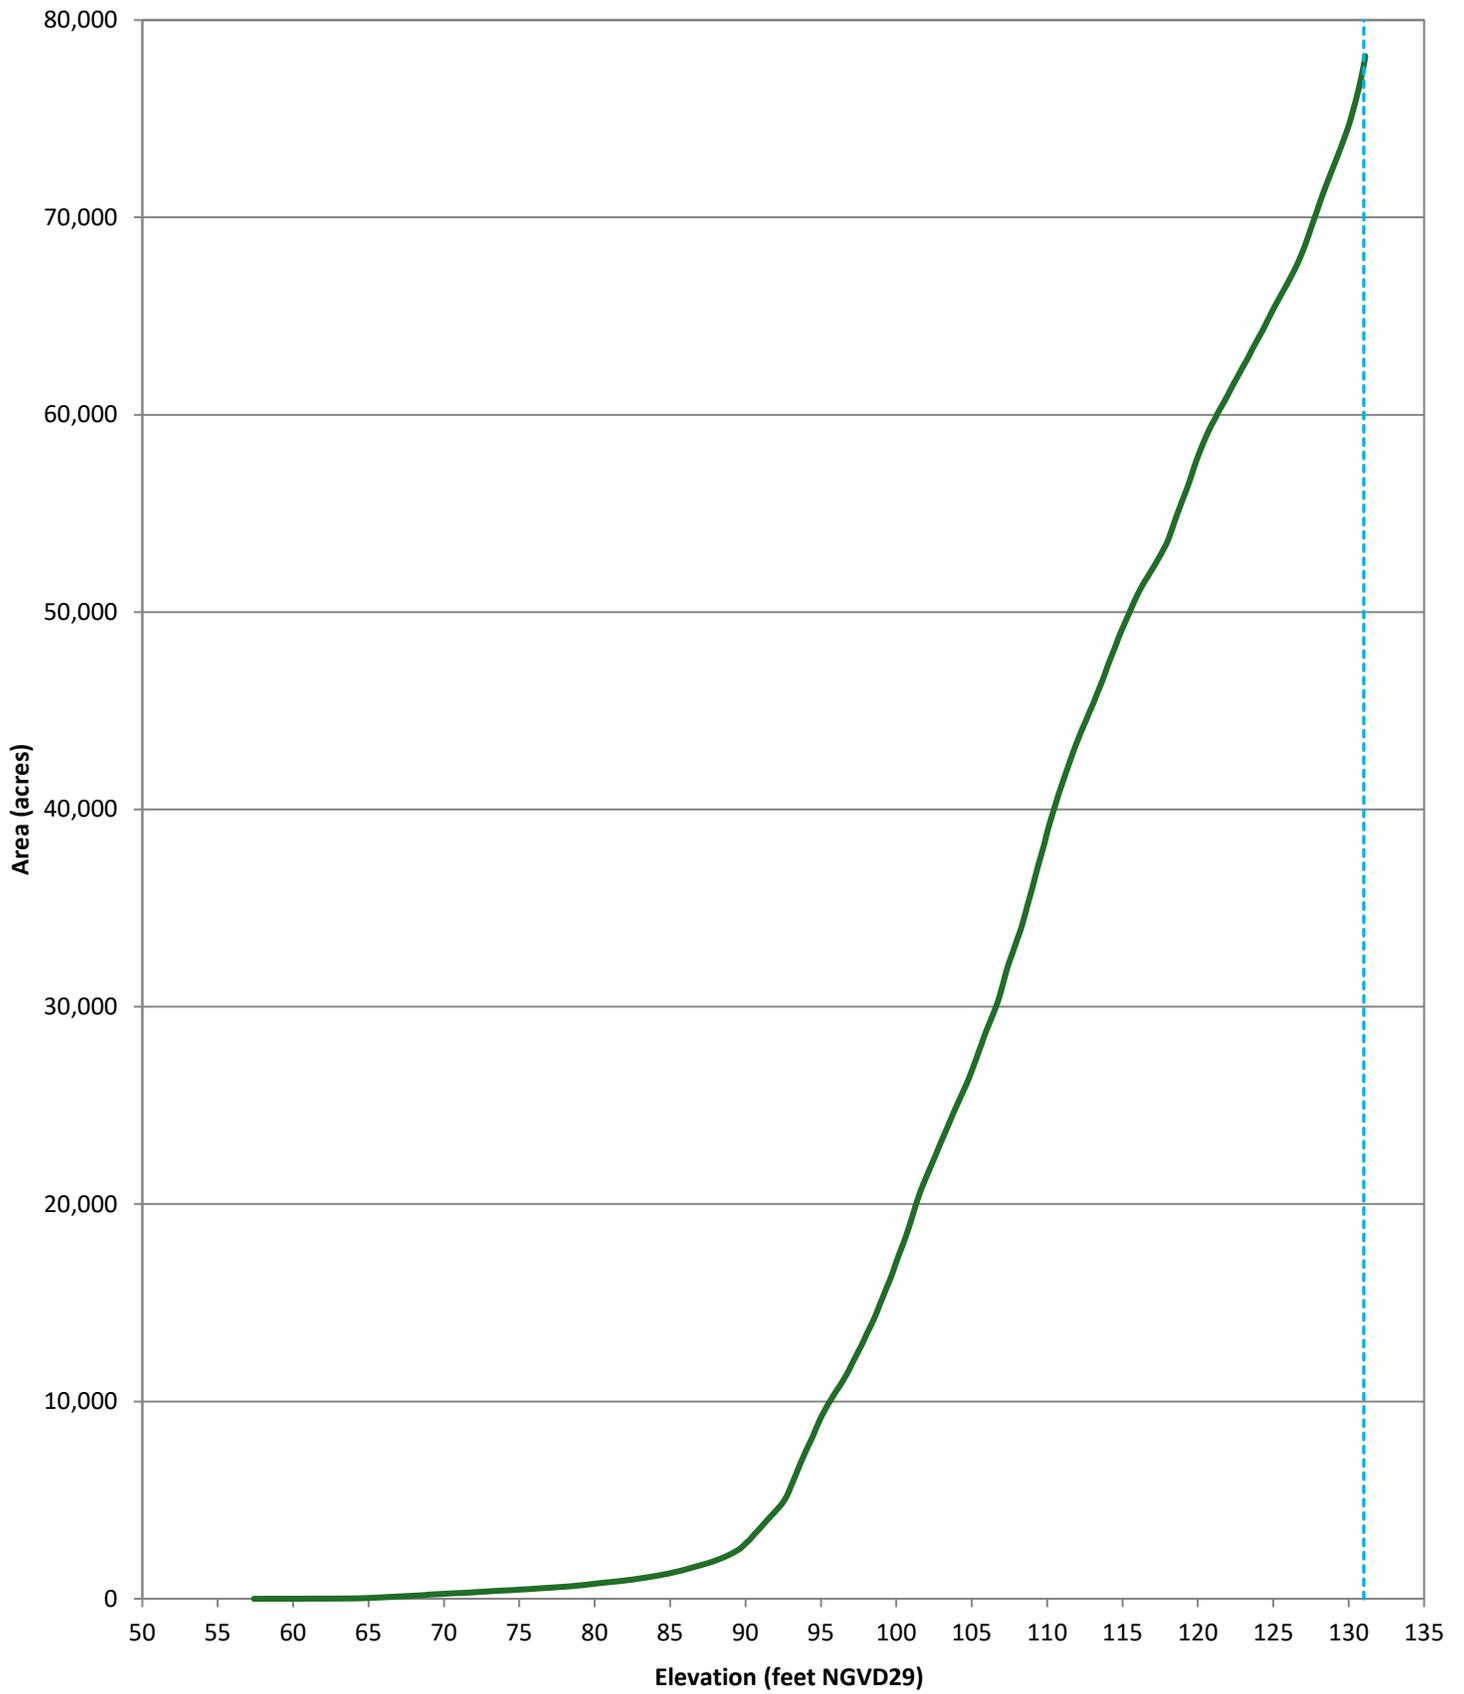
Total area 2019
 Conservation pool elevation 131.0 feet NGVD29
