Travis County Drainage Basin Study — Volume 1

Travis County Drainage Basin Study Volume 1

For Arroyo Doble and Twin Creek Park
Subdivision analysis only

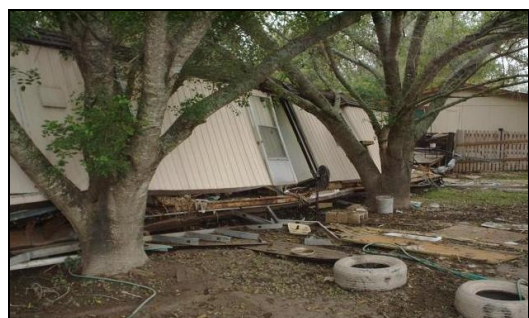
Flood Damage in Timber Creek, November 2001

areas of Travis County.⁶ This study identified flooding problems in the Onion Creek Watershed for specific stream reaches including the Timber Creek area, Bear Creek/Onion Creek confluence (Arroyo Doble) area, and Bluff Springs Road area. Flood mitigation plans were developed for these areas and the plans for Timber Creek and Arroyo Doble are

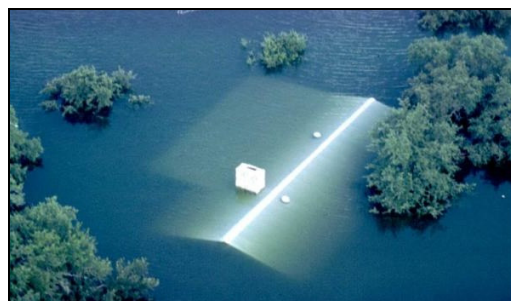
Flood Damage in Graveyard Point, December 1991

County is also evaluating the potential for acquisition of flood prone structures in the Graveyard Point area along Lake Travis. Many of the homes in Graveyard Point have incurred flood damages on a relatively frequent basis. The County has applied for a hazard mitigation grant from FEMA for potential acquisition of 30 properties in the Graveyard Point area and the County is evaluating other options in cooperation with the USACE to mitigate the flooding in this area.

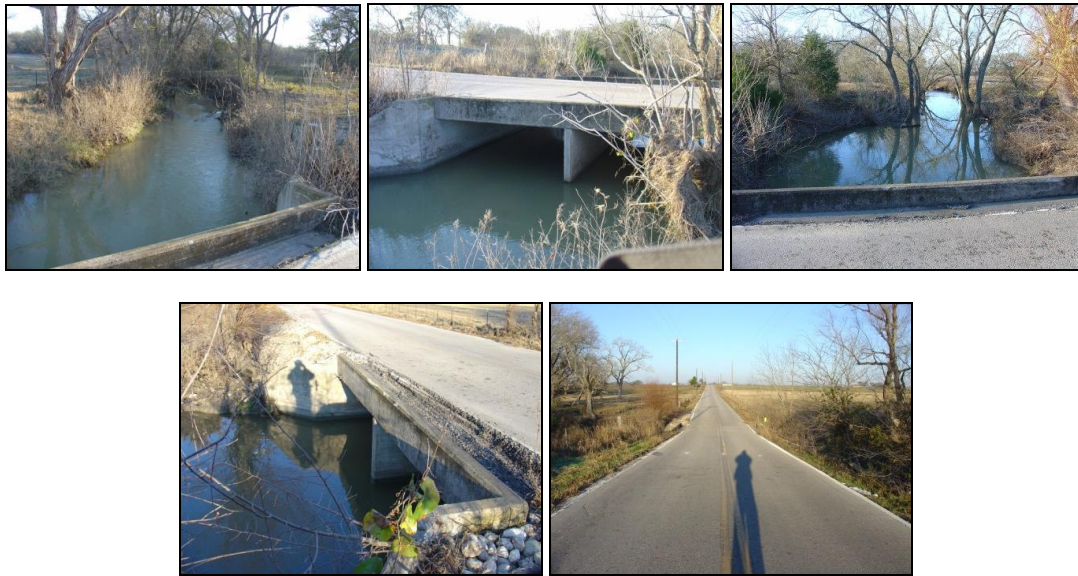
Figure 3-2. Sample Field Recon Photos, Gregg Lane at Wilbarger Creek

During each site visit, a digital photographic survey was taken of the drainage structures and their surroundings. At a minimum, the upstream and downstream ends of drainage structures, upstream and downstream channels, and road profiles were photographed, as shown in the example below (Figure 3-2).

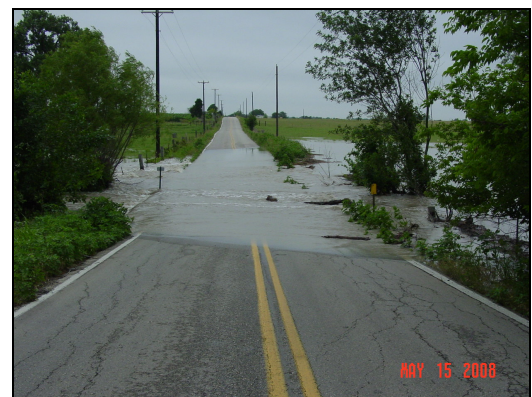
Figure 3-3. Gregg Lane at Wilbarger Creek

Several significant storm events occurred during the field reconnaissance effort which was mostly performed throughout calendar year 2007. The year 2007 was one of the wettest years on record for the Travis County area including a new record rainfall total for the month of June. Photographs were taken of several problem areas while minor to moderate flooding was occurring during some of the more significant storm events, as shown in Figure 3-3. The observed flooding was helpful in determining the nature of the flooding at the identified problem areas, however, the observed flooding was not sufficient to perform detailed calibration of hydrologic and hydraulic models.

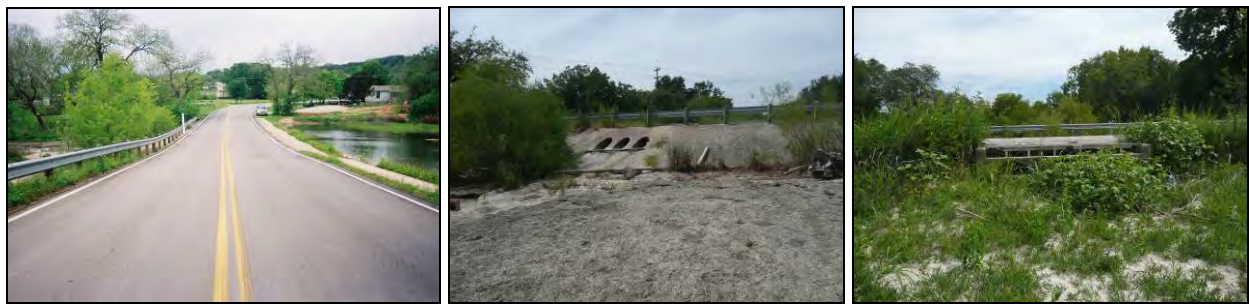
Figure 5-4. Big Sandy Dr. @ Long Hollow Creek

Long Hollow is a large tributary to Big Sandy Creek in northwest Travis County with a watershed area of 1.8 square miles at the Big Sandy Drive crossing as shown on Figure 5-4. The Big Sandy Drive crossing is in the hill country area of northwest Travis County. The existing drainage structure consists of three 24” RCP with a concrete flow control structure on the upstream end as shown in the photos below. The flow control structure appears to be designed to provide a constant normal pool or pond upstream of the crossing given the location of the low level openings above existing grade.

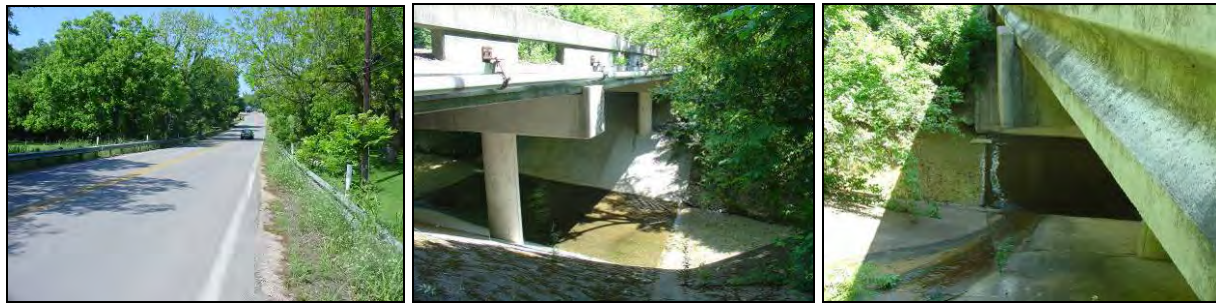
Figure 5-5. Springdale Road @ Walnut Creek

Walnut Creek is a major waterway with a watershed area of approximately 29 square miles at the Springdale Road crossing in eastern Travis County as shown on Figure 5-5. The existing drainage structure is a three-span slab beam bridge as shown in the photos below. This crossing is included in the current effective FEMA FIS of Walnut Creek as a Zone AE SFHA. The headwaters of Walnut Creek lie in the developed area of the City of Austin. Rainfall runoff from this urban area contributes to flooding of this roadway crossing.

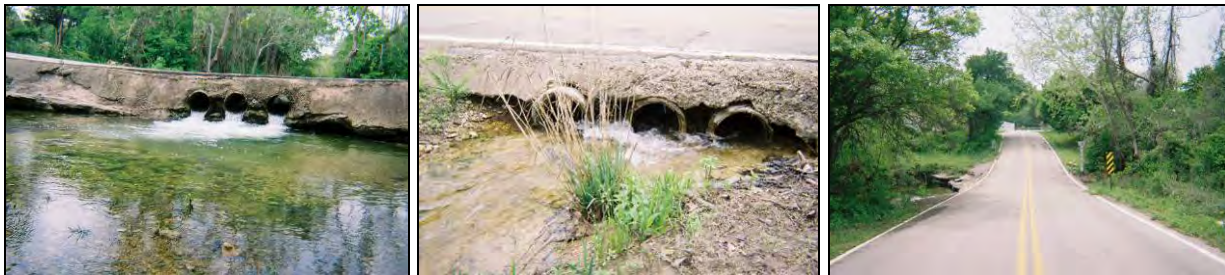
Figure 5-6. Juniper Trail @ Long Hollow

Long Hollow is a large tributary to Big Sandy Creek with a watershed area of 5.705 square miles at the Juniper Trail crossing as shown on Figure 5-6. The Long Hollow is in the hill country area of northwest Travis County. The existing drainage structure is a typical low water crossing consisting of three shallow 24” RCP at the bottom of a steep sag vertical curve as shown in the photos below.

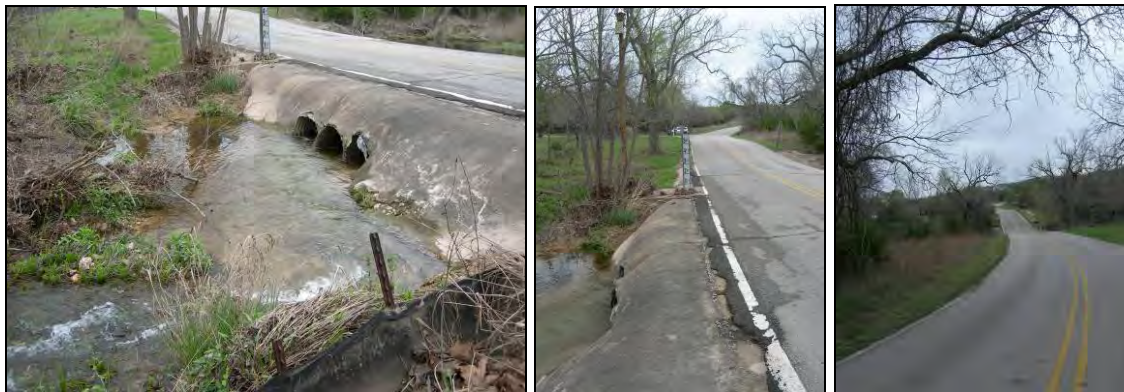
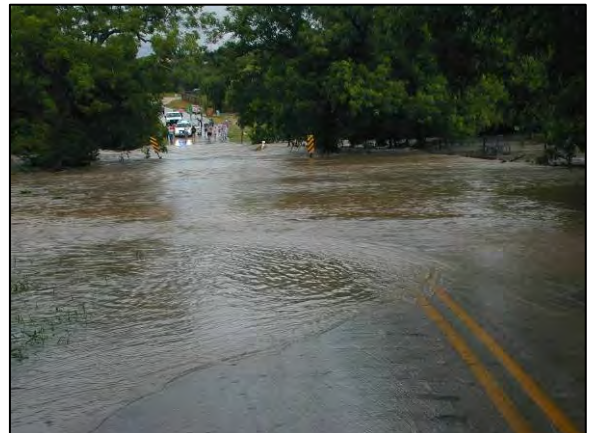
Figure 5-8. Great Divide Road @ Little Barton Creek

Little Barton Creek is a major waterway with a watershed area of 8.2 square miles at the Great Divide Road crossing in western Travis County as shown on Figure 5-8. The existing drainage structure is a low water crossing consisting of three shallow 18” CMP at the bottom of a sag vertical curve as shown in the photos below. This stream crossing is located within the unincorporated area of Travis County, however, the approach roadways are both located within the City of Bee Cave.

With only these small pipes to pass stream flows, this low water crossing experiences frequent and severe overtopping as shown in Table 4.2 and Appendix B, with a depth of overtopping from a 2-year storm event of 3.92 feet. A significant overtopping event from July of 2007 is shown in the photograph to the right. Great Divide Road connects to State Hwy. 71 and is a single access way into the Homestead Subdivision including over 150 residences. The drainage structure is in poor condition with minor erosion upstream and downstream of the crossing.

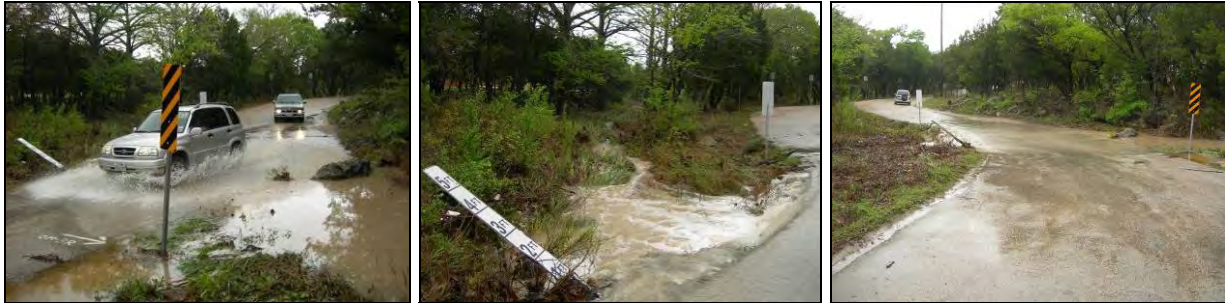
Figure 5-9. Fall Creek Road @ Unnamed Tributary to Fall Creek

The Unnamed Tributary to Fall Creek is a major waterway with a watershed area of 2.0 square miles at the Fall Creek Road crossing in far western Travis County as shown on Figure 5-9. The existing drainage structure is a typical low water crossing consisting of one shallow 18” CMP at the low point of a relatively flat roadway as shown in the photos below.

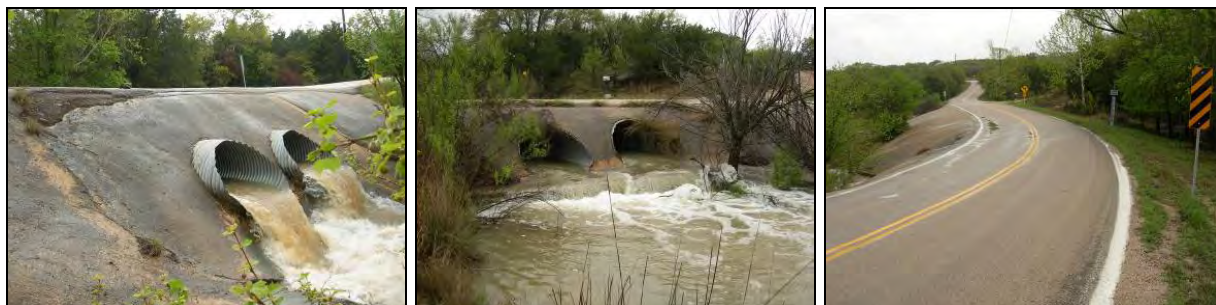
Figure 5-10. Pedernales Canyon Trail @ Lick Creek

Lick Creek is a major waterway with a watershed area of 3.3 square miles at the Pedernales Canyon Trail crossing as shown on Figure 5-10. The crossing is located at the confluence of Lick Creek and one of its large tributaries. Thus, there are two separate existing drainage structures each consisting of two shallow 36-inch diameter CMP as shown in the photos below.

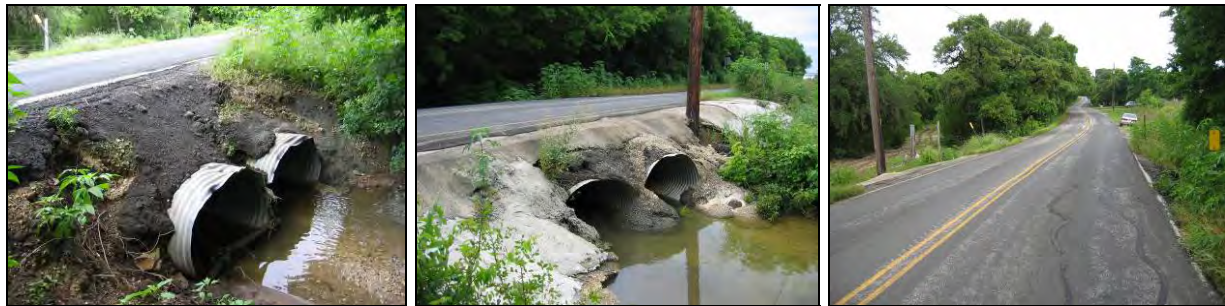
Figure 5-11. Slaughter Creek Drive @ Trib 1 to Slaughter Creek

Tributary 1 to Slaughter Creek is major waterway with a watershed area of approximately 0.87 square miles at the Slaughter Creek Drive crossing in southern Travis County as shown on Figure 5-11. The existing drainage structure is a low water crossing consisting of two shallow 36-inch diameter CMP at the low point of a relatively flat roadway as shown in the photos below. This crossing is included in the current effective FEMA FIS for Slaughter Creek as a Zone AE SFHA.

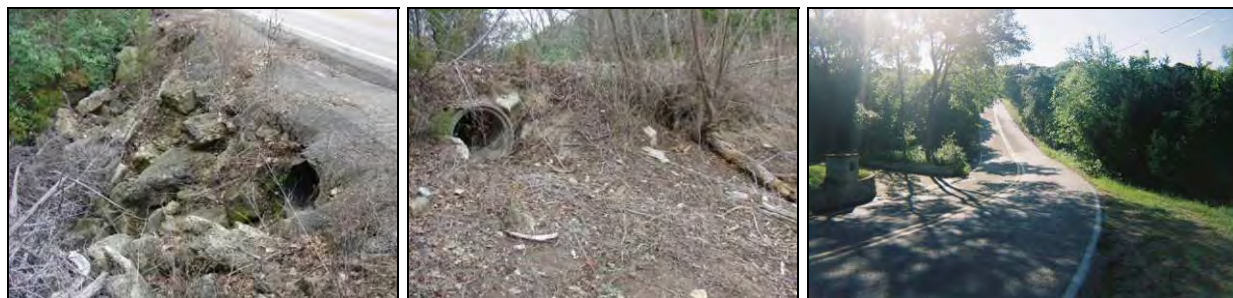
Figure 5-12. Tumbleweed Trail @ Unnamed Trib to Lake Austin

The unnamed tributary is a large tributary to Lake Austin with a watershed area of 248 acres at the Tumbleweed Trail crossing in central Travis County as shown on Figure 5-12. The existing drainage structure is a low water crossing consisting of one shallow 36” RCP at the bottom of a steep sag vertical curve as shown in the photos below.

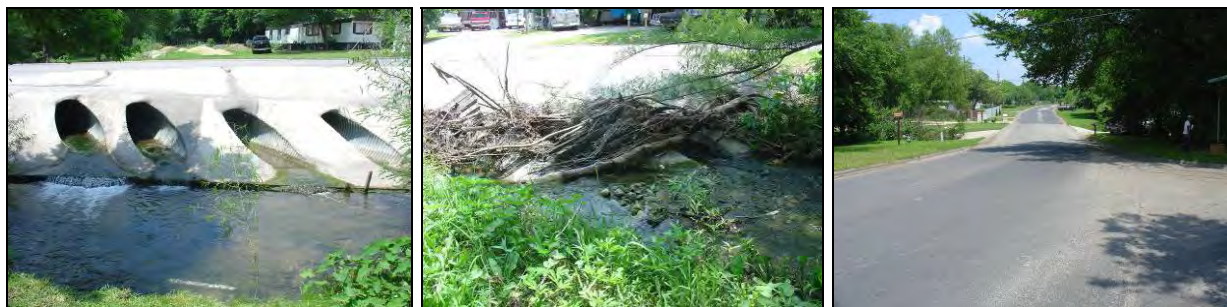
Figure 5-13. Crystal Bend Drive @ Harris Branch

Harris Branch is a major waterway with a watershed area of approximately 4 square miles at the Crystal Bend Drive crossing in northeast Travis County as shown on Figure 5-13. The existing drainage structure consists of four 36-inch diameter CMP as shown in the photos below. This crossing is included in the current effective FEMA FIS for Harris Branch as a Zone AE SFHA.

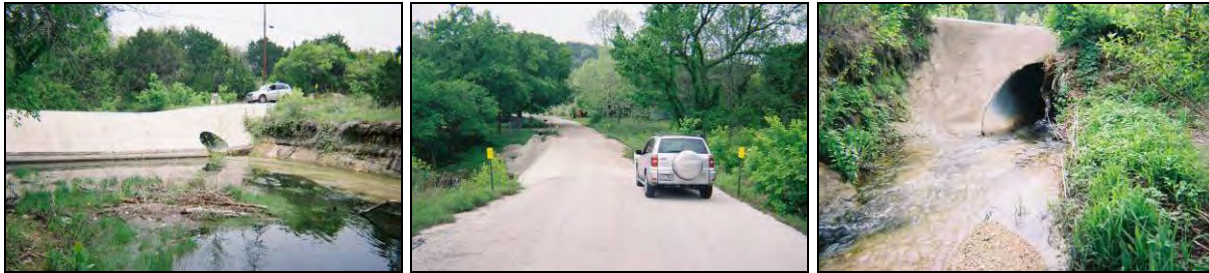
Figure 5-14. Cottonwood Drive @ Long Hollow

Long Hollow is a large tributary to Big Sandy Creek with a watershed area of 7.2 square miles at the Cottonwood Drive crossing in northwest Travis County as shown on Figure 5-14. The existing drainage structure is a typical low water crossing consisting of one shallow 60” CMP at the bottom of a sag vertical curve as shown in the photos below. This crossing is on the same stream as the Juniper Trail and Big Sandy crossings presented previously.

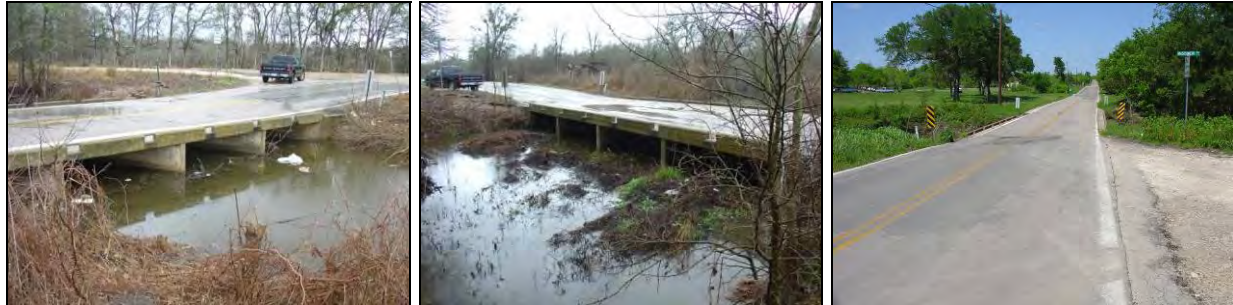
Figure 5-16. Linden Road @ Maha Creek

Maha Creek is a major waterway with a watershed area of 1.6 square miles at the Linden Road crossing in southeast Travis County as shown on Figure 5-16. The existing drainage structure is a typical low water crossing consisting of four shallow 10’x4’ RCB culverts at the low point of a relatively flat roadway as shown in the photos below.

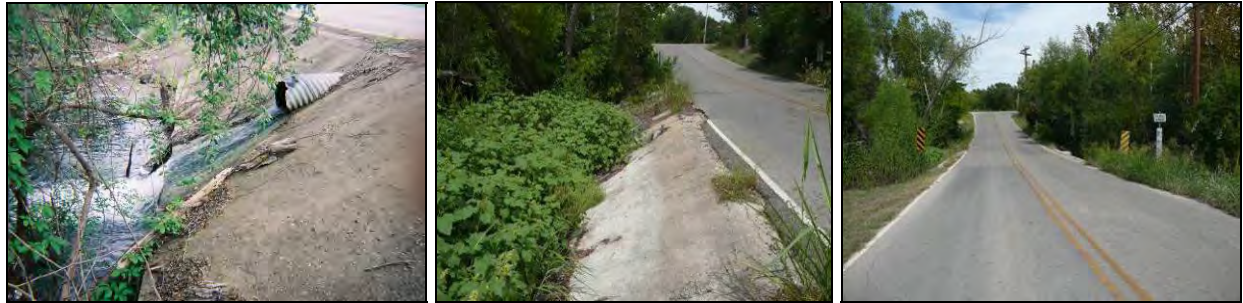
Sheep Hollow is a large tributary to Long Hollow with a watershed area of 1.4 square miles at the Live Oak Drive crossing in northwest Travis County as shown on Figure 5-17. The existing drainage structure is a low water crossing consisting of three shallow 24-inch diameter RCP at the bottom of a steep sag vertical curve as shown in the photos below.

This low water crossing experiences frequent and severe overtopping as shown in Table 4.2 and Appendix B, with a depth of overtopping from a 2-year storm event of 1.97 feet. Live Oak Drive is one of two primary access ways into a residential area including over 100 residences. At least one habitable structure LFE is below the computed 100-year floodplain directly upstream of the crossing. The drainage structure is in fair condition with no significant erosion or sedimentation problems at the crossing.

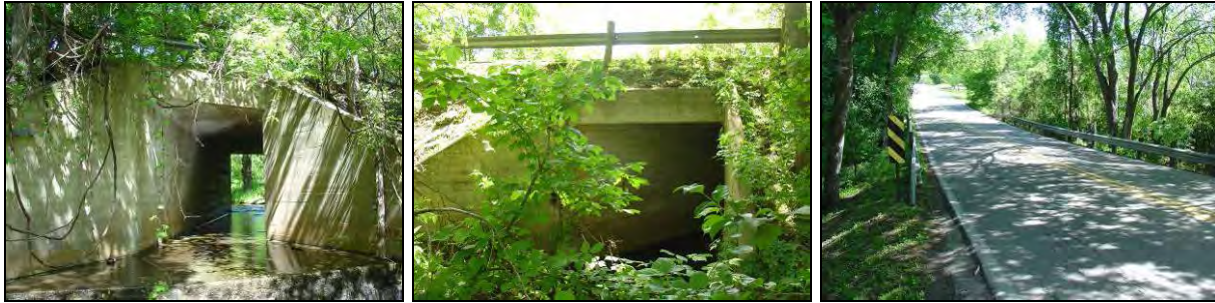
Tributary 5 is a major tributary to Walnut Creek with a watershed area of approximately 1.2 square miles at the Springdale Road crossing in eastern Travis County as shown on Figure 5-18. The existing drainage structure is an 8’ x 10’ box culvert as shown in the photos below. This crossing is included in the current effective FEMA FIS of Tributary 5 to Walnut Creek as a Zone AE SFHA.

Based on the FEMA FIS data, this stream crossing experiences frequent and severe overtopping as shown in Table 4.2 and Appendix B, with a depth of overtopping from a 2-year storm event of 2.11 feet. Springdale Road connects to US Hwy. 290 and is one of two primary access routes into a residential neighborhood including over 100 residences. One habitable structure encroaches the FEMA 100-year floodplain directly upstream of the crossing. The drainage structure is in satisfactory condition with no significant erosion or sedimentation problems at the crossing.

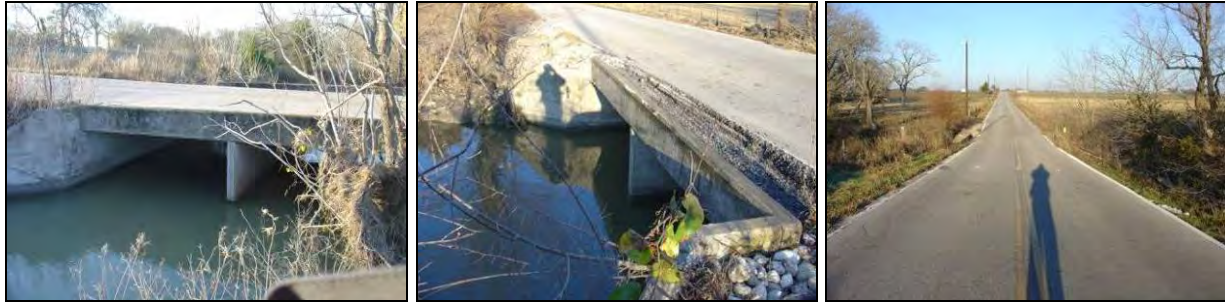
Wilbarger Creek is a major waterway with a watershed area of 1.6 square miles at the Gregg Lane crossing in northeast Travis County, east of Pflugerville as shown on Figure 5-19. The existing drainage structure is a low water crossing consisting of two 10-ft concrete spans at the low point of a relatively flat roadway as shown in the photos below.

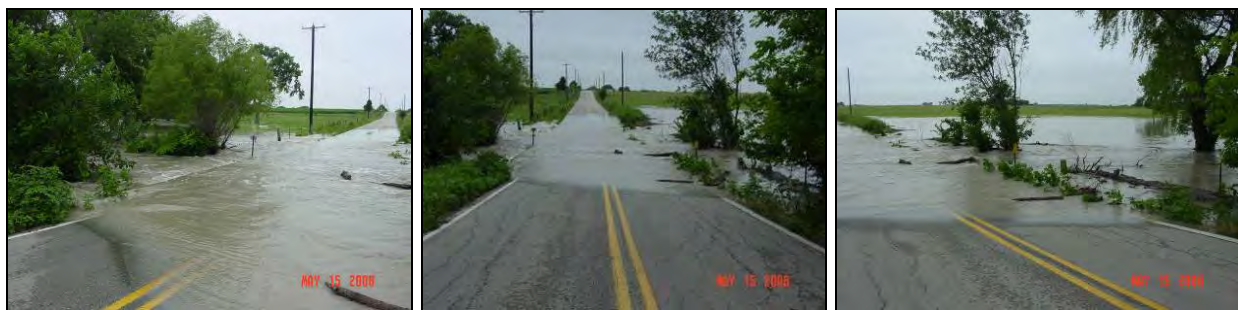
This low water crossing experiences frequent and severe overtopping as shown in Table 4.2 and Appendix B, with a depth of overtopping from a 2-year storm event of 2.67 feet. Overtopping from a moderate storm event in May 2008 is shown in the photos below. Gregg Lane connects to FM 973 and is one of two primary access routes for 3 rural residences. The drainage structure is in satisfactory condition with no significant erosion or sedimentation problems at the crossing.

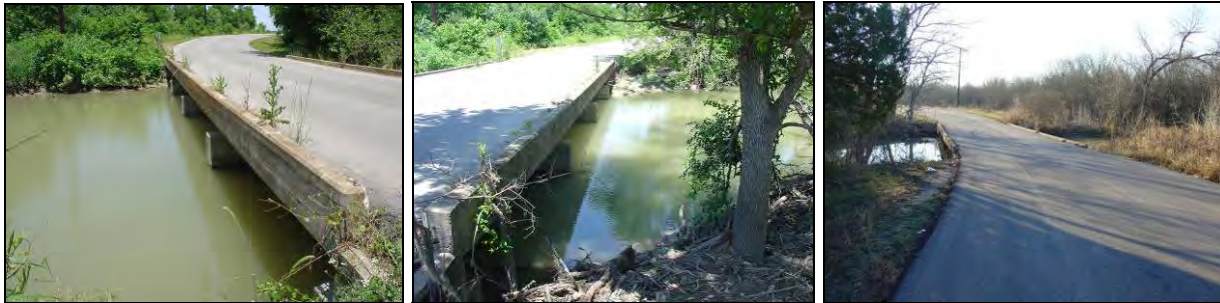
The unnamed tributary to Wilbarger Creek is a major waterway with a watershed area of 10.4 square miles at the Jesse Bohls Road crossing in northeast Travis County east of Pflugerville as shown on Figure 5-20. The existing drainage structure consists of four 14-ft concrete spans at the crossing on a relatively flat roadway as shown in the photos below.

This low water crossing experiences frequent and severe overtopping as shown in Table 4.2 and Appendix B, with a depth of overtopping from a 2-year storm event of 1.8 feet. Jesse Bohls Road connects to Weiss Lane at Cameron Road and is one of two primary access routes for approximately 8 rural residences. The drainage structure is in satisfactory condition with no significant erosion or sedimentation problems at the crossing.

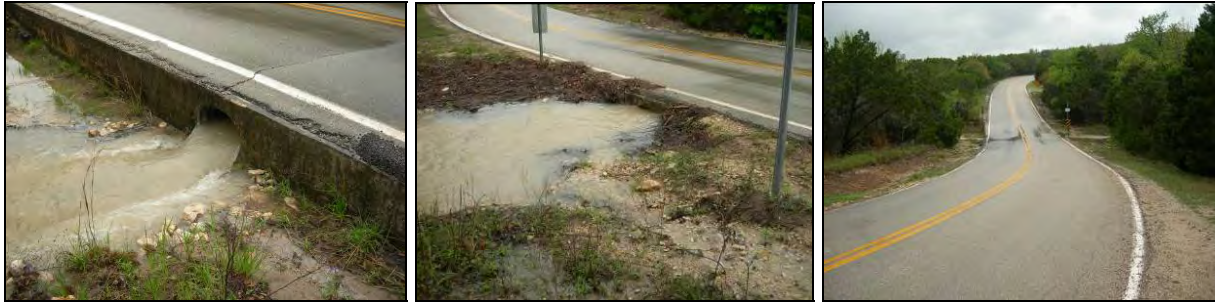
Fisher Hollow is a large tributary to Lime Creek with a watershed area of 0.86 square miles at the Lime Creek Road crossing north of Lake Travis in north Travis County as shown on Figure 5-21. The existing drainage structure is a typical low water crossing consisting of one shallow 15” CMP at the bottom of a steep sag vertical curve as shown in the photos below.

This low water crossing experiences frequent and severe overtopping as shown in Table 4.2 and Appendix B, with a depth of overtopping from a 2-year storm event of 2.7 feet. Lime Creek Road connects to Anderson Mill Rd. to the north of the crossing and Volente Rd. to the south and is one of two primary access routes for over 15 rural residences and businesses. The drainage structure is in good condition with no significant erosion or sedimentation problems at the crossing.

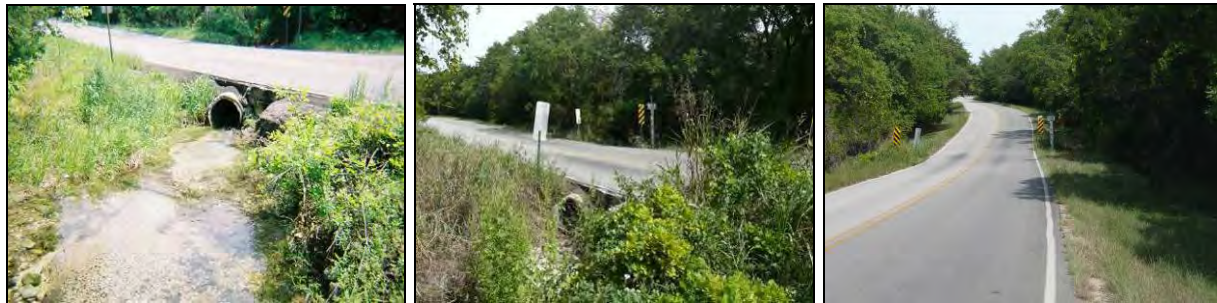
The unnamed tributary to Big Sandy Creek is a large tributary with a watershed area of 0.86 square miles at the Nameless Road crossing near Honeycomb Drive in north Travis County as shown on Figure 5-22. The existing drainage structure is a typical low water crossing consisting of one shallow 24” RCP at the bottom of a sag vertical curve as shown in the photos below.

This low water crossing experiences frequent and moderate overtopping as shown in Table 4.2 and Appendix B, with a depth of overtopping from a 2-year storm event of 1.42 feet. Nameless Road is one of two primary access routes for a rural neighborhood of over 50 residences. The drainage structure is in fair condition with minor erosion at the downstream end of the crossing. The crossing appears to have a high potential for clogging from woody debris.

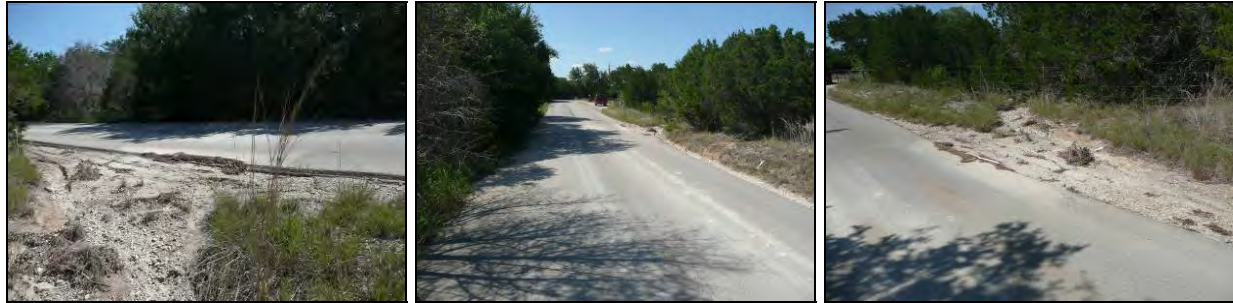
The unnamed tributary is a major tributary to Grape Creek with a watershed area of 371.5 acres at the D Morgan Road crossing in south Travis County as shown on Figure 5-23. The existing low water crossing has no drainage structure. All storm events flow over the roadway at the low point of the sag vertical curve as shown in the photos below.

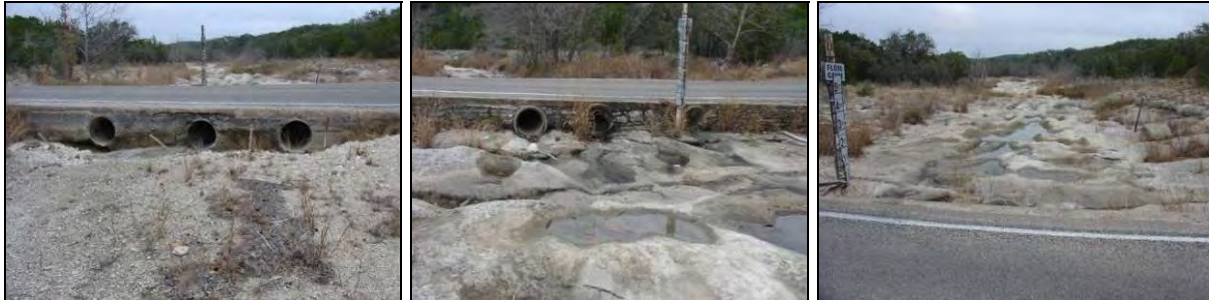
Bee Creek is a major waterway with a watershed area of 13.12 square miles at the Bee Creek Road crossing as shown on Figure 5-24. The existing drainage structure is a typical low water crossing consisting of three shallow 24” RCP at the bottom of a sag vertical curve as shown in the photos below.

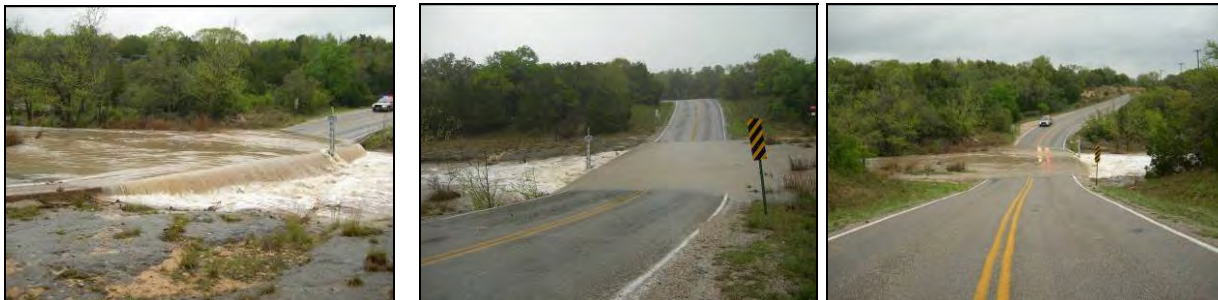
This low water crossing experiences frequent and severe overtopping as shown in Table 4.2 and Appendix B, with a depth of overtopping from a 2-year storm event of 4.73 feet. A significant overtopping event from March of 2007 is shown in the photographs below. Bee Creek Road is a rural residential collector roadway. The drainage structure is in fair condition with no significant erosion or sedimentation problems at the crossing.

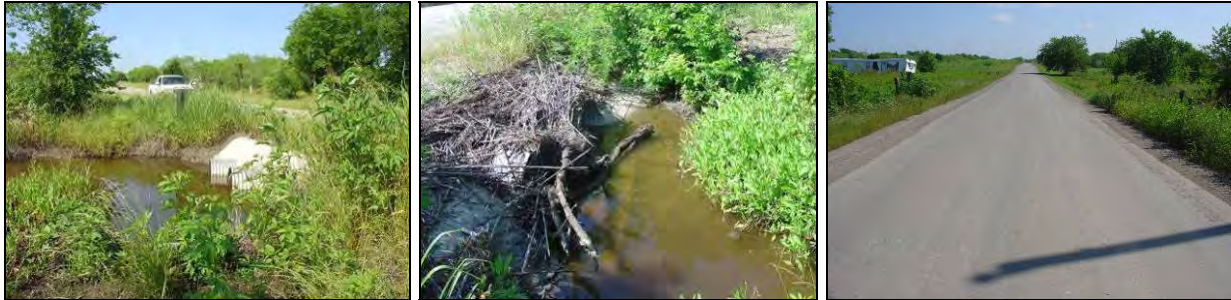
Navarro Creek is a large tributary to Dry East Creek with a watershed area of 1.6 square miles at the Navarro Creek Road crossing as shown on Figure 5-25. The existing drainage structure is a typical low water crossing consisting of two shallow 48” CMP at the low point of a relatively flat roadway as shown in the photos below.

This low water crossing experiences frequent and moderate overtopping as shown in Table 4.2 and Appendix B, with an overtopping depth from the 100-year storm event of 2.08 feet. Navarro Creek Road is also a single access way into a rural residential area including approximately 36 residences. The drainage structure is in fair condition with minor erosion at the downstream side of the crossing. The crossing appears to have potential for clogging from woody debris.

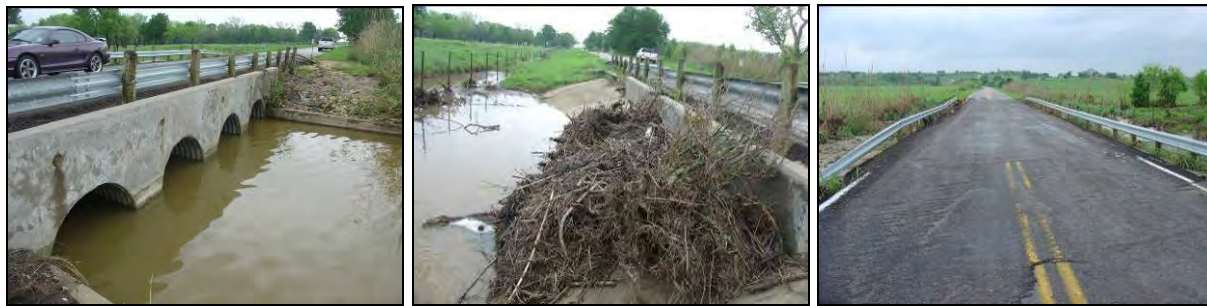
The unnamed tributary is a large tributary to Wilbarger Creek with a watershed area of 315.64 acres at the Bitting School Road crossing as shown on Figure 5-26. This crossing is adjacent to the Wilbarger Creek main channel crossing which has a contributing watershed area of 53.7 square miles. The existing drainage structure at the unnamed tributary is a typical low water crossing consisting of four shallow 60” CMP at the low point of a relatively flat roadway as shown in the photos below.

This crossing becomes inundated by the adjacent Wilbarger Creek main channel floodplains for the 10-, 25-, and 100-year storm events. The following table provides a summary of computed discharges at the crossing:

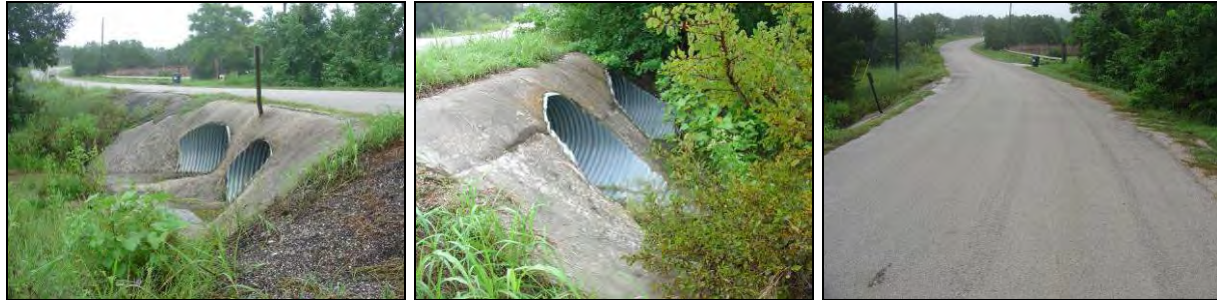
Devil's Pen Creek is a large tributary to Slaughter Creek with a watershed area of 307 acres at the Weir Loop Circle crossing as shown on Figure 5-27. The existing drainage structure is a typical low water crossing consisting of two shallow 48" CMP at the low point of a relatively flat roadway as shown in the photos below.

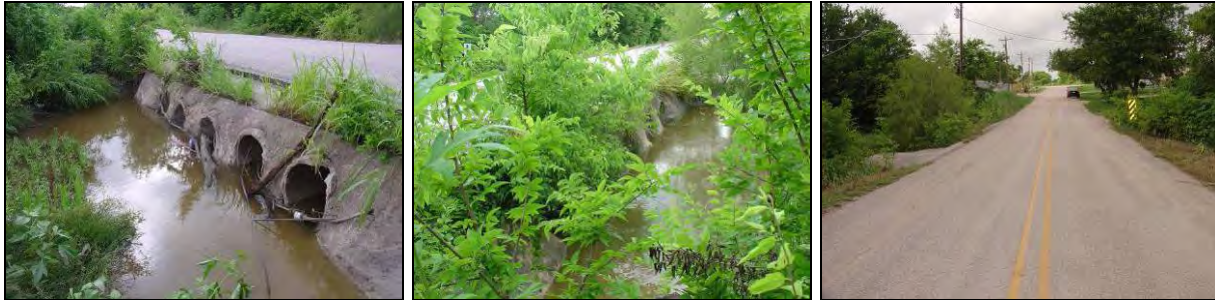
Maha Creek is a large waterway with a watershed area of 1.4 square miles at the Tom Sassman Road crossing as shown on Figure 5-28. The existing drainage structure is a typical low water crossing consisting of five shallow 24” CMP at the low point of a relatively flat roadway as shown in the photos below.

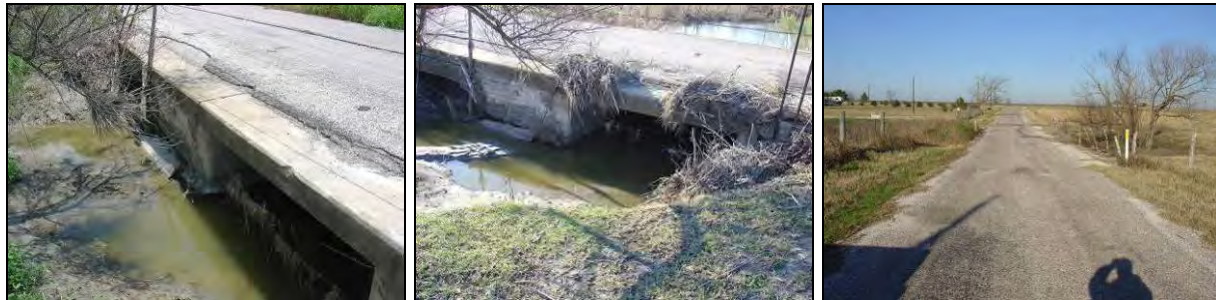
Cottonwood Creek is a large waterway with a watershed area of 1.8 square miles at the Felder Lane crossing as shown on Figure 5-29. The existing drainage structure is a typical low water crossing consisting of one shallow 10'x3' concrete box culvert at the low point of a relatively flat roadway as shown in the photos below.

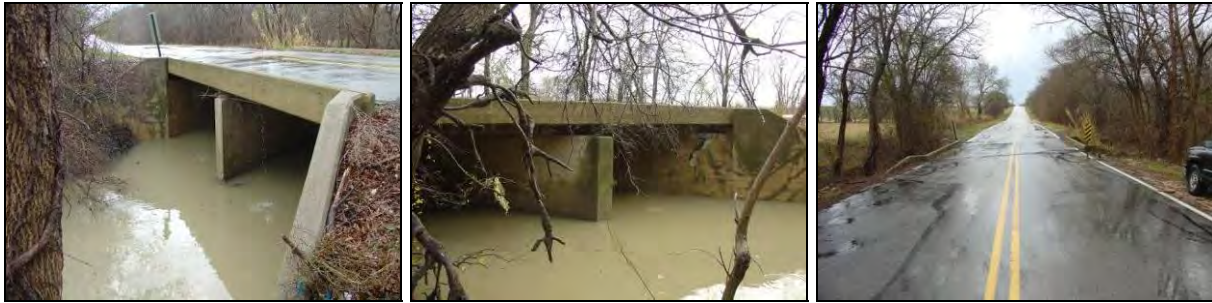
Wilbarger Creek is a major waterway with a watershed area of 17.3 square miles at the Parsons Road crossing as shown on Figure 5-30. The existing drainage structure consists of two 13-ft concrete spans at the crossing on a relatively flat roadway as shown in the photos below.

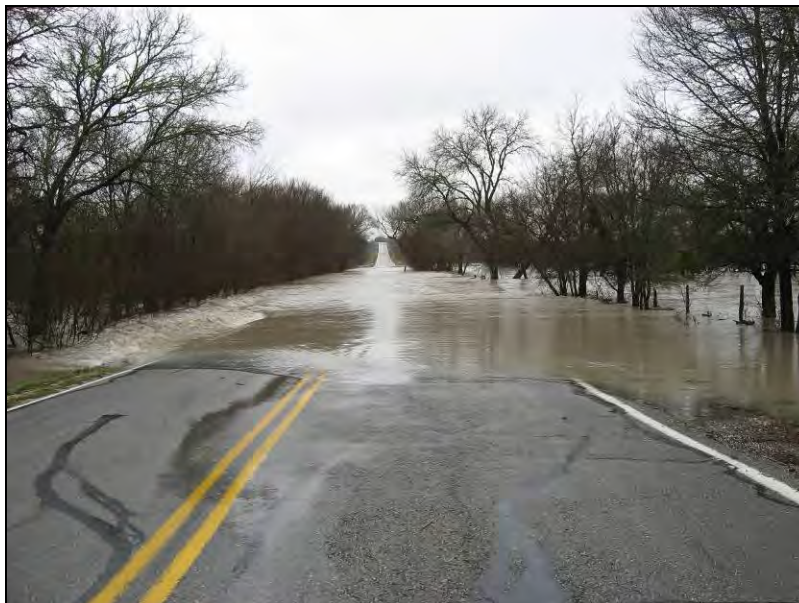
This low water crossing experiences frequent and severe overtopping as shown in Table 4.2 and Appendix B, with an average depth from the annual peak storm of 1.1 feet. A significant overtopping event from January of 2007 is shown in the photograph below. Parsons Road is one of two primary access routes for approximately 16 rural residences.

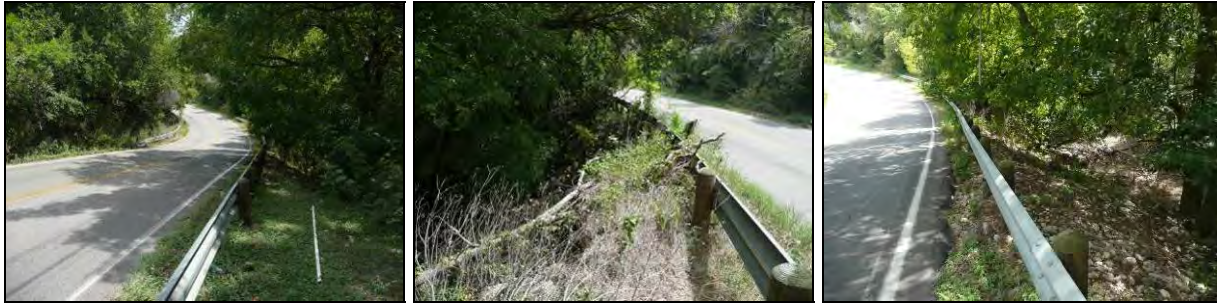
The unnamed tributary is a minor tributary to Lake Austin with a watershed area of 98 acres at the Westlake Drive crossing as shown on Figure 5-31. The existing low water crossing has no drainage structure. All storm events flow over the roadway at the low point of the sag vertical curve as shown in the photos below.

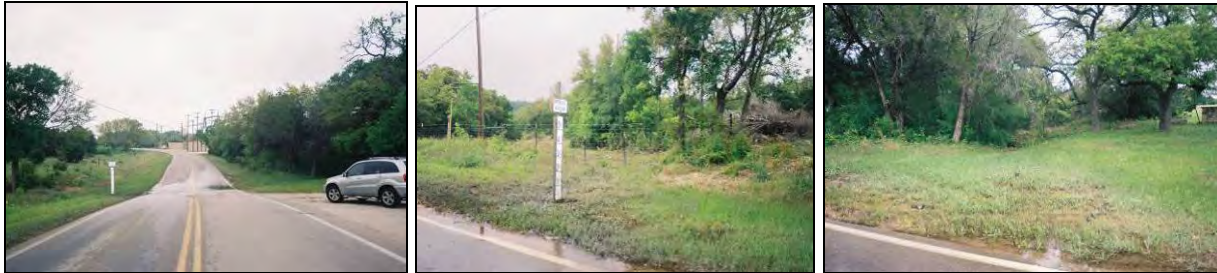
Nameless Hollow is a large tributary to Big Sandy Creek with a watershed area of 217.55 acres at the Nameless Road crossing as shown on Figure 5-32. The existing low water crossing has no drainage structure. All storm events flow over the roadway at the low point of the sag vertical curve as shown in the photos below.

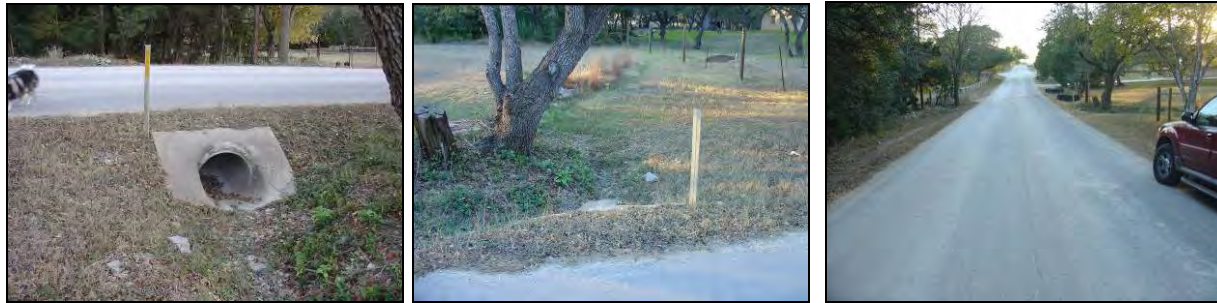
The unnamed tributary to Pen Creek is a minor waterway with a watershed area of 69.10 acres at the Ledgestone Terrace crossing as shown on Figure 5-33. The existing drainage structure is a typical low water crossing consisting of one shallow 24” RCP at the bottom of a sag vertical curve as shown in the photos below.

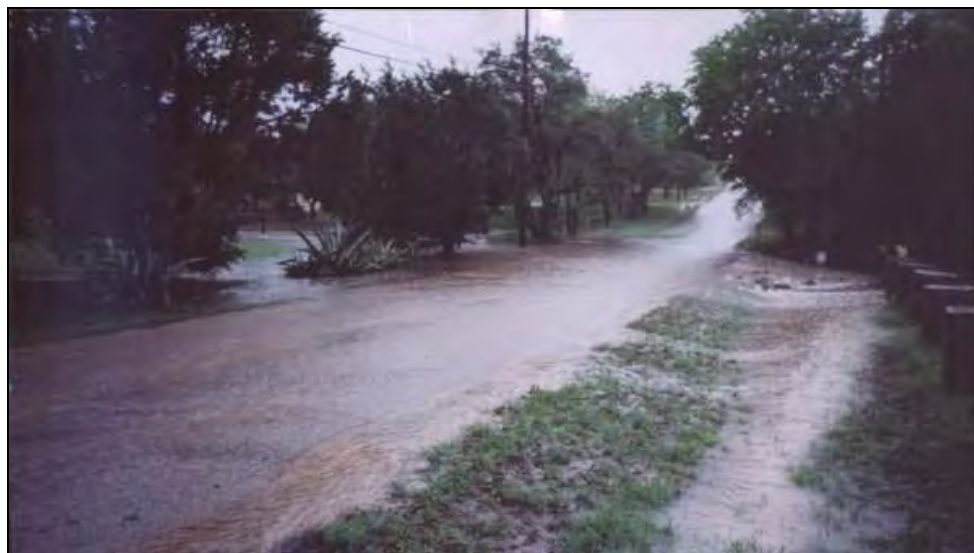
This low water crossing experiences frequent and moderate overtopping as shown in Table 4.2 and Appendix B, with an overtopping depth from the 100-year storm event of 1.41 feet. An overtopping event from December of 2007 is shown in the photograph below. Ledgestone Terrace is also a single access way into a neighborhood including over 50 residences.

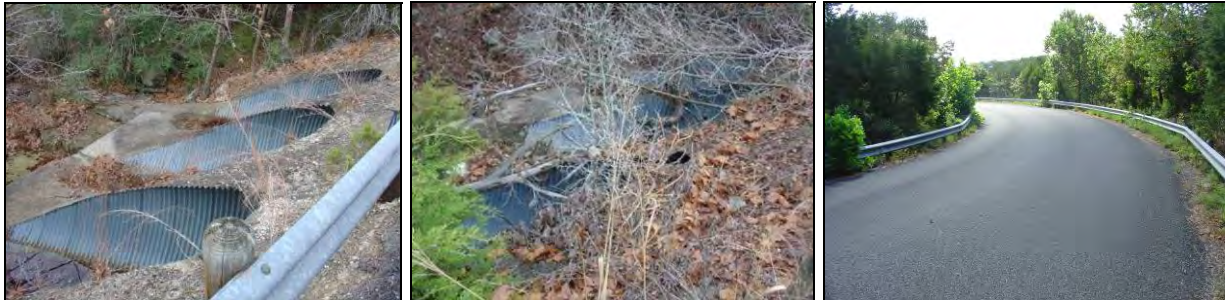
The unnamed tributary to Bee Creek is an intermediate waterway with a watershed area of 452.35 acres at the Wild Basin Street crossing as shown on Figure 5-34. The existing drainage structure consists of three shallow 84” CMP at the low point of a relatively flat roadway as shown in the photos below.

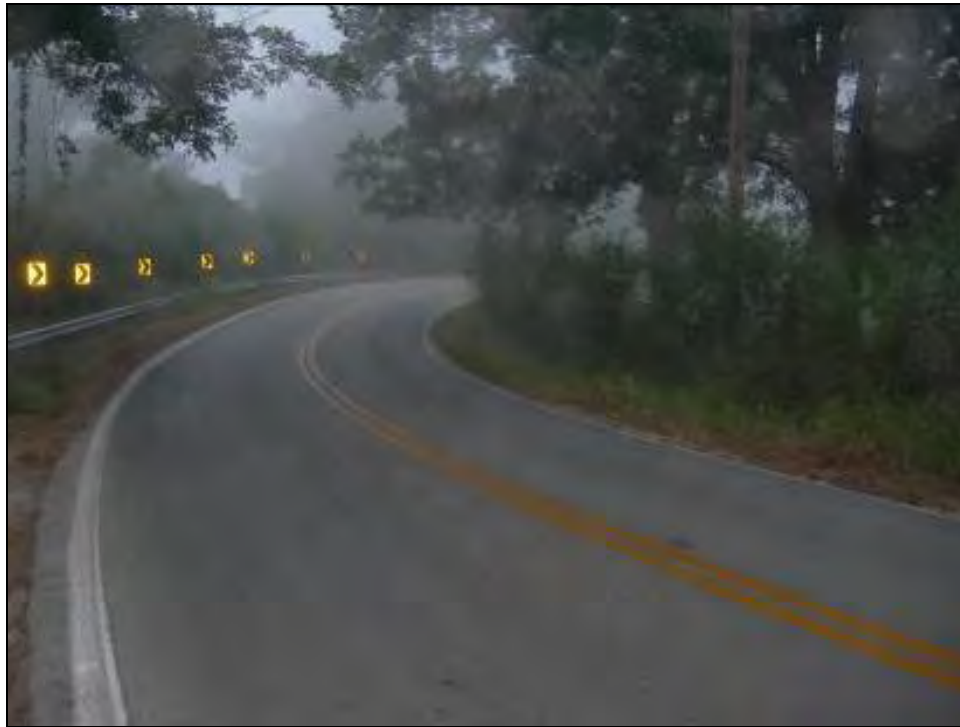
The watershed area at the low point on the curve between Caldwell Lane and River Timber Drive is 47.48 acres as shown on Figure 5-35. The existing low point has no drainage structure and has no outfall channel or pipe to drain runoff from the watershed. All storm events pond within the roadway and right-of-way at the low point of the sag vertical curve as shown in the photo below.

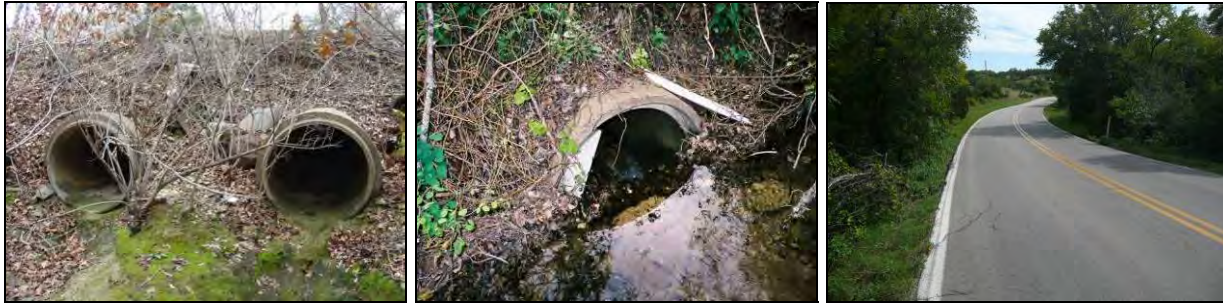
The unnamed tributary to Big Sandy Creek is a large tributary with a watershed area of 448.38 acres at the Nameless Road crossing as shown on Figure 5-36. The existing drainage structure is a typical low water crossing consisting of two shallow 36” RCP at the bottom of a sag vertical curve as shown in the photos below.

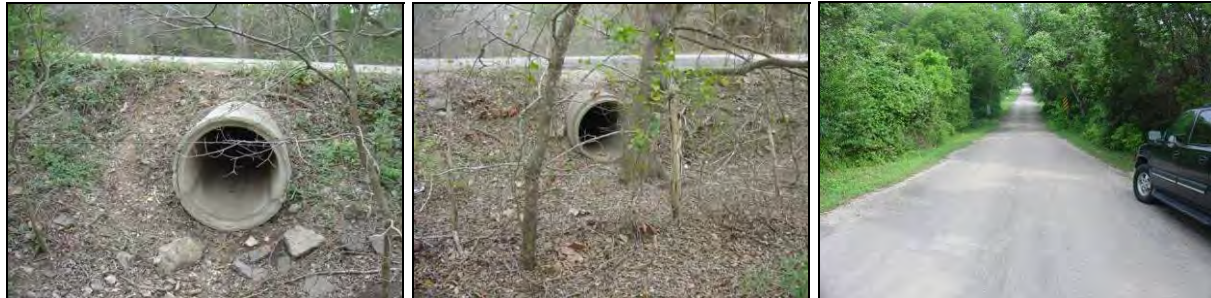
Williamson Creek is a minor waterway with a watershed area of 191.12 acres at the Weir Loop crossing as shown on Figure 5-37. The existing drainage structure is a typical low water crossing consisting of one shallow 36” RCP culvert at the low point of a sag vertical curve as shown in the photos below.

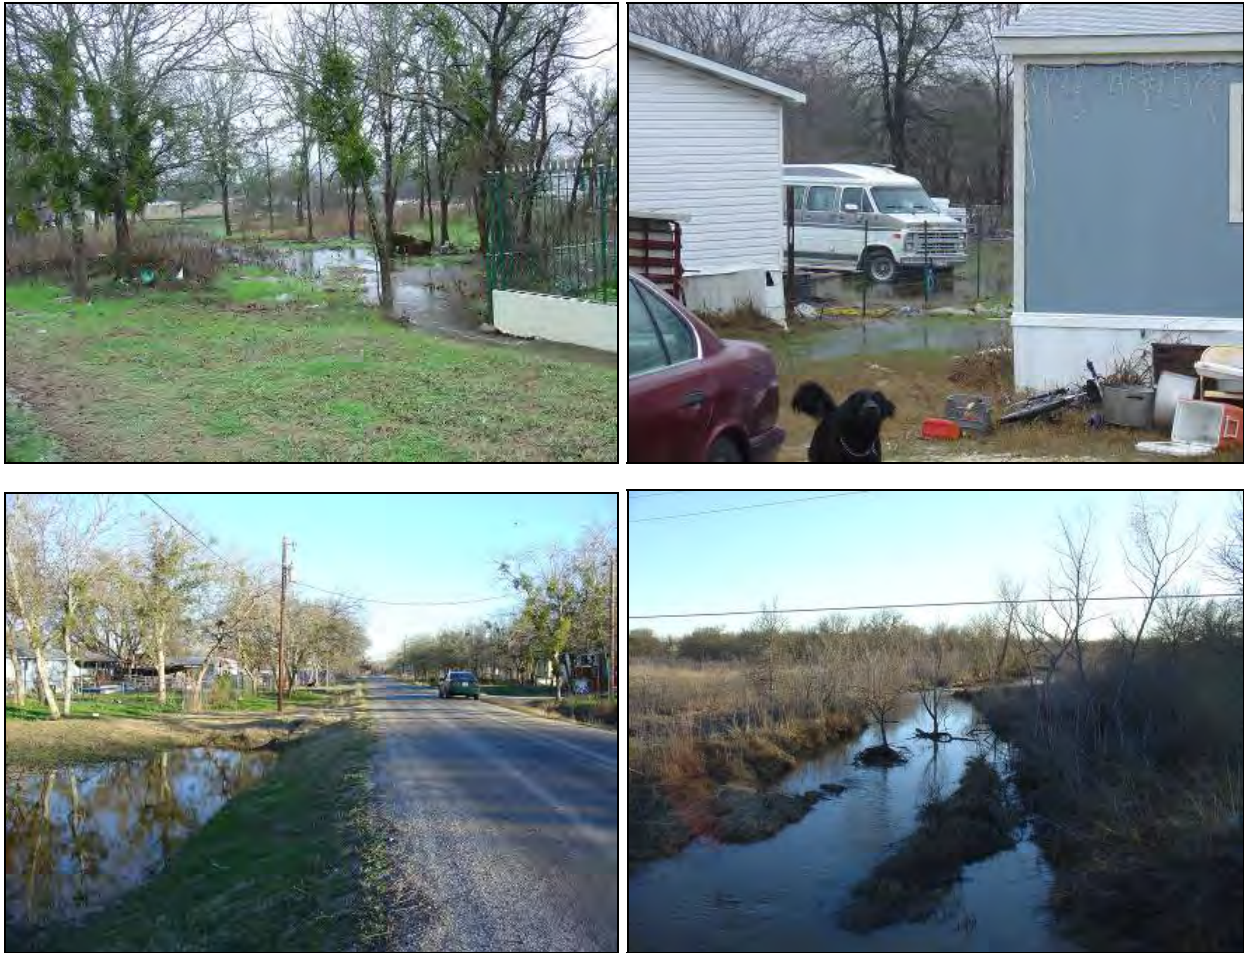
Swiss Alpine Village Subdivision experiences flooding from both major and minor watersheds. The subdivision is situated next to Maha Creek in eastern Travis County with a minor tributary coursing through the middle of the development as shown on the Swiss Alpine Existing Conditions Flooding Analysis map in Appendix B. Approximately 12 habitable structures are within the Maha Creek computed 100-year floodplain. Another 6 habitable structures are located within the computed 100-year floodplain for the minor tributary. The minor tributary also causes frequent and severe overtopping of three residential collector streets within the subdivision. Additionally, there are numerous instances of severe roadway and property flooding within the subdivision due to lack of roadside ditches, cross culverts, and driveway culverts. Some examples of minor flooding after a smaller storm event are shown in the photos below.
