Travis County Drainage Basin Study — Volume 1

Travis County Drainage Basin Study Volume 1

For Arroyo Doble and Twin Creek Park
Subdivision analysis only

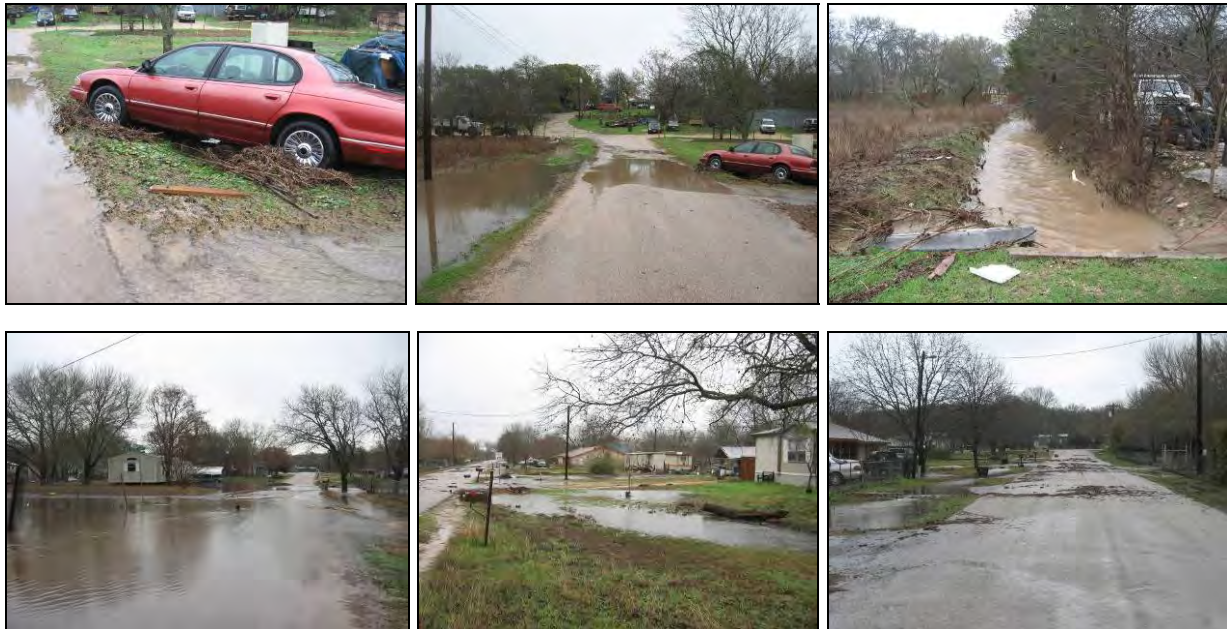
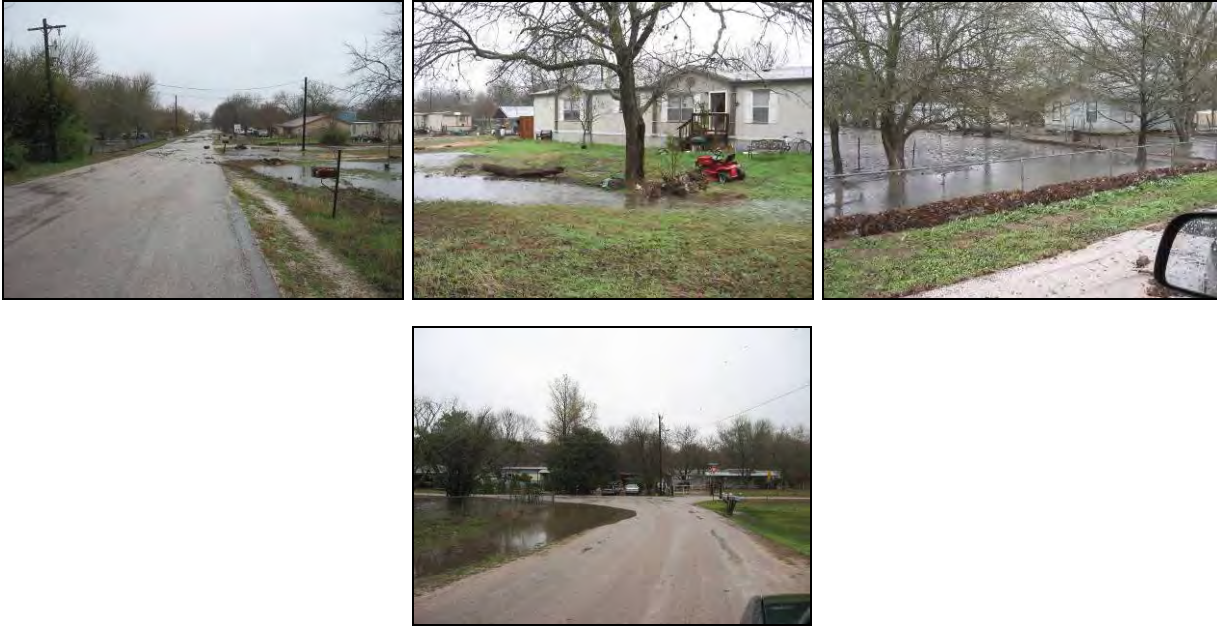
Twin Creek Park Subdivision experiences flooding from mostly minor watersheds. The subdivision is adjacent to Arroyo Doble Subdivision and is also situated near the confluence of Bear Creek and Onion Creek as shown on the Twin Creek Park Existing Flood Areas map in Appendix B. There are numerous instances of severe roadway and property flooding within the subdivision due to the flat terrain and lack of drainage infrastructure. Additionally, two roadway cross culverts experience frequent and severe overtopping within the subdivision. Some examples of flooding from a major storm event in January 2007 are shown in the photos below.

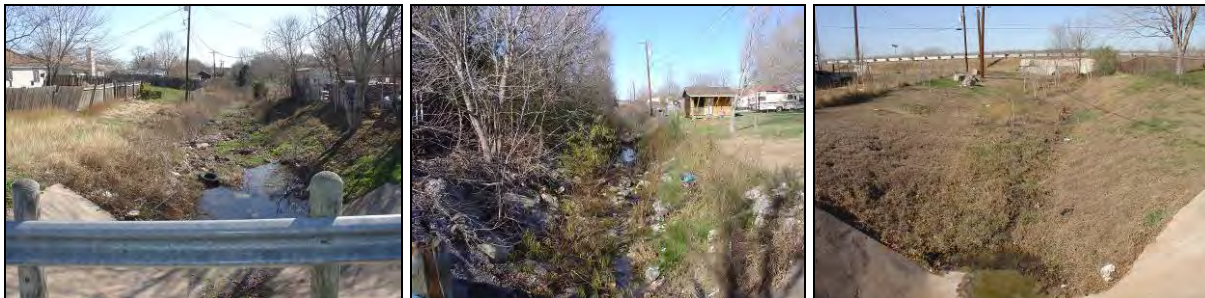
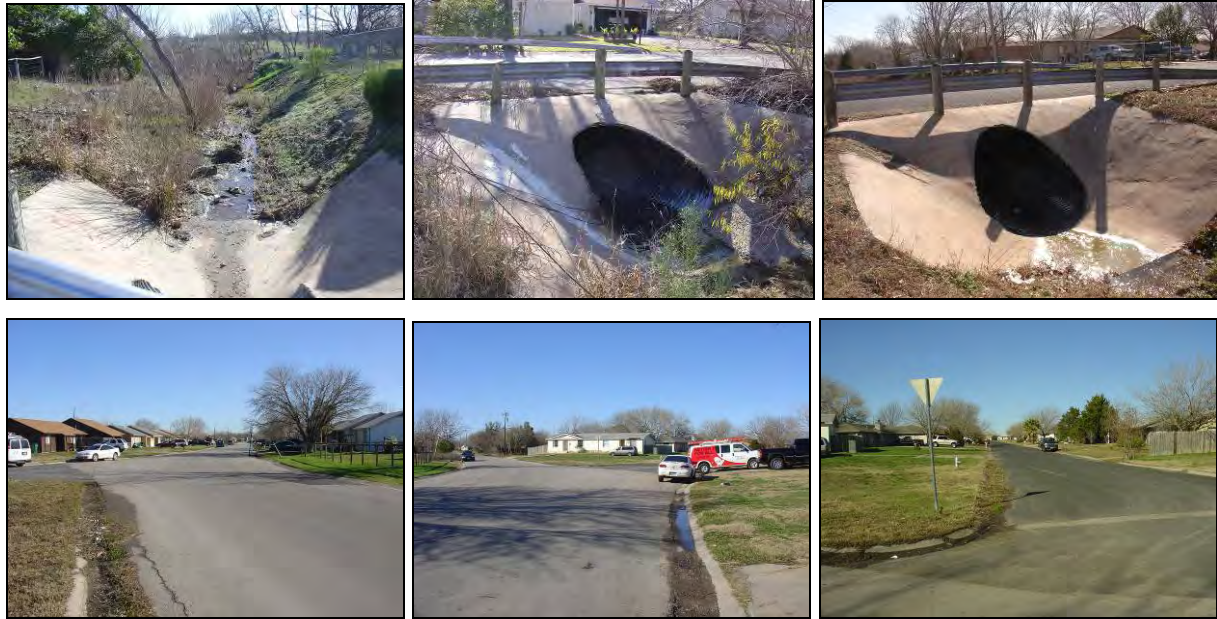
Thoroughbred Farms Subdivision is situated next to the South Fork of Dry East Creek in eastern Travis County with a large manmade channel running through the middle of the development as shown on the Thoroughbred Farms Subdivision Existing Conditions Flooding Analysis map in Appendix B. Funding was approved by Travis County for acquiring a portion of approximately 12 habitable structures that were previously identified by the County as having repeated flood damage as mentioned in Section 1.4. The large manmade channel causes roadway and property flooding within the subdivision due to the lack of channel and culvert capacity. One habitable structure is within the computed 100-year floodplain of the large channel. Two roadway cross culverts experience frequent and moderate overtopping. Additionally, there are several areas of frequent roadway and property flooding within the subdivision due to lack of a street drainage system. Photos of the manmade channel, deficient culverts, and streets are shown below.

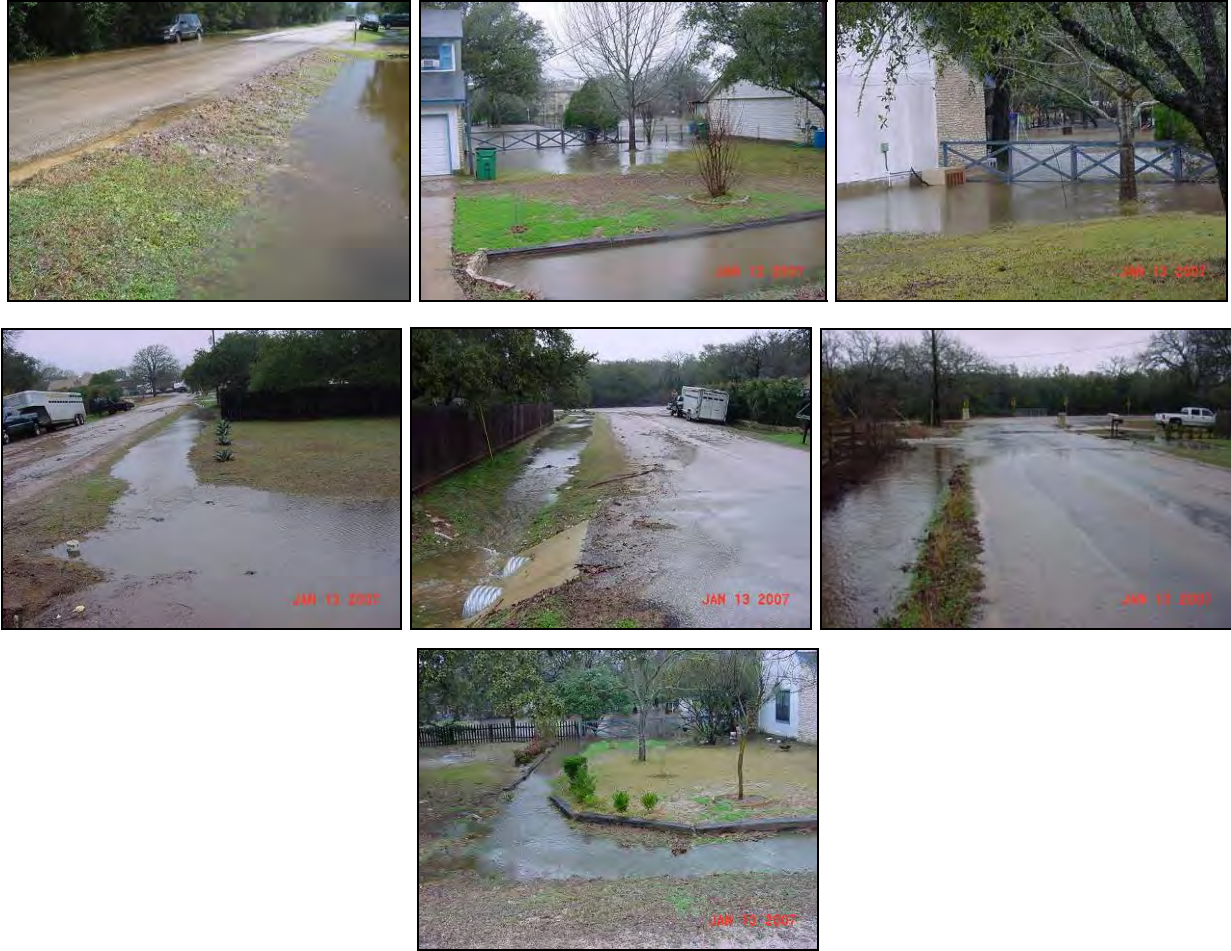
Southwest Territory Subdivision experiences flooding from mostly minor watersheds. The subdivision is situated near Little Bear Creek in southern Travis County with a minor tributary coursing through the middle of the development as shown on the Southwest Territory Subdivision Existing Conditions Flooding Analysis map in Appendix B. Approximately 10 habitable structures are within the computed 100-year floodplain of the minor tributary. The minor tributary also causes frequent overtopping of two residential streets within the subdivision. Additionally, there are numerous instances of frequent roadway and property flooding within the subdivision due to lack of roadside ditches, cross culverts, and driveway culverts. Some examples of flooding from previous storm events are shown in the photos below.

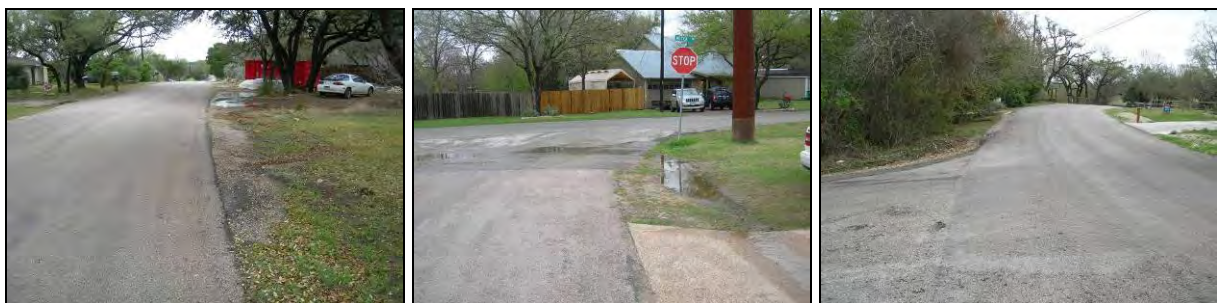
Austin Lake Estates is a large residential development in central Travis County that experiences flooding from mostly minor watersheds. The subdivision is adjacent to Lake Austin with several minor tributaries coursing through the development as shown on the Austin Lake Estates Existing Conditions Flooding Analysis maps in Appendix B. There are numerous instances of frequent roadway and property flooding within the subdivision due to lack of roadside ditches, cross culverts, and driveway culverts. Photos of some of the problem areas are shown below.
