**Monitoring Program to Evaluate Water Quantity/Quality Impacts
of Vegetation Restoration in the Leon River Watershed**

Final Report

Texas Agricultural Experiment Station /
Blackland Research and Extension Center

May, 2005

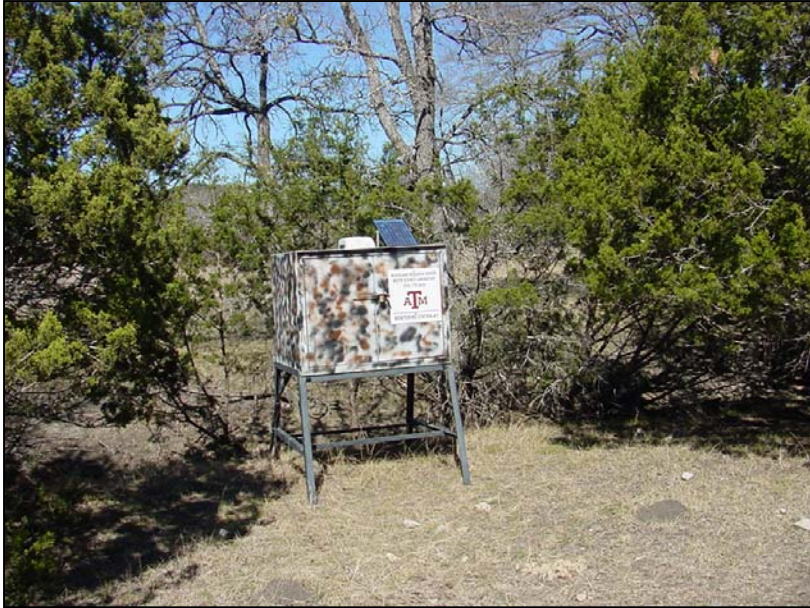
Figure 2. Water monitoring station

- 1) ISCO 4230 Bubble Flow Meter
 - 2) ISCO 3700 Automated Water Sampler
 - 3) Texas Electronics Tipping bucket rain gauge
 - 4) Remote power system (180 Amp hour Deep Cycle Marine Battery and Solarex 10 watt Solar Panel)

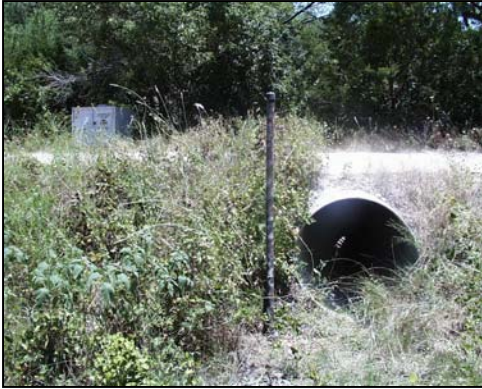
Station LRP1 (Cook Canyon) – Located in the Coryell Creek Sub-Watershed. This is a treatment watershed containing approximately 140 acres with 75 acres of brush. Round culvert at the drainage point is utilized as a primary measuring device for determining storm flow.

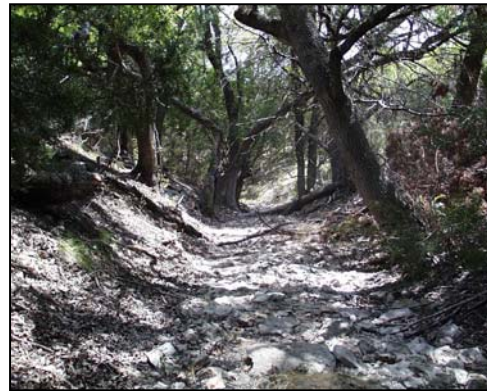
Station LRP2 (Sutton Canyon) – Located in the Coryell Creek Sub-Watershed. This is a control watershed containing approximately 65 acres. Vegetation will not be removed until the termination of the project. A level to area discharge curve has been developed to determine storm flow at this location.

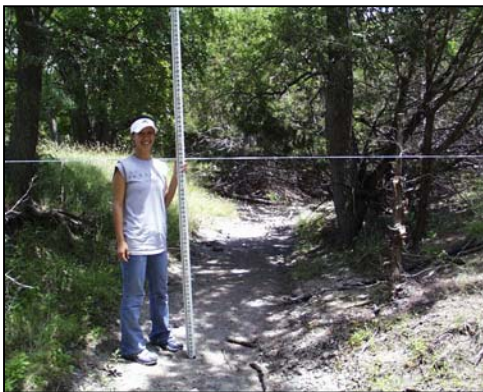
Station LRP3 (Hall Ranch) – Located in the Bullard Creek Sub-Watershed and contains approximately 550 acres. With no primary flow device available, a level to area discharge curve has been developed to measure storm flow in this irregular channel.

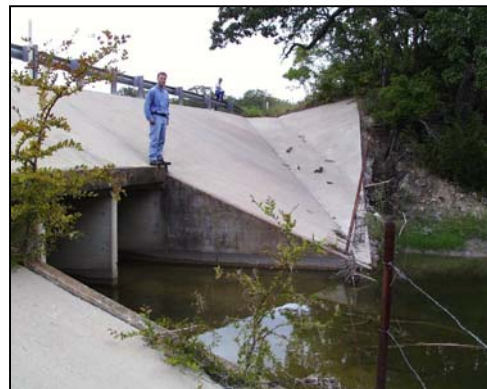
Station LRP4 (TX Hwy 183) – This basin is Paired with Station 3 and is located on the Bullard Creek Sub-Watershed. It contains approximately 4900 acres and drains through a large square culvert which acts as a primary measuring device for determining storm flow.

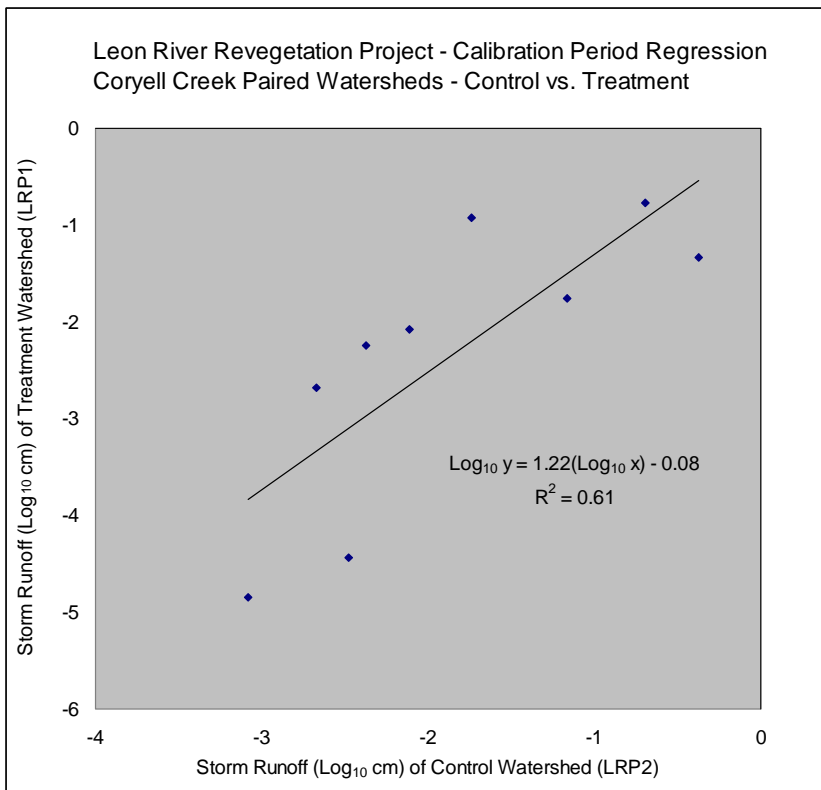
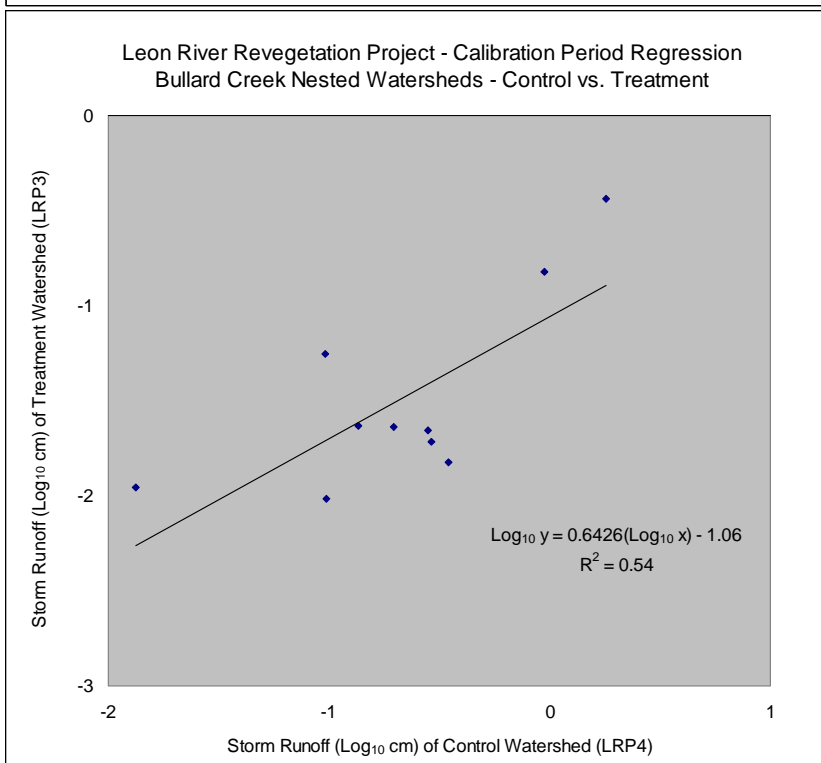
Figures 3 and 4. Comparisons of storm discharge from control watersheds verses storm discharge from treatment watersheds in Coryell paired and Bullard Creek nested Watersheds during the calibration (pre BMP) period

- The original calibration regression coefficients were reported to have exhibited quantifiable relationships between treatment and control watersheds (Figures 3 and 4). While the linear fits appeared to be reasonable for natural systems ($r^2 = 0.61$ and 0.54 , for Coryell and Bullard Creek watersheds respectively), a closer examination of data variation indicated that they were not sufficient to detect runoff differences due to the BMP of less than ~47% (using Equation 9 in EPA "Paired Watershed Study Design"). These relationships were expected to improve as more data were gathered from successive runoff events. This, however, was not the case.

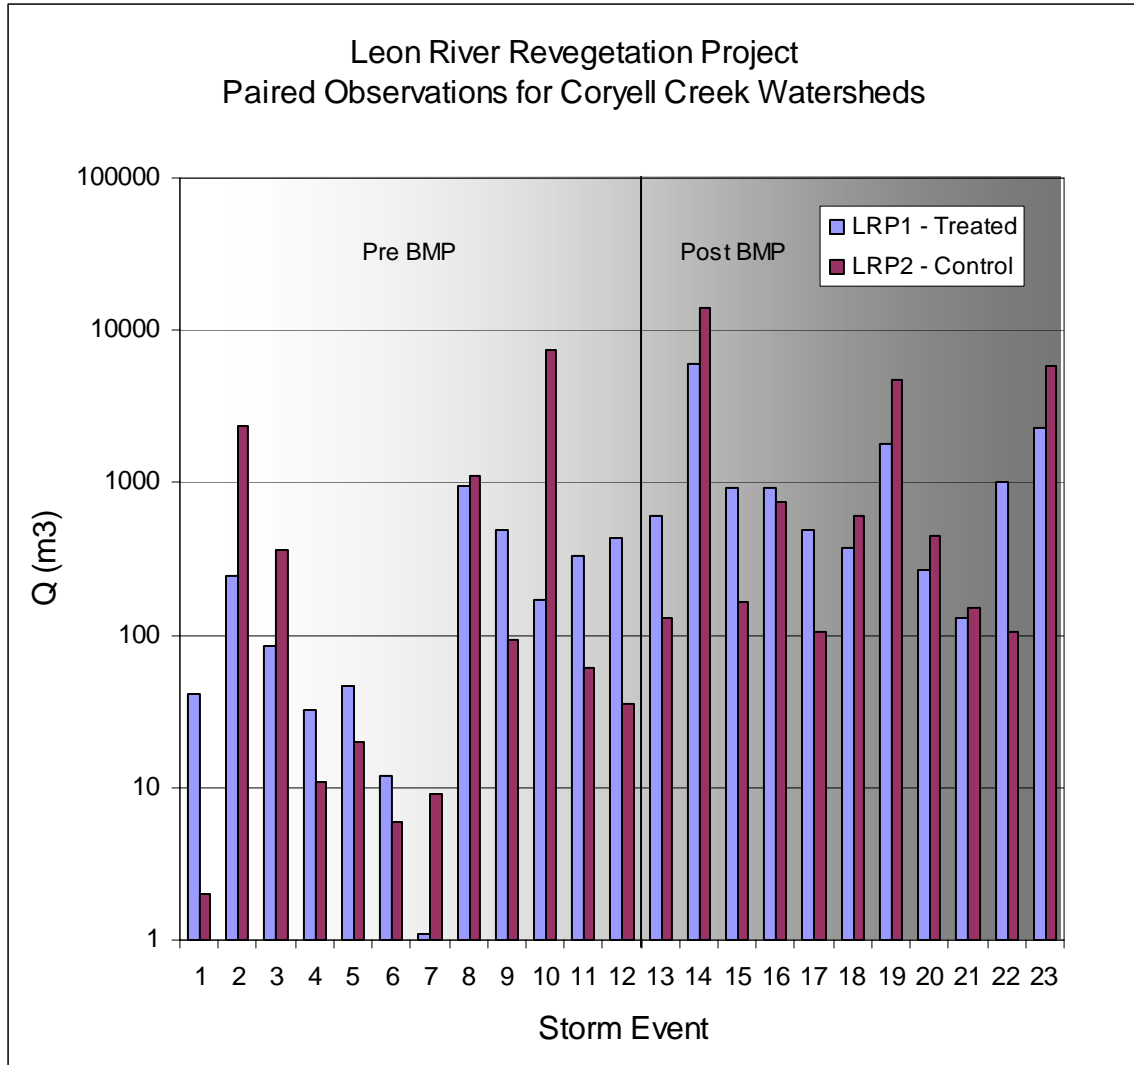
Figure 5. Histogram for Coryell Creek paired watersheds (LRP1 & 2). Five minute data interval based stormwater discharge volumes (Q) pre and post BMP establishment (clearing of Ashe Juniper), for individual storm events producing runoff on both watersheds. Note use of log scale.

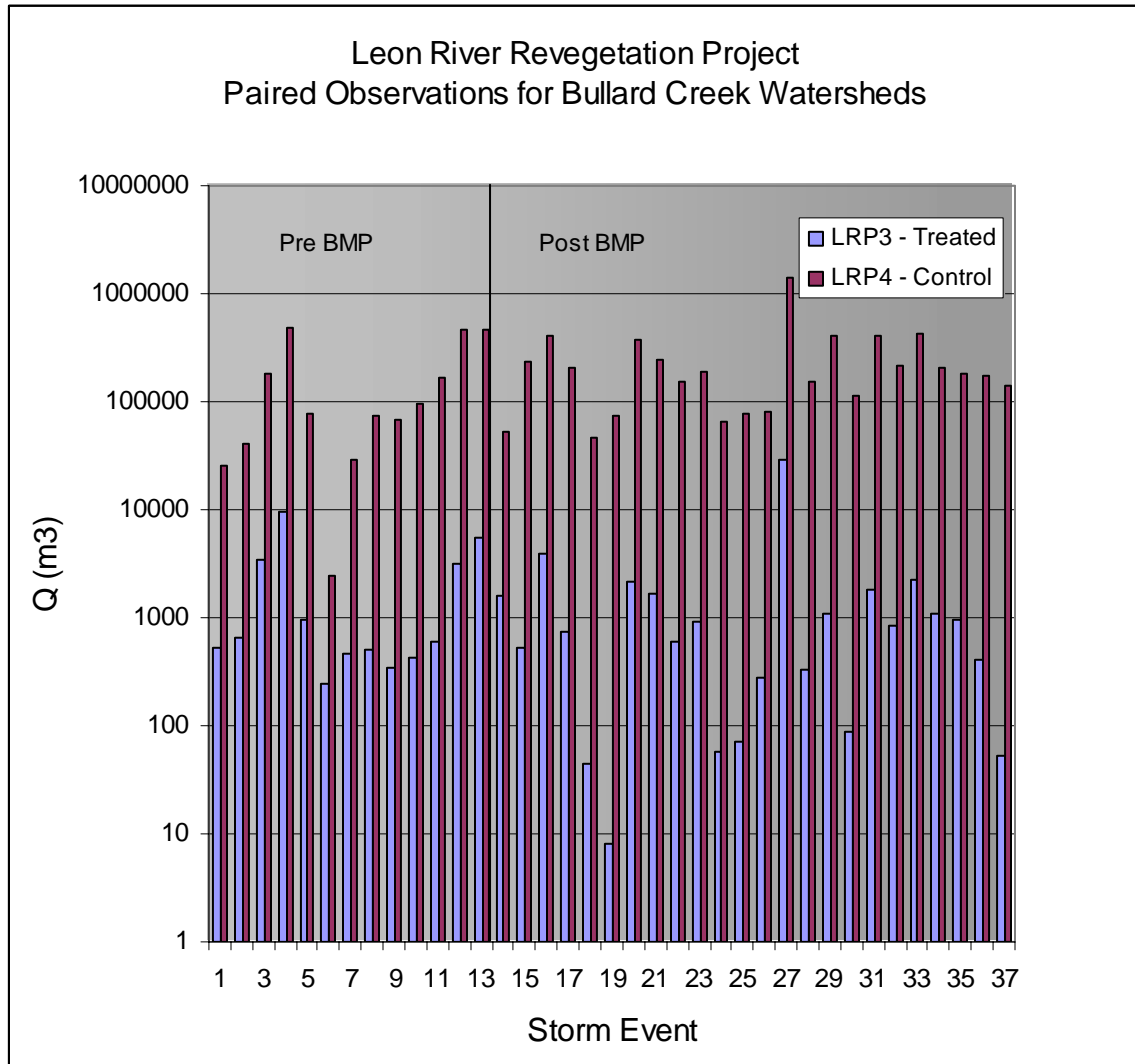
Figure 6. Histogram for Bullard Creek nested watersheds (LRP1 & 2). Five minute data interval based stormwater discharge volumes (Q) pre and post BMP establishment (clearing of Ashe Juniper), for individual storm events producing runoff on both watersheds. Note use of log scale.

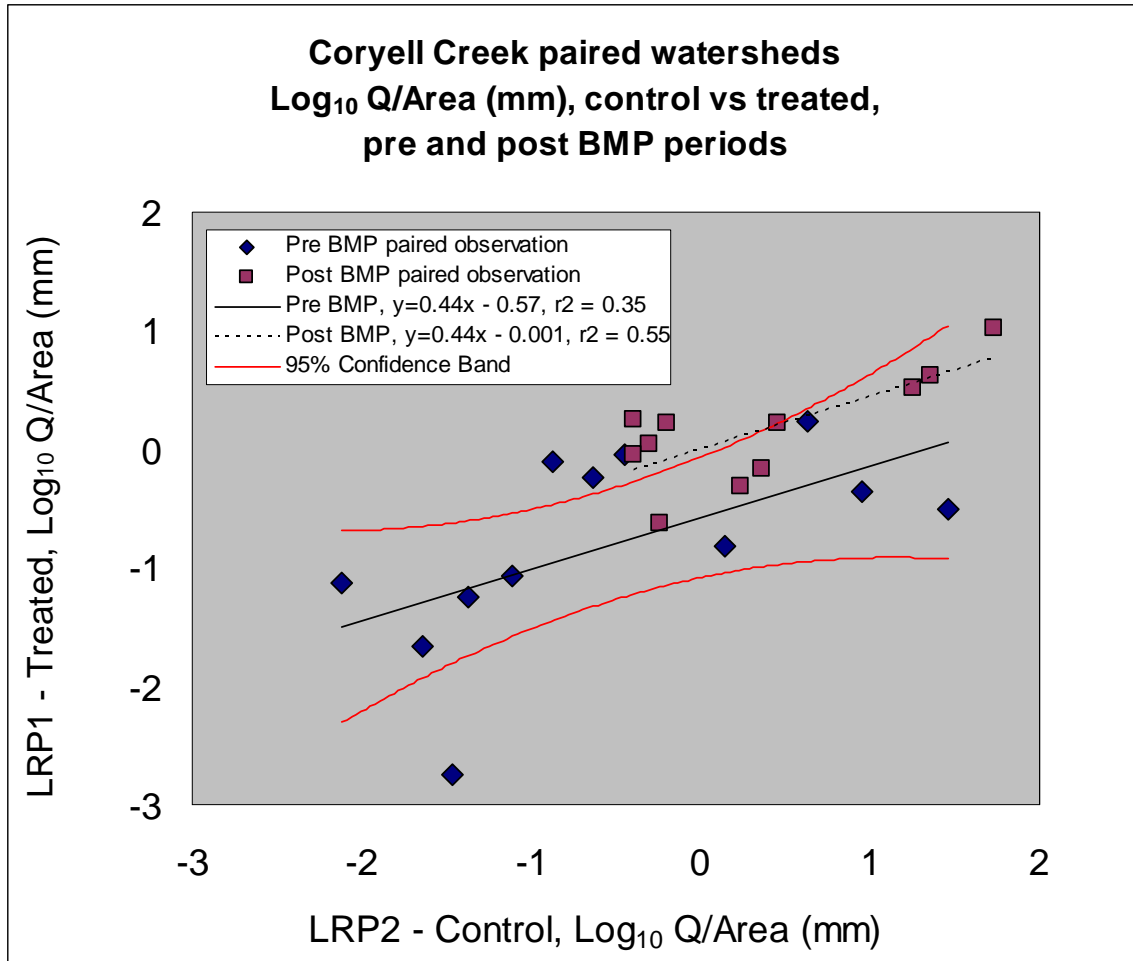
Figure 9. Coryell Creek paired watersheds; Log₁₀ stormwater runoff (Q/Area, expressed in millimeters) with linear regressions and 95% confidence band for control (LRP2) versus treatment (LRP1) watersheds during pre and post BMP periods. Paired runoff observations are log-log transformed to approach normal distribution.

The Pre BMP ANOVA indicates that the regression model adequately explains most of the variability in the paired runoff data ($F_{1, 10} = 5.28$, $p = 0.044$). The Post BMP ANOVA also explains most of the variability in the paired runoff data ($F_{1, 9} = 10.97$, $p = 0.009$) with an improved regression relationship. The regression coefficients of determination (r^2) were 0.35 and 0.55 for the pre and post BMP treatment periods respectively (Figure 9). Given the amount of pre BMP data collected, the ratio between the residual variance for the pre BMP regression and the smallest detectable difference due to the BMP was determined to be > 80% (from Equation 9 in EPA "Paired Watershed Study Design"). That is, the amount of variation in the pre BMP data would require a change of > 80% in runoff to statistically infer an effect due to the BMP. The 95% confidence bands about the pre BMP regression equation indicate the level of change necessary to have a significant treatment effect for any paired observation (i.e. how far away from the pre BMP regression does the post BMP data need to be to infer statistical significance?). The 95% confidence band is shown in Figure 9.

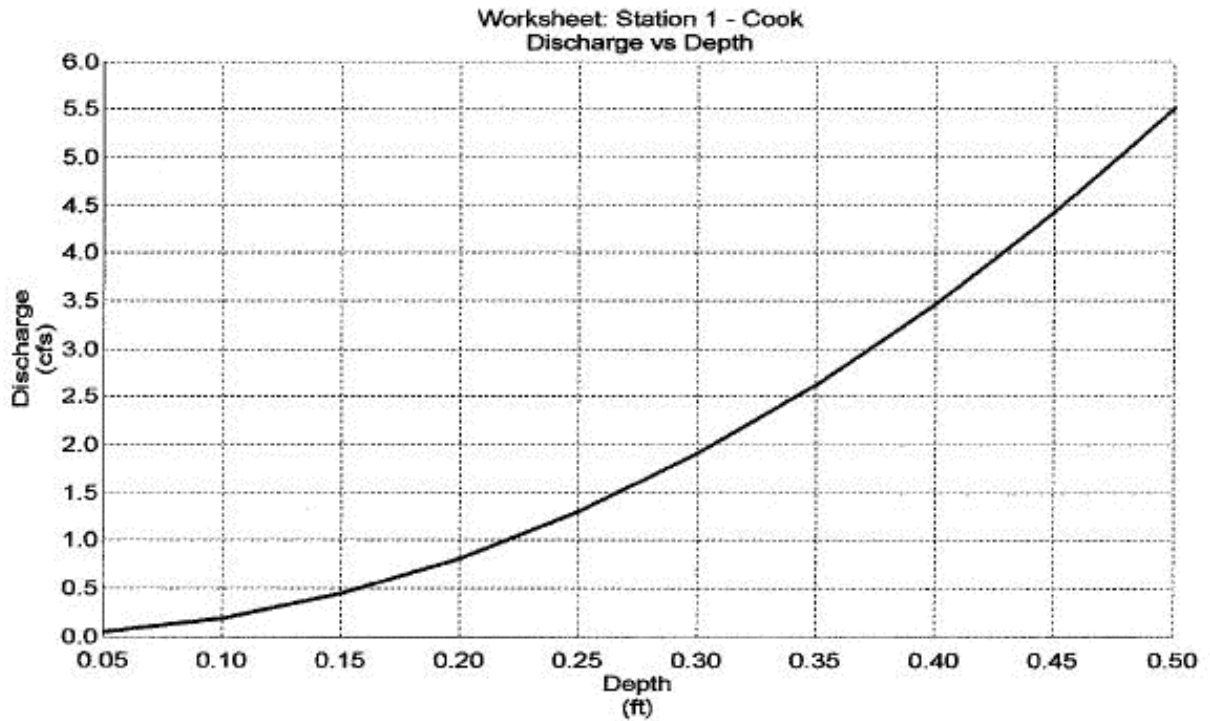
Table
Rating Table for Circular Channel

Project Description	
Worksheet	Station 1 - Cook
Flow Element	Circular Chann
Method	Manning's Forr
Solve For	Discharge

Input Data	
Mannings Coeffic	0.013
Slope	018667 ft/ft
Diameter	36 in

Attribute	Minimum	Maximum	Increment
Depth (ft)	0.00	0.50	0.05

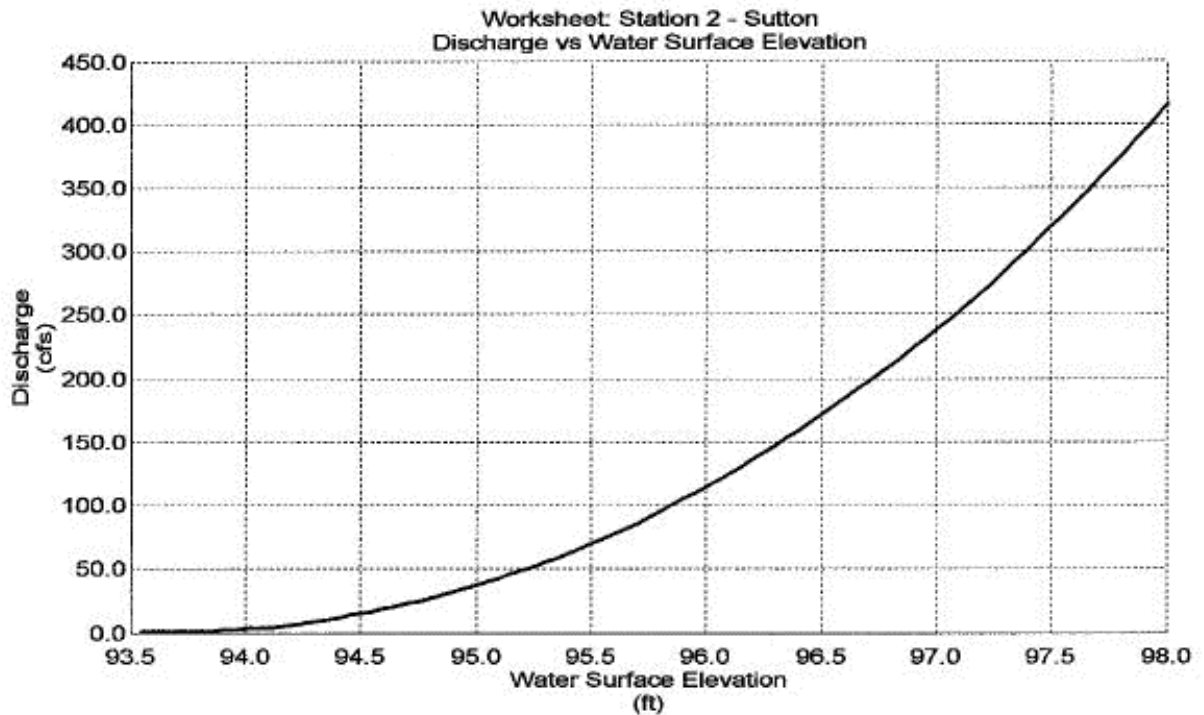
**Table
Rating Table for Irregular Channel**

Project Description	
Worksheet	Station 2 - Sutton
Flow Element	Irregular Chann
Method	Manning's Form
Solve For	Discharge

Options	
Current Roughness Method	Used Lotter's Method
Open Channel Weighting	Used Lotter's Method
Closed Channel Weighting	Horton's Method

Attribute	Minimum	Maximum	Increment
Water Surface Elevation	93.50	98.00	0.05

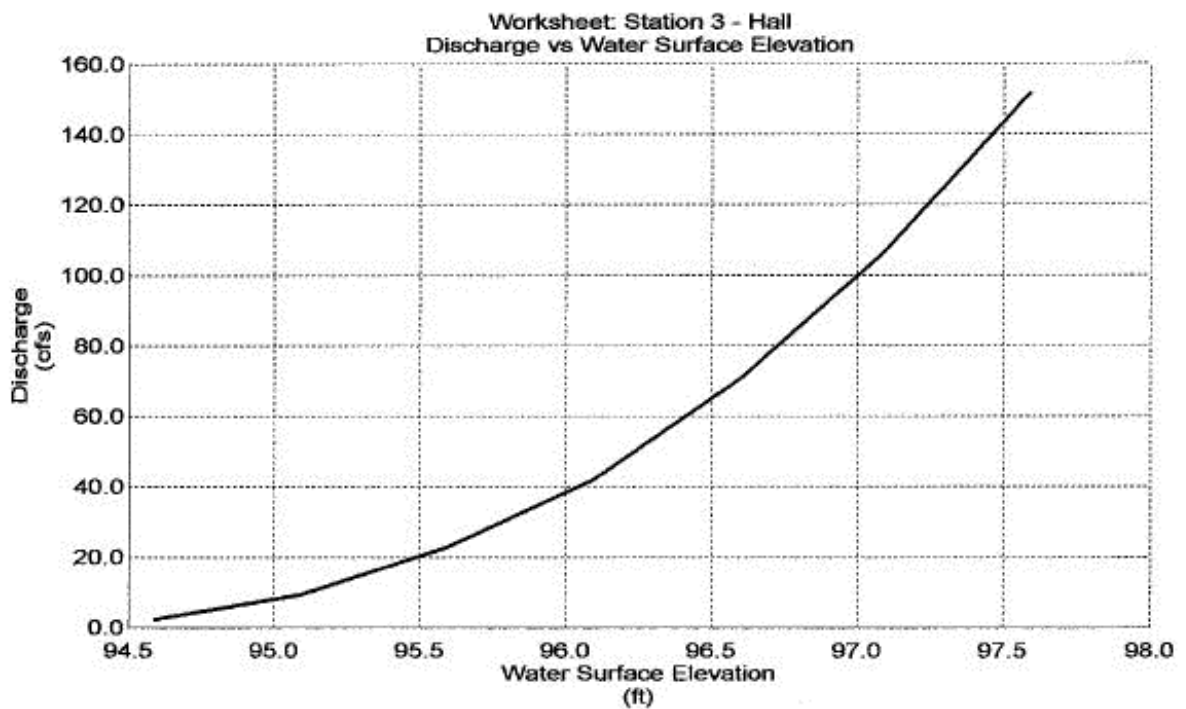
Table
Rating Table for Irregular Channel

Options	
Current Roughness Method	oved Lotter's Method
Open Channel Weighting	oved Lotter's Method
Closed Channel Weighting	Horton's Method

Attribute	Minimum	Maximum	Increment
Water Surface Elevat	94.09	98.00	0.50

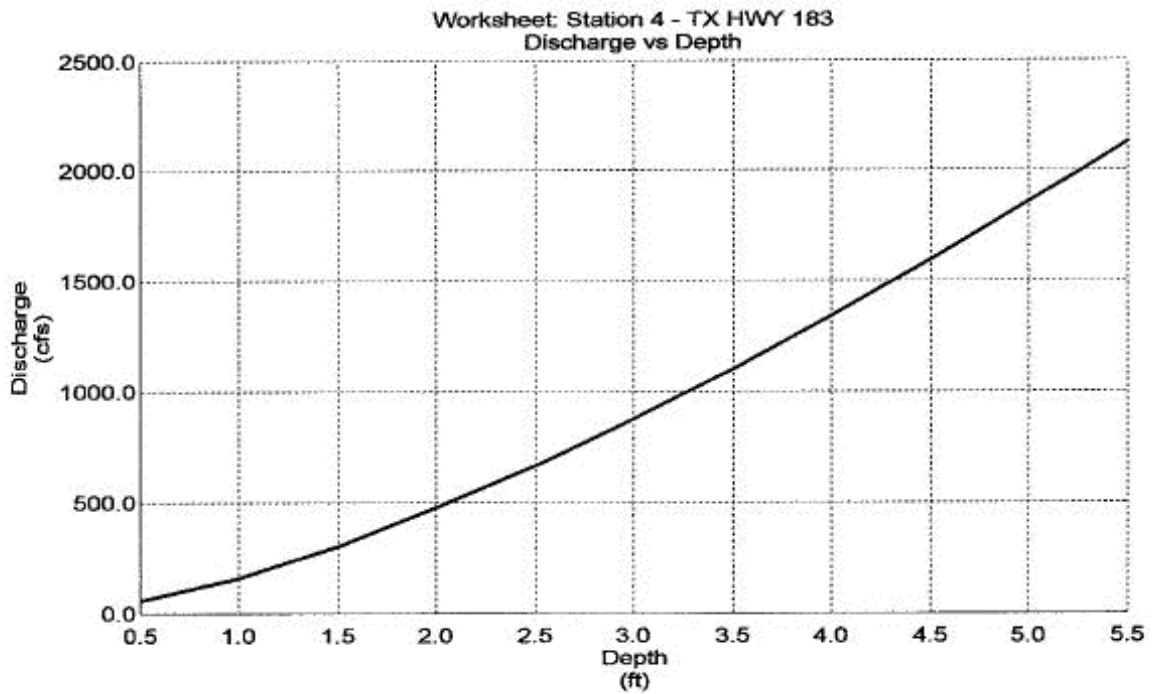
**Table
Rating Table for Rectangular Channel**

Project Description	
Worksheet	Station 4 - TX HWY
Flow Element	Rectangular Chanr
Method	Manning's Formula
Solve For	Discharge

Input Data	
Mannings Coeffic	0.015
Slope	009130 ft/ft
Bottom Width	18.00 ft

Attribute	Minimum	Maximum	Increment
Depth (ft)	0.00	5.50	0.50
