**Volumetric and
Sedimentation Survey
of
LAKE GRANBURY**

May – June 2015 Survey

August 2016

Texas Water Development Board

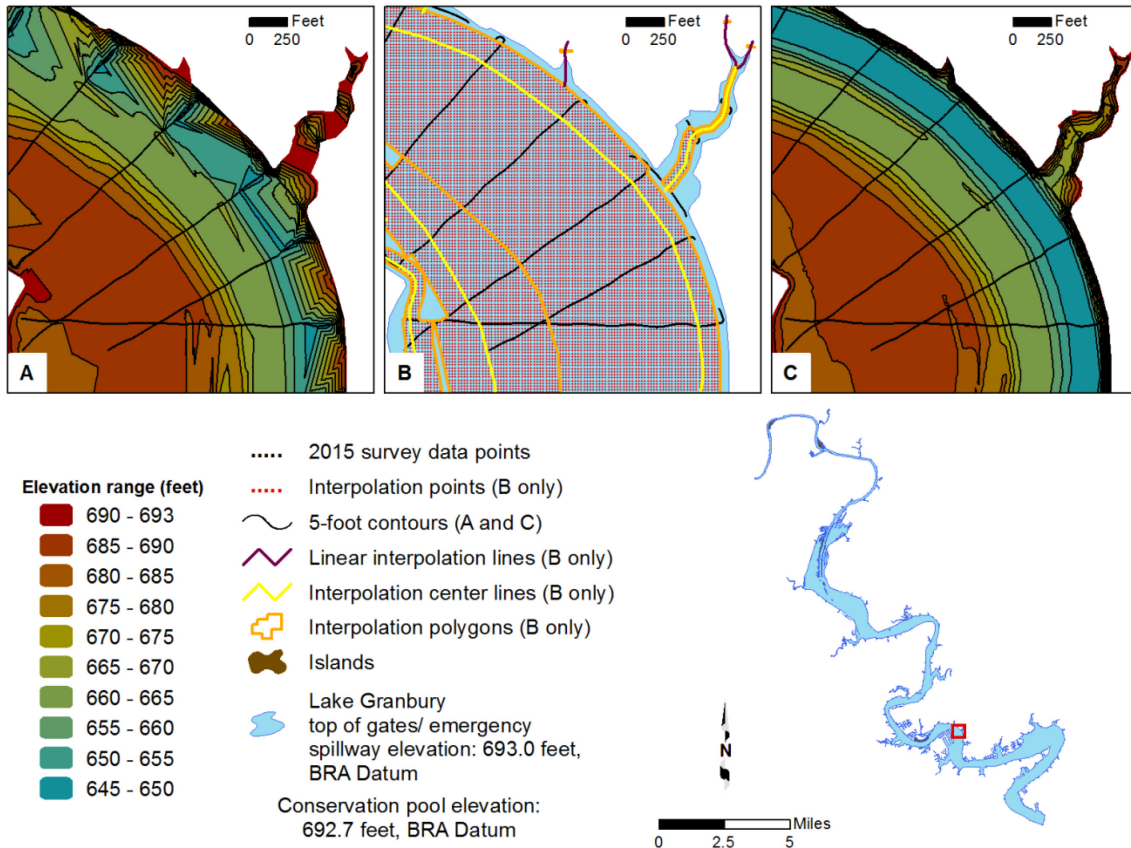
Figure 3. Anisotropic spatial interpolation and linear interpolation of Lake Granbury sounding data; A) bathymetric contours without interpolated points, B) sounding points (*black*) and interpolated points (*red*), C) bathymetric contours with interpolated points.

Figure 3 illustrates typical results from application of the anisotropic interpolation and linear interpolation techniques to Lake Granbury. In Figure 3A, deeper channels and steep slopes indicated by surveyed cross-sections are not continuously represented in areas between survey cross-sections. This is an artifact of the TIN generation routine rather than an accurate representation of the physical bathymetric surface. Inclusion of interpolation points in creation of the volumetric TIN model, represented in Figure 3B, directs Delaunay triangulation to better represent the reservoir bathymetry between survey cross-sections. The bathymetry shown in Figure 3C was used in computing reservoir elevation-capacity (Appendix A) and elevation-area (Appendix B) tables.

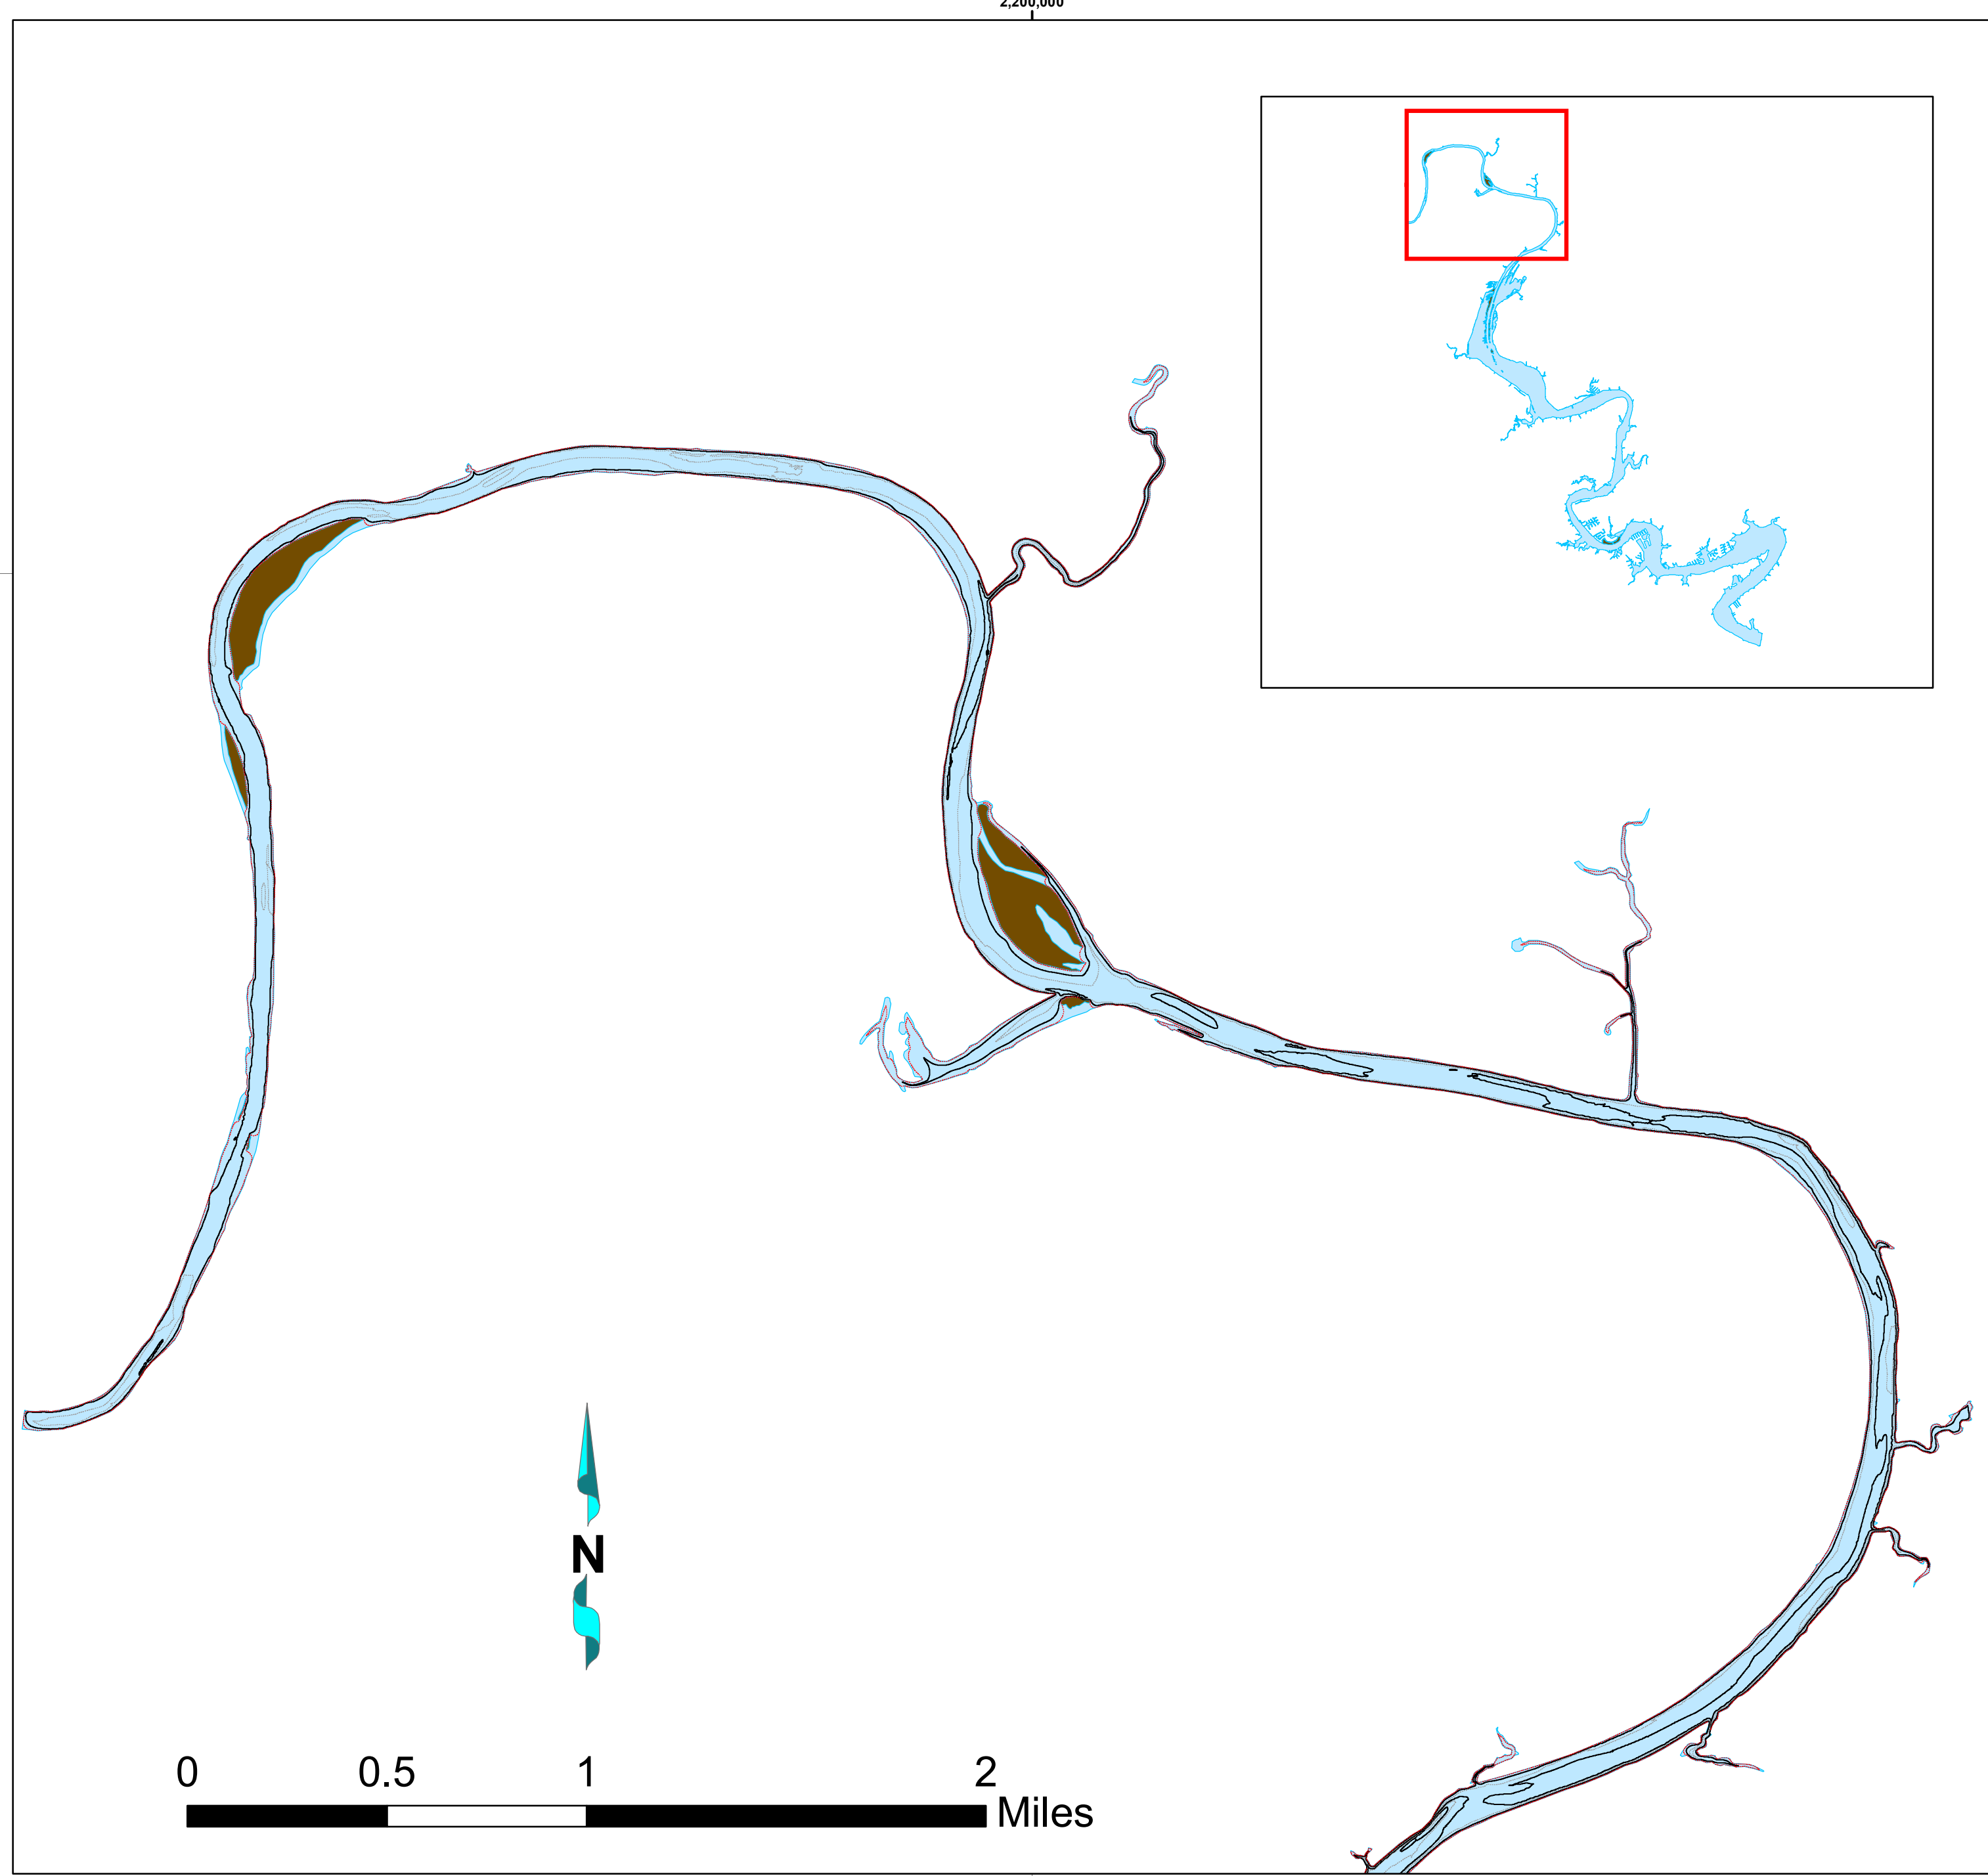
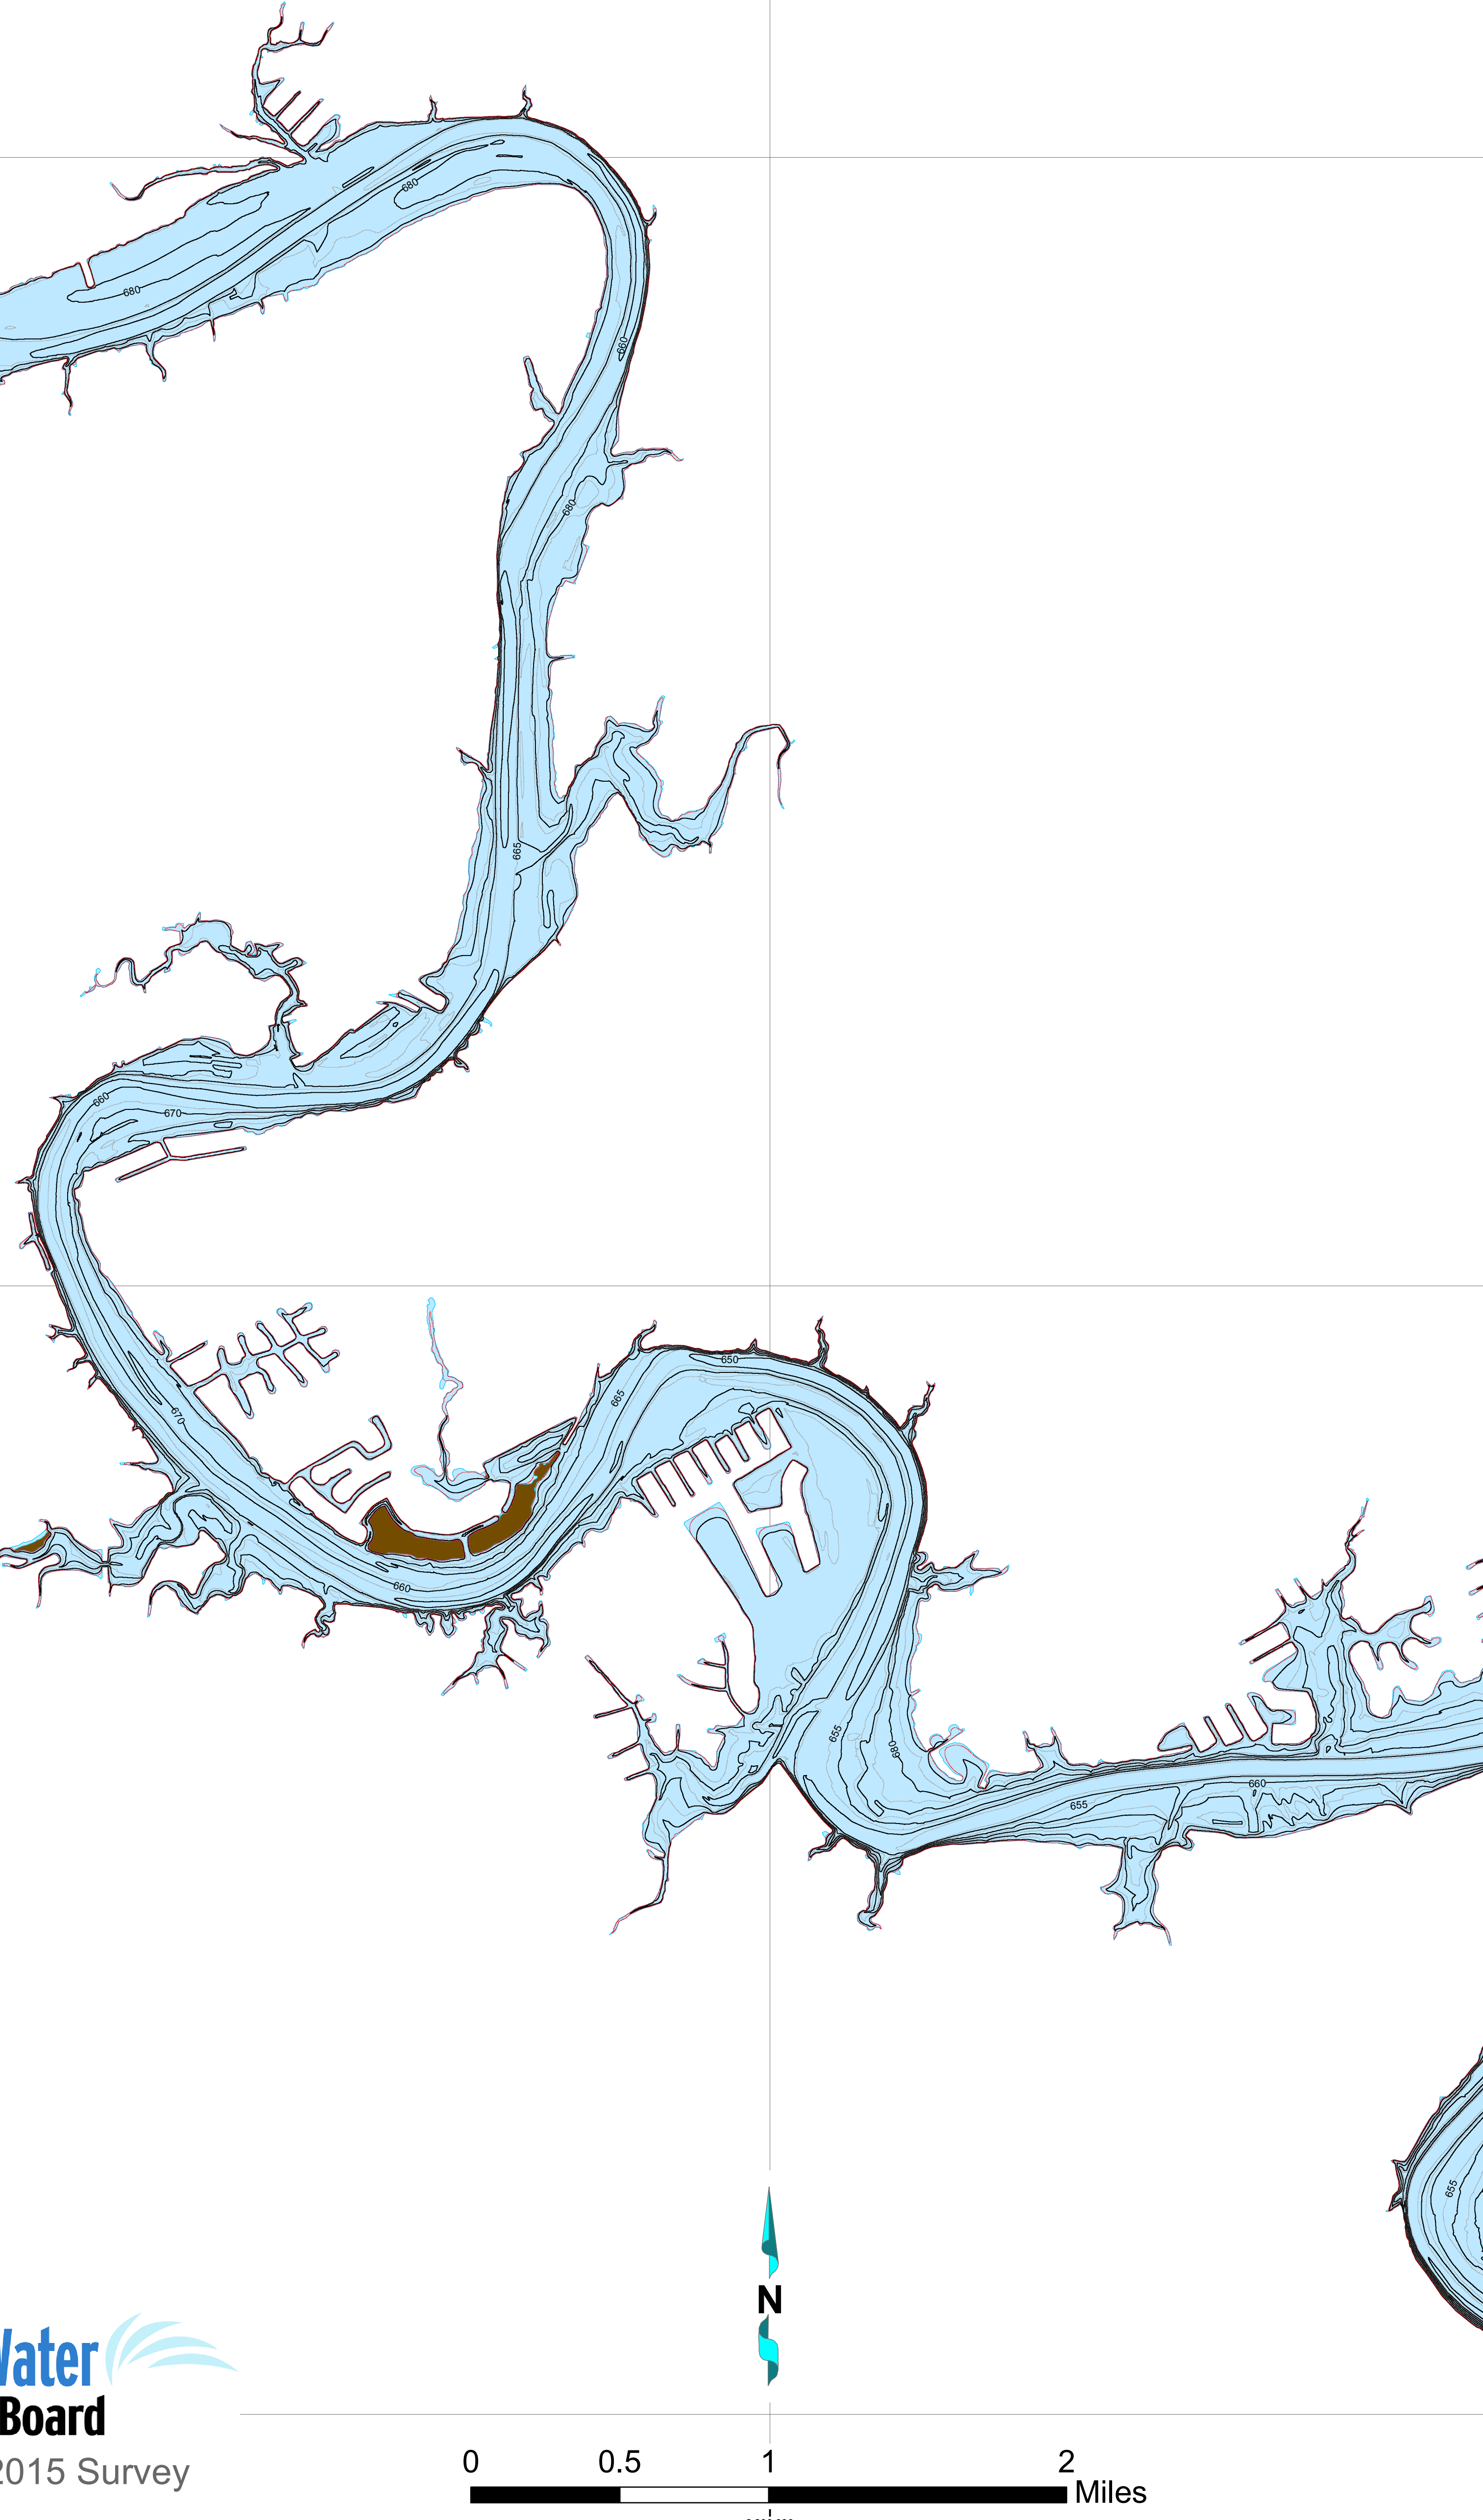
Figure 6
Contours
(feet, BRA Datum)

5' - contour map

Lake Granbury top of gate/ emergency spillway elevation: 693.0 feet, BRA Datum

The volumetric TIN model was converted to a raster representation using a cell size of two feet by two feet. The raster data was then used to produce three figures: (1) an elevation relief map representing the topography of the reservoir bottom (Figure 4); (2) a depth range map showing shaded depth ranges for Lake Granbury (Figure 5); and, (3) a five-foot contour map (Figure 6).
