QUARTERLY PROGRESS REPORT NO. 5 Victoria ASR Demonstration Project

Subject:
Quarterly Progress Report for the Victoria ASR Demonstration Project (**Contract No. 1600011958**) for **October 1, 2017 through December 31, 2017**.

The Victoria Aquifer Storage and Recovery (ASR) Demonstration Project is being partially funded by the Texas Water Development Board (TWDB) under Rider 25 to HB 1 (General Appropriations Act) of the 84th Legislature. The “Project” generally consists of: permitting, designing, and constructing an ASR retrofit to an existing City of Victoria groundwater production well (Well No. 19); constructing a potable water pipeline for recharge and recovery purposes; conducting training and preparing an operation and maintenance (O&M) manual; cycle testing and assessment of the operational ASR well; and making presentations summarizing results. The Project Contractor is the Victoria County Groundwater Conservation District (the “Victoria County GCD”) and the primary Project Participant is the City of Victoria, Texas (the “City”). The Project consulting and engineering team consists of Arcadis U.S., Inc.; ASR Systems, LLC; and INTERA, Inc. (the “Arcadis Team”).

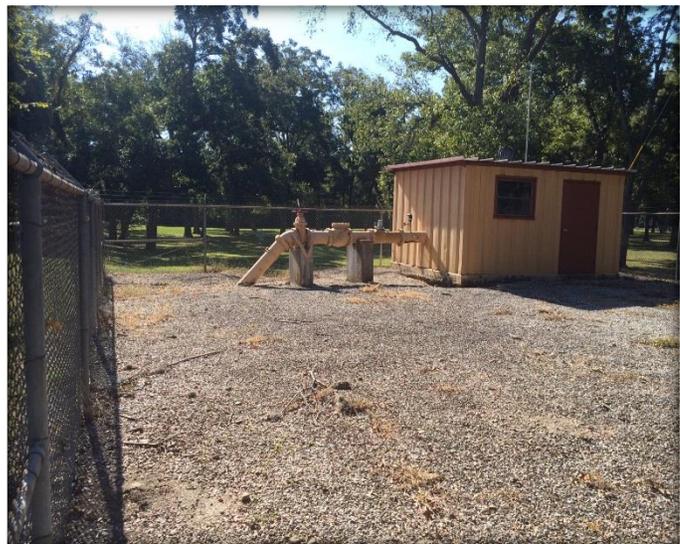
Figure 1: Existing Well 19 Pumphouse and Piping

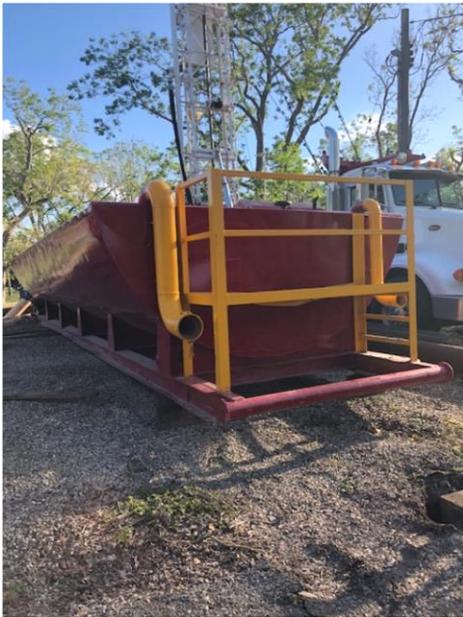
Figure 2: Frac Tank—Used to Collect and Stabilize Acid From the Well

Therefore, Weisinger, the City and the Arcadis Team developed a modified rehabilitation approach that included aggressive treatment with 15 percent hydrochloric acid and an acid enhancer. This approach should provide sufficient surging without the risk of using downhole equipment and damaging the casing. On December 4, 2017 Weisinger began the well rehabilitation process by installing a temporary 10-inch pipe from about 410 feet bgs to the ground surface to act as an educator pipe for airlift surging and jetting. A frac tank was also moved on site. See photos below. In addition, a mud pump and diffuser pipe were used to move fluid downhole under pressure. By December 22, 2017, the well rehabilitation had been completed. The next step will be to conduct a second video log of the well to document the results of the rehabilitation and the condition of the well.

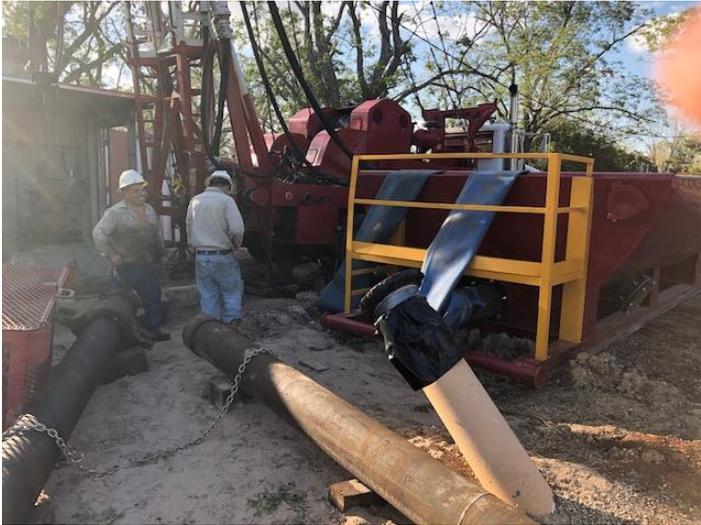
Figure 3: Piping Used For Acidization and Jetting of Well 19
