LiDAR Acquisition and Flow Assessment for the Middle Trinity River

For: Trinity and San Jacinto Rivers and Galveston Bay Stakeholder Committee through the Texas Water Development Board

Contract No. 1400011696

Final Report – October 15, 2015

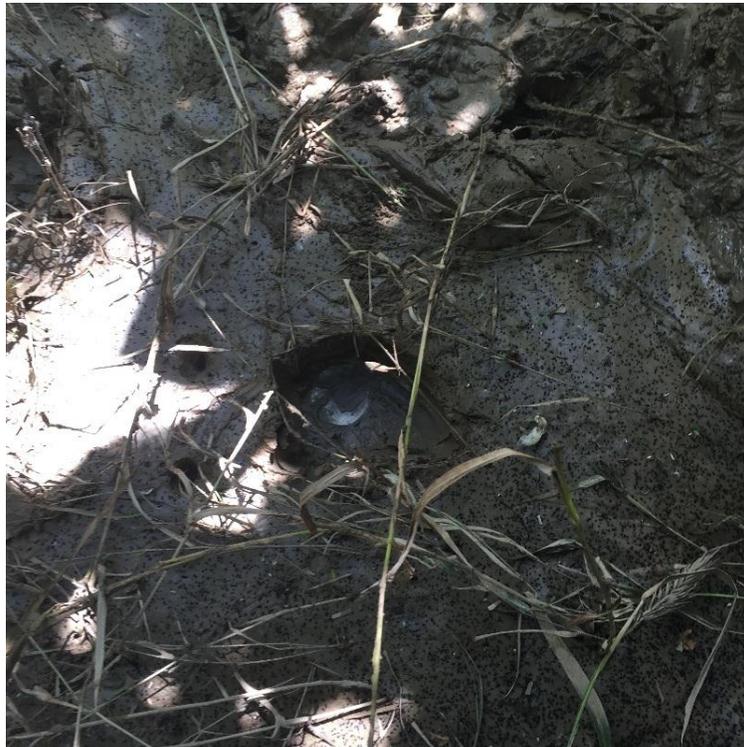
Figure 12. Deposition on top of a benchmark at 080444.

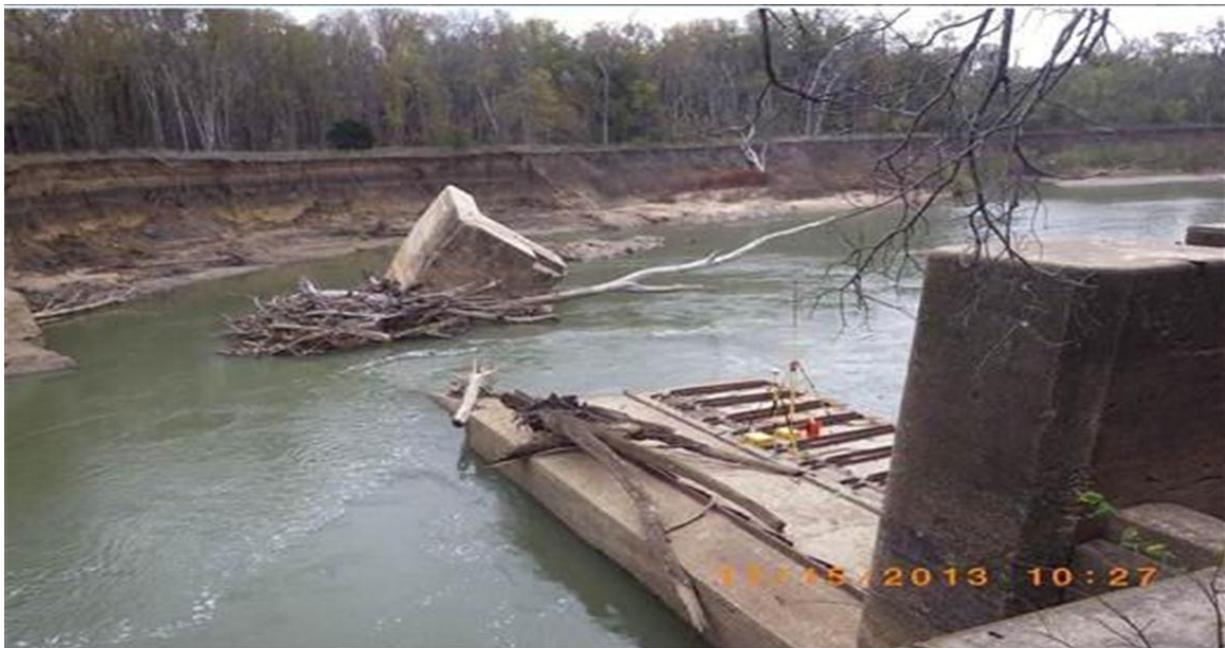
Figure 23. Photograph showing the river flanking the historic lock structure. Downstream is towards the right.

Significant changes in the channel were observed and are expected to continue as the system adjusts to the recent slope changes caused by the failure of the relic USACE Lock 3 structure located between Cross-sections 4 and 5 within this site (Figure 23).

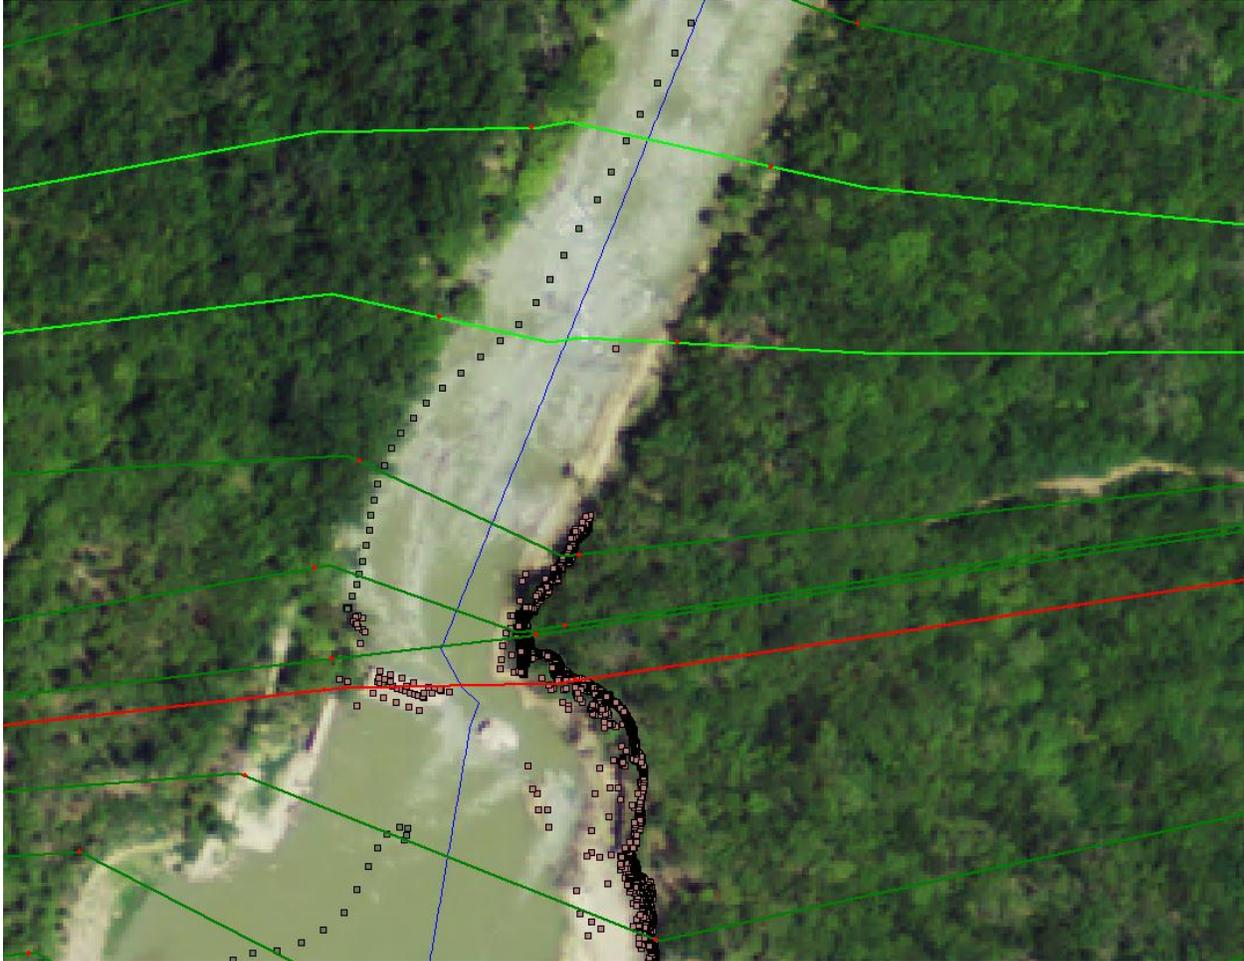
Figure 27. 080444 HEC-RAS model showing the failed lock structure, large concrete obstruction, and immediate movement of water to the left of the channel around the relic lock. The green squares show depth measurement locations during the 2011 Longitudinal Survey and the pink squares show the locations of topographic survey measurement points.

For the 4 cross-sections immediately upstream of the failed lock, the Manning’s roughness factors were increased to 0.35, 0.04, 0.14, and 0.14 from upstream to downstream due to the lock failure which is creating complex flow patterns, pushing water to the left of the relic lock, and splitting the flow around a large concrete obstruction which used to be part of the lock (Figure 27).

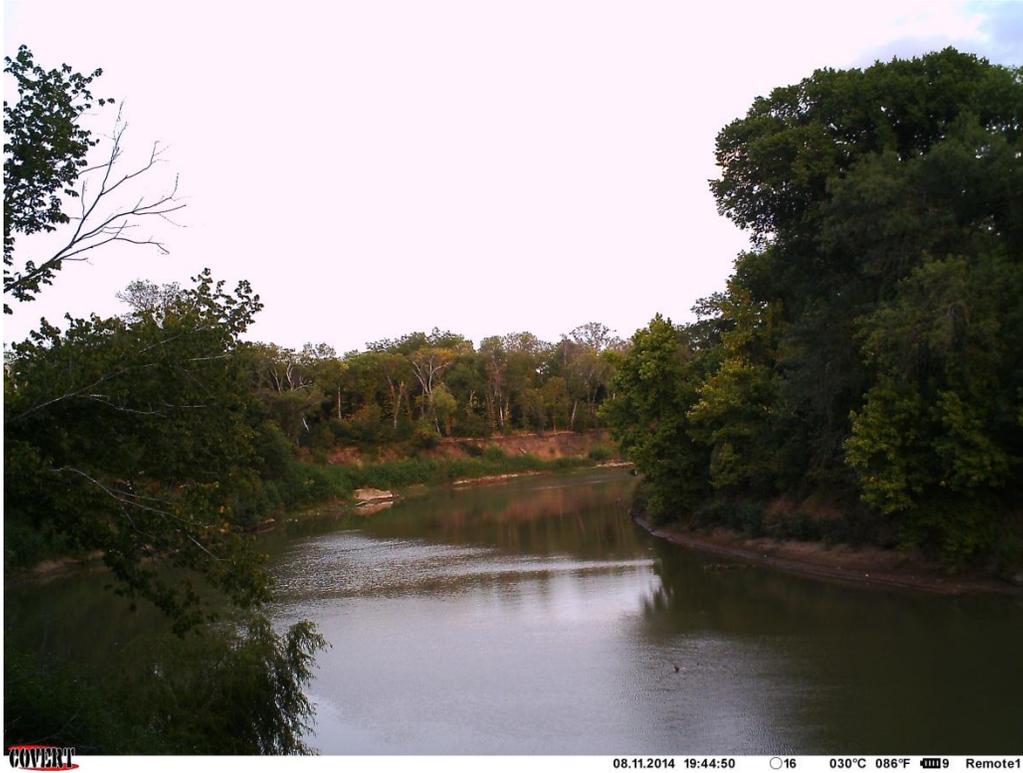
Figure 47. 080444 - Cross-section 2 at 557 cfs 2014-8-11.

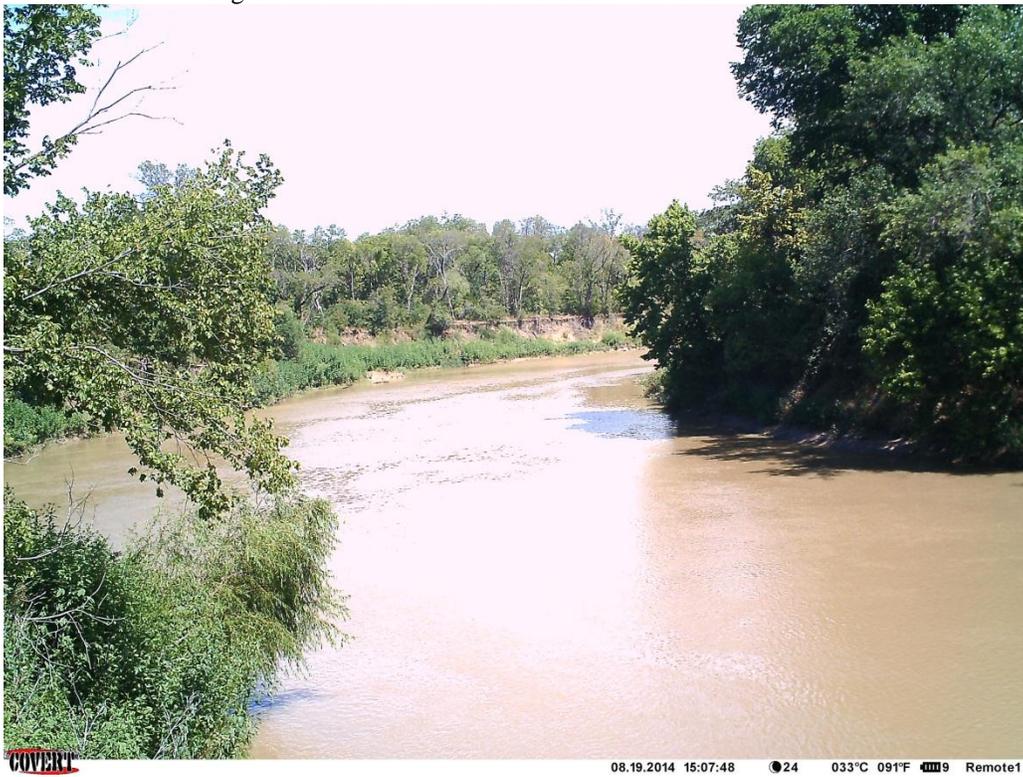
Figure 49. 080444 - Cross-section 2 at 1150 cfs 2014-8-19.

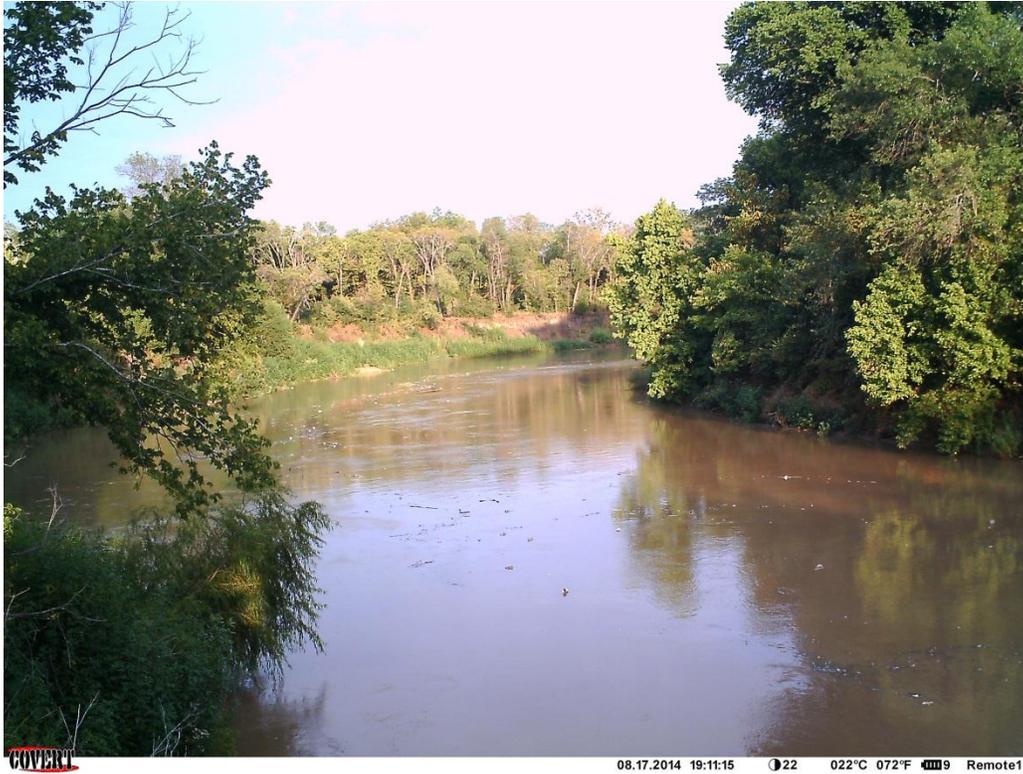
Figure 50. 080444 – Cross-section 2 at 4150 cfs 2014-8-17.

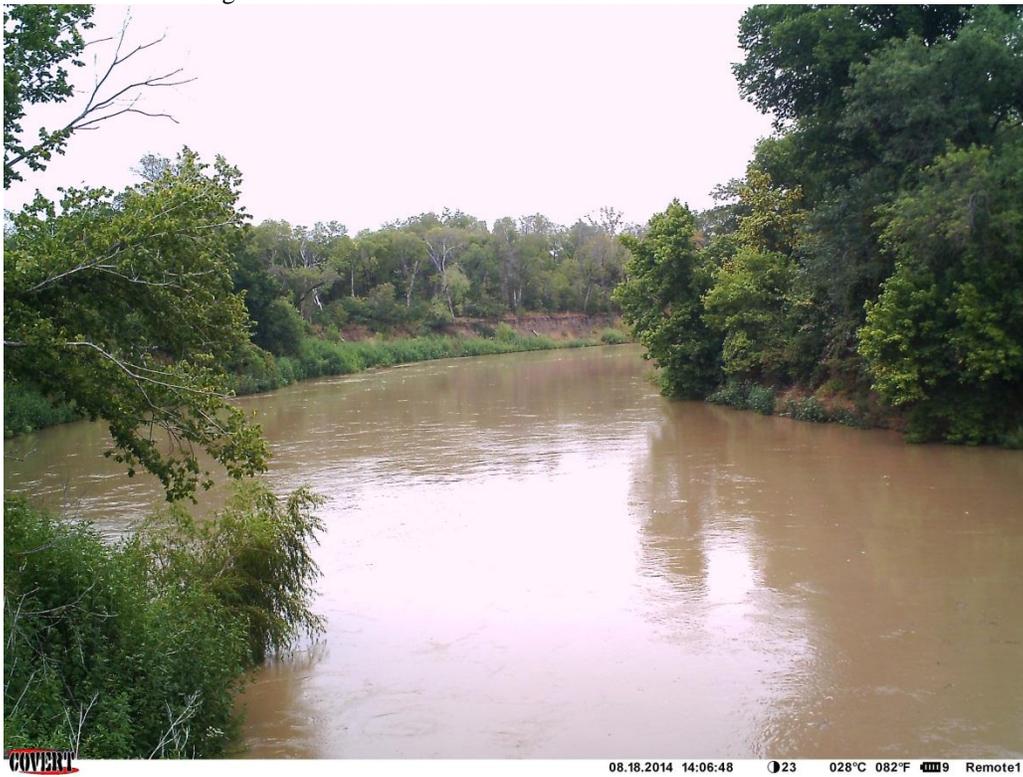
Figure 51. 080444 - Cross-section 2 at 6300 cfs 2014-8-18.

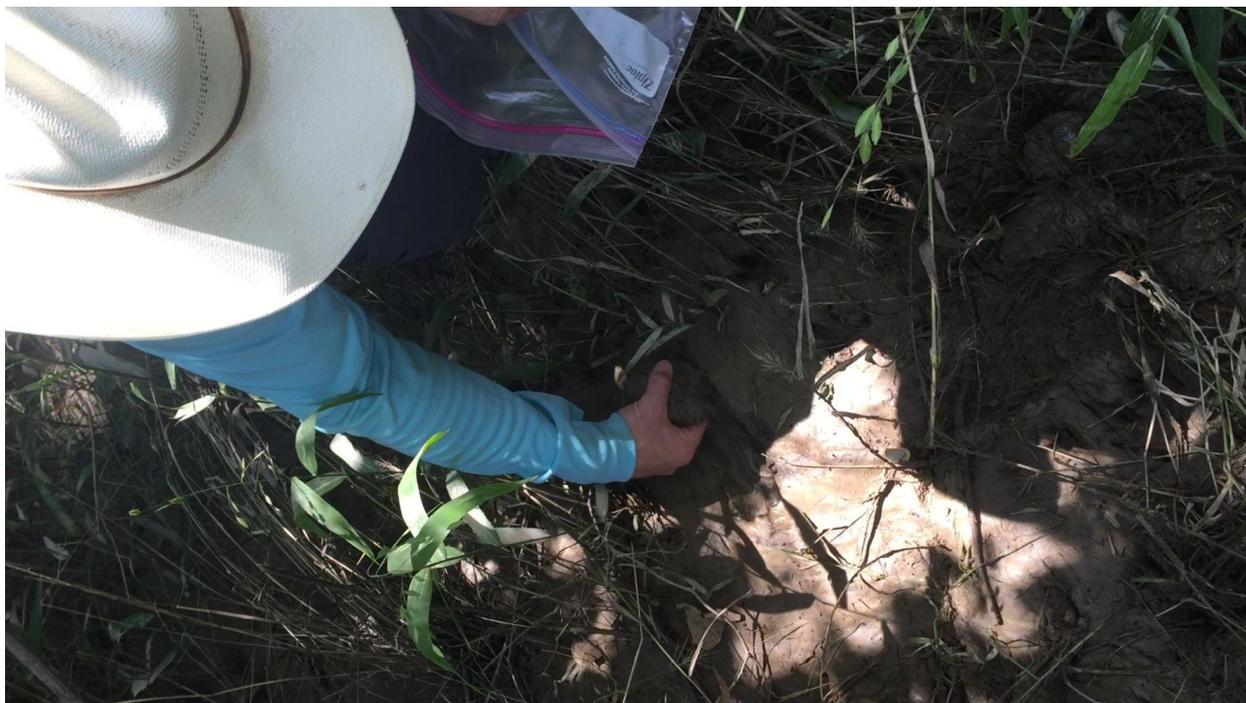
Figure 53. TRA staff collection sand and clay from on top of benchmark at 080444 Cross-section 4, left bank.

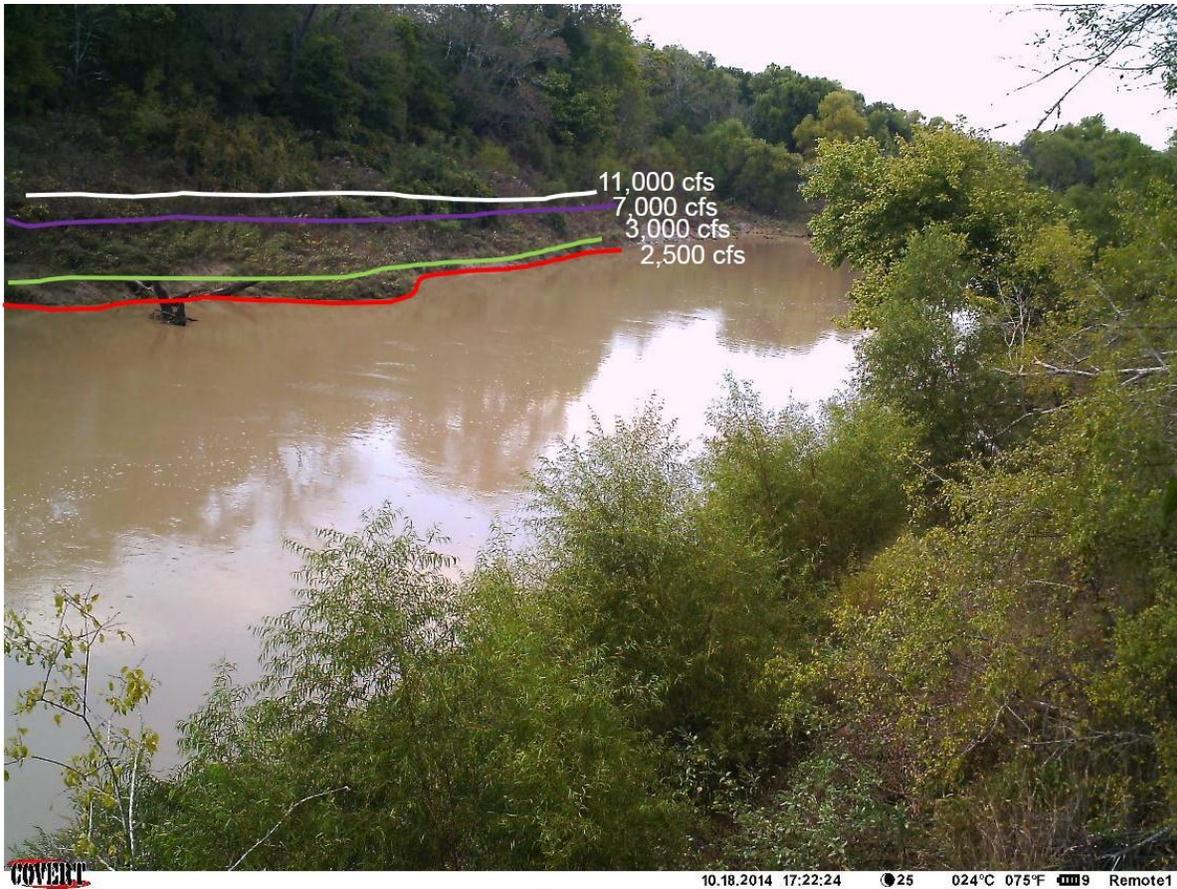
Figure 83. Game camera photograph showing the water line at 1,000 cfs and approximately 11,000 cfs.

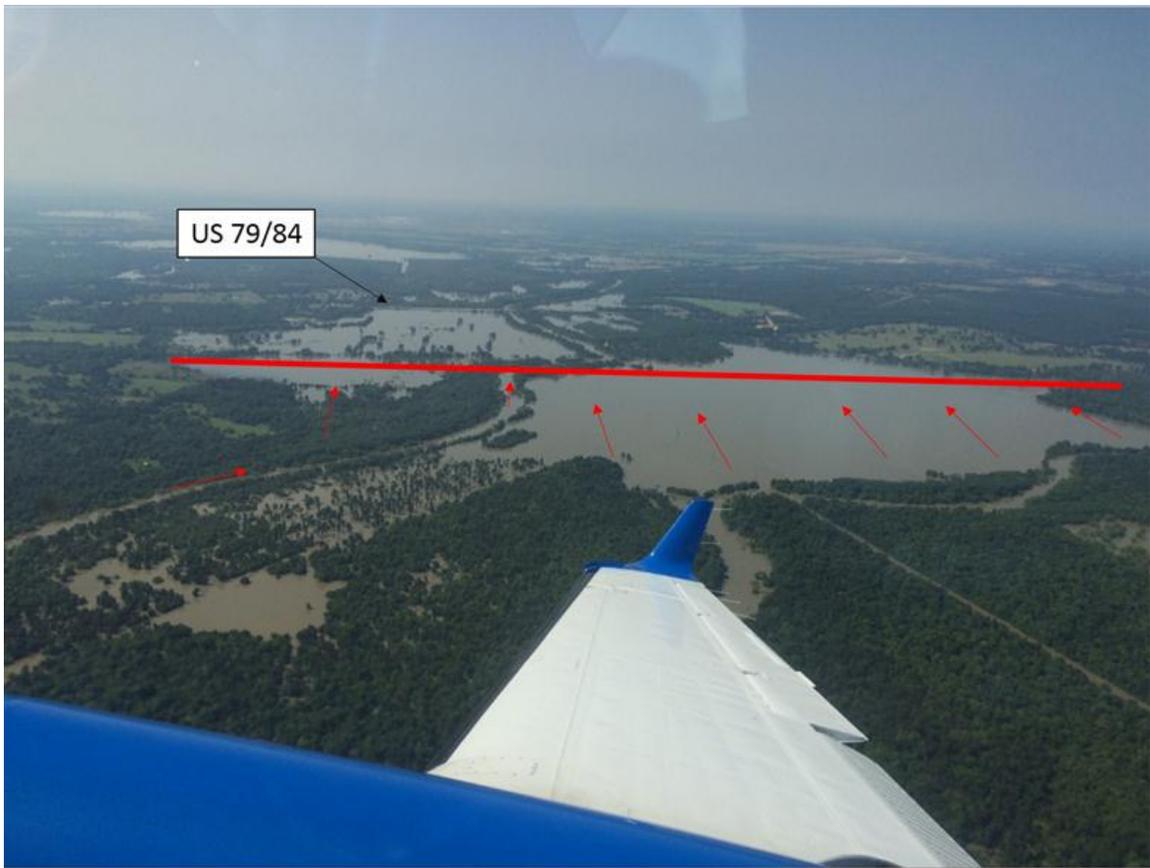
Figure 86. 080295 – Overbank flow condition and velocity direction, at same cross-section. The river reach under the airplane wing is experiencing reverse flow; the reach behind the wing is experiencing transverse flow.

This site was unique in that predominant flow direction was transverse or slightly reverse to the direction of typical river channel flows, predominantly overtopping the right bank to flow southward through a large agriculture area (Figure 85). Flow generally bypassed the meander bend and riffle at Cross-section 3. Channel flow appeared to slow considerably and reverse at the confluence with Keechi Creek, creating a large backwater area upstream of the confluence. However, flow in the down-channel direction was observed in the Trinity River channel downstream of Keechi Creek. An attempt to collect an extended discharge cross-section across the inundated agriculture field and the Trinity River channel accounted for the majority of the flow within this part of the Trinity River (Figure 86).

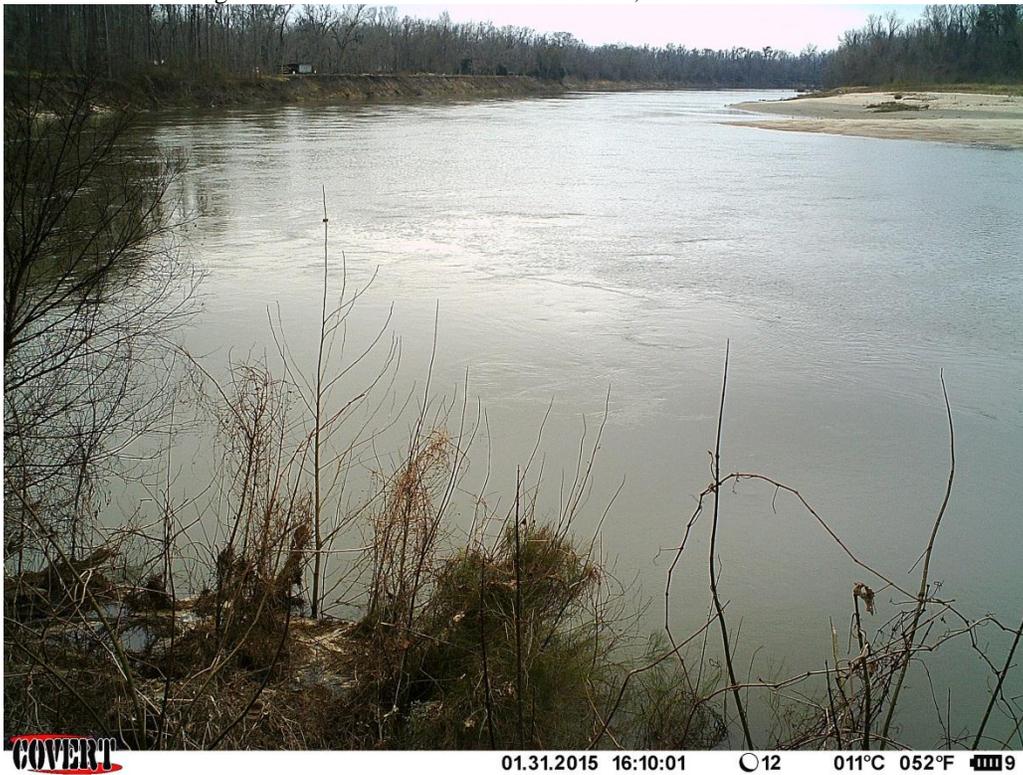
Figure 106. 080075 - Cross-section 1 at 8,040 cfs 2015-1-31.

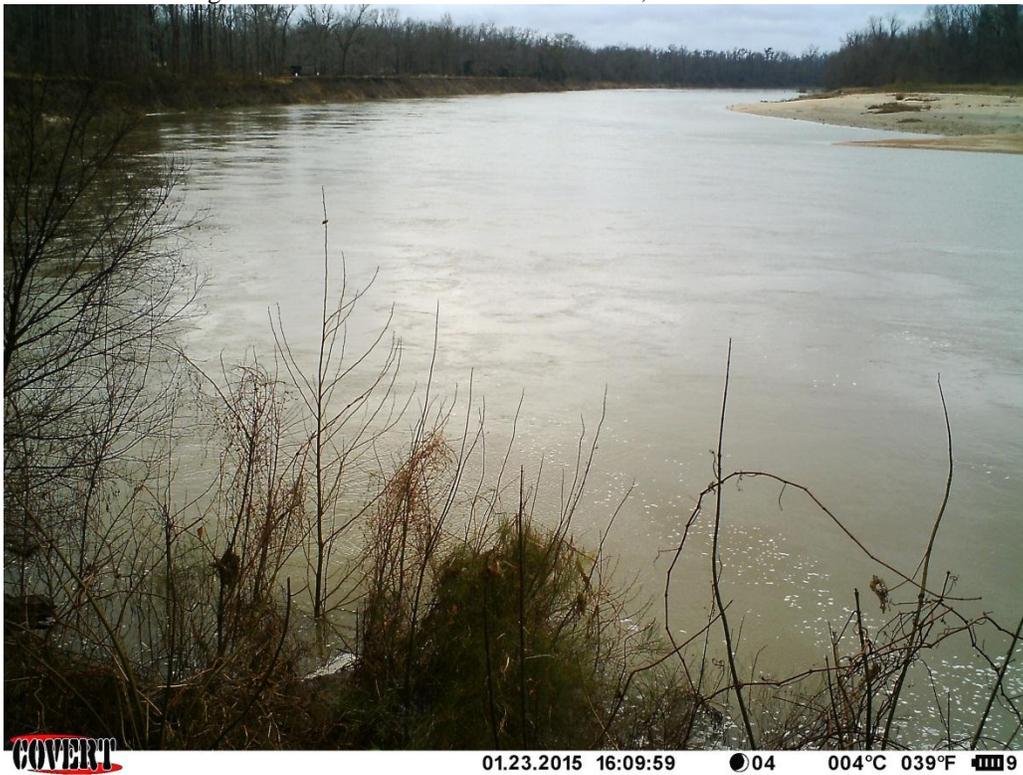
Figure 108. 080075 - Cross-section 1 at 11,400 cfs 2015-1-23.
