Using Landform and Hydraulic Modifications to Increase the Benefit of Fresh Water Inflows to Nueces Bay and Nueces Delta -- Phase II: Verification and Feasibility Assessment for Landform Modifications in the Nueces Delta

Texas Water Development Board

TWDB Contract No. 1600012013

October 2017

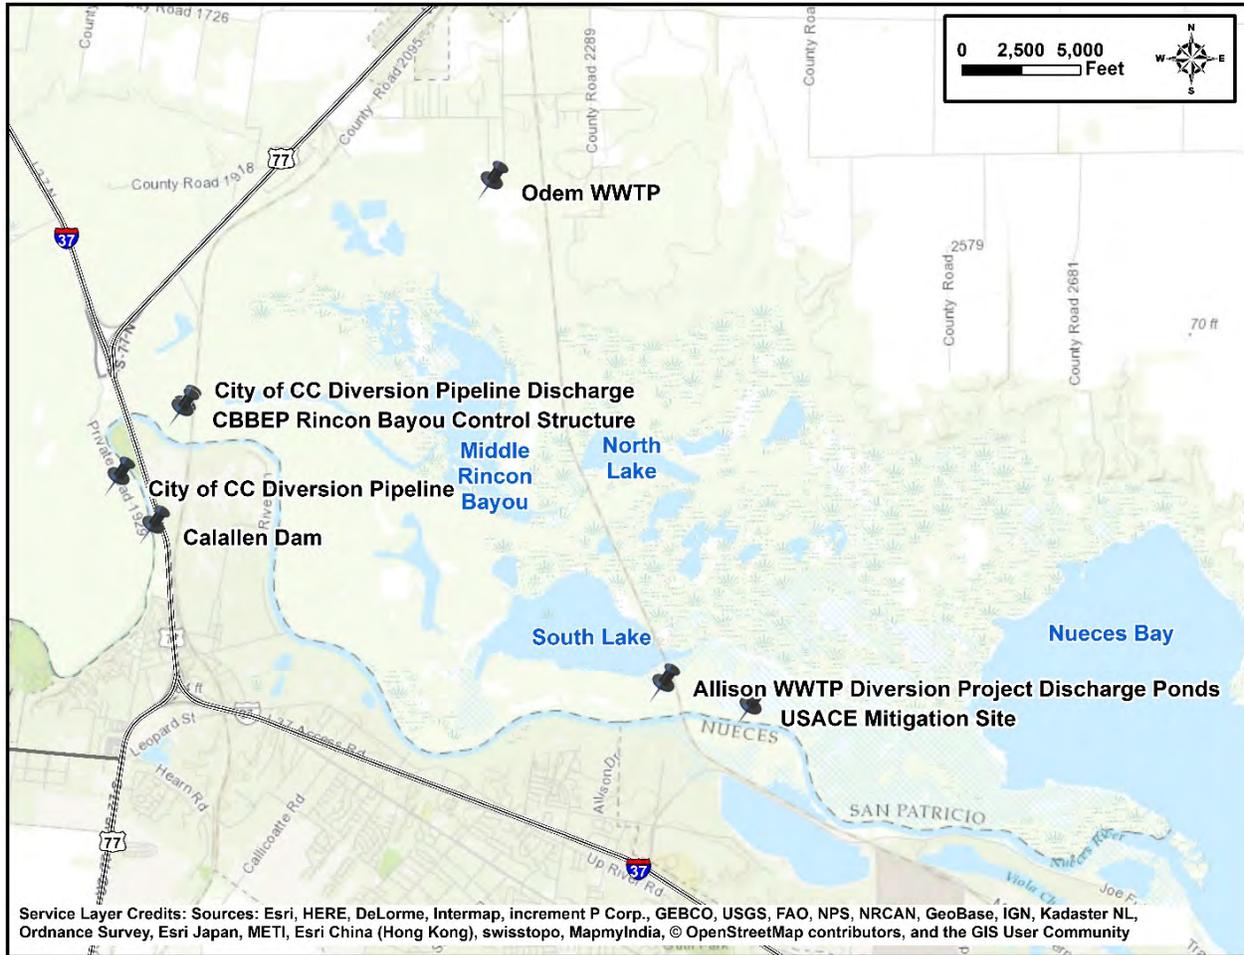
Figure 1-1. Nueces Delta Landform Modifications Project Phase I study area.

The Senate Bill 3 (SB3) Nueces Basin and Bay Area Stakeholder Committee's (Nueces BBASC) 2012 Work Plan for Adaptive Management, submitted to the SB3 Environmental Flows Advisory Group and the Texas Commission on Environmental Quality (TCEQ), included "Landform Modifications to Nueces Bay and Nueces Delta" as a strategy option for achieving the environmental flow standards for the Nueces Estuary. In 2014, based on recommendations of the Nueces BBASC, the Texas Water Development Board (TWDB) awarded a contract to Naismith Engineering Inc. (NEI), and a diverse team of scientists with extensive experience and expertise in the Nueces Delta, for a study to evaluate this strategy option (NEI, 2016). The study area was within San Patricio County and included the Nueces River from the Calallen Saltwater Barrier Dam to Nueces Bay, the Nueces Delta, and Nueces Bay (see Figure 1-1).

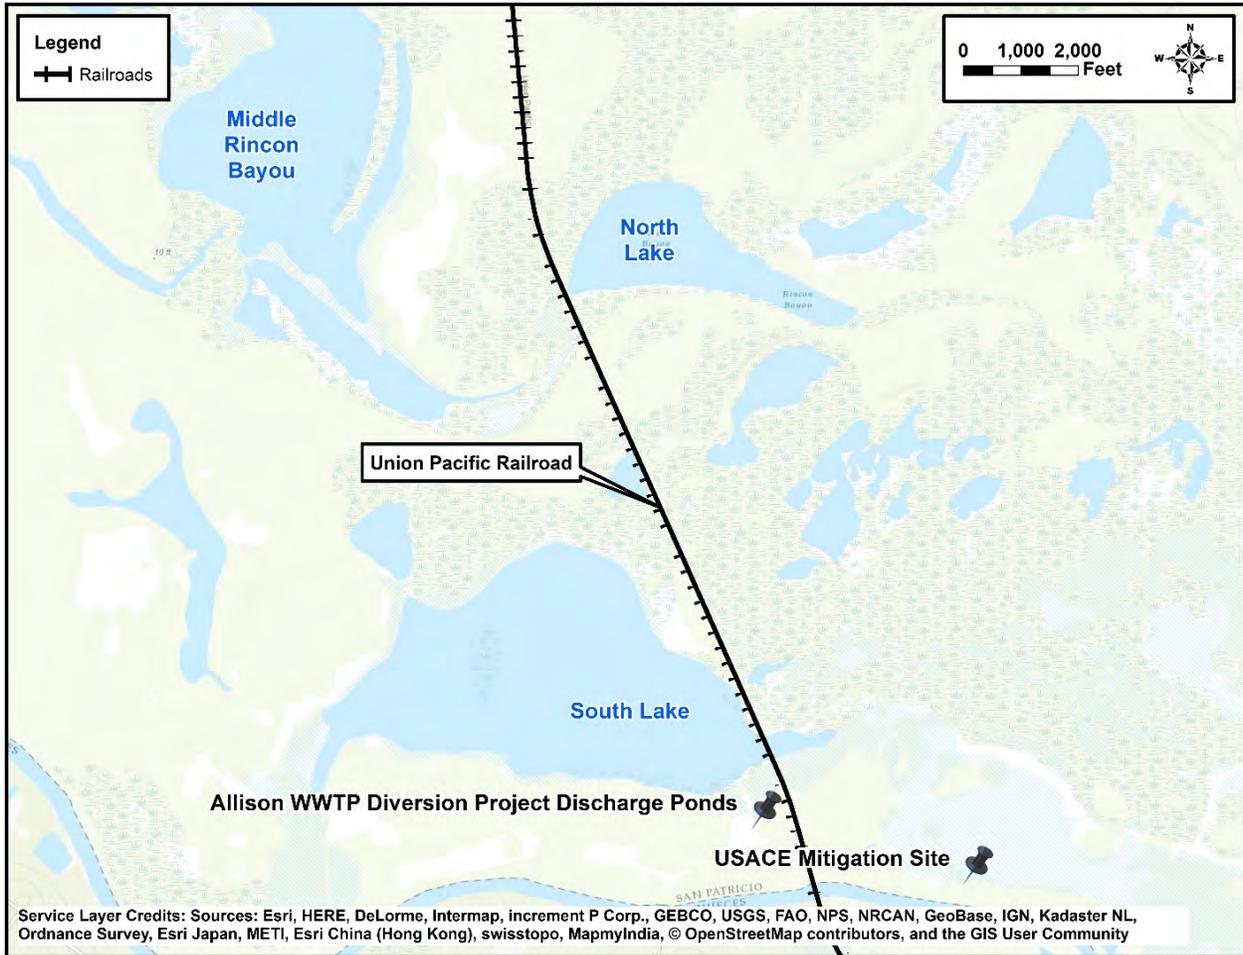
Figure 1-2. Nueces Delta Landform Modifications Project Phase II study area.

Results from the Phase I study (NEI, 2016) identified two potential water diversion projects that, based on evaluations using the Nueces Delta Hydrodynamic Model (NDHM) (NEI, 2016), would be expected to improve the ecological results from the freshwater inflow volumes delivered into the Rincon Bayou from the Calallen Pool via the City of Corpus Christi's Nueces Delta Pipeline. The two potential water diversion projects would improve ecological benefits by increasing the area of inundated acreage around South Lake, an area of concern that previously received limited freshwater from pumping events. Those two proposed projects are the Middle Rincon Bayou Diversion to South Lake Area (Project #4) and the North Lake Diversion to South Lake System (Project #5) (see Figure 1-2).

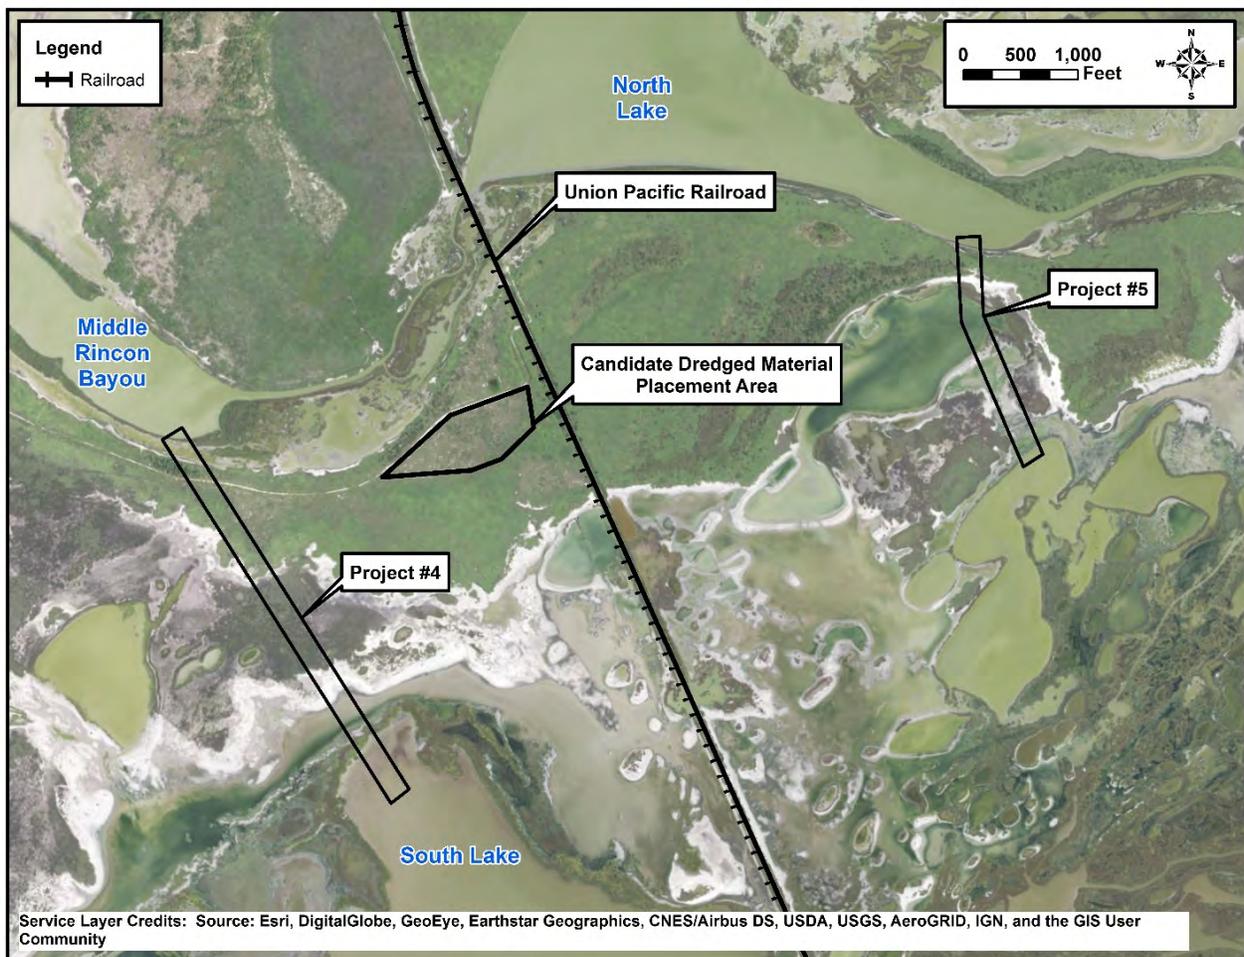
Figure 3-1. Location of Project #4, Project #5, and the candidate dredged material placement area.

The two diversion projects proposed in the Phase I Study would move water from the lower end of Middle Rincon Bayou and the North Lake segment of Rincon Bayou into a wetlands complex bordering the north-east side of the South Lake system, an area of tidal flats and wetlands located south of Rincon Bayou, on both sides the railroad tracks crossing the mid-Delta area (see Figure 3-1).

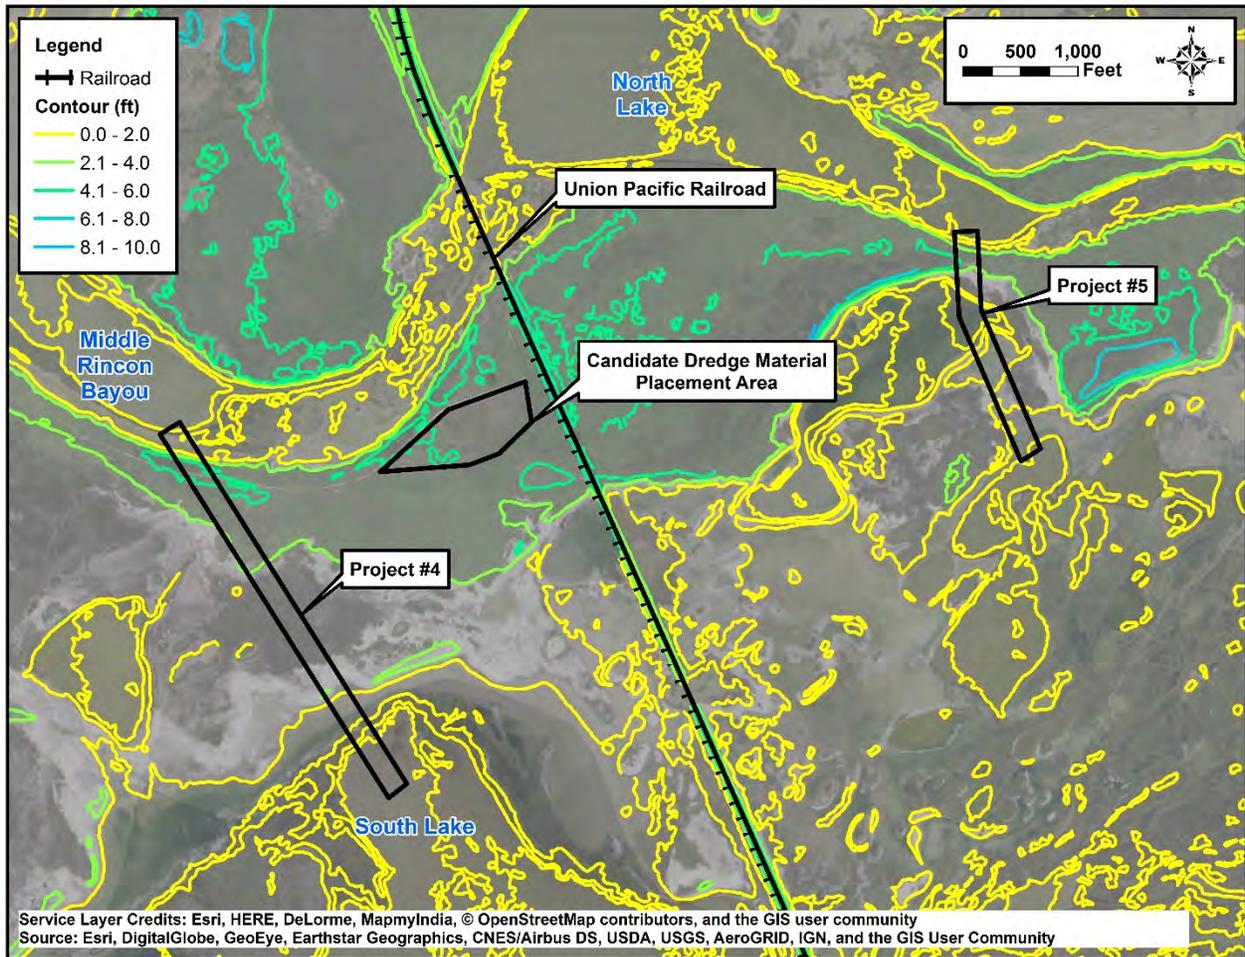
A map depicting the (LiDAR data can be found in Figure 4-1. Surveyed elevations within the Project #4 area range from 0.8 feet to 6.4 feet and within the Project #5 area, elevations range from 0.1 feet to 5.8 feet North American Vertical Datum of 1988 (NAVD88). Generally, the northern end of both project areas gradually slopes towards the southern end. The primary topographic feature of both project areas is floodplain. Secondary topographic features within the project areas include open water, tidal flats, marsh, prairie, and prairie shrubland with the highest elevation points located within prairie shrublands and the lowest elevation points located within open water areas (see Figure 4-1).

Figure 4-1. San Patricio County light detection and ranging data map of project area.

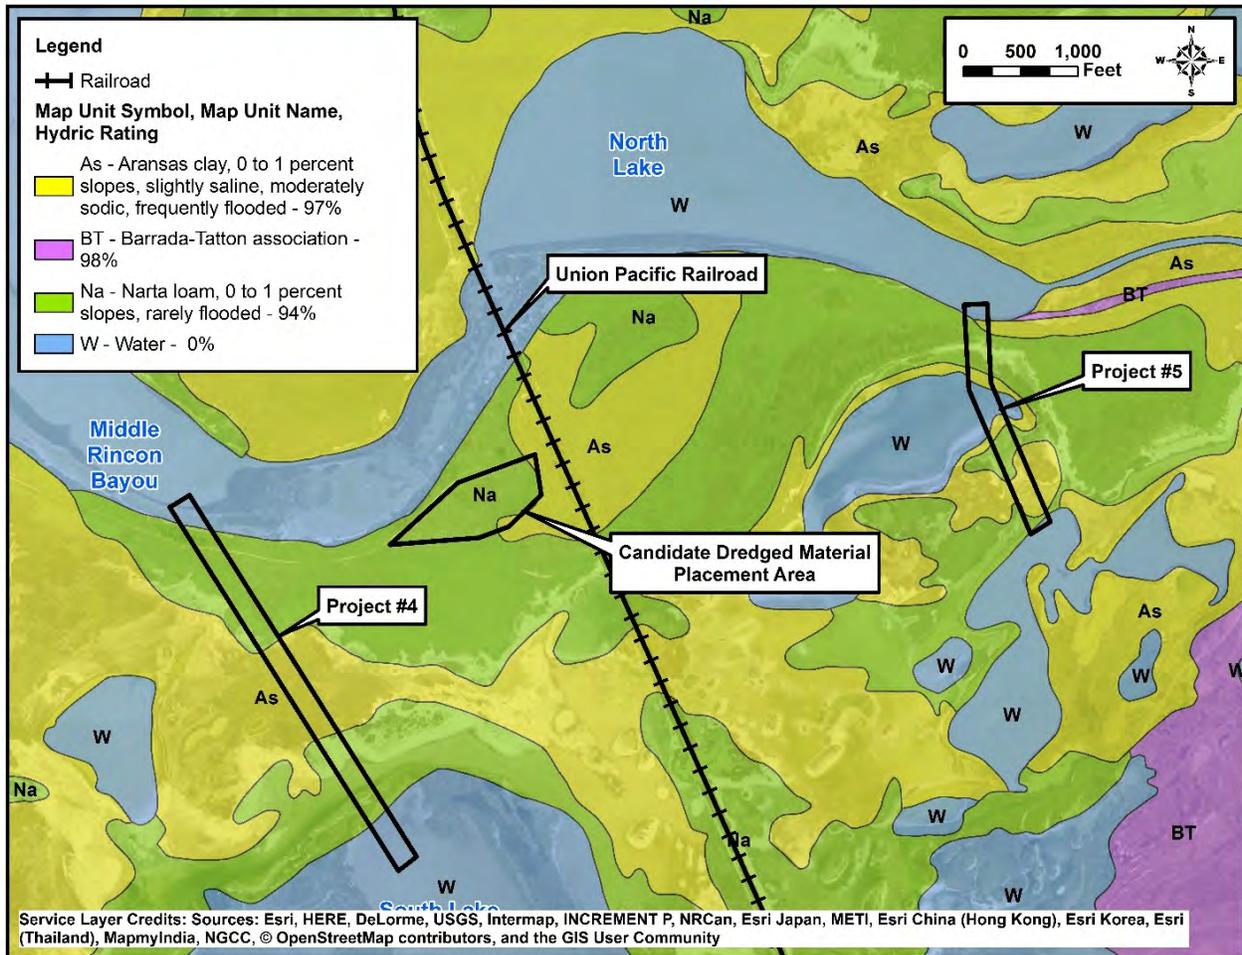
Figure 4-2. Natural Resources Conservation Service soil series and hydric rating map (USDA, 2017b).

The National Technical Committee for Hydric Soils has defined hydric soils as soils that formed under conditions of saturation, flooding, or ponding long enough during the growing season to develop anaerobic conditions in the upper portion (USDA, 2017a). Under natural conditions, these soils are either saturated or inundated long enough during the growing season to support the growth and reproduction of hydrophytic vegetation.

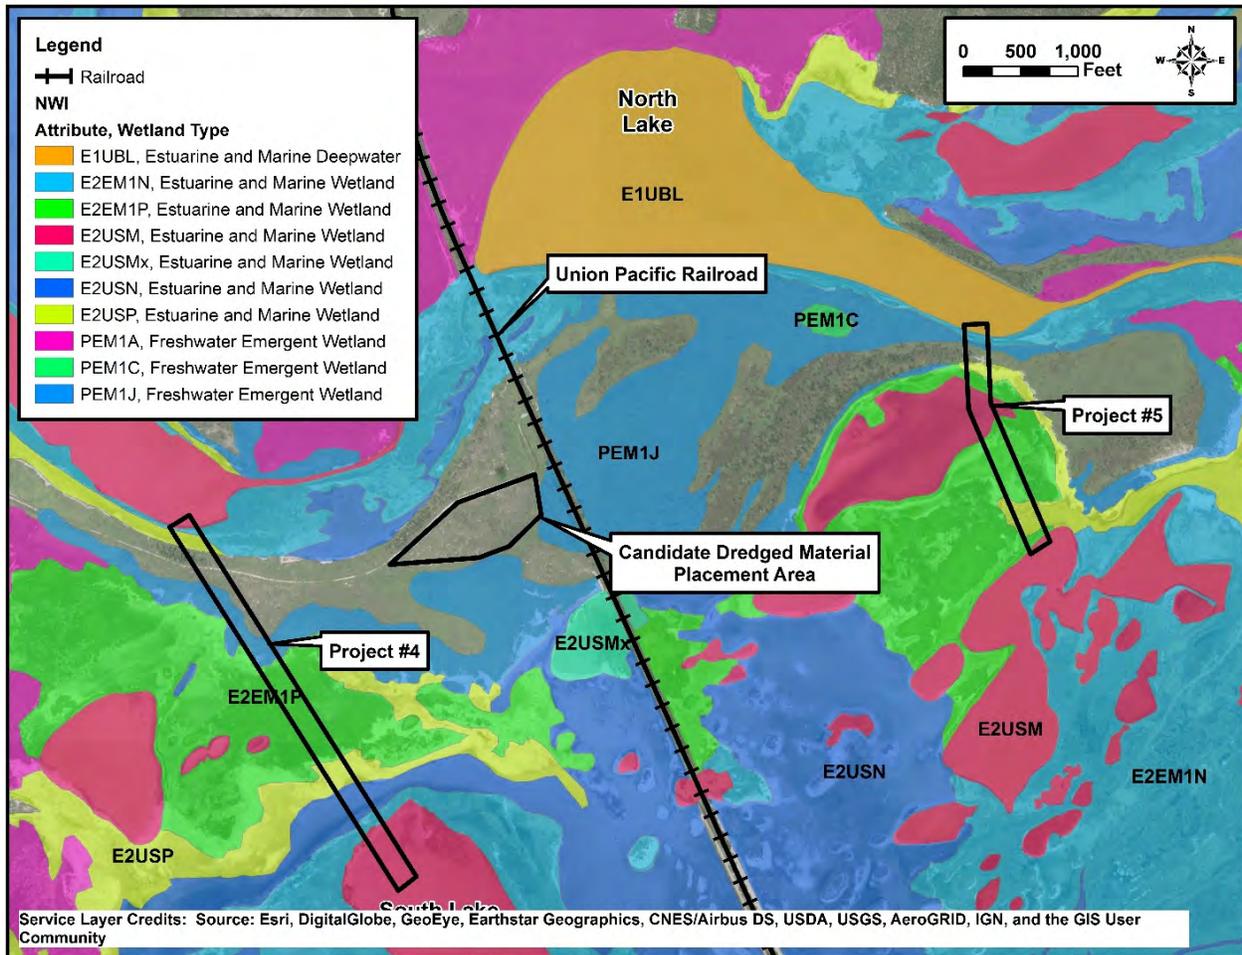
Figure 4-4. U.S. Fish and Wildlife Service National Wetland Inventory map (USFWS, 2017b).

The candidate DMPA location does not contain any NWI-mapped wetlands (see Figure 4-4, below).

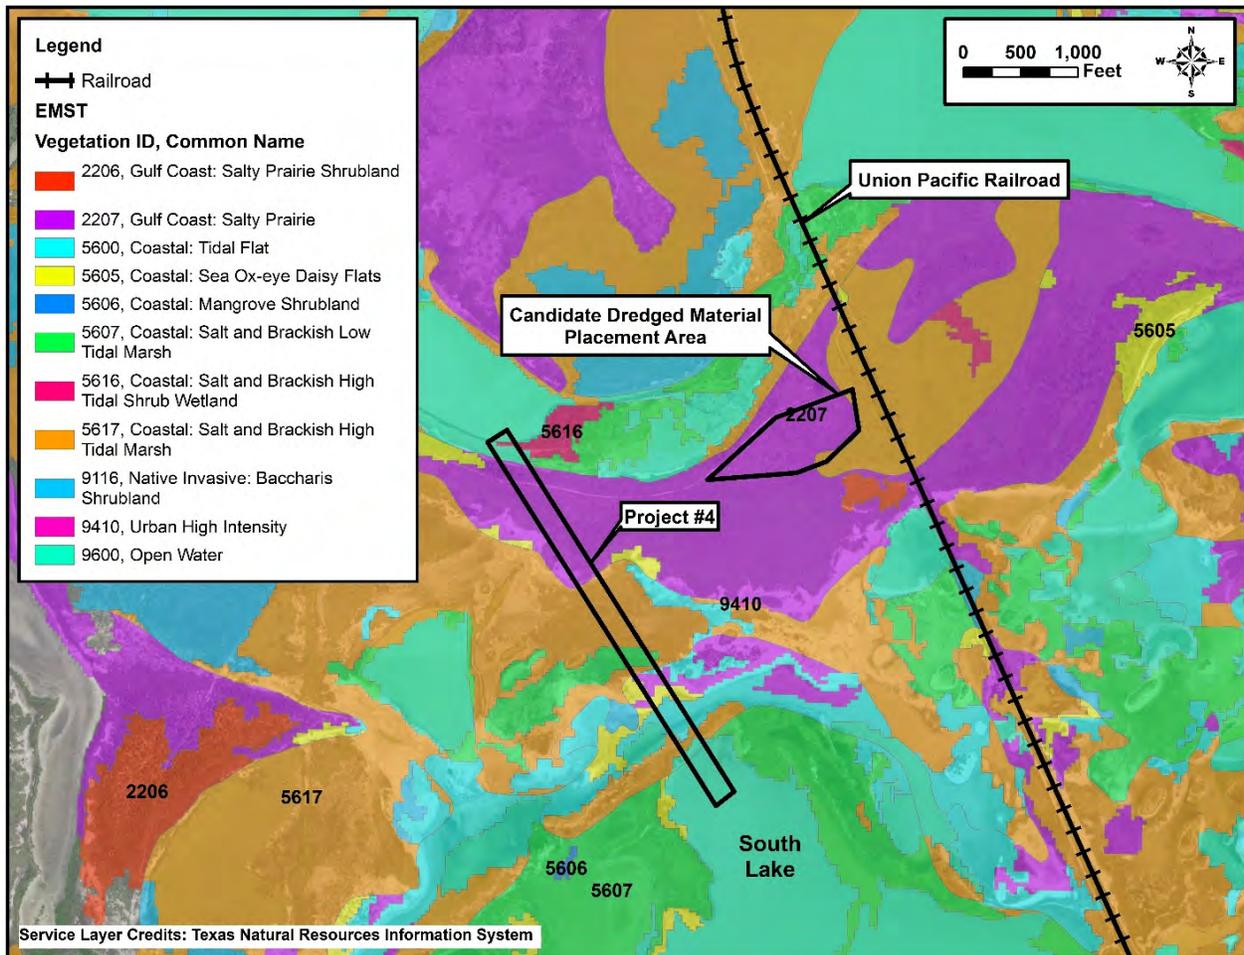
Figure 4-5. Texas Parks and Wildlife Department Ecological Mapping Systems of Texas map for Project #4 and the candidate dredged material placement area (TPWD, 2017a).

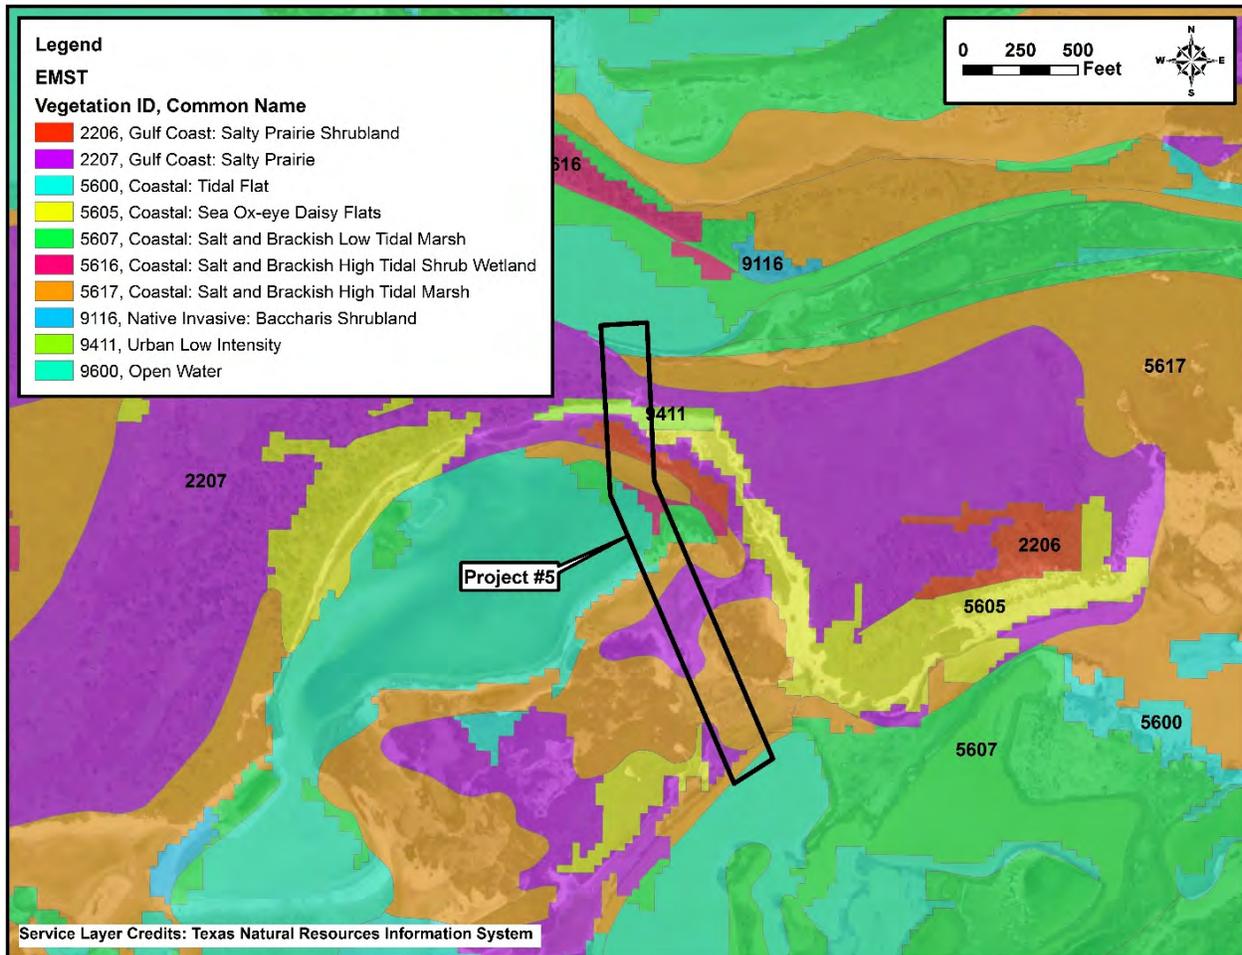
Figure 4-6. Texas Parks and Wildlife Department Ecological Mapping Systems of Texas map for Project #5 (TPWD, 2017a).

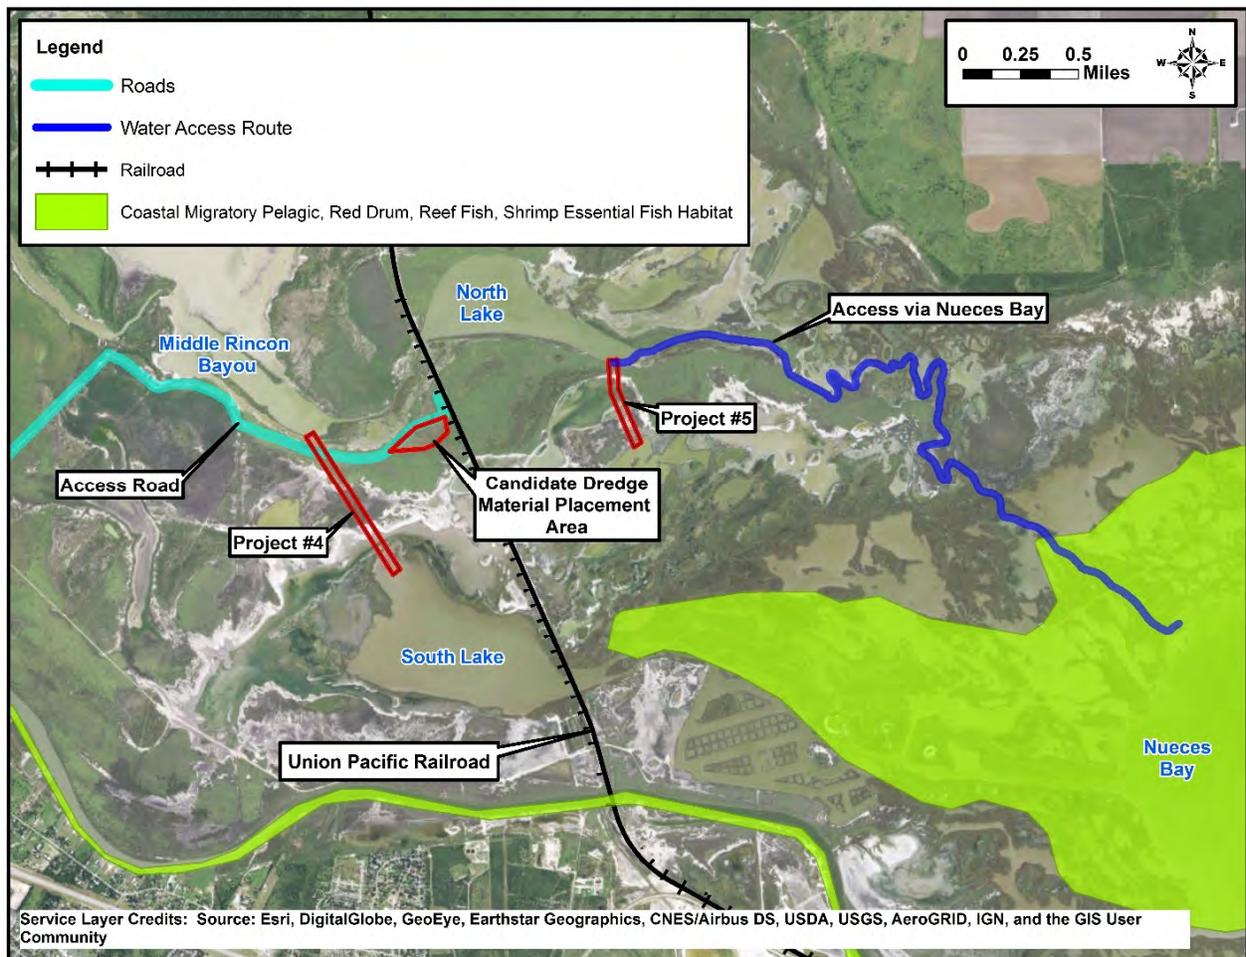
Although the immediate project area does not include mapped EFH, EFH is mapped downstream (see Figure 4-7). The EFH mapped areas are designated for migratory pelagic species such as red drum (*Sciaenops ocellatus*), reef fish species, and shrimp species. These species could potentially be adversely affected during construction due to the disturbance of sediment and downstream migration of sediment. These species could also potentially be affected by the project since the channels are intended to increase and re-direct freshwater flow regimes but the effect would be expected to be a positive one.

Figure 4-7. The National Marine Fisheries Service essential fish habitat map (NOAA, 2017).

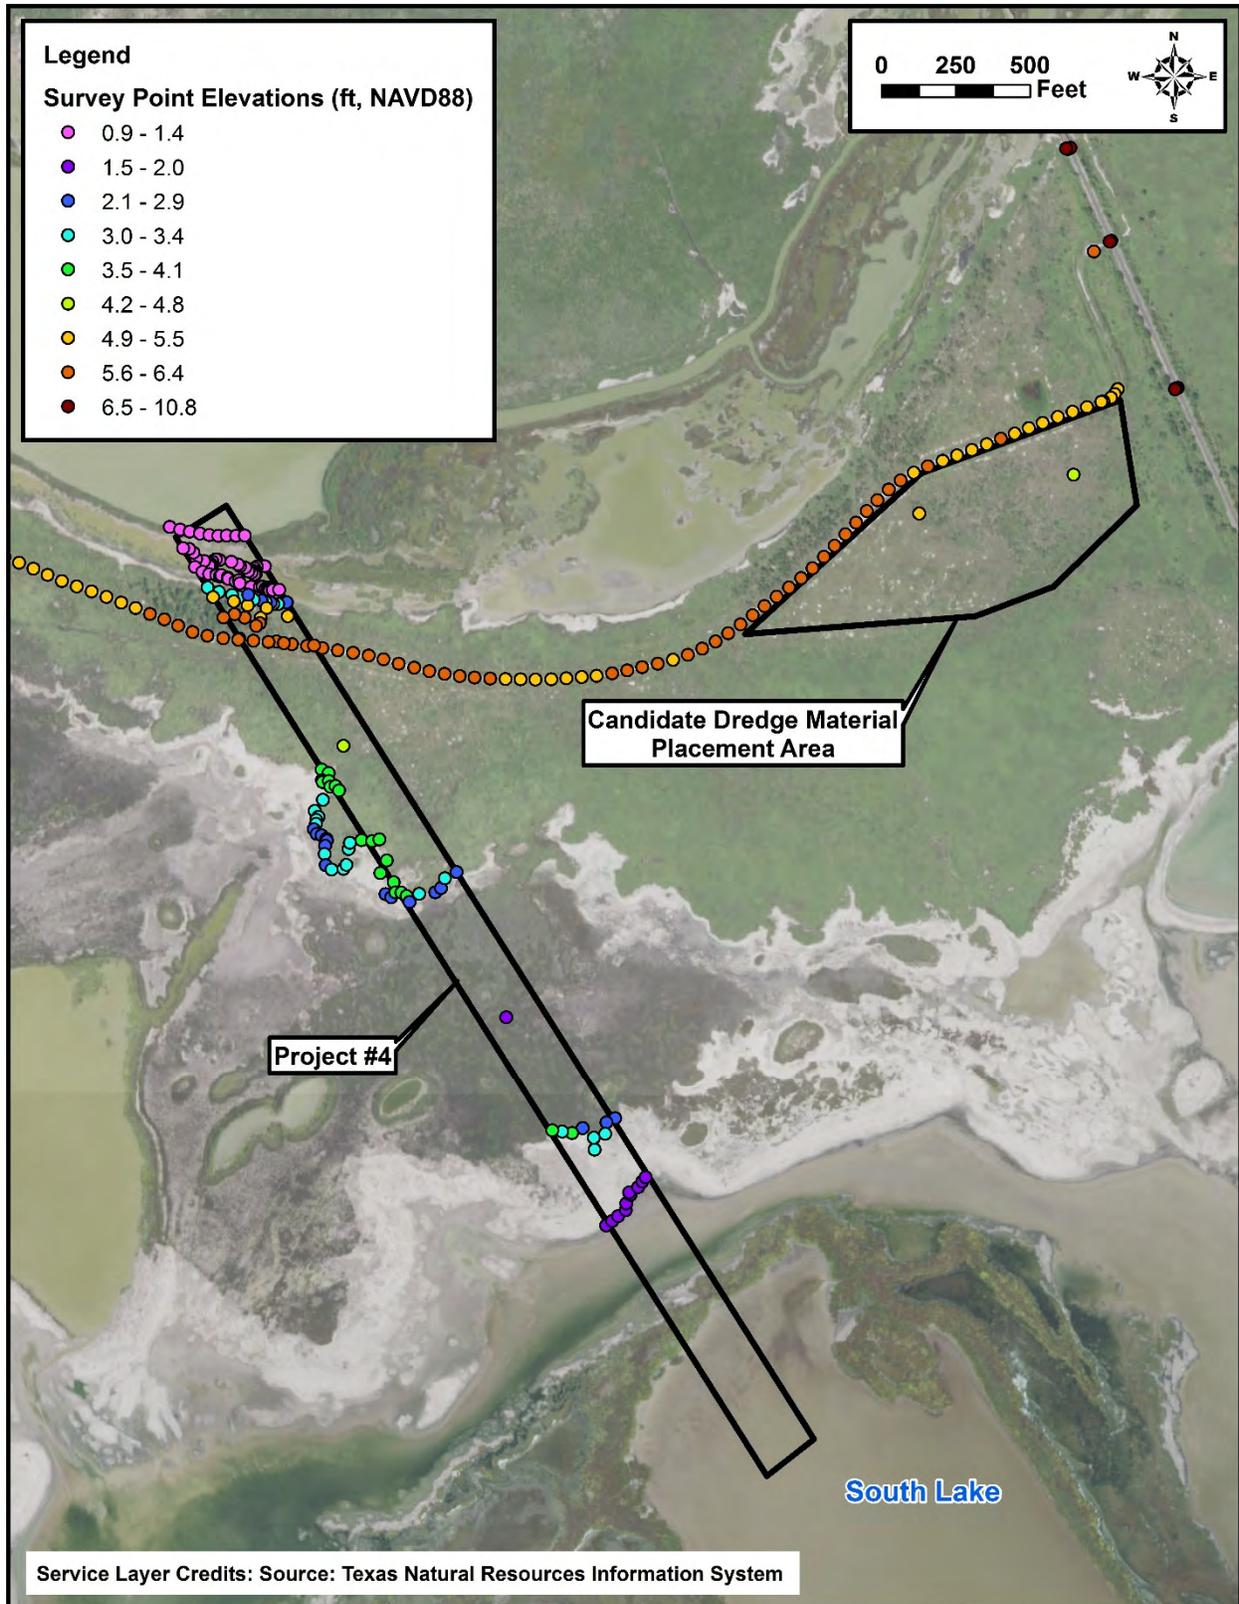
Figure 5-1. Survey data map for Project #4 and candidate dredged material placement area.

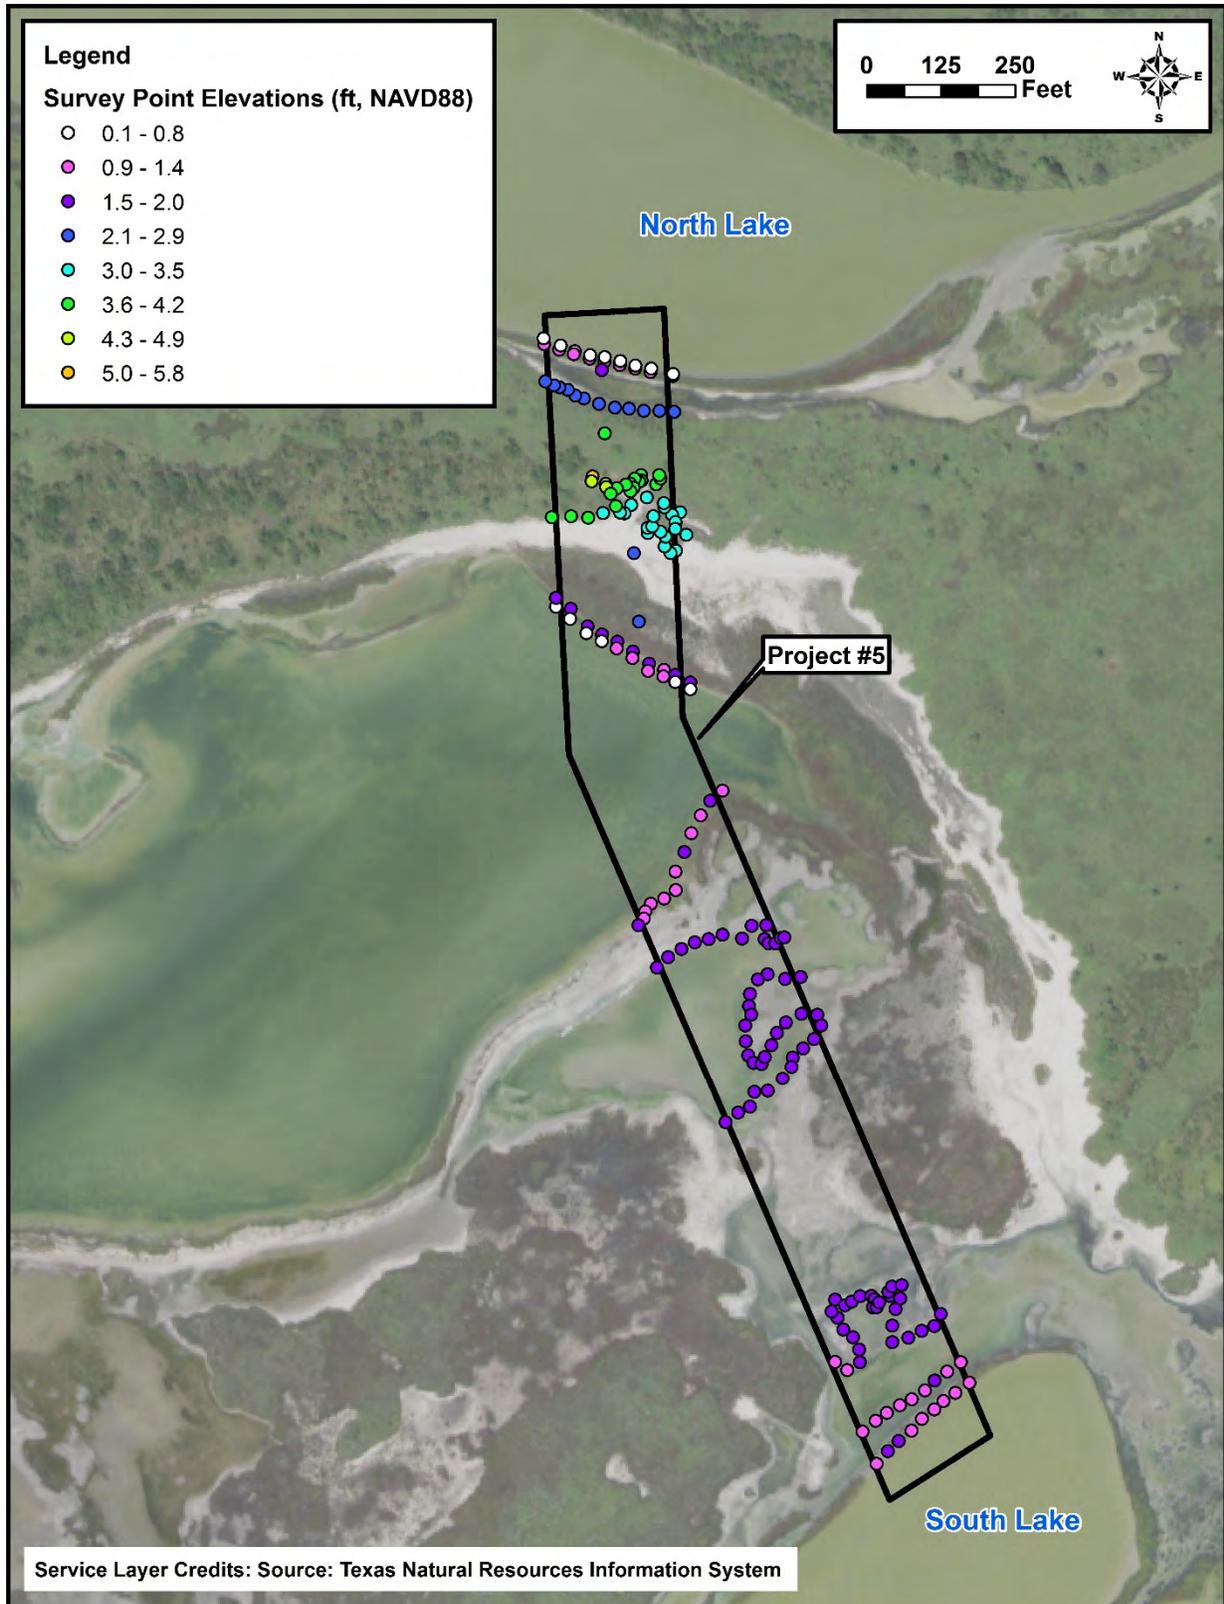
Figure 5-2. Survey data map for Project #5.

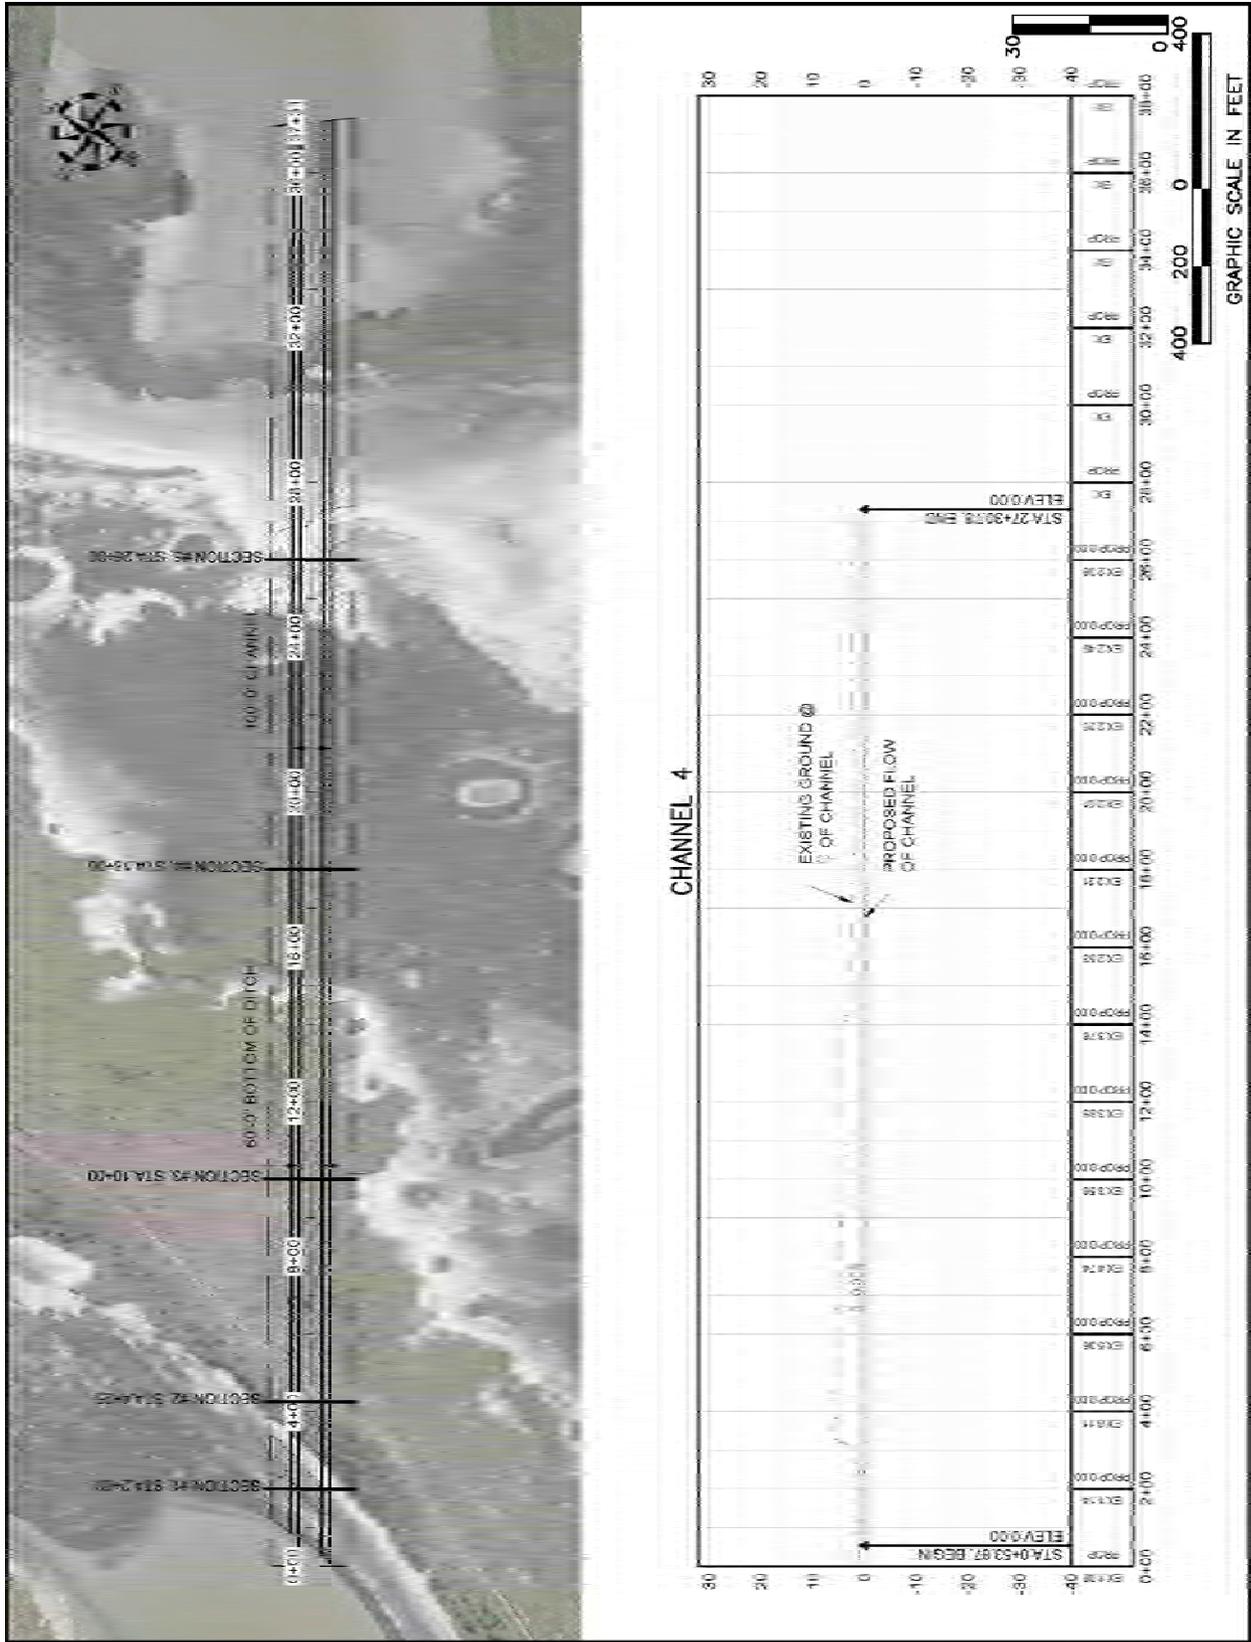
Figure 5-3. Overview of station locations for each of the cross-sections and profile views of Project #4.

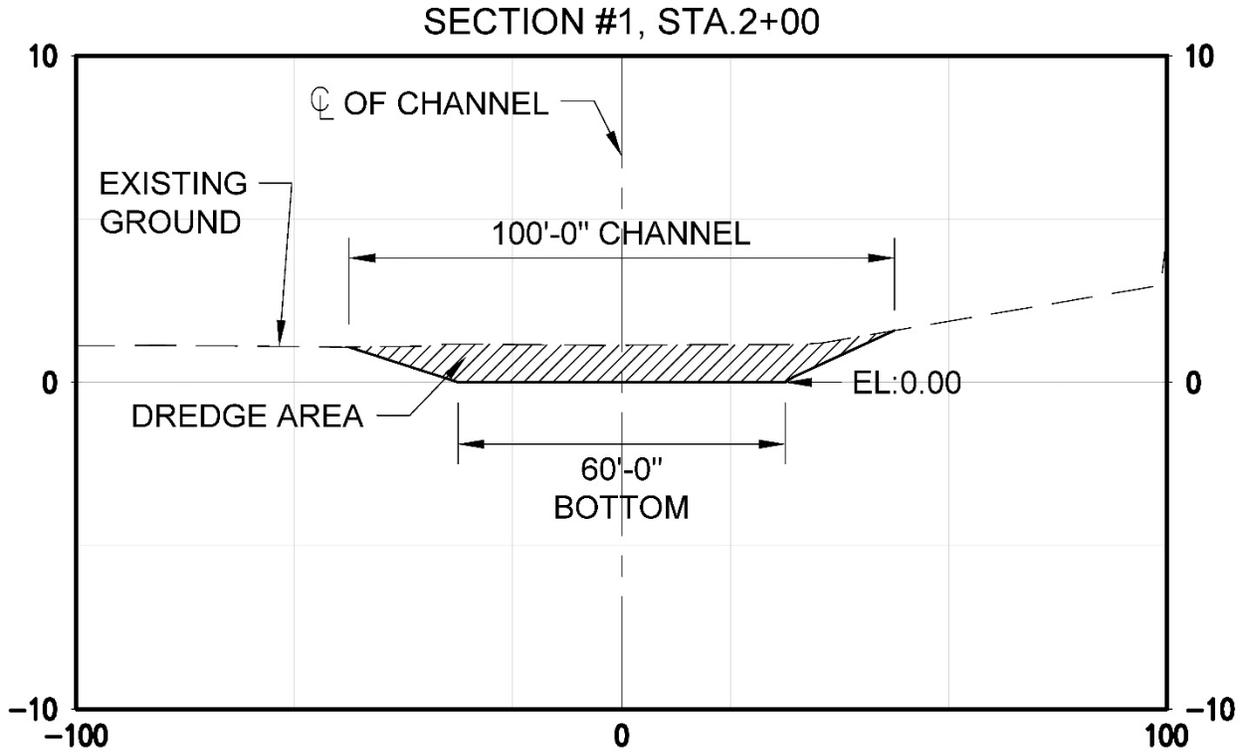
Figure 5-4. Station #1 cross-section of Project #4.

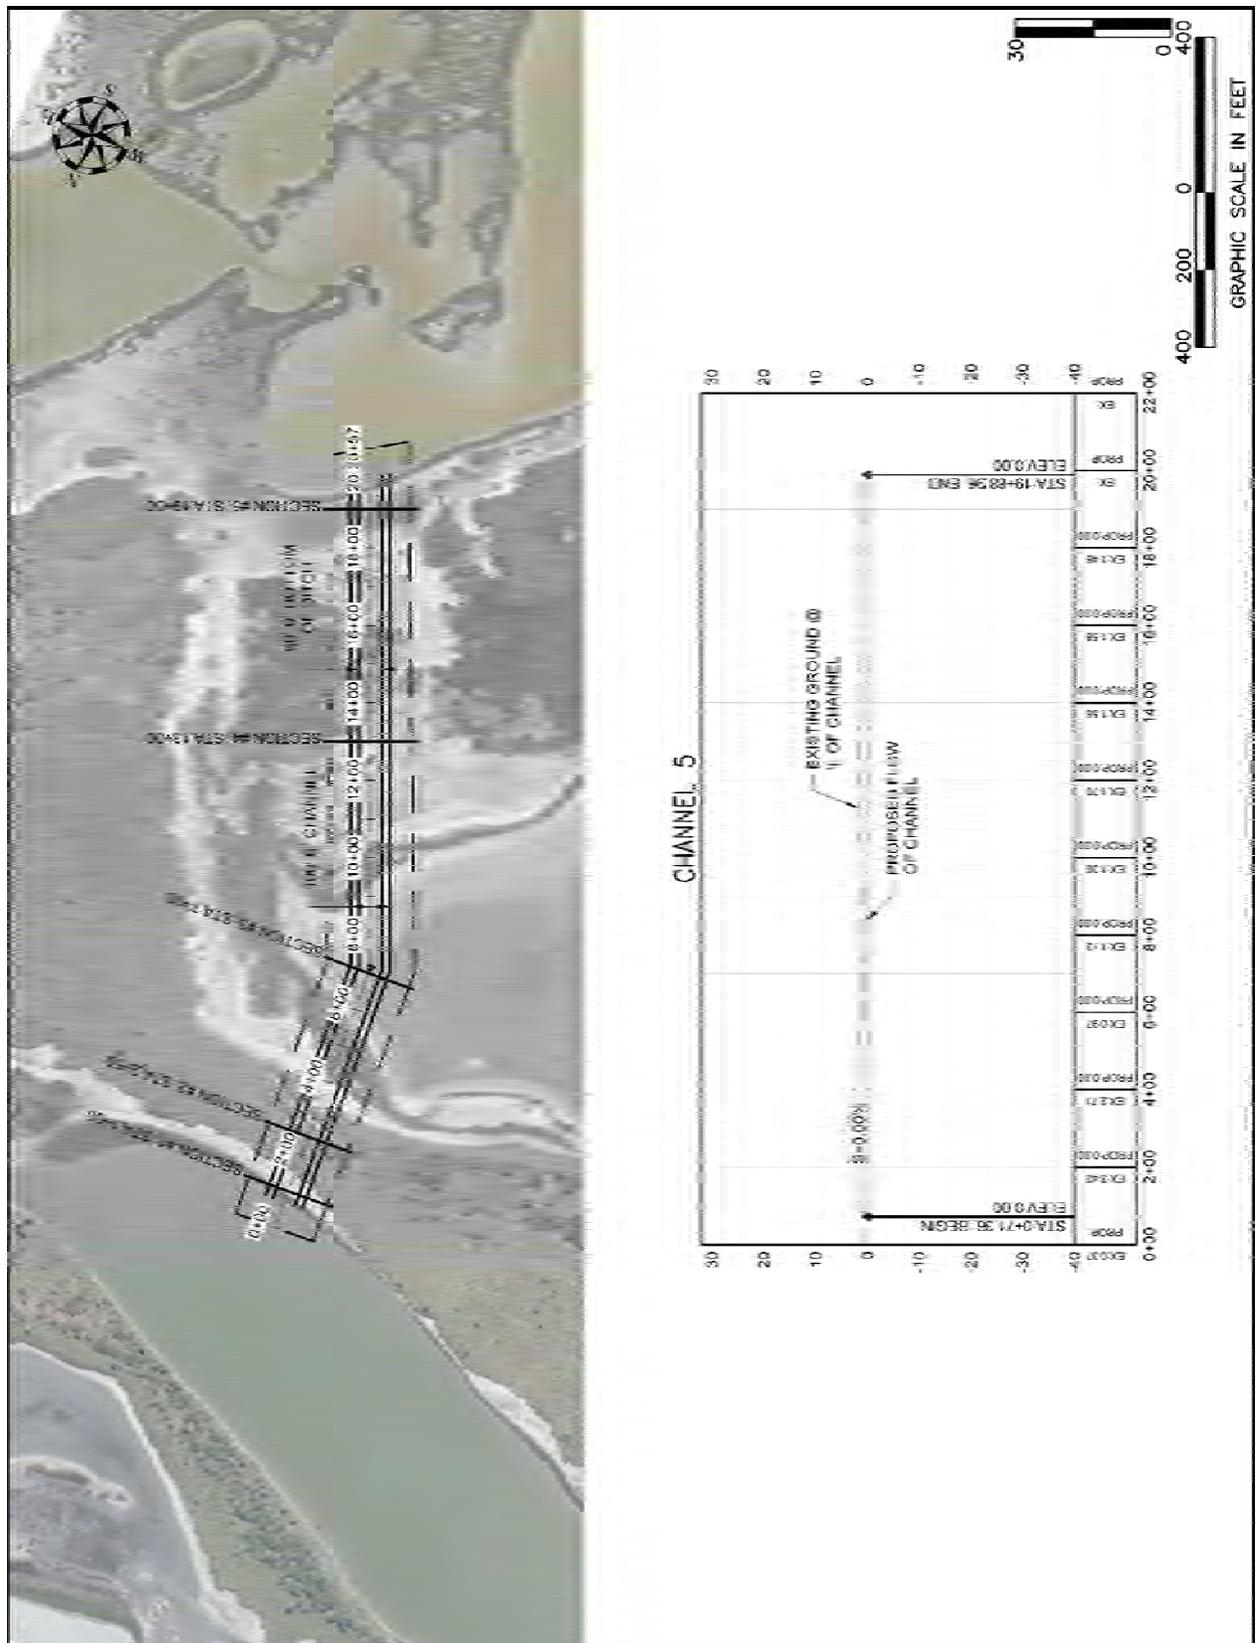
Figure 5-9. Overview of station locations for each of the cross-sections and profile views of Project #5.
