Using Landform and Hydraulic Modifications to Increase the Benefit of Fresh Water Inflows to Nueces Bay and Nueces Delta -- Phase II: Verification and Feasibility Assessment for Landform Modifications in the Nueces Delta

Texas Water Development Board

TWDB Contract No. 1600012013

October 2017

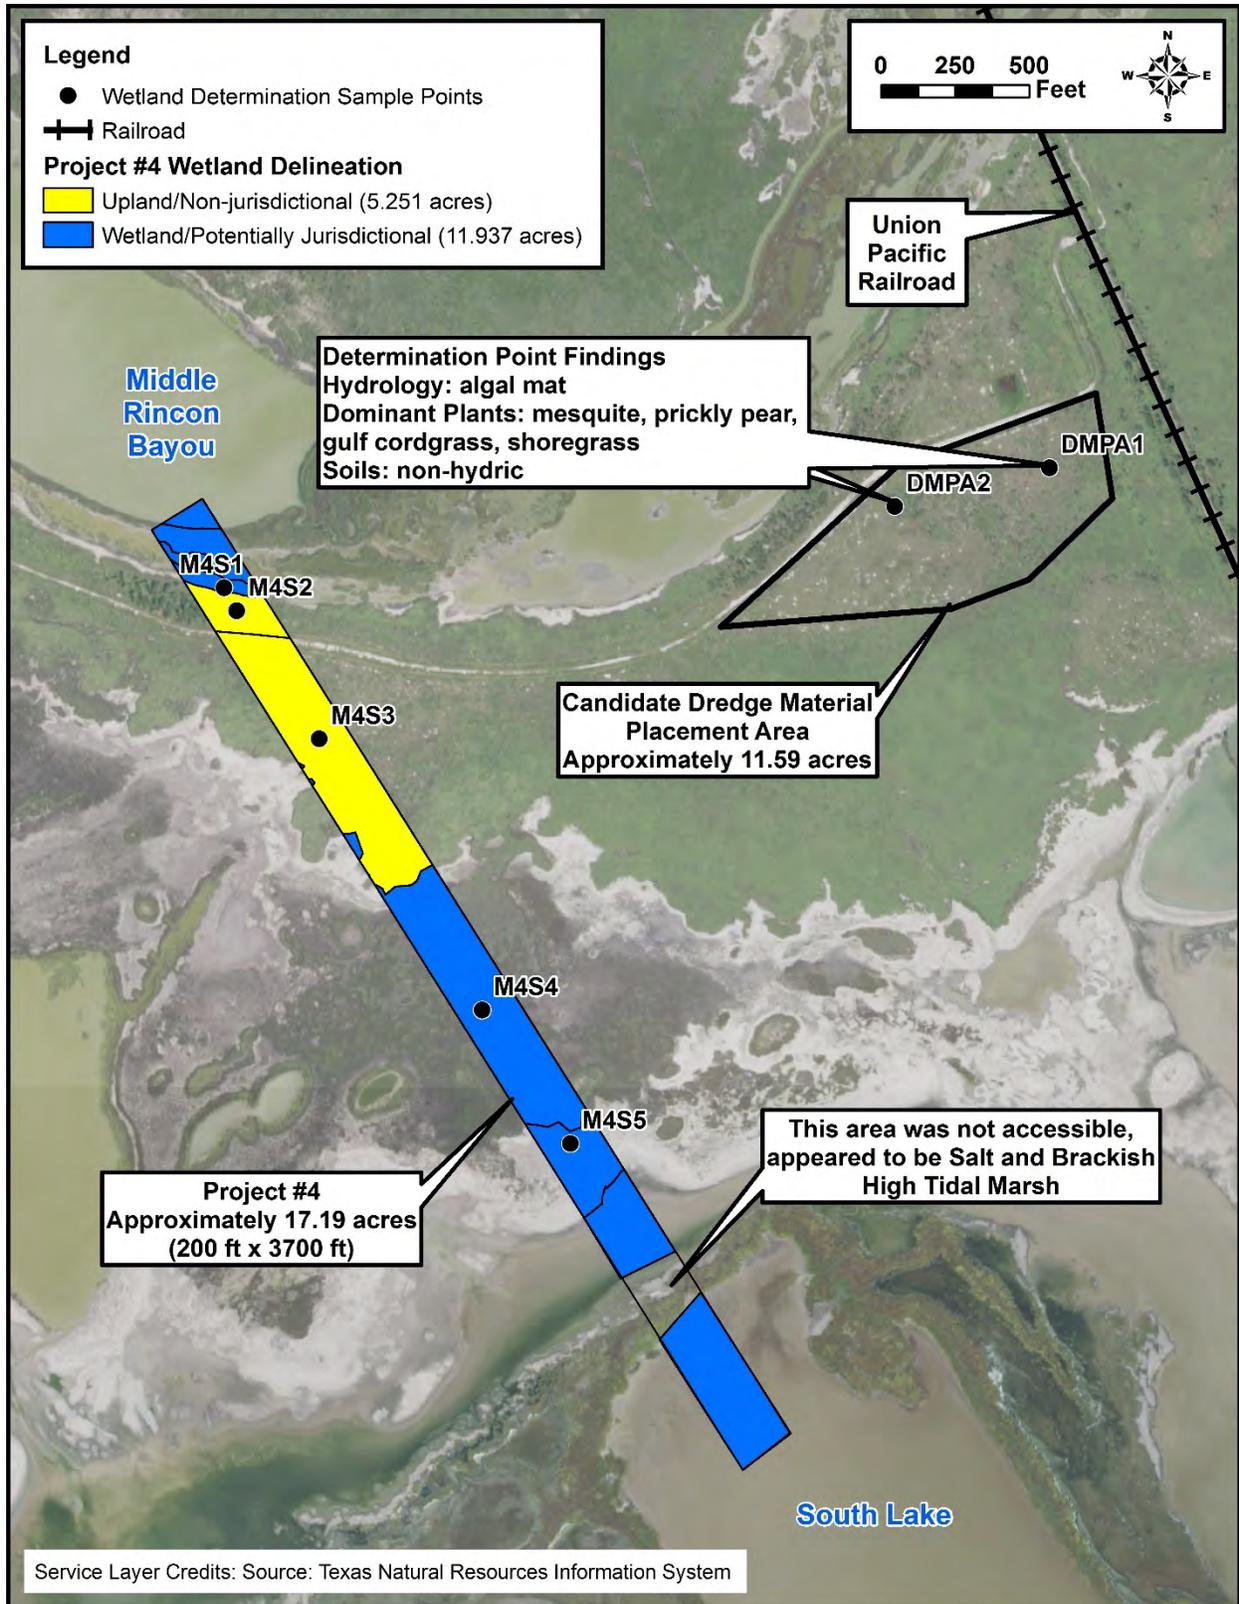
Within the candidate DMPA location, it was determined that the area was within uplands due to the lack of hydric soils (see Figure 5-15). The boundary of this area was not delineated via survey because the size of the habitat exceeded the boundary drawn in-office and also because the candidate DMPA location may change. The habitat characterization, which includes the Wetland Determination Forms, may be utilized to determine the best placement area for the dredged material.

Figure 5-15. Project #4 wetland delineation and candidate dredged material placement area wetland determination sample points map.

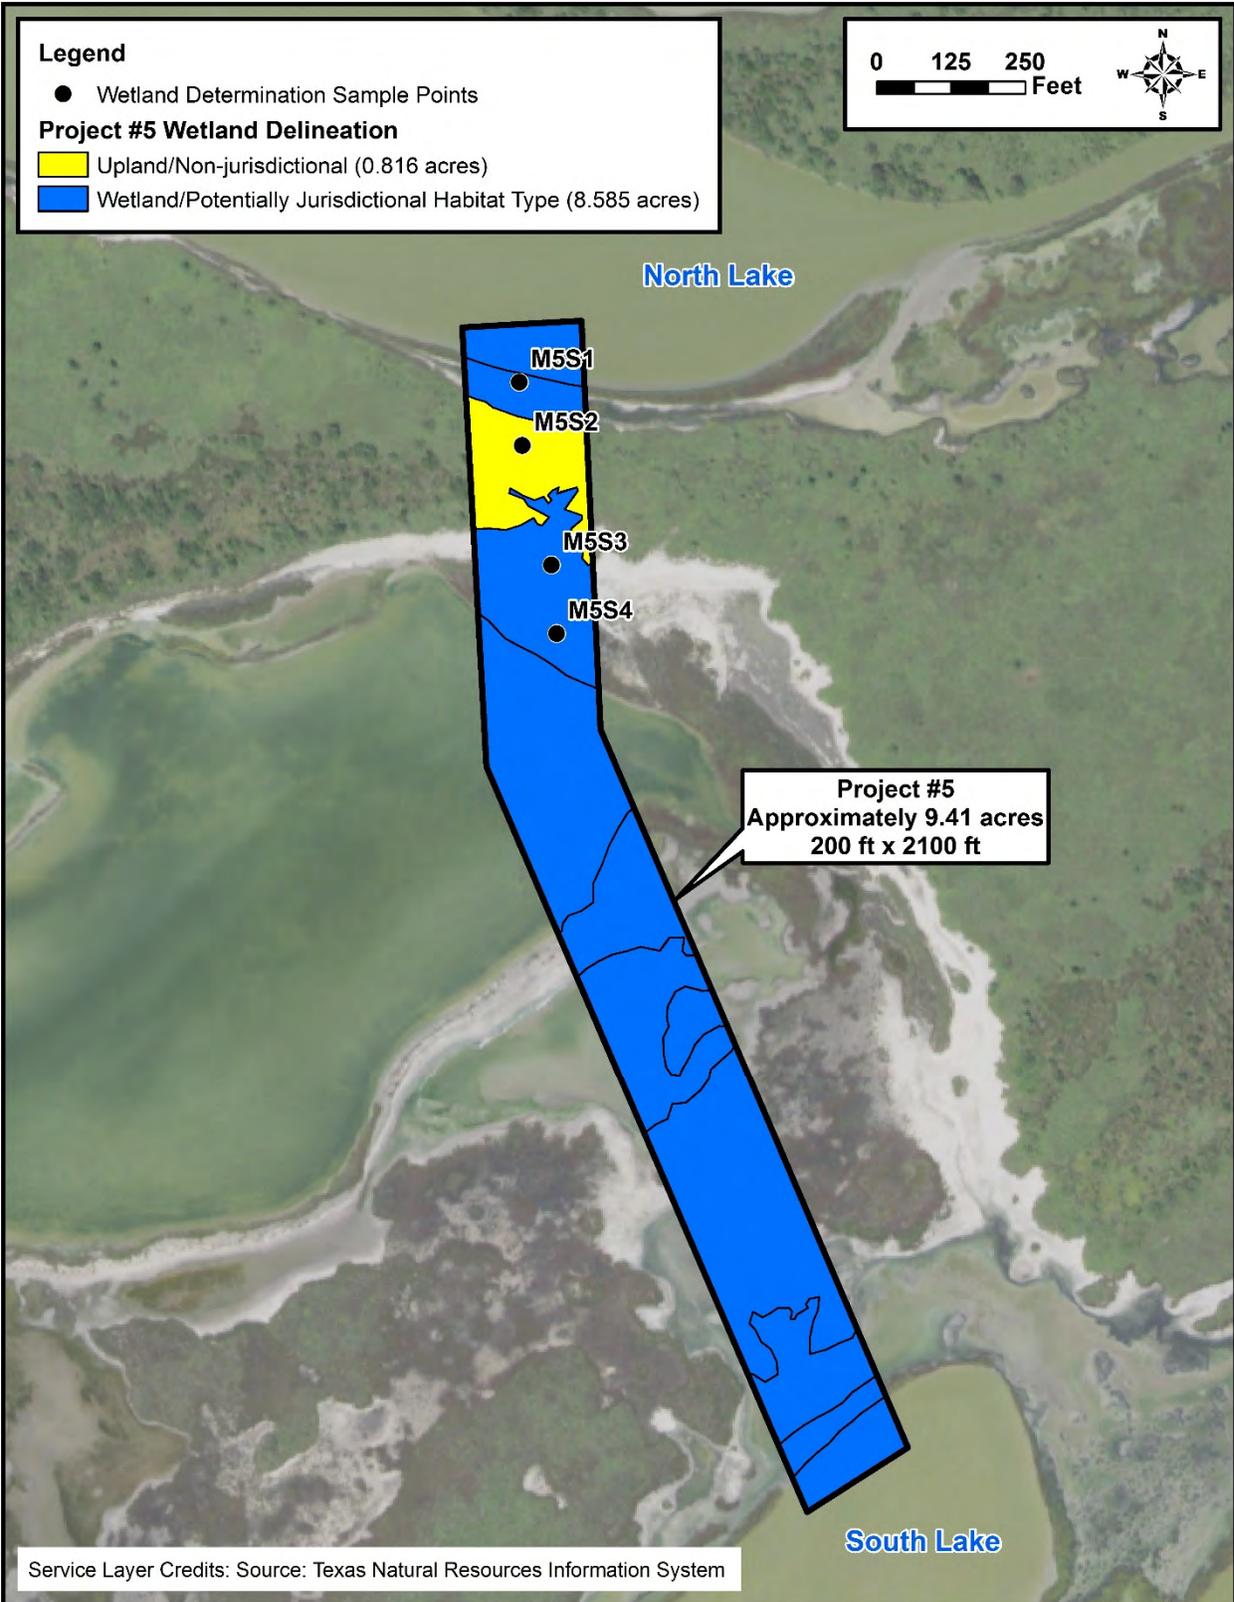
Figure 5-16. Project #5 wetland delineation map.

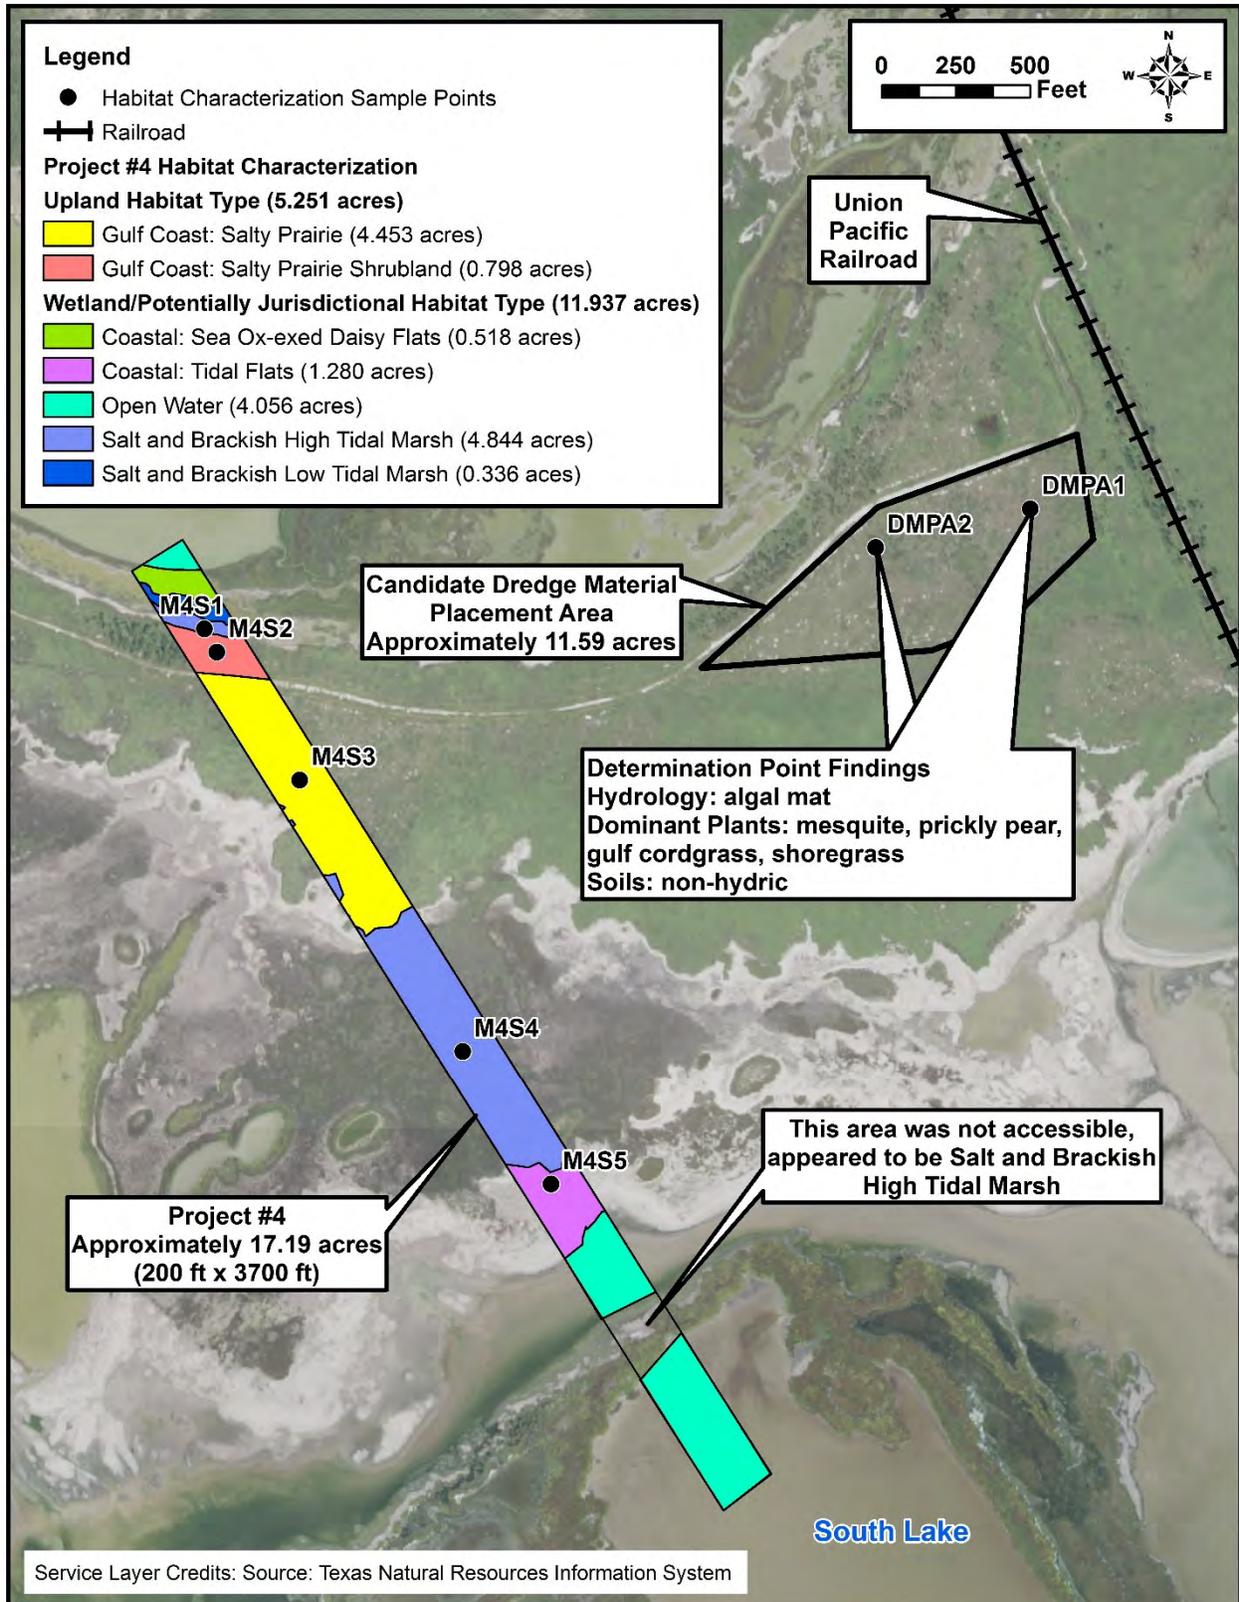
Figure 5-17. Habitat characterization results for Project #4.

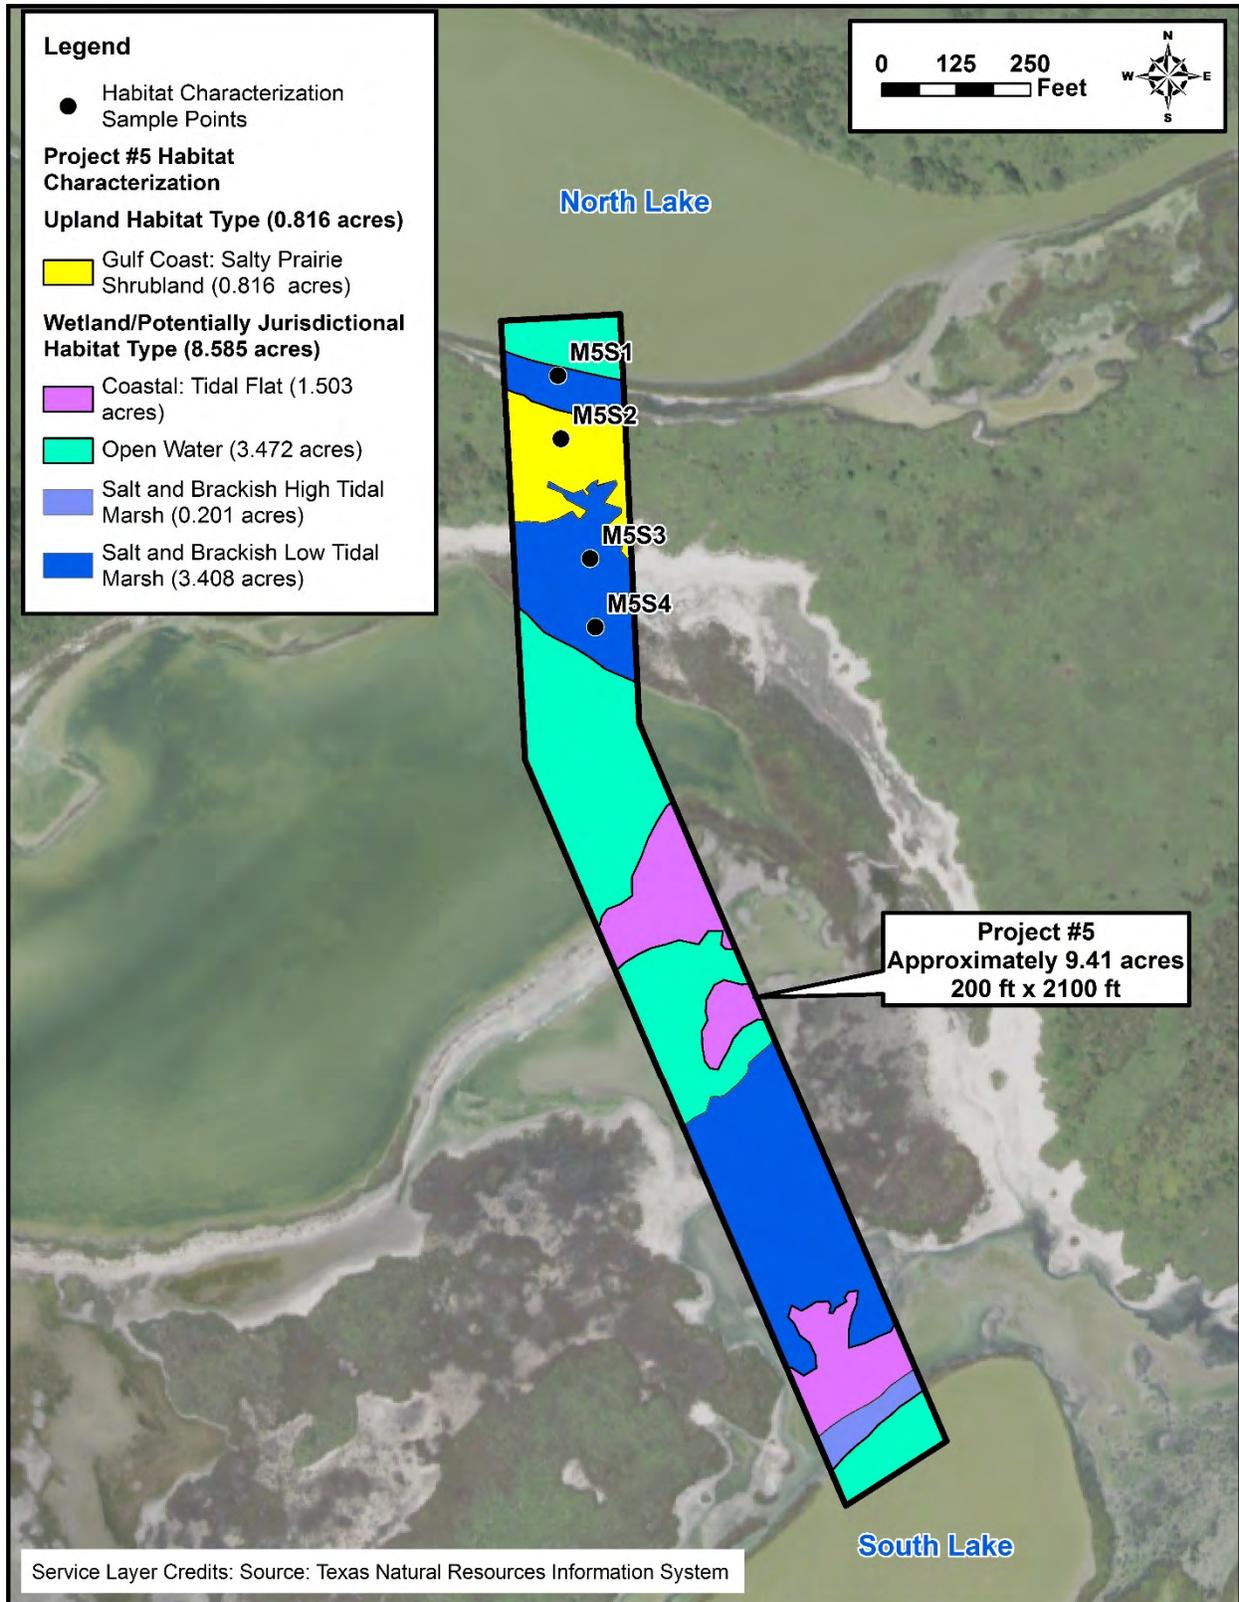
Figure 5-18. Habitat characterization results for Project #5.

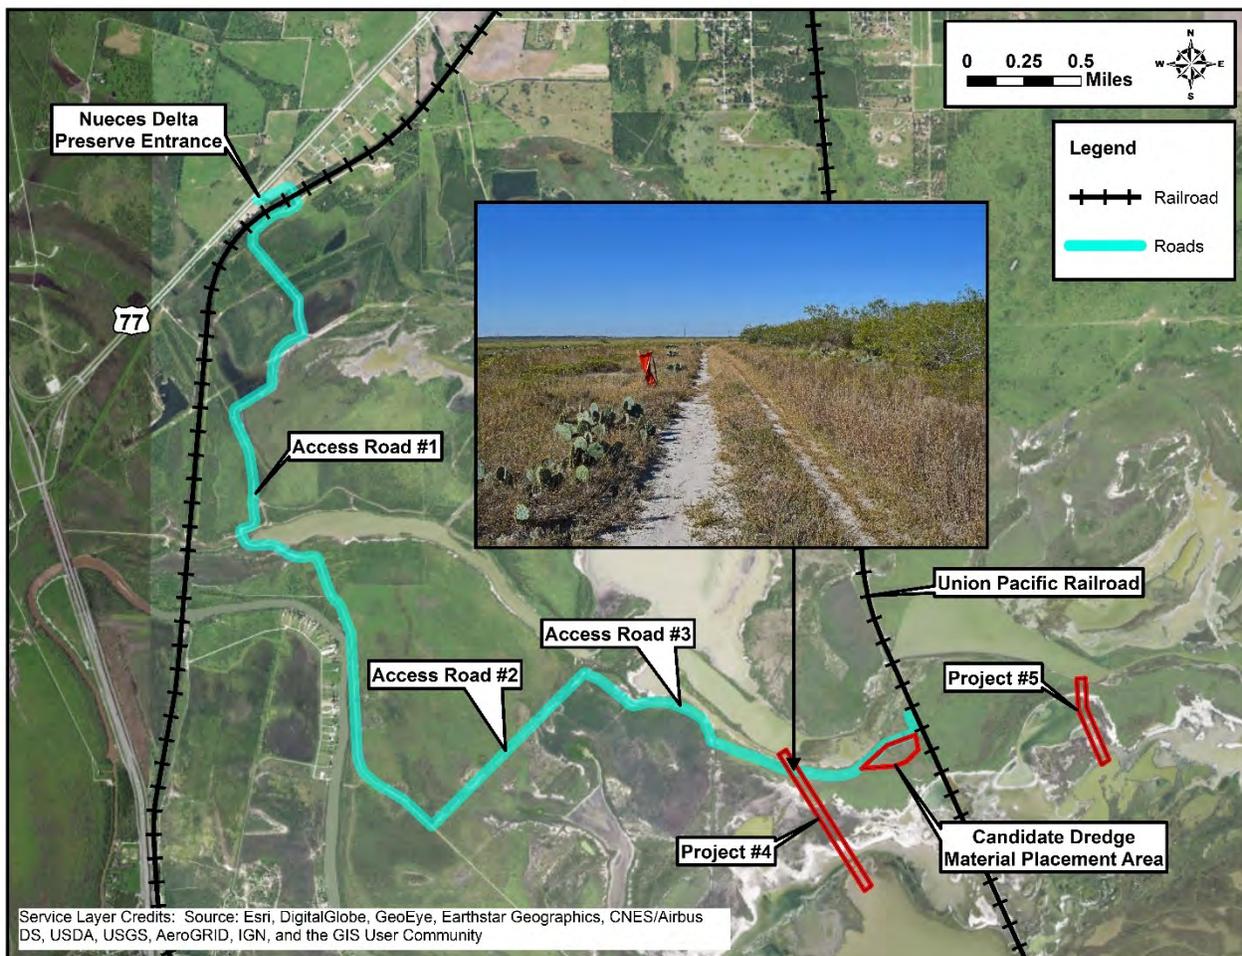
Figure 5-19. Project site access route via road.

For the November 2016 field work, site access was granted by the landowner, the CBBEP. The project site is located within the Nueces Delta Preserve (Preserve) which spans over 10,000 acres, all of which is owned by CBBEP. The entrance to the Preserve is located on the southeast side of State Highway 77 approximately three miles southwest of Odem, Texas (see Figure 5-19).

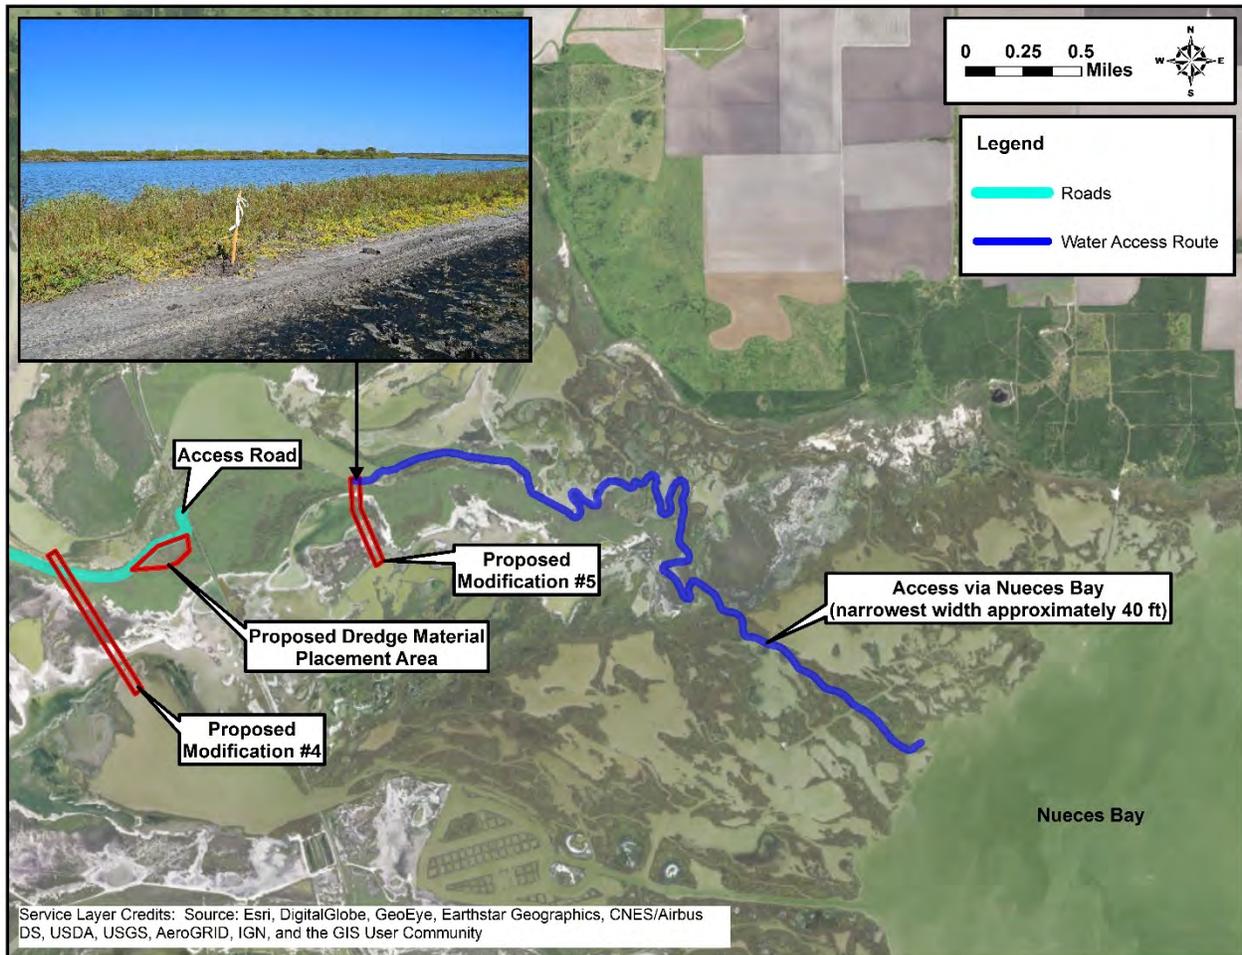
Access via airboat is feasible for light loads and sometimes preferable due to the extensive access it can offer but using an airboat to transport heavy equipment is not feasible.

Figure 5-20. Project site access via water.

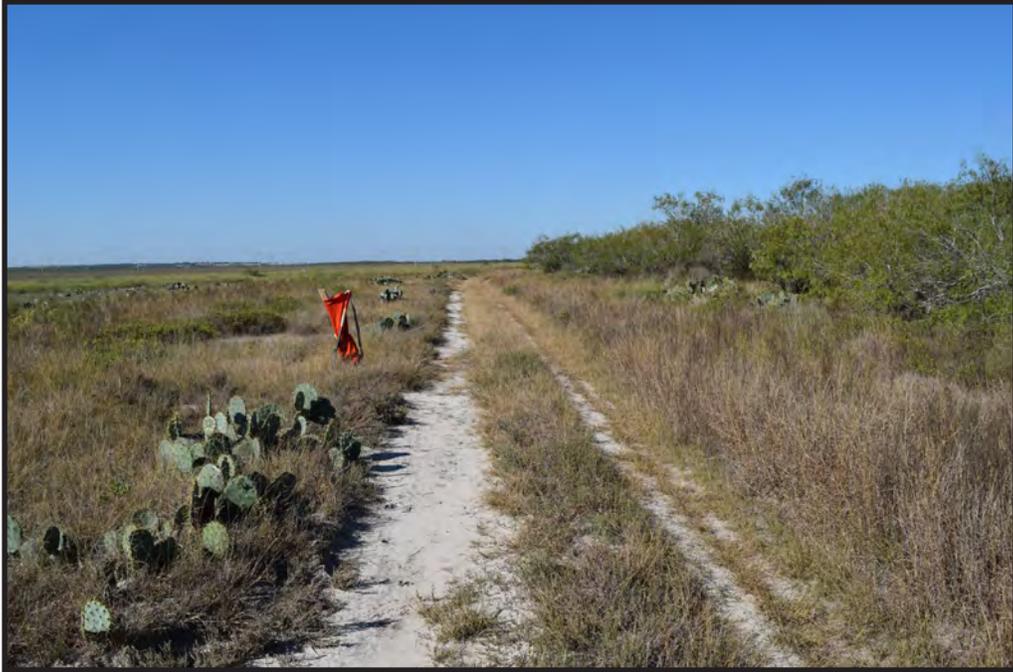
Photograph 1. Bisecting the Project #4 corridor is Road #3 which has not been improved with caliche but the condition is still fair and driveable (looking west).

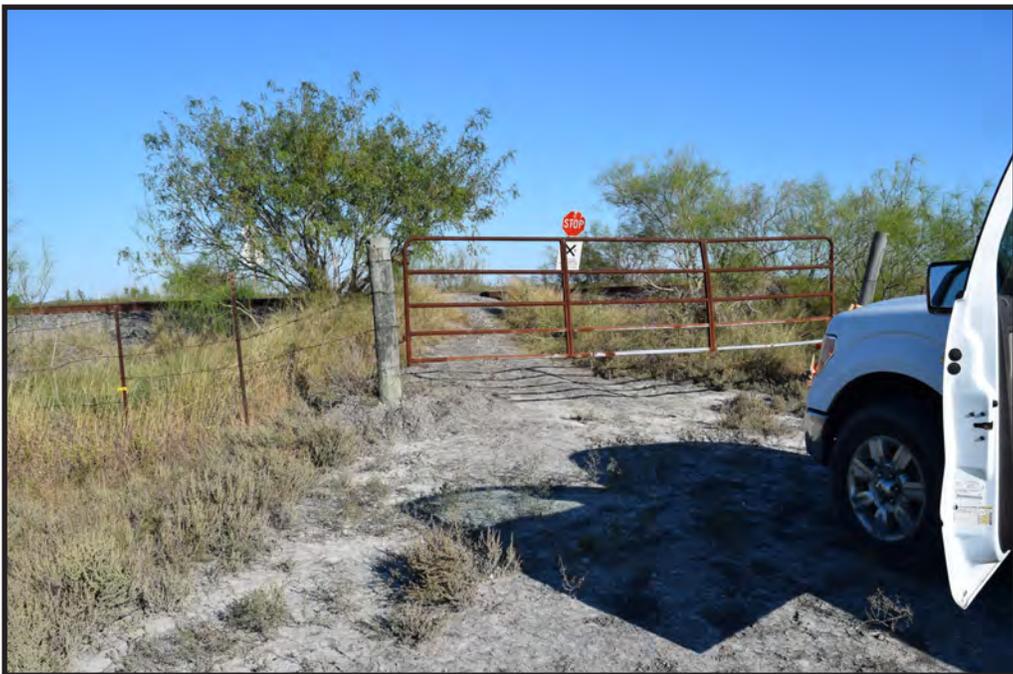
Photograph 2. Road #3 ends at the Union Pacific railroad track (looking east northeast).

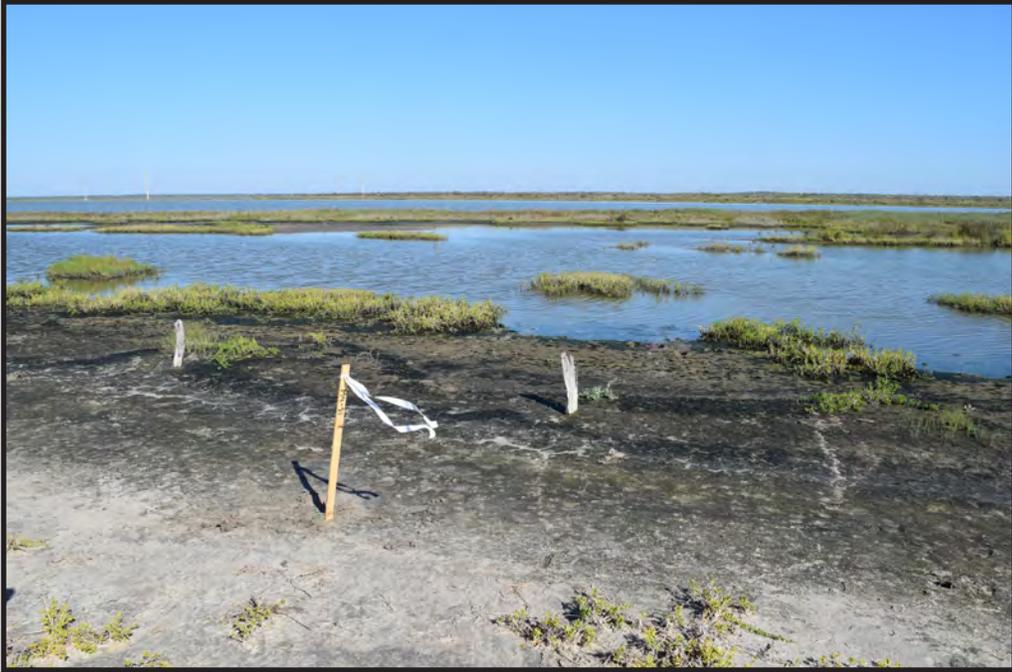
Photograph 5. Open water, high tidal marsh, low tidal marsh, and sea ox-eye daisy/tidal flats located in the northern-most section of Project #4 corridor (looking north northwest). Wetland determination sample point M4S1 is pictured.

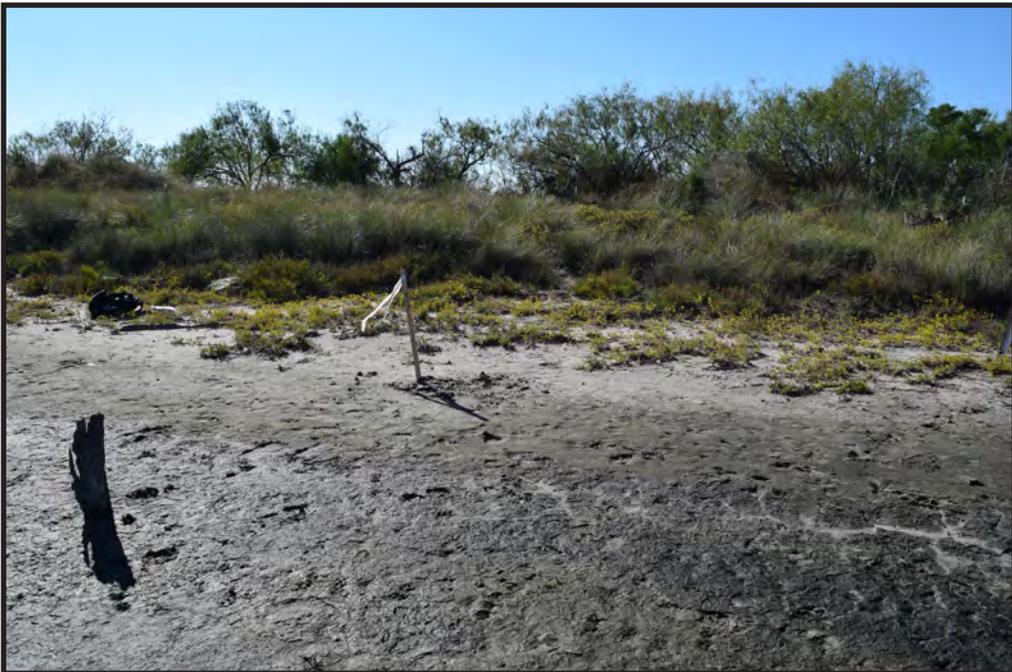
Photograph 6. Proceeding south from Photograph 5, within the Project #4 corridor, the habitat boundary between high tidal marsh and salty prairie shrubland. Wetland determination sample point M4S1 is pictured (looking south southeast).

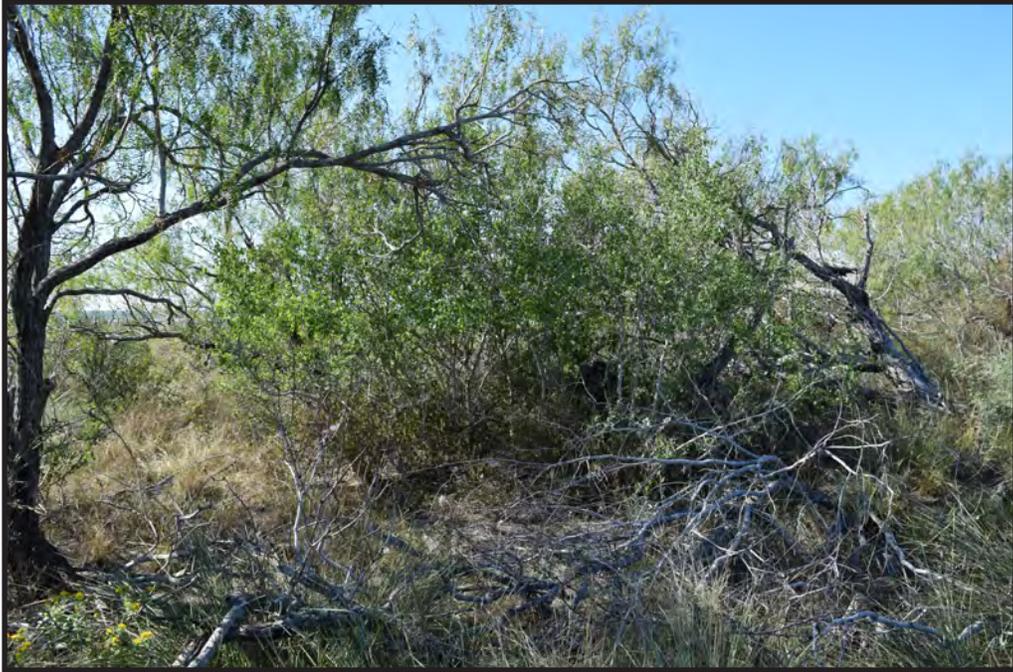
Photograph 7. Proceeding south from Photograph 6, within the Project #4 corridor, the salty prairie shrubland habitat is dominated by honey mesquite, retama, guinea grass, and gulf cordgrass (looking west southwest).

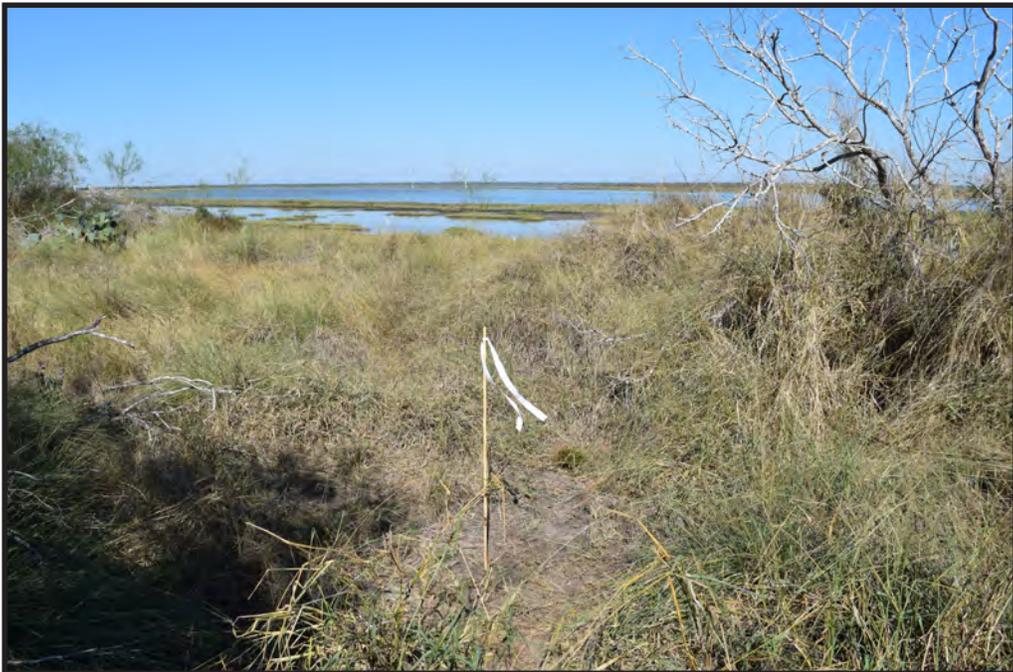
Photograph 8. Wetland determination sample point M4S2 taken in the Project #4 corridor was within the salty prairie shrubland habitat (looking north northwest).

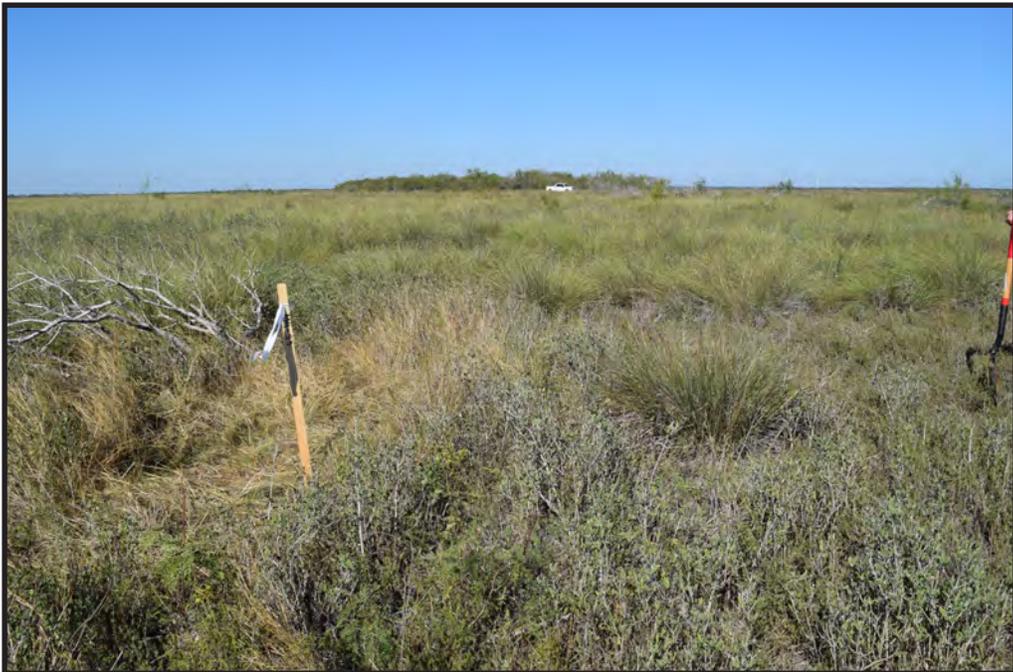
Photograph 10. Proceeding south from Photograph 9, wetland determination sample point M4S3 taken in the Project #4 corridor was within the salty prairie habitat which includes sparse honey mesquite, gulf cordgrass, sea ox-eye daisy, shoregrass, gaping grass, and western ragweed (looking north northwest).

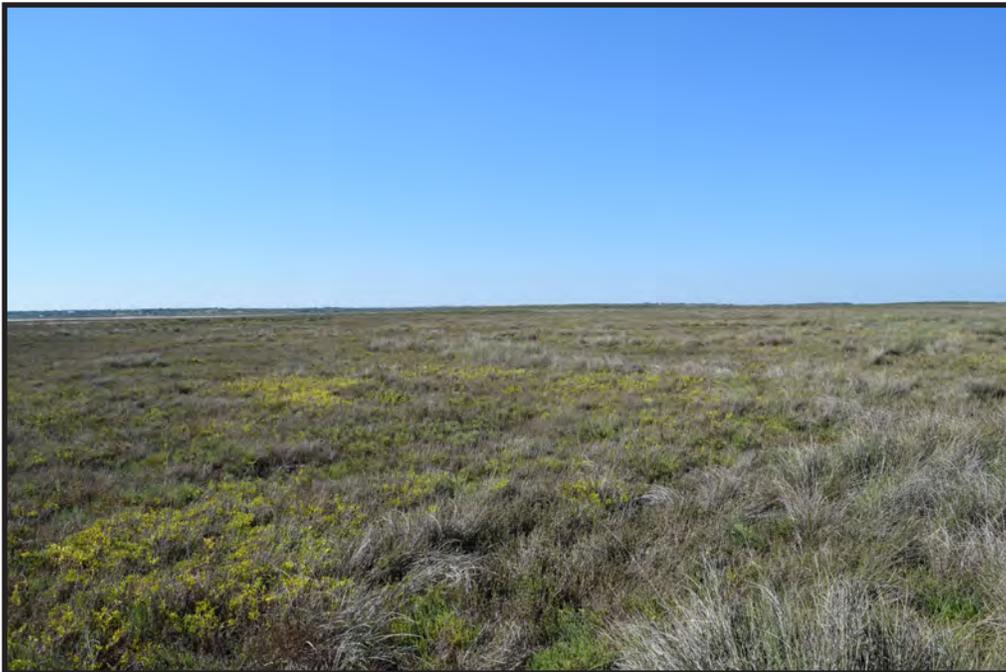
Photograph 11. Proceeding south from Photograph 10, wetland determination sample point M4S4 (not pictured) taken in the Project #4 corridor was within the high tidal marsh habitat which includes shoregrass, gulf cordgrass, saltwort, glasswort, annual seepweed, sea ox-eye daisy, and Carolina wolfberry (looking west).

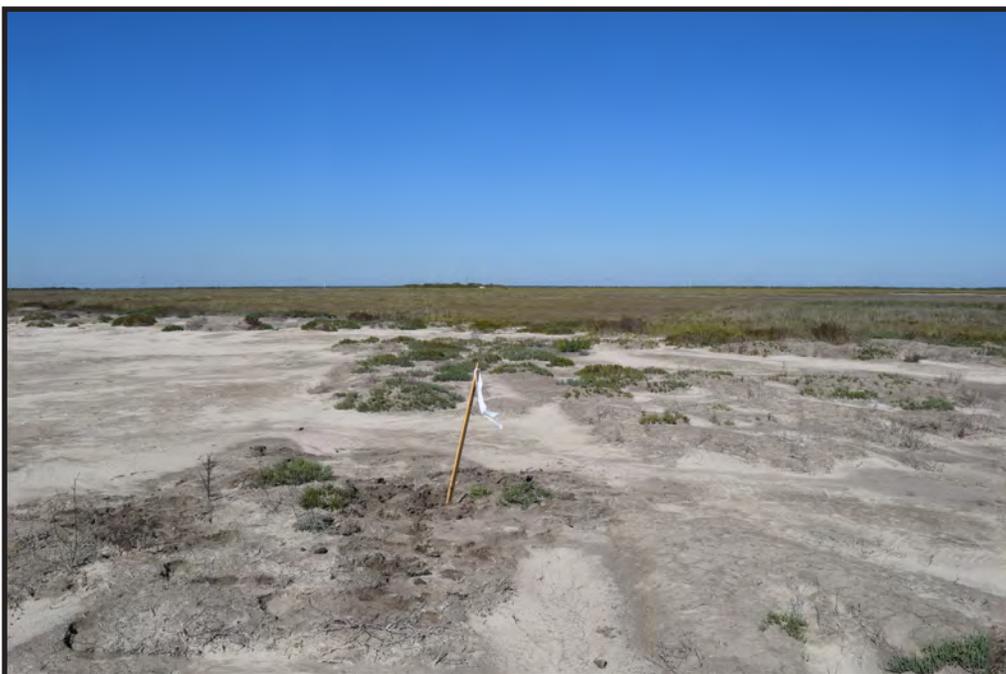
Photograph 12. Proceeding south from Photograph 11, wetland determination sample point M4S5 taken in the Project #4 corridor within tidal flats habitat which was sparsely vegetated and dominated by saltwort, glasswort, and shoregrass (looking north northwest).

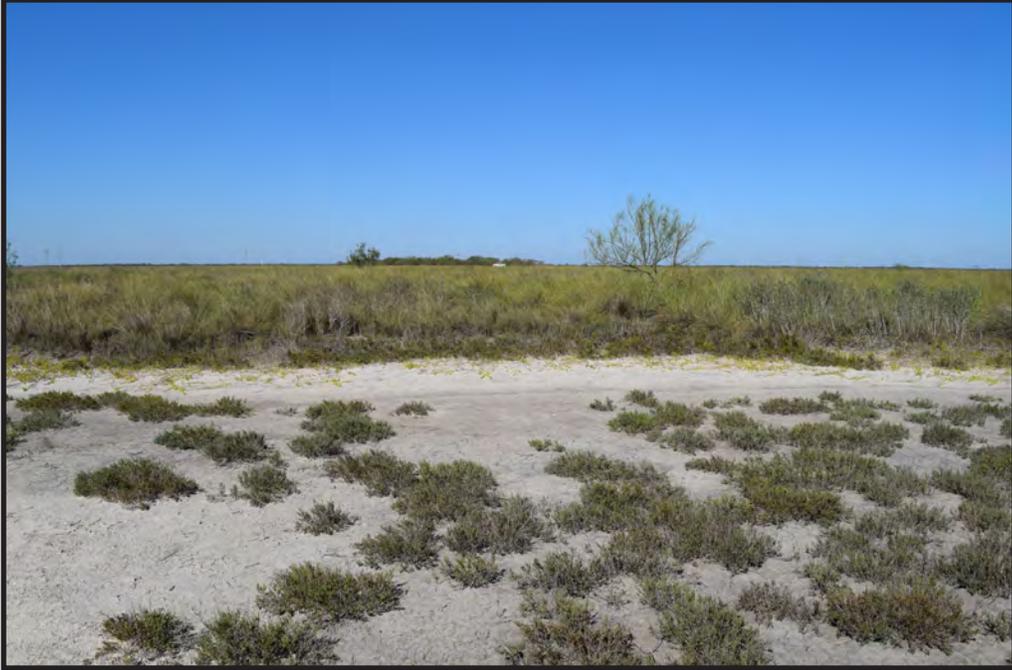
Photograph 13. Looking north northwest, boundary between the high tidal marsh habitat (background) and the tidal flats habitat (foreground) in the Project #4 corridor.

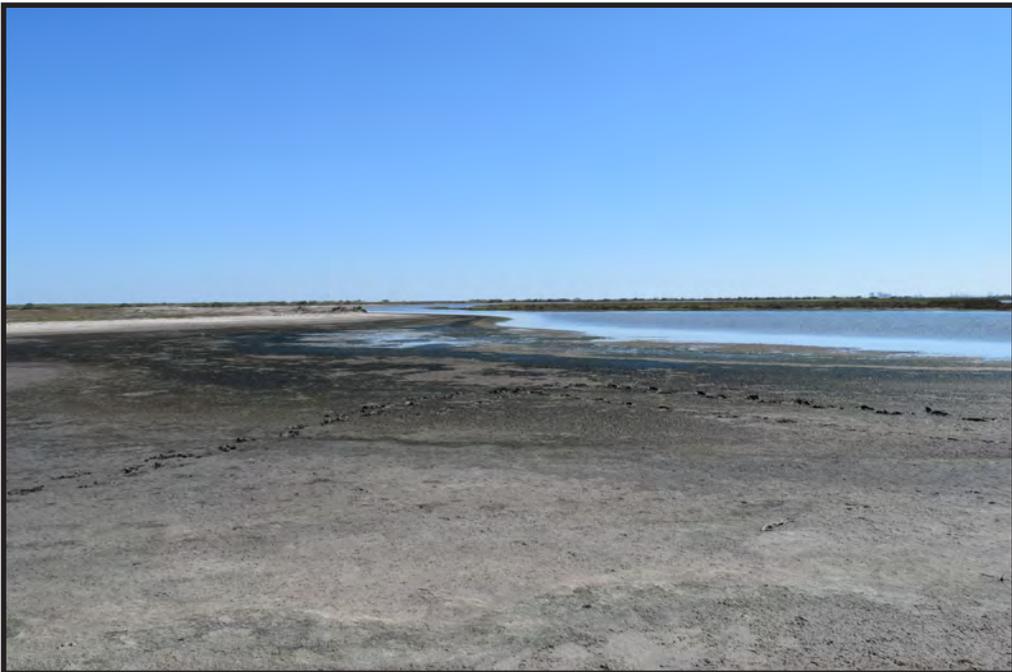
Photograph 14. Proceeding south from Photographs 12 and 13, the southern-most section of the Project #4 corridor includes tidal flats, open water, and high tidal marsh habitats (looking southeast).

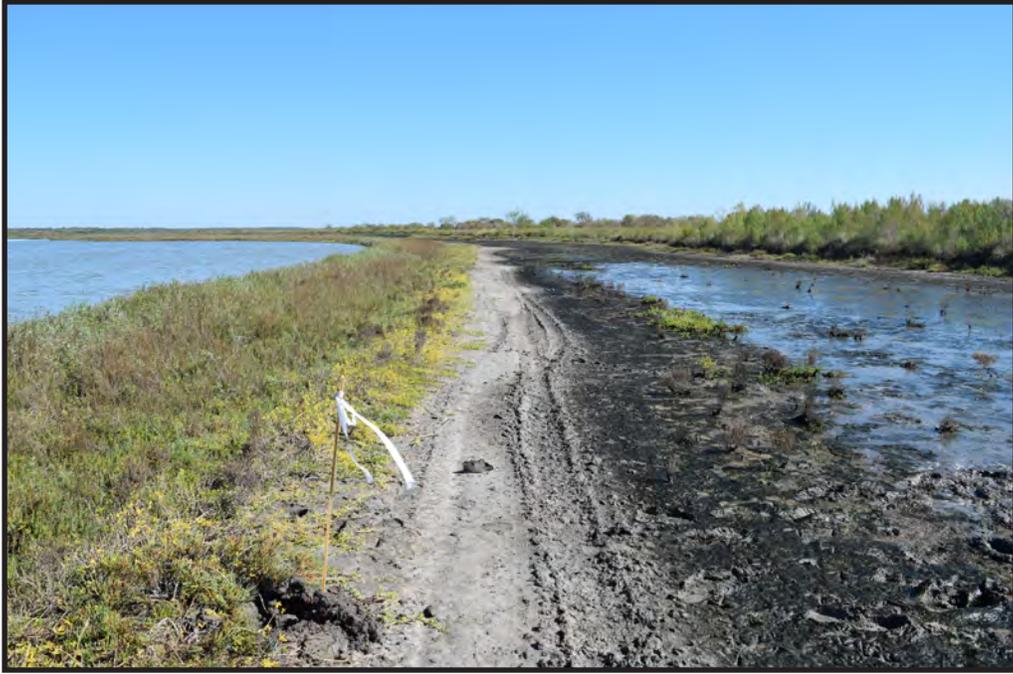
Photograph 15. Wetland determination sample point M5S1 was taken in the northernmost section of the Project #5 corridor which includes open water and low tidal marsh habitats (looking east southeast).

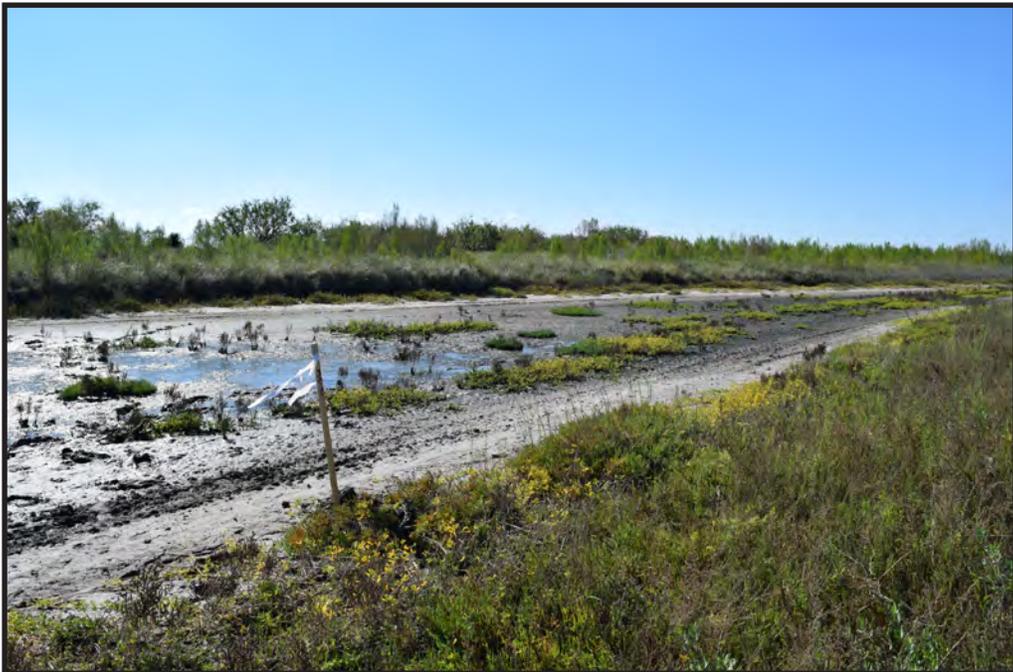
Photograph 16. In the Project #5 corridor, looking southwest, the boundary between the low tidal marsh (foreground) and the salty prairie shrubland (background) habitats. Vegetation within the low tidal marsh included sea ox-eye daisy, shoregrass, saltwort, glasswort, Carolina wolfberry, saltgrass, and annual seepweed.

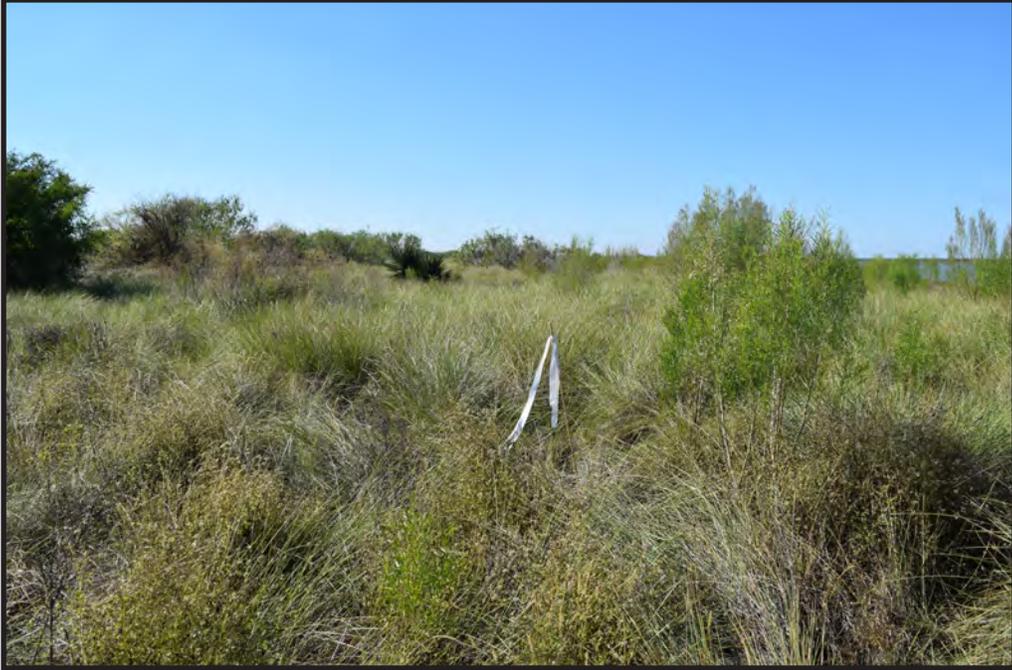
Photograph 17. Proceeding south from Photographs 15 and 16, wetland determination sample point M5S2 was taken in the Project #5 corridor within the salty prairie shrubland habitat (looking north northwest).

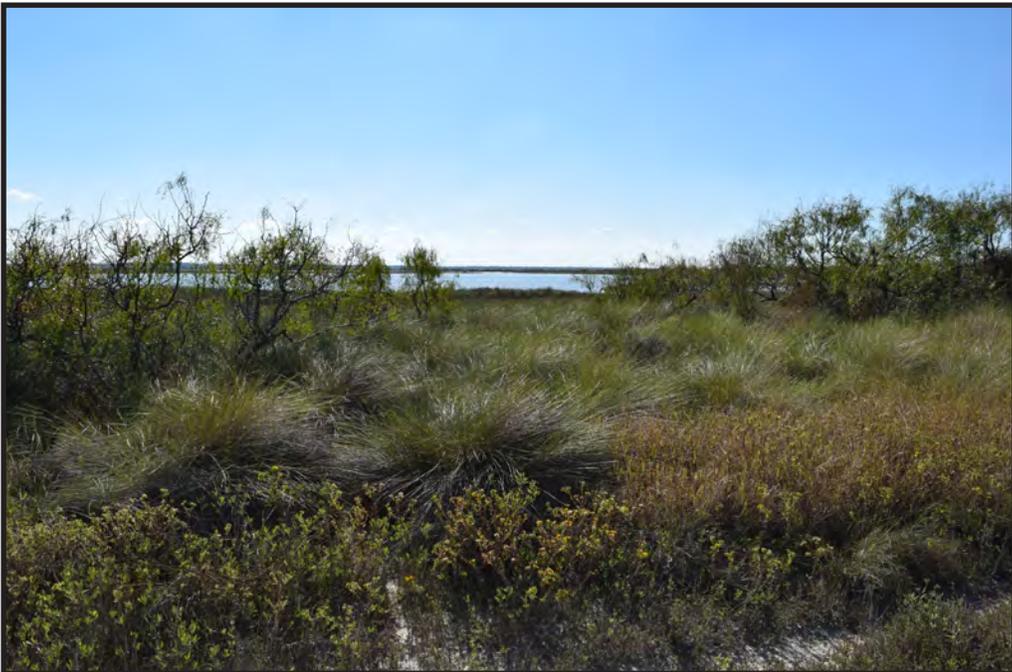
Photograph 18. The salty prairie shrubland habitat in the Project #5 corridor is dominated by honey mesquite, baccharis, and gulf cordgrass (looking south).

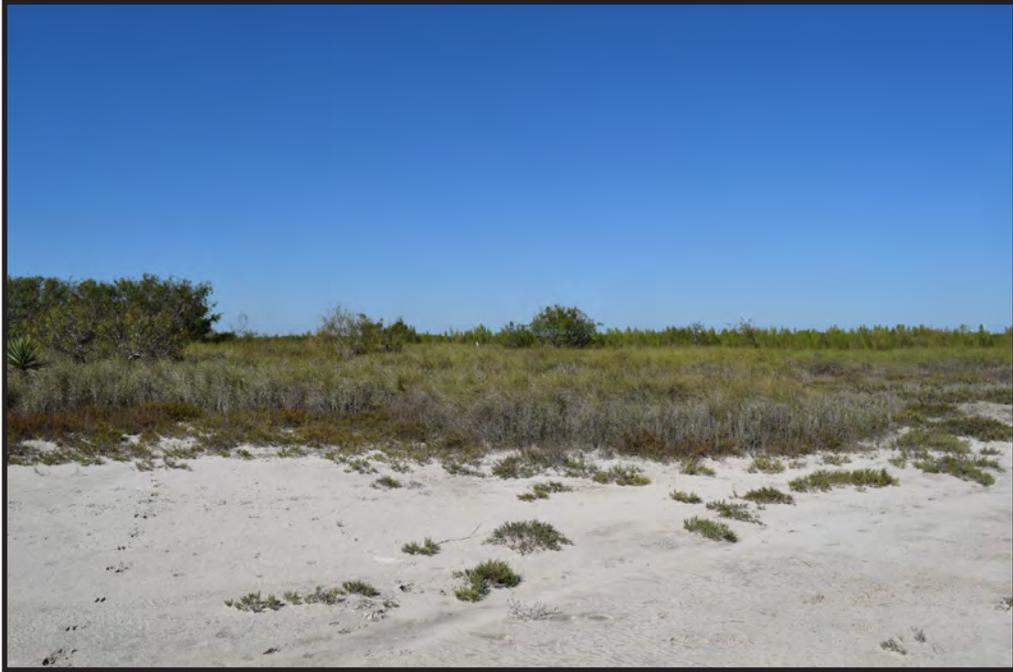
Photograph 19. Proceeding south from Photographs 17 and 18, looking north in the Project #5 corridor, the boundary between the low tidal marsh (foreground) and the salty prairie shrubland (background) habitats.
