Using Landform and Hydraulic Modifications to Increase the Benefit of Fresh Water Inflows to Nueces Bay and Nueces Delta -- Phase II: Verification and Feasibility Assessment for Landform Modifications in the Nueces Delta

Texas Water Development Board

TWDB Contract No. 1600012013

October 2017

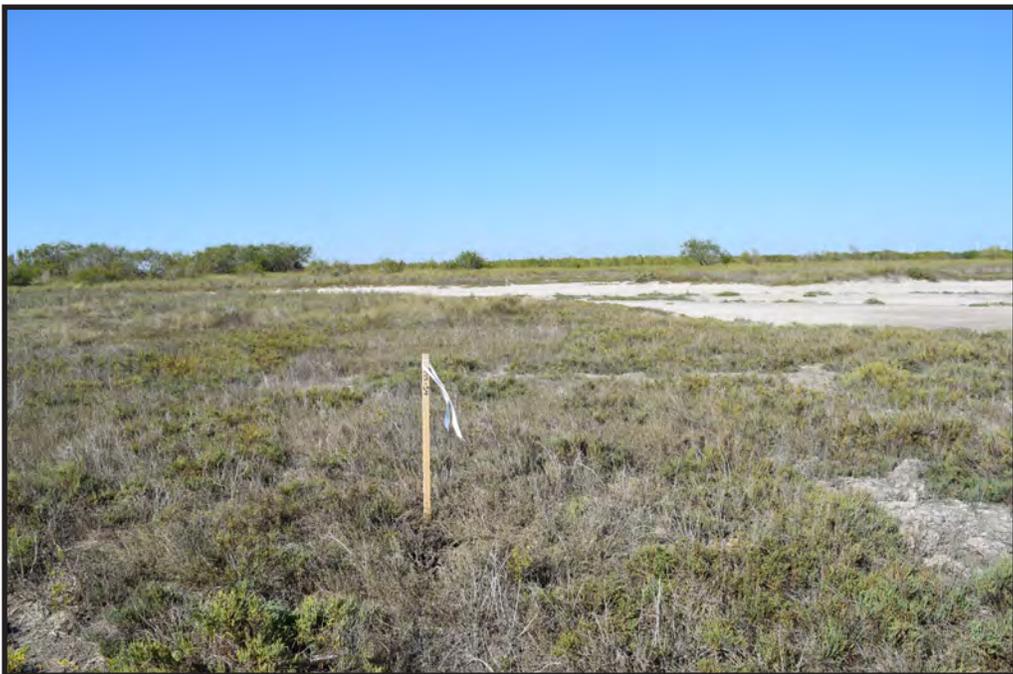
Photograph 20. Wetland determination sample points M5S3 and M5S4 (pictured in foreground) were taken within the low tidal marsh habitat. The dominant vegetation in this habitat type is saltwort, glasswort, shoregrass, and sea ox-eye daisy (looking north).

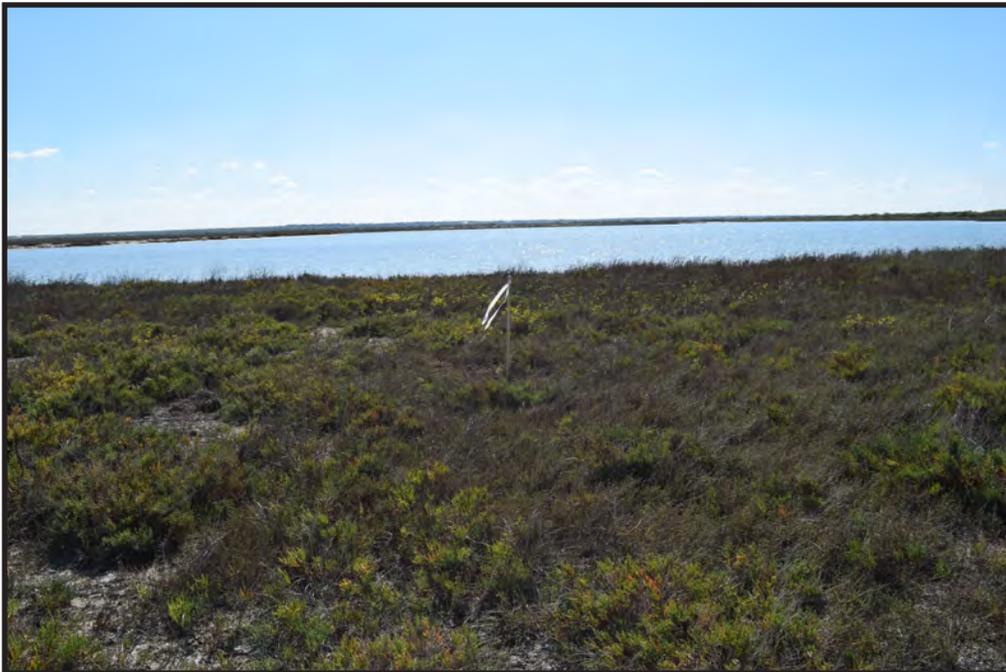
Photograph 21. Looking south in the Project #5 corridor, wetland determination sample point M5S4 is pictured within the low tidal marsh habitat and open water habitat is pictured in the background.

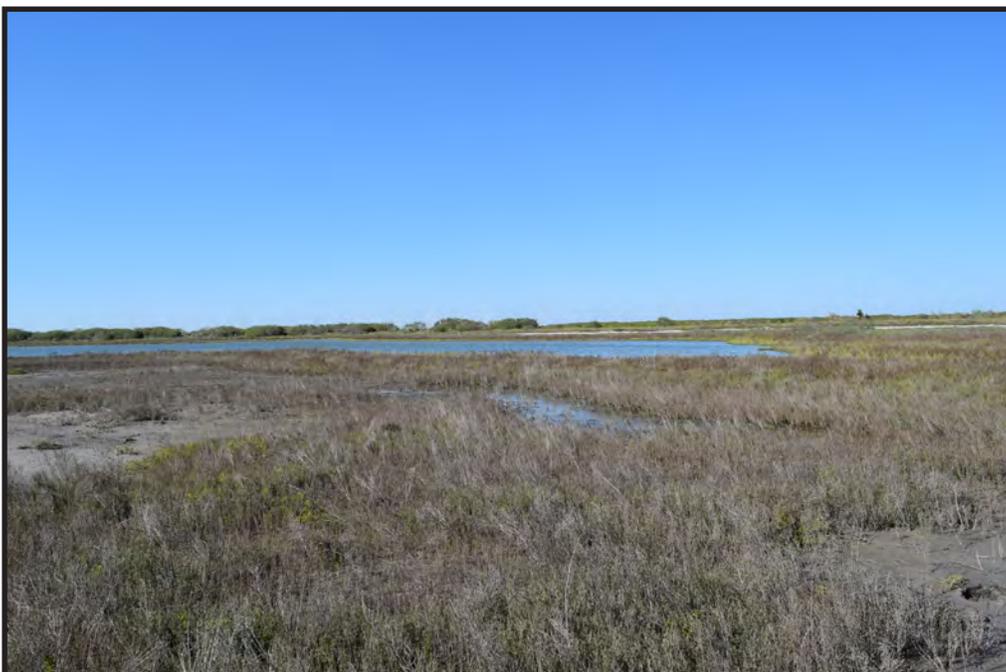
Photograph 22. Proceeding south from Photograph 21, sparsely vegetated tidal flats (foreground) and open water (background) habitats in the Project #5 corridor (looking north).

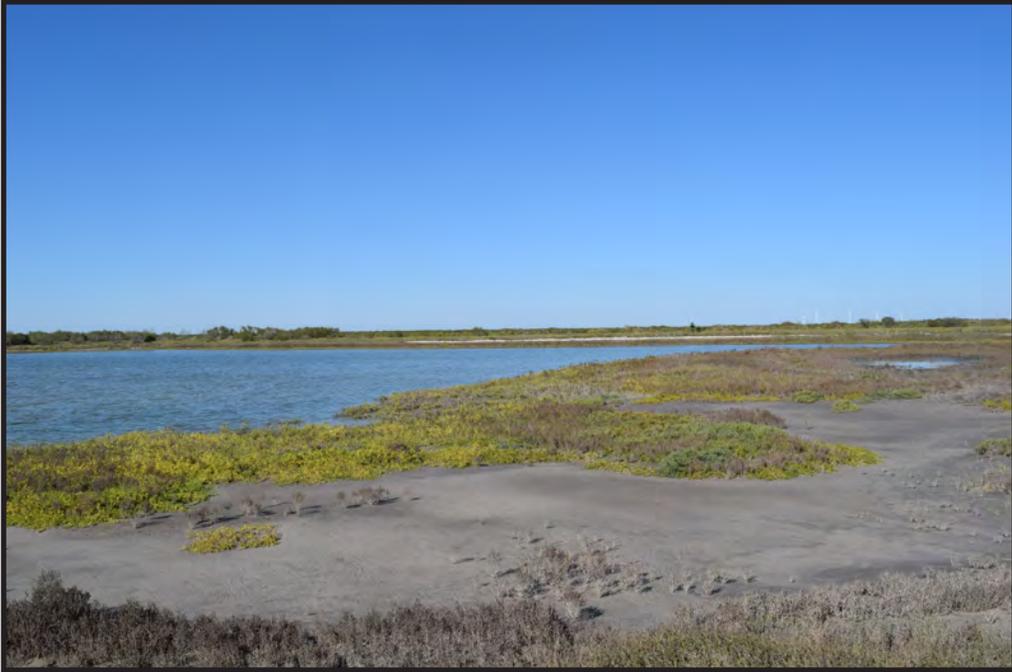
Photograph 23. Sparsely vegetated tidal flats (foreground) and open water (background) habitats in the Project #5 corridor (looking north).

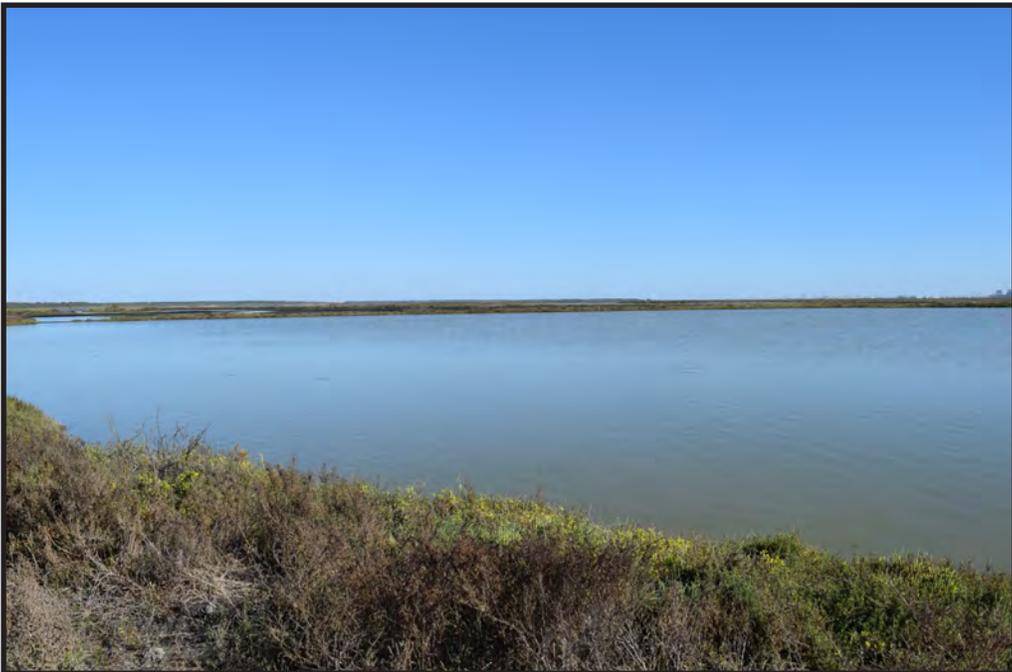
Photograph 24. Looking southeast, the southern-most section of the Project #5 corridor ends with open water habitat bounded by high tidal marsh habitat (foreground).

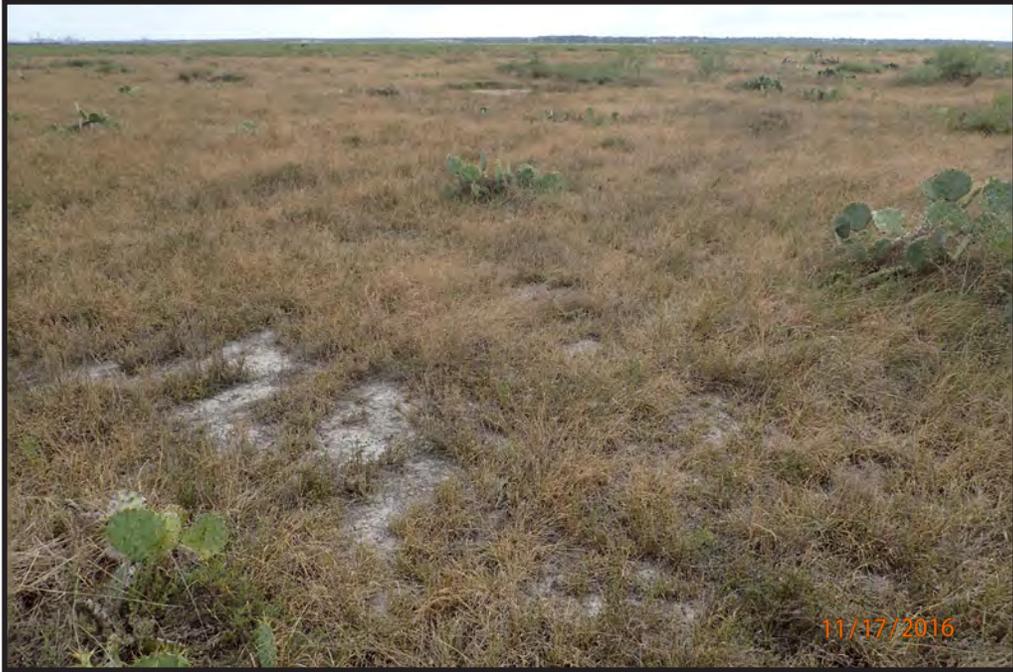
Photograph 25. The proposed dredge material placement area is located within the salty prairie habitat which includes honey mesquite, shoregrass, gulf cordgrass, and prickly pear.

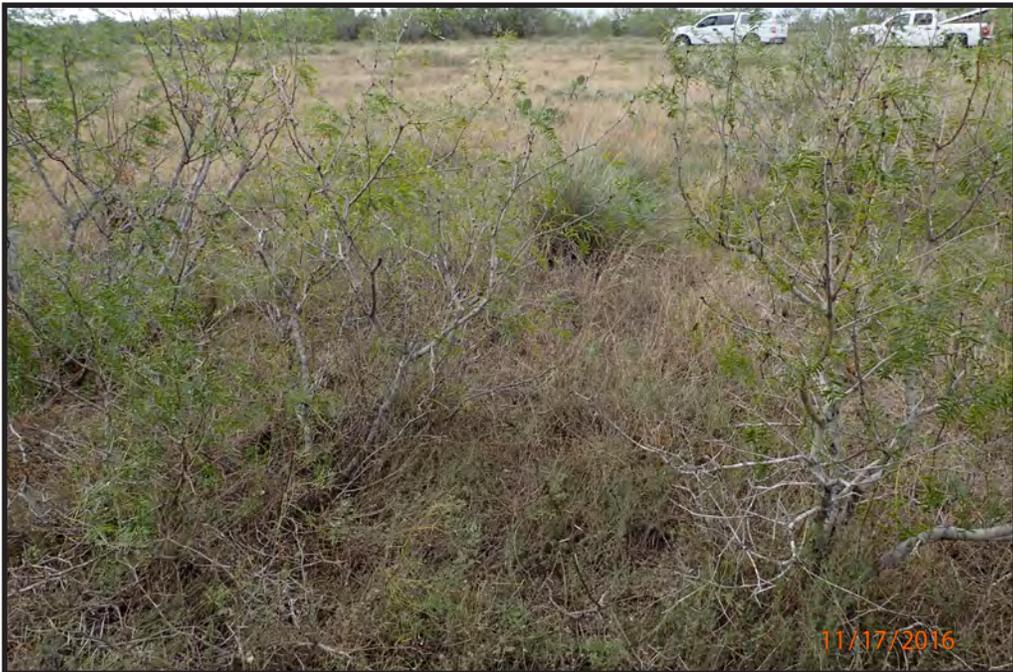
Photograph 26. The proposed dredge material placement area shown in relation to Road #3 (background), looking west northwest.

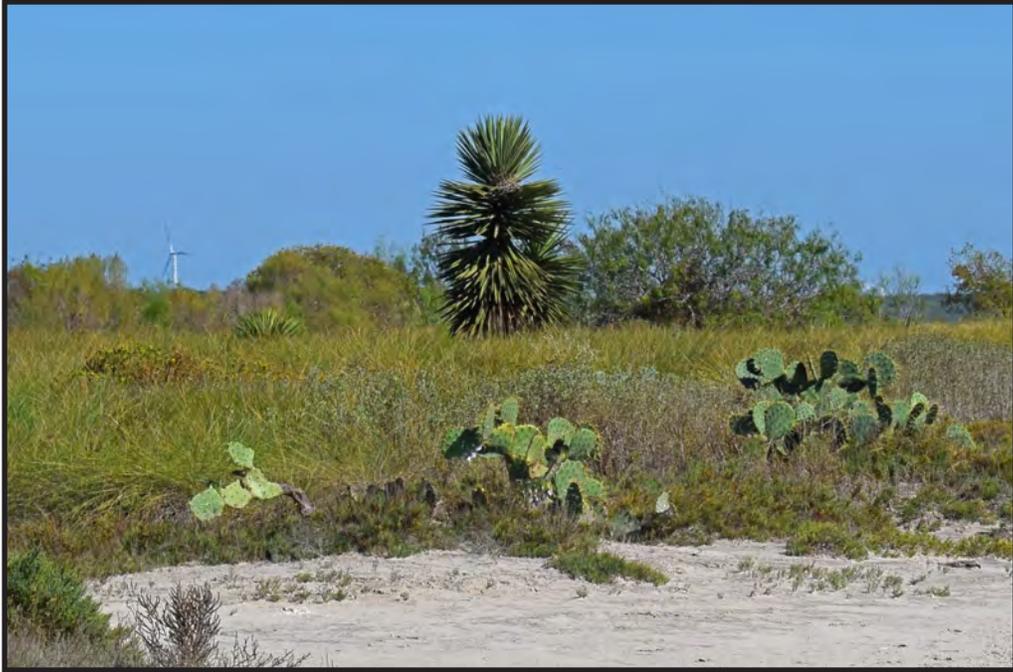
Photograph 33. Spanish dagger, located near the Project #5 corridor, could potentially serve as nesting habitat for the aplomado falcon, which is federal and state-listed endangered.

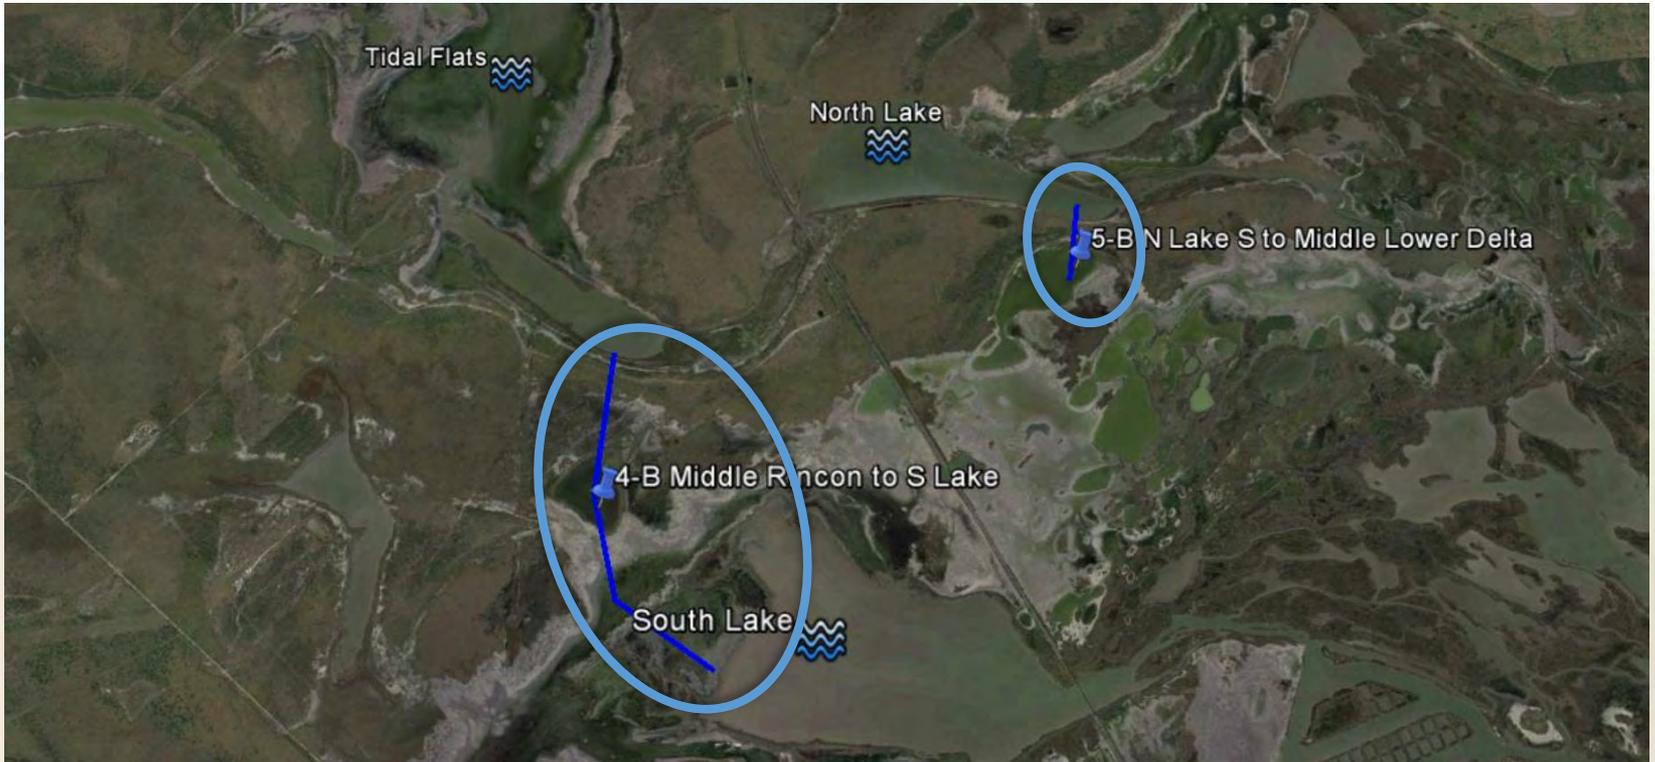
Project Options Included in Final Modeling

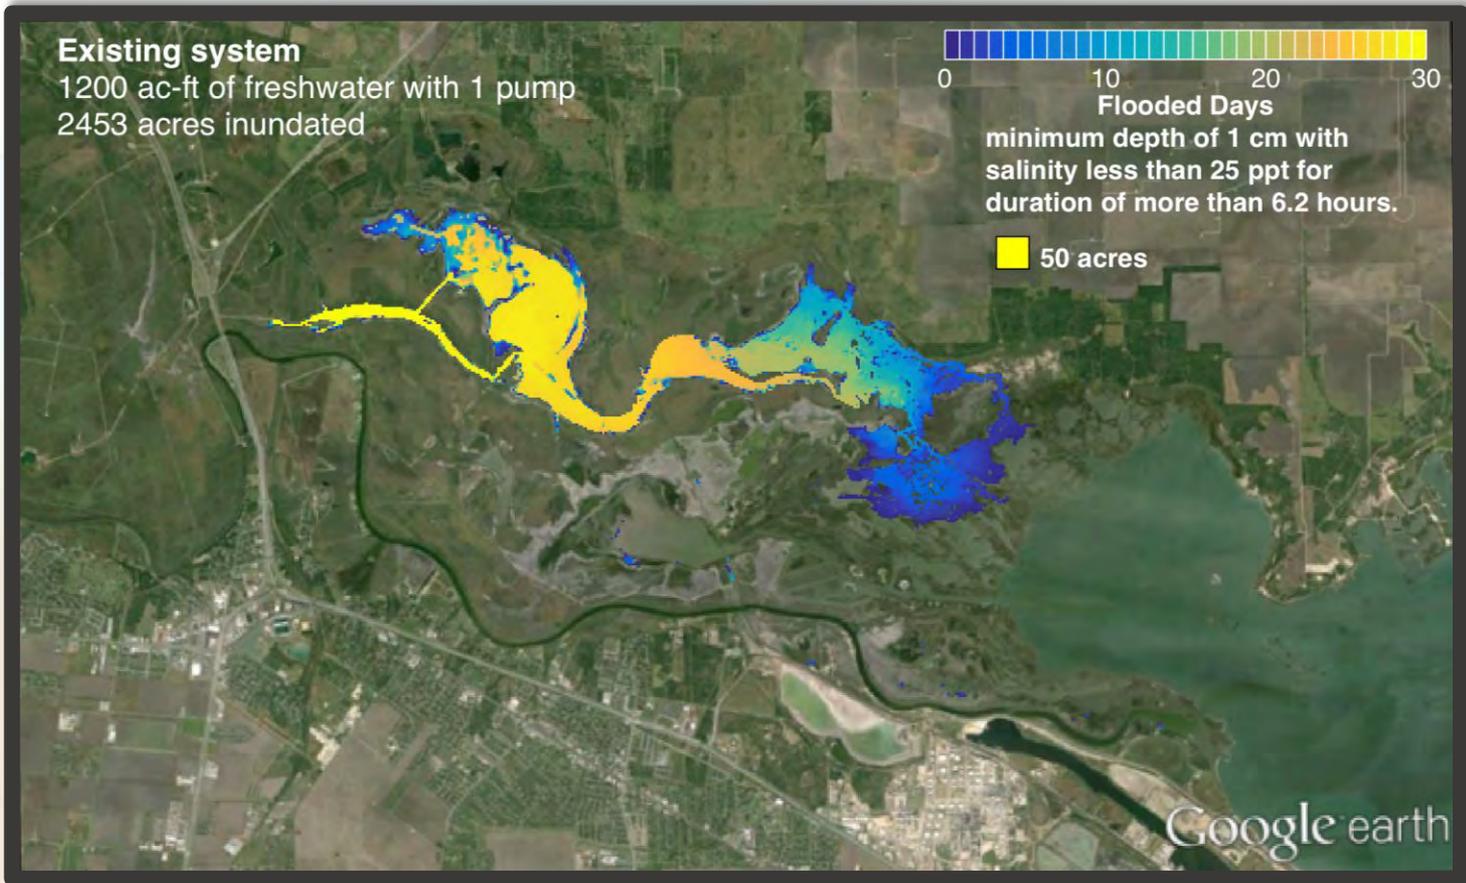
NDHM Used to Evaluate Inundation Duration and Salinity Changes Due to Pumping “Pass-Thru” Flows into the Rincon Bayou 1,200 ac-ft | 2,453 acres inundated

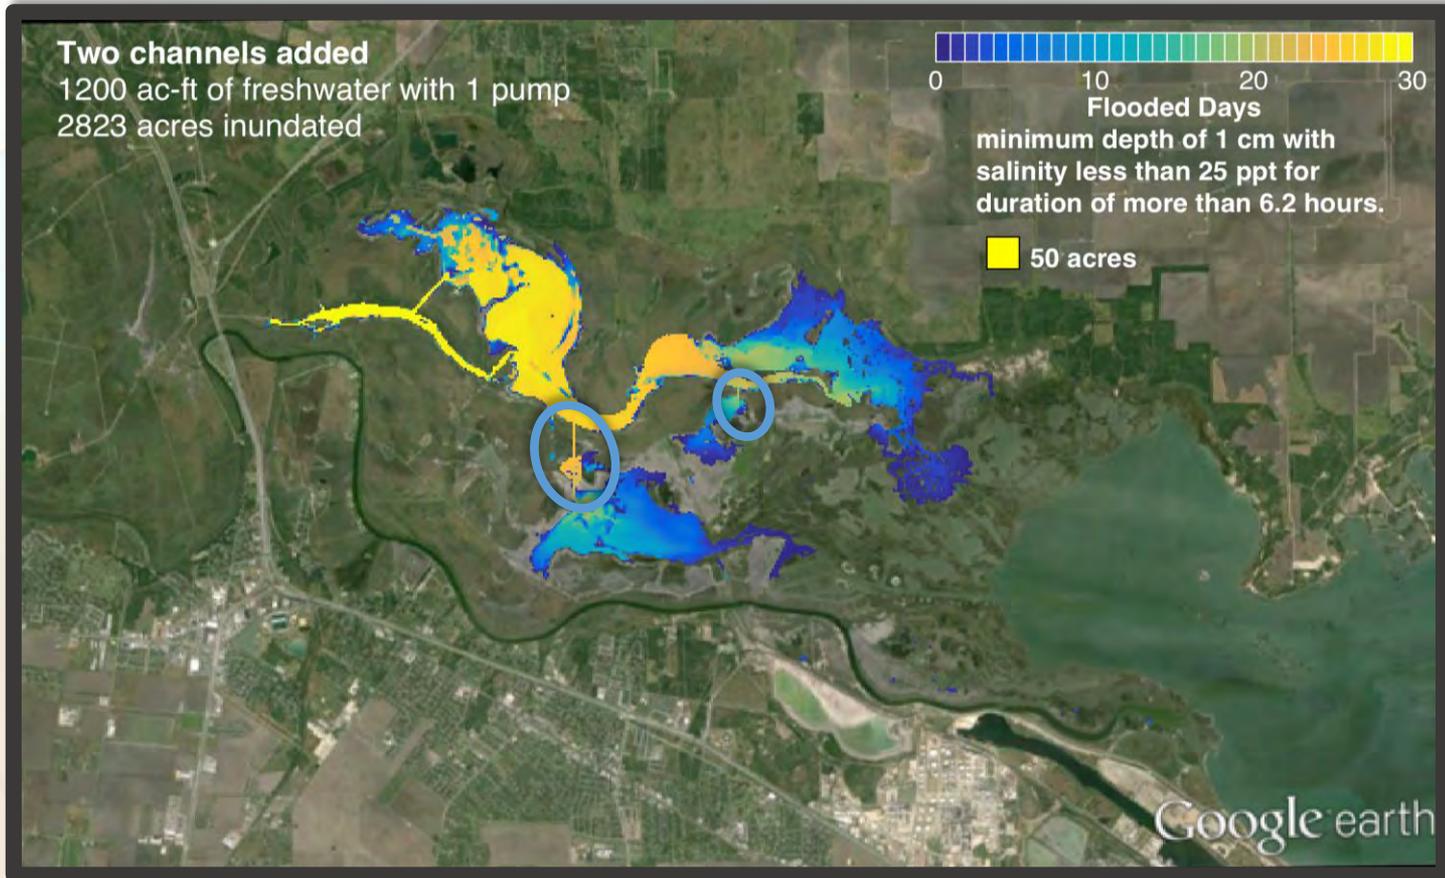
NDHM Used to Evaluate Inundation Duration and Salinity Changes Due to Pumping “Pass-Thru” Flows into the Rincon Bayou Modified System: Projects 4 & 5 | 1,200 ac-ft | 2,823 acres inundated

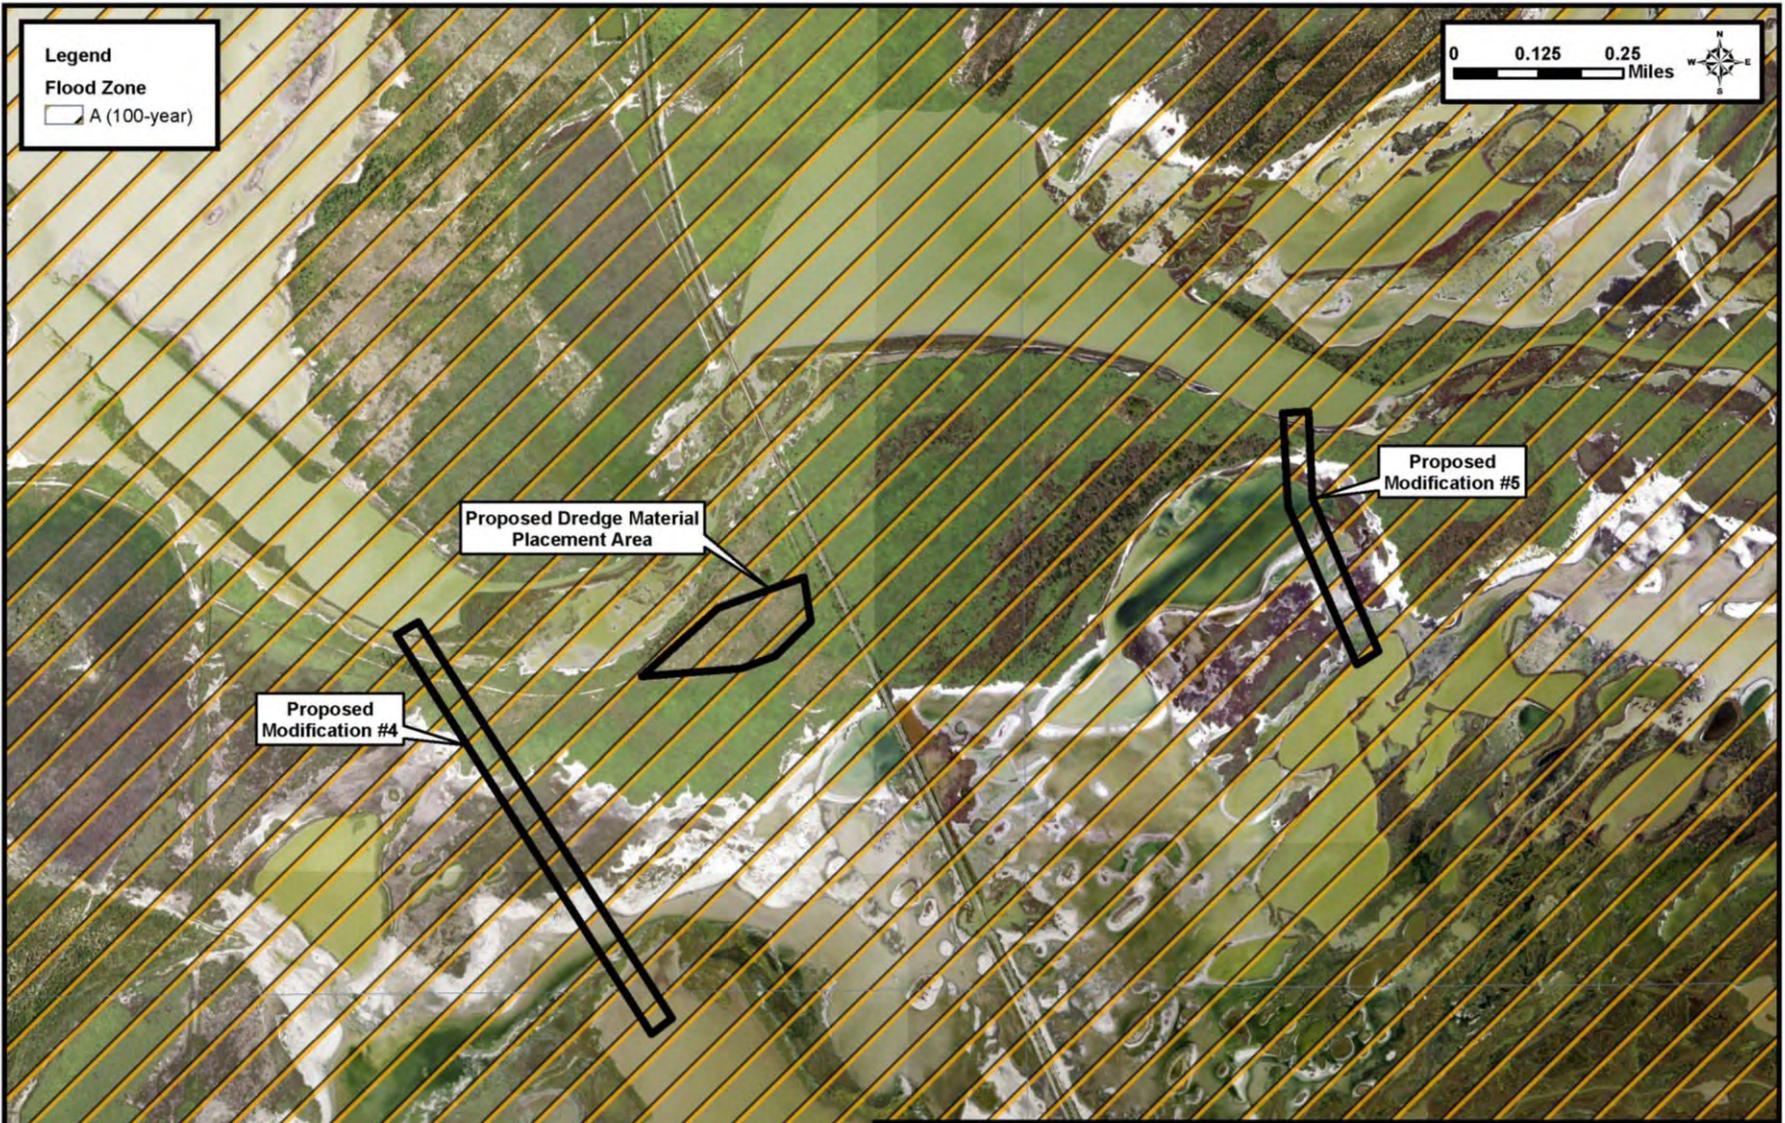
FLOOD ZONE MAP

Legend
Flood Zone
A (100-year)

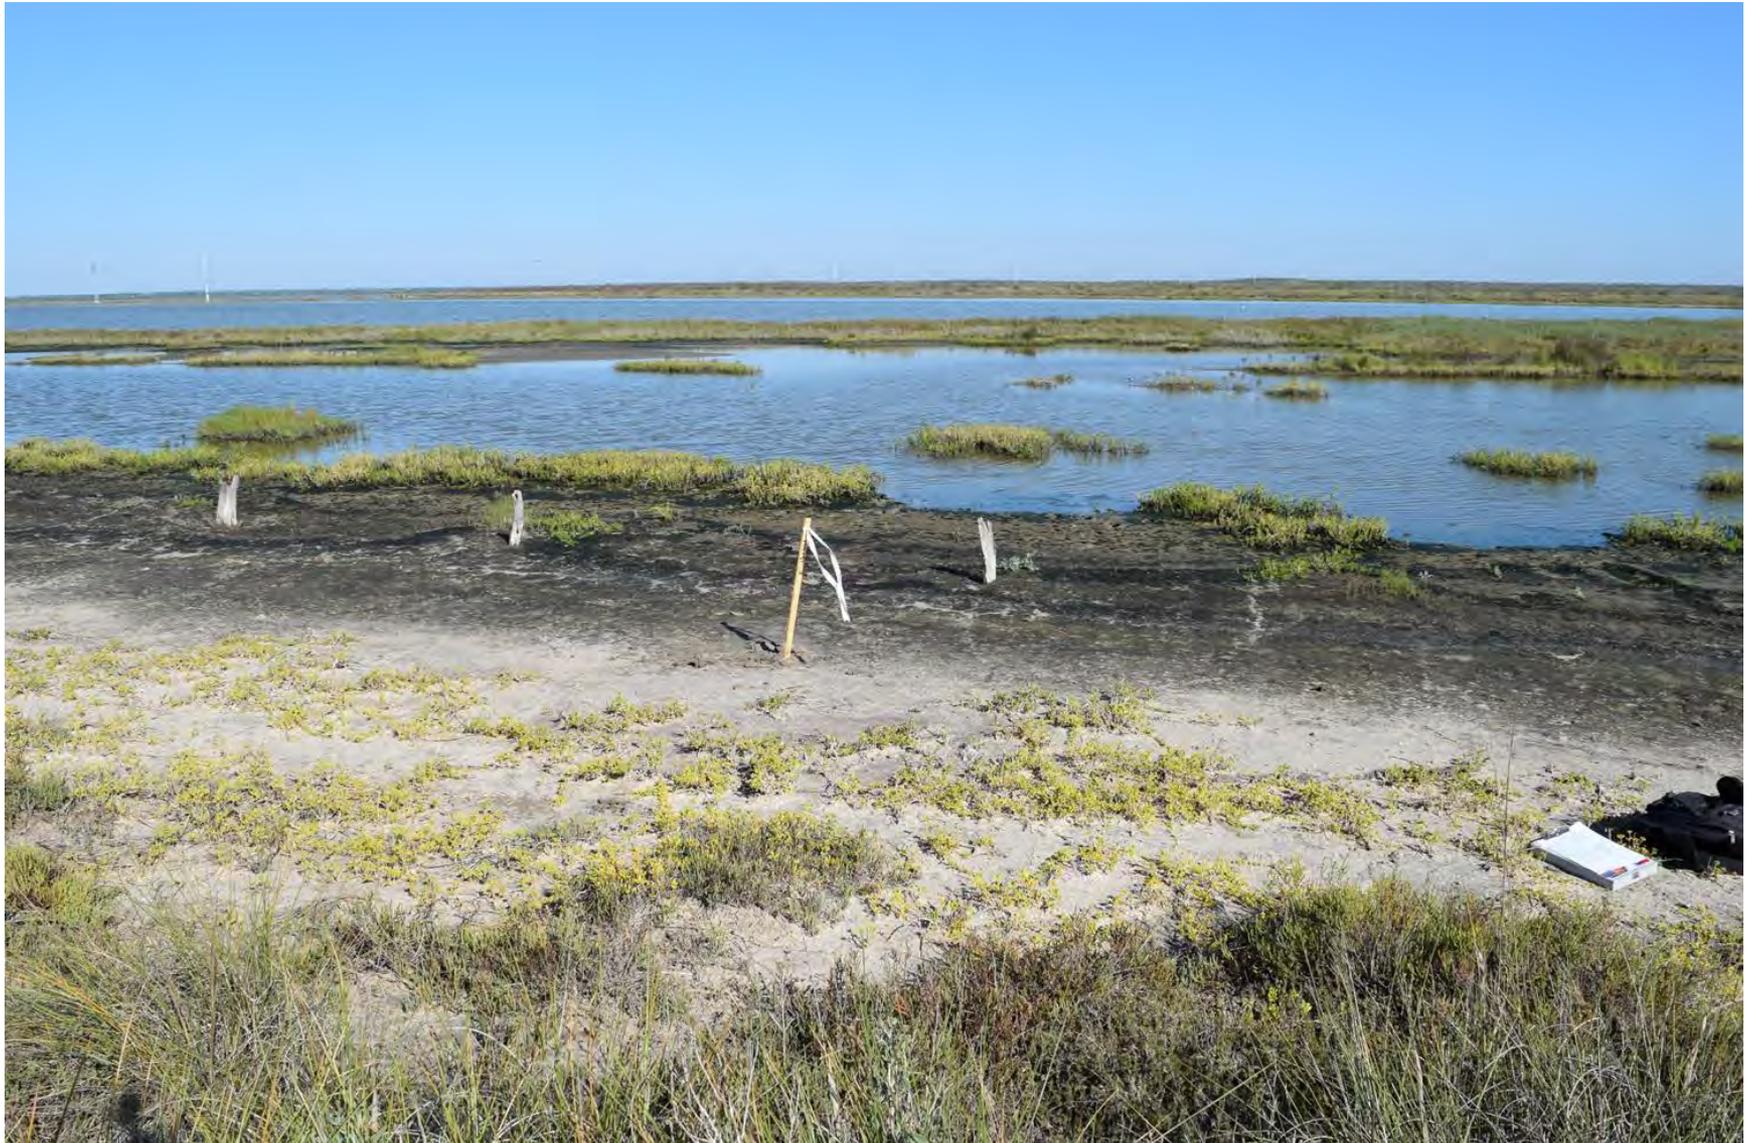
Modification Site #4 (north end)

Open Water, Coastal: Sea Ox-eyed Daisy Flats, Salt and Brackish Low Tidal Marsh, Salt and Brackish High Tidal

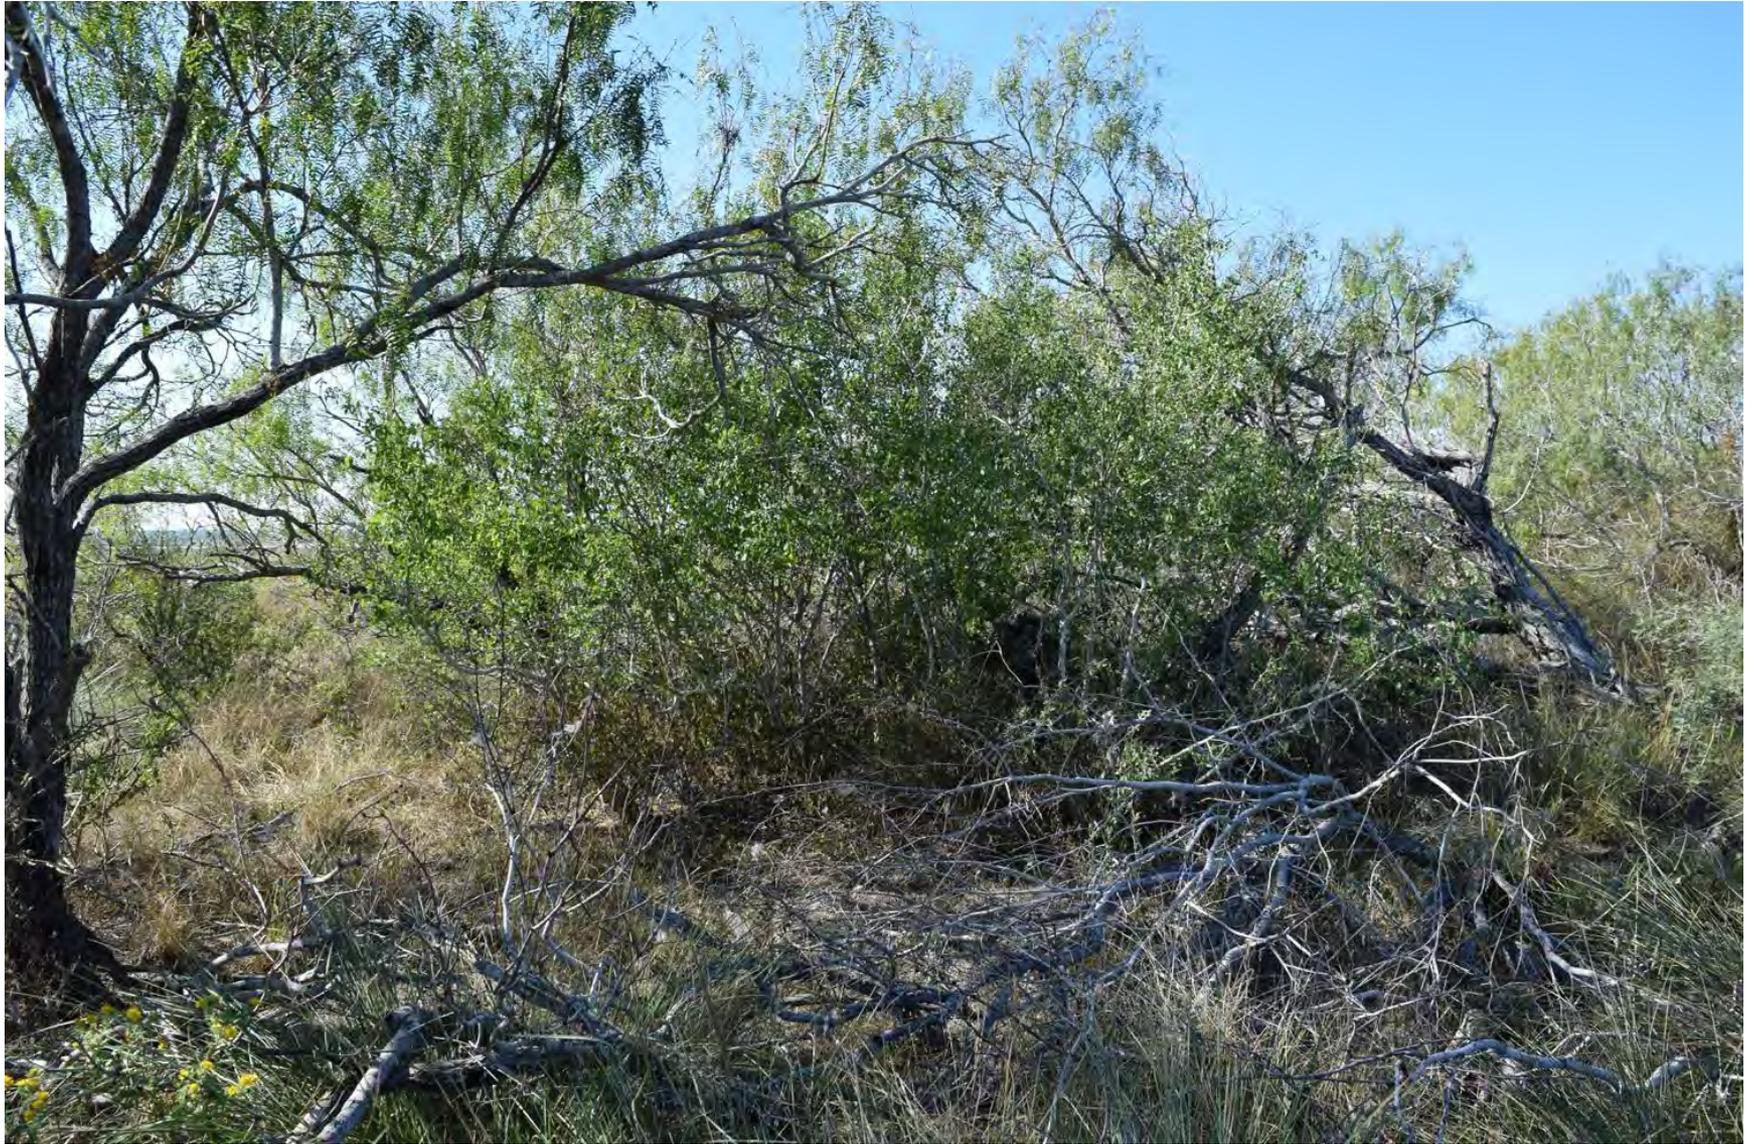
Modification Site #4

Gulf Coast Salty Prairie Shrubland

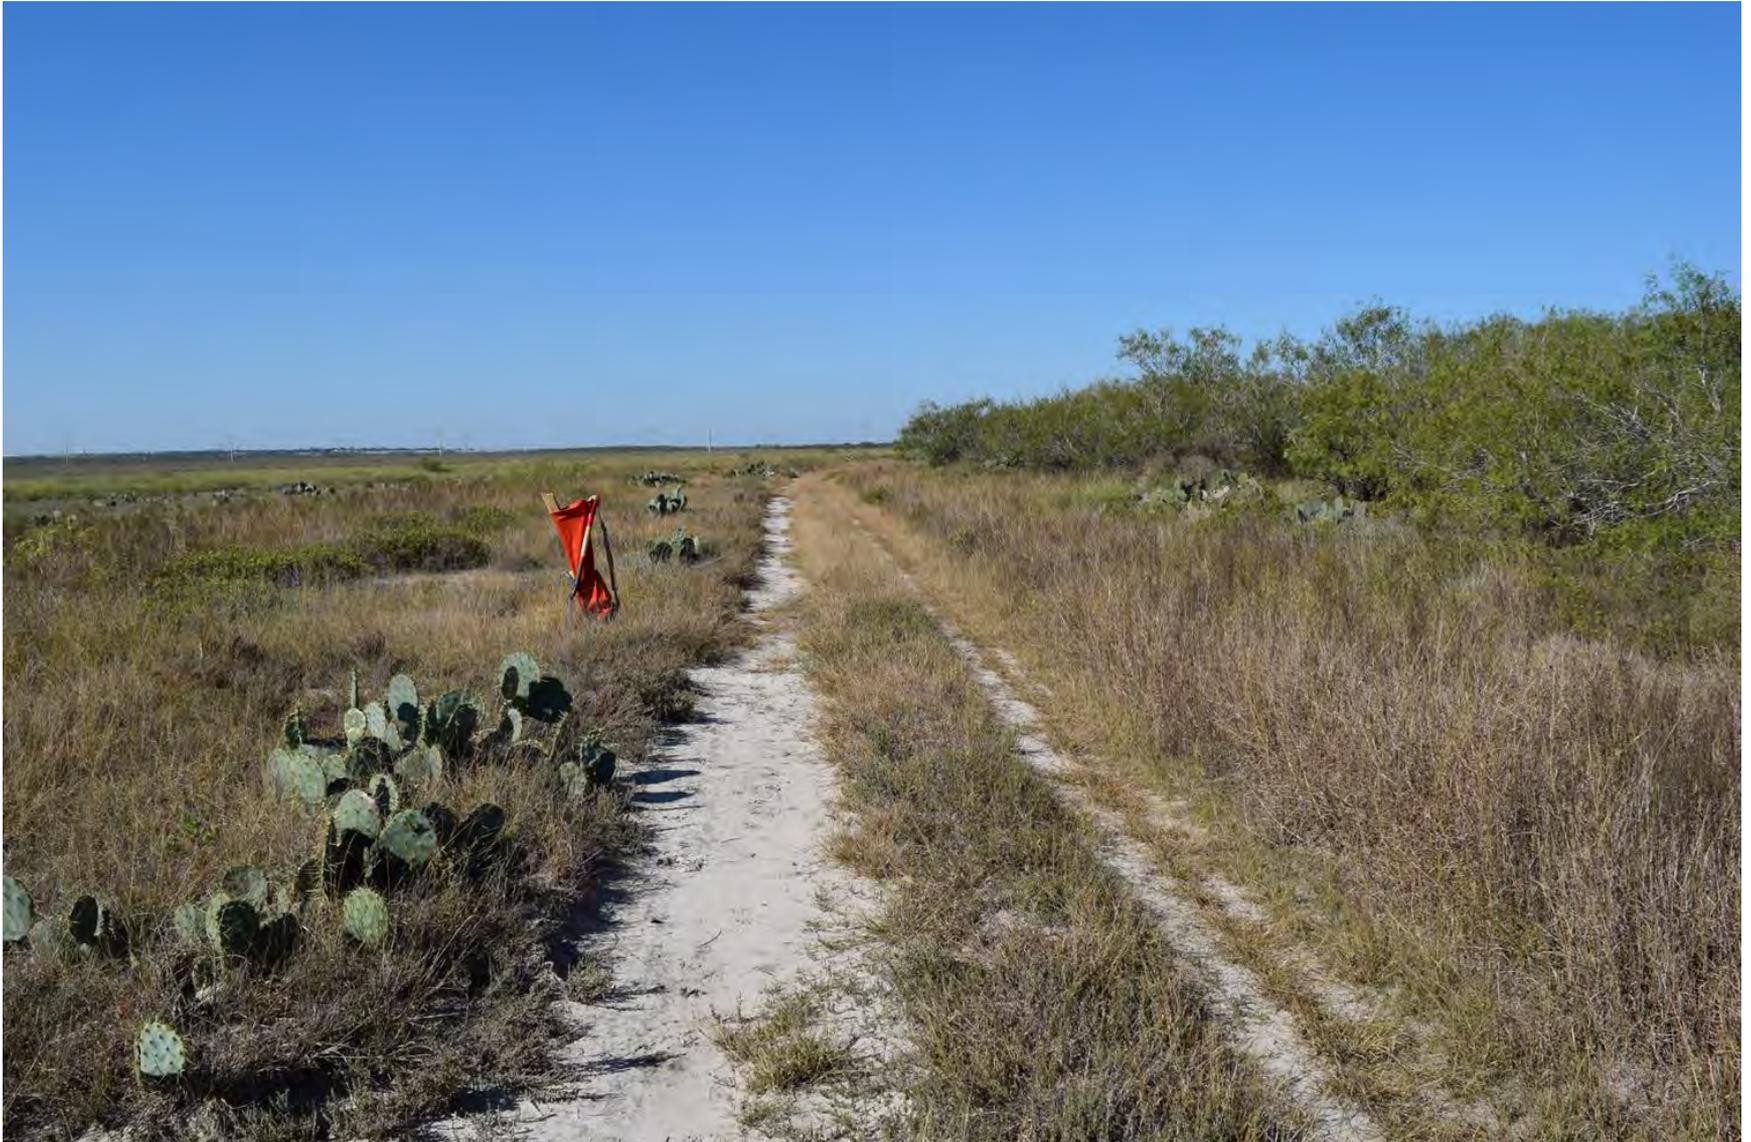
Modification Site #4

Gulf Coast Salty Prairie Shrubland (right) and Gulf Coast Salt Prairie (left)

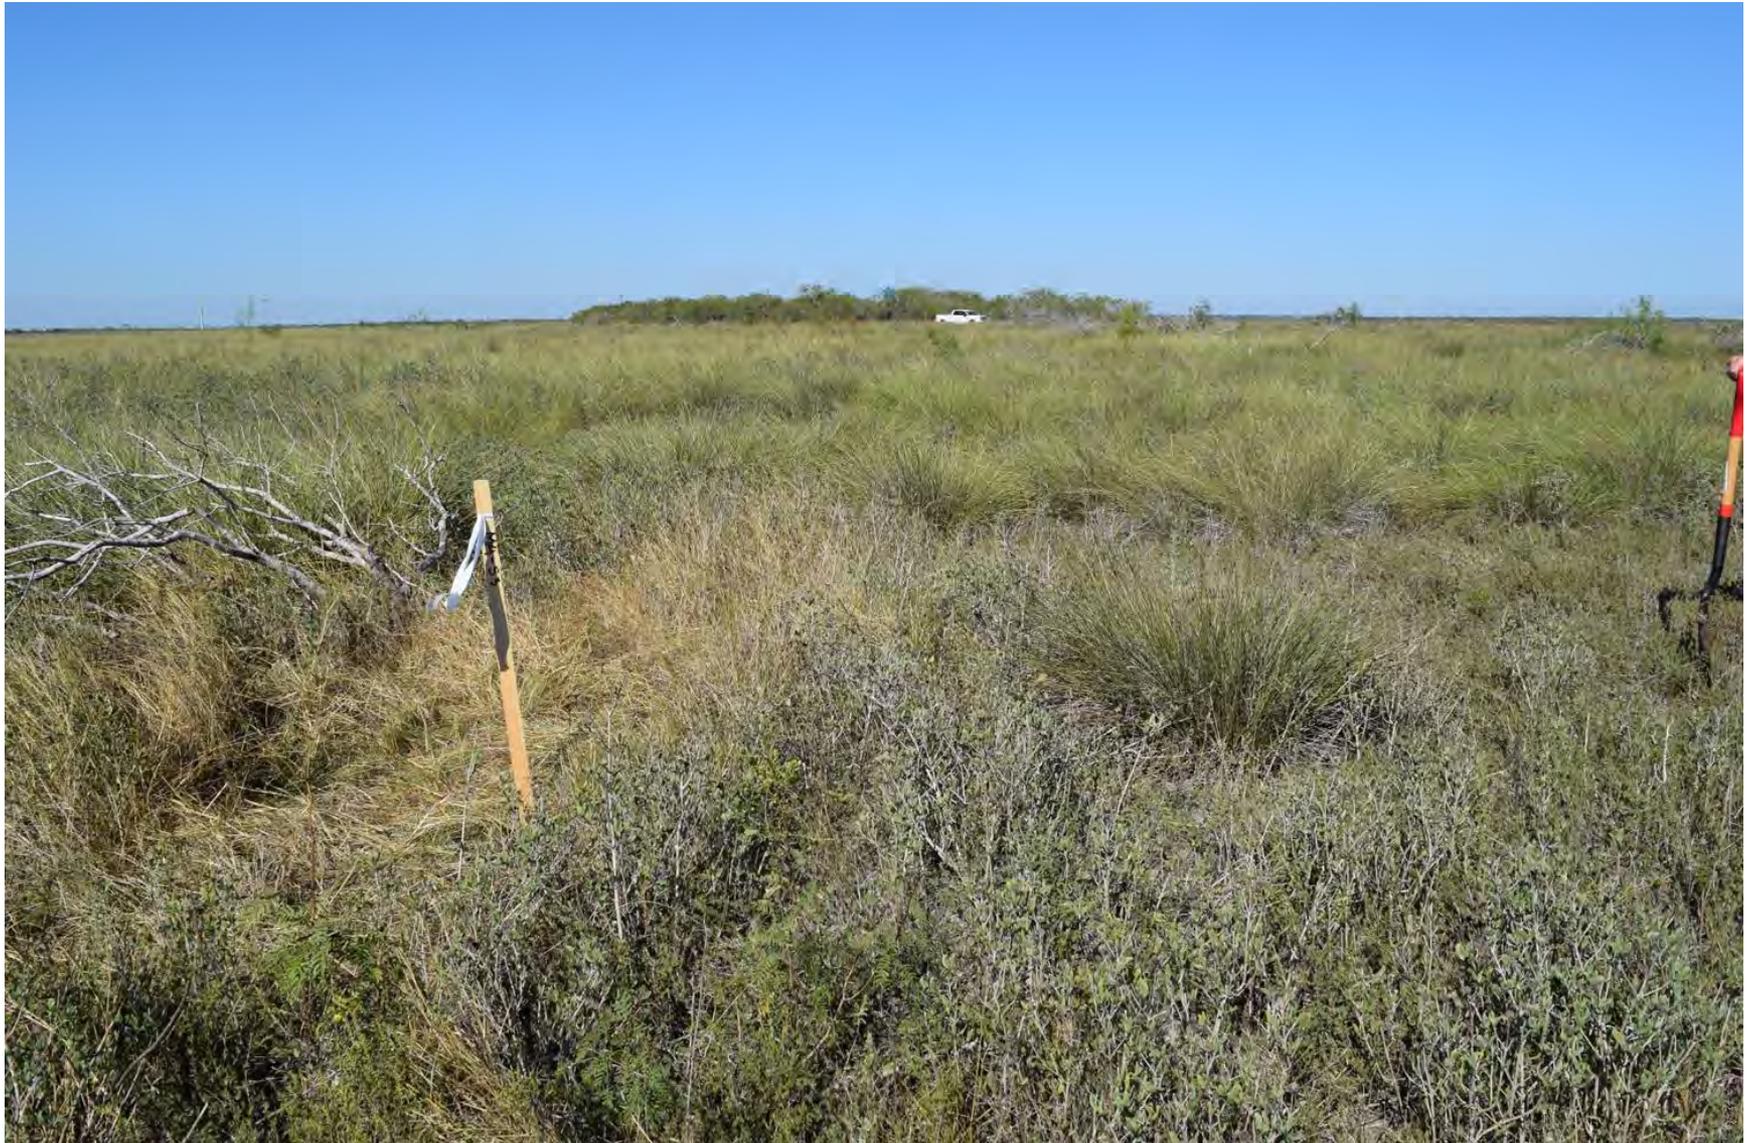
Modification Site #4

Gulf Coast Salty Prairie

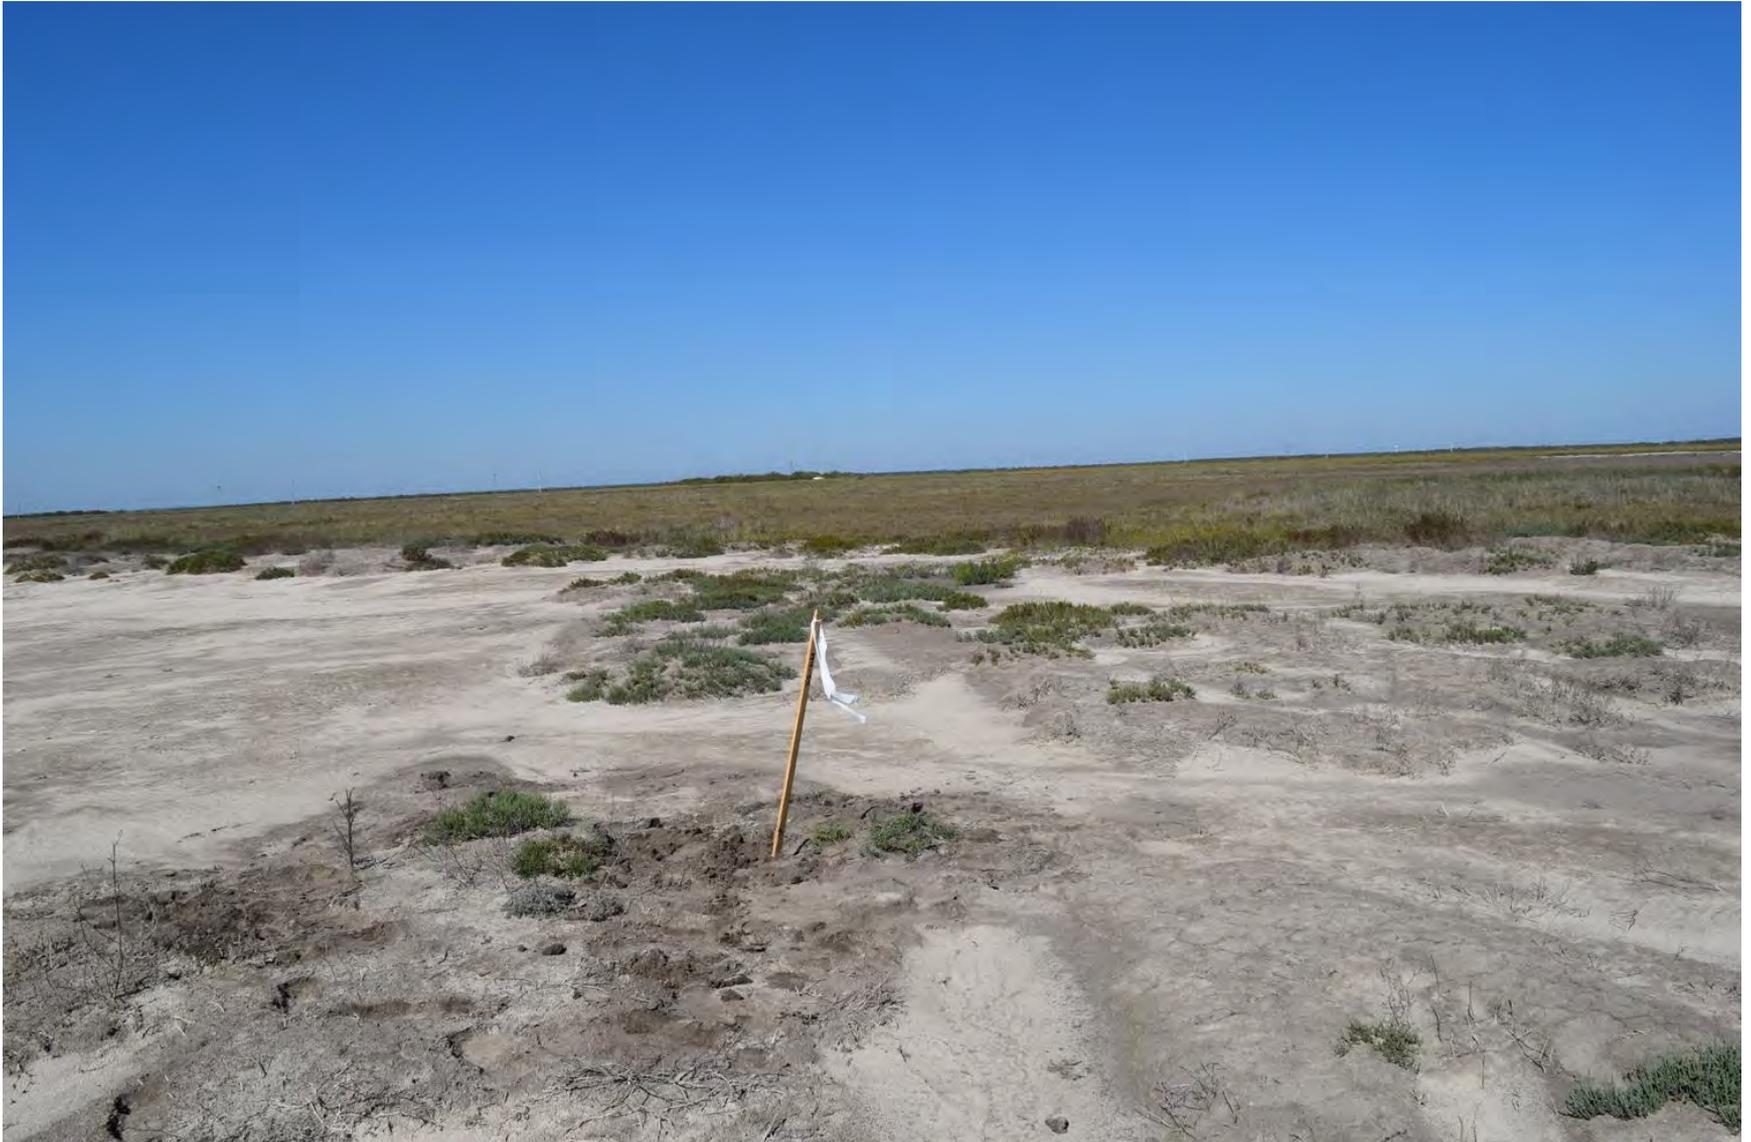
Modification Site #4

Coastal: Tidal Flats (foreground) and Salt and Brackish High Tidal Marsh (background)
