Using Landform and Hydraulic Modifications to Increase the Benefit of Fresh Water Inflows to Nueces Bay and Nueces Delta -- Phase II: Verification and Feasibility Assessment for Landform Modifications in the Nueces Delta

Texas Water Development Board

TWDB Contract No. 1600012013

October 2017

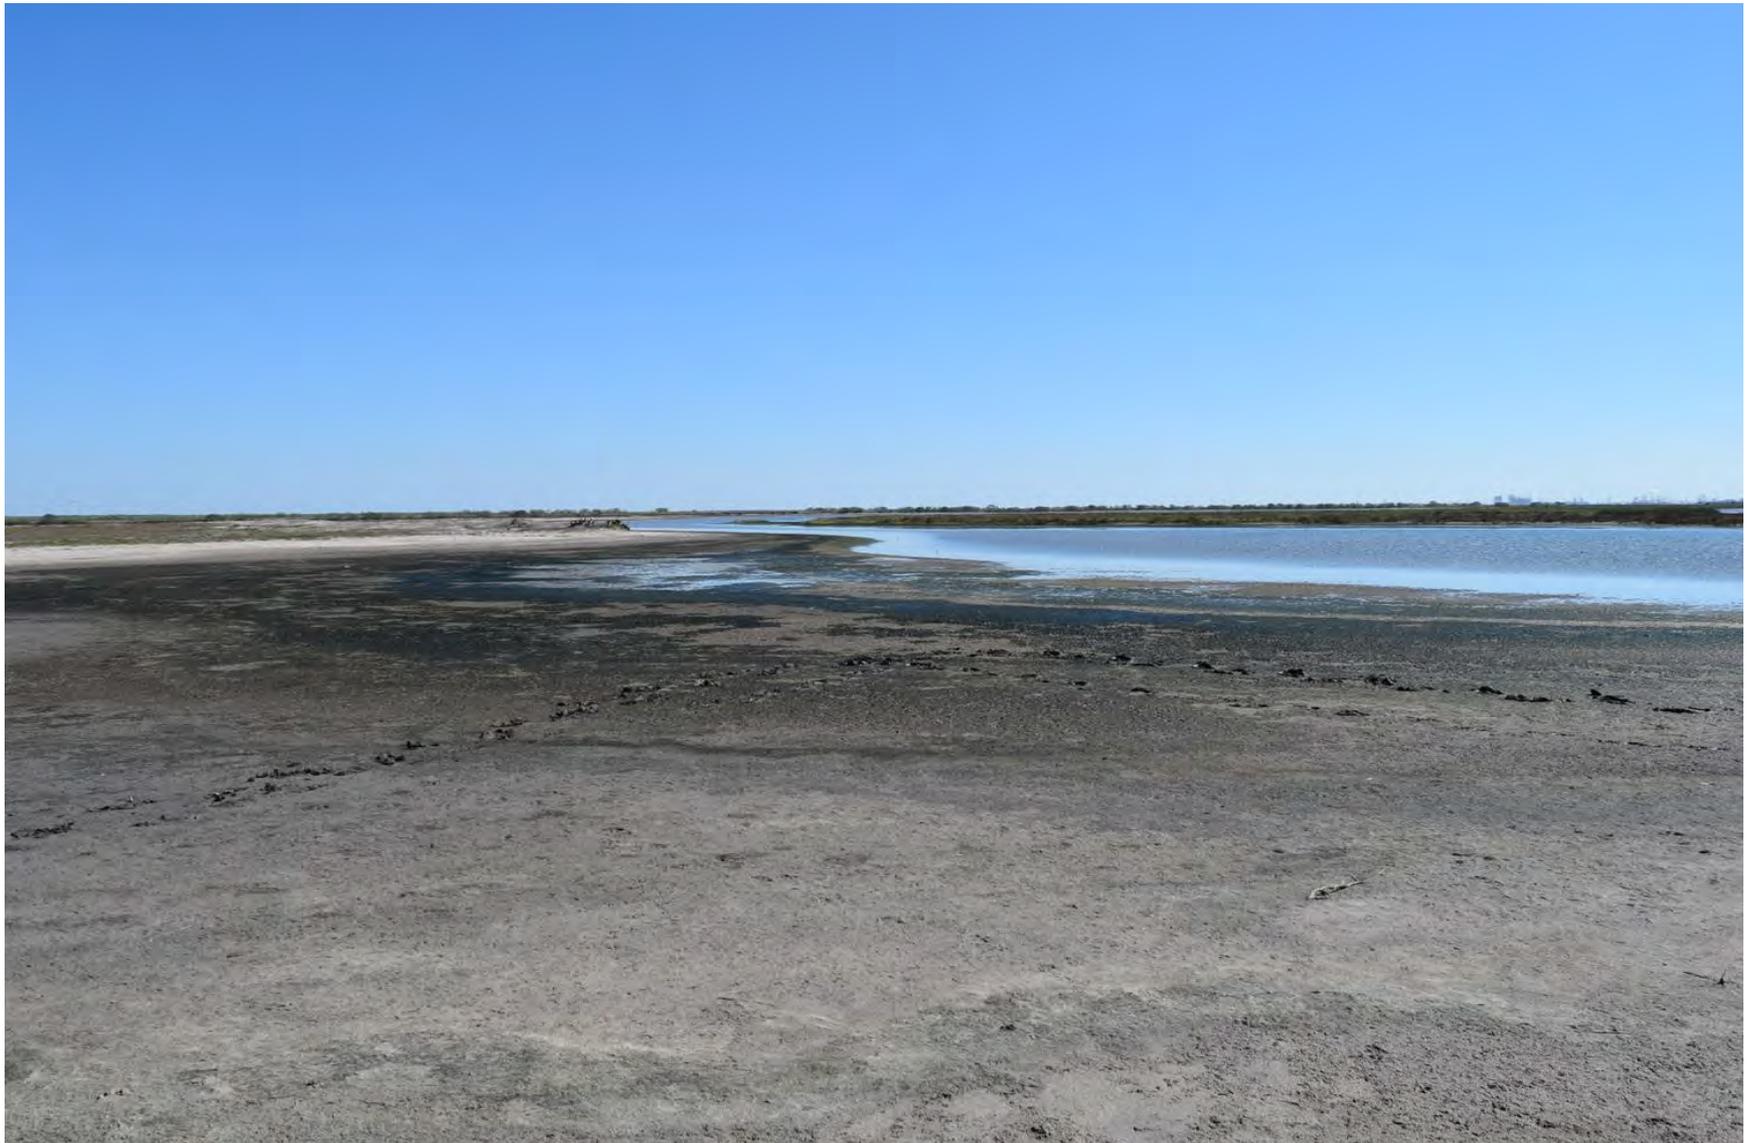
Modification Site #4 (south end)

Coastal: Tidal Flats and Open Water

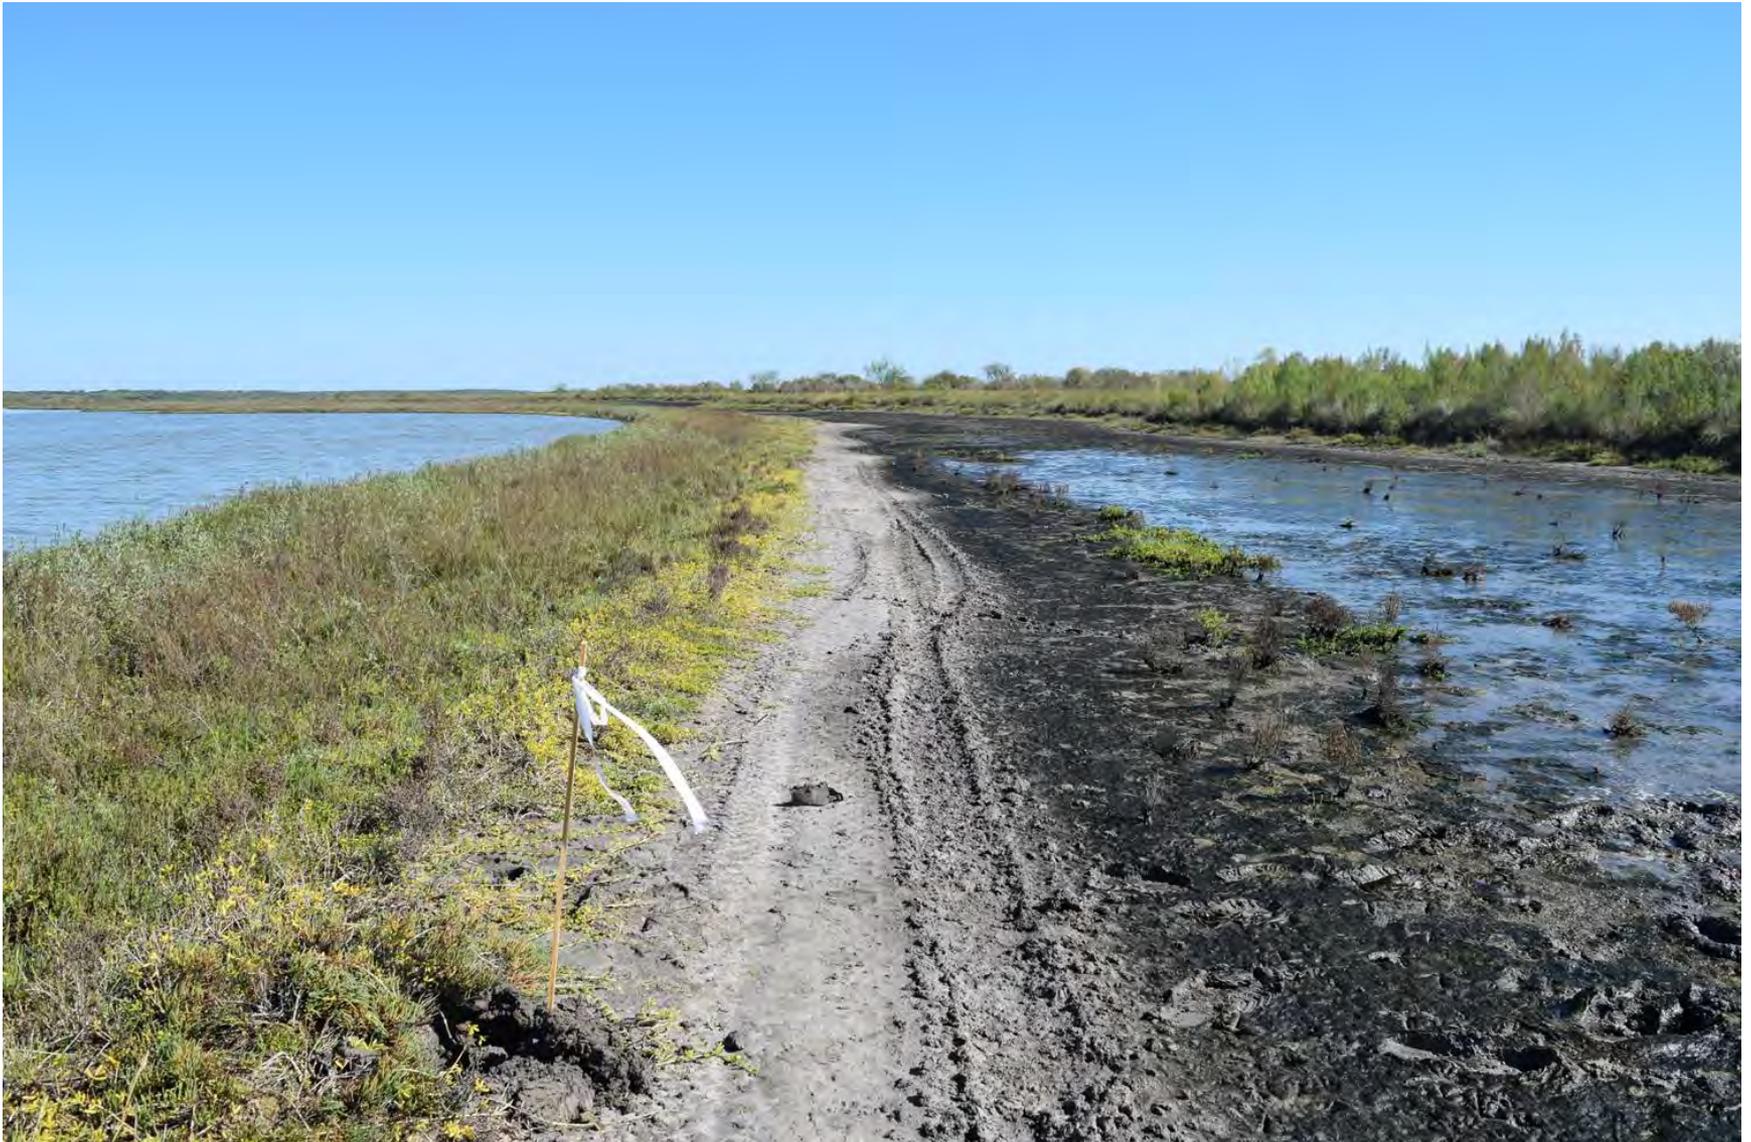
Modification Site #5 (north end)

Open Water, Salt and Brackish Low Tidal Marsh, Gulf Coast Salty Prairie Shrubland

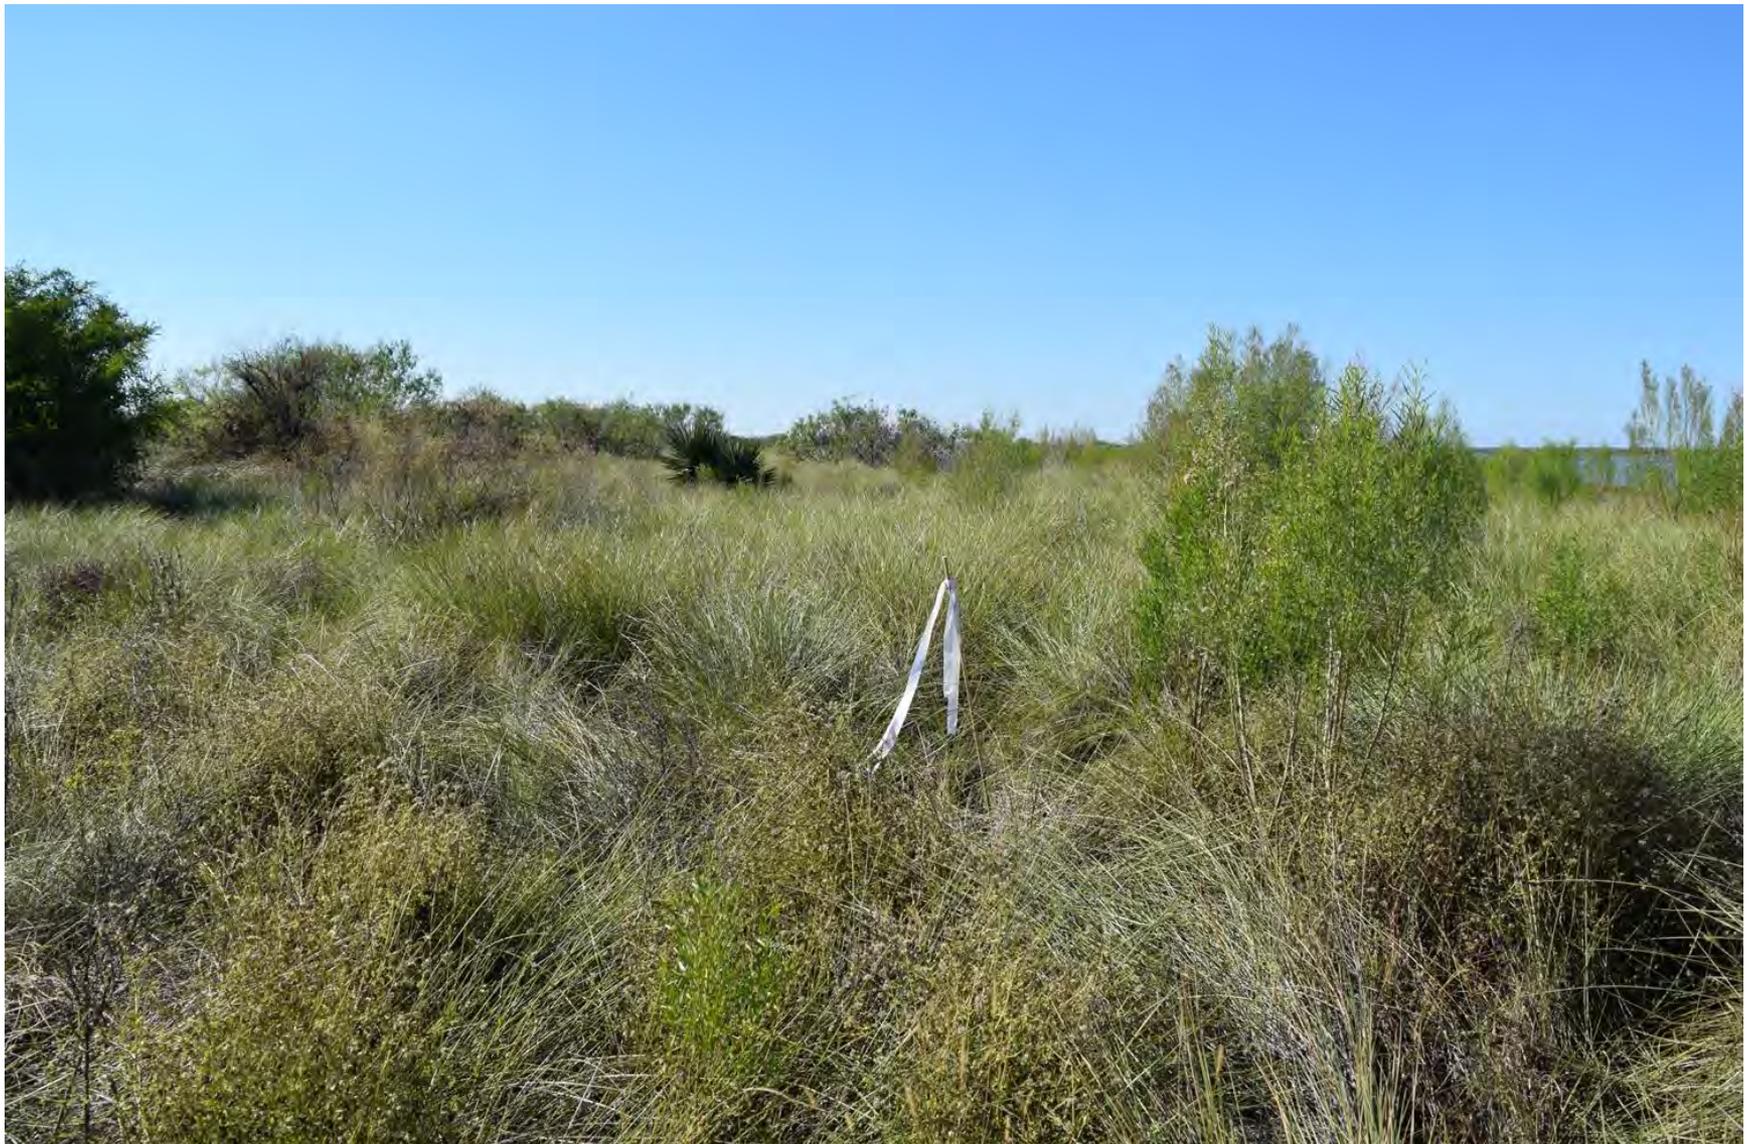
Modification Site #5

Gulf Coast Salty Prairie Shrubland

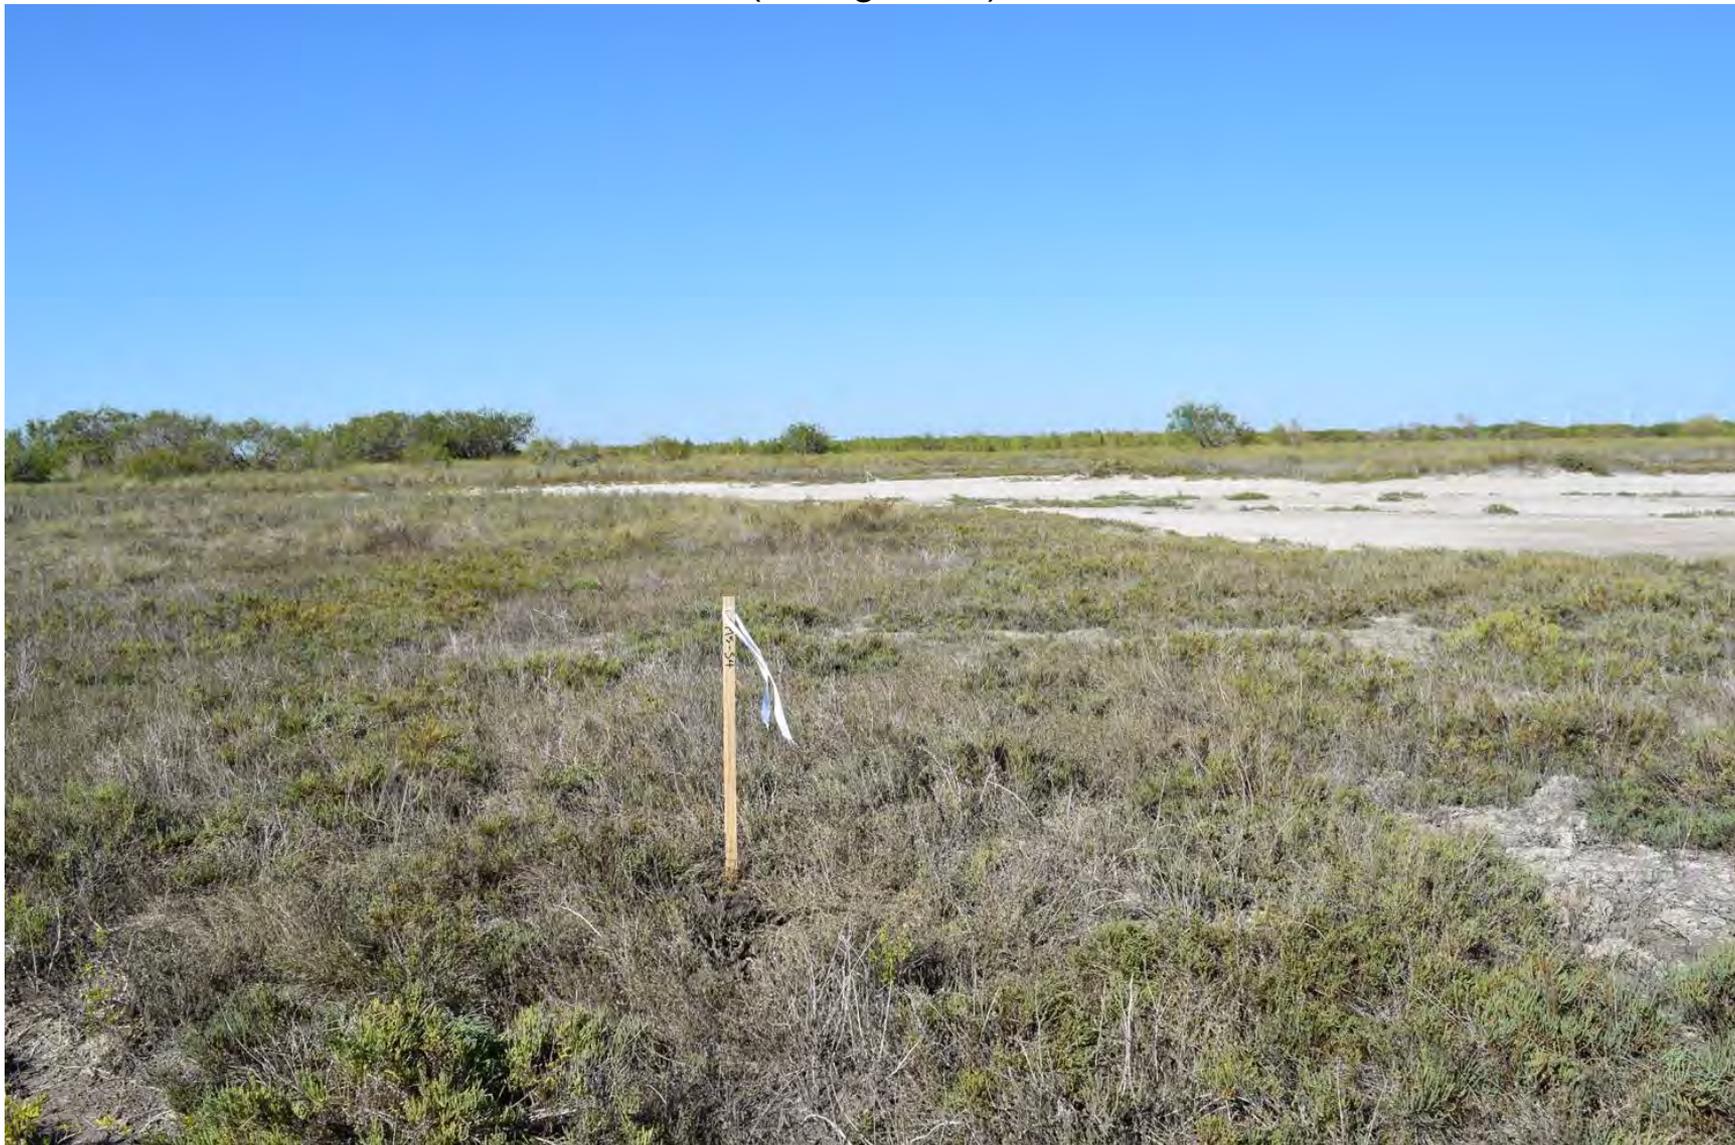
Modification Site #5

Salt and Brackish Low Tidal Marsh (foreground) and Gulf Coast Salty Prairie Shrubland (background)

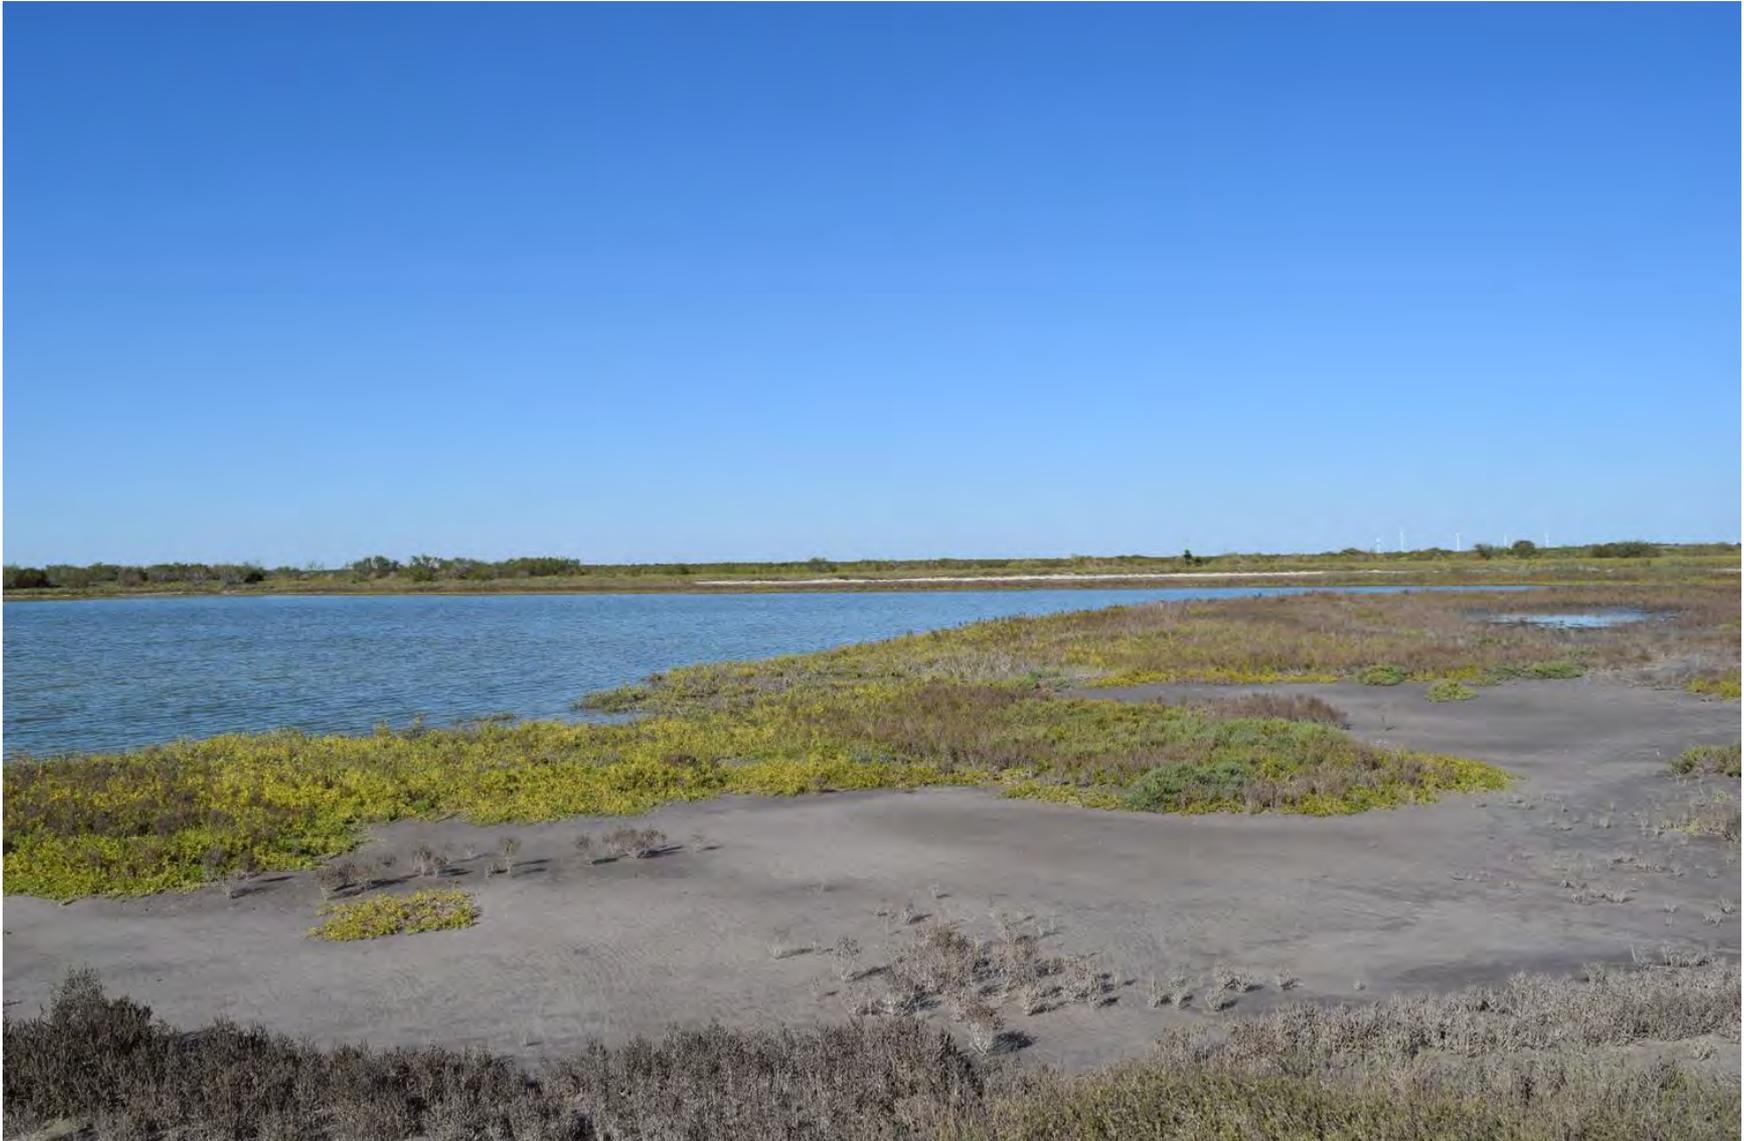
Modification Site #5

Salt and Brackish Low Tidal Marsh, Open Water

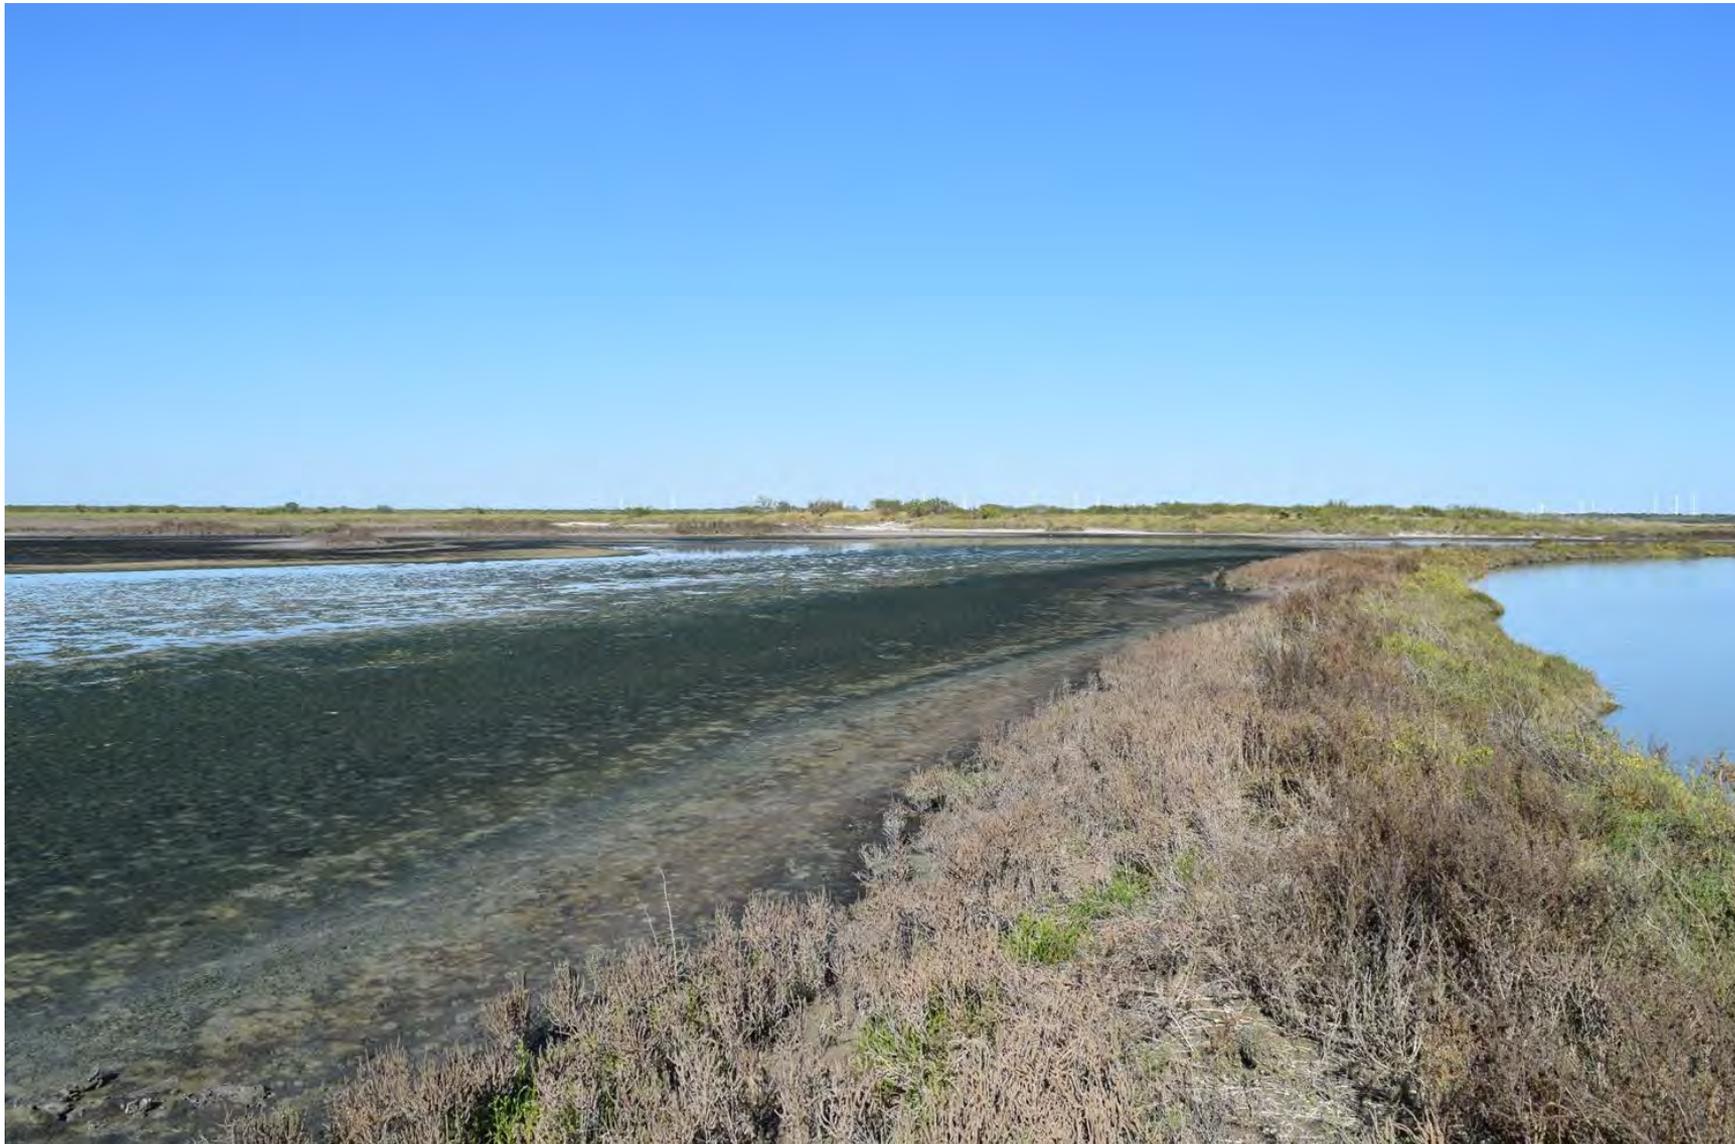
Modification Site #5

Coastal: Tidal Flats, Salt and Brackish High Tidal Marsh, Open Water

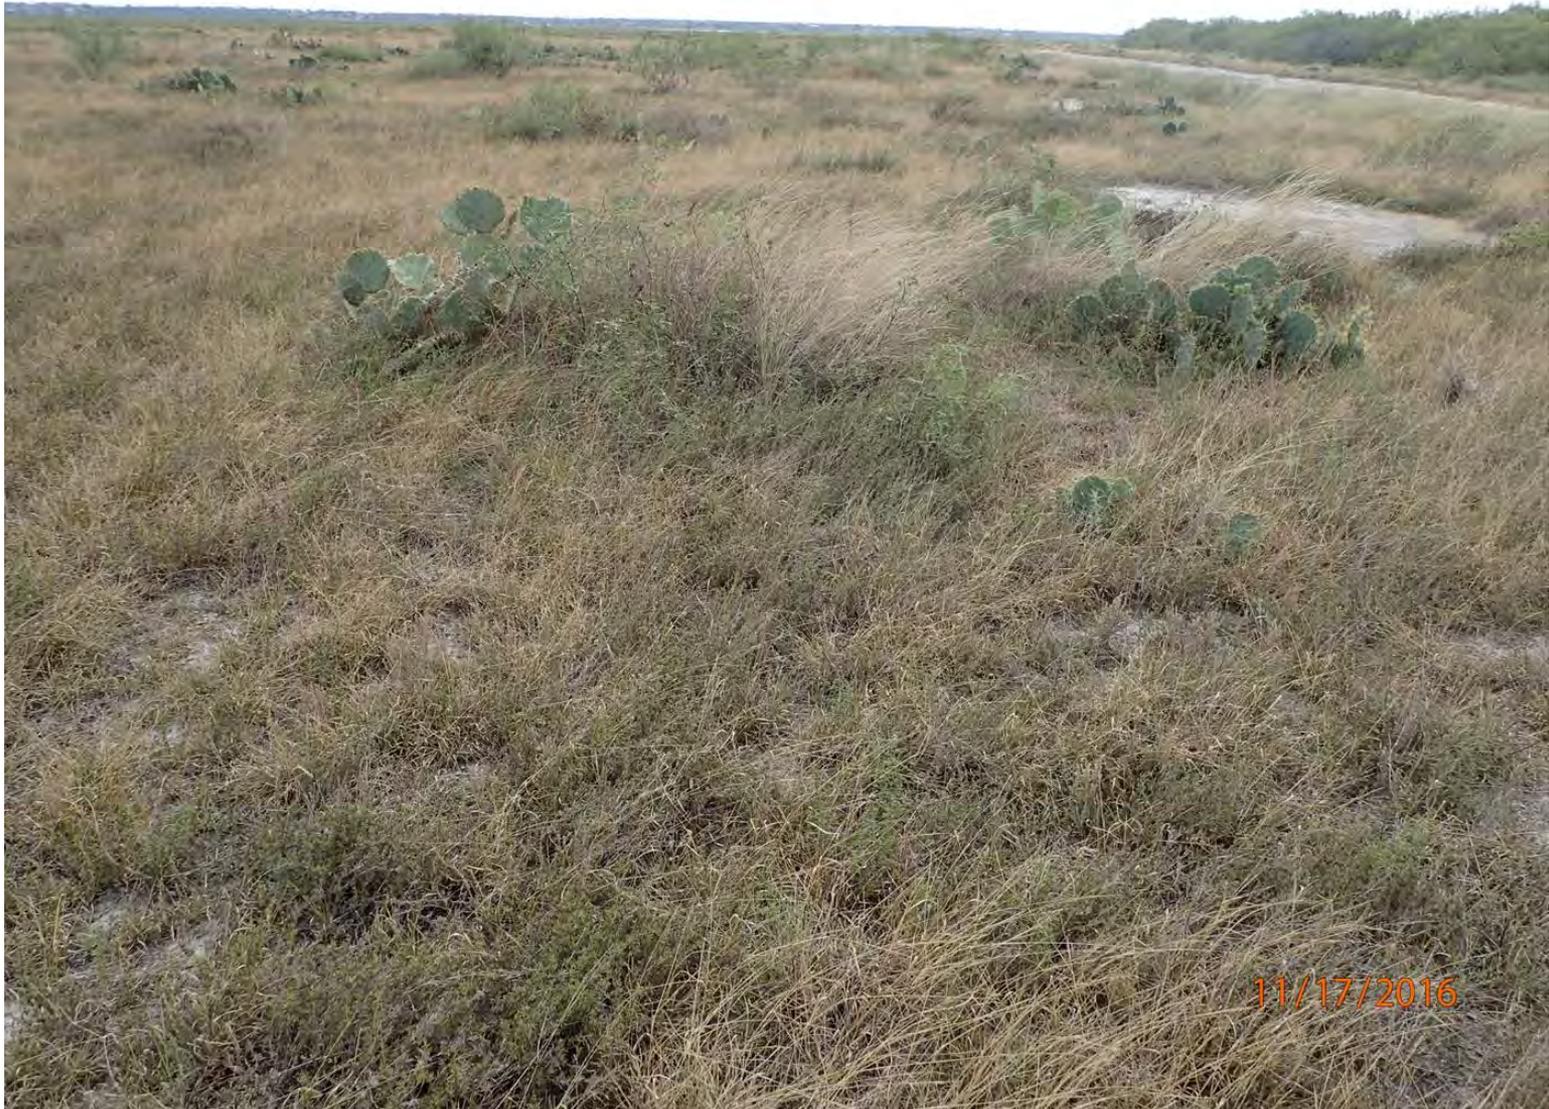
DMPA
Gulf Coast Salty Prairie Shrubland

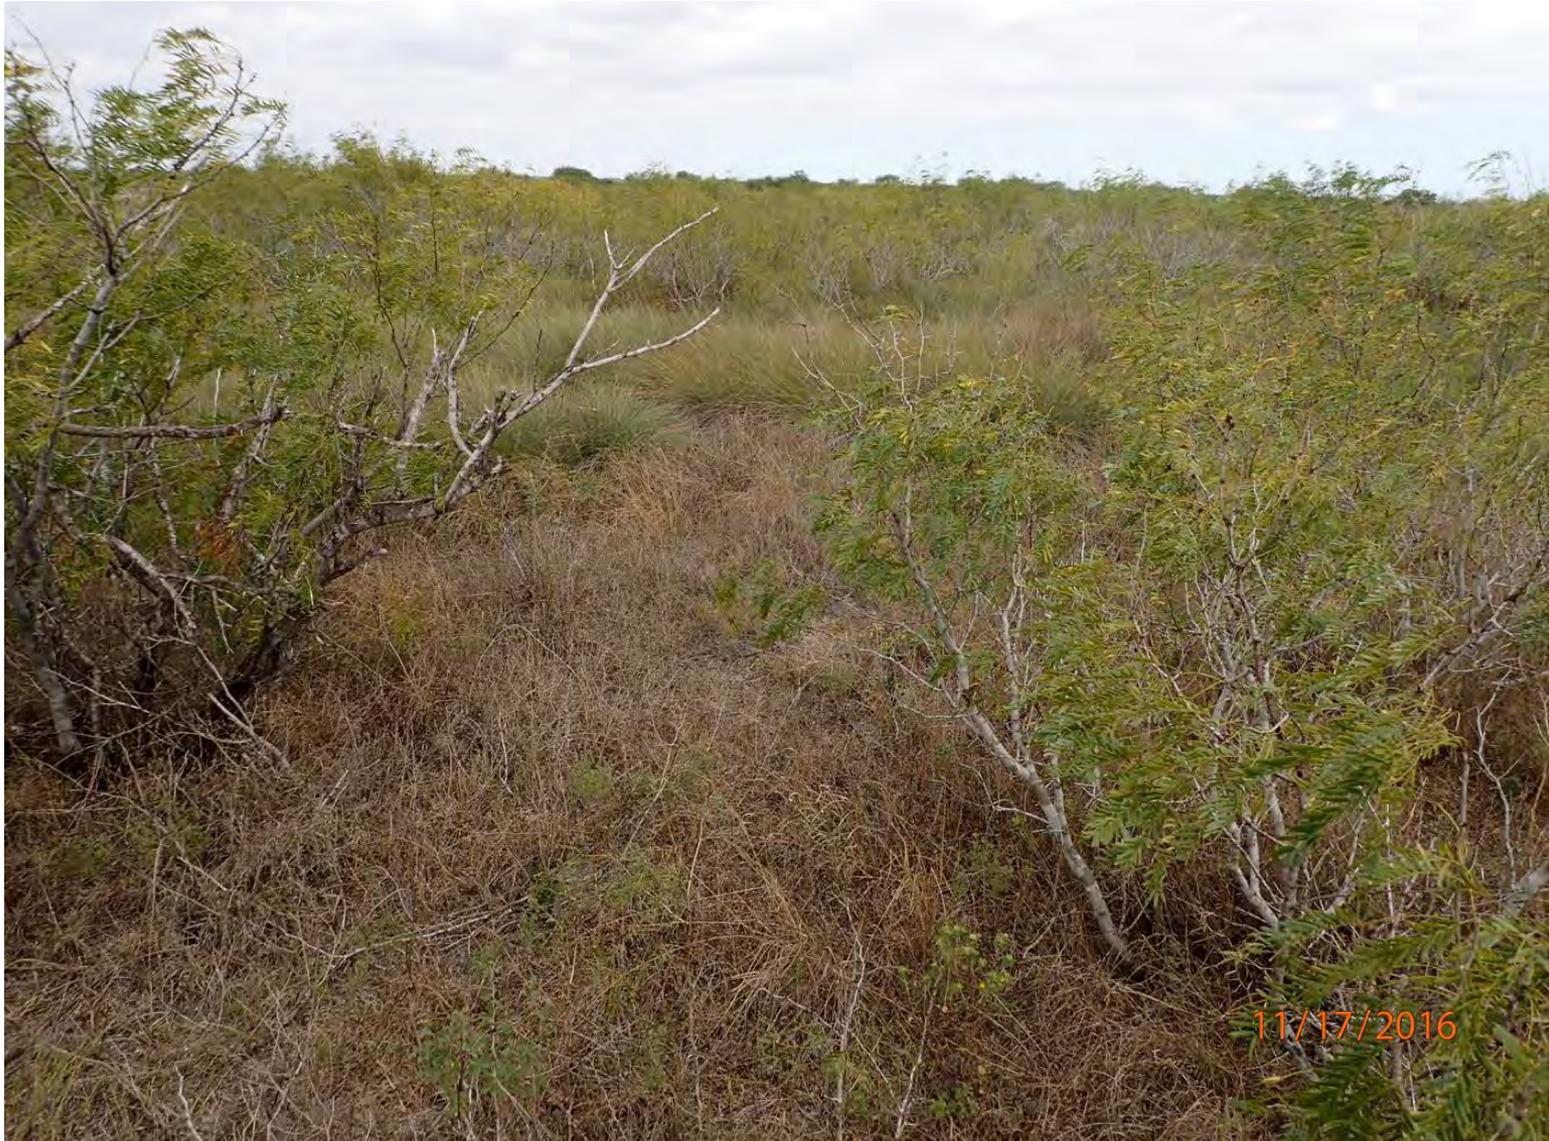
DMPA
Gulf Coast Salty Prairie Shrubland

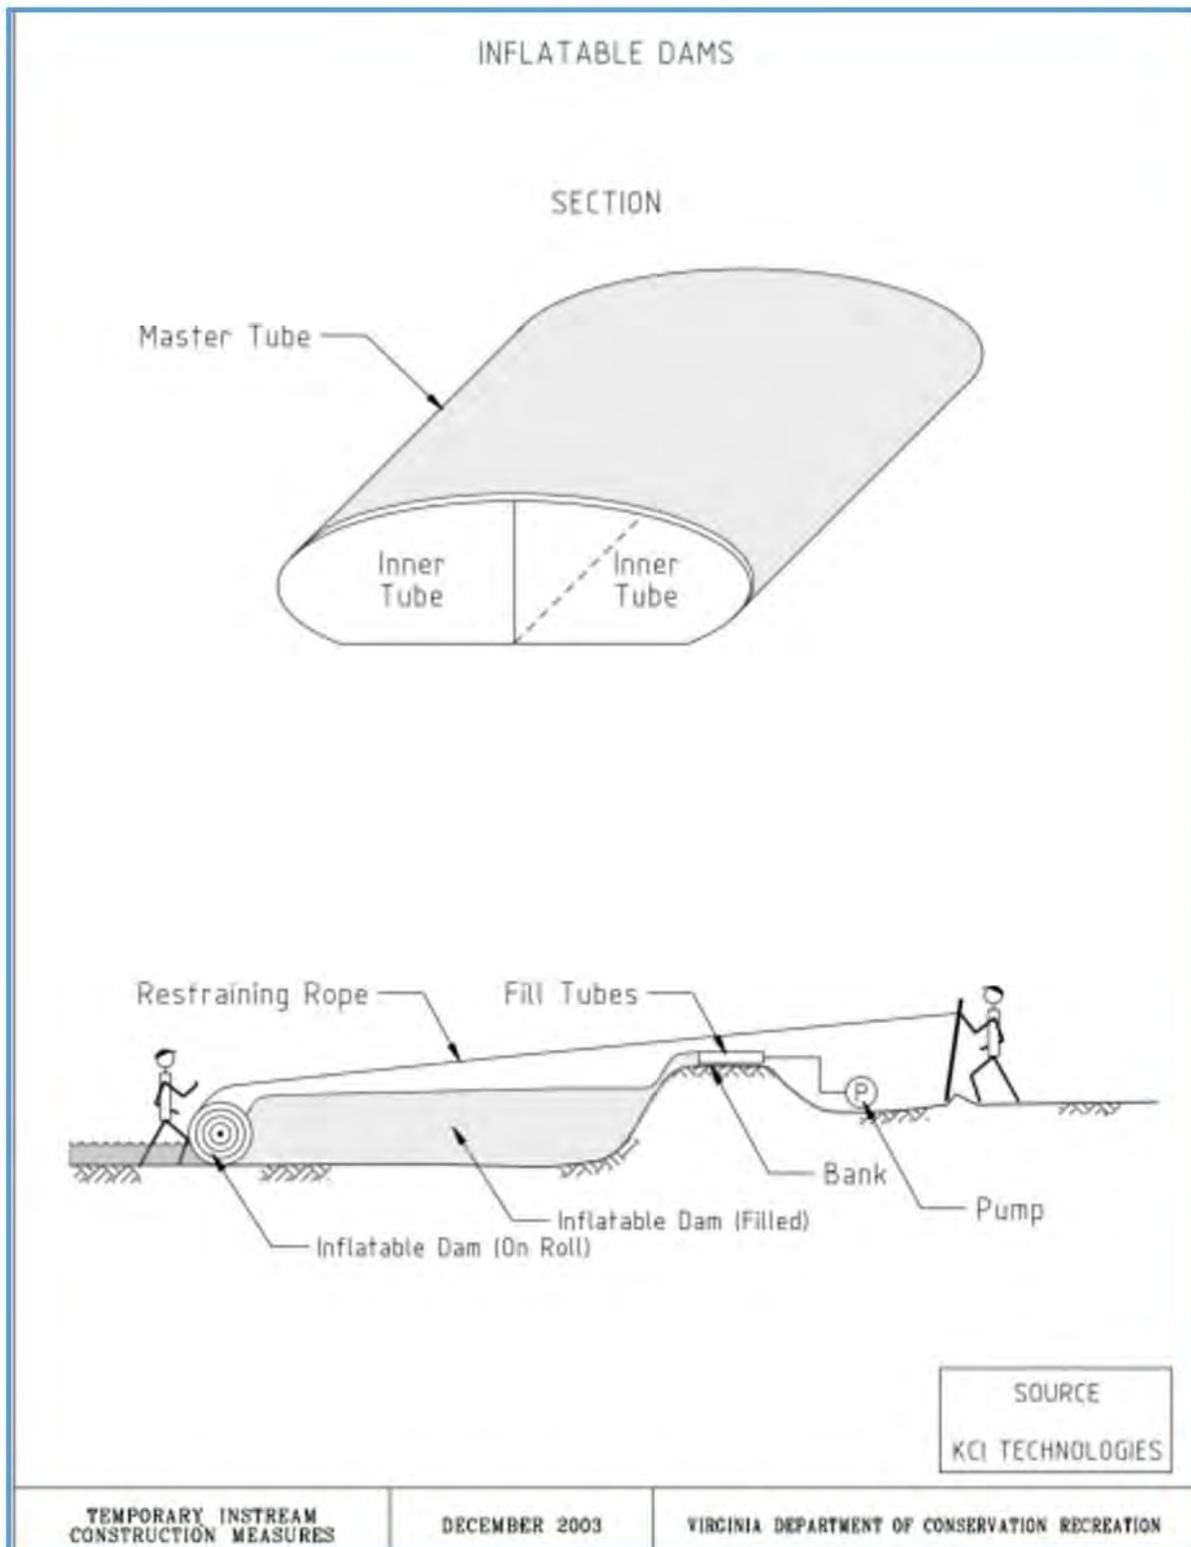
Figure 3.2.1-9 Example of deploying an inflatable barrier in the field
