**CLEAR CREEK REGIONAL FLOOD CONTROL PLAN**

**ENVIRONMENTAL BASELINE REPORT**

**CLEAR CREEK WATERSHED**

**JULY 1991**

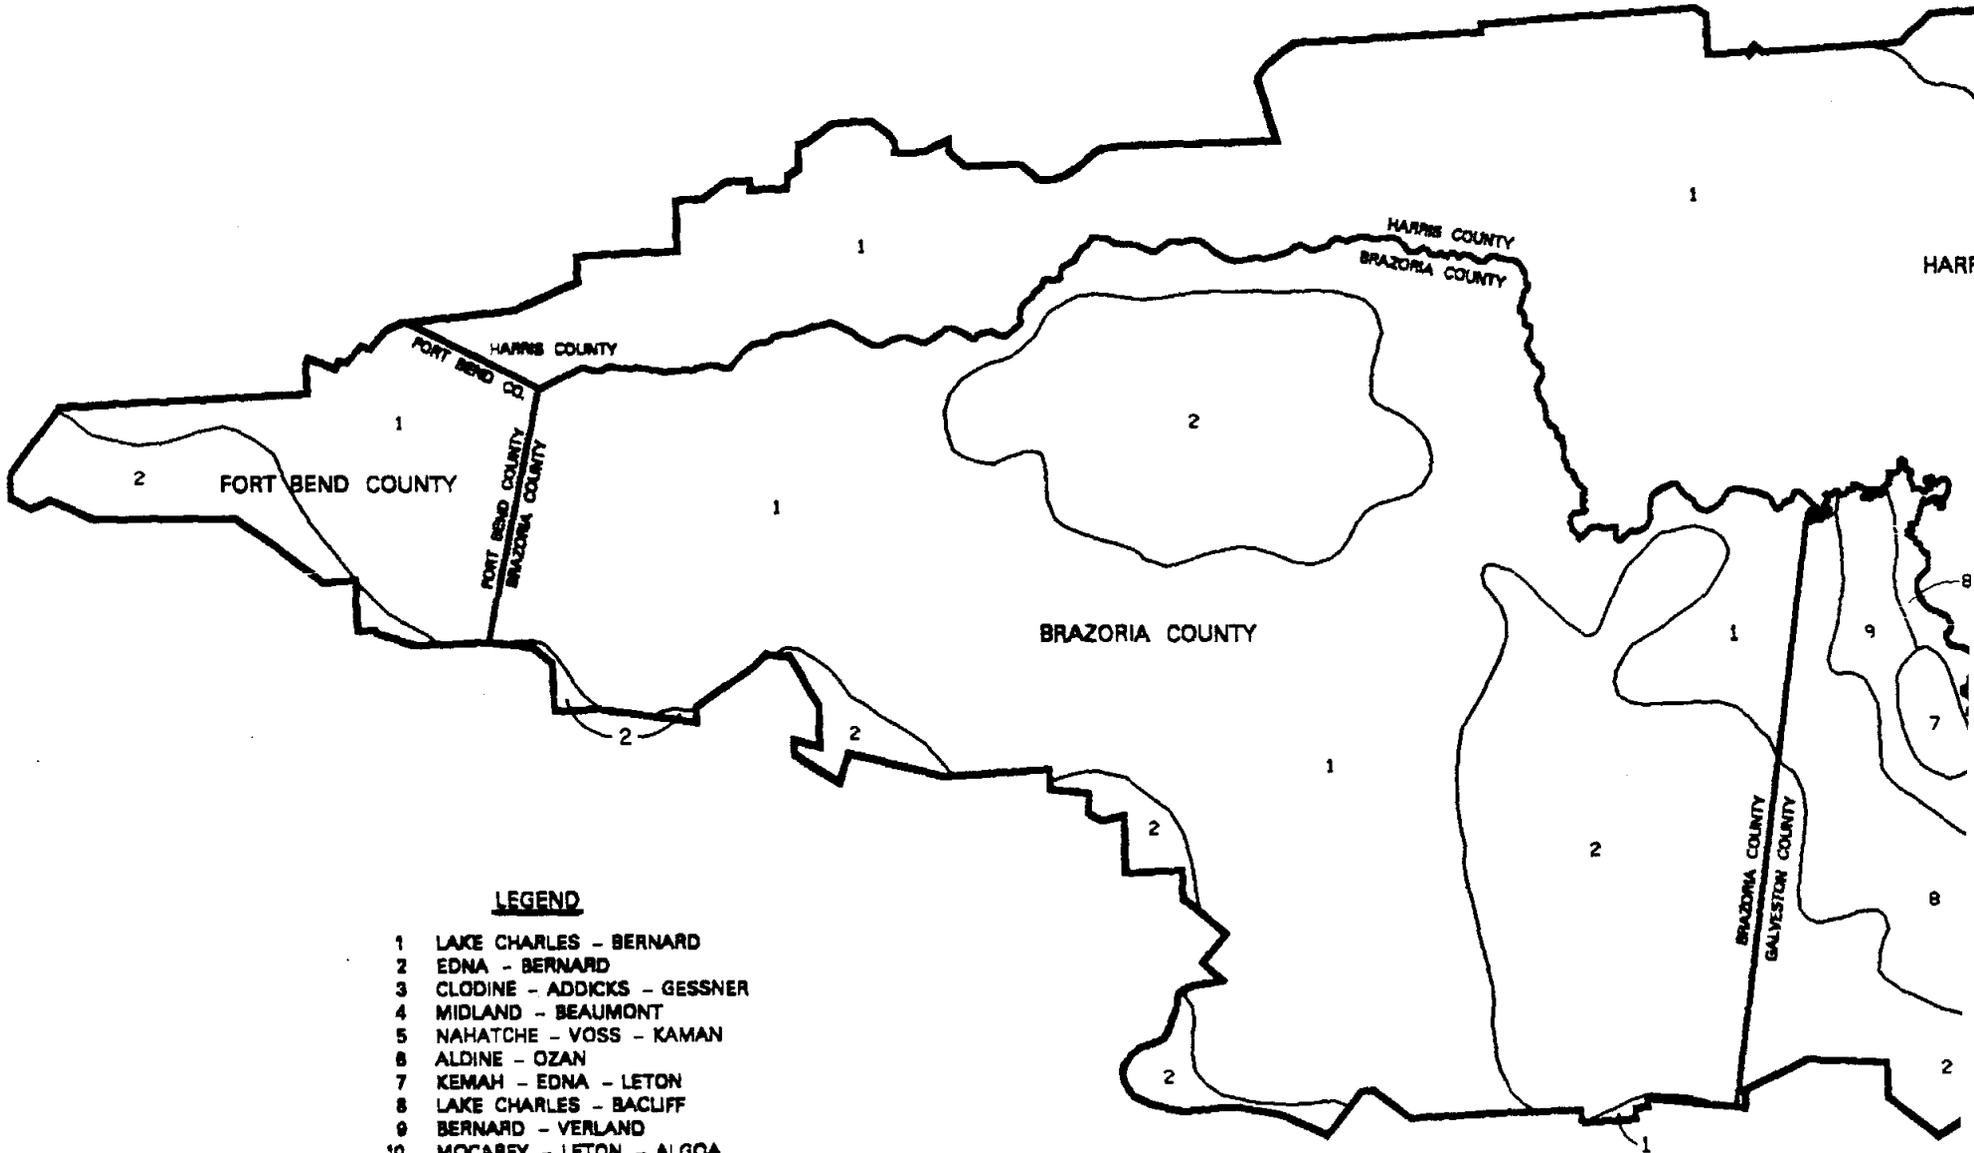
- 1 LAKE CHARLES - BERNARD
- 2 EDNA - BERNARD
- 3 CLODINE - ADDICKS - GESSNER
- 4 MIDLAND - BEAUMONT
- 5 NAHATCHE - VOSS - KAMAN
- 6 ALDINE - OZAN
- 7 KEMAH - EDNA - LETON
- 8 LAKE CHARLES - BACLIF
- 9 BERNARD - VERLAND
- 10 MOCAREY - LETON - ALGCA
