Volumetric and Sedimentation Survey of LAKE BUCHANAN

July 2019 Survey

Texas Water Development Board

July 2020

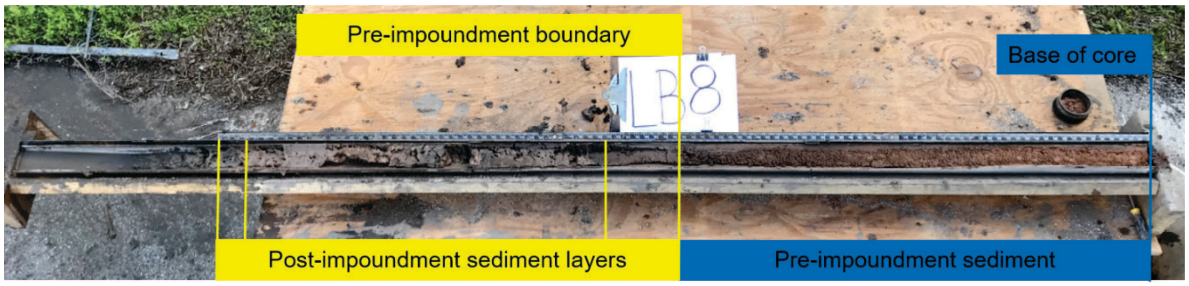
A photograph of sediment core LB-8 (for location, refer to Figure 2) is shown in Figure 7 and is representative of sediment cores sampled from Lake Buchanan. The base of the sample is denoted by the blue line. The pre-impoundment boundary (right most yellow line) was evident within this sediment core sample at 50.0 inches and identified by the change in color, texture, moisture, porosity, and structure. Identification of the pre-impoundment surface for each sediment core followed a similar procedure.

Figure 7. Sediment core LB-8 from Lake Buchanan. Post-impoundment sediment layers occur in the top 50.0 inches of this sediment core (identified by the yellow box). Pre-impoundment sediment layers were identified and are defined by the blue box.

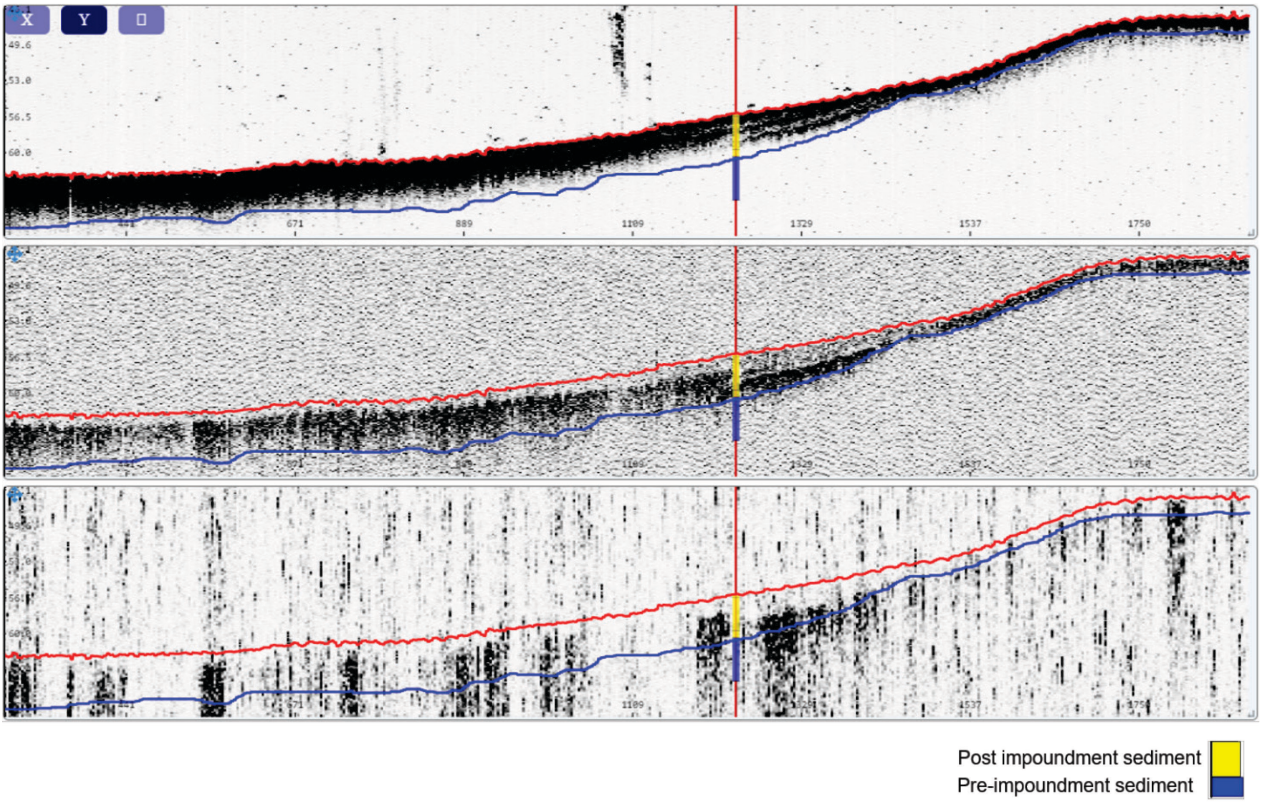
Figure 8 compares sediment core sample LB-8 with the acoustic signals as seen in Hydropick for each frequency: 208 kHz, 50 kHz, and 12 kHz. The current bathymetric surface is automatically determined based on signal returns from the 208 kHz transducer as represented by the top red line in Figure 8. The pre-impoundment surface is identified by comparing boundaries observed in the 208 kHz, 50 kHz, and 12 kHz signals to the location of the pre-impoundment surface of the sediment core sample. Many layers of sediment were identified during analysis based on changes in observed characteristics such as water content, organic matter content, and sediment particle size, and each layer is classified as either post-impoundment or pre-impoundment. The boundary of each layer of sediment identified in the sediment core sample during analysis (Table 2) is represented in Figures 8 and 9 by a yellow or blue box. A yellow box represents post-impoundment sediments. A blue box indicates pre-impoundment sediments that were identified.

Figure 8. Comparison of sediment core LB-8 with acoustic signal returns. A) 208 kHz frequency, B) 50 kHz frequency, and C) 12 kHz frequency. The current surface in red and pre-impoundment surface in blue.

In this case, the boundary in the 50 kHz signal most closely matched the pre-impoundment interface of the sediment core sample; therefore, the 50 kHz signal was used to locate the pre-impoundment surface (blue line in the top panel in Figure 8). Figure 9 shows sediment core sample LB-8 correlated with the 50 kHz frequency of the nearest surveyed cross-section. The pre-impoundment surface is first identified along cross-sections for which sediment core samples have been collected. This information then is used as a guide for identifying the pre-impoundment surface along cross-sections where sediment core samples were not collected.

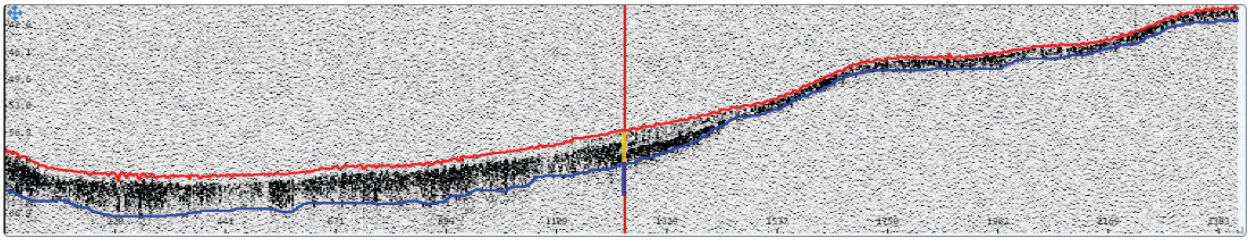
Figure 9. Cross-section of data collected during survey, displayed in Hydropick (50 kHz frequency), correlated with sediment core sample LB-8 and showing the current surface in red and pre-impoundment surface in blue.

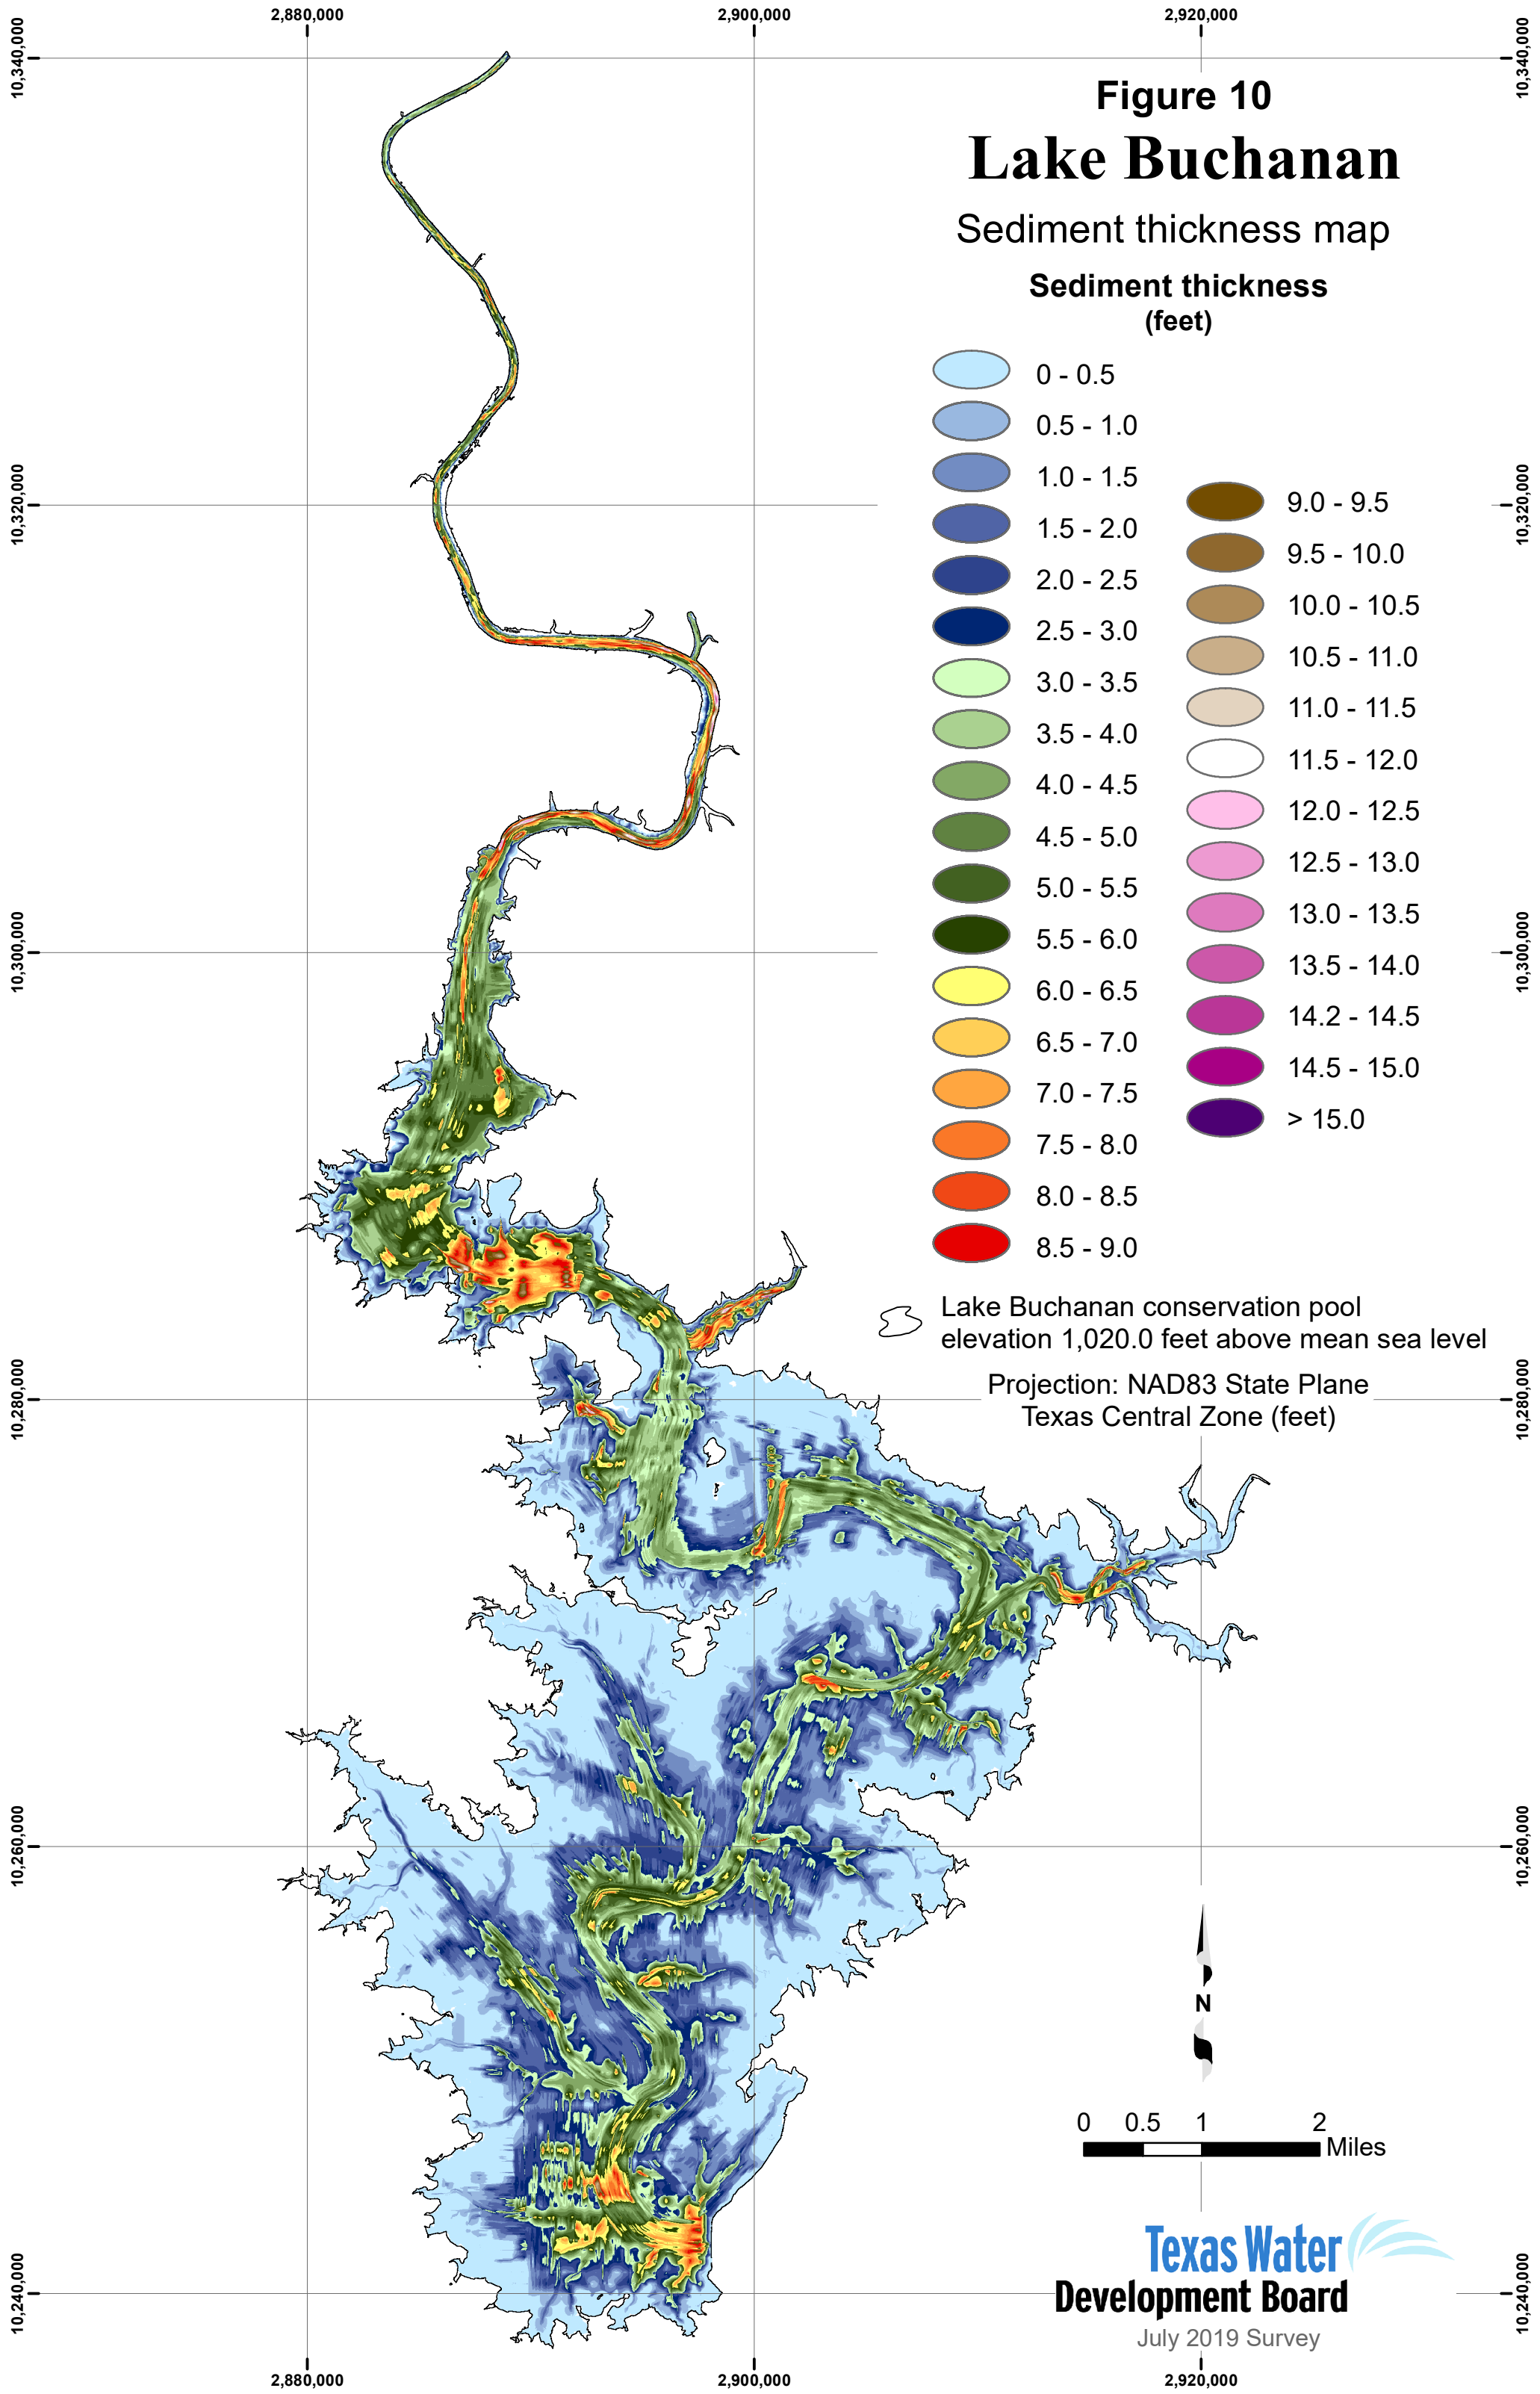
Figure 10
Lake Buchanan
Sediment thickness map
Sediment thickness
(feet)
0 - 0.5
0.5 - 1.0
1.0 - 1.5
1.5 - 2.0
2.0 - 2.5
2.5 - 3.0
3.0 - 3.5
3.5 - 4.0
4.0 - 4.5
4.5 - 5.0
5.0 - 5.5
5.5 - 6.0
6.0 - 6.5
6.5 - 7.0
7.0 - 7.5
7.5 - 8.0
8.0 - 8.5
8.5 - 9.0
9.0 - 9.5
9.5 - 10.0
10.0 - 10.5
10.5 - 11.0
11.0 - 11.5
11.5 - 12.0
12.0 - 12.5
12.5 - 13.0
13.0 - 13.5
13.5 - 14.0
14.2 - 14.5
14.5 - 15.0
> 15.0
Lake Buchanan conservation pool
elevation 1,020.0 feet above mean sea level
Projection: NAD83 State Plane
Texas Central Zone (feet)
N
0 0.5 1 2
Miles
Texas Water
Development Board
July 2019 Survey
2,880,000
2,900,000
2,920,000
10,340,000
10,320,000
10,300,000
10,280,000
10,260,000
10,240,000

The 2019 TWDB sedimentation survey measured 49,812 acre-feet of sediment. The sedimentation survey indicates sediment accumulation is greatest in the river channels. Accumulation is also occurring in the floodplains below elevation 980.0 feet. Comparison of capacity estimates of Lake Buchanan derived using differing methodologies are provided in Table 4 for sedimentation rate calculation. The 2019 TWDB sedimentation survey indicates Lake Buchanan has lost capacity at an average of 609 acre-feet per year since impoundment due to sedimentation below conservation pool elevation (1,020.0 feet above mean sea level). Previous capacity estimates and comparison with historical cross sections (see section below titled "Historical range lines") suggest the TWDB sedimentation survey results are likely an underestimate of the total sediment volume in Lake Buchanan. Lake Buchanan has periodically experienced low water levels leading to the desiccation of any exposed sediment. Upon inundation and re-saturation, exposed sediment will not return to its original high level of water content (Dunbar and Allen, 2003). Drying of sediment in exposed areas create hard surfaces that cannot be penetrated with gravity coring techniques, and compressive stresses on the sediments may also increase sediment density, inhibiting the measurement of the original, pre-impoundment surface. Density stratification in the sediment layers can also scatter and attenuate acoustic return signals of the multi-frequency depth sounder (U.S. Army Corps of Engineers, 2013). Long-term trends indicate Lake Buchanan loses capacity at an average of 1,266 acre-feet per year since impoundment due to sedimentation below conservation pool elevation (1,020.0 feet above mean sea level) (Figure 11). However, the capacity estimates of 1997, 2006, and 2019, suggest sedimentation has slowed considerably. Construction of O. H. Ivie Reservoir upstream in 1990 likely reduced the contributing watershed area from 19,350 acres to 6,703 acres, effectively reducing the sedimentation rate in Lake Buchanan. Based on the accuracy assessment of the 2019 TWDB volumetric survey, the differences between the 2019 TWDB survey, 2006 TWDB survey, and 1997 LCRA survey fall within the range of uncertainty. Differences in methodology may also contribute to differences between these surveys.

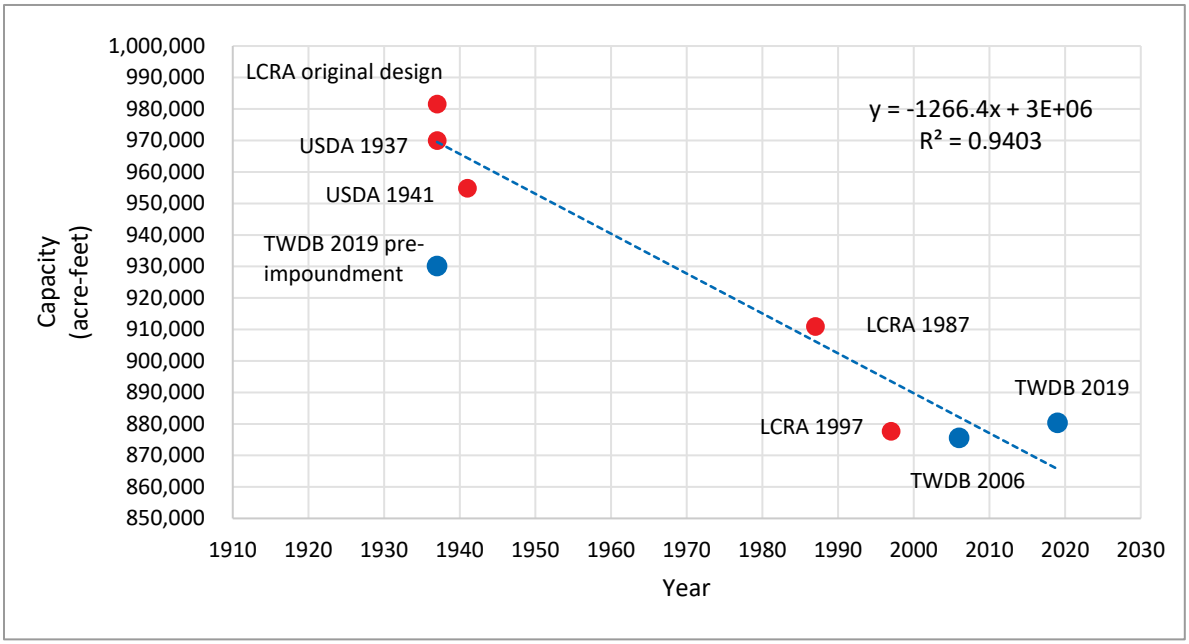
Figure 11. Plot of current and previous capacity estimates (acre-feet) at elevation 1,020.0 feet for Lake Buchanan. Capacity estimates for each TWDB survey plotted as blue dots and other surveys as red dots. The blue trend line illustrates the total average loss of capacity through 2019.
