Volumetric and Sedimentation Survey of LAKE CORPUS CHRISTI

October 2024

TEXAS WATER DEVELOPMENT BOARD

City of Corpus Christi, Texas

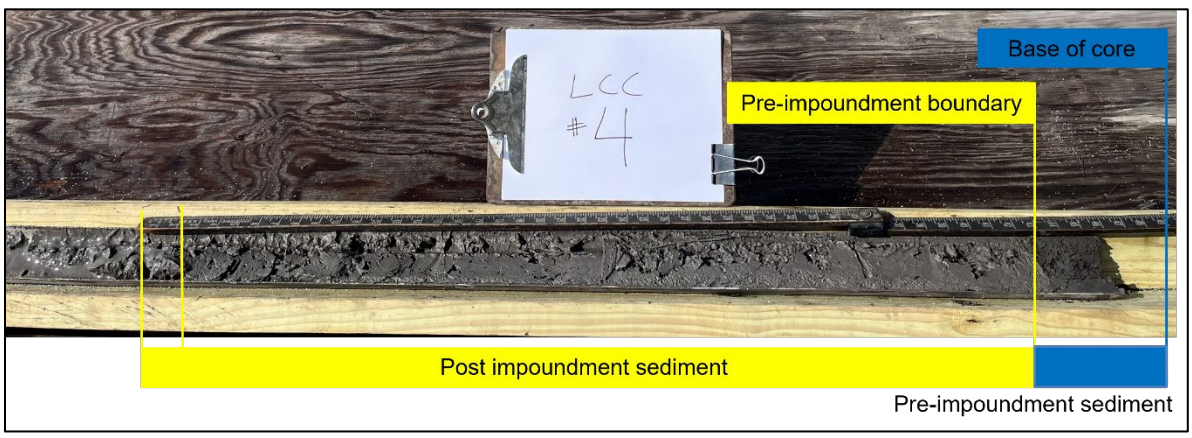
A photograph of sediment core LCC-4 (refer to Figure 3 for location) is shown in Figure 8. The base, or deepest part of the sample, is denoted by the blue line. The pre-impoundment boundary (yellow line closest to the base) was evident within this sediment core sample at 42 inches and identified by the change in color, texture, moisture, porosity, and structure. Identification of the pre-impoundment surface for each sediment core followed a similar procedure.

Figure 8. **Sediment core LCC-4. Post-impoundment sediment layers occur in the top 42 inches of this sediment core (identified by the yellow box). Pre-impoundment sediment layers were identified and are defined by the blue box.**
