BULLETIN 6506

BASE-FLOW STUDIES

LAMPASAS RIVER, TEXAS

Quantity and Quality, June 3-6, 1963

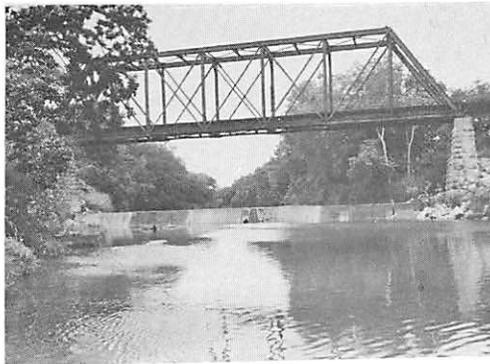
Dam on Lampasas River which forms a mile-long pool above the mouth of Sulphur Creek. At mile 79.0.

Investigation was begun on June 3 above a mile-long pool that was formed by a dam across the solid-rock channel of the Lampasas River. (See Figure 2.) In the first 2 miles of the reach the streamflow increased from 2.27 to 10.1 cfs, and the dissolved-solids content increased more than 250 percent due to the inflow of highly mineralized water from Sulphur Creek.

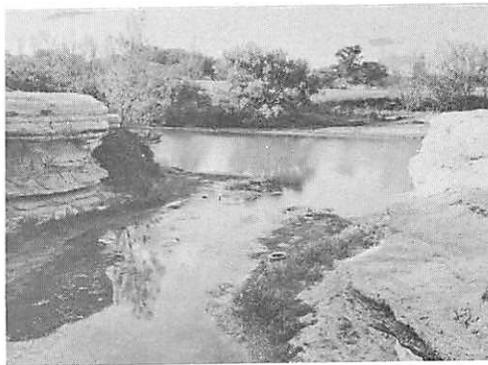
Mouth of Rocky Creek. Note channel through limestone outcrop. At mile 65.0.

At mile 64.9 (site 6) the discharge of the Lampasas River was 9.25 cfs. Tributary inflow between miles 77.8 and 64.9 from Rocky and Taylor Creeks was 0.53 cfs, and the net loss in this reach was 1.38 cfs. No diversion was noted. An analysis of the water shows a decrease in dissolved-solids content of about 29 percent; sodium and chloride decreased the most. The decrease in dissolved solids and the decrease in streamflow indicate that the river in this area is intermittently losing water to, and receiving water from, the underlying Glen Rose Limestone, which results in a dilution of the river water. The inflows from Rocky and Taylor Creeks are calcium bicarbonate waters, and are low in sodium and chloride (Figure 4). This chemical composition is typical of water that drains a limestone terrane and is probably indicative of the chemical character of shallow ground water in the area. The flow of Rocky Creek was entirely from springs at its mouth, through limestone outcrop (Figure 2).

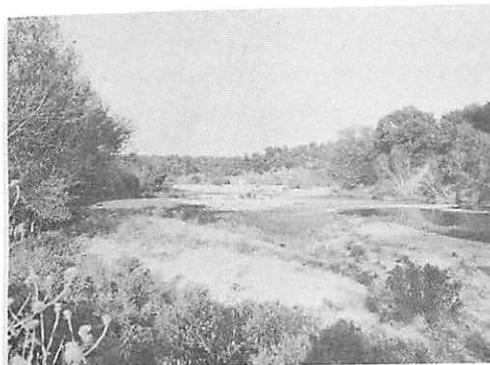
Lampasas River at mouth of Rocky Creek. Channel is composed of gravel bars and limestone. At mile 65.0.

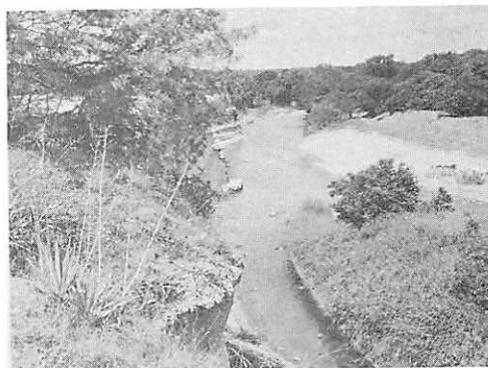
Reese Creek at mouth. Note limestone channel in Lampasas River. At mile 51.0.

At mile 49.6 (site 10) the flow of the Lampasas River decreased to 8.95 cfs, an apparent loss of 0.76 cfs. About 0.6 cfs of the loss is attributed to a diversion by the Texas Highway Department at mile 49.7. Evaporation from large pools along this reach probably accounts for the remainder of the loss. Tributary inflow was 0.01 cfs from Reese Creek. A chemical analysis shows that the inflow from Reese Creek is a calcium bicarbonate water, indicative of the limestone terrane which Reese Creek drains (Figure 2).

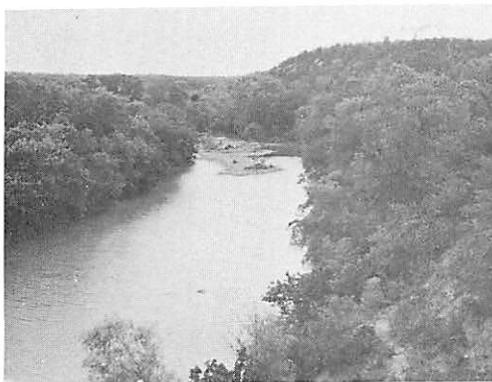
Lampasas River at FM 1670. Note typically long pool and profuse growth. At mile 19.3.

Between miles 22.0 and 12.6 the channel of the Lampasas River is composed alternately of solid rock and gravel. Throughout this reach there are long pools in the river channel, and vegetation grows profusely on the alluvial terraces (Figure 2). The flow at mile 12.6 (site 20) decreased to 7.52 cfs, and the dissolved solids decreased to 336 ppm, with sodium and chloride showing the most significant decrease. Apparently, the river is intermittently losing water to, and receiving water from, the underlying Walnut Clay. This results in an exchange of water and a dilution of the river water. The type of shallow ground water in this area is probably similar in chemical character to the inflow from an unnamed tributary, which consists entirely of spring flow, at mile 13.9 (site 18) and from a spring at mile 12.6 (site 19). These waters have dissolved-solids concentrations of 259 and 308 ppm; they are calcium bicarbonate waters and are low in sodium and chloride.

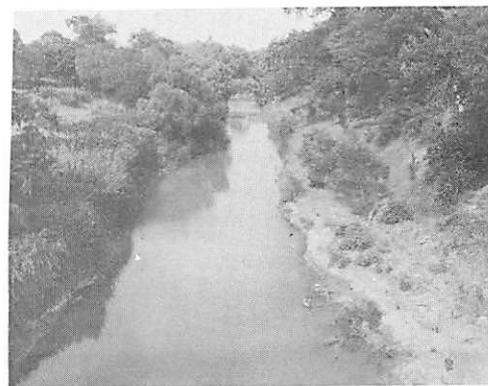
Lampasas River near confluence with Leon River. Long pool is caused by backwater from the Leon River. At mile 0.3.

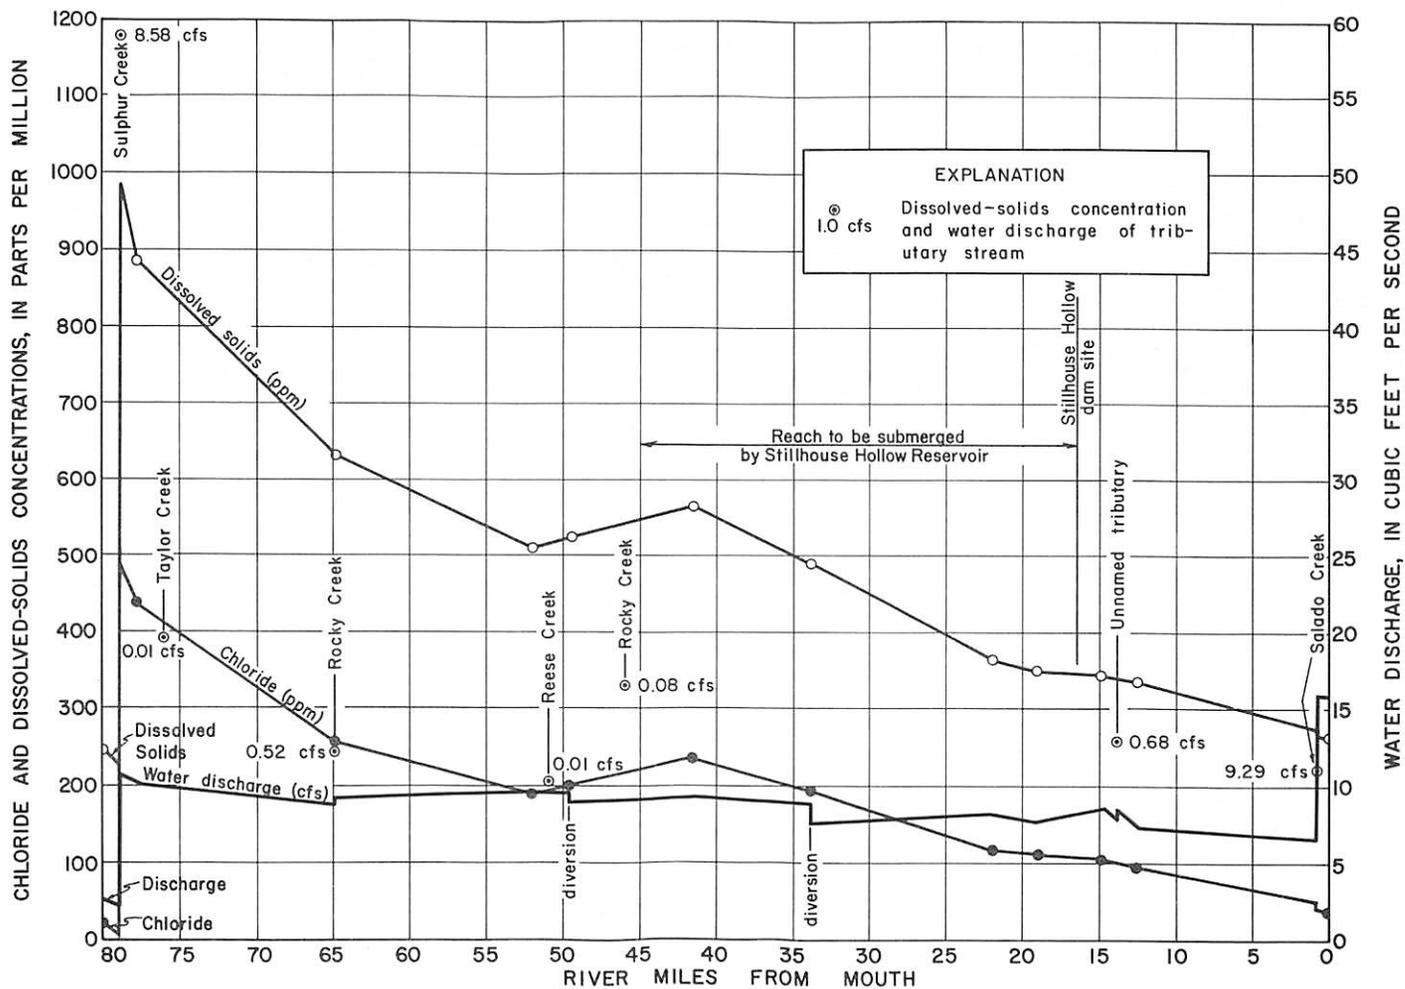
Figure 3
 Profiles of Chloride and Dissolved-Solids Concentrations and Water Discharge, Lampasas River, June 3-6, 1963, with Dissolved-Solids Concentrations and Discharges of Tributary Streams

Discharge was measured and samples for chemical analyses were collected at 20 sites in the Lampasas River watershed (Plate 1). The results of discharge measurements are given in Table 1 and chemical analyses are shown in Table 2. These data, which are also shown graphically on Figure 3, define changes in chemical quality and amount of flow throughout the reach. Analyses of five samples collected from the river and of three samples from tributary streams are shown graphically in Figure 4. The total height of each vertical bar graph is proportional to the total concentration of anions (negatively charged constituents) or cations (positively charged constituents) expressed in equivalents per million. The bar is divided into segments to show the concentrations of the cations and anions which make up the total.

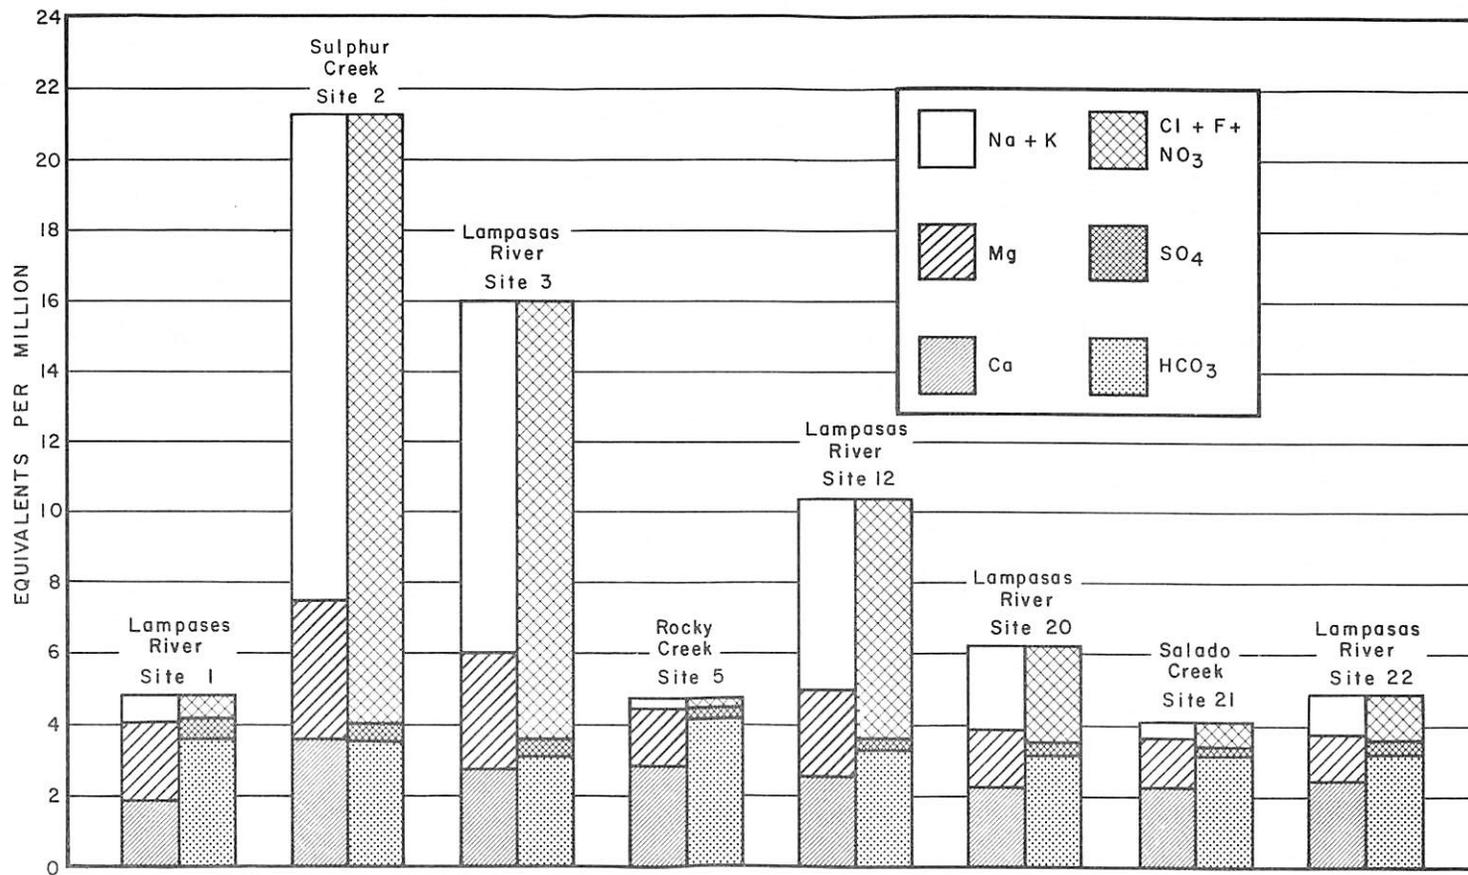
Figure 4
 Chemical Analyses of Water of the Lampasas River Watershed

At mile 80.1 (site 1) the discharge of the Lampasas River was 2.27 cfs, and the water contained 247 ppm (parts per million) dissolved solids. A chemical analysis of the water, shown graphically in Figure 4, shows that the principal dissolved constituents are bicarbonate, magnesium, and calcium. Magnesium and calcium are present in approximately equivalent amounts, and together they are approximately equivalent to the bicarbonate. This chemical relationship is typical of waters that drain a terrane of dolomite or impure limestone, such as the Glen Rose Limestone.

The inflow from Sulphur Creek increased the flow of the Lampasas River at mile 77.8 (site 3) to 10.1 cfs and the dissolved-solids content of the water to 887 ppm. The river water is altered in chemical character from calcium bicarbonate water to a sodium chloride water (Figure 4); sodium constitutes about 62 percent of the cations (positively charged ions), while chloride constitutes about 78 percent of the anions (negatively charged ions).

(Figure 4). Tributary inflow from Rocky Creek at mile 46.1 was 0.08 cfs. The principal dissolved constituents of water from Rocky Creek are calcium and bicarbonate.

The inflow from Salado Creek increased the flow of the river at mile 0.3 (site 22) to 16.0 cfs. The dissolved-solids content of the water decreased to 265 ppm, and the water was altered in chemical composition (Figure 4). The principal dissolved constituents of the river water are calcium and bicarbonate. This water does not differ greatly in chemical composition from the inflow from Salado Creek.
