STORMWATER DRAINAGE PLANNING

The Colonias of the Lower Rio Grande Valley (LRGV)

Phase 2 Report

JSW & Associates, Inc. Hazard Mitigation Consultants

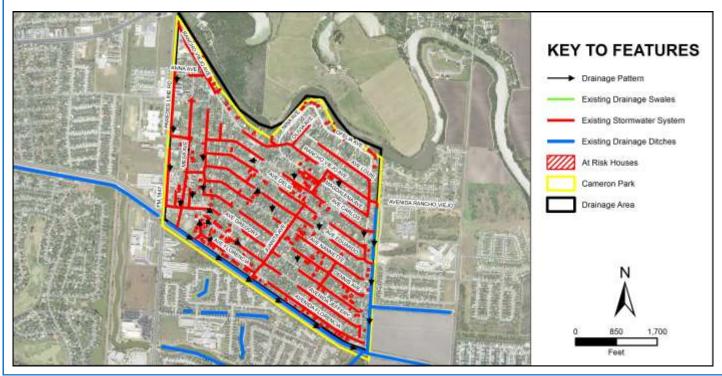
Drainage patterns within this 20-acre colonia are generally to the south and west. The existing drainage system consists of a small stormwater system and roadside swales that are generally undersized and restricted by sediment and vegetation. Cameron Park experiences residential lot, street, and structure flooding in nearly every rainfall event. Figures 1-5 illustrate the existing and proposed conditions inundation maps for the 2-, 5-, 10-, 25-, and 100-year storms, respectively. These maps illustrate the depth of flooding as follows: light blue represents a depth of 6 to 9 inches, blue 9 to 12 inches, green 1 to 1.5 feet, yellow 1.5 to 2 feet, orange 2 to 3 feet, and red more than 3 feet.

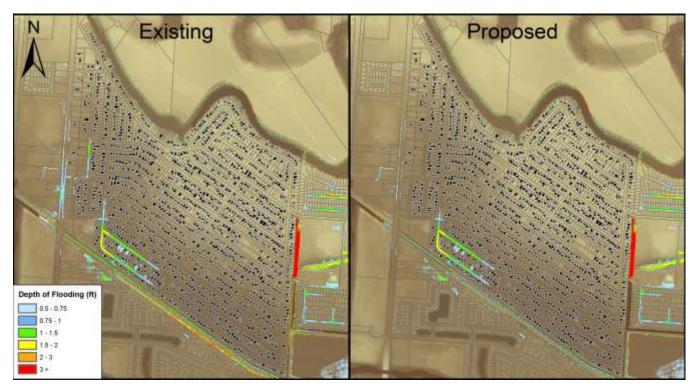
Figure 1: Existing and Proposed Conditions - 2-yr Storm Inundation Map

The goal of this study was to size the system to be capable of carrying up to the 10-Year storm runoff with no inundation in the colonia. However, some structures lie within low areas of the colonia and still show risk of flooding. When comparing the 6-inch inundation map for the 25- and 100-Year storms, it is observed that the inundation depths are lower than the existing conditions model, resulting in fewer structures at risk of being flooded once improvements are in place. Figures 1, 2, 3, 4, and 5 show the existing and proposed conditions inundation maps for the 2-, 5-, 10-, 25-, and 100-Yr storms respectively.

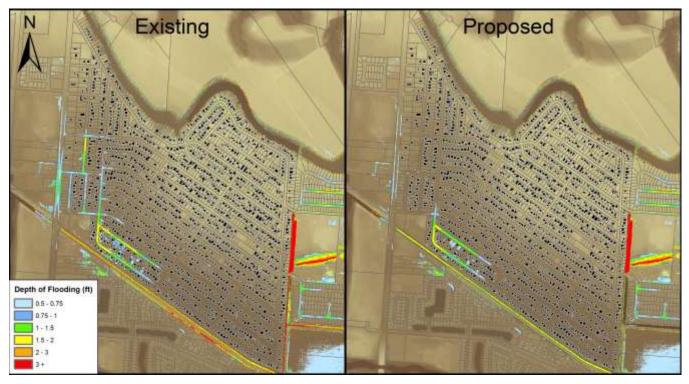
Figure 2: Existing and Proposed Conditions - 5-yr Storm Inundation Map

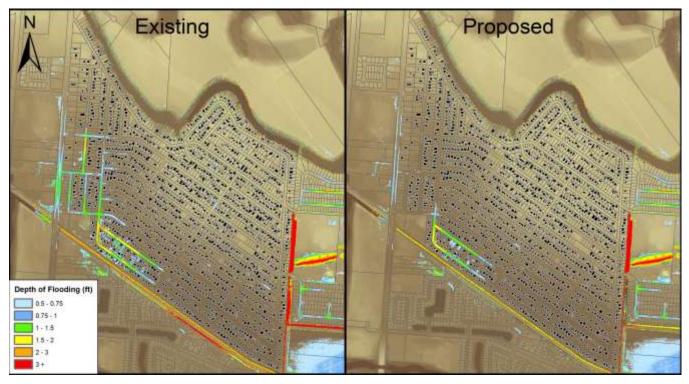
Figure 3: Existing and Proposed Conditions - 10-yr Storm Inundation Map

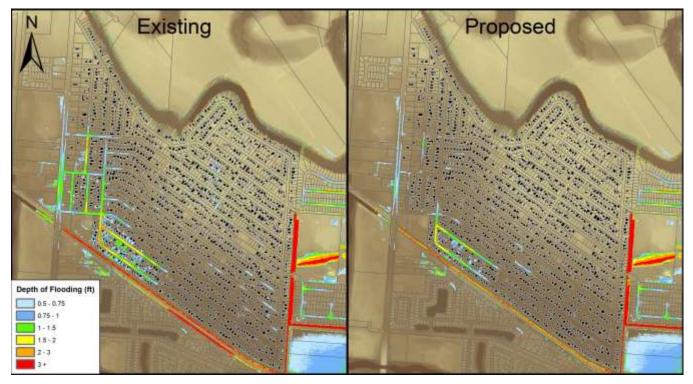
Figure 4: Existing and Proposed Conditions - 25-yr Storm Inundation Map

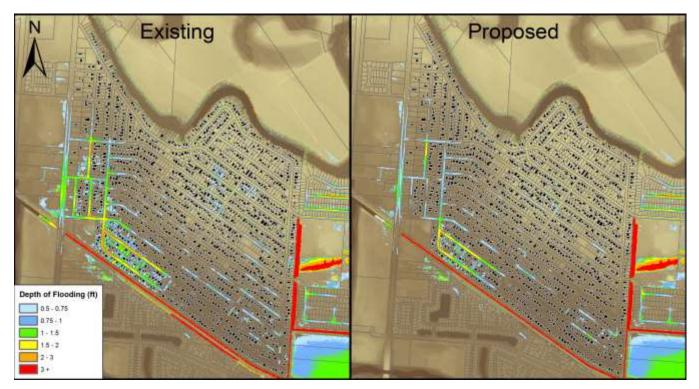
Figure 5: Existing and Proposed Conditions - 100-yr Storm Inundation Map

1% (100-Year) Flood Recurrence	Pre-Project	Post-Project	Removed
Inundated Structures	221	108	113
Inundated Lots	885	570	315
Inundated Roadway (LF)	20250	13290	6960

- 1. The number of inundated structures are based strictly on finished floor elevations compared to computed water surface elevations.
- 2. The inundation maps above only display flooding depths greater than 6 inches.
- 3. The number of inundated lots are based strictly on the inundation maps above and therefore do not count as inundated if the depth of flooding is less than 6 inches.

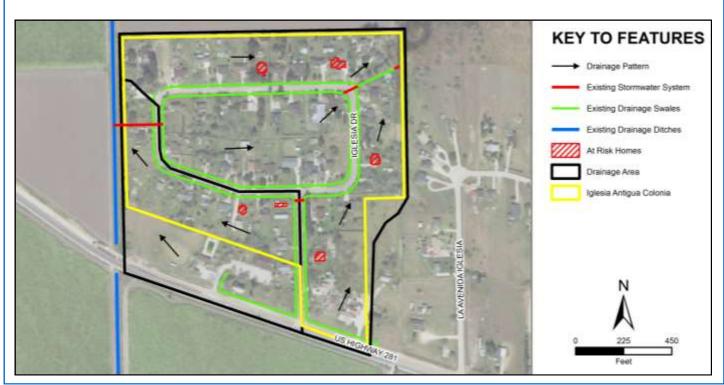
Drainage patterns within this 31-acre colonia are generally from the south to the northeast with the southwest portion of the colonia draining towards a drainage ditch to the west. This colonia is located entirely within the FEMA Zone AH 100-year floodplain. The colonia does not have adequate roadside swale conveyance and frequently experiences residential lot and street flooding as well as some structural flooding during significant regional storm events. Model results indicate that high-risk flooding areas exist throughout the very flat terrain of the colonia. Figures 1-5 illustrate the existing and proposed conditions inundation maps for the 2-, 5-, 10-, 25-, and 100-year storms, respectively. These maps illustrate the depth of flooding as follows: light blue represents a depth of 6 to 9 inches, blue 9 to 12 inches, green 1 to 1.5 feet, yellow 1.5 to 2 feet, orange 2 to 3 feet, and red more than 3 feet.

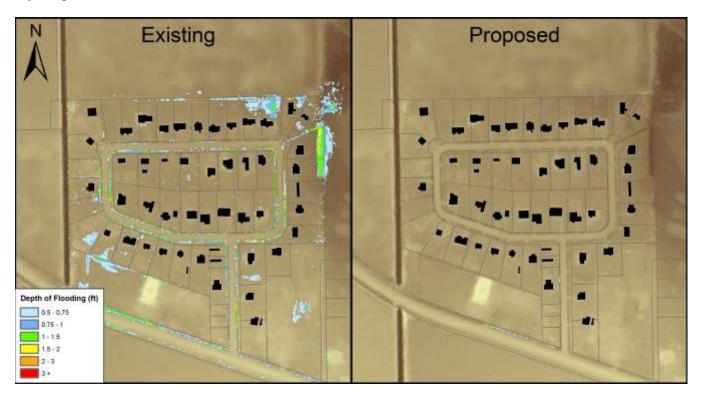
Figure 1: Existing and Proposed Conditions - 2-yr Storm Inundation Map

The goal of this study was to size the system to be capable of carrying up to the 10-Year storm runoff with no inundation in the colonia. However, some structures lie within low areas of the colonia and still show risk of flooding. When comparing the 6-inch inundation map for the 25- and 100-Year storms, it is observed that the inundation depths are lower than the existing conditions model, resulting in fewer structures at risk of being flooded once improvements are in place. Figures 1, 2, 3, 4, and 5 show the existing and proposed conditions inundation maps for the 2-, 5-, 10-, 25-, and 100-Yr storms respectively.

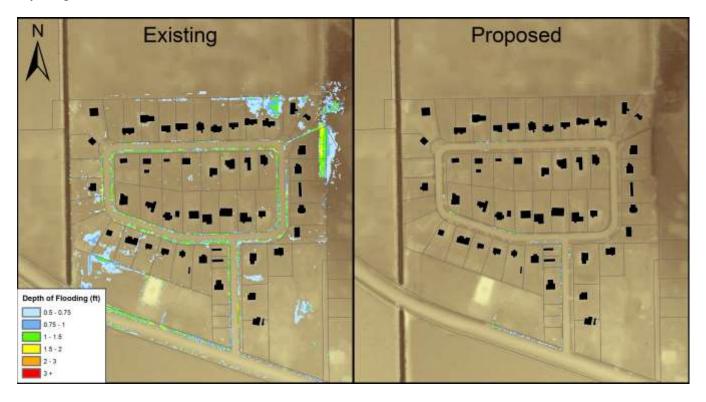
Figure 1: Existing and Proposed Conditions - 5-yr Storm Inundation Map

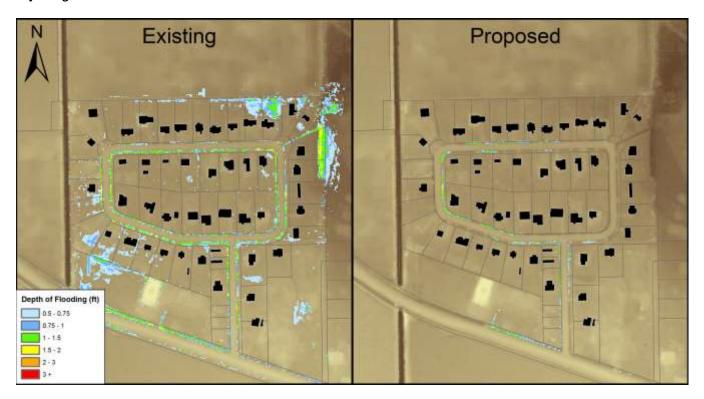
Figure 1: Existing and Proposed Conditions - 10-yr Storm Inundation Map

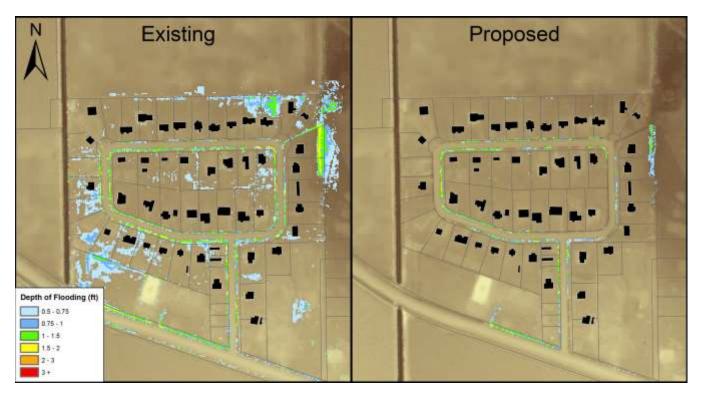
Figure 1: Existing and Proposed Conditions - 25-yr Storm Inundation Map

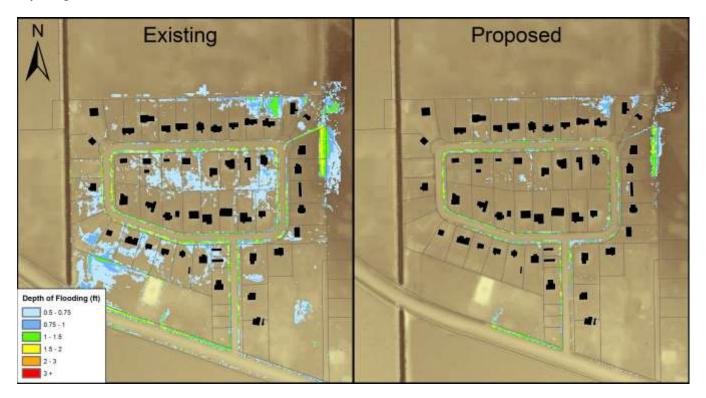
Figure 1: Existing and Proposed Conditions - 100-yr Storm Inundation Map

1% (100-Year) Flood Recurrence	Pre-Project	Post-Project	Removed
Inundated Structures	6	0	6
Inundated Lots	54	38	16
Inundated Roadway (LF)	0	0	0

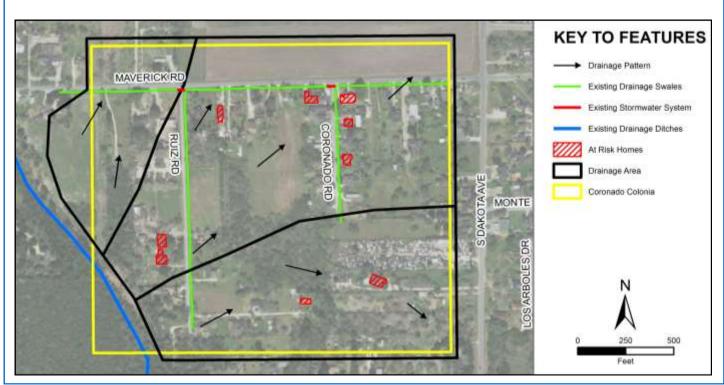
Drainage patterns within this 47-acre colonia are generally from the west to the northeast towards Maverick Rd and southeast towards a low-lying area on the west side of South Dakota Ave. The existing drainage system consists of roadside swales that are generally undersized and restricted by sediment and vegetation. The colonia experiences frequent residential lot and street flooding as well as structure flooding during local events. Areas with a high flooding potential exist throughout the colonia due to the flat terrain. Model results show that homes in the northeast portion of the colonia along Coronado Street have the highest risk of inundation. Figures 1-5 illustrate the existing and proposed conditions inundation maps for the 2-, 5-, 10-, 25-, and 100-year storms, respectively. These maps illustrate the depth of flooding as follows: light blue represents a depth of 6 to 9 inches, blue 9 to 12 inches, green 1 to 1.5 feet, yellow 1.5 to 2 feet, orange 2 to 3 feet, and red more than 3 feet.

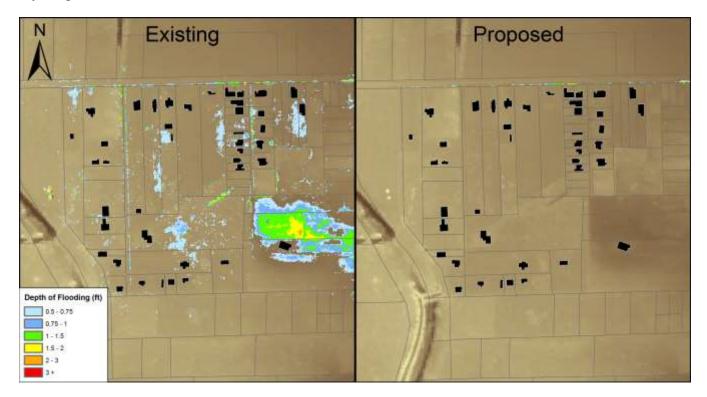
Figure 1: Existing and Proposed Conditions - 2-yr Storm Inundation Map

The goal of this study was to size the system to be capable of carrying up to the 10-Year storm runoff with no inundation in the colonia. However, some structures lie within low areas of the colonia and still show risk of flooding. When comparing the 6-inch inundation map for the 25- and 100-Year storms, it is observed that the inundation depths are lower than the existing conditions model, resulting in fewer structures at risk of being flooded once improvements are in place. Figures 1, 2, 3, 4, and 5 show the existing and proposed conditions inundation maps for the 2-, 5-, 10-, 25-, and 100-Yr storms respectively.

50% (2-Year)	Pre-Project	Post-Project	Removed
Flood Recurrence	rie-rioject	rost-rroject	Removed
Inundated Structures	5	0	5
Inundated Lots	55	9	46
Inundated Roadway (LF)	45	0	45

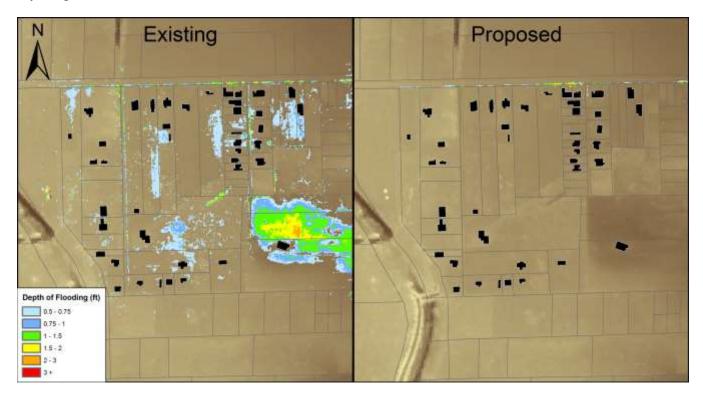
Figure 2: Existing and Proposed Conditions - 5-yr Storm Inundation Map

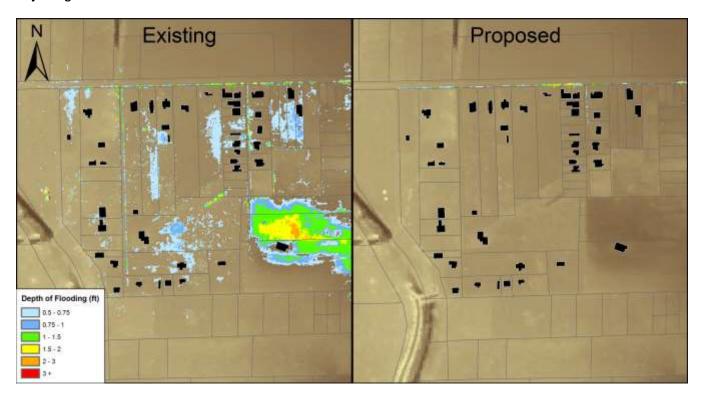
Figure 3: Existing and Proposed Conditions - 10-yr Storm Inundation Map

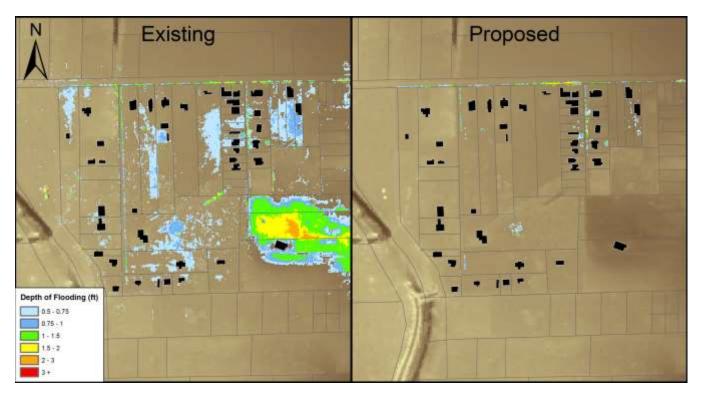
Figure 4: Existing and Proposed Conditions - 25-yr Storm Inundation Map

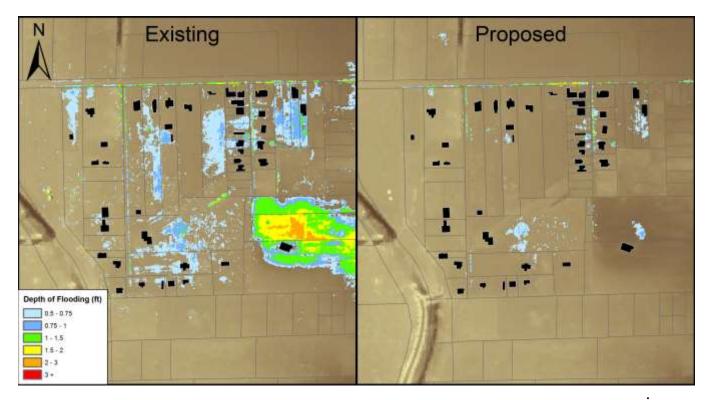
Figure 5: Existing and Proposed Conditions - 100-yr Storm Inundation Map

1% (100-Year) Flood Recurrence	Pre-Project	Post-Project	Removed
Inundated Structures	9	2	7
Inundated Lots	56	36	20
Inundated Roadway (LF)	165	55	110

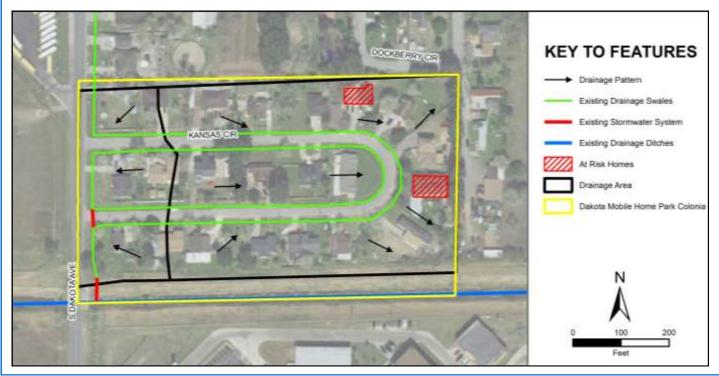
Drainage patterns within this 8-acre colonia are generally to the east with a portion draining to the west towards S. Dakota Ave. The existing drainage system consists of open swales along Kansas Circle and S. Dakota Ave that outfall into the regional drainage system to the south. The colonia does not have adequate roadside swale conveyance due to undersized swales, vegetation and sediment build-up. The colonia experiences residential lot and street flooding in nearly every rainfall event. Figures 1-5 illustrate the existing and proposed conditions inundation maps for the 2-, 5-, 10-, 25-, and 100-year storms, respectively. These maps illustrate the depth of flooding as follows: light blue represents a depth of 6 to 9 inches, blue 9 to 12 inches, green 1 to 1.5 feet, yellow 1.5 to 2 feet, orange 2 to 3 feet, and red more than 3 feet.

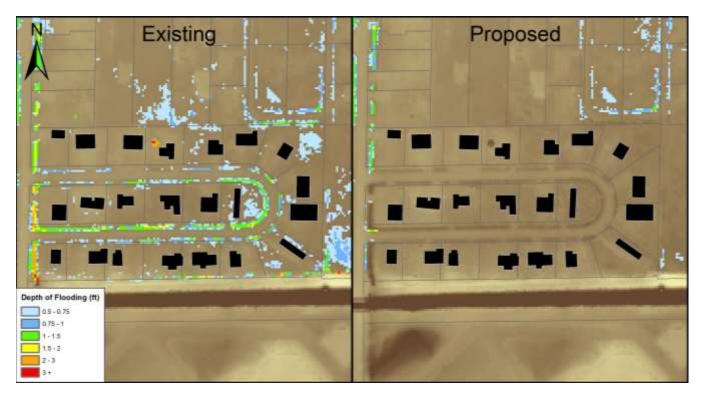
Figure 1: Existing and Proposed Conditions - 2-yr Storm Inundation Map

The goal of this study was to size the system to be capable of carrying up to the 10-Year storm runoff with no inundation in the colonia. However, some structures lie within low areas of the colonia and still show risk of flooding. When comparing the 6-inch inundation map for the 25- and 100-Year storms, it is observed that the inundation depths are lower than the existing conditions model, resulting in fewer structures at risk of being flooded once improvements are in place. Figures 1, 2, 3, 4, and 5 show the existing and proposed conditions inundation maps for the 2-, 5-, 10-, 25-, and 100-Yr storms respectively.

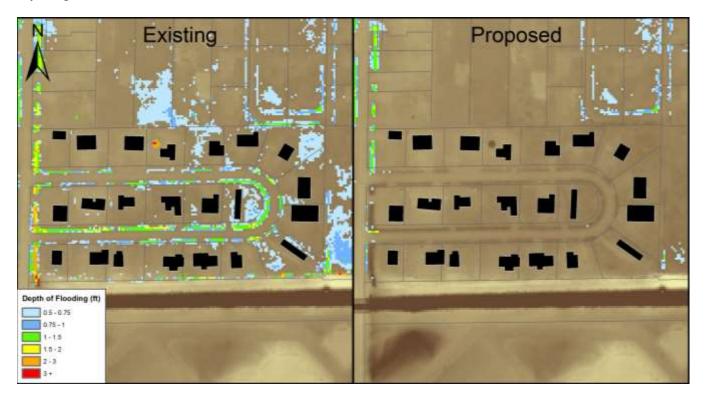
Figure 2: Existing and Proposed Conditions - 5-yr Storm Inundation Map

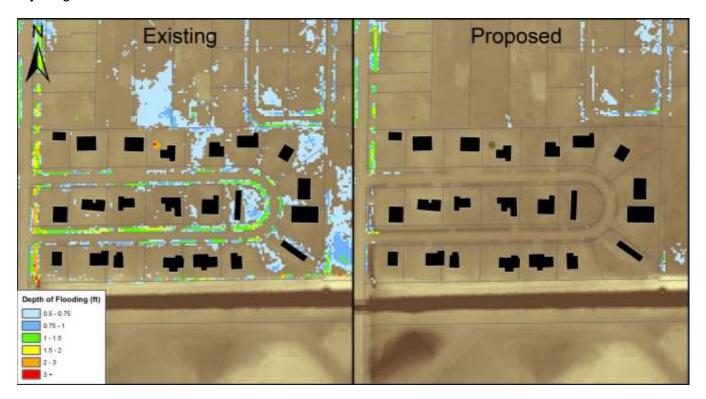
Figure 3: Existing and Proposed Conditions - 10-yr Storm Inundation Map

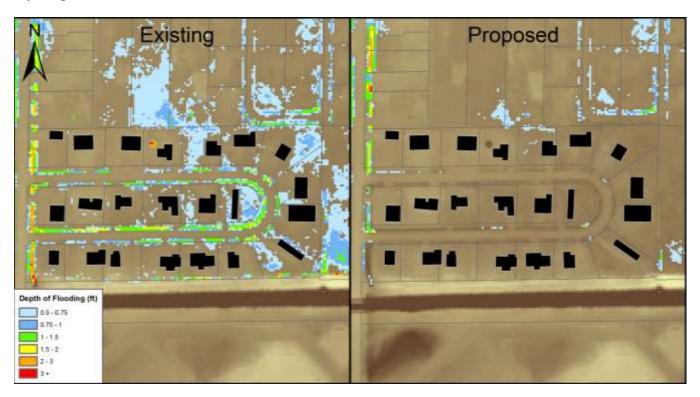
Figure 4: Existing and Proposed Conditions - 25-yr Storm Inundation Map

4% (25-Year)	Pre-Project	Post-Project	Removed
Flood Recurrence	rie-rioject	rost-rroject	Kellioveu
Inundated Structures	1	0	1
Inundated Lots	22	7	15
Inundated Roadway (LF)	0	0	0

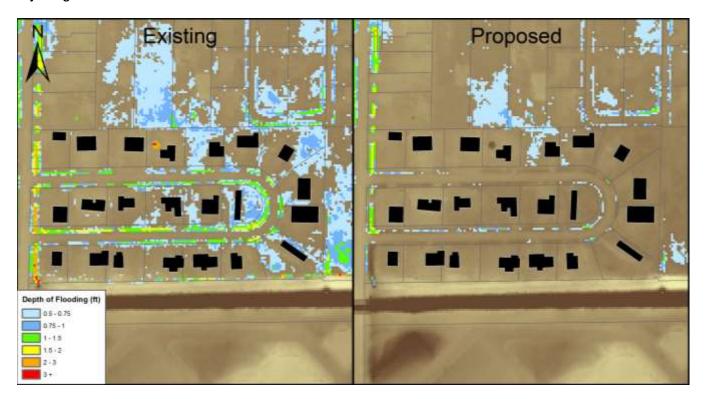
Figure 5: Existing and Proposed Conditions - 100-yr Storm Inundation Map

1% (100-Year) Flood Recurrence	Pre-Project	Post-Project	Removed
Inundated Structures	2	0	2
Inundated Lots	22	11	11
Inundated Roadway (LF)	0	0	0

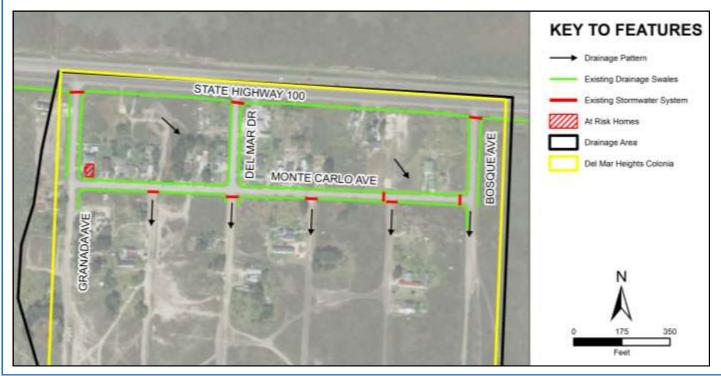
Drainage patterns within this 300-acre colonia are from the north to south towards the lower 250 acres of the colonia, which are within the FEMA Zone AE 100-year floodplain. The existing drainage system in the northern portion of the colonia consists of roadsides swales that are generally undersized and restricted by sediment and vegetation. The colonia experiences frequent residential lot and street flooding from local storm events as well as some structure flooding during significant regional storm events. Areas with a high flooding potential exist throughout the colonia due to the flat terrain. Cameron County has recently acquired four homes exist within the southern Zone AE floodplain, and therefore, no proposed improvements are evaluated in this area. Figures 1-5 illustrate the existing and proposed conditions inundation maps in the northern portion of the colonia for the 2-, 5-, 10-, 25-, and 100-year storms, respectively. These maps illustrate the depth of flooding as follows: light blue represents a depth of 6 to 9 inches, blue 9 to 12 inches, green 1 to 1.5 feet, yellow 1.5 to 2 feet, orange 2 to 3 feet, and red more than 3 feet.

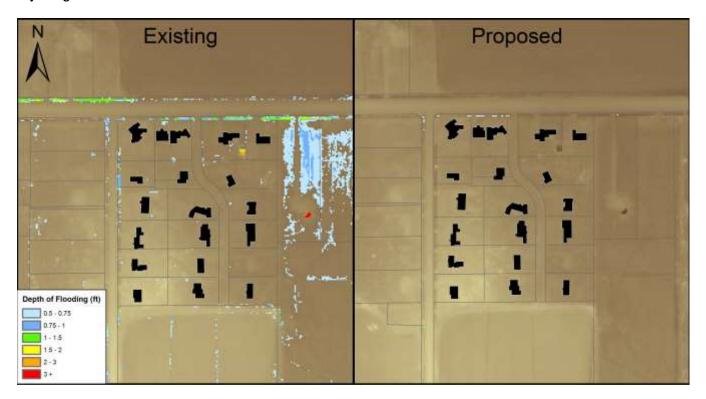
Figure 1: Existing and Proposed Conditions - 2-yr Storm Inundation Map

The goal of this study was to size the system to be capable of carrying up to the 10-Year storm runoff with no inundation in the colonia. However, some structures lie within low areas of the colonia and still show risk of flooding. When comparing the 6-inch inundation map for the 25- and 100-Year storms, it is observed that the inundation depths are lower than the existing conditions model, resulting in fewer structures at risk of being flooded once improvements are in place. Figures 1, 2, 3, 4, and 5 show the existing and proposed conditions inundation maps for the 2-, 5-, 10-, 25-, and 100-Yr storms respectively.

50% (2-Year)	Pre-Project	Post-Project	Removed
Flood Recurrence	rie-rioject	rost-rroject	Kellioveu
Inundated Structures	1	0	1
Inundated Lots	119	44	75
Inundated Roadway (LF)	220	0	220

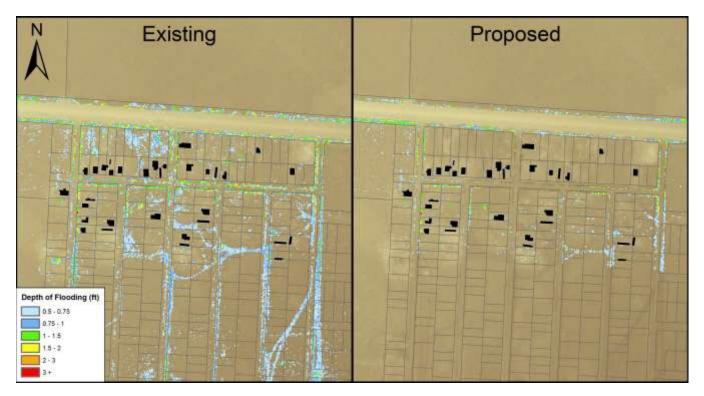
Figure 2: Existing and Proposed Conditions - 5-yr Storm Inundation Map

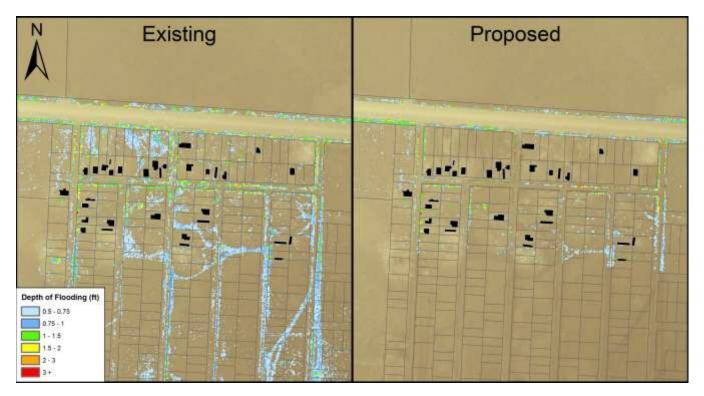
Figure 3: Existing and Proposed Conditions - 10-yr Storm Inundation Map

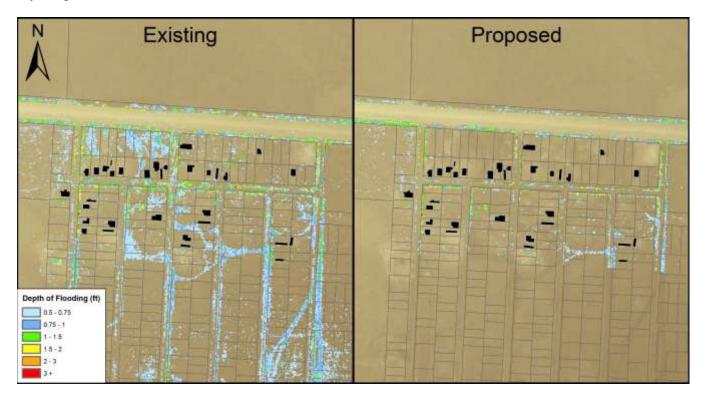
Figure 4: Existing and Proposed Conditions - 25-yr Storm Inundation Map

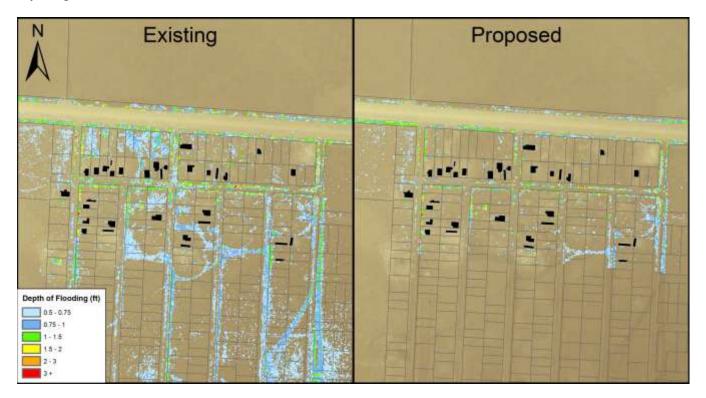
Figure 5: Existing and Proposed Conditions - 100-yr Storm Inundation Map

1% (100-Year)	Pre-Project	Post-Project	Removed
Flood Recurrence	The Project	1 030 1 10 jede	Removed
Inundated Structures	1	0	1
Inundated Lots	122	92	30
Inundated Roadway (LF)	810	80	730

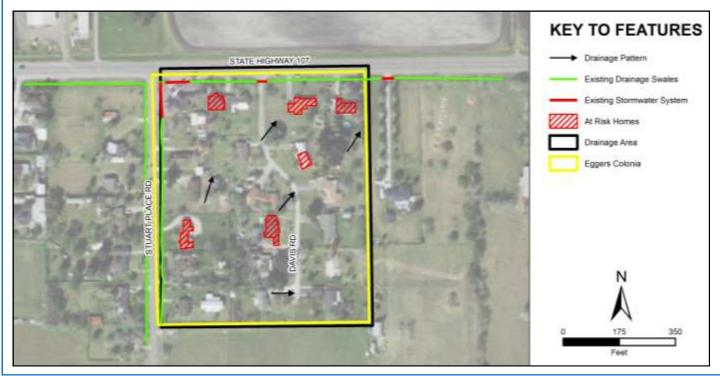
Drainage patterns within this 27-acre colonia are generally from the southwest to northeast, towards Combes-Santa Rosa Road (TX-107). The colonia does not have adequate roadside ditch conveyance and frequently experiences residential lot and street flooding as well as some structural flooding from local events. Model results indicate that the northeast corner of the colonia within the FEMA Zone AH 100-year floodplain is a high-risk flooding area, as well as other areas throughout the very flat terrain of the colonia. Figures 1-5 illustrate the existing and proposed conditions inundation maps for the 2-, 5-, 10-, 25-, and 100-year storms, respectively. These maps illustrate the depth of flooding as follows: light blue represents a depth of 6 to 9 inches, blue 9 to 12 inches, green 1 to 1.5 feet, yellow 1.5 to 2 feet, orange 2 to 3 feet, and red more than 3 feet.

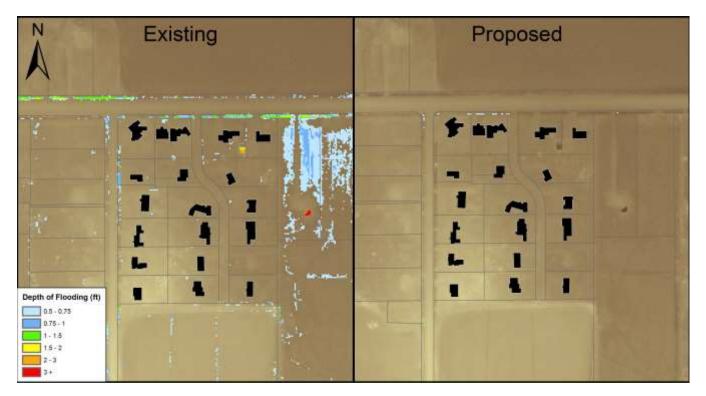
Figure 1: Existing and Proposed Conditions - 2-yr Storm Inundation Map

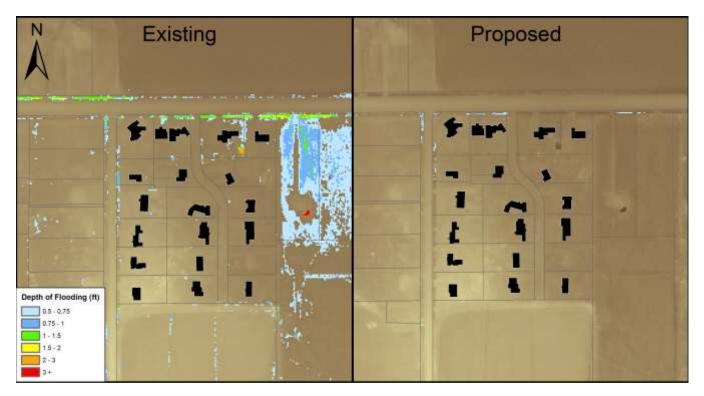
Figure 2: Existing and Proposed Conditions - 5-yr Storm Inundation Map

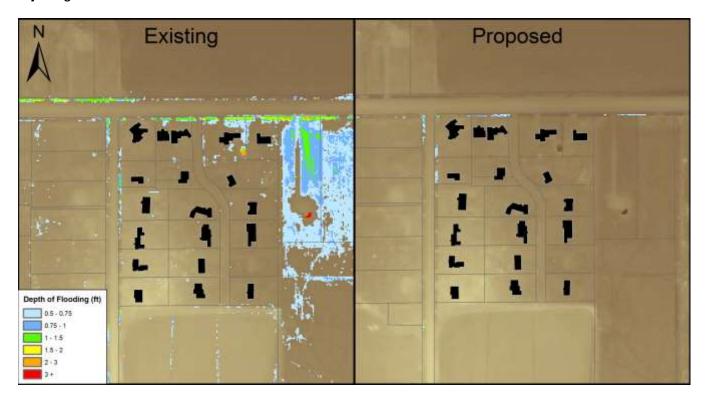
Figure 3: Existing and Proposed Conditions - 10-yr Storm Inundation Map

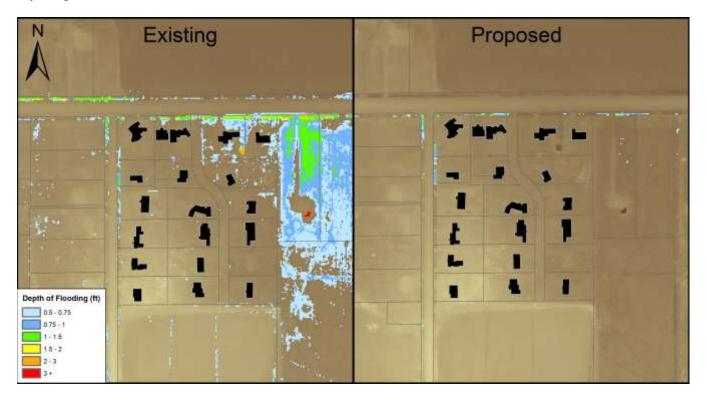
Figure 4: Existing and Proposed Conditions - 25-yr Storm Inundation Map

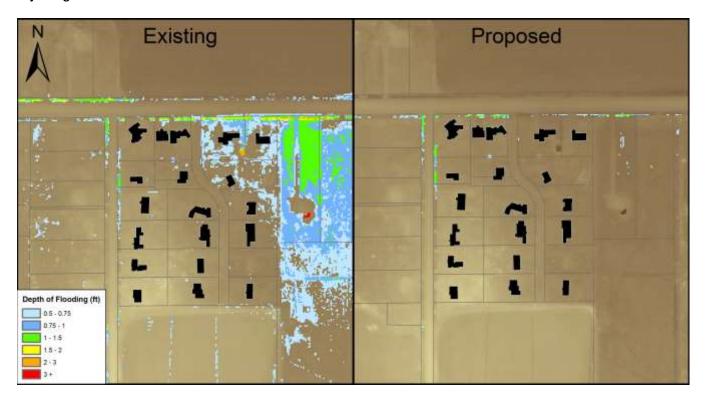
Figure 5: Existing and Proposed Conditions - 100-yr Storm Inundation Map

1% (100-Year) Flood Recurrence	Pre-Project	Post-Project	Removed
Inundated Structures	6	1	5
Inundated Lots	18	7	11
Inundated Roadway (LF)	10	0	10

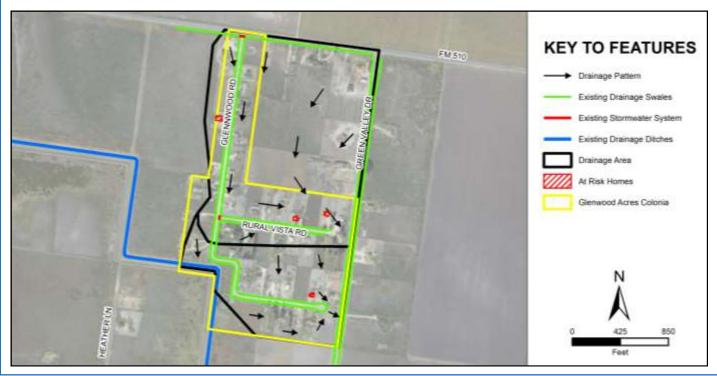
Drainage patterns within this 51-acre colonia are generally to the south. This colonia is located entirely within the FEMA Zone AH 100-year floodplain. The colonia has an existing roadside drainage system. Due to inadequate roadside swale conveyance, Glenwood Acres experiences residential lot, street, and structure flooding in nearly every rainfall event. Figures 1-5 illustrate the existing and proposed conditions inundation maps for the 2-, 5-, 10-, 25-, and 100-year storms, respectively. These maps illustrate the depth of flooding as follows: light blue represents a depth of 6 to 9 inches, blue 9 to 12 inches, green 1 to 1.5 feet, yellow 1.5 to 2 feet, orange 2 to 3 feet, and red more than 3 feet.

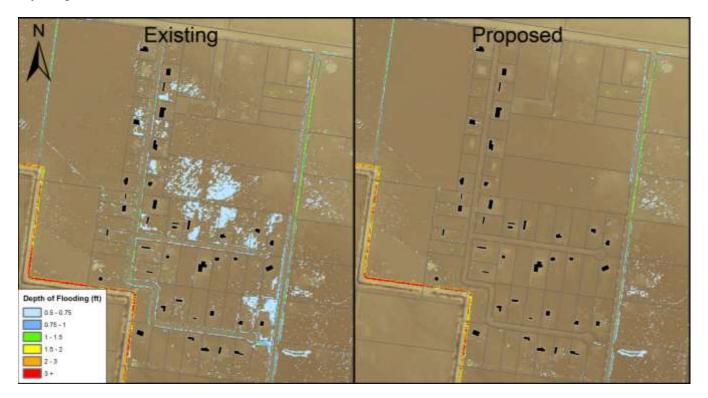
Figure 1: Existing and Proposed Conditions - 2-yr Storm Inundation Map

The goal of this study was to size the system to be capable of carrying up to the 10-Year storm runoff with no inundation in the colonia. However, some structures lie within low areas of the colonia and still show risk of flooding. When comparing the 6-inch inundation map for the 25- and 100-Year storms, it is observed that the inundation depths are lower than the existing conditions model, resulting in fewer structures at risk of being flooded once improvements are in place. Figures 1, 2, 3, 4, and 5 show the existing and proposed conditions inundation maps for the 2-, 5-, 10-, 25-, and 100-Yr storms respectively.

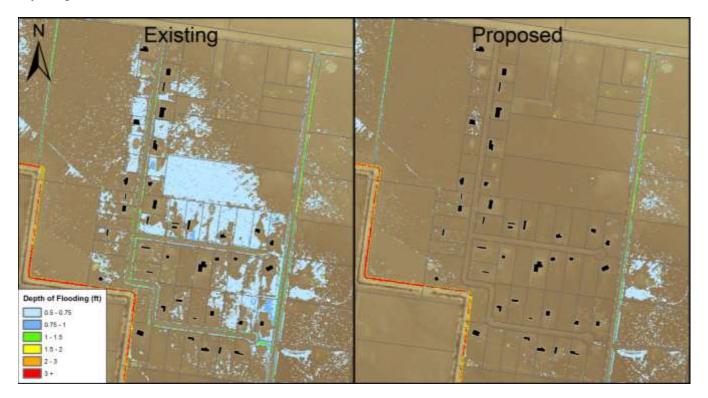
Figure 2: Existing and Proposed Conditions - 5-yr Storm Inundation Map

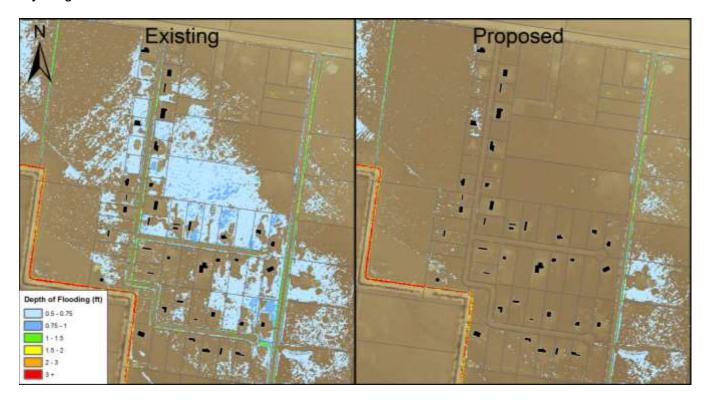
Figure 3: Existing and Proposed Conditions - 10-yr Storm Inundation Map

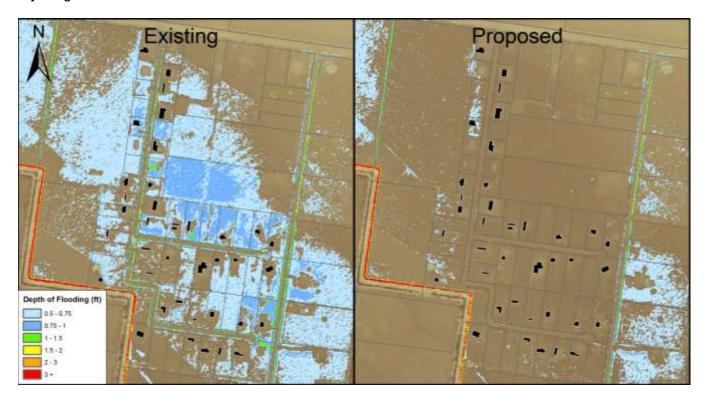
Figure 4: Existing and Proposed Conditions - 25-yr Storm Inundation Map

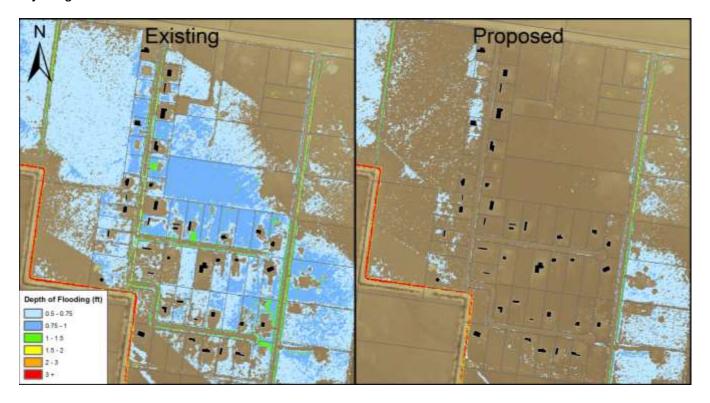
Figure 5: Existing and Proposed Conditions - 100-yr Storm Inundation Map

1% (100-Year) Flood Recurrence	Pre-Project	Post-Project	Removed
Inundated Structures	4	1	3
Inundated Lots	56	43	13
Inundated Roadway (LF)	270	5	265

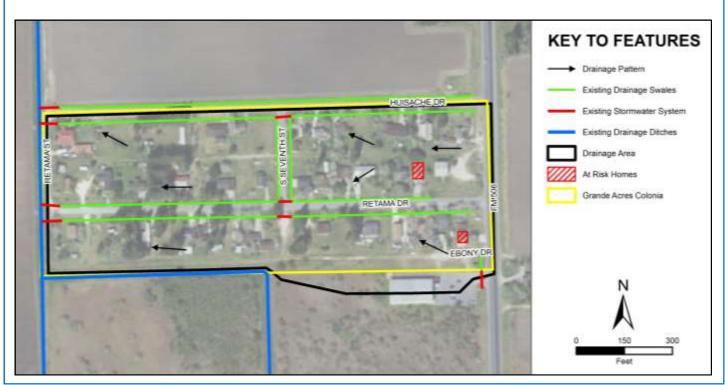
Drainage patterns within this 17-acre colonia are generally to the west towards Retama Street. The colonia has an existing roadside drainage system, and pipe culverts under S. Seventh Street and Retama Street. Due to inadequate conveyance of stormwater caused by undersized infrastructure, vegetation, and sediment build-up, Grande Acres experiences residential lot, street, and structure flooding in nearly every rainfall event. Figures 1-5 illustrate the existing and proposed conditions inundation maps for the 2-, 5-, 10-, 25-, and 100-year storms, respectively. These maps illustrate the depth of flooding as follows: light blue represents a depth of 6 to 9 inches, blue 9 to 12 inches, green 1 to 1.5 feet, yellow 1.5 to 2 feet, orange 2 to 3 feet, and red more than 3 feet.

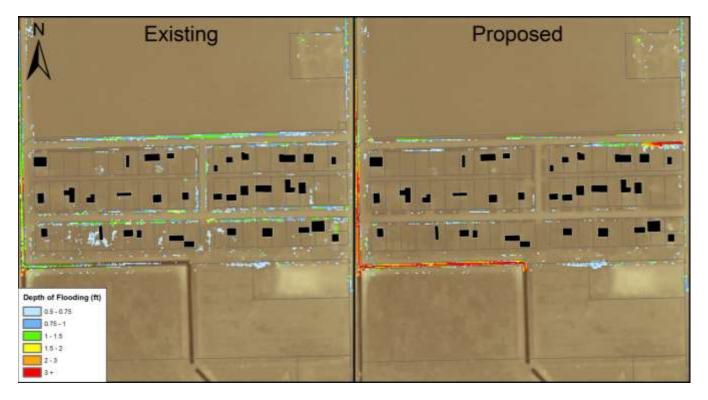
Figure 1: Existing and Proposed Conditions - 2-yr Storm Inundation Map

The goal of this study was to size the system to be capable of carrying up to the 10-Year storm runoff with no inundation in the colonia. However, some structures lie within low areas of the colonia and still show risk of flooding. When comparing the 6-inch inundation map for the 25- and 100-Year storms, it is observed that the inundation depths are lower than the existing conditions model, resulting in fewer structures at risk of being flooded once improvements are in place. Figures 1, 2, 3, 4, and 5 show the existing and proposed conditions inundation maps for the 2-, 5-, 10-, 25-, and 100-Yr storms respectively.

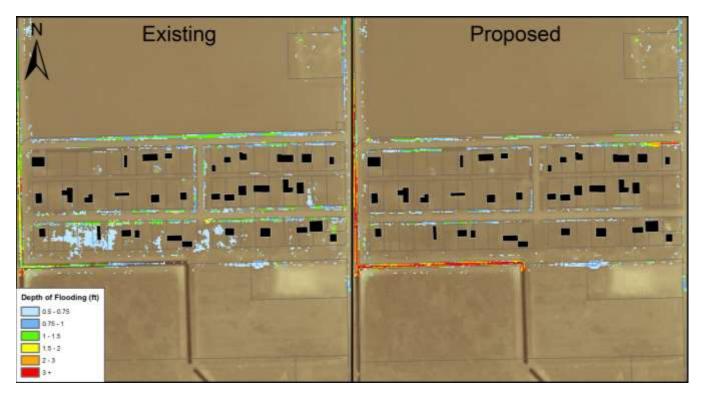
Figure 2: Existing and Proposed Conditions - 5-yr Storm Inundation Map

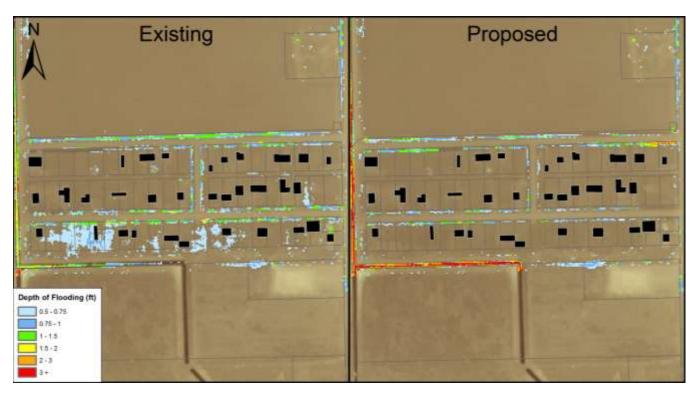
Figure 3: Existing and Proposed Conditions - 10-yr Storm Inundation Map

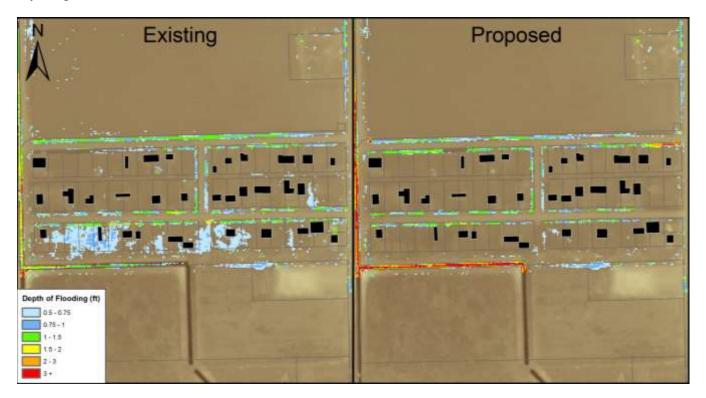
Figure 4: Existing and Proposed Conditions - 25-yr Storm Inundation Map

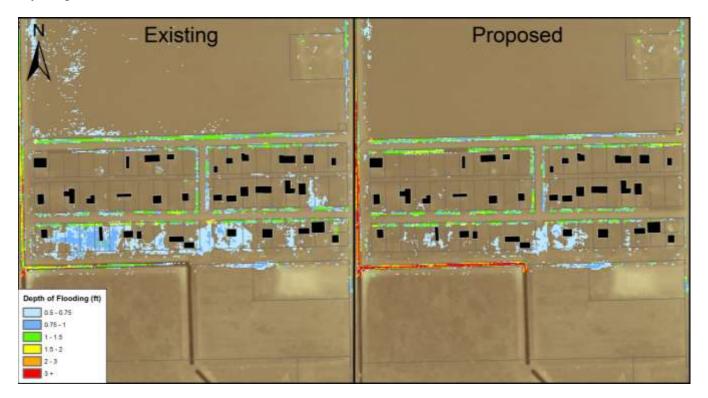
Figure 5: Existing and Proposed Conditions - 100-yr Storm Inundation Map

1% (100-Year) Flood Recurrence	Pre-Project	Post-Project	Removed
Inundated Structures	2	0	2
Inundated Lots	53	53	0
Inundated Roadway (LF)	0	0	0

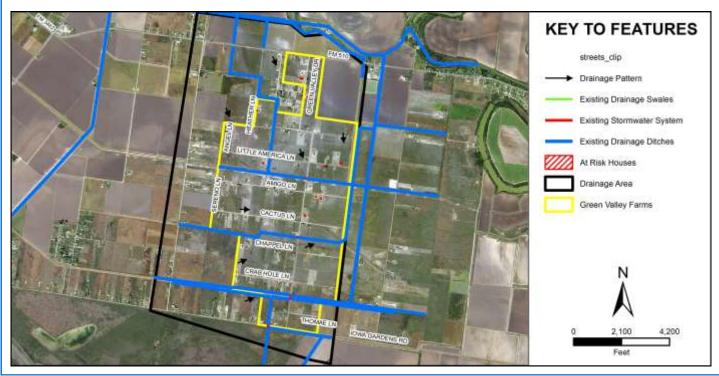
Drainage patterns within this 1,122-acre colonia are generally to the south and east. The existing drainage system consists of a small stormwater system, roadside swales, and drainage ditches that are generally undersized and restricted by sediment and vegetation. The county has recently bought the land for a retention pond in this area after a study was conducted over the drainage in this site. Green Valley Farms experiences residential lot, street, and structure flooding in nearly every rainfall event. Figures 1-5 illustrate the existing and proposed conditions inundation maps for the 2-, 5-, 10-, 25-, and 100-year storms, respectively. These maps illustrate the depth of flooding as follows: light blue represents a depth of 6 to 9 inches, blue 9 to 12 inches, green 1 to 1.5 feet, yellow 1.5 to 2 feet, orange 2 to 3 feet, and red more than 3 feet.

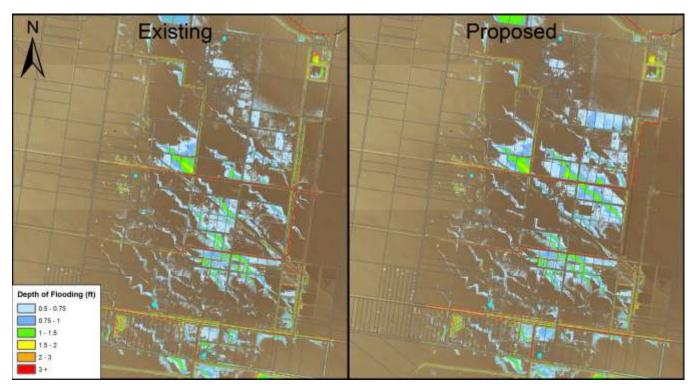
Figure 1: Existing and Proposed Conditions - 2-yr Storm Inundation Map

The goal of this study was to size the system to be capable of carrying up to the 10-Year storm runoff with no inundation in the colonia. However, some structures lie within low areas of the colonia and still show risk of flooding. When comparing the 6-inch inundation map for the 25- and 100-Year storms, it is observed that the inundation depths are lower than the existing conditions model, resulting in fewer structures at risk of being flooded once improvements are in place. Figures 1, 2, 3, 4, and 5 show the existing and proposed conditions inundation maps for the 2-, 5-, 10-, 25-, and 100-Yr storms respectively.

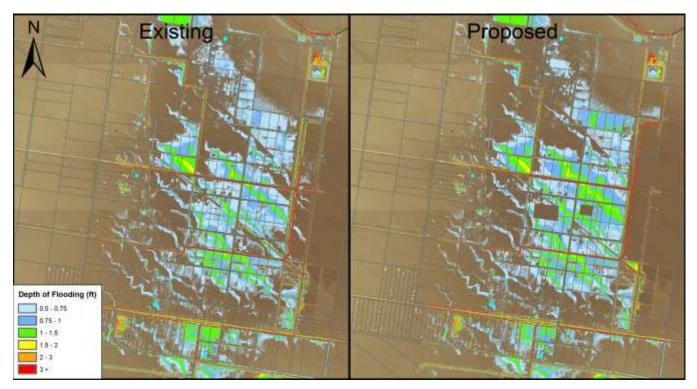
Figure 2: Existing and Proposed Conditions - 5-yr Storm Inundation Map

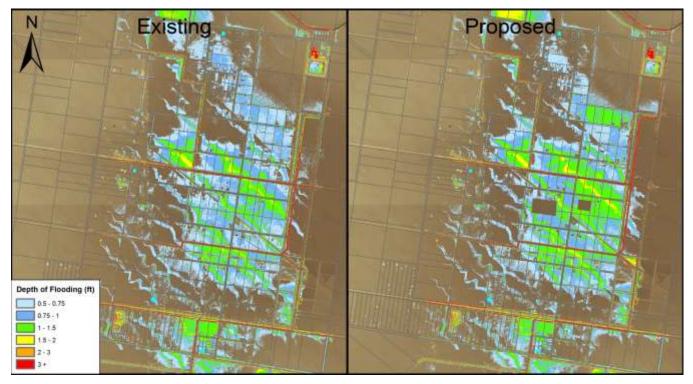
Figure 3: Existing and Proposed Conditions - 10-yr Storm Inundation Map

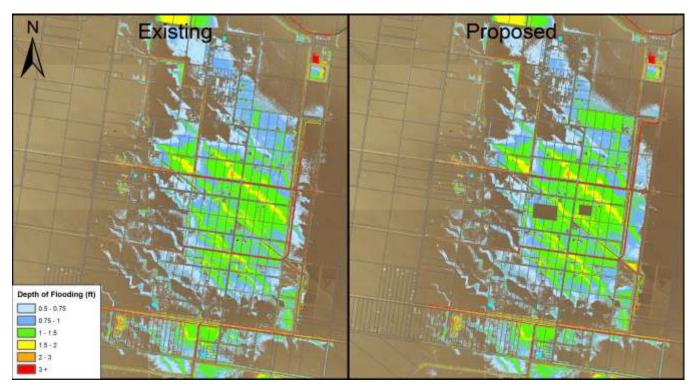
Figure 4: Existing and Proposed Conditions - 25-yr Storm Inundation Map

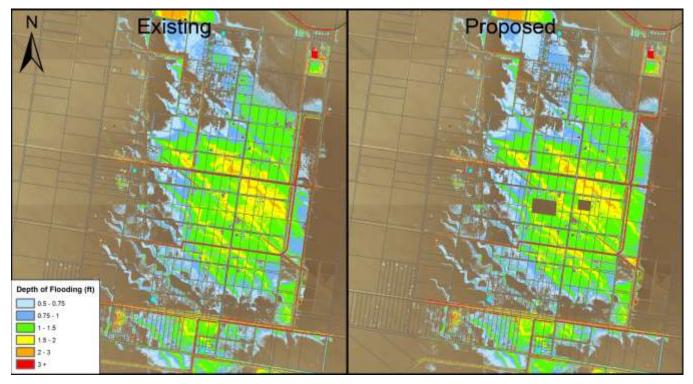
Figure 5: Existing and Proposed Conditions - 100-yr Storm Inundation Map

1% (100-Year) Flood Recurrence	Pre-Project	Post-Project	Removed
Inundated Structures	10	8	2
Inundated Lots	241	241	0
Inundated Roadway (LF)	7240	7240	0

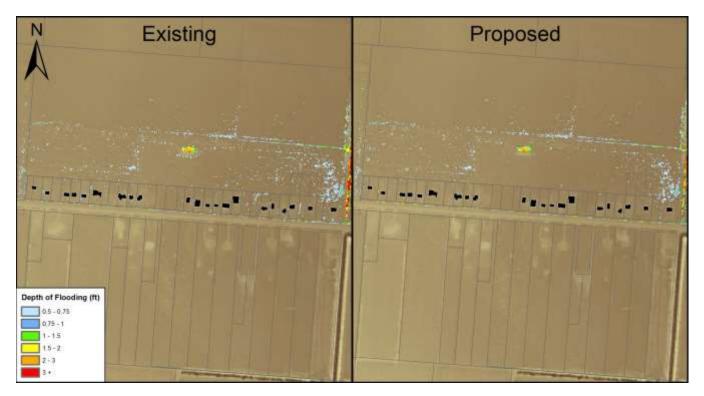
Figure 1: Existing and Proposed Conditions - 2-yr Storm Inundation Map

The goal of this study was to size the system to be capable of carrying up to the 10-Year storm runoff with no inundation in the colonia. However, some structures lie within low areas of the colonia and still show risk of flooding. When comparing the 6-inch inundation map for the 25- and 100-Year storms, it is observed that the inundation depths are lower than the existing conditions model, resulting in fewer structures at risk of being flooded once improvements are in place. Figures 1, 2, 3, 4, and 5 show the existing and proposed conditions inundation maps for the 2-, 5-, 10-, 25-, and 100-Yr storms respectively.

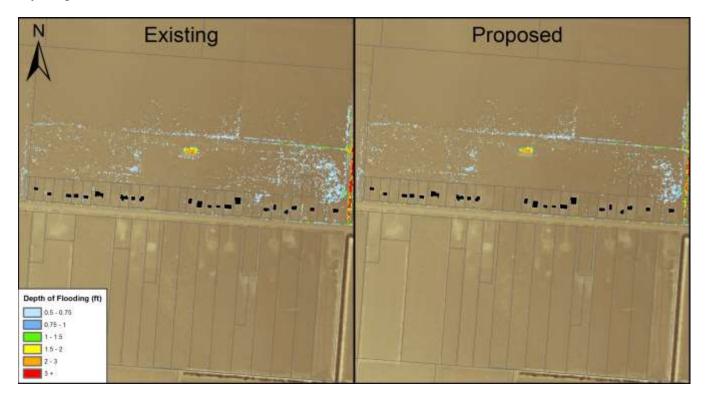
Figure 2: Existing and Proposed Conditions - 5-yr Storm Inundation Map

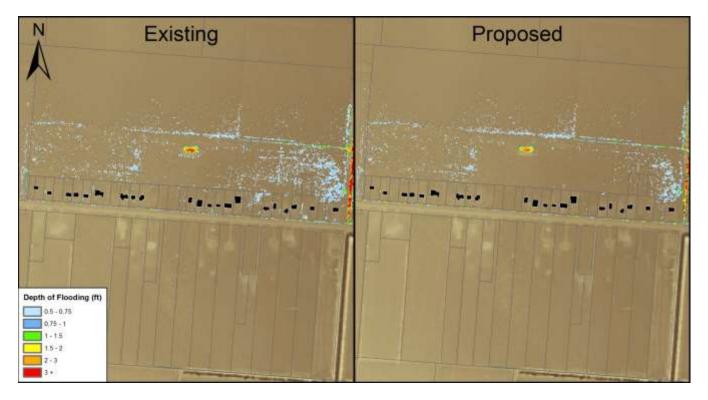
Figure 3: Existing and Proposed Conditions - 10-yr Storm Inundation Map

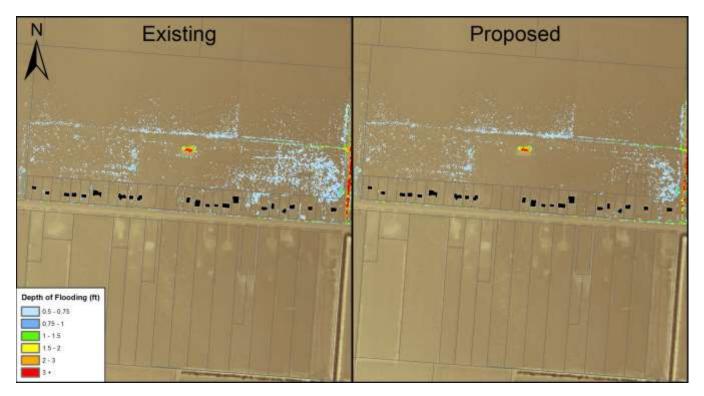
Figure 4: Existing and Proposed Conditions - 25-yr Storm Inundation Map

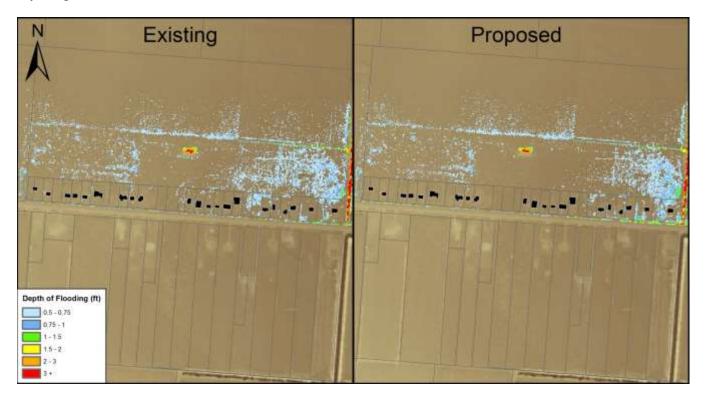
Figure 5: Existing and Proposed Conditions - 100-yr Storm Inundation Map

1% (100-Year)	(100-Year) Pre-Project Post-Project		Removed
Flood Recurrence	The Project	r ost i roject	Removed
Inundated Structures	2	1	1
Inundated Lots	27	24	3
Inundated Roadway (LF)	270	5	265

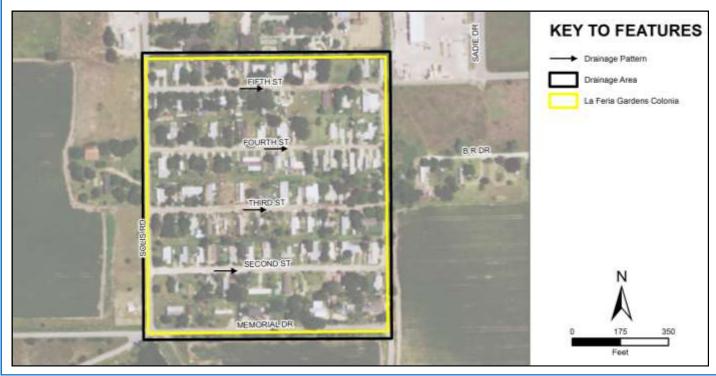
Drainage patterns within this 20-acre colonia are generally from the higher ground on the western half of the colonia to the lower eastern half. While the colonia currently consists entirely of mobile homes elevated above 100-year flood depths, the colonia does not have an existing drainage system and experiences residential lot and street flooding in nearly every rainfall event. Figures 1-5 illustrate the existing and proposed conditions inundation maps for the 2-, 5-, 10-, 25-, and 100-year storms, respectively. These maps illustrate the depth of flooding as follows: light blue represents a depth of 6 to 9 inches, blue 9 to 12 inches, green 1 to 1.5 feet, yellow 1.5 to 2 feet, orange 2 to 3 feet, and red more than 3 feet.
