STORMWATER DRAINAGE PLANNING

The Colonias of the Lower Rio Grande Valley (LRGV)

Phase 2 Report

JSW & Associates, Inc. Hazard Mitigation Consultants

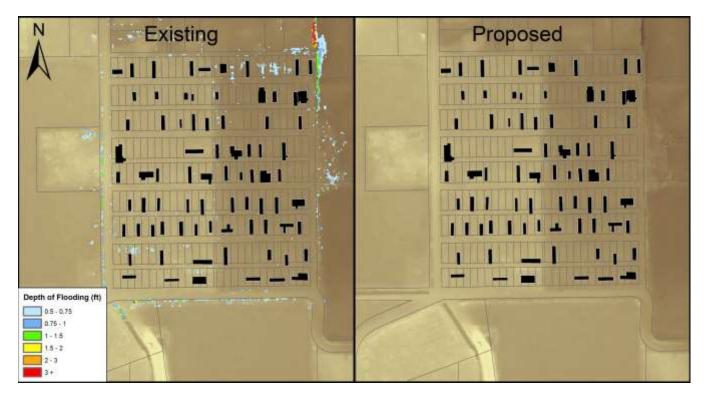
Figure 1: Existing and Proposed Conditions - 2-yr Storm Inundation Map

The goal of this study was to size the system to be capable of carrying up to the 10-Year storm runoff with no inundation in the colonia. However, some structures lie within low areas of the colonia and still show risk of flooding. When comparing the 6-inch inundation map for the 25- and 100-Year storms, it is observed that the inundation depths are lower than the existing conditions model, resulting in less overall ponding and the street is at lower risk of being flooded once improvements are in place. Figures 1, 2, 3, 4, and 5 show the existing and proposed conditions inundation maps for the 2-, 5-, 10-, 25-, and 100-Yr storms respectively.

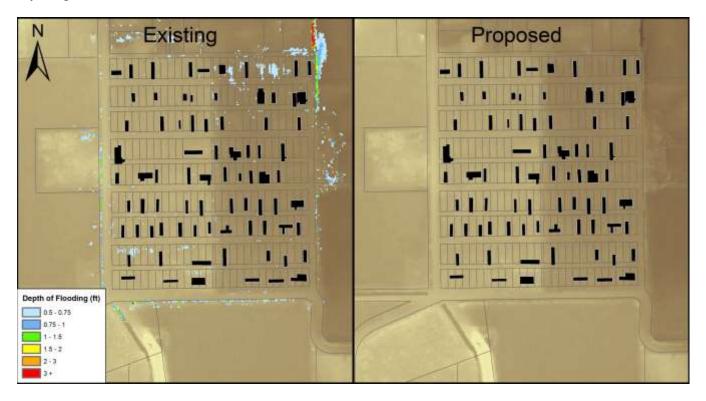
Figure 2: Existing and Proposed Conditions - 5-yr Storm Inundation Map

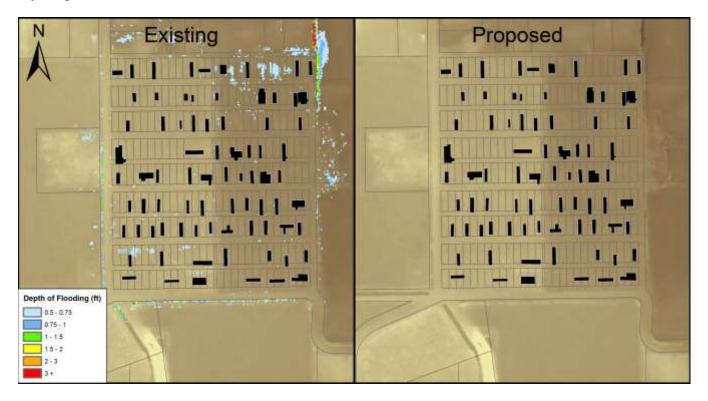
Figure 3: Existing and Proposed Conditions - 10-yr Storm Inundation Map

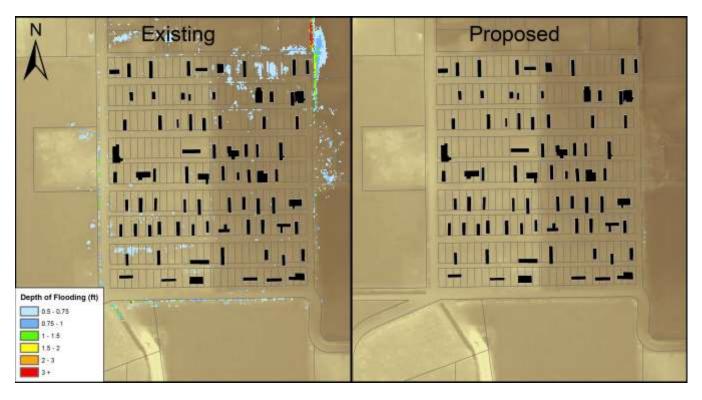
Figure 4: Existing and Proposed Conditions - 25-yr Storm Inundation Map

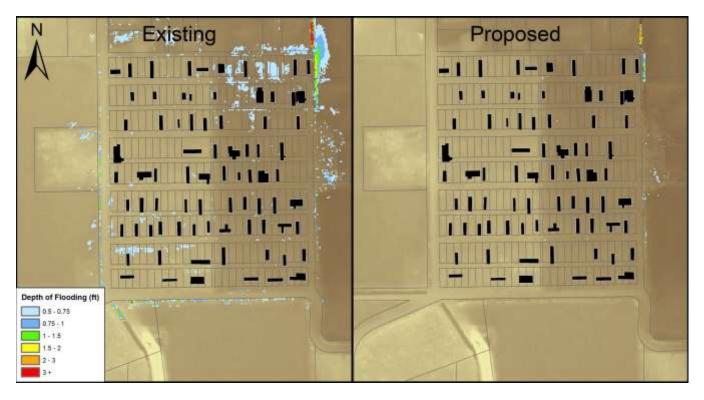
Figure 5: Existing and Proposed Conditions - 100-yr Storm Inundation Map

1% (100-Year) Flood Recurrence	Pre-Project	Post-Project	Removed
Inundated Structures	0	0	0
Inundated Lots	93	2	91
Inundated Roadway (LF)	70	0	70

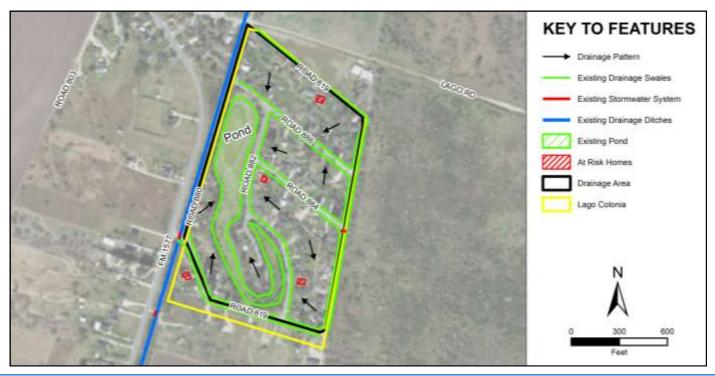
Drainage patterns within this 35-acre colonia are generally towards the west of the colonia, where there is an existing pond. The pond is about 5 acres, highly vegetated, and is in the FEMA Zone A 100-year floodplain. The colonia has an existing roadside drainage system. Due to inadequate conveyance of stormwater, Lago experiences residential lot and street flooding in nearly every rainfall event. Figures 1-5 illustrate the existing and proposed conditions inundation maps for the 2-, 5-, 10-, 25-, and 100-year storms, respectively. These maps illustrate the depth of flooding as follows: light blue represents a depth of 6 to 9 inches, blue 9 to 12 inches, green 1 to 1.5 feet, yellow 1.5 to 2 feet, orange 2 to 3 feet, and red more than 3 feet.

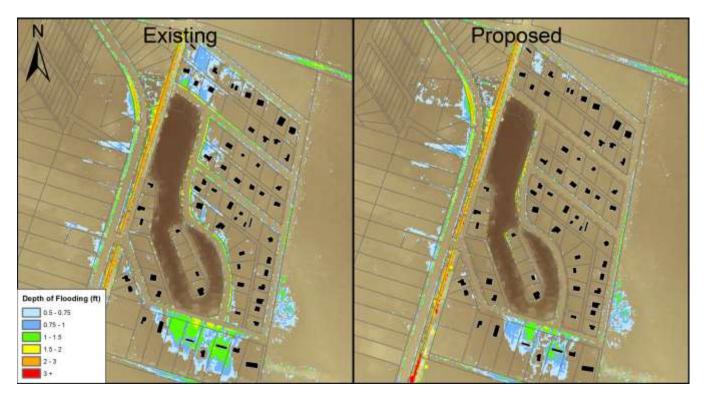
Figure 1: Existing and Proposed Conditions - 2-yr Storm Inundation Map

The goal of this study was to size the system to be capable of carrying up to the 10-Year storm runoff with no inundation in the colonia. However, some structures lie within low areas of the colonia and still show risk of flooding. When comparing the 6-inch inundation map for the 25- and 100-Year storms, it is observed that the inundation depths are lower than the existing conditions model, resulting in fewer structures at risk of being flooded once improvements are in place. Figures 1, 2, 3, 4, and 5 show the existing and proposed conditions inundation maps for the 2-, 5-, 10-, 25-, and 100-Yr storms respectively.

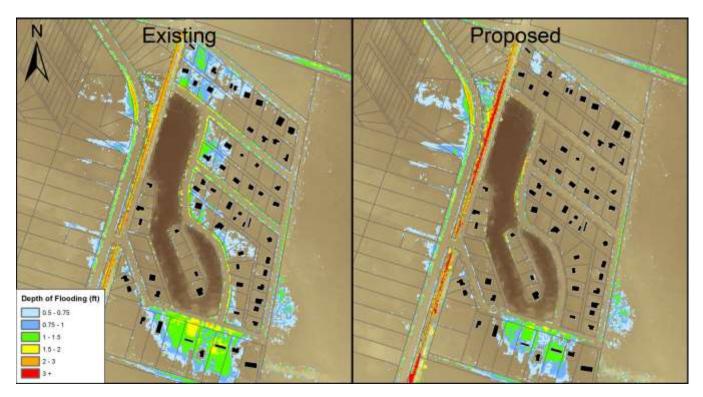
Figure 2: Existing and Proposed Conditions - 5-yr Storm Inundation Map

20% (5-Year)	Pre-Project	Post-Project	Removed
Flood Recurrence	Fierrioject	rost-rroject	Removed
Inundated Structures	0	0	0
Inundated Lots	77	63	14
Inundated Roadway (LF)	10	0	10

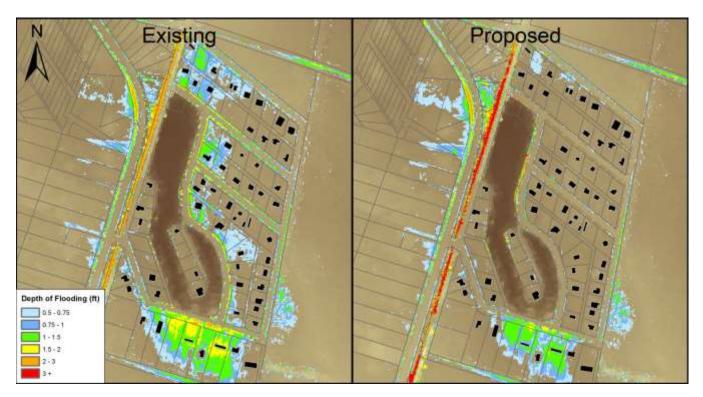
Figure 3: Existing and Proposed Conditions - 10-yr Storm Inundation Map

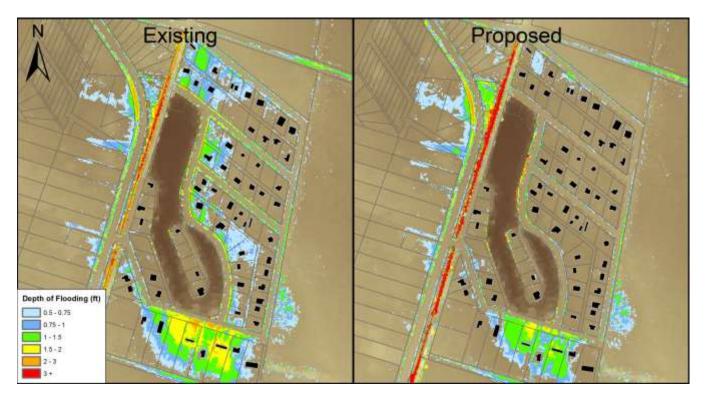
Figure 4: Existing and Proposed Conditions - 25-yr Storm Inundation Map

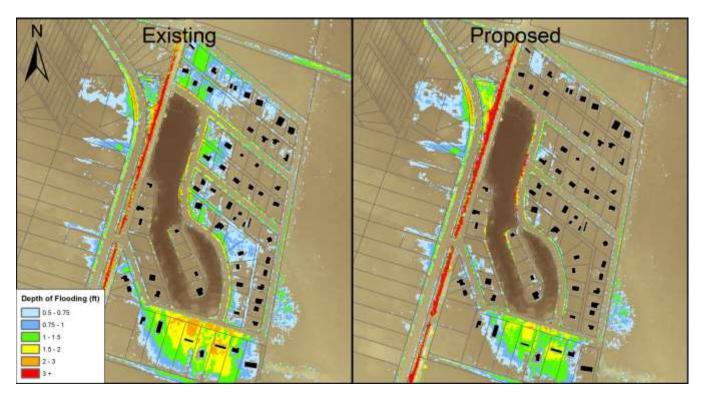
Figure 5: Existing and Proposed Conditions - 100-yr Storm Inundation Map

1% (100-Year)	Pre-Project	Post-Project	Removed
Flood Recurrence	rie-rioject	rost-rroject	Removed
Inundated Structures	4	0	4
Inundated Lots	79	70	9
Inundated Roadway (LF)	10	0	10

- 1. The number of inundated structures are based strictly on finished floor elevations compared to computed water surface elevations.
- 2. The inundation maps above only display flooding depths greater than 6 inches.
- 3. The number of inundated lots are based strictly on the inundation maps above and therefore do not count as inundated if the depth of flooding is less than 6 inches.

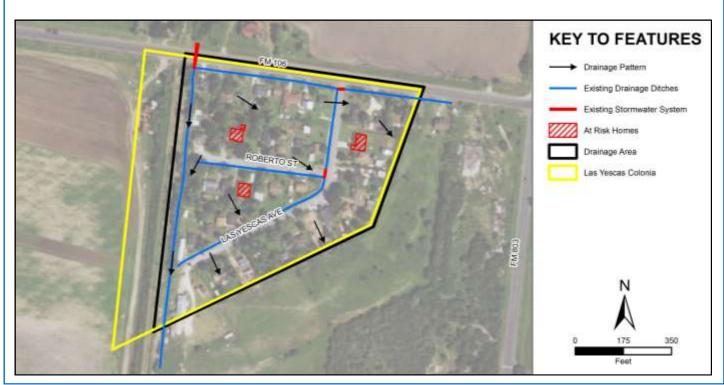
Drainage patterns within this 16-acre colonia are generally from the northwest to the south and southeast. This colonia is located entirely within the FEMA Zone AH 100-year floodplain. The colonia does not have adequate roadside swale conveyance and frequently experiences residential lot and street flooding, as well as some structural flooding during significant regional storm events. Model results indicate that high-risk flooding areas exist throughout the very flat terrain of the colonia. Figures 1-5 illustrate the existing and proposed conditions inundation maps for the 2-, 5-, 10-, 25-, and 100-year storms, respectively. These maps illustrate the depth of flooding as follows: light blue represents a depth of 6 to 9 inches, blue 9 to 12 inches, green 1 to 1.5 feet, yellow 1.5 to 2 feet, orange 2 to 3 feet, and red more than 3 feet.

A two-dimensional hydrodynamic model of the Las Yescas colonia was built using the software program InfoWorks ICM. The model integrates hydrologic and hydraulic modeling and simulates the interactions of the storm drain system and the movement of overland flow using a three-dimensional digital terrain model of the existing ground surface. This report assesses the adequacy and capacity of the existing drainage system and recommends system improvements that will provide protection from flooding for up to the 10-year storm. Rainfall-runoff simulations were conducted for the 2-, 5-, 10-, 25-, and 100-year storm events. Please refer to the Localized Analysis Document for modeling and mapping methodology and assumptions.

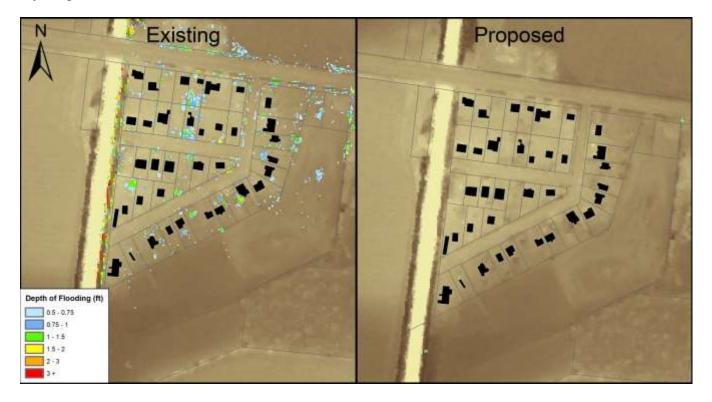
Figure 1: Existing and Proposed Conditions - 2-yr Storm Inundation Map

50% (2-Year)	Pre-Project	Post-Project	Removed
Flood Recurrence	Fierrioject	rost-rroject	Kellioveu
Inundated Structures	3	0	3
Inundated Lots	39	0	39
Inundated Roadway (LF)	0	0	0

To reduce local flooding potential, the recommended project includes an underground drainage system with a retention facility. The improvements include 630 linear feet of 18-inch diameter pipe, 590 linear feet of 24-inch diameter pipe, 340 feet of 30-inch diameter pipe, pavement and curb/gutter for 1,320 linear feet of roadway, 8 curb inlets, and two 60-inch manholes. The project also include excavation and grading of the perimeter swales along FM 106 and the west side of the colonia to improve drainage from perimeter home lots. The proposed retention pond is sized to retain onsite runoff up to the 25-year storm with a total effective storage area of 8 acre-feet.

The goal of this study was to size the system to be capable of carrying up to the 10-Year storm runoff with no inundation in the colonia. However, some structures lie within low areas of the colonia and still show risk of flooding. When comparing the 6-inch inundation map for the 25- and 100-Year storms, it is observed that the inundation depths are lower than the existing conditions model, resulting in fewer structures at risk of being flooded once improvements are in place. Figures 1, 2, 3, 4, and 5 show the existing and proposed conditions inundation maps for the 2-, 5-, 10-, 25-, and 100-Yr storms respectively.

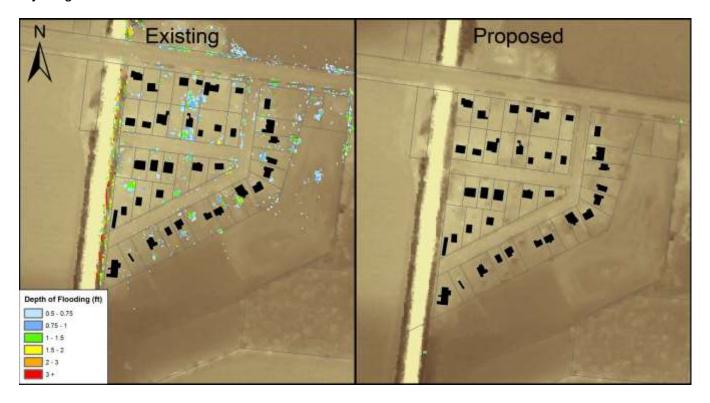
Figure 2: Existing and Proposed Conditions - 5-yr Storm Inundation Map

20% (5-Year)	Pre-Project	Post-Project	Removed
Flood Recurrence	rie-rioject	rost-rroject	Removed
Inundated Structures	3	0	3
Inundated Lots	39	0	39
Inundated Roadway (LF)	0	0	0

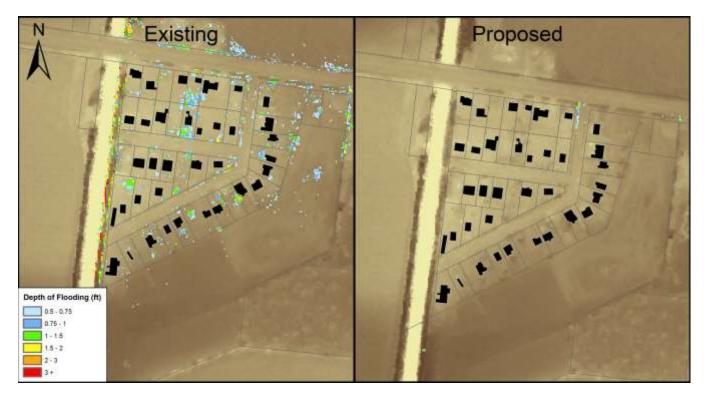
Figure 3: Existing and Proposed Conditions - 10-yr Storm Inundation Map

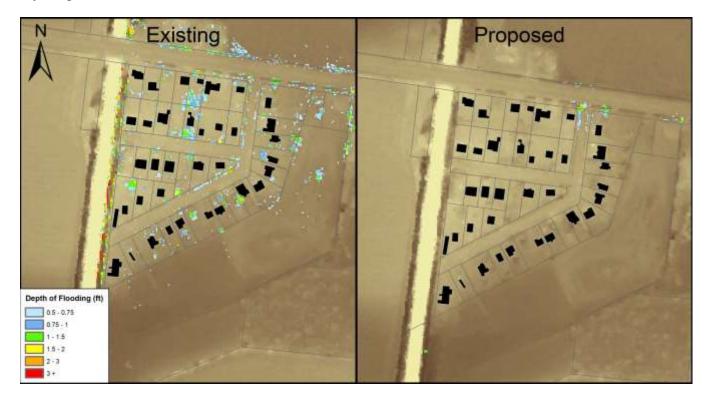
Figure 4: Existing and Proposed Conditions - 25-yr Storm Inundation Map

4% (25-Year)	Pre-Project	Post-Project	Removed
Flood Recurrence	rie-rioject	rost-rroject	Removed
Inundated Structures	3	0	3
Inundated Lots	39	2	37
Inundated Roadway (LF)	21	20	1

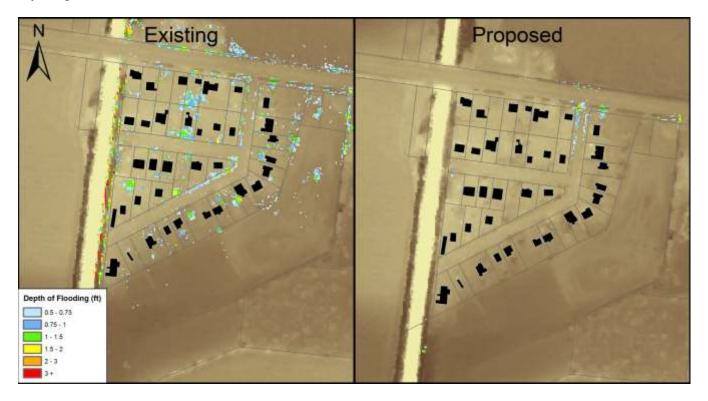
Figure 5: Existing and Proposed Conditions - 100-yr Storm Inundation Map

1% (100-Year)	Pre-Project	Post-Project	Removed
Flood Recurrence			
Inundated Structures	3	0	3
Inundated Lots	39	2	37
Inundated Roadway (LF)	26	26	0

- 1. The number of inundated structures are based strictly on finished floor elevations compared to computed water surface elevations.
- 2. The inundation maps above only display flooding depths greater than 6 inches.
- 3. The number of inundated lots are based strictly on the inundation maps above and therefore do not count as inundated if the depth of flooding is less than 6 inches.

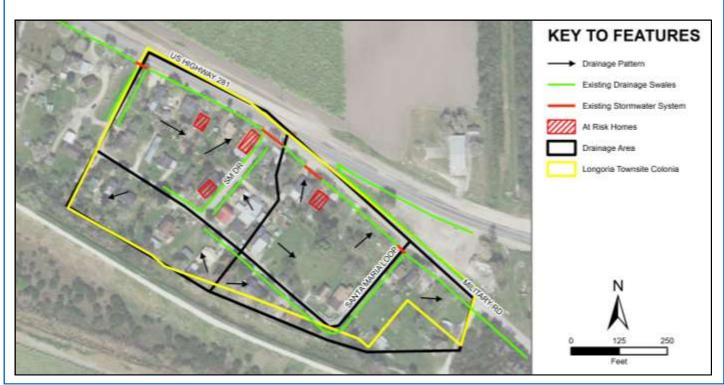
Drainage patterns within this 9-acre colonia are northerly in general, however, conveyance patterns vary within the colonia due to flat terrain. The colonia has an existing roadside swale drainage system, and a very small amount of underground storm drain system. Longoria Townsite does not have the infrastructure to adequately convey stormwater runoff and therefore experiences residential lot, street, and structure flooding in nearly every rainfall event. Figures 1-5 illustrate the existing and proposed conditions inundation maps for the 2-, 5-, 10-, 25-, and 100-year storms, respectively. These maps illustrate the depth of flooding as follows: light blue represents a depth of 6 to 9 inches, blue 9 to 12 inches, green 1 to 1.5 feet, yellow 1.5 to 2 feet, orange 2 to 3 feet, and red more than 3 feet.

A two-dimensional hydrodynamic model of the Longoria Townsite colonia was built using the software program InfoWorks ICM. The model integrates hydrologic and hydraulic modeling and simulates the interactions of the storm drain system and the movement of overland flow using a three-dimensional digital terrain model of the existing ground surface. This report assesses the adequacy and capacity of the existing drainage system and recommends system improvements that will provide protection from flooding for up to the 10-year storm. Rainfall-runoff simulations were conducted for the 2-, 5-, 10-, 25-, and 100-year storm events. Please refer to the Localized Analysis Document for modeling and mapping methodology and assumptions.

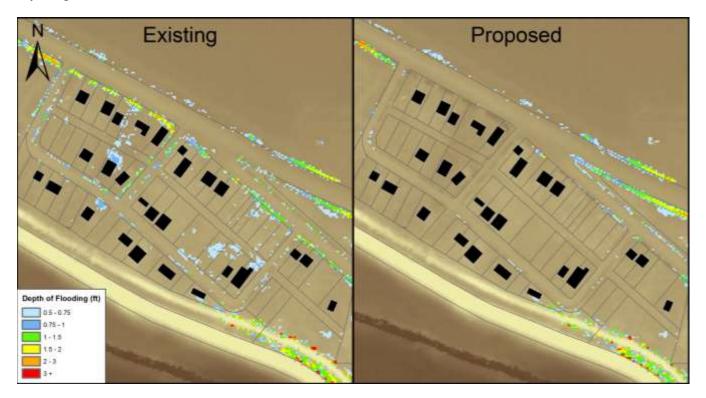
Figure 1: Existing and Proposed Conditions - 2-yr Storm Inundation Map

To reduce local flooding potential, the recommended project includes an underground drainage system with a retention facility to mitigate off-site impacts. The improvements include 665 linear feet of 18-inch diameter pipe, 360 linear feet of 24 -inch diameter pipe, pavement and curb/gutter for 2,300 linear feet of curb and gutter, 8 curb inlets, and associated pavements improvements. The proposed retention pond is sized to retain on-site runoff up to the 25-year storm with a total effective storage area of 6.6 acre-feet.

The goal of this study was to size the system to be capable of carrying up to the 10-Year storm runoff with no inundation in the colonia. However, some structures lie within low areas of the colonia and still show risk of flooding. When comparing the 6-inch inundation map for the 25- and 100-Year storms, it is observed that the inundation depths are lower than the existing conditions model, resulting in fewer structures at risk of being flooded once improvements are in place. Figures 1, 2, 3, 4, and 5 show the existing and proposed conditions inundation maps for the 2-, 5-, 10-, 25-, and 100-Yr storms respectively.

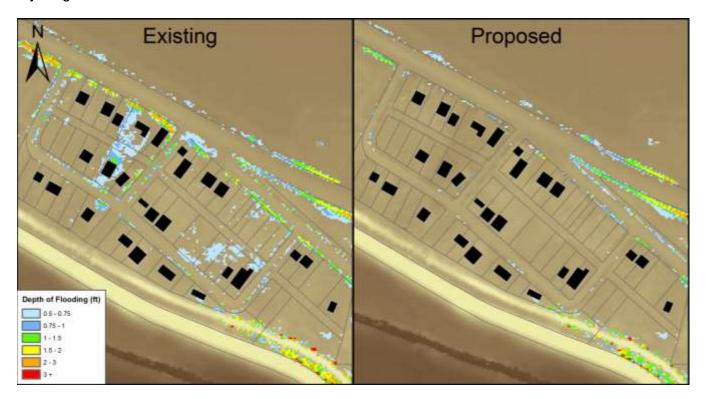
Figure 2: Existing and Proposed Conditions - 5-yr Storm Inundation Map

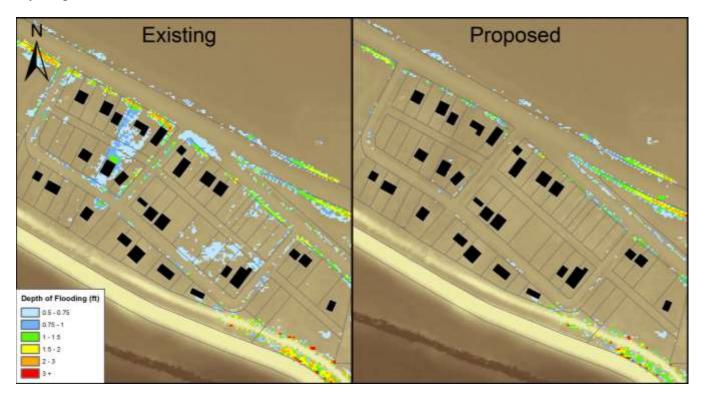
Figure 3: Existing and Proposed Conditions - 10-yr Storm Inundation Map

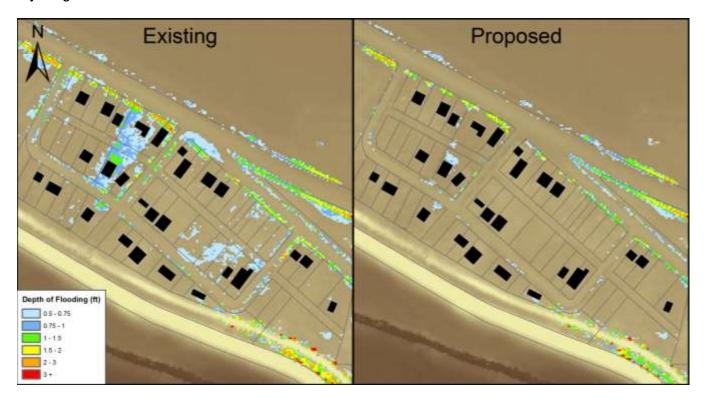
Figure 4: Existing and Proposed Conditions - 25-yr Storm Inundation Map

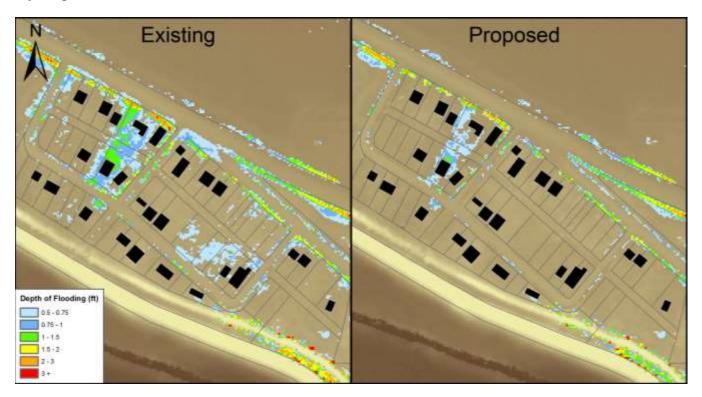
Figure 5: Existing and Proposed Conditions - 100-yr Storm Inundation Map

1% (100-Year) Flood Recurrence	Pre-Project	Post-Project	Removed
Inundated Structures	4	2	4
Inundated Lots	43	27	16
Inundated Roadway (LF)	0	0	0

- 1. The number of inundated structures are based strictly on finished floor elevations compared to computed water surface elevations.
- 2. The inundation maps above only display flooding depths greater than 6 inches.
- 3. The number of inundated lots are based strictly on the inundation maps above and therefore do not count as inundated if the depth of flooding is less than 6 inches.

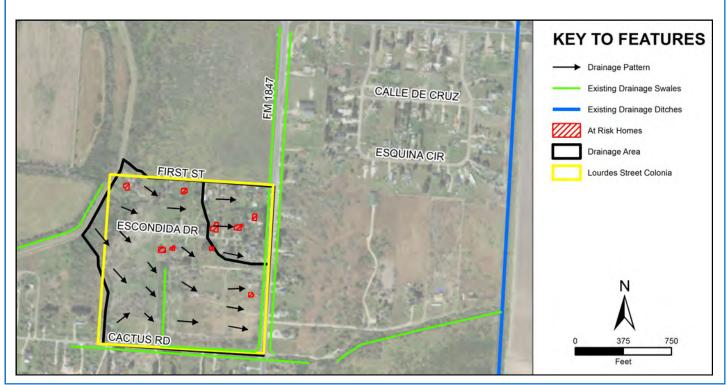
Drainage patterns within this 37-acre colonia are generally from the west to east towards FM 1847. The entire colonia is located within the FEMA 100-year floodplain. The highest concentration of habitable structures is located in the northern portion of the colonia. Homes located in this area have the highest risk of inundation. The colonia does not have adequate roadside ditch conveyance and frequently experiences residential lot and street flooding, as well as some structural flooding from local events. Culverts under driveways are either non-existent, damaged, or undersized. The colonia also lacks a proper lateral ditch connection to a Drainage District 4 drain located southeast of the colonia. Figures 1-5 illustrate the existing and proposed conditions inundation maps for the 2-, 5-, 10-, 25-, and 100-year storms, respectively. These maps illustrate the depth of flooding as follows: light blue represents a depth of 6 to 9 inches, blue 9 to 12 inches, green 1 to 1.5 feet, yellow 1.5 to 2 feet, orange 2 to 3 feet, and red more than 3 feet.

A two-dimensional hydrodynamic model of the Lourdes Street colonia was built using the software program InfoWorks ICM. The model integrates hydrologic and hydraulic modeling and simulates the interactions of the storm drain system and the movement of overland flow using a three-dimensional digital terrain model of the existing ground surface. This report assesses the adequacy and capacity of the existing drainage system and recommends system improvements that will provide protection from flooding for up to the 10-year storm. Rainfall-runoff simulations were conducted for the 2-, 5-, 10-, 25-, and 100-year storm events. Please refer to the Localized Analysis Document for modeling and mapping methodology and assumptions.

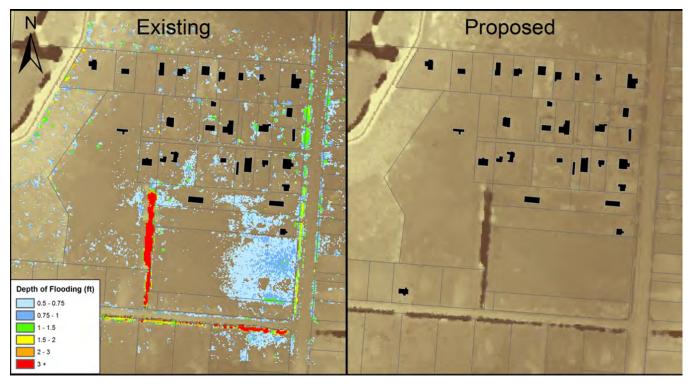
Figure 1: Existing and Proposed Conditions - 2-yr Storm Inundation Map

To reduce local flooding potential, the recommended project includes roadside ditch and driveway culvert improvements along First St., Escondida Dr., Cactus Rd. and FM 1847. The improvements include 820 linear feet of 18 inch driveway culverts and 1,528 linear feet of ditch excavation and grading along First St., Escondida Dr., Cactus Rd., and FM 1847. In addition, construction of 1,900 linear feet of grassy swales between homes are proposed in order to allow drainage to the roadside swales. The proposed retention ponds are sized to retain onsite runoff up to the 25-year storm with a total effective storage area of 24 acre-feet.

The goal of this study was to size the system to be capable of carrying up to the 10-Year storm runoff with no inundation in the colonia. However, some structures lie within low areas of the colonia and still show risk of flooding. When comparing the 6-inch inundation map for the 25- and 100-Year storms, it is observed that the inundation depths are lower than the existing conditions model, resulting in fewer structures at risk of being flooded once improvements are in place. Figures 1, 2, 3, 4, and 5 show the existing and proposed conditions inundation maps for the 2-, 5-, 10-, 25-, and 100-Yr storms respectively.

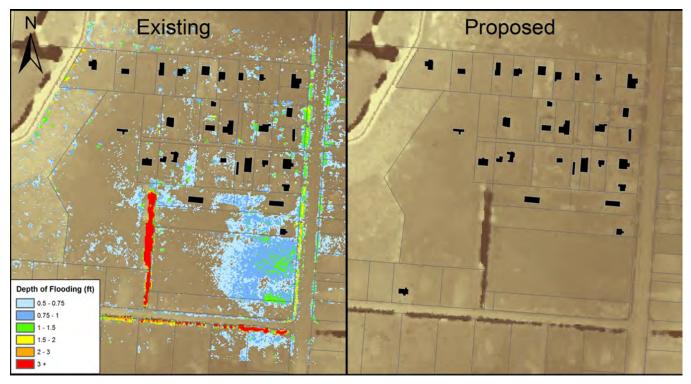
Figure 2: Existing and Proposed Conditions - 5-yr Storm Inundation Map

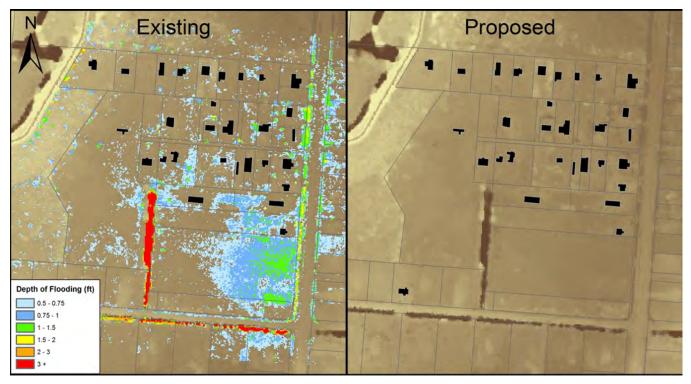
Figure 3: Existing and Proposed Conditions - 10-yr Storm Inundation Map

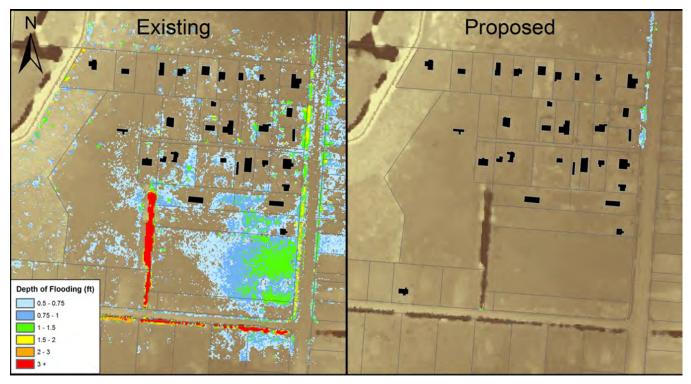
Figure 4: Existing and Proposed Conditions - 25-yr Storm Inundation Map

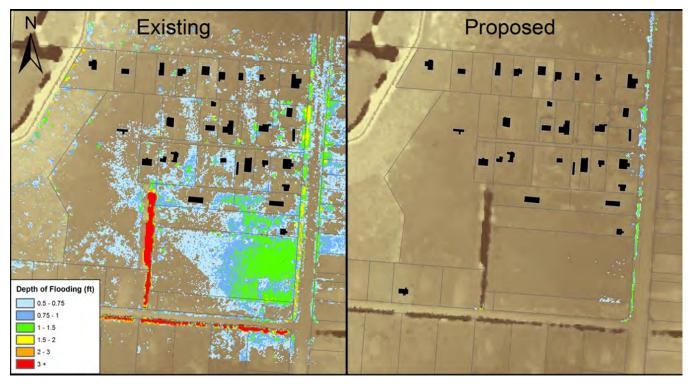
Figure 5: Existing and Proposed Conditions - 100-yr Storm Inundation Map

1% (100-Year) Flood Recurrence	Pre-Project	Post-Project	Removed
Inundated Structures	9	1	8
Inundated Lots	37	8	29
Inundated Roadway (LF)	740	2	738

- 1. The number of inundated structures are based strictly on finished floor elevations compared to computed water surface elevations.
- 2. The inundation maps above only display flooding depths greater than 6 inches.
- 3. The number of inundated lots are based strictly on the inundation maps above and therefore do not count as inundated if the depth of flooding is less than 6 inches.

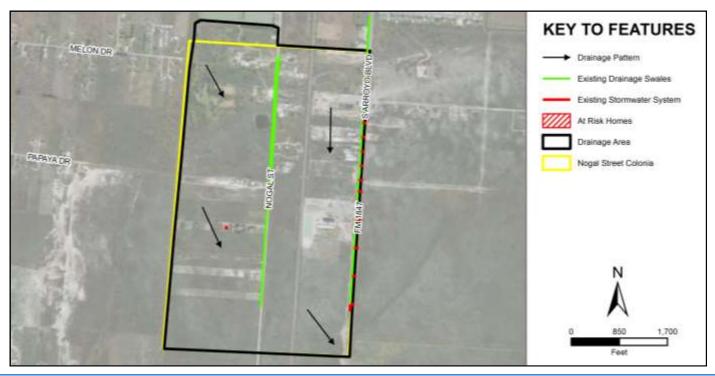
Drainage patterns within this 403-acre colonia are generally southeasterly. More than 90% of the Nogal Street colonia is located within the FEMA Zone AH 100-year floodplain. The colonia has an existing roadside drainage system, and pipe culverts that cross under FM 1847. Nogal Street experiences residential lot and street flooding in nearly every rainfall event. Figures 1-5 illustrate the existing and proposed conditions inundation maps for the 2-, 5-, 10-, 25-, and 100-year storms, respectively. These maps illustrate the depth of flooding as follows: light blue represents a depth of 6 to 9 inches, blue 9 to 12 inches, green 1 to 1.5 feet, yellow 1.5 to 2 feet, orange 2 to 3 feet, and red more than 3 feet.

A two-dimensional hydrodynamic model of the Nogal Street colonia was built using the software program InfoWorks ICM. The model integrates hydrologic and hydraulic modeling and simulates the interactions of the storm drain system and the movement of overland flow using a three-dimensional digital terrain model of the existing ground surface. This report assesses the adequacy and capacity of the existing drainage system and recommends system improvements that will provide protection from flooding for up to the 10-year storm. Rainfall-runoff simulations were conducted for the 2-, 5-, 10-, 25-, and 100-year storm events. Please refer to the Localized Analysis Document for modeling and mapping methodology and assumptions.

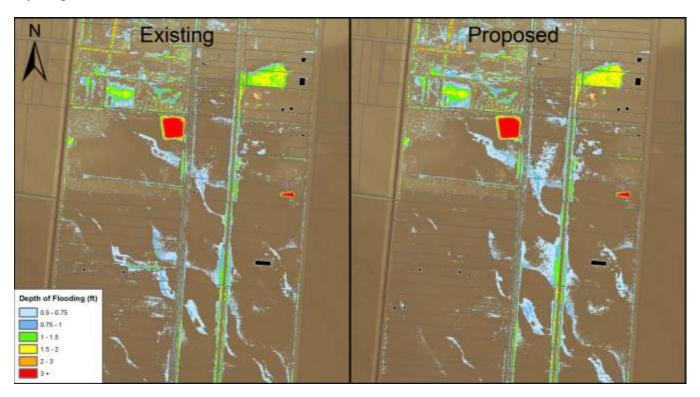
Figure 1: Existing and Proposed Conditions - 2-yr Storm Inundation Map

To reduce local flooding potential, the recommended project includes a roadside drainage system improvements and the addition of a retention facility to mitigate off-site impacts. The improvements include 2,300 linear feet of ditch excavation and grading, 45 linear feet of 36-inch diameter pipe, four 36-inch safety end treatments, and 3,800 linear feet of grassy swales between homes in order to allow drainage to roadside swales. The proposed retention pond is sized to retain on-site runoff up to the 25-year storm with a total effective storage area of 31.5 acre-feet.

The goal of this study was to size the system to be capable of carrying up to the 10-Year storm runoff with no inundation in the colonia. However, some structures lie within low areas of the colonia and still show risk of flooding. When comparing the 6-inch inundation map for the 25- and 100-Year storms, it is observed that the inundation depths are lower than the existing conditions model, resulting in fewer structures at risk of being flooded once improvements are in place. Figures 1, 2, 3, 4, and 5 show the existing and proposed conditions inundation maps for the 2-, 5-, 10-, 25-, and 100-Yr storms respectively.

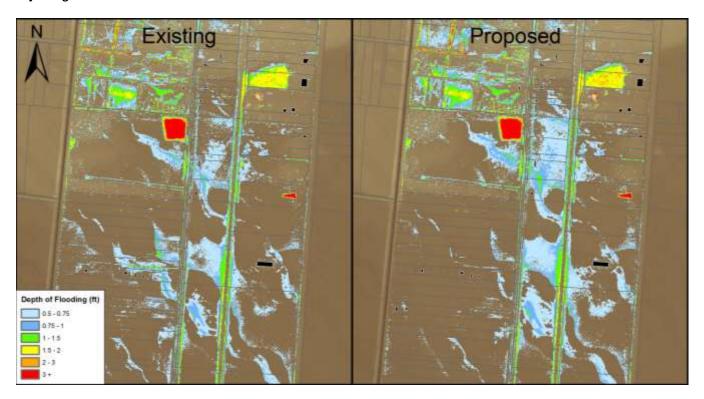
Figure 2: Existing and Proposed Conditions - 5-yr Storm Inundation Map

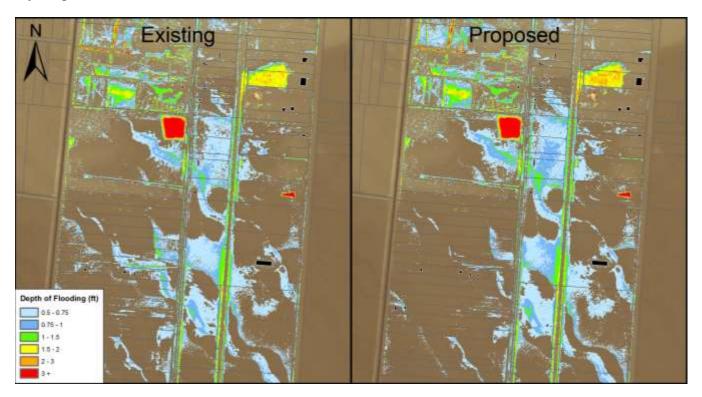
Figure 3: Existing and Proposed Conditions - 10-yr Storm Inundation Map

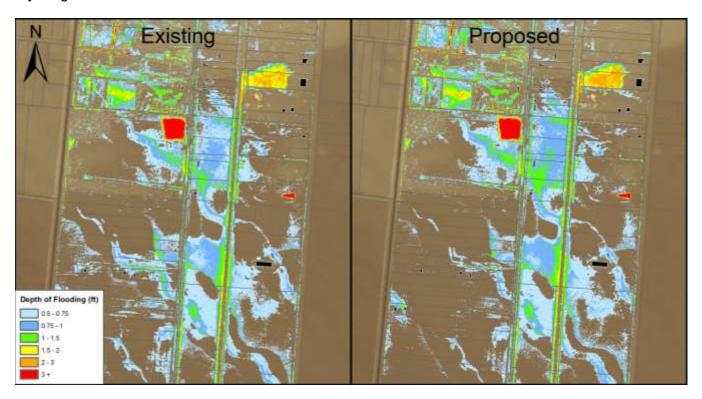
Figure 4: Existing and Proposed Conditions - 25-yr Storm Inundation Map

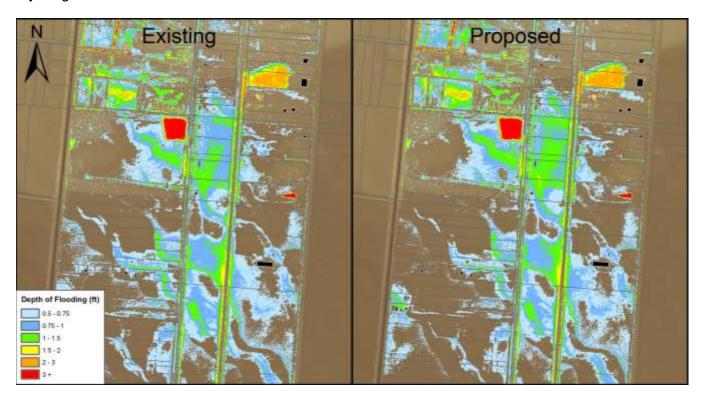
Figure 5: Existing and Proposed Conditions - 100-yr Storm Inundation Map

1% (100-Year) Flood Recurrence	Pre-Project	Post-Project	Removed
Inundated Structures	1	0	1
Inundated Lots	67	66	1
Inundated Roadway (LF)	1370	1370	0

- 1. The number of inundated structures are based strictly on finished floor elevations compared to computed water surface elevations.
- 2. The inundation maps above only display flooding depths greater than 6 inches.
- 3. The number of inundated lots are based strictly on the inundation maps above and therefore do not count as inundated if the depth of flooding is less than 6 inches.

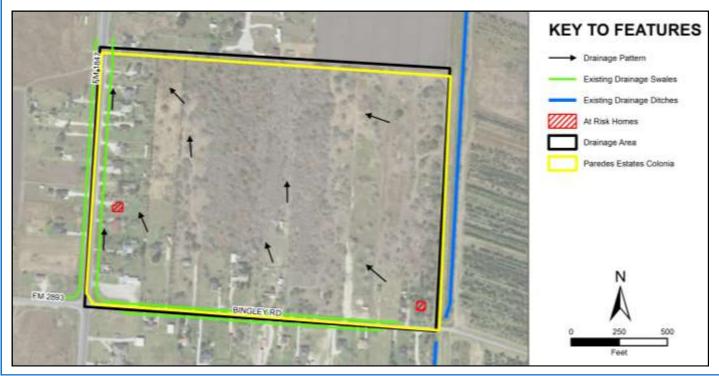
Drainage patterns within this 20-acre colonia are generally from the south to the north and northwest towards the existing regional drainage ditch approximately 1,200 feet north of the colonia along FM 1847. This colonia is located entirely within the FEMA Zone AE 100-year floodplain. The existing drainage system consists of roadside swales along Bingley Rd. and FM 1847; however, there are no direct connections to the regional drainage systems immediately east and northwest of the colonia. Model results show that high-risk areas exist throughout the very flat terrain of the colonia, especially within a large low-lying area behind homes near the center of the colonia. Figures 1-5 illustrate the existing and proposed conditions inundation maps for the 2-, 5-, 10-, 25-, and 100-year storms, respectively. These maps illustrate the depth of flooding as follows: light blue represents a depth of 6 to 9 inches, blue 9 to 12 inches, green 1 to 1.5 feet, yellow 1.5 to 2 feet, orange 2 to 3 feet, and red more than 3 feet.

A two-dimensional hydrodynamic model of the Paredes Estates colonia was built using the software program InfoWorks ICM. The model integrates hydrologic and hydraulic modeling and simulates the interactions of the storm drain system and the movement of overland flow using a three-dimensional digital terrain model of the existing ground surface. This report assesses the adequacy and capacity of the existing drainage system and recommends system improvements that will provide protection from flooding for up to the 10-year storm. Rainfall-runoff simulations were conducted for the 2-, 5-, 10-, 25-, and 100-year storm events. Please refer to the Localized Analysis Document for modeling and mapping methodology and assumptions

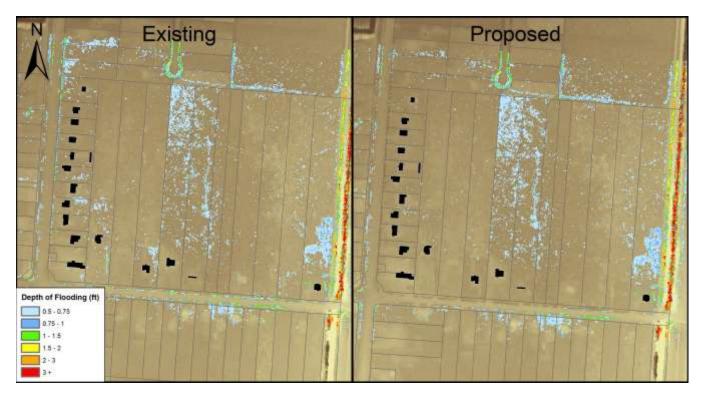
Figure 1: Existing and Proposed Conditions - 2-yr Storm Inundation Map

To reduce local flooding potential, the recommended project includes roadside swales and driveway culvert improvements with a retention facility. The improvements include 2,500 linear feet of swale excavation and grading along Bingley Rd. and FM 1847, 350 linear feet of 18-inch diameter driveway culverts, 100 linear feet of 36-inch diameter pipe, and 1,700 linear feet of grassy swales between homes in order to allow drainage to the roadside swales. The proposed retention pond is sized to retain onsite runoff up to the 25-year storm with a total effective storage area of 13 acre-feet.

The goal of this study was to size the system to be capable of carrying up to the 10-Year storm runoff with no inundation in the colonia. However, some structures lie within low areas of the colonia and still show risk of flooding. When comparing the 6-inch inundation map for the 25- and 100-Year storms, it is observed that the inundation depths are lower than the existing conditions model, resulting in fewer structures at risk of being flooded once improvements are in place. Figures 1, 2, 3, 4, and 5 show the existing and proposed conditions inundation maps for the 2-, 5-, 10-, 25-, and 100-Yr storms respectively.

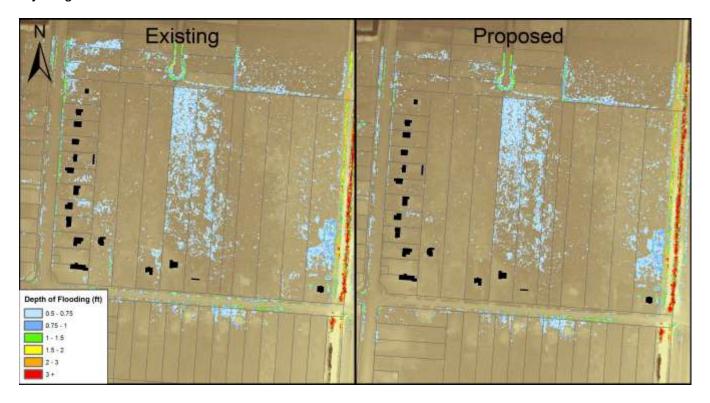
Figure 2: Existing and Proposed Conditions - 5-yr Storm Inundation Map

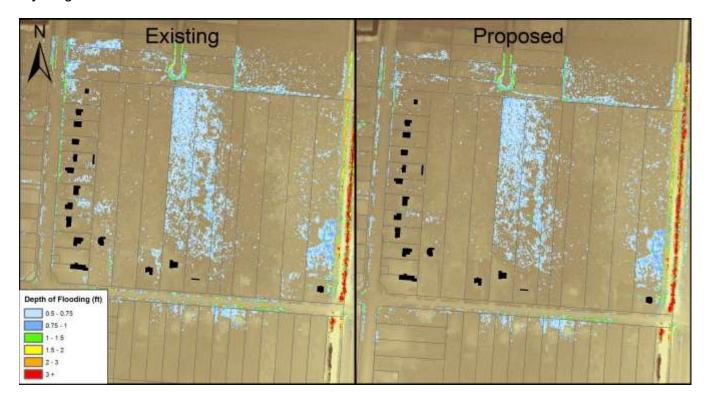
Figure 3: Existing and Proposed Conditions - 10-yr Storm Inundation Map

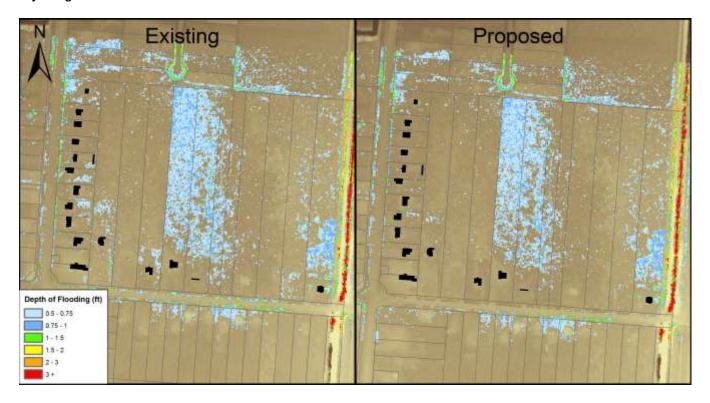
Figure 4: Existing and Proposed Conditions - 25-yr Storm Inundation Map

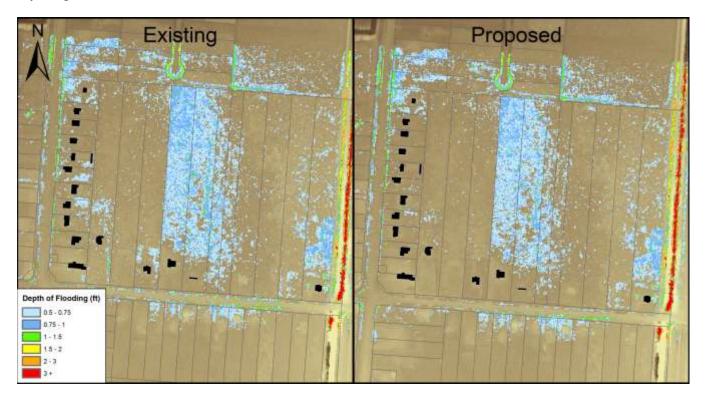
Figure 5: Existing and Proposed Conditions - 100-yr Storm Inundation Map

1% (100-Year)	Pre-Project Post-Project		Removed
Flood Recurrence	,		
Inundated Structures	2	0	2
Inundated Lots	24	24	0
Inundated Roadway (LF)	0	0	0

- 1. The number of inundated structures are based strictly on finished floor elevations compared to computed water surface elevations.
- 2. The inundation maps above only display flooding depths greater than 6 inches.
- 3. The number of inundated lots are based strictly on the inundation maps above and therefore do not count as inundated if the depth of flooding is less than 6 inches.

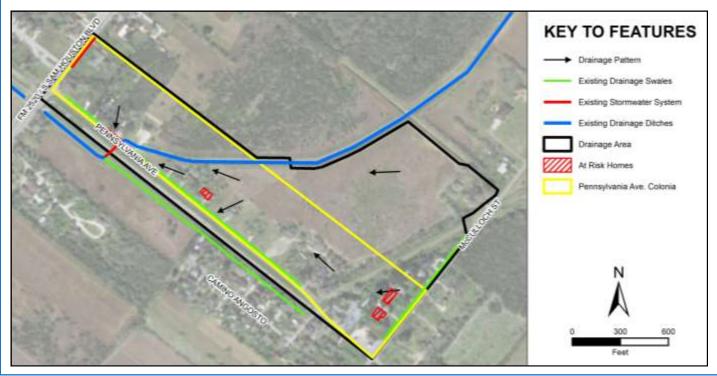
Drainage patterns within this 27-acre colonia are generally towards the drainage ditch that runs through the center of the colonia. The colonia has an existing drainage ditch system, roadside drainage system, and a very small amount of underground storm drain system. Pennsylvania Ave. experiences residential lot, street, and structure flooding in nearly every rainfall event. Figures 1-5 illustrate the existing and proposed conditions inundation maps for the 2-, 5-, 10-, 25-, and 100-year storms, respectively. These maps illustrate the depth of flooding as follows: light blue represents a depth of 6 to 9 inches, blue 9 to 12 inches, green 1 to 1.5 feet, yellow 1.5 to 2 feet, orange 2 to 3 feet, and red more than 3 feet.

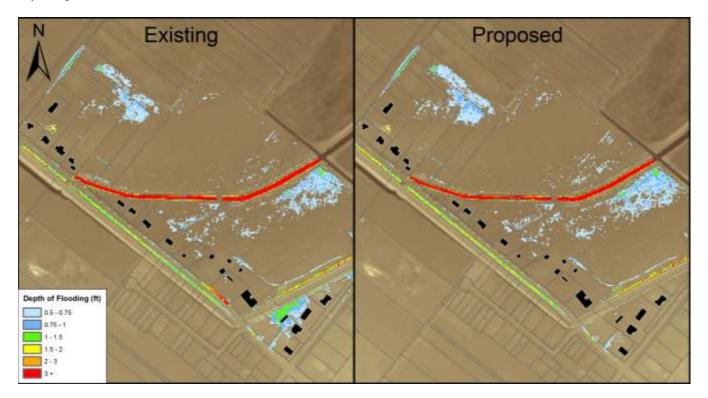
Figure 1: Existing and Proposed Conditions - 2-yr Storm Inundation Map

The goal of this study was to size the system to be capable of carrying up to the 10-Year storm runoff with no inundation in the colonia. However, some structures lie within low areas of the colonia and still show risk of flooding. When comparing the 6-inch inundation map for the 25- and 100-Year storms, it is observed that the inundation depths are lower than the existing conditions model, resulting in fewer structures at risk of being flooded once improvements are in place. Figures 1, 2, 3, 4, and 5 show the existing and proposed conditions inundation maps for the 2-, 5-, 10-, 25-, and 100-Yr storms respectively.

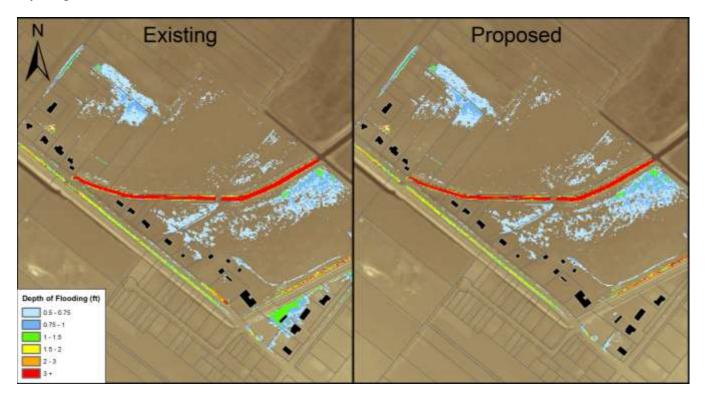
Figure 2: Existing and Proposed Conditions - 5-yr Storm Inundation Map

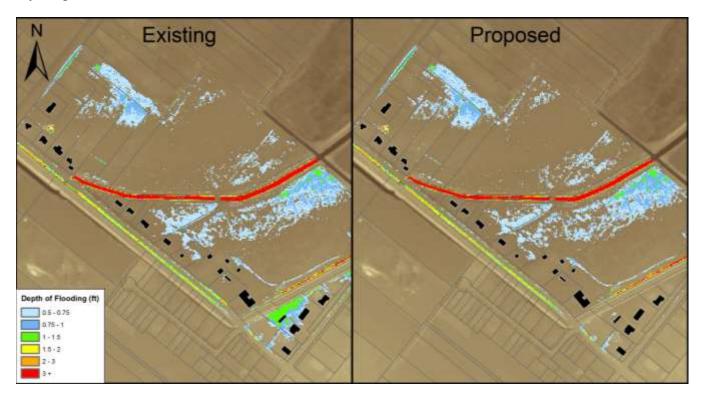
Figure 3: Existing and Proposed Conditions - 10-yr Storm Inundation Map

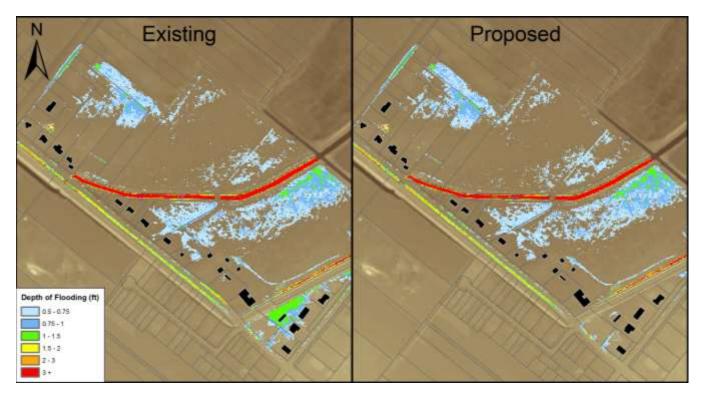
Figure 4: Existing and Proposed Conditions - 25-yr Storm Inundation Map

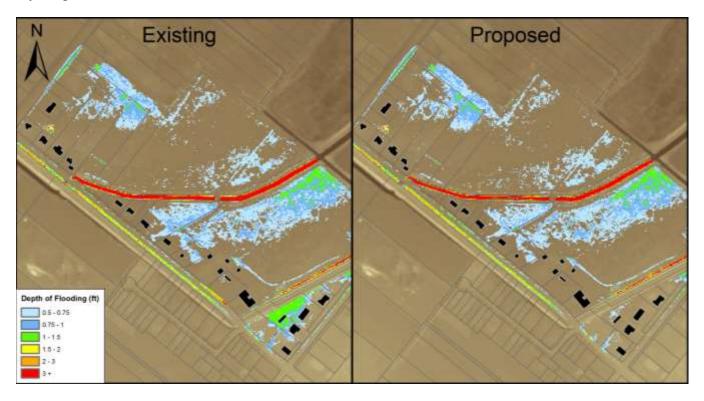
Figure 5: Existing and Proposed Conditions - 100-yr Storm Inundation Map

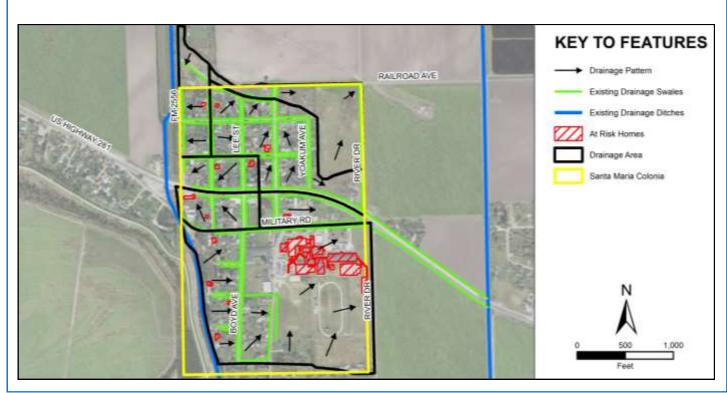
Drainage patterns within this 117-acre colonia runoff are generally towards the north and east with the northwest portion drainage towards the west. Runoff flows through residential roadside swales towards FM 2556 and US Highway 281 (main arterials), which do not have proper outfall connectivity to adjacent drainage ditches. Culverts under the main arterial roadways are undersized or restricted by sediment and vegetation. Although the County has improved the residential roadside swales, model results show that structures throughout the colonia have a high flooding potential due to very flat terrain within the colonia. Figures 1-5 illustrate the existing and proposed conditions inundation maps for the 2-, 5-, 10-, 25-, and 100-year storms, respectively. These maps illustrate the depth of flooding as follows: light blue represents a depth of 6-9 inches, dark blue 9 to 12 inches, green 1 to 1.5 feet, yellow 1.5 to 2 feet, orange 2 to 3 feet, and red is more than 3 feet. Flood damages and potential benefits to the Santa Maria High School are not included in this analysis and should be evaluated in future phases of design.

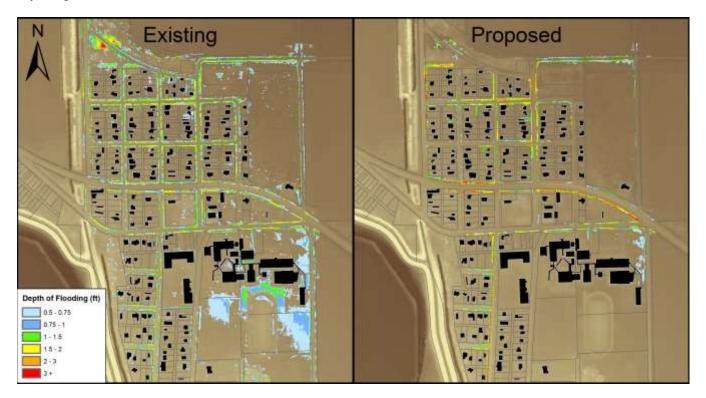
Figure 1: Existing and Proposed Conditions - 2-yr Storm Inundation Map

The goal of this study was to size the system to be capable of carrying up to the 10-Year storm runoff with no inundation in the colonia. However, some structures lie within low areas of the colonia and still show risk of flooding. When comparing the 6-inch inundation map for the 25- and 100-Year storms, it is observed that the inundation depths are lower than the existing conditions model, resulting in fewer structures at risk of being flooded once improvements are in place. Figures 1, 2, 3, 4, and 5 show the existing and proposed conditions inundation maps for the 2-, 5-, 10-, 25-, and 100-Yr storms respectively.

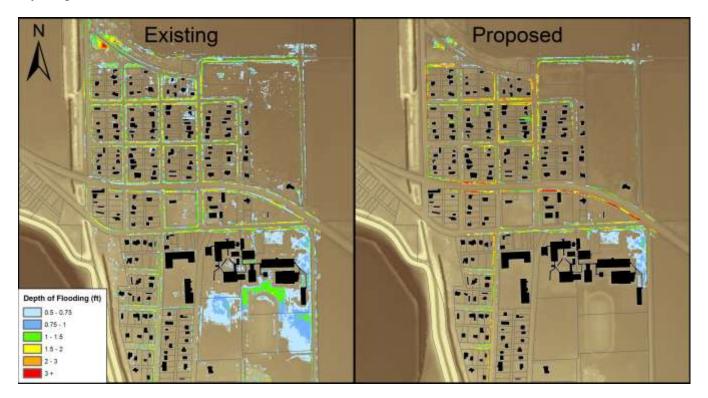
Figure 2: Existing and Proposed Conditions - 5-yr Storm Inundation Map

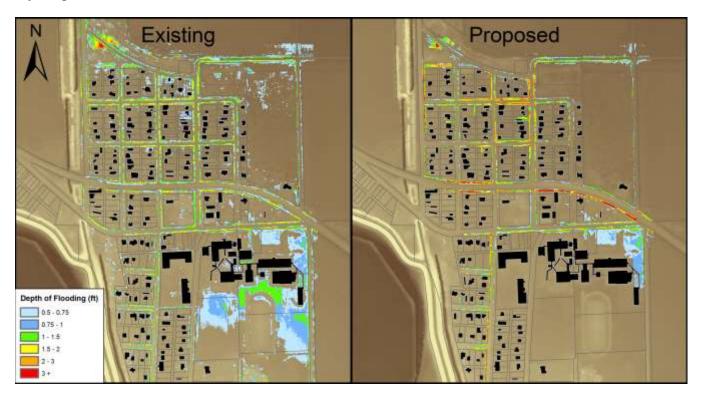
Figure 3: Existing and Proposed Conditions - 10-yr Storm Inundation Map

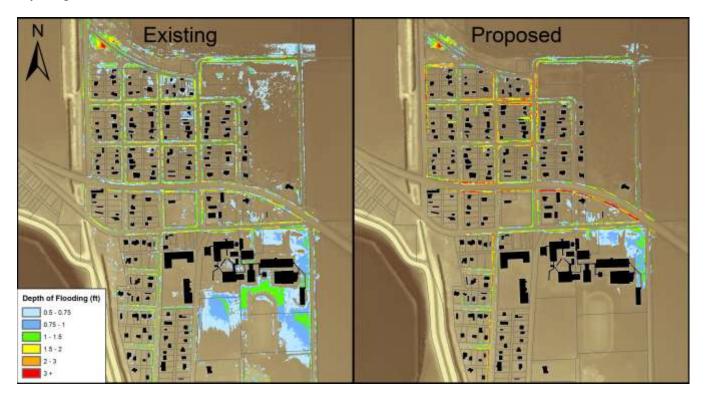
Figure 4: Existing and Proposed Conditions - 25-yr Storm Inundation Map

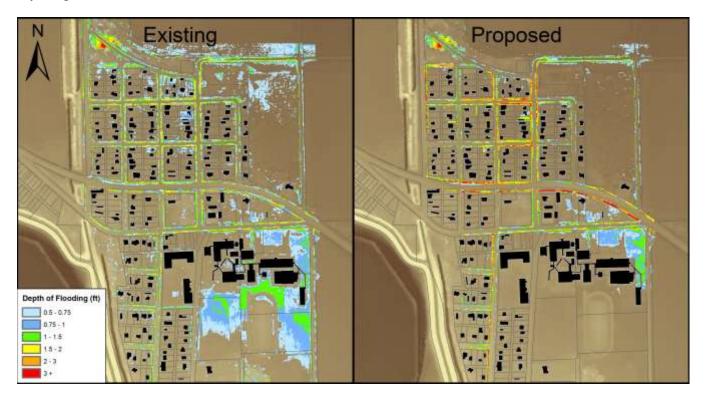
Figure 5: Existing and Proposed Conditions - 100-yr Storm Inundation Map
