STORMWATER DRAINAGE PLANNING

The Colonias of the Lower Rio Grande Valley (LRGV)

Phase 2 Report

JSW & Associates, Inc. Hazard Mitigation Consultants

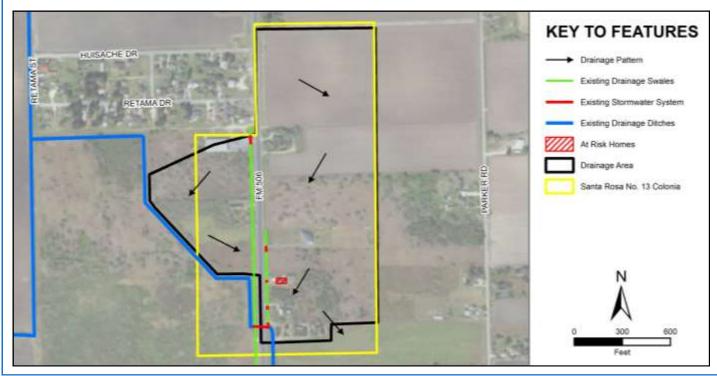
Drainage patterns within this 47-acre colonia are southerly. The colonia has an existing roadside drainage system, and a very small amount of underground storm drain system. Due to inadequate conveyance of stormwater, Santa Rosa No. 13 experiences residential lot and street flooding in nearly every rainfall event. Ponding occurs in areas of low terrain, especially on the west side of FM 506. Figures 1-5 illustrate the existing and proposed conditions inundation maps for the 2 -, 5-, 10-, 25-, and 100-year storms, respectively. These maps illustrate the depth of flooding as follows: light blue represents a depth of 6 to 9 inches, blue 9 to 12 inches, green 1 to 1.5 feet, yellow 1.5 to 2 feet, orange 2 to 3 feet, and red more than 3 feet.

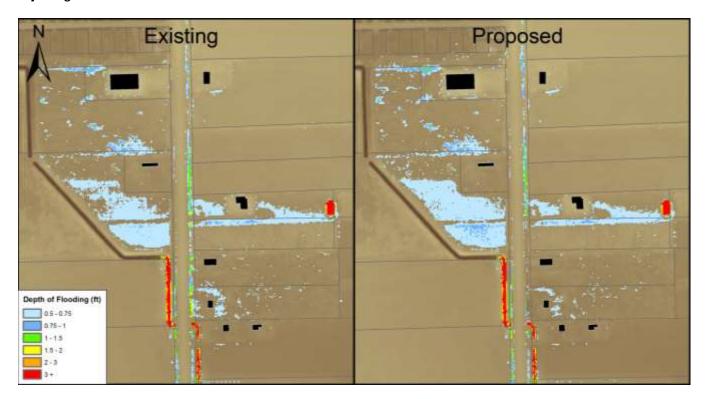
Figure 1: Existing and Proposed Conditions - 2-yr Storm Inundation Map

The goal of this study was to size the system to be capable of carrying up to the 10-Year storm runoff with no inundation in the colonia. However, some structures lie within low areas of the colonia and still show risk of flooding. When comparing the 6-inch inundation map for the 25- and 100-Year storms, it is observed that the inundation depths are lower than the existing conditions model, resulting in fewer structures at risk of being flooded once improvements are in place. Figures 1, 2, 3, 4, and 5 show the existing and proposed conditions inundation maps for the 2-, 5-, 10-, 25-, and 100-Yr storms respectively.

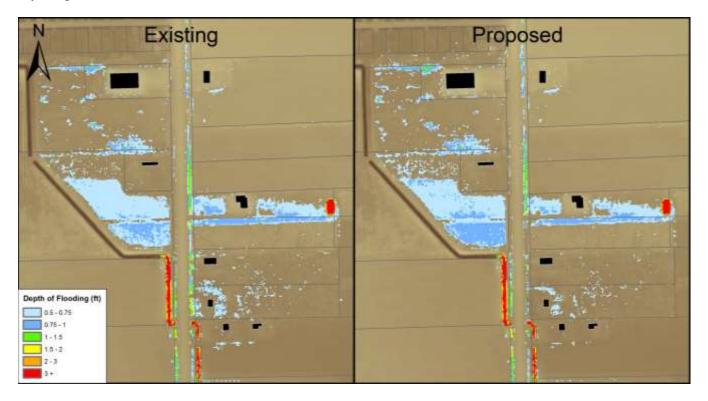
Figure 2: Existing and Proposed Conditions - 5-yr Storm Inundation Map

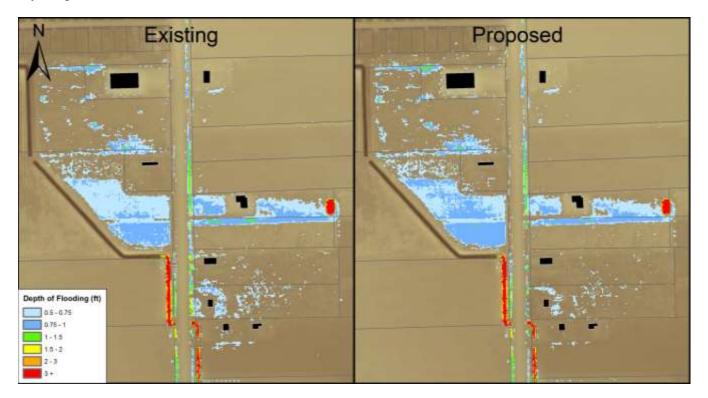
Figure 3: Existing and Proposed Conditions - 10-yr Storm Inundation Map

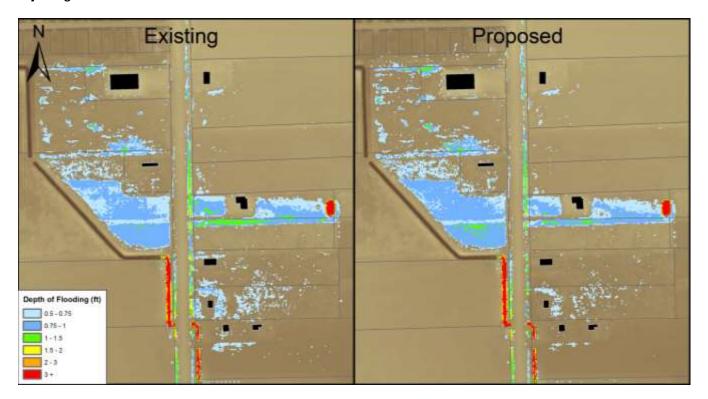
Figure 4: Existing and Proposed Conditions - 25-yr Storm Inundation Map

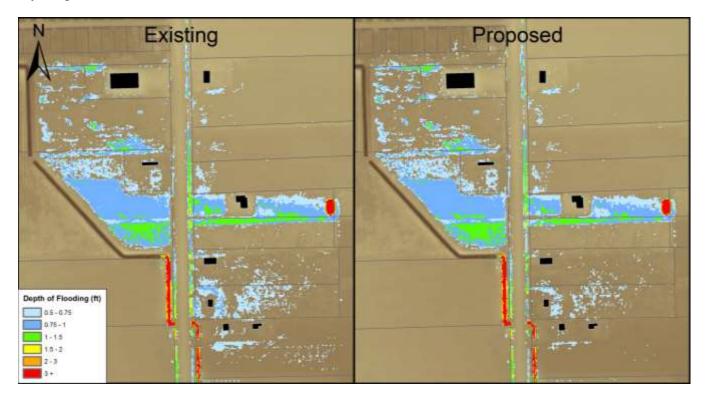
Figure 5: Existing and Proposed Conditions - 100-yr Storm Inundation Map

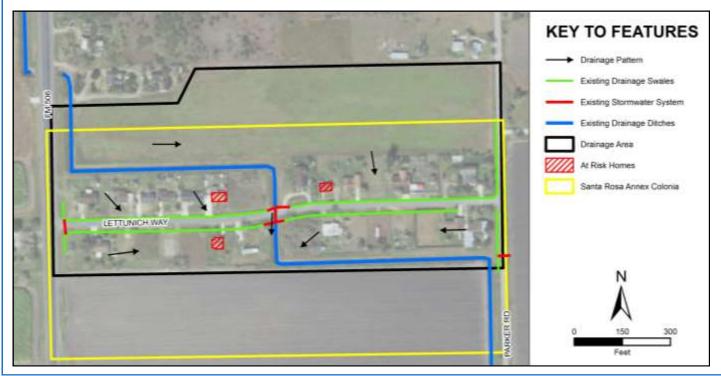
Drainage patterns within this 23-acre colonia are generally towards the center of the colonia. Runoff collects in an existing drainage ditch system flowing through the center of the colonia. Roadside drainage system, and pipe culverts connect roadside swales and outfall into the drainage ditch. Due to undersized infrastructure, Santa Rosa Annex experiences residential lot, street, and structure flooding in nearly every rainfall event. Figures 1-5 illustrate the existing and proposed conditions inundation maps for the 2-, 5-, 10-, 25-, and 100-year storms, respectively. These maps illustrate the depth of flooding as follows: light blue represents a depth of 6 to 9 inches, blue 9 to 12 inches, green 1 to 1.5 feet, yellow 1.5 to 2 feet, orange 2 to 3 feet, and red more than 3 feet.

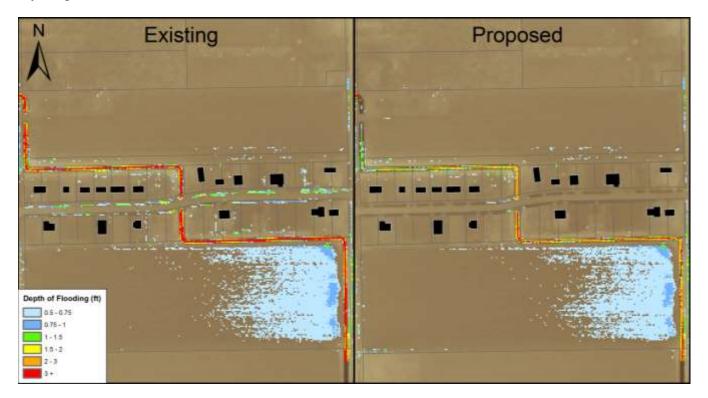
Figure 1: Existing and Proposed Conditions - 2-yr Storm Inundation Map

The goal of this study was to size the system to be capable of carrying up to the 10-Year storm runoff with no inundation in the colonia. However, some structures lie within low areas of the colonia and still show risk of flooding. When comparing the 6-inch inundation map for the 25- and 100-Year storms, it is observed that the inundation depths are lower than the existing conditions model, resulting in fewer structures at risk of being flooded once improvements are in place. Figures 1, 2, 3, 4, and 5 show the existing and proposed conditions inundation maps for the 2-, 5-, 10-, 25-, and 100-Yr storms respectively.

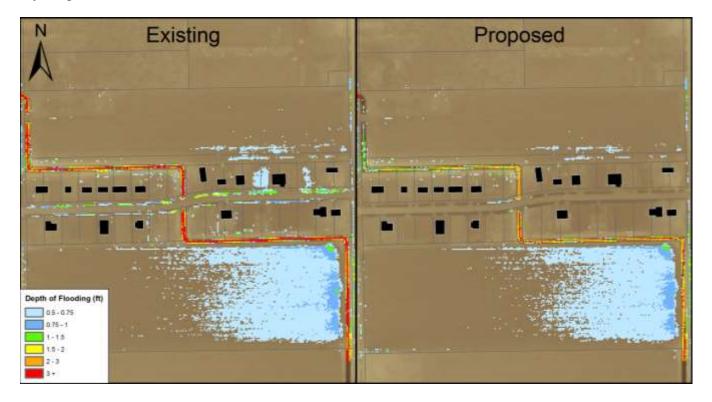
Figure 2: Existing and Proposed Conditions - 5-yr Storm Inundation Map

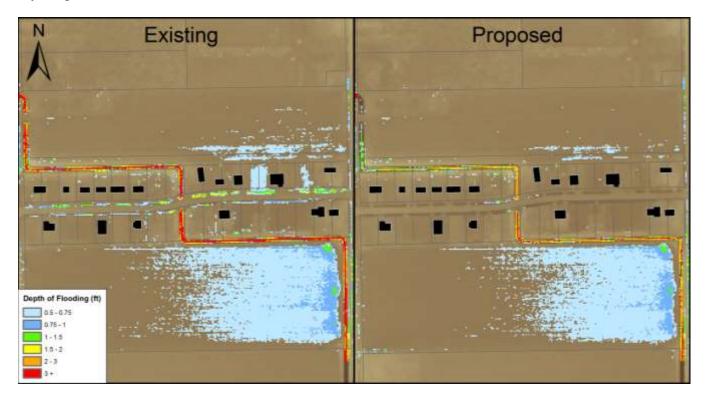
Figure 10: Existing and Proposed Conditions - 10-yr Storm Inundation Map

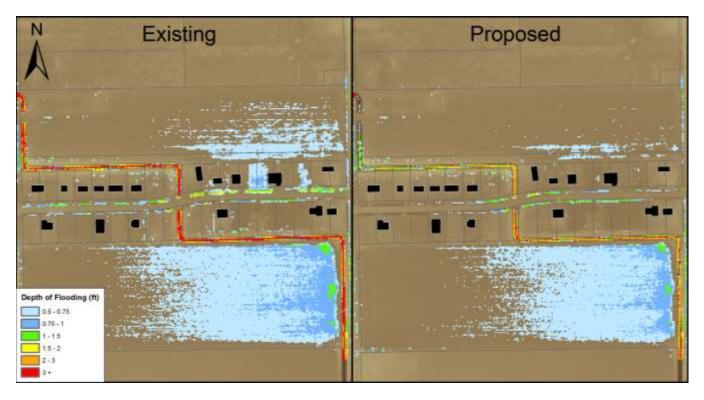
Figure 4: Existing and Proposed Conditions - 25-yr Storm Inundation Map

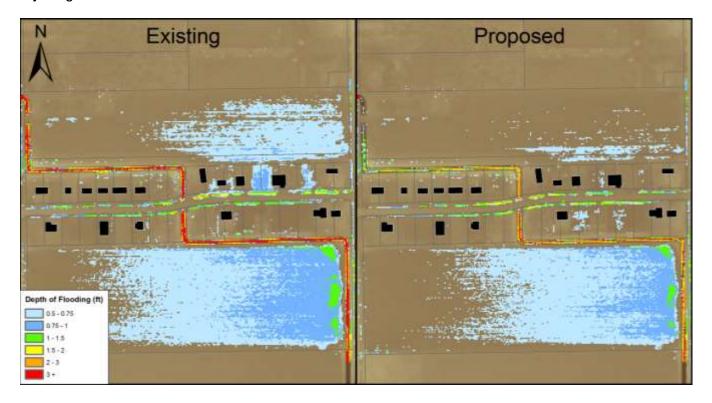
Figure 5: Existing and Proposed Conditions - 100-yr Storm Inundation Map

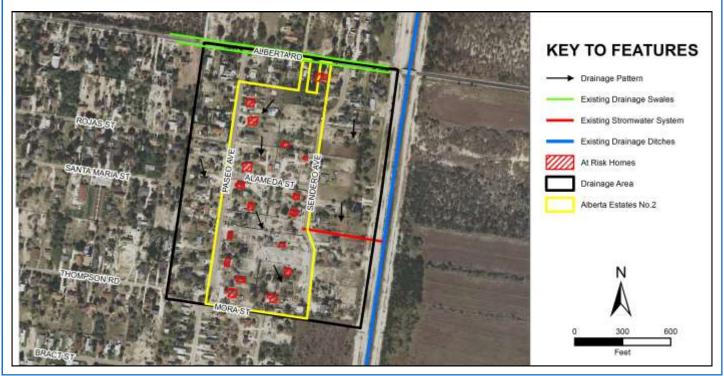
Drainage patterns within this 19-acre colonia are generally to the south and east. The existing drainage system consists of a small stormwater system and roadside swales that are generally undersized and restricted by sediment and vegetation. Alberta Estates No. 2 experiences residential lot, street, and structure flooding in nearly every rainfall event. Figures 1-5 illustrate the existing and proposed conditions inundation maps for the 2-, 5-, 10-, 25-, and 100-year storms, respectively. These maps illustrate the depth of flooding as follows: light blue represents a depth of 3 to 6 inches, blue 6 to 9 inches, green 9 to 12 inches, yellow 1 to 2 feet, orange 2 to 3 feet, and red more than 3 feet.

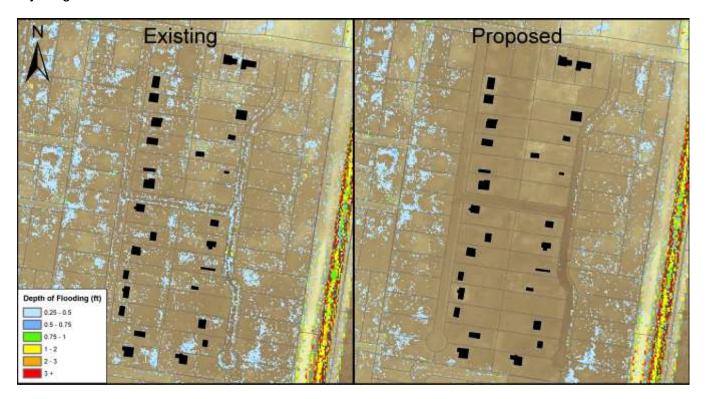
Figure 1: Existing and Proposed Conditions - 2-yr Storm Inundation Map

The goal of this study was to size the system to be capable of carrying up to the 10-Year storm runoff with no inundation in the colonia. However, some structures lie within low areas of the colonia and still show risk of flooding. When comparing the 6-inch inundation map for the 25- and 100-Year storms, it is observed that the inundation depths are lower than the existing conditions model, resulting in fewer structures at risk of being flooded once improvements are in place. Figures 1, 2, 3, 4, and 5 show the existing and proposed conditions inundation maps for the 2-, 5-, 10-, 25-, and 100-Yr storms respectively.

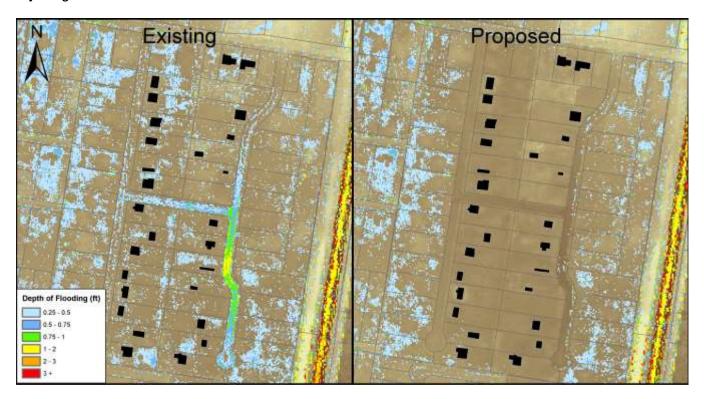
Figure 2: Existing and Proposed Conditions - 5-yr Storm Inundation Map

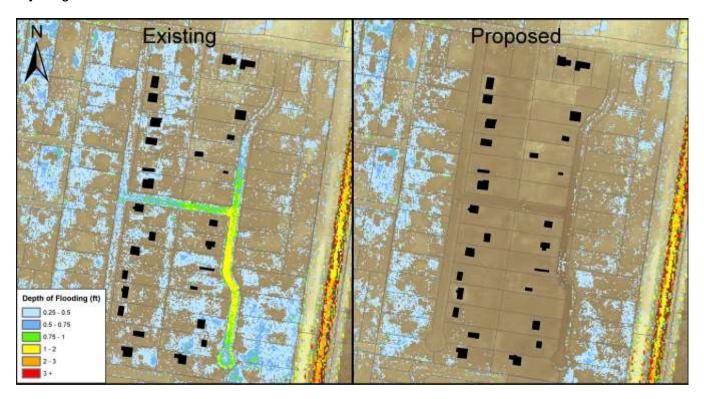
Figure 3: Existing and Proposed Conditions - 10-yr Storm Inundation Map

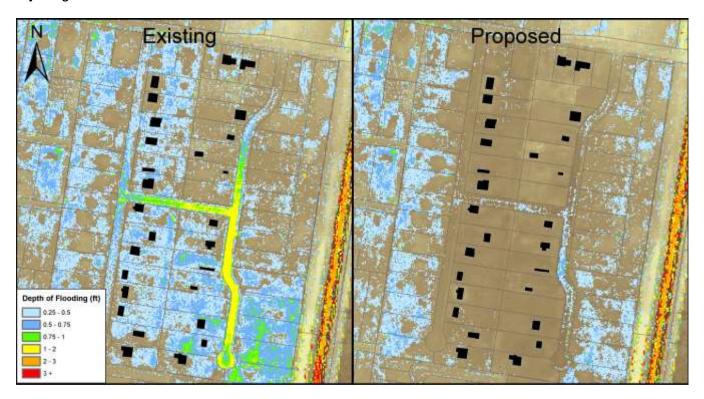
Figure 4: Existing and Proposed Conditions - 25-yr Storm Inundation Map

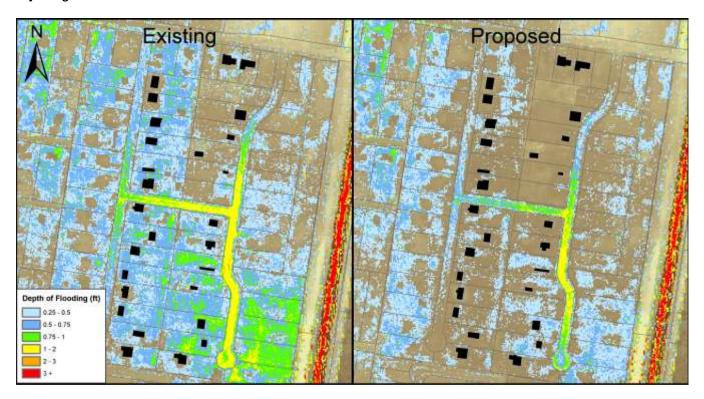
Figure 5: Existing and Proposed Conditions - 100-yr Storm Inundation Map

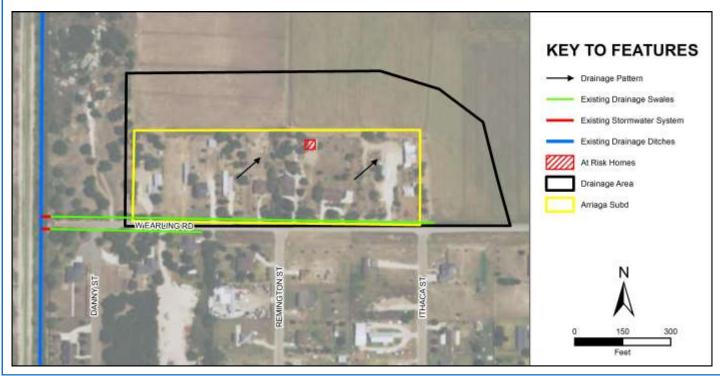
Drainage patterns within this 6-acre colonia are generally to the north. The existing drainage system consists of roadside swales that are generally undersized and restricted by sediment and vegetation. Arriaga Subdivision experiences residential lot, street, and structure flooding in nearly every rainfall event. Figures 1-5 illustrate the existing and proposed conditions inundation maps for the 2-, 5-, 10-, 25-, and 100-year storms, respectively. These maps illustrate the depth of flooding as follows: light blue represents a depth of 3 to 6 inches, blue 6 to 9 inches, green 9 to 12 inches, yellow 1 to 2 feet, orange 2 to 3 feet, and red more than 3 feet.

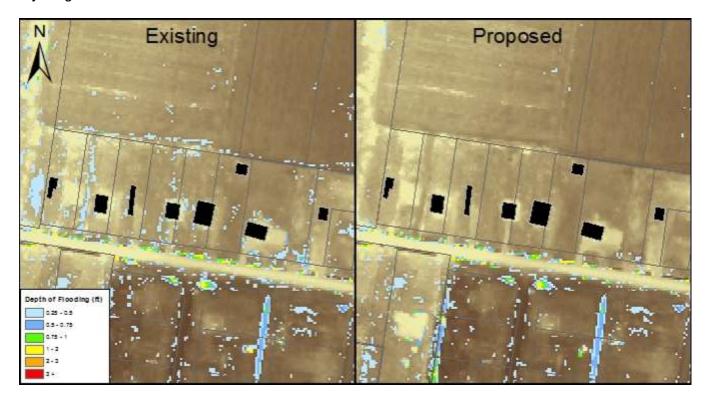
Figure 1: Existing and Proposed Conditions - 2-yr Storm Inundation Map

The goal of this study was to size the system to be capable of carrying up to the 10-Year storm runoff with no inundation in the colonia. However, some structures lie within low areas of the colonia and still show risk of flooding. When comparing the 6-inch inundation map for the 25- and 100-Year storms, it is observed that the inundation depths are lower than the existing conditions model, resulting in fewer structures at risk of being flooded once improvements are in place. Figures 1, 2, 3, 4, and 5 show the existing and proposed conditions inundation maps for the 2-, 5-, 10-, 25-, and 100-Yr storms respectively.

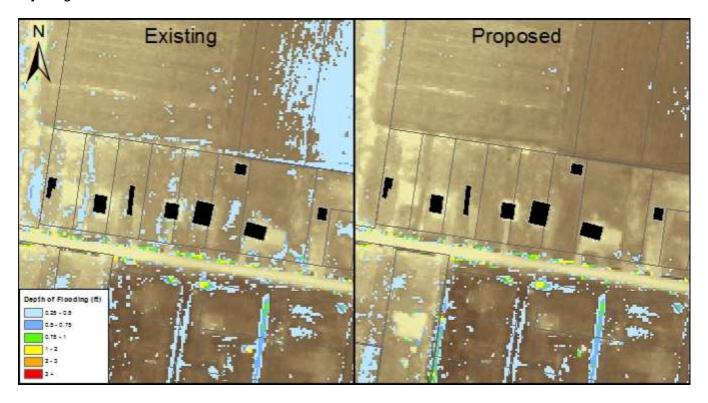
Figure 2: Existing and Proposed Conditions - 5-yr Storm Inundation Map

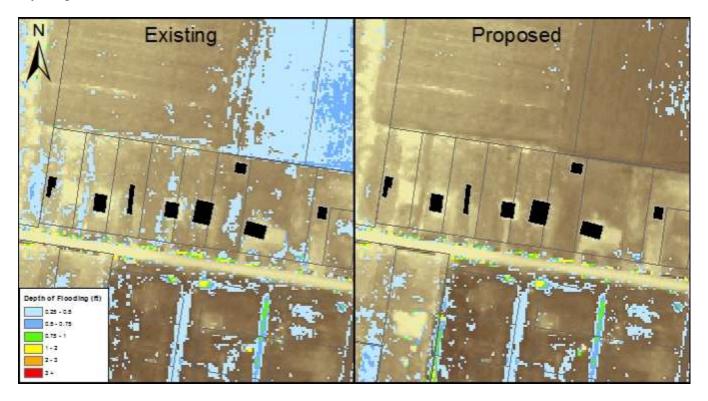
Figure 3: Existing and Proposed Conditions - 10-yr Storm Inundation Map

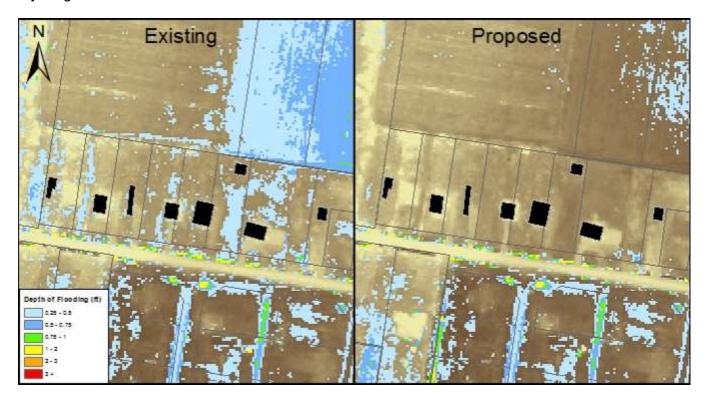
Figure 4: Existing and Proposed Conditions - 25-yr Storm Inundation Map

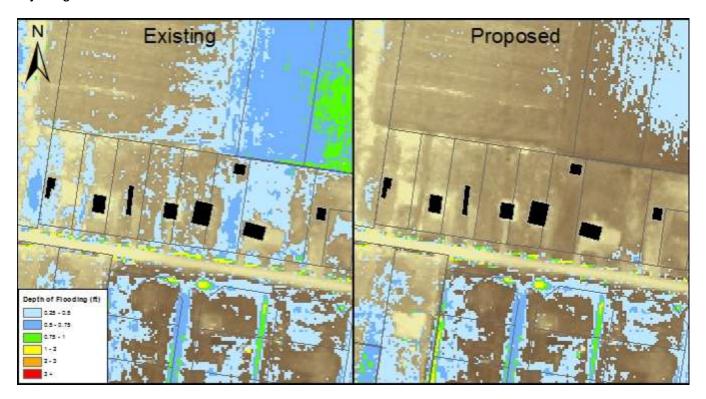
Figure 5: Existing and Proposed Conditions - 100-yr Storm Inundation Map

1% (100-Year)	Pre-Project	Post-Project	Removed
Flood Recurrence	The Project	roserrojece	Removed
Inundated Structures	1	0	1
Inundated Lots	8	5	3
Inundated Roadway (LF)	0	0	0

- 1. The number of inundated structures are based strictly on finished floor elevations compared to computed water surface elevations.
- 2. The inundation maps above only display flooding depths greater than 3 inches.
- 3. The number of inundated lots are based strictly on the inundation maps above and therefore do not count as inundated if the depth of flooding is less than 3 inches.

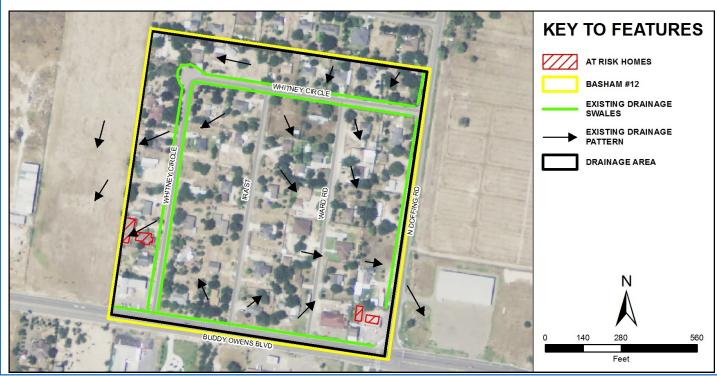
Basham #12 consist of approximately 26 acres of fully developed residential land. Currently there are swales and culverts along Whitney Circle, however these swales do not have an outfall. The swales along Doffing Road appear to drain into a grate inlet at the south end of Doffing Road. From LIDAR observations it is apparent that the runoff currently flows toward the southeast and southwest, as a result structures on low lots and along the west and southeast corner of the subdivisions are at risk of flooding. Figures 1, 2, 3, 4, and 5 illustrate the existing and proposed inundation maps for the 2-, 5-, 10-, 25-, and 100-Year storms respectively. The color coded inundation maps illustrate the depth of flooding as follows: light blue represents a depth of 3 to 4.5 inches, blue 4.5 to 6 inches, green 6 to 9 inches, yellow 9 to 11.7 inches, orange 11.7 to 14.4 inches, and red more than 14.4 inches.

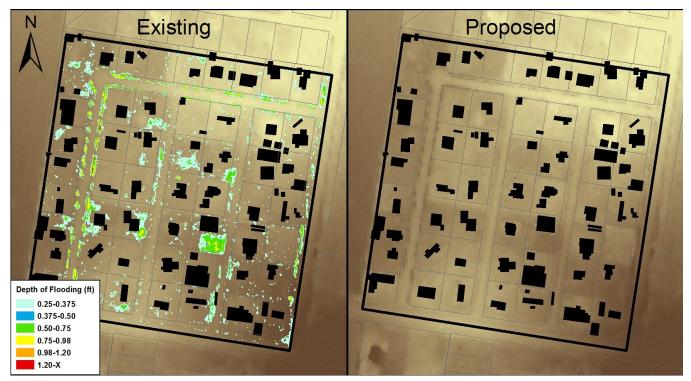
Figure 1: Existing and Proposed Conditions - 2-Yr Storm Inundation Map

50% (2-Year) Flood Recurrence	Pre-Project	Post-Project	Removed
Inundated Structures	0	0	0
Inundated Lots	53	0	53
Inundated Roadway (LF)	0	0	0

The goal of this study was to size the system to be capable of carrying up to the 10-Year storm with no inundation in the colonia. However, some structures lie within low areas of the colonia and still show risk of flooding. When comparing the 6-inch inundation maps for the 25- and 100-Year storms, it is observed that the inundation depths are lower than the existing conditions model, resulting in less overall ponding and the street is at lower risk of being flooded once improvements are in place. Figures 1, 2, 3, 4, and 5 show the existing and proposed conditions inundation maps for the 2-, 5-, 10-, 25-, and 100-Yr storms respectively.

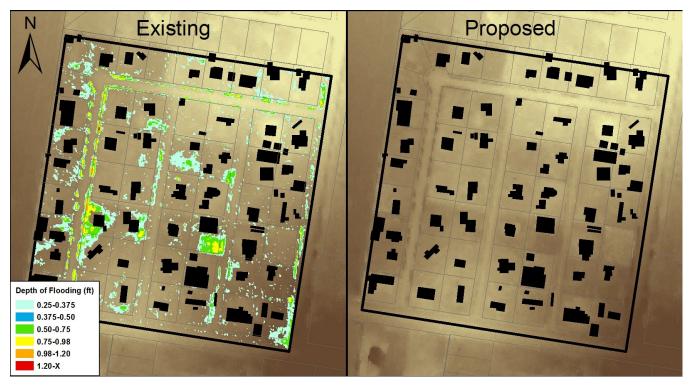
Figure 2: Existing and Proposed Conditions - 5-Yr Storm Inundation Map

20% (5-Year) Flood Recurrence	Pre-Project	Post-Project	Removed
Inundated Structures	0	0	0
Inundated Lots	53	0	53
Inundated Roadway (LF)	0	0	0

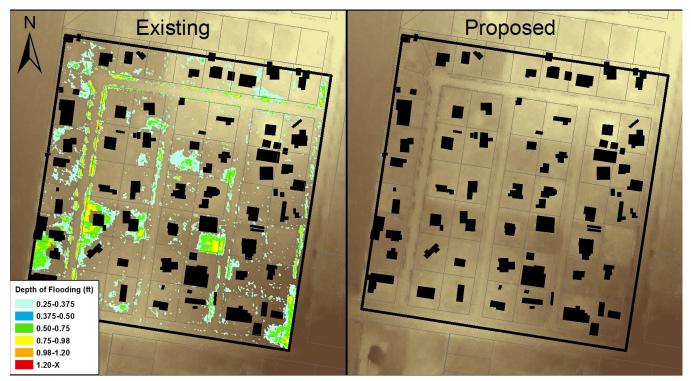
Figure 3: Existing and Proposed Conditions - 10-Yr Storm Inundation Map

10% (10-Year) Flood Recurrence	Pre-Project	Post-Project	Removed
Inundated Structures	2	0	2
Inundated Lots	53	0	53
Inundated Roadway (LF)	0	0	0

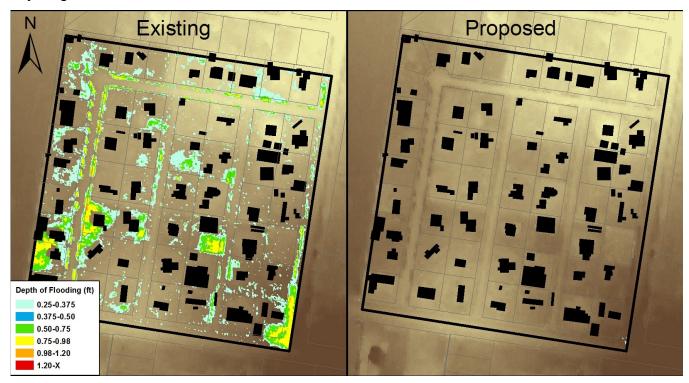
Figure 4: Existing and Proposed Conditions - 25-Yr Storm Inundation Map

4% (25-Year) Flood Recurrence	Pre-Project	Post-Project	Removed
Inundated Structures	2	0	2
Inundated Lots	53	0	53
Inundated Roadway (LF)	0	0	0

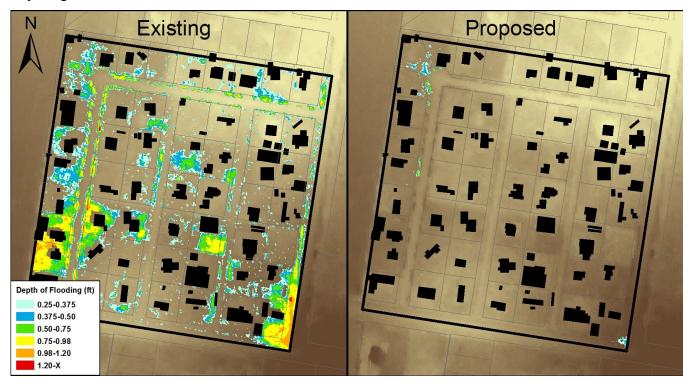
Figure 5: Existing and Proposed Conditions - 100-Yr Storm Inundation Map

1% (100-Year) Flood Recurrence	Pre-Project	Post-Project	Removed
Inundated Structures	4	0	4
Inundated Lots	53	5	48
Inundated Roadway (LF)	0	0	0

- 1. The number of inundated structures are based strictly on finished floor elevations compared to computed water surface elevations.
- 2. The inundation maps above only display flooding depths greater than three inches.
- 3. The number of inundated lots are based strictly on the inundation maps above and therefore do not count as inundated if the depth of flooding is less than three inches.

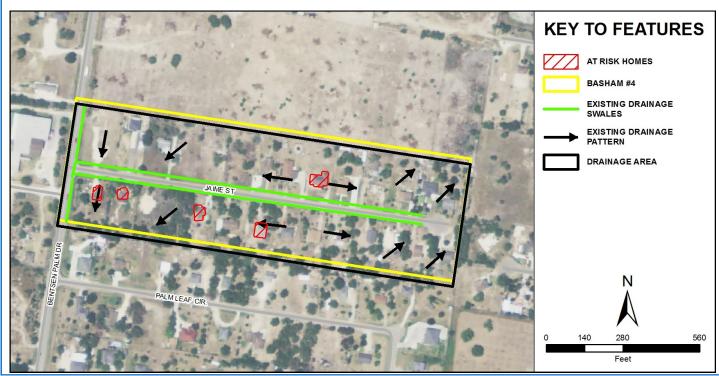
Basham #4 consist of approximately 15 acres. Currently the colonia does not have a drainage system. The terrain is fairly flat and a portion of the northeast corner of the colonia is in the 100-Yr floodplain. The model results indicate that the northeast and southwest corners of the colonia are high-risk flooding areas. Figures 1, 2, 3, 4, and 5 illustrate the existing and proposed inundation maps for the 2-, 5-, 10-, 25-, and 100-Year storms respectively. The color coded inundation maps illustrate the depth of flooding as follows: light blue represents a depth of 6 to 8 inches, blue 8 to 10 inches, green 10 to 12 inches, yellow 12 to 18 inches, orange 18 to 28 inches, and red more than 28 inches.

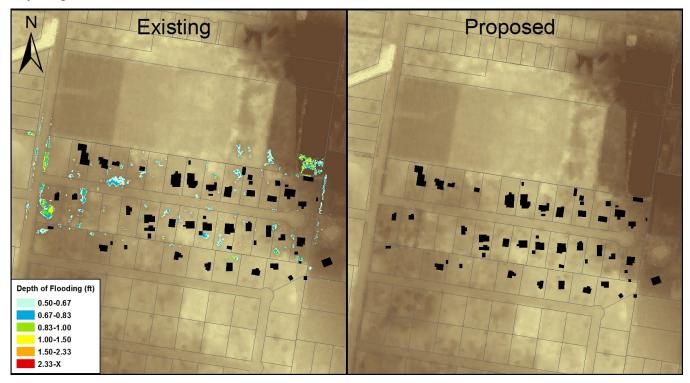
Figure 1: Existing and Proposed Conditions - 2-Yr Storm Inundation Map

The goal of this study was to size the system to be capable of carrying up to the 10-Year storm with no inundation in the colonia. However, some structures lie within low areas of the colonia and still show risk of flooding. When comparing the 6-inch inundation maps for the 25- and 100-Year storms, it is observed that the inundation depths are lower than the existing conditions model, resulting in fewer structures at risk of being flooded once improvements are in place. Figures 1, 2, 3, 4, and 5 show the existing and proposed conditions inundation maps for the 2-, 5-, 10-, 25-, and 100-Yr storms respectively.

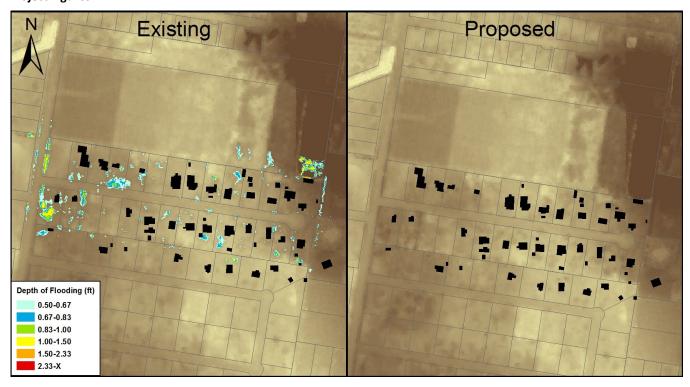
Figure 2: Existing and Proposed Conditions - 5-Yr Storm Inundation Map

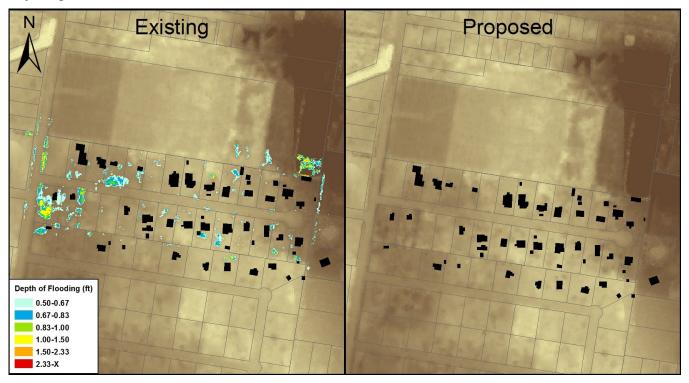
Figure 3: Existing and Proposed Conditions - 10-Yr Storm Inundation Map

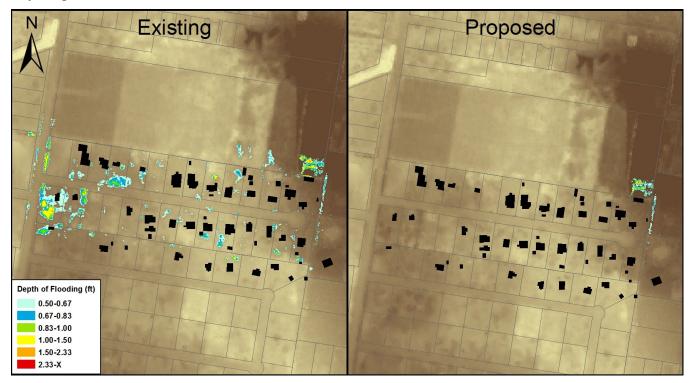
Figure 4: Existing and Proposed Conditions - 25-Yr Storm Inundation Map

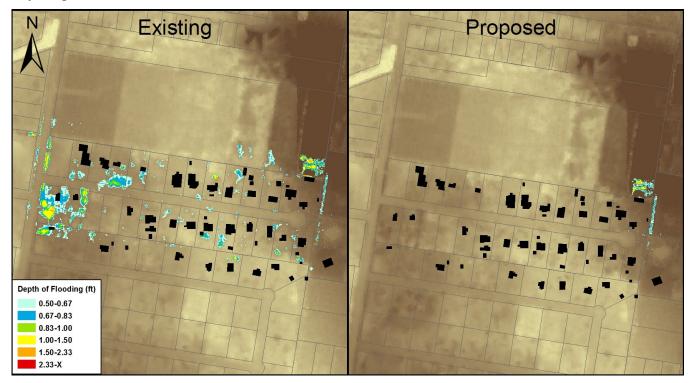
Figure 5: Existing and Proposed Conditions - 100-Yr Storm Inundation Map

1% (100-Year) Flood Recurrence	Pre-Project	Post-Project	Removed
Inundated Structures	2	0	2
Inundated Lots	28	1	27
Inundated Roadway (LF)	0	0	0

- 1. The number of inundated structures are based strictly on finished floor elevations compared to computed water surface elevations.
- 2. The inundation maps above only display flooding depths greater than six inches.
- 3. The number of inundated lots are based strictly on the inundation maps above and therefore do not count as inundated if the depth of flooding is less than six inches.

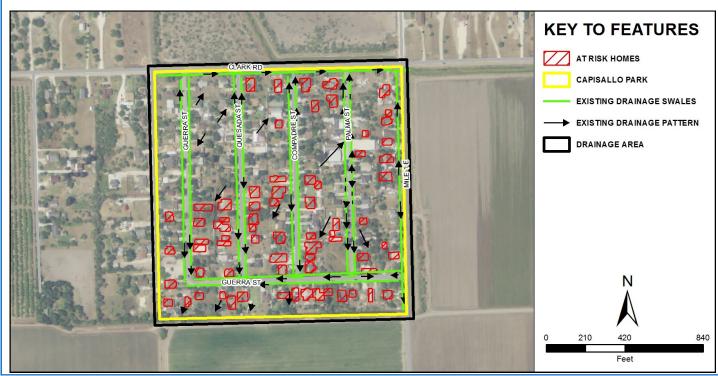
Capisallo Park consists of approximately 44 acres. The current drainage system consists of swales and culverts that outfall into existing drain ditches along the north, south, and east sides of the colonia. The model results indicate that the high-risk flooding areas are along the northeast and south portions of the colonia. Figures 1, 2, 3, 4, and 5 illustrate the existing and proposed inundation maps for the 2-, 5-, 10-, 25-, and 100-Year storms respectively. The color coded inundation maps illustrate the depth of flooding as follows: light blue represents a depth of 6-15 inches, blue 15 to 24, green 24 to 30 inches, yellow 30 to 36 inches, orange 36 to 48 inches and red more than 48 inches.

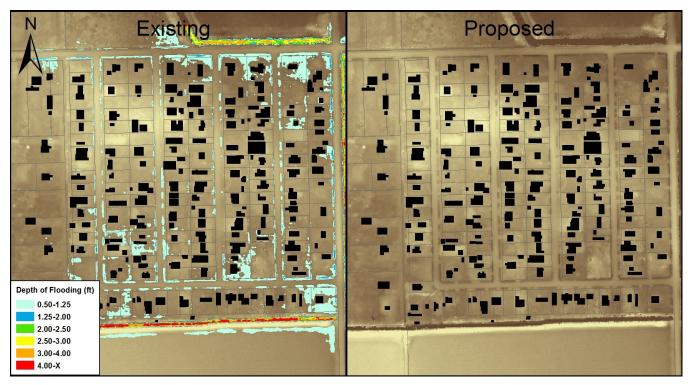
Figure 1: Existing and Proposed Conditions - 2-Yr Storm Inundation Map

50% (2-Year) Flood Recurrence	Pre-Project	Post-Project	Removed
Inundated Structures	5	2	3
Inundated Lots	112	0	112
Inundated Roadway (LF)	0	0	0

The goal of this study was to size the system to be capable of carrying up to the 10-Year storm with no inundation in the colonia. However, some structures lie within low areas of the colonia and still show risk of flooding. When comparing the 6-inch inundation maps for the 25- and 100-Year storms, it is observed that the inundation depths are lower than the existing conditions model, resulting in fewer structures at risk of being flooded once improvements are in place. Figures 1, 2, 3, 4, and 5 show the existing and proposed conditions inundation maps for the 2-, 5-, 10-, 25-, and 100-Yr storms respectively.

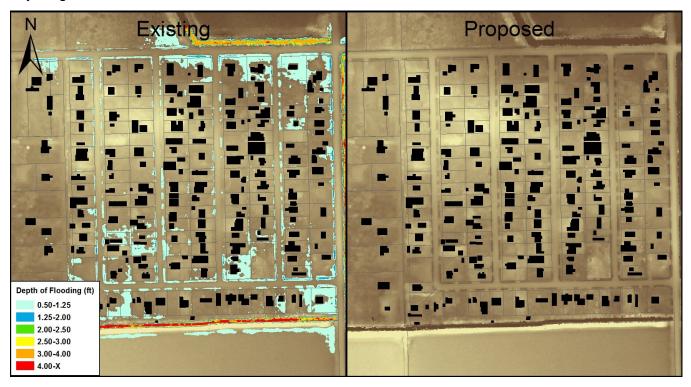
Figure 2: Existing and Proposed Conditions - 5-Yr Storm Inundation Map

20% (5-Year) Flood Recurrence	Pre-Project	Post-Project	Removed
Inundated Structures	7	2	5
Inundated Lots	119	0	119
Inundated Roadway (LF)	0	0	0

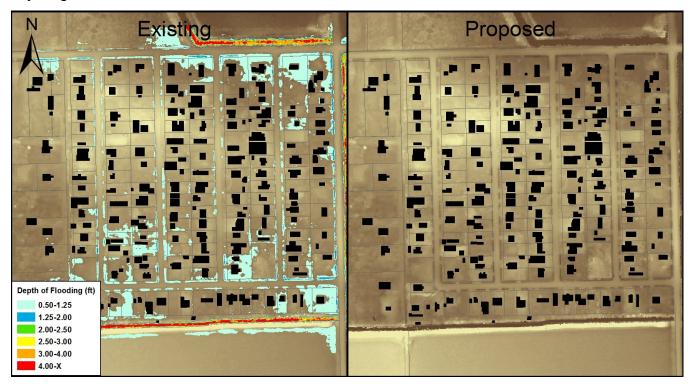
Figure 3: Existing and Proposed Conditions - 10-Yr Storm Inundation Map

10% (10-Year) Flood Recurrence	Pre-Project	Post-Project	Removed
Inundated Structures	10	2	8
Inundated Lots	121	0	121
Inundated Roadway (LF)	0	0	0

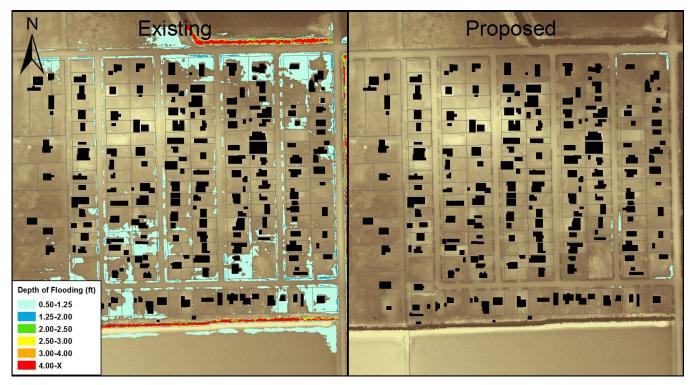
Figure 4: Existing and Proposed Conditions - 25-Yr Storm Inundation Map

4% (25-Year) Flood Recurrence	Pre-Project	Post-Project	Removed
Inundated Structures	11	2	9
Inundated Lots	121	7	114
Inundated Roadway (LF)	0	0	0

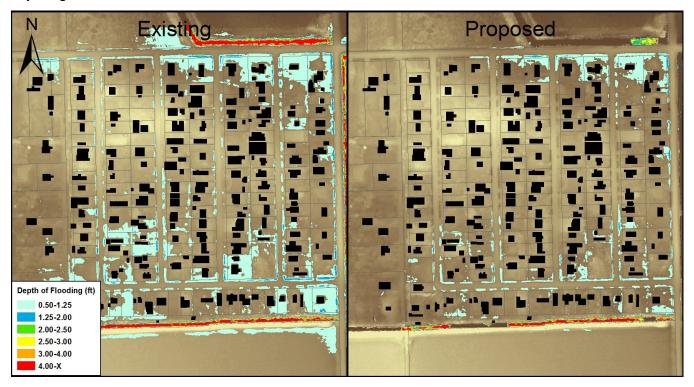
Figure 5: Existing and Proposed Conditions - 100-Yr Storm Inundation Map

1% (100-Year) Flood Recurrence	Pre-Project	Post-Project	Removed
Inundated Structures	11	2	9
Inundated Lots	124	63	61
Inundated Roadway (LF)	0	0	0

- 1. The number of inundated structures are based strictly on finished floor elevations compared to computed water surface elevations.
- 2. The inundation maps above only display flooding depths greater than six inches.
- 3. The number of inundated lots are based strictly on the inundation maps above and therefore do not count as inundated if the depth of flooding is less than six inches.

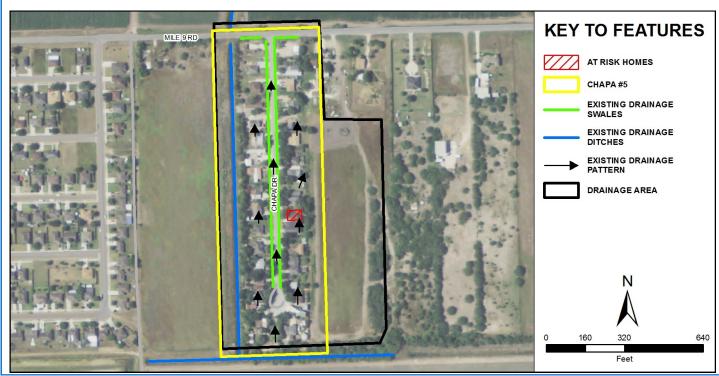
Chapa #5 consists of approximately 7 acres of residential developed land with an offsite drainage area of approximately 11 acres of agricultural land. The current drainage system consists of very poorly maintained swales along Chapa Drive that do not provide adequate drainage for the colonia. The existing drainage pattern indicates runoff flows toward the north of the subdivision and outfalls to the Mile 9 Road swale. There are major drainage ditches along the west side and south side of the colonia. The results of the existing conditions 2D model indicate highest risk of flooding in the northern portion of the subdivision. Based on the LIDAR observations, this colonia may experience flooding from localized events, but should also be evaluated for risk of flooding due to regional storm events that may overflow the existing drain ditches into the colonia. Figures 1, 2, 3, 4, and 5 illustrate the existing and proposed inundation maps for the 2-, 5-, 10-, 25-, and 100-Year storms respectively. The color coded inundation maps illustrate the depth of flooding as follows: light blue represents a depth of 3 to 4.5 inches, blue 4.5 to 6 inches, green 6 to 9 inches, yellow 9 to 14.4 inches, orange 14.4 to 20 inches, and red more than 20 inches.

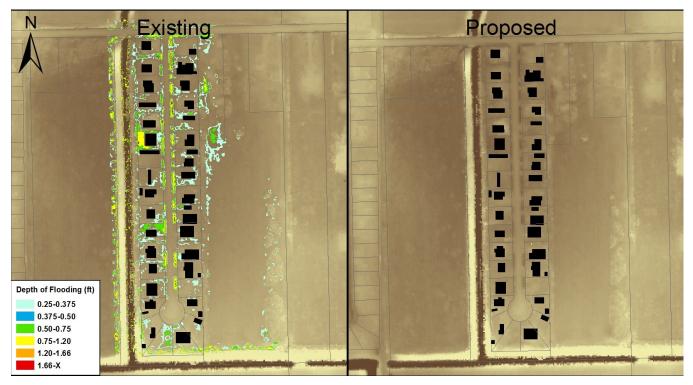
Figure 1: Existing and Proposed Conditions - 2-Yr Storm Inundation Map

50% (2-Year) Flood Recurrence	Pre-Project	Post-Project	Removed
Inundated Structures	0	0	0
Inundated Lots	34	0	34
Inundated Roadway (LF)	0	0	0

The goal of this study was to size the system to be capable of carrying up to the 10-Year storm with no inundation in the colonia. However, some structures lie within low areas of the colonia and still show risk of flooding. When comparing the 6-inch inundation maps for the 25- and 100-Year storms, it is observed that the inundation depths are lower than the existing conditions model, resulting in fewer structures at risk of being flooded once improvements are in place. Figures 1, 2, 3, 4, and 5 show the existing and proposed conditions inundation maps for the 2-, 5-, 10-, 25-, and 100-Yr storms respectively.

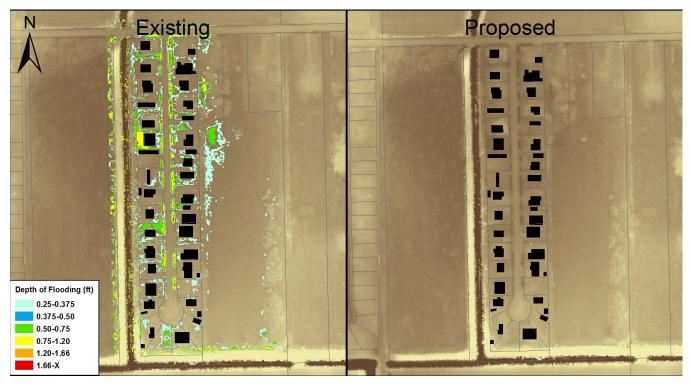
Figure 2: Existing and Proposed Conditions - 5-Yr Storm Inundation Map

20% (5-Year) Flood Recurrence	Pre-Project	Post-Project	Removed
Inundated Structures	1	0	1
Inundated Lots	34	0	34
Inundated Roadway (LF)	0	0	0

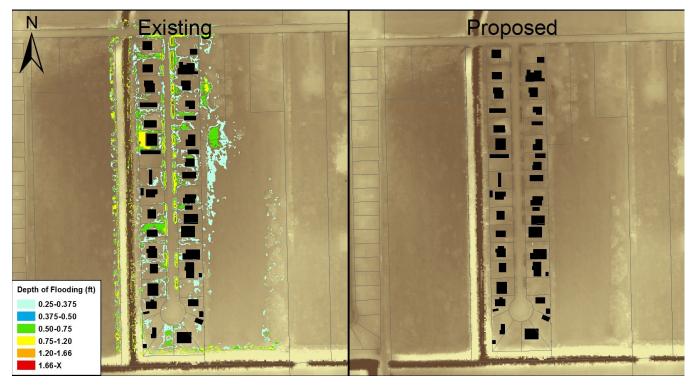
Figure 3: Existing and Proposed Conditions - 10-Yr Storm Inundation Map

10% (10-Year) Flood Recurrence	Pre-Project	Post-Project	Removed
Inundated Structures	1	0	1
Inundated Lots	34	8	26
Inundated Roadway (LF)	0	0	0

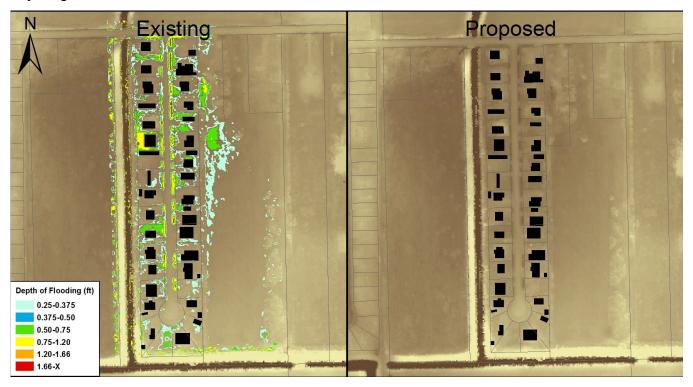
Figure 4: Existing and Proposed Conditions - 25-Yr Storm Inundation Map

4% (25-Year) Flood Recurrence	Pre-Project	Post-Project	Removed
Inundated Structures	1	0	1
Inundated Lots	34	13	21
Inundated Roadway (LF)	0	0	0

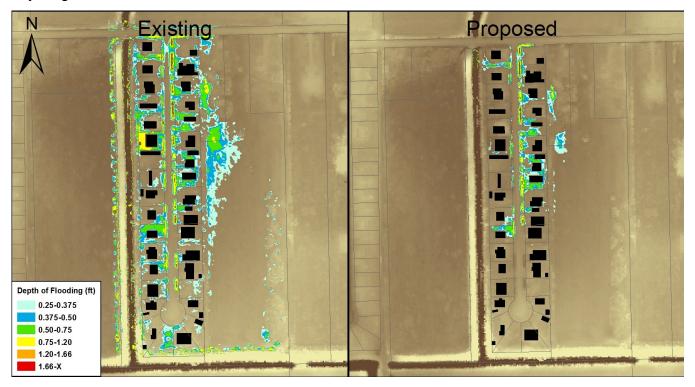
Figure 5: Existing and Proposed Conditions - 100-Yr Storm Inundation Map

1% (100-Year) Flood Recurrence	Pre-Project	Post-Project	Removed
Inundated Structures	1	0	1
Inundated Lots	34	17	17
Inundated Roadway (LF)	0	0	0

- 1. The number of inundated structures are based strictly on finished floor elevations compared to computed water surface elevations.
- 2. The inundation maps above only display flooding depths greater than three inches.
- 3. The number of inundated lots are based strictly on the inundation maps above and therefore do not count as inundated if the depth of flooding is less than three inches.

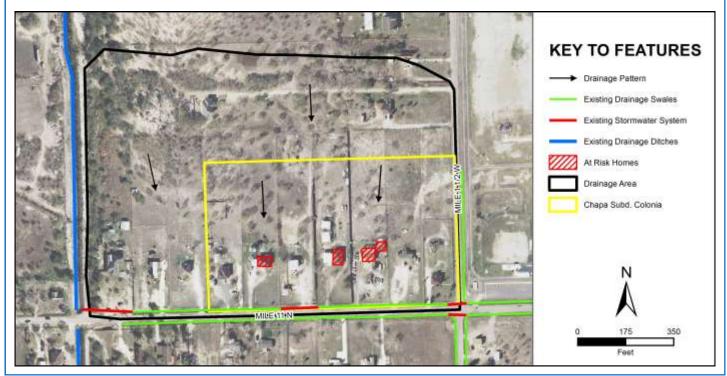
Drainage patterns within this 12-acre colonia are generally to the south. The existing drainage system consists of roadside swales that are generally undersized and restricted by sediment and vegetation. Chapa Subdivision experiences residential lot, street, and structure flooding in nearly every rainfall event. Figures 1-5 illustrate the existing and proposed conditions inundation maps for the 2-, 5-, 10-, 25-, and 100-year storms, respectively. These maps illustrate the depth of flooding as follows: light blue represents a depth of 3 to 6 inches, blue 6 to 9 inches, green 9 to 12 inches, yellow 1 to 2 feet, orange 2 to 3 feet, and red more than 3 feet.

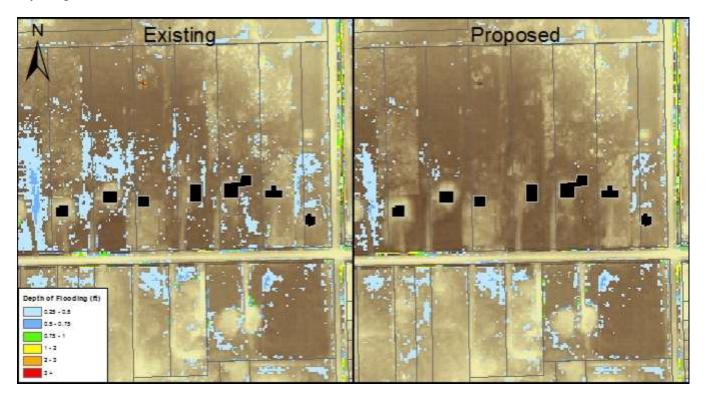
Figure 1: Existing and Proposed Conditions - 2-yr Storm Inundation Map

The goal of this study was to size the system to be capable of carrying up to the 10-Year storm runoff with no inundation in the colonia. However, some structures lie within low areas of the colonia and still show risk of flooding. When comparing the 6-inch inundation map for the 25- and 100-Year storms, it is observed that the inundation depths are lower than the existing conditions model, resulting in fewer structures at risk of being flooded once improvements are in place. Figures 1, 2, 3, 4, and 5 show the existing and proposed conditions inundation maps for the 2-, 5-, 10-, 25-, and 100-Yr storms respectively.

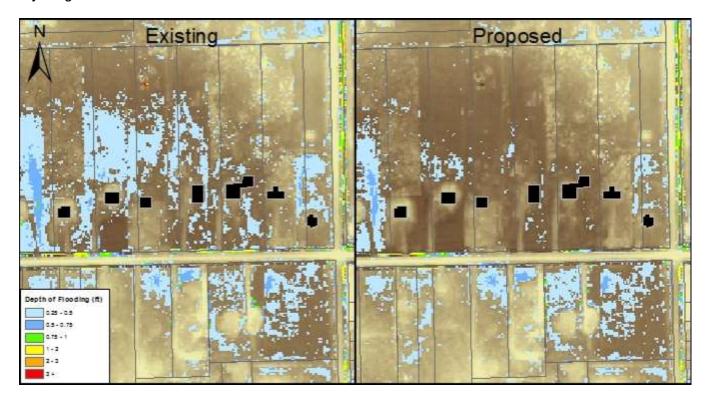
Figure 2: Existing and Proposed Conditions - 5-yr Storm Inundation Map

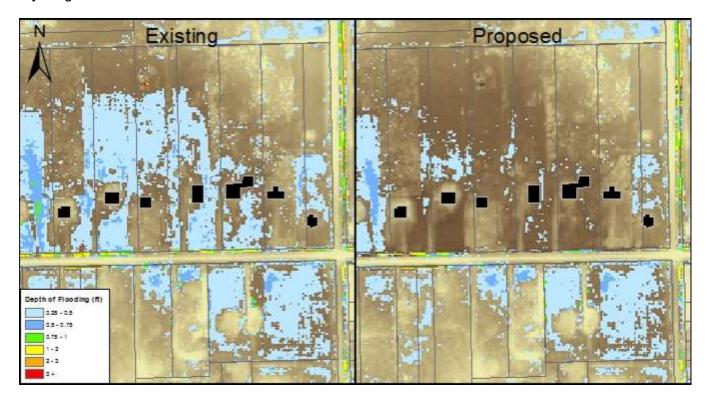
Figure 3: Existing and Proposed Conditions - 10-yr Storm Inundation Map

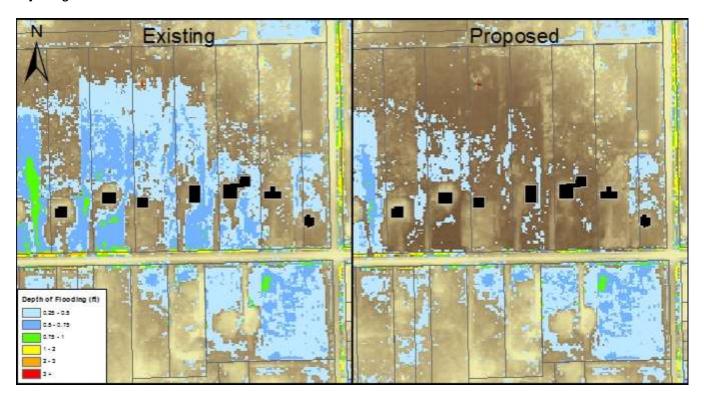
Figure 4: Existing and Proposed Conditions - 25-yr Storm Inundation Map

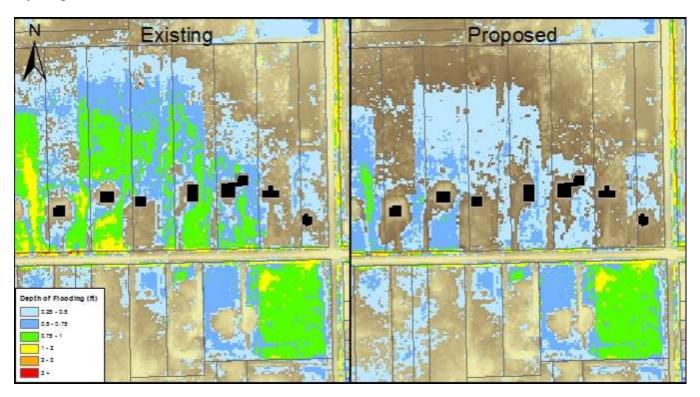
Figure 5: Existing and Proposed Conditions - 100-yr Storm Inundation Map

1% (100-Year) Flood Recurrence	Pre-Project	Post-Project	Removed
Inundated Structures	3	0	3
Inundated Lots	7	0	7
Inundated Roadway (LF)	0	0	0

- 1. The number of inundated structures are based strictly on finished floor elevations compared to computed water surface elevations.
- 2. The inundation maps above only display flooding depths greater than 3 inches.
- 3. The number of inundated lots are based strictly on the inundation maps above and therefore do not count as inundated if the depth of flooding is less than 3 inches.

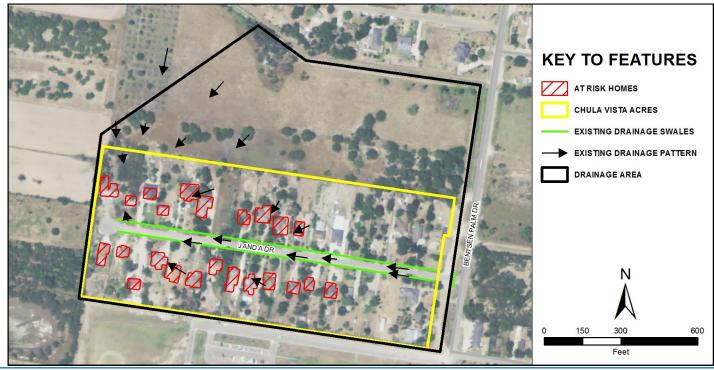
Chula Vista Acres consists of approximately 19.8 acres with an additional contributing drainage basin of approximately 13.1 acres. The current drainage system consists of swales and culverts that appear to drain toward Bentsen Palm Drive. The model results indicate that the current drainage system does not adequately carry the storm runoff even when subjected to the 10-Year storm and smaller storm events. Figures 1, 2, 3, 4, and 5 illustrate the existing and proposed inundation maps for the 2-, 5-, 10-, 25-, and 100-Year storms respectively. The color coded inundation maps illustrate the depth of flooding as follows: light blue represents a depth of 6 to 8 inches, blue 8 to 12 inches, green 12 to 18 inches, yellow 18 to 24 inches, orange 24 to 30 inches and red more than 30 inches.

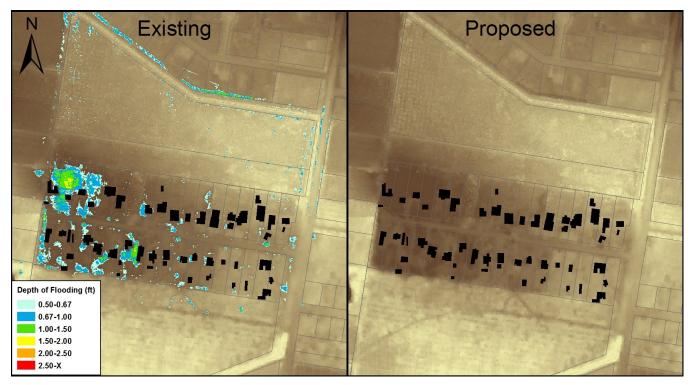
Figure 1: Existing and Proposed Conditions - 2-Yr Storm Inundation Map

50% (2-Year) Flood Recurrence	Pre-Project	Post-Project	Removed
Inundated Structures	17	8	9
Inundated Lots	36	0	36
Inundated Roadway (LF)	0	0	0

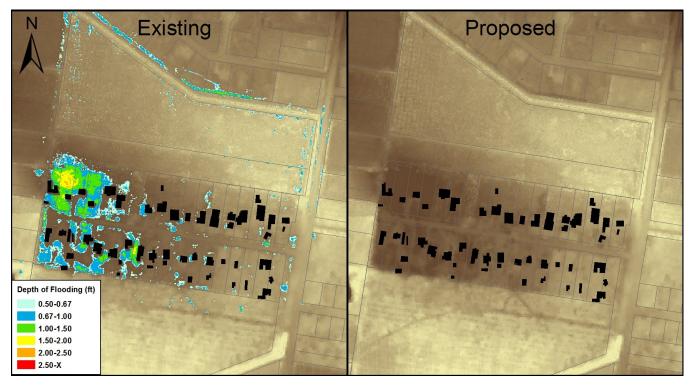
Figure 2: Existing and Proposed Conditions - 5-Yr Storm Inundation Map

20% (5-Year) Flood Recurrence	Pre-Project	Post-Project	Removed
Inundated Structures	17	8	9
Inundated Lots	36	0	36
Inundated Roadway (LF)	0	0	0

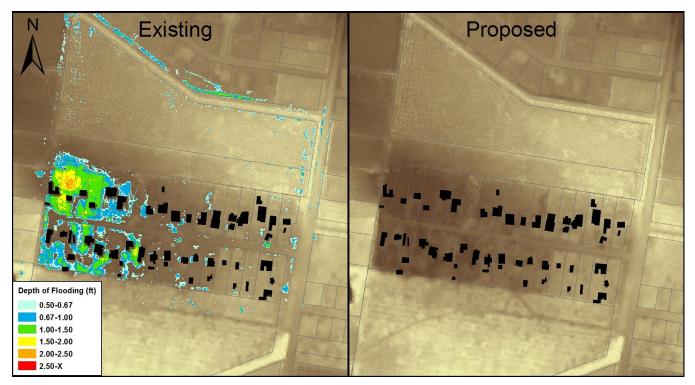
Figure 3: Existing and Proposed Conditions - 10-Yr Storm Inundation Map

10% (10-Year) Flood Recurrence	Pre-Project	Post-Project	Removed
Inundated Structures	19	8	11
Inundated Lots	36	0	36
Inundated Roadway (LF)	14	0	14

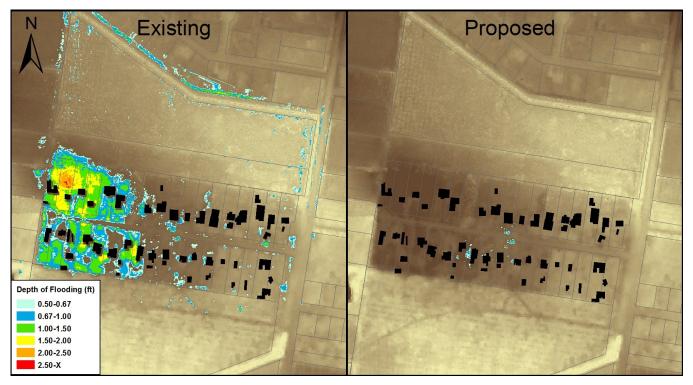
Figure 4: Existing and Proposed Conditions - 25-Yr Storm Inundation Map

4% (25-Year) Flood Recurrence	Pre-Project	Post-Project	Removed
Inundated Structures	20	9	11
Inundated Lots	36	8	28
Inundated Roadway (LF)	135	0	135
