STORMWATER DRAINAGE PLANNING

The Colonias of the Lower Rio Grande Valley (LRGV)

Phase 2 Report

JSW & Associates, Inc. Hazard Mitigation Consultants

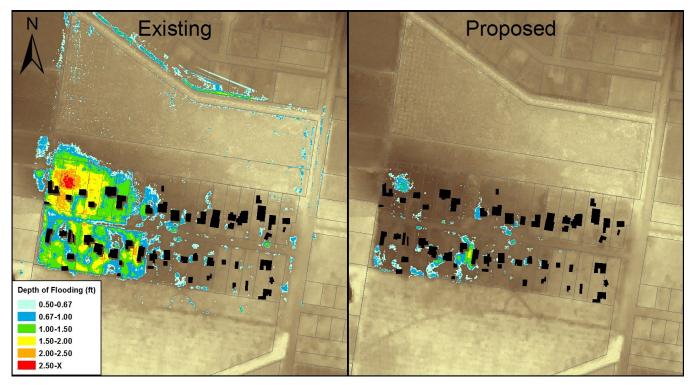
Figure 5: Existing and Proposed Conditions - 100-Yr Storm Inundation Map

1% (100-Year) Flood Recurrence	Pre-Project	Post-Project	Removed
Inundated Structures	21	17	4
Inundated Lots	36	26	10
Inundated Roadway (LF)	416	0	416

- 1. The number of inundated structures are based strictly on finished floor elevations compared to computed water surface elevations.
- 2. The inundation maps above only display flooding depths greater than six inches.
- 3. The number of inundated lots are based strictly on the inundation maps above and therefore do not count as inundated if the depth of flooding is less than six inches.

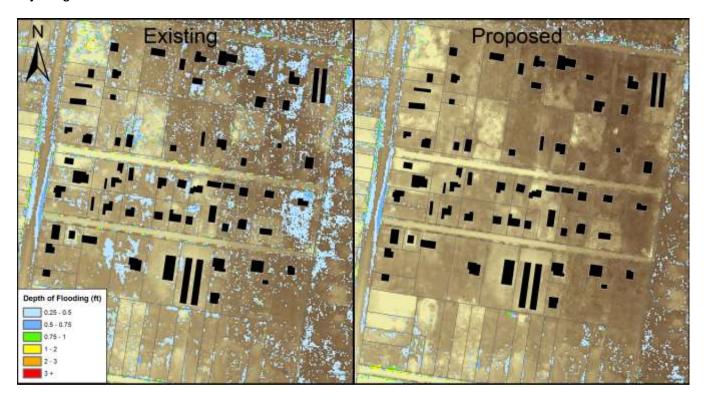
Figure 1: Existing and Proposed Conditions - 2-yr Storm Inundation Map

The goal of this study was to size the system to be capable of carrying up to the 10-Year storm runoff with no inundation in the colonia. However, some structures lie within low areas of the colonia and still show risk of flooding. When comparing the 6-inch inundation map for the 25- and 100-Year storms, it is observed that the inundation depths are lower than the existing conditions model, resulting in fewer structures at risk of being flooded once improvements are in place. Figures 1, 2, 3, 4, and 5 show the existing and proposed conditions inundation maps for the 2-, 5-, 10-, 25-, and 100-Yr storms respectively.

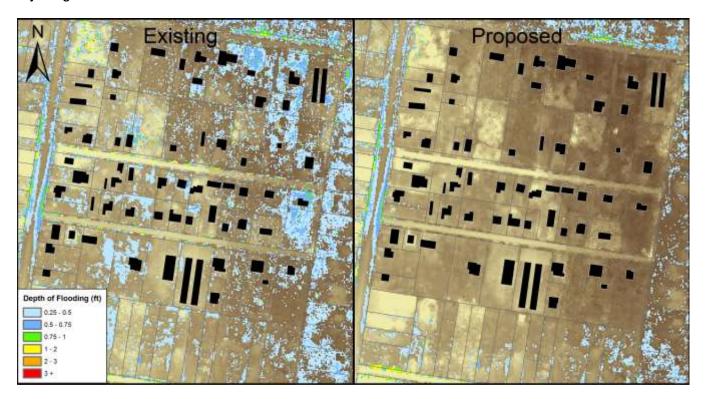
Figure 2: Existing and Proposed Conditions - 5-yr Storm Inundation Map

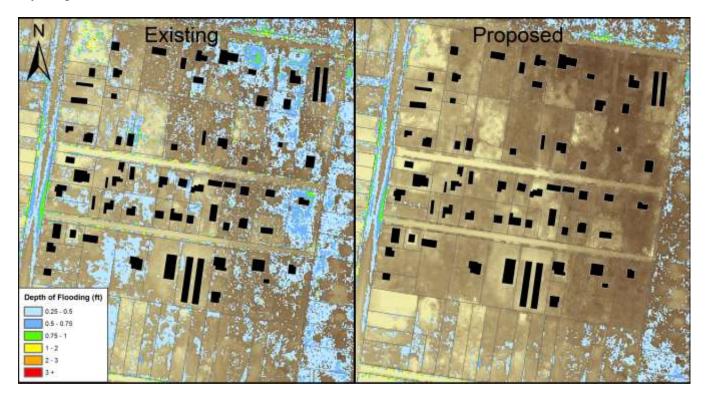
Figure 3: Existing and Proposed Conditions - 10-yr Storm Inundation Map

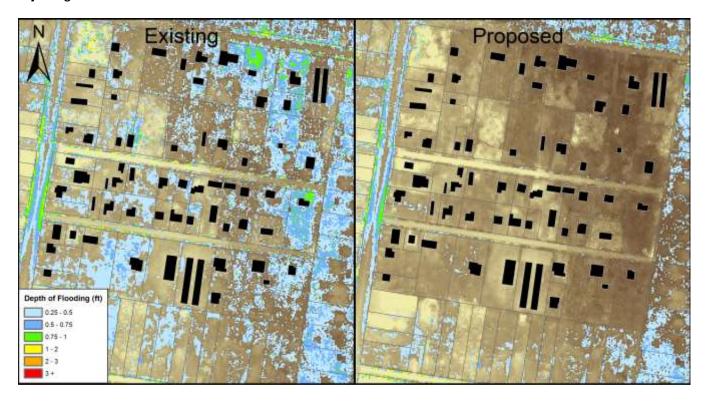
Figure 4: Existing and Proposed Conditions - 25-yr Storm Inundation Map

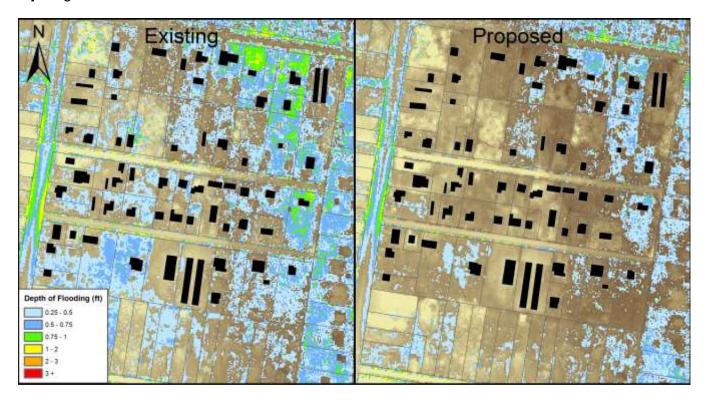
Figure 5: Existing and Proposed Conditions - 100-yr Storm Inundation Map

1% (100-Year) Flood Recurrence	Pre-Project	Post-Project	Removed
Inundated Structures	34	8	26
Inundated Lots	58	39	19
Inundated Roadway (LF)	635	395	240

- 1. The number of inundated structures are based strictly on finished floor elevations compared to computed water surface elevations.
- 2. The inundation maps above only display flooding depths greater than 3 inches.
- 3. The number of inundated lots are based strictly on the inundation maps above and therefore do not count as inundated if the depth of flooding is less than 3 inches.

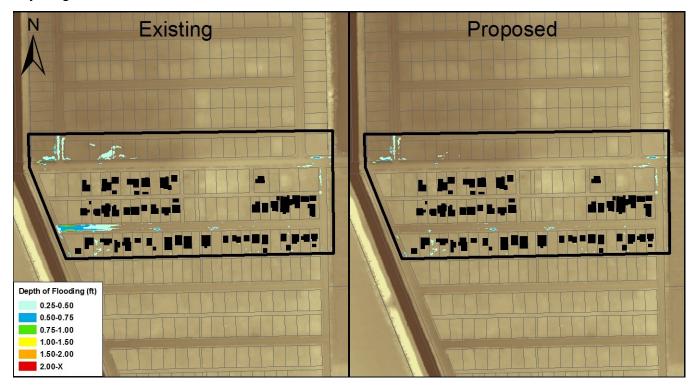
Figure 1: Existing and Proposed Conditions - 2-Yr Storm Inundation Map

50% (2-Year) Flood Recurrence	Pre-Project	Post-Project	Removed
Inundated Structures	0	0	0
Inundated Lots	15	14	1
Inundated Roadway (LF)	270	0	270

The goal of this study was to size the system to be capable of carrying up to the 10-Year storm with no inundation in the colonia. However, some structures lie within low areas of the colonia and still show risk of flooding. When comparing the 6-inch inundation maps for the 25- and 100-Year storms, it is observed that the inundation depths are lower than the existing conditions model, resulting in less overall ponding and the street is at lower risk of being flooded once improvements are in place. Figures 1, 2, 3, 4, and 5 show the existing and proposed conditions inundation maps for the 2-, 5-, 10-, 25-, and 100-Yr storms respectively.

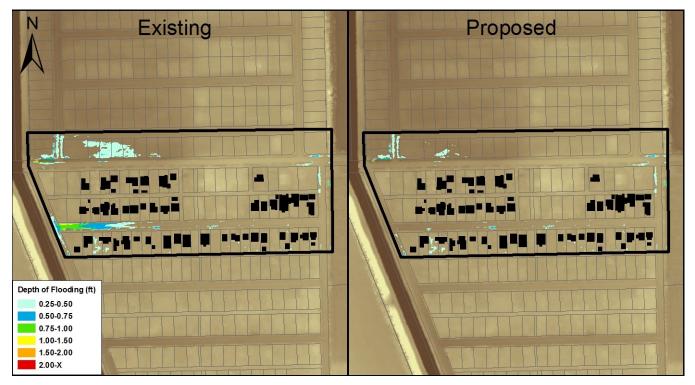
Figure 2: Existing and Proposed Conditions - 5-Yr Storm Inundation Map

20% (5-Year) Flood Recurrence	Pre-Project	Post-Project	Removed
Inundated Structures	0	0	0
Inundated Lots	15	14	1
Inundated Roadway (LF)	360	0	360

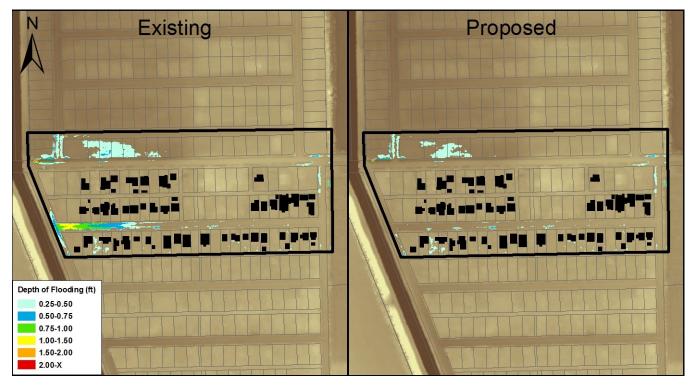
Figure 3: Existing and Proposed Conditions - 10-Yr Storm Inundation Map

10% (10-Year) Flood Recurrence	Pre-Project	Post-Project	Removed
Inundated Structures	0	0	0
Inundated Lots	16	14	2
Inundated Roadway (LF)	393	0	393

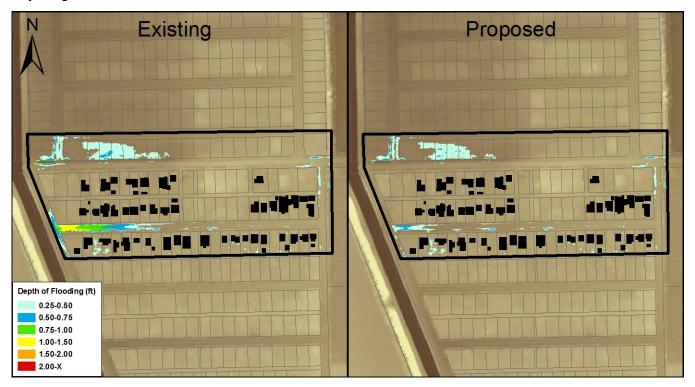
Figure 4: Existing and Proposed Conditions - 25-Yr Storm Inundation Map

4% (25-Year) Flood Recurrence	Pre-Project	Post-Project	Removed
Inundated Structures	0	0	0
Inundated Lots	18	17	1
Inundated Roadway (LF)	423	141	282

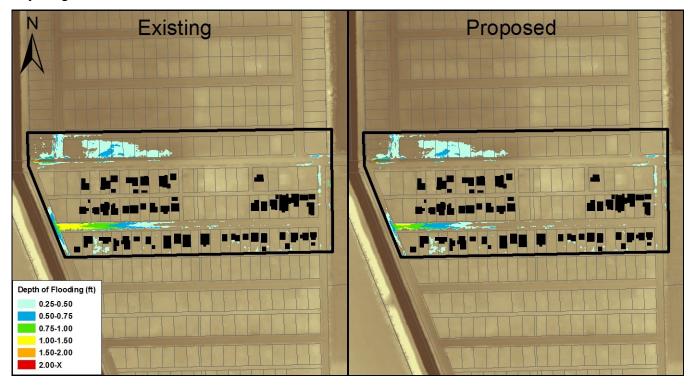
Figure 5: Existing and Proposed Conditions - 100-Yr Storm Inundation Map

1% (100-Year) Flood Recurrence	Pre-Project	Post-Project	Removed
Inundated Structures	0	0	0
Inundated Lots	20	18	2
Inundated Roadway (LF)	502	380	122

- 1. The number of inundated structures are based strictly on finished floor elevations compared to computed water surface elevations.
- 2. The inundation maps above only display flooding depths greater than three inches.
- 3. The number of inundated lots are based strictly on the inundation maps above and therefore do not count as inundated if the depth of flooding is less than three inches.

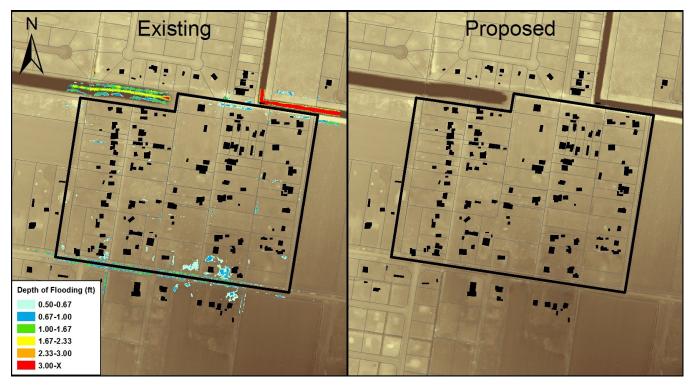
Figure 1: Existing and Proposed Conditions - 2-Yr Storm Inundation Map

50% (2-Year) Flood Recurrence	Pre-Project	Post-Project	Removed
Inundated Structures	2	1	1
Inundated Lots	37	0	37
Inundated Roadway (LF)	0	0	0

El Gato consists of approximately 49.6 acres and currently does not have a drainage system. The model results indicate most high-risk flooding areas are along the west and south portions of the colonia. Figures 1, 2, 3, 4, and 5 illustrate the existing and proposed inundation maps for the 2-, 5-, 10-, 25-, and 100-Year storms respectively. The color coded inundation maps illustrate the depth of flooding as follows: light blue represents a depth of 6 to 8 inches, blue 8 to 12, green 12 to 20 inches, yellow 20 to 28 inches, orange 28 to 36 inches and red more than 36 inches.

The goal of this study was to size the system to be capable of carrying up to the 10-Year storm with no inundation in the colonia. However, some structures lie within low areas of the colonia and still show risk of flooding. When comparing the 6-inch inundation maps for the 25- and 100-Year storms, it is observed that the inundation depths are lower than the existing conditions model, resulting in fewer structures at risk of being flooded once improvements are in place. Figures 1, 2, 3, 4, and 5 show the existing and proposed conditions inundation maps for the 2-, 5-, 10-, 25-, and 100-Yr storms respectively.

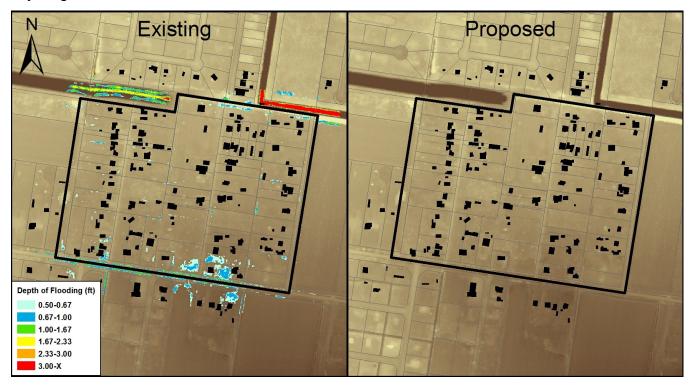
Figure 2: Existing and Proposed Conditions - 5-Yr Storm Inundation Map

20% (5-Year) Flood Recurrence	Pre-Project	Post-Project	Removed
Inundated Structures	2	1	1
Inundated Lots	41	0	41
Inundated Roadway (LF)	0	0	0

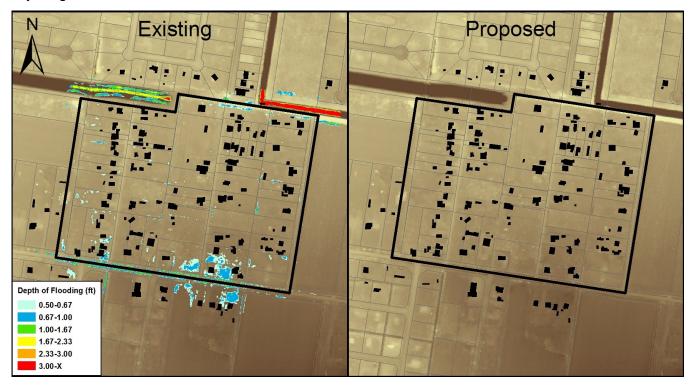
Figure 3: Existing and Proposed Conditions - 10-Yr Storm Inundation Map

10% (10-Year) Flood Recurrence	Pre-Project	Post-Project	Removed
Inundated Structures	2	1	1
Inundated Lots	43	0	43
Inundated Roadway (LF)	0	0	0

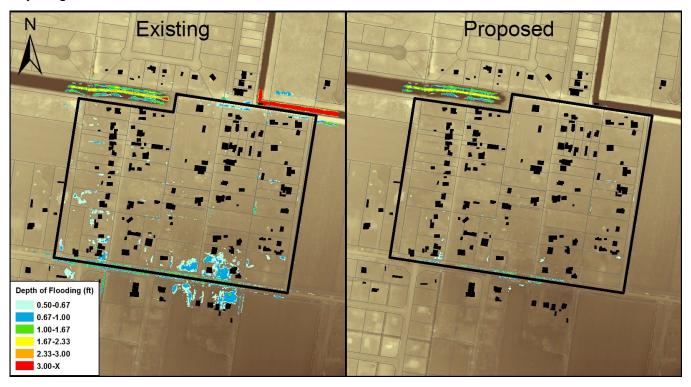
Figure 4: Existing and Proposed Conditions - 25-Yr Storm Inundation Map

4% (25-Year) Flood Recurrence	Pre-Project	Post-Project	Removed
Inundated Structures	3	1	2
Inundated Lots	48	18	30
Inundated Roadway (LF)	0	0	0

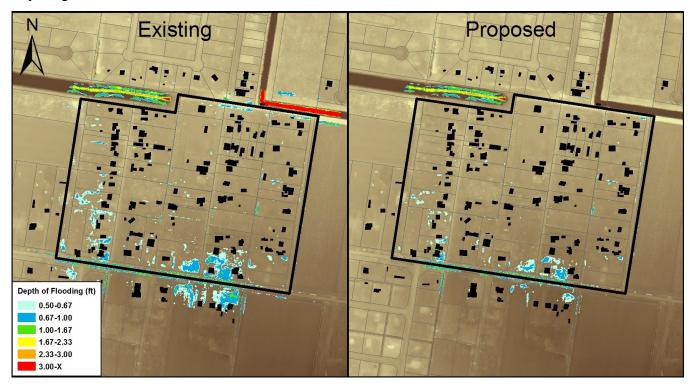
Figure 5: Existing and Proposed Conditions - 100-Yr Storm Inundation Map

1% (100-Year) Flood Recurrence	Pre-Project	Post-Project	Removed
Inundated Structures	4	2	2
Inundated Lots	51	34	17
Inundated Roadway (LF)	0	0	0

- 1. The number of inundated structures are based strictly on finished floor elevations compared to computed water surface elevations.
- 2. The inundation maps above only display flooding depths greater than six inches.
- 3. The number of inundated lots are based strictly on the inundation maps above and therefore do not count as inundated if the depth of flooding is less than six inches.

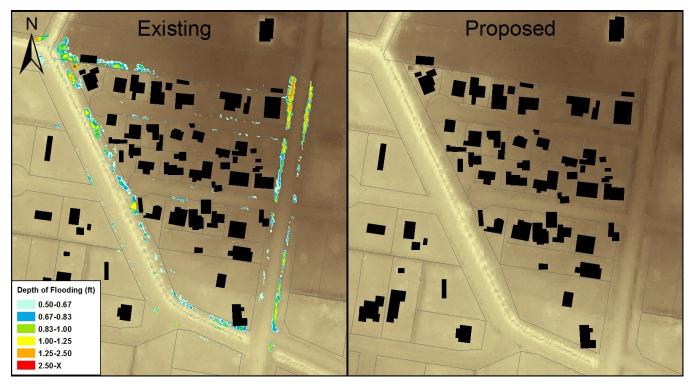
Figure 1: Existing and Proposed Conditions - 2-Yr Storm Inundation Map

50% (2-Year) Flood Recurrence	Pre-Project	Post-Project	Removed
Inundated Structures	6	3	3
Inundated Lots	22	0	22
Inundated Roadway (LF)	0	0	0

Enrique Bazan Subdivision consists of approximately 10 acres of which approximately 1.7 acres are within the 100-Year floodplain. The model results indicate runoff flows toward the northeast corner of the colonia, however high-risk flooding areas were identified throughout the colonia. Figures 1, 2, 3, 4, and 5 illustrate the existing and proposed inundation maps for the 2-, 5-, 10-, 25-, and 100-Year storms respectively. The color coded inundation maps illustrate the depth of flooding as follows: light blue represents a depth of 6 to 8 inches, blue 8 to 10 inches, green 10 to 12 inches, yellow 12 to 15 inches, orange 15 to 30 inches, and red more than 30 inches.

The goal of this study was to size the system to be capable of carrying up to the 10-Year storm with no inundation in the colonia. However, some structures lie within low areas of the colonia and still show risk of flooding. When comparing the 6-inch inundation maps for the 25- and 100-Year storms, it is observed that the inundation depths are lower than the existing conditions model, resulting in fewer structures at risk of being flooded once improvements are in place. Figures 1, 2, 3, 4, and 5 show the existing and proposed conditions inundation maps for the 2-, 5-, 10-, 25-, and 100-Yr storms respectively.

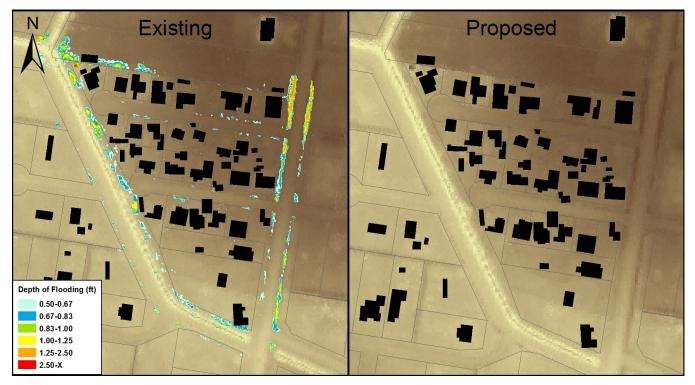
Figure 2: Existing and Proposed Conditions - 5-Yr Storm Inundation Map

20% (5-Year) Flood Recurrence	Pre-Project	Post-Project	Removed
Inundated Structures	6	3	3
Inundated Lots	22	0	22
Inundated Roadway (LF)	0	0	0

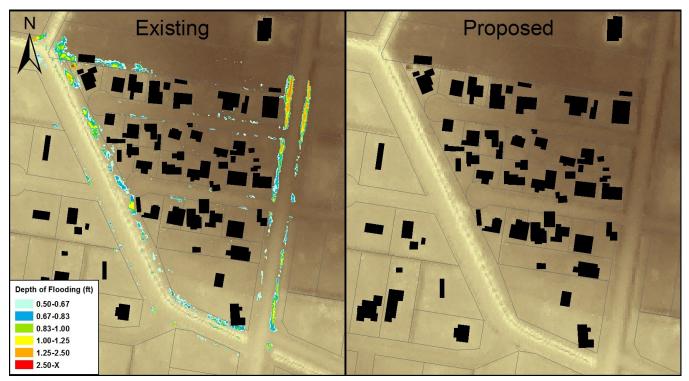
Figure 3: Existing and Proposed Conditions - 10-Yr Storm Inundation Map

10% (10-Year) Flood Recurrence	Pre-Project	Post-Project	Removed
Inundated Structures	6	3	3
Inundated Lots	22	0	22
Inundated Roadway (LF)	0	0	0

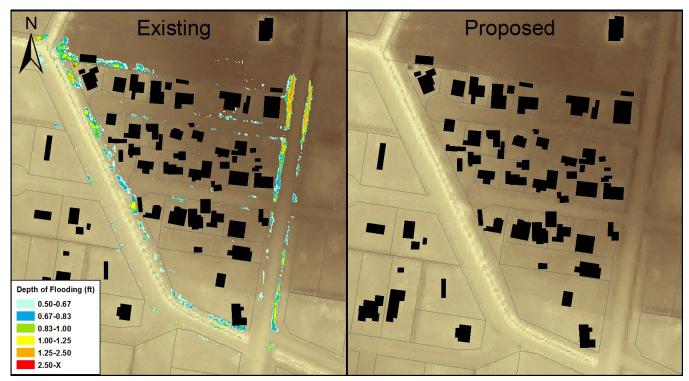
Figure 4: Existing and Proposed Conditions - 25-Yr Storm Inundation Map

4% (25-Year) Flood Recurrence	Pre-Project	Post-Project	Removed
Inundated Structures	6	3	3
Inundated Lots	22	0	22
Inundated Roadway (LF)	0	0	0

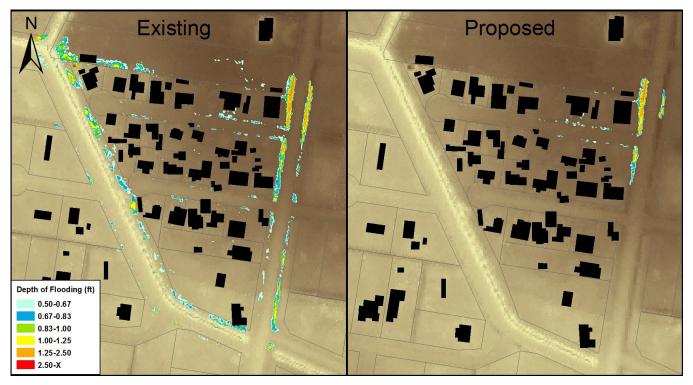
Figure 5: Existing and Proposed Conditions - 100-Yr Storm Inundation Map

1% (100-Year) Flood Recurrence	Pre-Project	Post-Project	Removed
Inundated Structures	6	4	2
Inundated Lots	22	7	15
Inundated Roadway (LF)	0	0	0

- 1. The number of inundated structures are based strictly on finished floor elevations compared to computed water surface elevations.
- 2. The inundation maps above only display flooding depths greater than six inches.
- 3. The number of inundated lots are based strictly on the inundation maps above and therefore do not count as inundated if the depth of flooding is less than six inches.

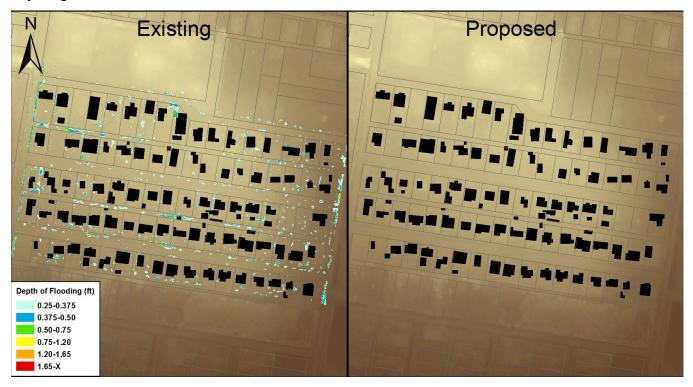
Figure 1: Existing and Proposed Conditions - 2-Yr Storm Inundation Map

50% (2-Year) Flood Recurrence	Pre-Project	Post-Project	Removed
Inundated Structures	0	0	0
Inundated Lots	88	0	88
Inundated Roadway (LF)	0	0	0

The goal of this study was to size the system to be capable of carrying up to the 10-Year storm with no inundation in the colonia. However, some structures lie within low areas of the colonia and still show risk of flooding. When comparing the 6-inch inundation maps for the 25- and 100-Year storms, it is observed that the inundation depths are lower than the existing conditions model, resulting in fewer structures at risk of being flooded once improvements are in place. Figures 1, 2, 3, 4, and 5 show the existing and proposed conditions inundation maps for the 2-, 5-, 10-, 25-, and 100-Yr storms respectively.

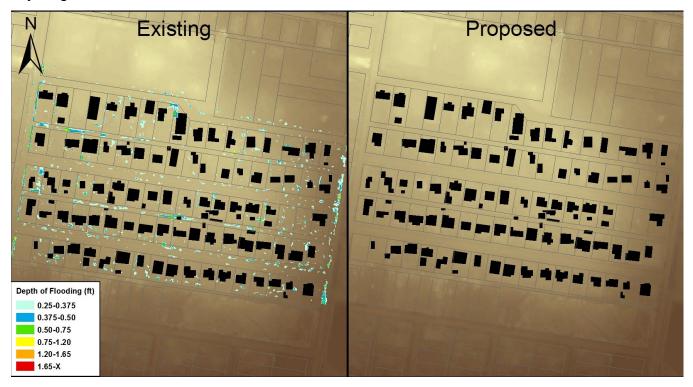
Figure 2: Existing and Proposed Conditions - 5-Yr Storm Inundation Map

20% (5-Year) Flood Recurrence	Pre-Project	Post-Project	Removed
Inundated Structures	1	0	1
Inundated Lots	88	0	88
Inundated Roadway (LF)	0	0	0

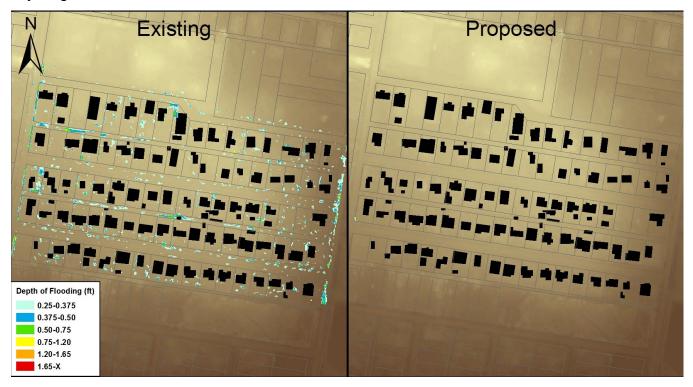
Figure 3: Existing and Proposed Conditions - 10-Yr Storm Inundation Map

10% (10-Year) Flood Recurrence	Pre-Project	Post-Project	Removed
Inundated Structures	2	0	2
Inundated Lots	88	1	87
Inundated Roadway (LF)	0	0	0

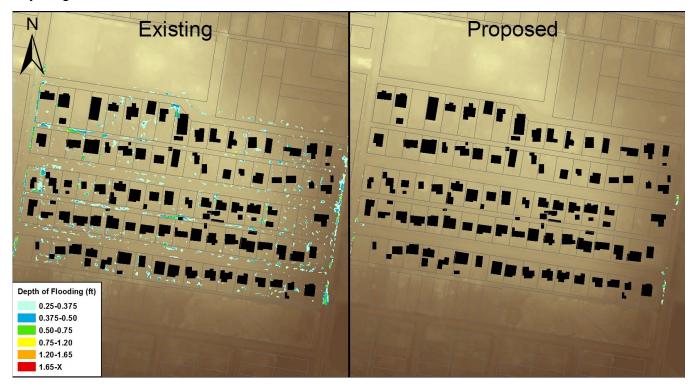
Figure 4: Existing and Proposed Conditions - 25-Yr Storm Inundation Map

4% (25-Year) Flood Recurrence	Pre-Project	Post-Project	Removed
Inundated Structures	2	0	2
Inundated Lots	88	3	85
Inundated Roadway (LF)	0	0	0

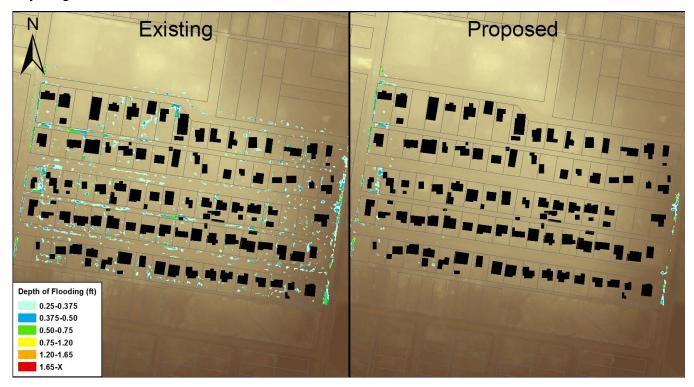
Figure 5: Existing and Proposed Conditions - 100-Yr Storm Inundation Map

1% (100-Year) Flood Recurrence	Pre-Project	Post-Project	Removed
Inundated Structures	2	0	2
Inundated Lots	89	13	76
Inundated Roadway (LF)	0	0	0

- 1. The number of inundated structures are based strictly on finished floor elevations compared to computed water surface elevations.
- 2. The inundation maps above only display flooding depths greater than three inches.
- 3. The number of inundated lots are based strictly on the inundation maps above and therefore do not count as inundated if the depth of flooding is less than three inches.

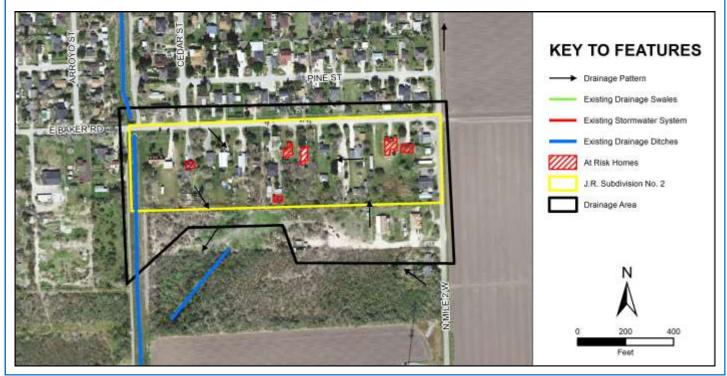
Drainage patterns within this 11-acre colonia are generally to the south and east. The existing drainage system consists of a small stormwater system and roadside swales that are generally undersized and restricted by sediment and vegetation. J.R. Subdivision No. 2 experiences residential lot, street, and structure flooding in nearly every rainfall event. Figures 1-5 illustrate the existing and proposed conditions inundation maps for the 2-, 5-, 10-, 25-, and 100-year storms, respectively. These maps illustrate the depth of flooding as follows: light blue represents a depth of 3 to 6 inches, blue 6 to 9 inches, green 9 to 12 inches, yellow 1 to 2 feet, orange 2 to 3 feet, and red more than 3 feet.

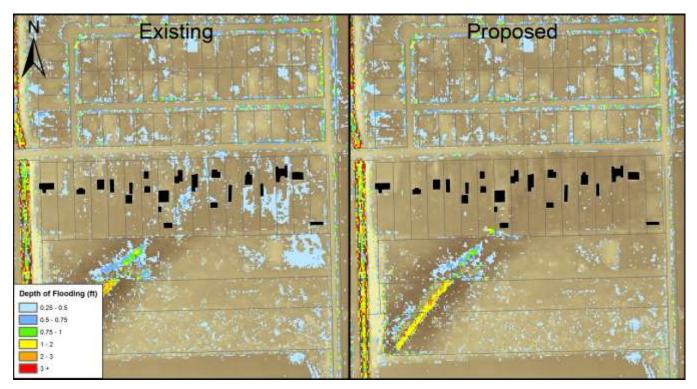
Figure 1: Existing and Proposed Conditions - 2-yr Storm Inundation Map

The goal of this study was to size the system to be capable of carrying up to the 10-Year storm runoff with no inundation in the colonia. However, some structures lie within low areas of the colonia and still show risk of flooding. When comparing the 6-inch inundation map for the 25- and 100-Year storms, it is observed that the inundation depths are lower than the existing conditions model, resulting in fewer structures at risk of being flooded once improvements are in place. Figures 1, 2, 3, 4, and 5 show the existing and proposed conditions inundation maps for the 2-, 5-, 10-, 25-, and 100-Yr storms respectively.

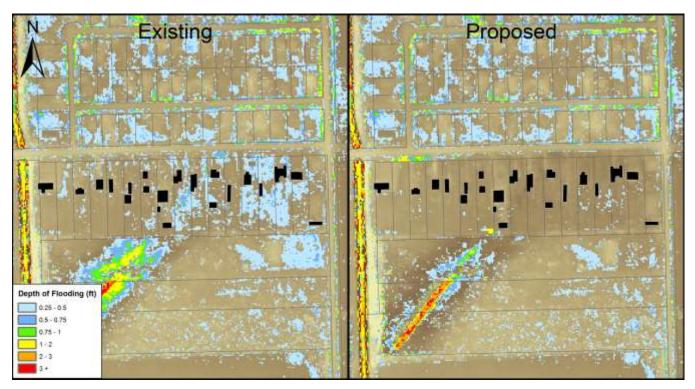
Figure 2: Existing and Proposed Conditions - 5-yr Storm Inundation Map

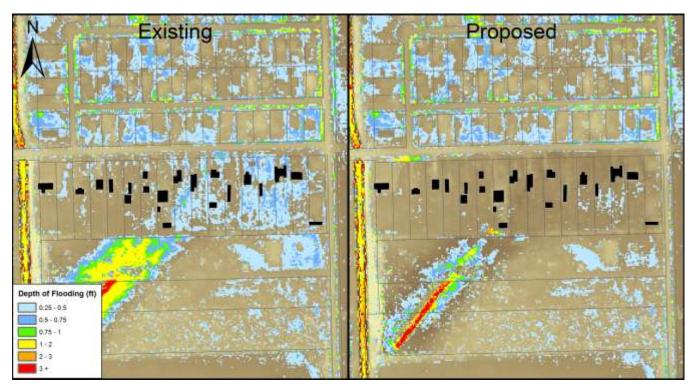
Figure 3: Existing and Proposed Conditions - 10-yr Storm Inundation Map

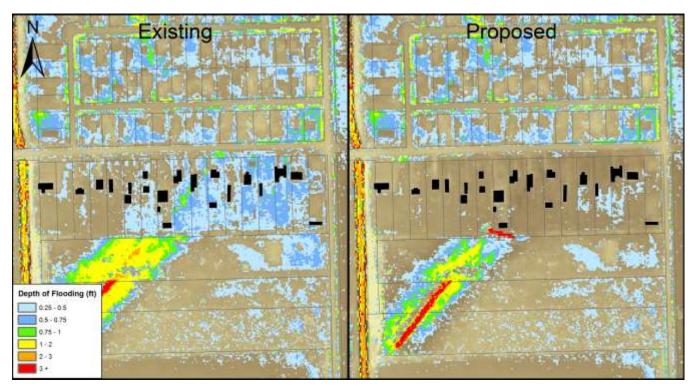
Figure 4: Existing and Proposed Conditions - 25-yr Storm Inundation Map

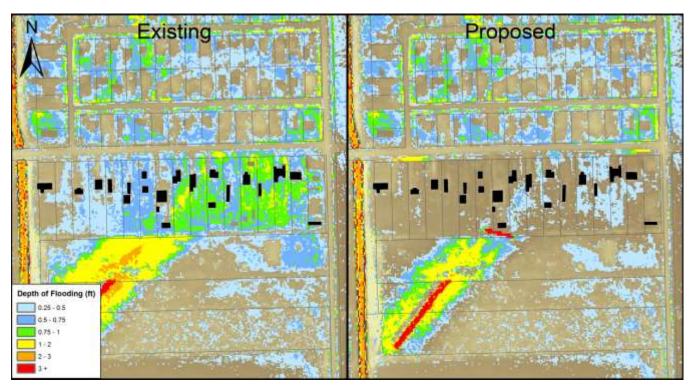
Figure 5: Existing and Proposed Conditions - 100-yr Storm Inundation Map

1% (100-Year) Flood Recurrence	Pre-Project	Post-Project	Removed
Inundated Structures	6	1	5
Inundated Lots	17	17	0
Inundated Roadway (LF)	45	0	45

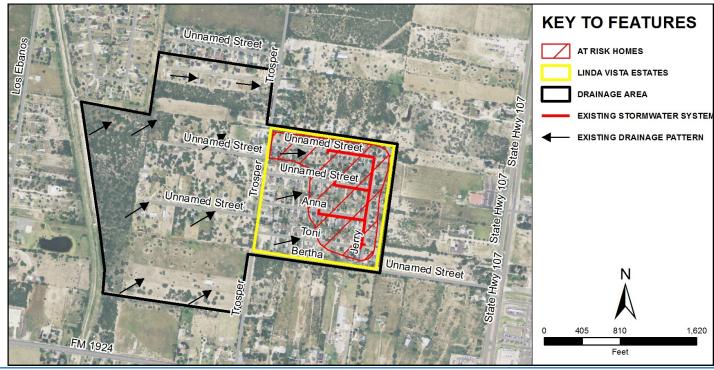
The colonia is relatively flat and receives waters from the west basins that flow over Trosper Rd. into the residential streets. The existing drainage system consists of 11 inlets and 2,850 linear feet of 18-inch diameter pipe draining a total of 40 acres of onsite runoff plus the offsite runoff of an additional 100 acres to the west of the colonia. The model results indicate that the current capacity of the existing drain system is clearly insufficient to adequately carry the storm runoff within the underground system even when subjected to the 10 year storm and smaller ones. Figures 1, 2, 3, 4, and 5 illustrate the existing and proposed inundation maps for the 2-, 5-, 10-, 25-, and 100-Year storms respectively, as the underground system became hydraulically surcharged and incapable of carrying the storm runoff. The color coded inundation maps illustrate the depth of flooding as follows: light blue represents a depth of 6 to 8 inches, blue 8 to 10 inches, green 10 to 12 inches, yellow 12 to 15 inches, orange 15 to 18 inches and red more than 18 inches.

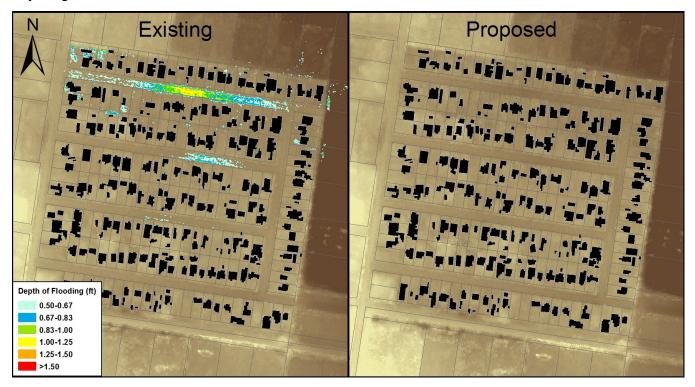
Figure 1: Existing and Proposed Conditions - 2-Yr Storm Inundation Map

50% (2-Year) Flood Recurrence	Pre-Project	Post-Project	Removed
Inundated Structures	15	0	15
Inundated Lots	58	0	58
Inundated Roadway (LF)	890	0	890

The goal of this study was to size the system to be capable of carrying up to the 10-Year storm with no inundation in the colonia. However, some structures lie within low areas of the colonia and still show risk of flooding. When comparing the 6-inch inundation maps for the 25- and 100-Year storms, it is observed that the inundation depths are lower than the existing conditions model, resulting in fewer structures at risk of being flooded once improvements are in place. Figures 1, 2, 3, 4, and 5 show the existing and proposed conditions inundation maps for the 2-, 5-, 10-, 25-, and 100-Yr storms respectively.

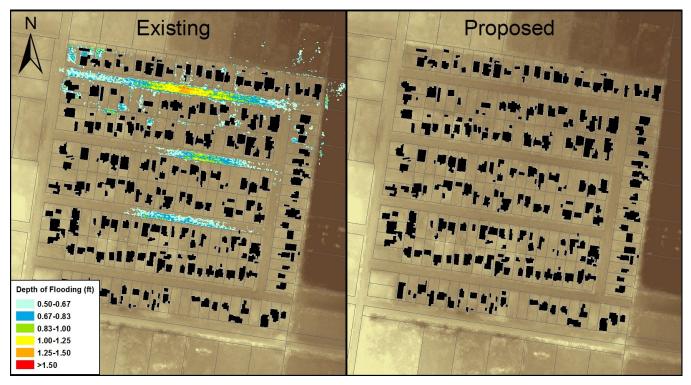
Figure 2: Existing and Proposed Conditions - 5-Yr Storm Inundation Map

20% (5-Year) Flood Recurrence	Pre-Project	Post-Project	Removed
Inundated Structures	23	0	23
Inundated Lots	77	0	77
Inundated Roadway (LF)	1885	0	1885

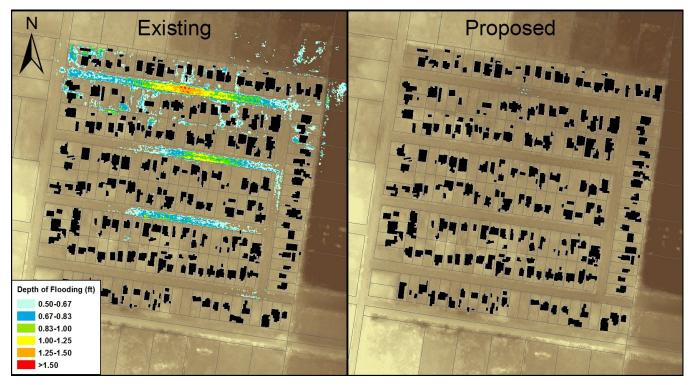
Figure 3: Existing and Proposed Conditions - 10-Yr Storm Inundation Map

10% (10-Year) Flood Recurrence	Pre-Project	Post-Project	Removed
Inundated Structures	25	0	25
Inundated Lots	101	0	101
Inundated Roadway (LF)	2132	0	2132

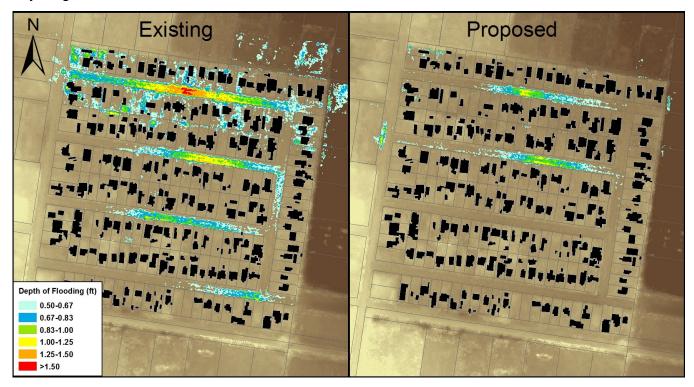
Figure 4: Existing and Proposed Conditions - 25-Yr Storm Inundation Map

4% (25-Year) Flood Recurrence	Pre-Project	Post-Project	Removed
Inundated Structures	28	5	23
Inundated Lots	110	41	69
Inundated Roadway (LF)	2890	970	1920

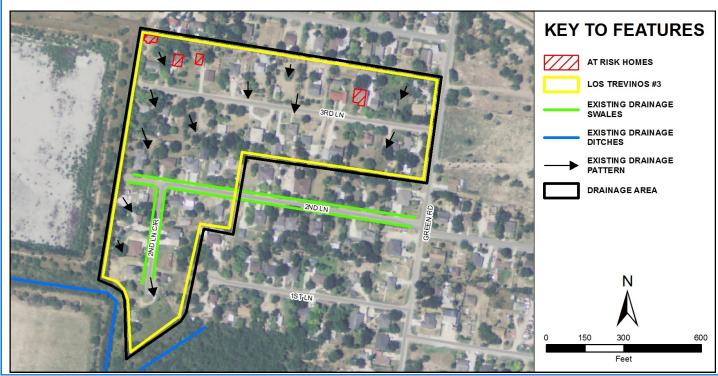
Los Trevinos #3 consist of approximately 18 acres of residential developed land. The existing swales and culverts currently do not provide adequate drainage for the subdivision. There is an existing major drainage ditch that runs along the southwest corner of the colonia. The existing drainage pattern indicates runoff flows toward the south, however the existing conditions 2D model results indicate that there are some areas at risk of flooding in the northern portion of the subdivision. This may be attributed to low lots or drainage obstructions. Based on LIDAR observations, this colonia may experience flooding from localized events, but should also be evaluated for risk of flooding due to regional storm events that may overflow the existing drain ditch into the colonia. Figures 1, 2, 3, 4, and 5 illustrate the existing and proposed inundation maps for the 2-, 5-, 10-, 25-, and 100-Year storms respectively. The color coded inundation maps illustrate the depth of flooding as follows: light blue represents a depth of 3 to 4.5 inches, blue 4.5 to 6 inches, green 6 to 9 inches, yellow 9 to 12 inches, orange 12 to 15 inches, and red more than 15 inches.

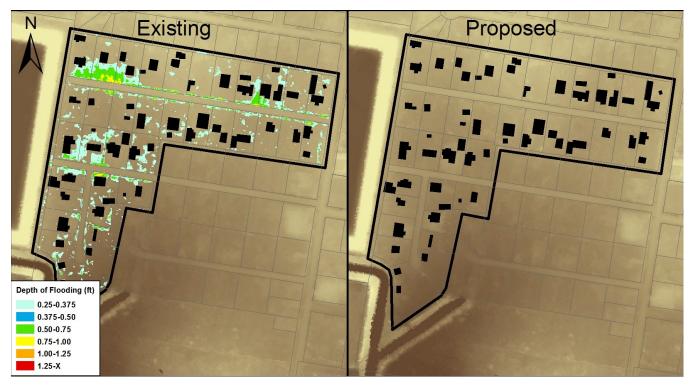
Figure 1: Existing and Proposed Conditions - 2-Yr Storm Inundation Map

50% (2-Year) Flood Recurrence	Pre-Project	Post-Project	Removed
Inundated Structures	2	0	2
Inundated Lots	35	0	35
Inundated Roadway (LF)	0	0	0

The goal of this study was to size the system to be capable of carrying up to the 10-Year storm with no inundation in the colonia. However, some structures lie within low areas of the colonia and still show risk of flooding. When comparing the 6-inch inundation maps for the 25- and 100-Year storms, it is observed that the inundation depths are lower than the existing conditions model, resulting in fewer structures at risk of being flooded once improvements are in place. Figures 1, 2, 3, 4, and 5 show the existing and proposed conditions inundation maps for the 2-, 5-, 10-, 25-, and 100-Yr storms respectively.

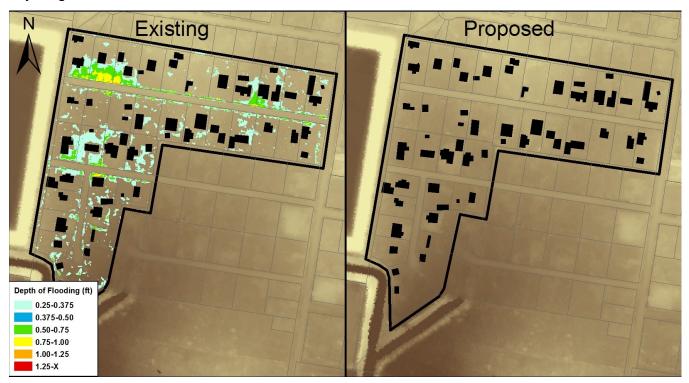
Figure 2: Existing and Proposed Conditions - 5-Yr Storm Inundation Map

20% (5-Year) Flood Recurrence	Pre-Project	Post-Project	Removed
Inundated Structures	4	0	4
Inundated Lots	35	0	35
Inundated Roadway (LF)	0	0	0

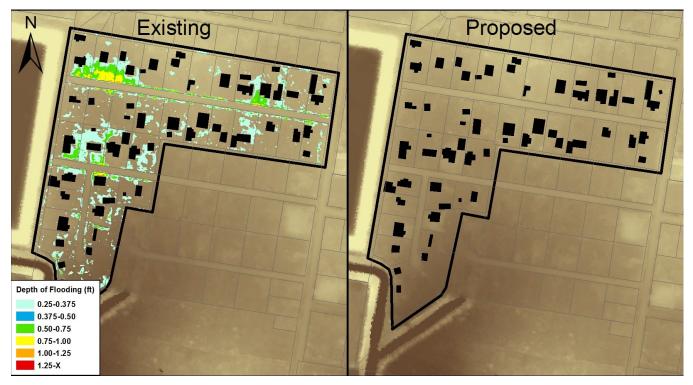
Figure 3: Existing and Proposed Conditions - 10-Yr Storm Inundation Map

10% (10-Year) Flood Recurrence	Pre-Project	Post-Project	Removed
Inundated Structures	4	0	4
Inundated Lots	35	0	35
Inundated Roadway (LF)	0	0	0

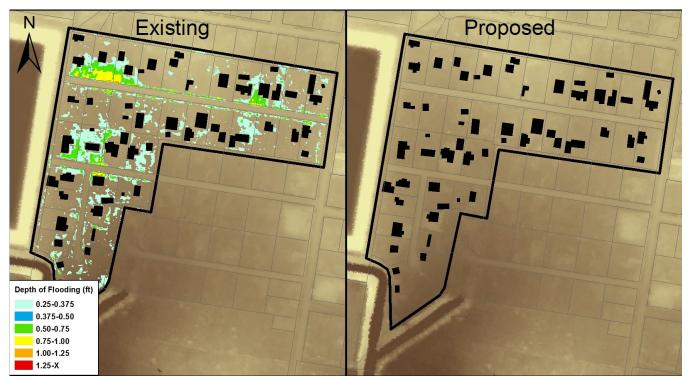
Figure 4: Existing and Proposed Conditions - 25-Yr Storm Inundation Map

4% (25-Year) Flood Recurrence	Pre-Project	Post-Project	Removed
Inundated Structures	4	0	4
Inundated Lots	35	0	35
Inundated Roadway (LF)	0	0	0

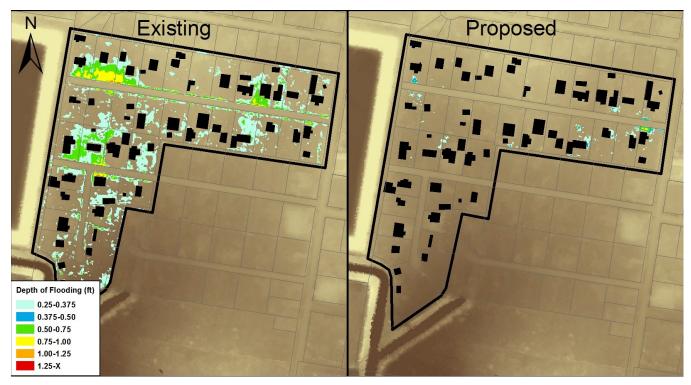
Figure 5: Existing and Proposed Conditions - 100-Yr Storm Inundation Map

1% (100-Year) Flood Recurrence	Pre-Project	Post-Project	Removed
Inundated Structures	4	0	4
Inundated Lots	35	16	19
Inundated Roadway (LF)	0	0	0

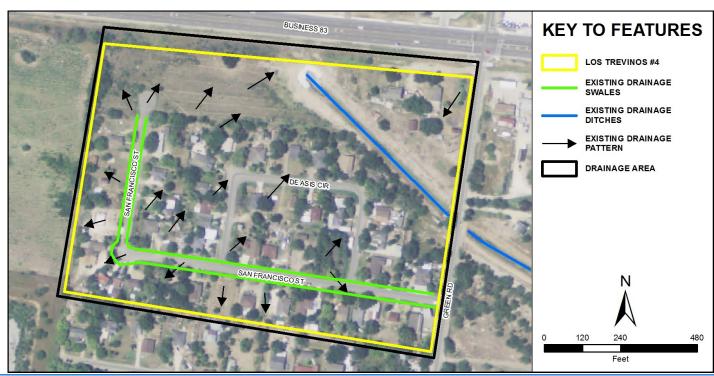
Los Trevinos #4 consists of approximately 24 acres of residential developed land. The existing drainage pattern indicates runoff flows toward the northeast corner of the subdivision. The existing swales and culverts that run along San Francisco Street do not have an outfall. The existing conditions 2D model results indicate that the areas of high risk of flooding are located along the northeast corner of the subdivision, where it appears the existing drainage ditch berm creates a drainage obstruction. Based on LIDAR observations, this colonia may experience flooding from localized events, but should also be evaluated for risk of flooding due to regional storm events that may overflow the existing drain ditch into the colonia. Figures 1, 2, 3, 4, and 5 illustrate the existing and proposed inundation maps for the 2-, 5-, 10-, 25-, and 100-Year storms respectively. The color coded inundation maps illustrate the depth of flooding as follows: light blue represents a depth of 3 to 4.5 inches, blue 4.5 to 6 inches, green 6 to 9 inches, yellow 9 to 12 inches, orange 12 to 20 inches, and red more than 20 inches.

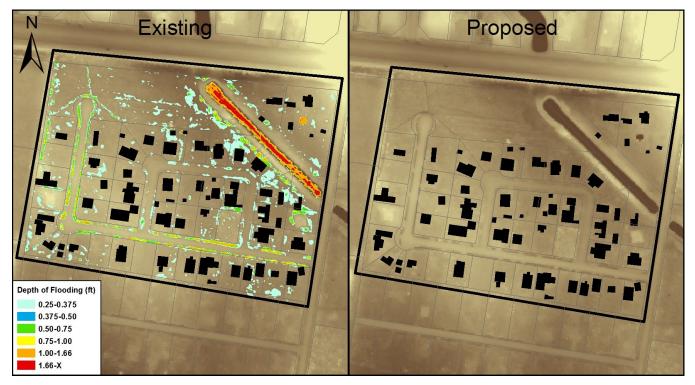
Figure 1: Existing and Proposed Conditions - 2-Yr Storm Inundation Map

50% (2-Year) Flood Recurrence	Pre-Project	Post-Project	Removed
Inundated Structures	0	0	0
Inundated Lots	49	0	49
Inundated Roadway (LF)	0	0	0

The goal of this study was to size the system to be capable of carrying up to the 10-Year storm with no inundation in the colonia. However, some structures lie within low areas of the colonia and still show risk of flooding. When comparing the 6-inch inundation maps for the 25- and 100-Year storms, it is observed that the inundation depths are lower than the existing conditions model, resulting in less overall ponding and the street is at lower risk of being flooded once improvements are in place. Figures 1, 2, 3, 4, and 5 show the existing and proposed conditions inundation maps for the 2-, 5-, 10-, 25-, and 100-Yr storms respectively.

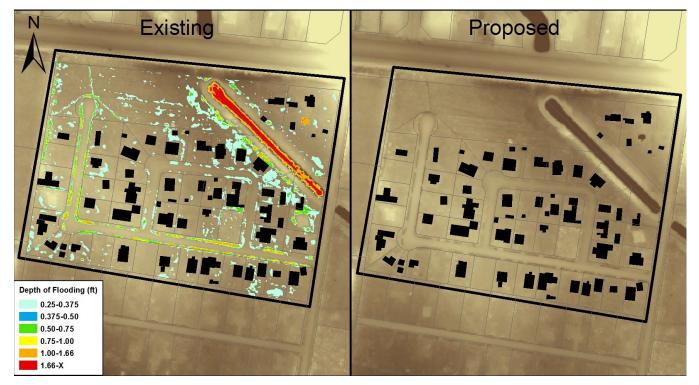
Figure 2: Existing and Proposed Conditions - 5-Yr Storm Inundation Map

20% (5-Year) Flood Recurrence	Pre-Project	Post-Project	Removed
Inundated Structures	0	0	0
Inundated Lots	49	0	49
Inundated Roadway (LF)	0	0	0

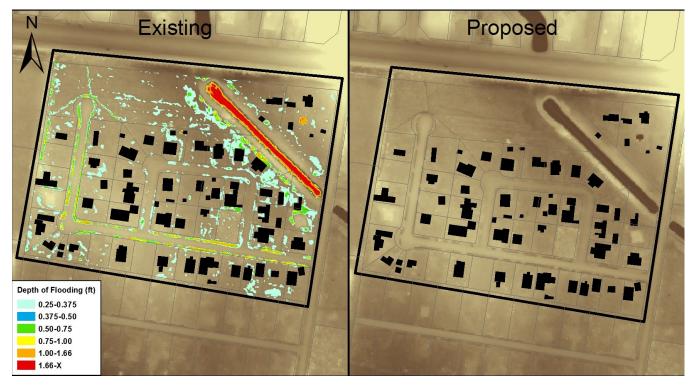
Figure 3: Existing and Proposed Conditions - 10-Yr Storm Inundation Map

10% (10-Year) Flood Recurrence	Pre-Project	Post-Project	Removed
Inundated Structures	0	0	0
Inundated Lots	49	0	49
Inundated Roadway (LF)	0	0	0

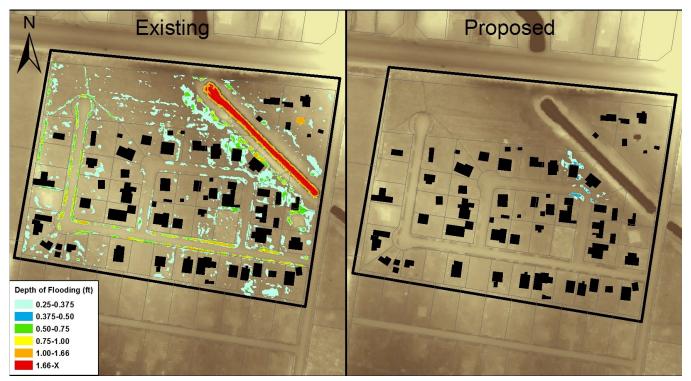
Figure 4: Existing and Proposed Conditions - 25-Yr Storm Inundation Map

4% (25-Year) Flood Recurrence	Pre-Project	Post-Project	Removed
Inundated Structures	0	0	0
Inundated Lots	49	5	44
Inundated Roadway (LF)	0	0	0

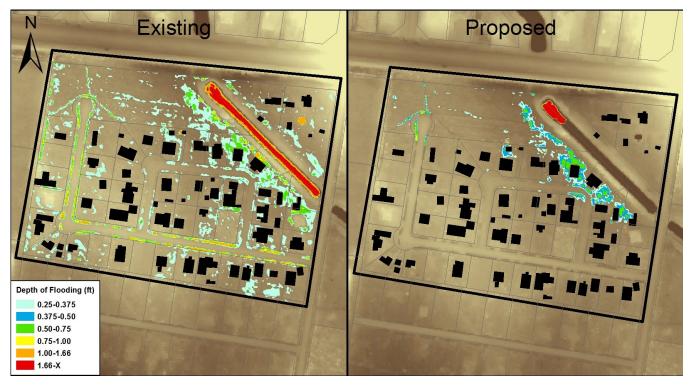
Figure 5: Existing and Proposed Conditions - 100-Yr Storm Inundation Map

1% (100-Year) Flood Recurrence	Pre-Project	Post-Project	Removed
Inundated Structures	0	0	0
Inundated Lots	49	10	39
Inundated Roadway (LF)	0	0	0

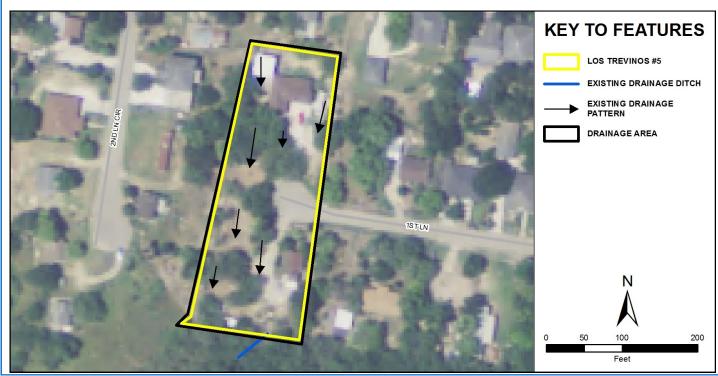
Los Trevinos #5 consists of two residential lots with an estimated area of 1.2 acres. The existing drainage pattern indicates runoff flows toward the existing drainage ditch located south of the colonia. The existing conditions 2D model results indicate that no structure is at high risk of flooding from a localized storm event. However, the model also indicates that the properties are at risk of flooding mostly due to the lots being low or having drainage obstructions. This colonia may experience flooding from localized events but should also be evaluated for risk of flooding due to regional storm events that may overflow the existing drain ditch into the colonia. Figures 1, 2, 3, 4, and 5 illustrate the existing and proposed inundation maps for the 2-, 5-, 10-, 25-, and 100-Year storms respectively. The color coded inundation maps illustrate the depth of flooding as follows: light blue represents a depth of 3 to 6 inches, blue 6 to 9 inches, green 9 to 12 inches, yellow 12 to 15 inches, orange 15 to 18 inches, and red more than 18 inches.

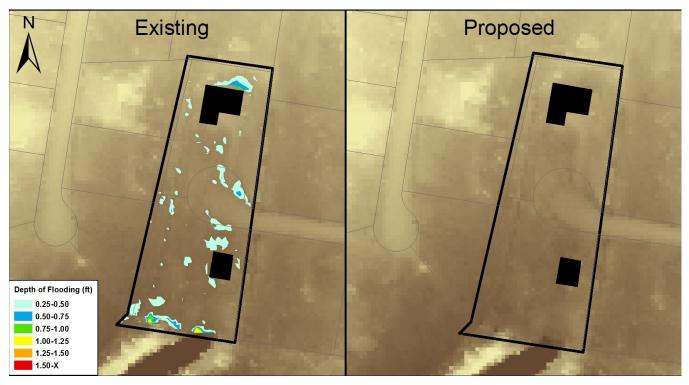
Figure 1: Existing and Proposed Conditions - 2-Yr Storm Inundation Map

50% (2-Year) Flood Recurrence	Pre-Project	Post-Project	Removed
Inundated Structures	0	0	0
Inundated Lots	2	0	2
Inundated Roadway (LF)	0	0	0

The goal of this study was to size the system to be capable of carrying up to the 10-Year storm with no inundation in the colonia. However, some structures lie within low areas of the colonia and still show risk of flooding. When comparing the 6-inch inundation maps for the 25- and 100-Year storms, it is observed that the inundation depths are lower than the existing conditions model, resulting in less overall ponding and the street is at lower risk of being flooded once improvements are in place. Figures 1, 2, 3, 4, and 5 show the existing and proposed conditions inundation maps for the 2-, 5-, 10-, 25-, and 100-Yr storms respectively.

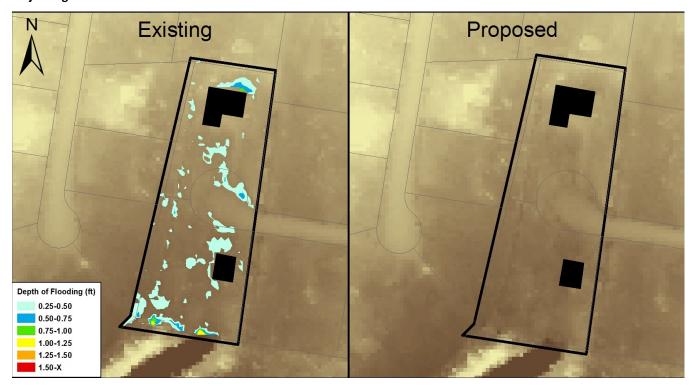
Figure 2: Existing and Proposed Conditions - 5-Yr Storm Inundation Map

20% (5-Year) Flood Recurrence	Pre-Project	Post-Project	Removed
Inundated Structures	0	0	0
Inundated Lots	2	0	2
Inundated Roadway (LF)	0	0	0

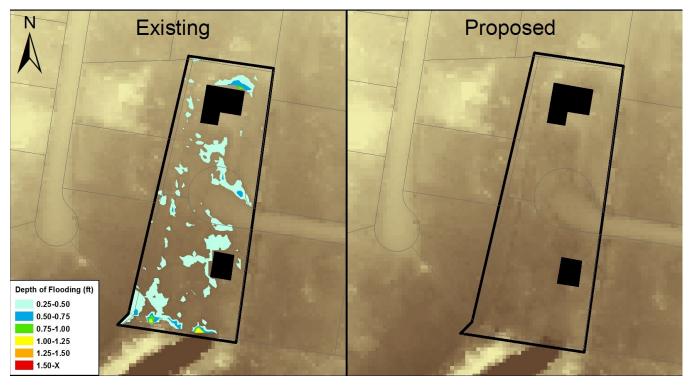
Figure 3: Existing and Proposed Conditions - 10-Yr Storm Inundation Map

10% (10-Year) Flood Recurrence	Pre-Project	Post-Project	Removed
Inundated Structures	0	0	0
Inundated Lots	2	0	2
Inundated Roadway (LF)	0	0	0

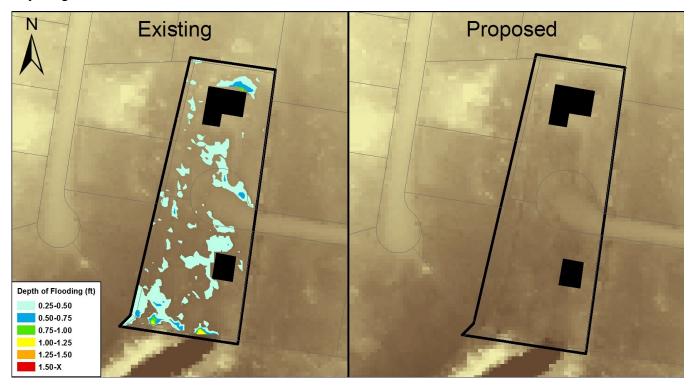
Figure 4: Existing and Proposed Conditions - 25-Yr Storm Inundation Map

4% (25-Year) Flood Recurrence	Pre-Project	Post-Project	Removed
Inundated Structures	0	0	0
Inundated Lots	2	0	2
Inundated Roadway (LF)	0	0	0

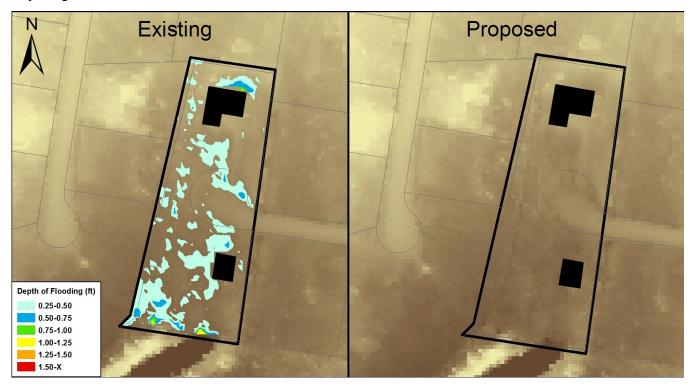
Figure 5: Existing and Proposed Conditions - 100-Yr Storm Inundation Map

1% (100-Year) Flood Recurrence	Pre-Project	Post-Project	Removed
Inundated Structures	0	0	0
Inundated Lots	2	0	2
Inundated Roadway (LF)	0	0	0

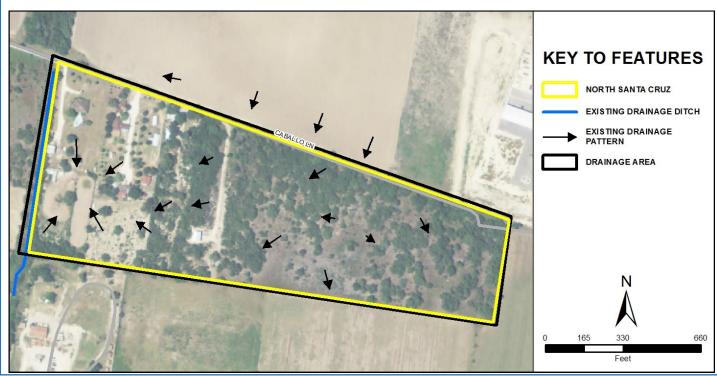
North Santa Cruz Subd. consists of approximately 31 acres of partially developed residential land. Currently the colonia does not have a drainage system and it appears the entire colonia is within the 100-Year Floodplain. The existing conditions 2D model results indicate runoff flows from the east toward the west and south through the properties. The existing drainage ditch currently does not serve as an outfall for the colonia. Based on LIDAR observations, this colonia may experience flooding from localized events, but should also be evaluated for risk of flooding due to regional storm events. The Figures 1, 2, 3, 4, and 5 illustrate the existing and proposed inundation maps for the 2-, 5-, 10-, 25-, and 100-Year storms respectively. The color coded inundation maps illustrate the depth of flooding as follows: light blue represents a depth of 3 to 6 inches, blue 6 to 9 inches, green 9 to 12 inches, yellow 12 to 18 inches, orange 18 to 24 inches, and red more than 24 inches.
