STORMWATER DRAINAGE PLANNING

The Colonias of the Lower Rio Grande Valley (LRGV)

Phase 2 Report

JSW & Associates, Inc. Hazard Mitigation Consultants

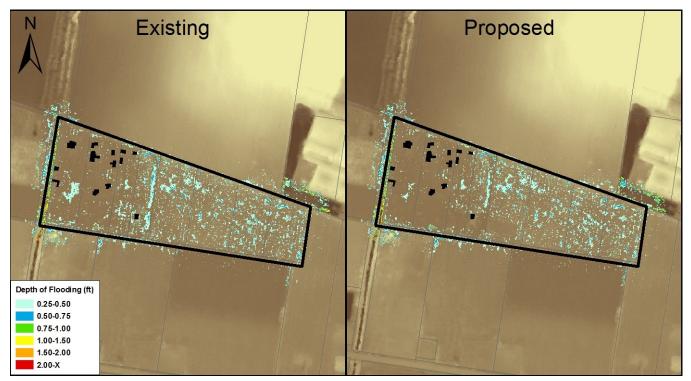
Figure 1: Existing and Proposed Conditions - 2-Yr Storm Inundation Map

50% (2-Year) Flood Recurrence	Pre-Project	Post-Project	Removed
Inundated Structures	0	0	0
Inundated Lots	8	8	0
Inundated Roadway (LF)	0	0	0

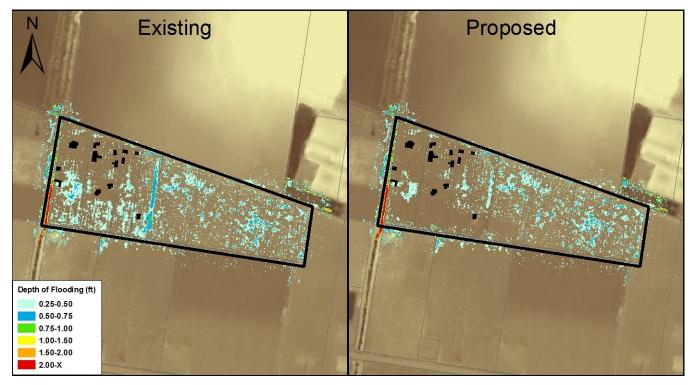
Figure 2: Existing and Proposed Conditions - 5-Yr Storm Inundation Map

20% (5-Year) Flood Recurrence	Pre-Project	Post-Project	Removed
Inundated Structures	0	0	0
Inundated Lots	8	8	0
Inundated Roadway (LF)	0	0	0

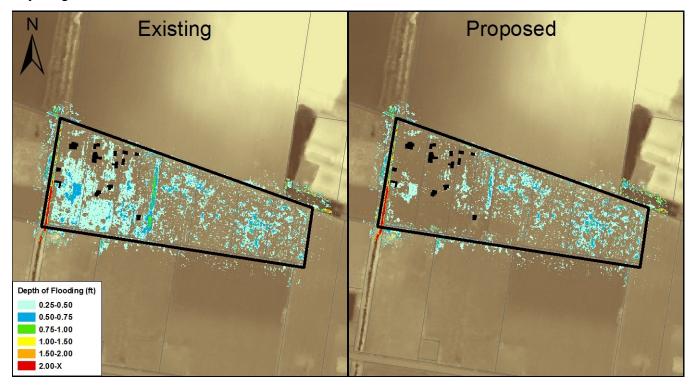
Figure 3: Existing and Proposed Conditions - 10-Yr Storm Inundation Map

10% (10-Year) Flood Recurrence	Pre-Project	Post-Project	Removed
Inundated Structures	0	0	0
Inundated Lots	8	8	0
Inundated Roadway (LF)	0	0	0

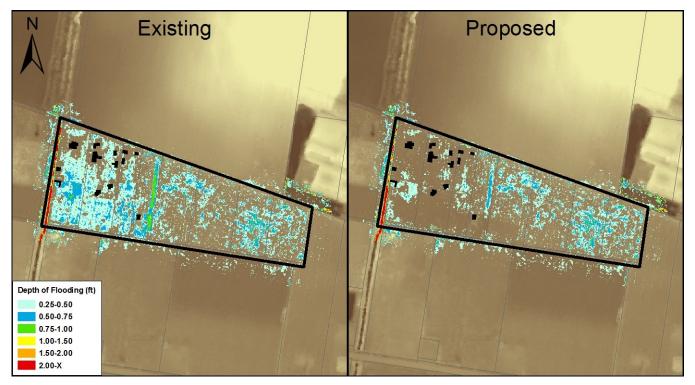
Figure 4: Existing and Proposed Conditions - 25-Yr Storm Inundation Map

4% (25-Year) Flood Recurrence	Pre-Project	Post-Project	Removed
Inundated Structures	0	0	0
Inundated Lots	8	8	0
Inundated Roadway (LF)	0	0	0

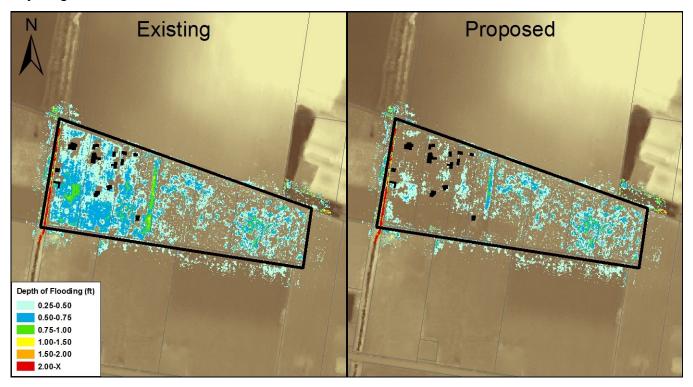
Figure 5: Existing and Proposed Conditions - 100-Yr Storm Inundation Map

50% (2-Year) Flood Recurrence	Pre-Project	Post-Project	Removed
Inundated Structures	0	0	0
Inundated Lots	8	8	0
Inundated Roadway (LF)	0	0	0

- 1. The number of inundated structures are based strictly on finished floor elevations compared to computed water surface elevations.
- 2. The inundation maps above only display flooding depths greater than three inches.
- 3. The number of inundated lots are based strictly on the inundation maps above and therefore do not count as inundated if the depth of flooding is less than three inches.

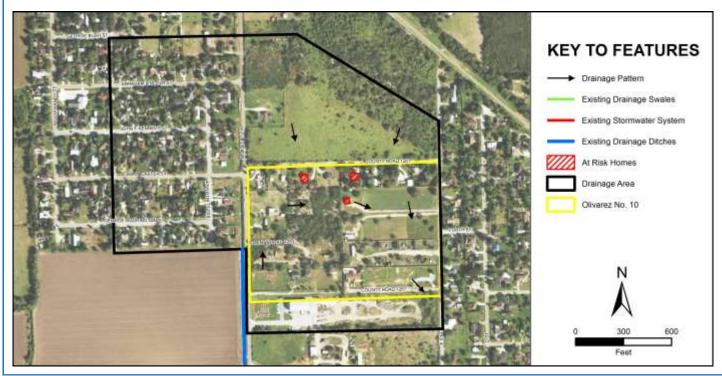
Drainage patterns within this 23-acre colonia are generally to the south and east. The existing drainage system consists of a small stormwater system and roadside swales that are generally undersized and restricted by sediment and vegetation. Olivarez No. 10 experiences residential lot, street, and structure flooding in nearly every rainfall event. Figures 1-5 illustrate the existing and proposed conditions inundation maps for the 2-, 5-, 10-, 25-, and 100-year storms, respectively. These maps illustrate the depth of flooding as follows: light blue represents a depth of 3 to 6 inches, blue 6 to 9 inches, green 9 to 12 inches, yellow 1 to 2 feet, orange 2 to 3 feet, and red more than 3 feet.

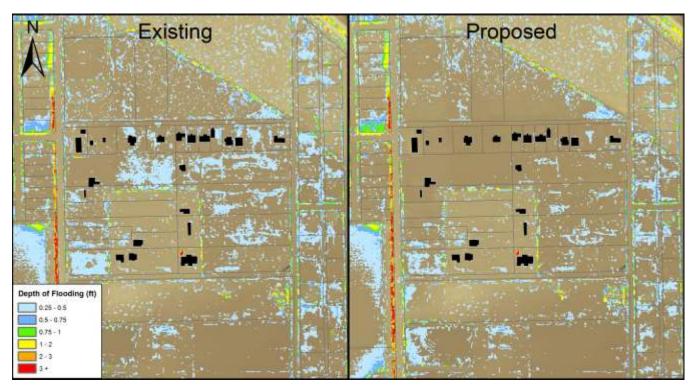
Figure 1: Existing and Proposed Conditions - 2-yr Storm Inundation Map

The goal of this study was to size the system to be capable of carrying up to the 10-Year storm runoff with no inundation in the colonia. However, some structures lie within low areas of the colonia and still show risk of flooding. When comparing the 6-inch inundation map for the 25- and 100-Year storms, it is observed that the inundation depths are lower than the existing conditions model, resulting in fewer structures at risk of being flooded once improvements are in place. Figures 1, 2, 3, 4, and 5 show the existing and proposed conditions inundation maps for the 2-, 5-, 10-, 25-, and 100-Yr storms respectively.

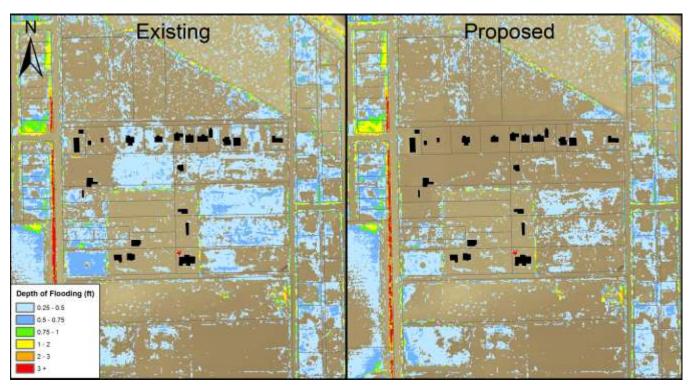
Figure 2: Existing and Proposed Conditions - 5-yr Storm Inundation Map

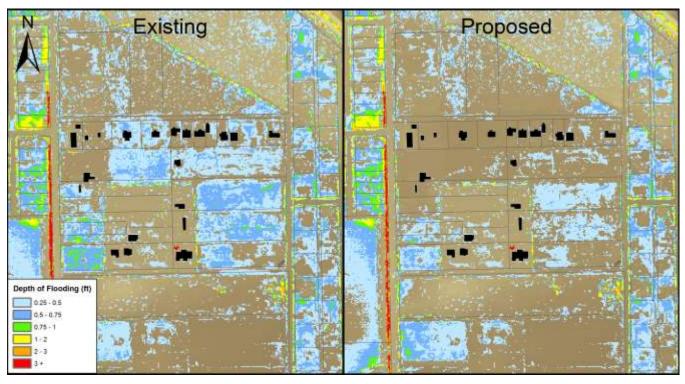
Figure 3: Existing and Proposed Conditions - 10-yr Storm Inundation Map

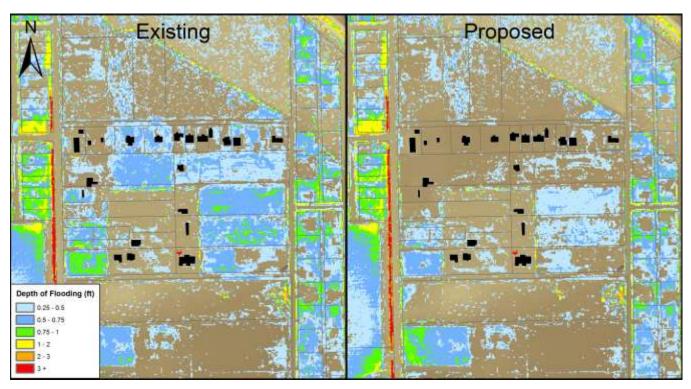
Figure 4: Existing and Proposed Conditions - 25-yr Storm Inundation Map

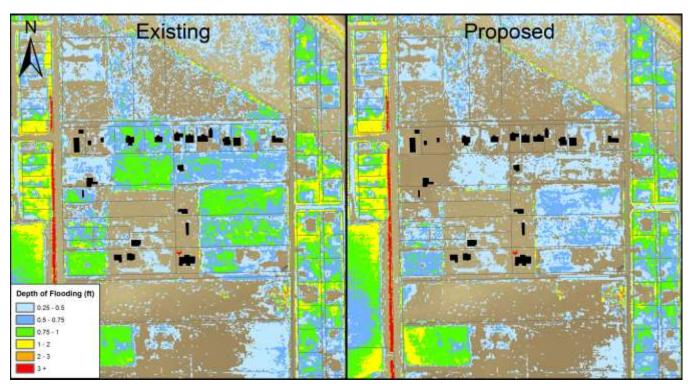
Figure 5: Existing and Proposed Conditions - 100-yr Storm Inundation Map

1% (100-Year) Flood Recurrence	Pre-Project	Post-Project	Removed
Inundated Structures	3	0	3
Inundated Lots	21	21	0
Inundated Roadway (LF)	1645	865	780

- 1. The number of inundated structures are based strictly on finished floor elevations compared to computed water surface elevations.
- 2. The inundation maps above only display flooding depths greater than 3 inches.
- 3. The number of inundated lots are based strictly on the inundation maps above and therefore do not count as inundated if the depth of flooding is less than 3 inches.

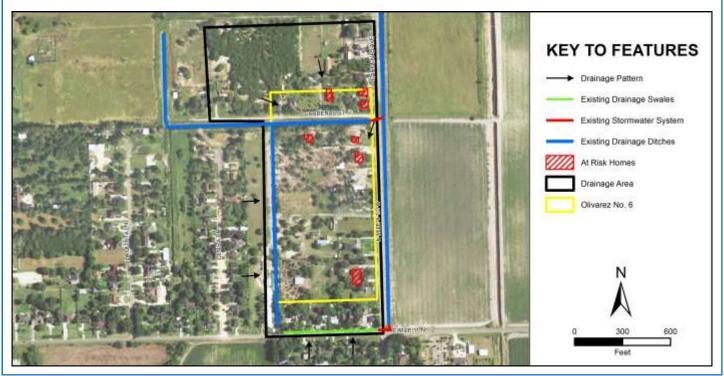
Drainage patterns within this 19-acre colonia are generally to the south and east. The existing drainage system consists of a small stormwater system and roadside swales that are generally undersized and restricted by sediment and vegetation. Olivarez No. 6 experiences residential lot, street, and structure flooding in nearly every rainfall event. Figures 1-5 illustrate the existing and proposed conditions inundation maps for the 2-, 5-, 10-, 25-, and 100-year storms, respectively. These maps illustrate the depth of flooding as follows: light blue represents a depth of 3 to 6 inches, blue 6 to 9 inches, green 9 to 12 inches, yellow 1 to 2 feet, orange 2 to 3 feet, and red more than 3 feet.

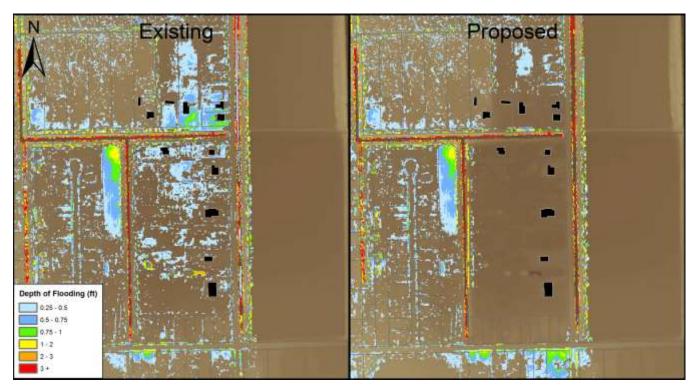
Figure 1: Existing and Proposed Conditions - 2-yr Storm Inundation Map

The goal of this study was to size the system to be capable of carrying up to the 10-Year storm runoff with no inundation in the colonia. However, some structures lie within low areas of the colonia and still show risk of flooding. When comparing the 6-inch inundation map for the 25- and 100-Year storms, it is observed that the inundation depths are lower than the existing conditions model, resulting in fewer structures at risk of being flooded once improvements are in place. Figures 1, 2, 3, 4, and 5 show the existing and proposed conditions inundation maps for the 2-, 5-, 10-, 25-, and 100-Yr storms respectively.

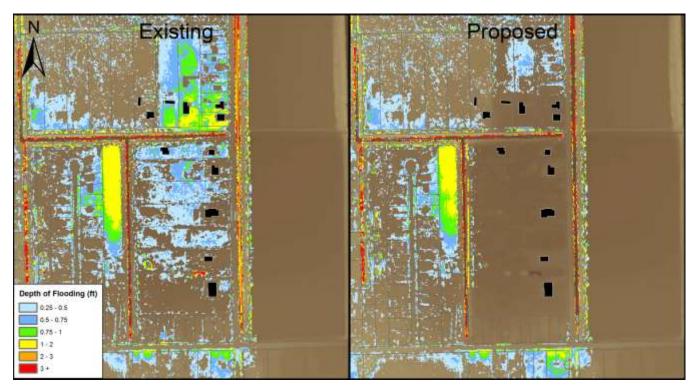
Figure 2: Existing and Proposed Conditions - 5-yr Storm Inundation Map

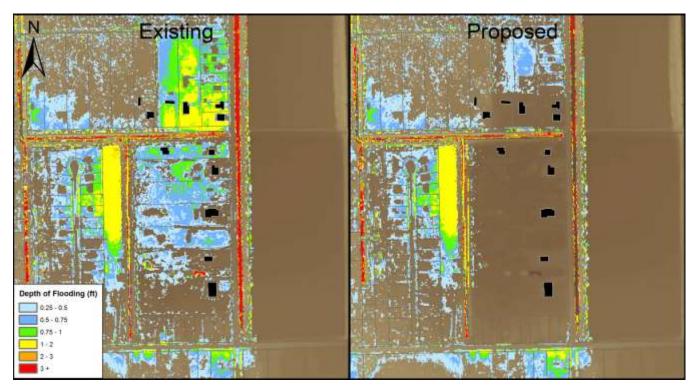
Figure 3: Existing and Proposed Conditions - 10-yr Storm Inundation Map

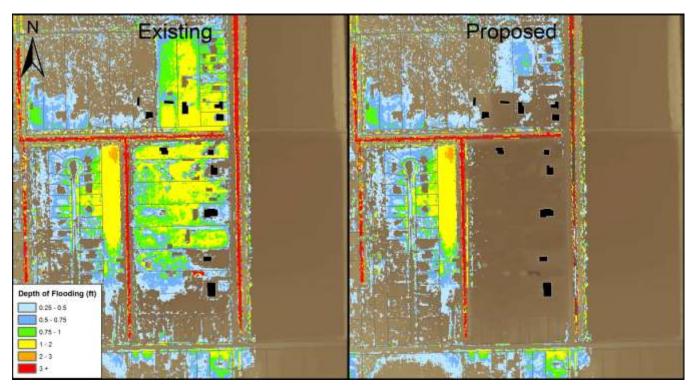
Figure 4: Existing and Proposed Conditions - 25-yr Storm Inundation Map

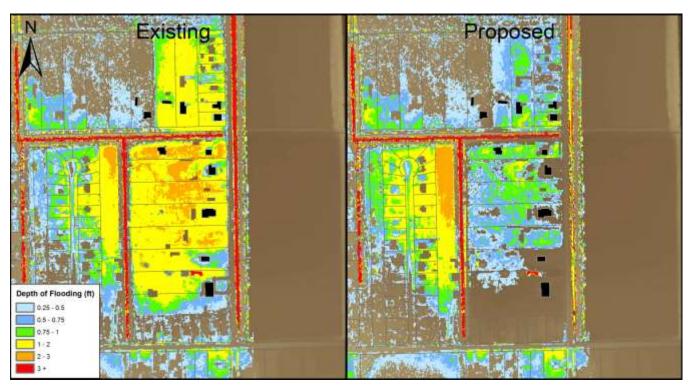
Figure 5: Existing and Proposed Conditions - 100-yr Storm Inundation Map

1% (100-Year) Flood Recurrence	Pre-Project	Post-Project	Removed
Inundated Structures	7	2	5
Inundated Lots	13	12	1
Inundated Roadway (LF)	670	390	280

- 1. The number of inundated structures are based strictly on finished floor elevations compared to computed water surface elevations.
- 2. The inundation maps above only display flooding depths greater than 3 inches.
- 3. The number of inundated lots are based strictly on the inundation maps above and therefore do not count as inundated if the depth of flooding is less than 3 inches.

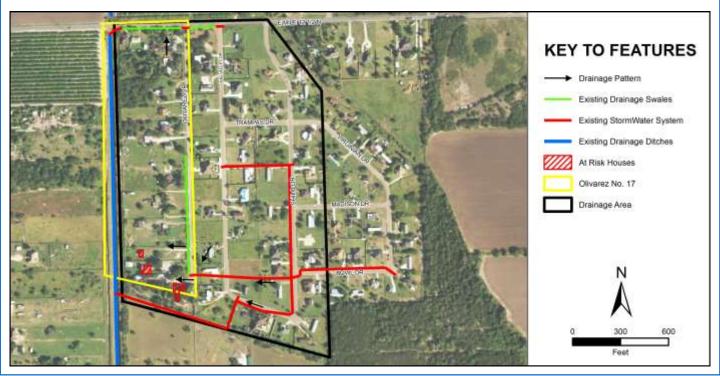
Drainage patterns within this 21-acre colonia are generally to the south and east. The existing drainage system consists of a small stormwater system and roadside swales that are generally undersized and restricted by sediment and vegetation. Olivarez No. 17 experiences residential lot, street, and structure flooding in nearly every rainfall event. Figures 1-5 illustrate the existing and proposed conditions inundation maps for the 2-, 5-, 10-, 25-, and 100-year storms, respectively. These maps illustrate the depth of flooding as follows: light blue represents a depth of 3 to 6 inches, blue 6 to 9 inches, green 9 to 12 inches, yellow 1 to 2 feet, orange 2 to 3 feet, and red more than 3 feet.

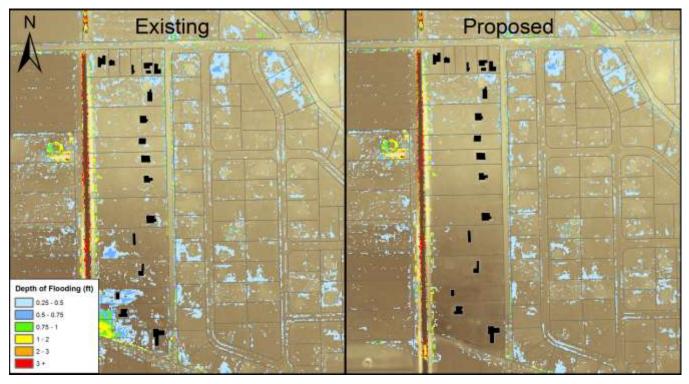
Figure 1: Existing and Proposed Conditions - 2-yr Storm Inundation Map

The goal of this study was to size the system to be capable of carrying up to the 10-Year storm runoff with no inundation in the colonia. However, some structures lie within low areas of the colonia and still show risk of flooding. When comparing the 6-inch inundation map for the 25- and 100-Year storms, it is observed that the inundation depths are lower than the existing conditions model, resulting in fewer structures at risk of being flooded once improvements are in place. Figures 1, 2, 3, 4, and 5 show the existing and proposed conditions inundation maps for the 2-, 5-, 10-, 25-, and 100-Yr storms respectively.

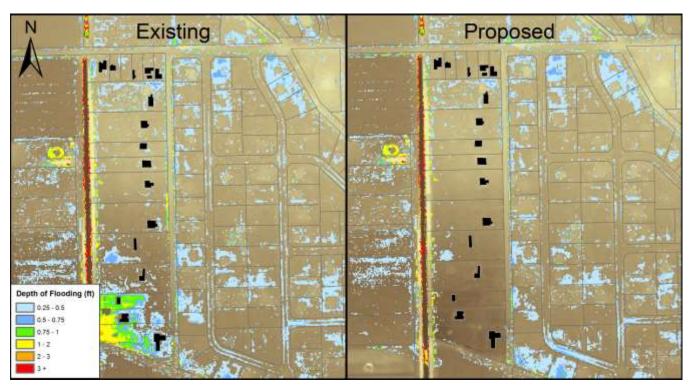
Figure 2: Existing and Proposed Conditions - 5-yr Storm Inundation Map

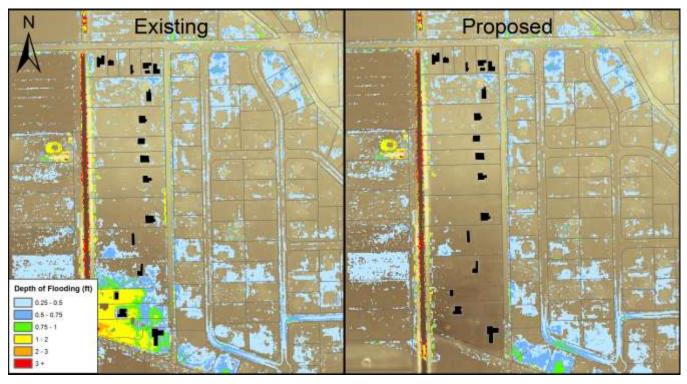
Figure 3: Existing and Proposed Conditions - 10-yr Storm Inundation Map

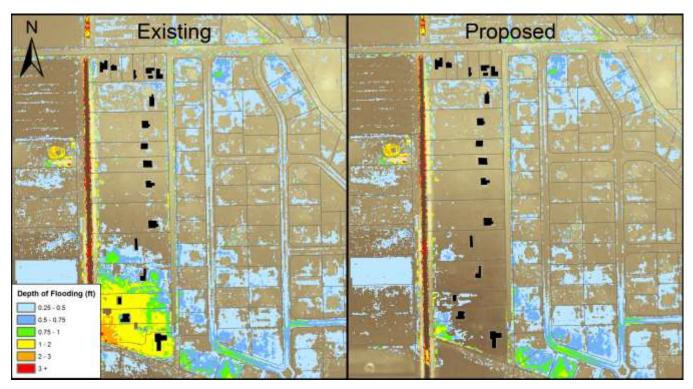
Figure 4: Existing and Proposed Conditions - 25-yr Storm Inundation Map

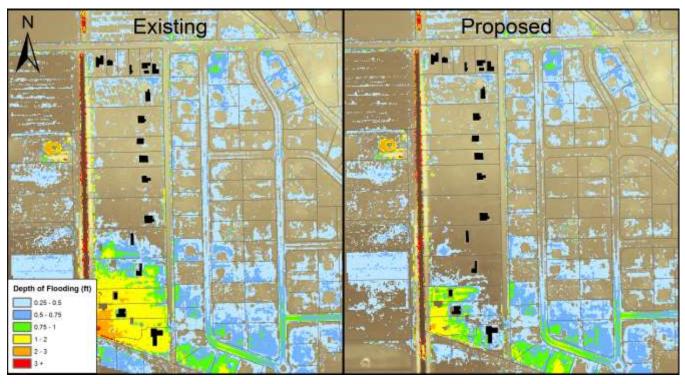
Figure 5: Existing and Proposed Conditions - 100-yr Storm Inundation Map

1% (100-Year)	Pre-Project	Post-Project	Removed
Flood Recurrence			
Inundated Structures	3	2	1
Inundated Lots	18	18	0
Inundated Roadway (LF)	350	185	165

- 1. The number of inundated structures are based strictly on finished floor elevations compared to computed water surface elevations.
- 2. The inundation maps above only display flooding depths greater than 3 inches.
- 3. The number of inundated lots are based strictly on the inundation maps above and therefore do not count as inundated if the depth of flooding is less than 3 inches.

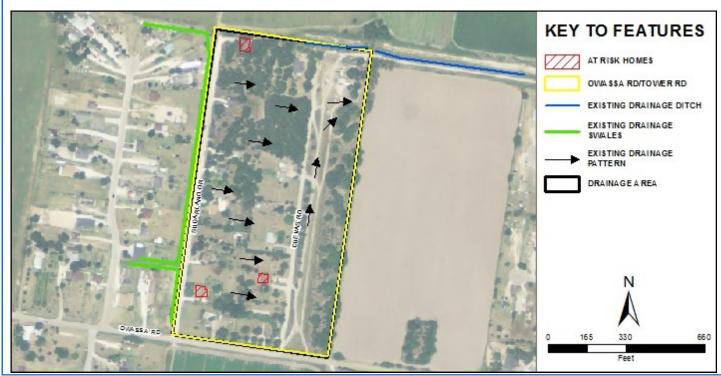
Owassa Rd/Tower Rd consists of approximately 19.7 acres of fully developed residential land. The existing drainage system consists of swales and culvers that appear to have no outfall. It is unclear whether the existing drainage ditch services the colonia. The existing drainage pattern indicates runoff flows toward the east. Based on the existing conditions 2D model results a couple of structures are at risk of flooding from a localized storm event. Figures 1, 2, 3, 4, and 5 illustrate the existing and proposed inundation maps for the 2-, 5-, 10-, 25-, and 100-Year storms respectively. The color coded inundation maps illustrate the depth of flooding as follows: light blue represents a depth of 3 to 6 inches, blue 6 to 9 inches, green 9 to 12 inches, yellow 12 to 18 inches, orange 18 to 24 inches, and red more than 24 inches.

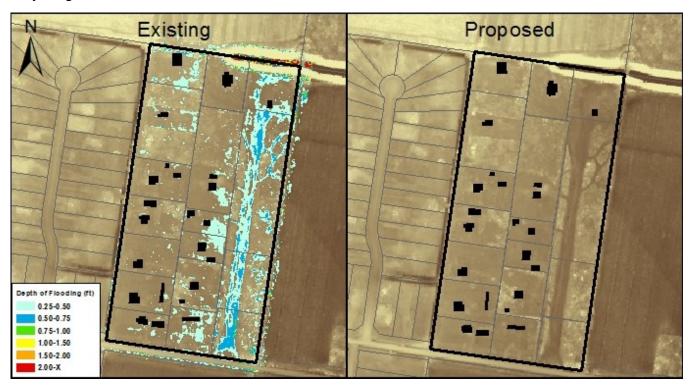
Figure 1: Existing and Proposed Conditions - 2-Yr Storm Inundation Map

The goal of this study was to size the system to be capable of carrying up to the 10-Year storm with no inundation in the colonia. However, some structures lie within low areas of the colonia and still show risk of flooding. When comparing the 6-inch inundation maps for the 25- and 100-Year storms, it is observed that the inundation depths are lower than the existing conditions model, resulting in fewer structures at risk of being flooded once improvements are in place. Figures 1, 2, 3, 4, and 5 show the existing and proposed conditions inundation maps for the 2-, 5-, 10-, 25-, and 100-Yr storms respectively.

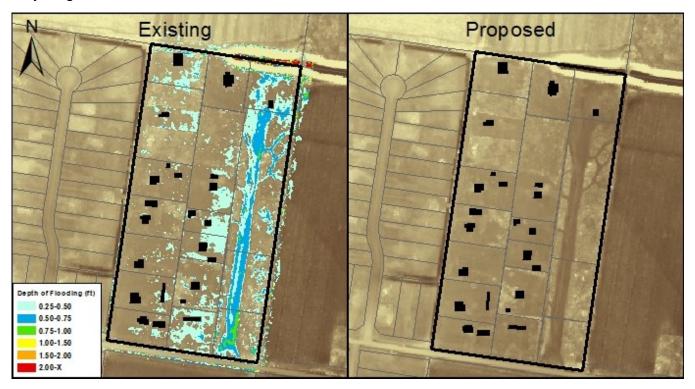
Figure 2: Existing and Proposed Conditions - 5-Yr Storm Inundation Map

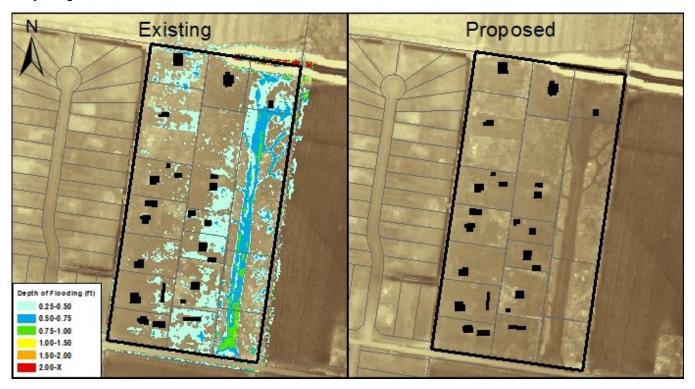
Figure 3: Existing and Proposed Conditions - 10-Yr Storm Inundation Map

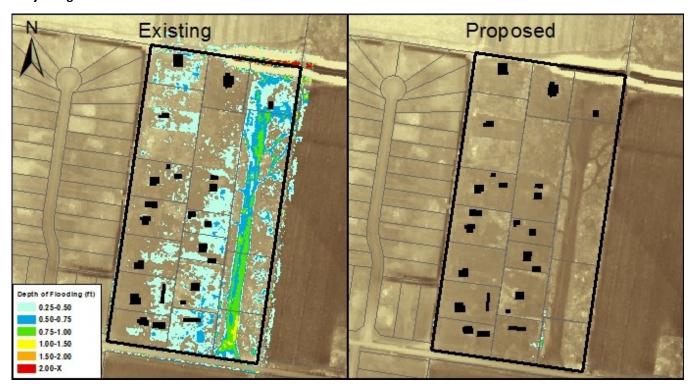
Figure 4: Existing and Proposed Conditions - 25-Yr Storm Inundation Map

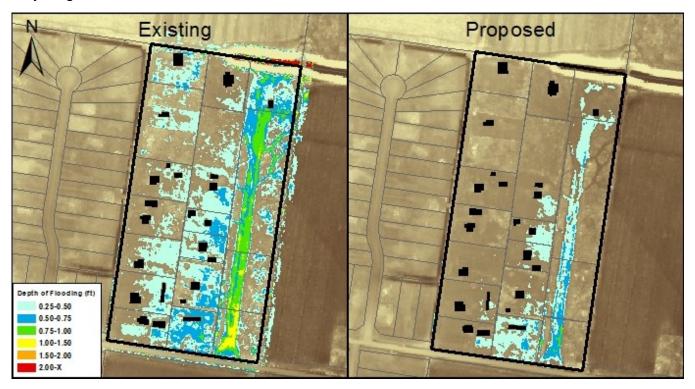
Figure 5: Existing and Proposed Conditions - 100-Yr Storm Inundation Map

1% (100-Year) Flood Recurrence	Pre-Project	Post-Project	Removed
Inundated Structures	3	0	3
Inundated Lots	17	12	5
Inundated Roadway (LF)	898	278	620

- 1. The number of inundated structures are based strictly on finished floor elevations compared to computed water surface elevations.
- 2. The inundation maps above only display flooding depths greater than three inches.
- 3. The number of inundated lots are based strictly on the inundation maps above and therefore do not count as inundated if the depth of flooding is less than three inches.

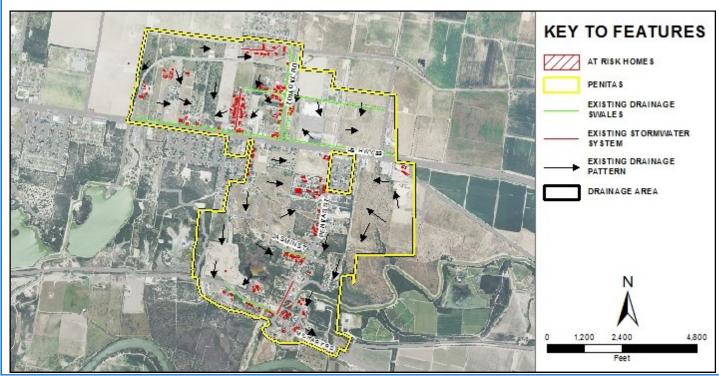
Penitas consists of approximately 1,239.4 acres of fully developed residential land. The existing drainage system varies within this colonia. Some areas only have swales and culverts whereas other areas have curb inlets with an underground drainage system. The final outfall for these systems was not observed. For the most part the existing drainage pattern indicates runoff flows toward the south. The southern portion of Penitas is under the 100-Yr floodplain, this colonia should be evaluated for risk of flooding due to regional storm events. Based on the existing conditions 2D model results several structures are at risk of flooding from a localized storm event. Figures 1, 2, 3, 4, and 5 illustrate the existing and proposed inundation maps for the 2-, 5-, 10-, 25-, and 100-Year storms respectively. The color coded inundation maps illustrate the depth of flooding as follows: light blue represents a depth of 3 to 6 inches, blue 6 to 9 inches, green 9 to 12 inches, yellow 12 to 18 inches, orange 18 to 24 inches, and red more than 24 inches.

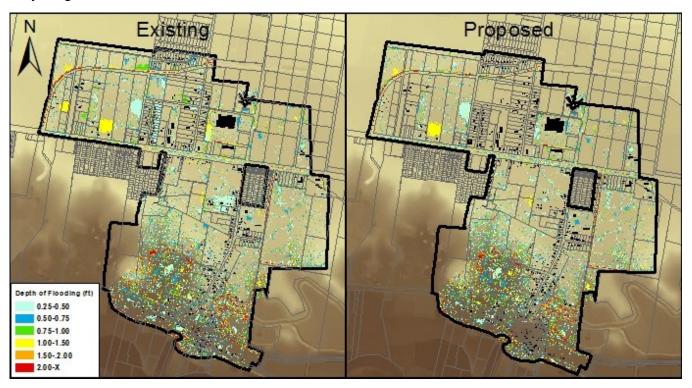
Figure 1: Existing and Proposed Conditions - 2-Yr Storm Inundation Map

The goal of this study was to size the system to be capable of carrying up to the 10-Year storm with no inundation in the colonia. However, some structures lie within low areas of the colonia and still show risk of flooding. When comparing the 6-inch inundation maps for the 25- and 100-Year storms, it is observed that the inundation depths are lower than the existing conditions model, resulting in fewer structures at risk of being flooded once improvements are in place. Figures 1, 2, 3, 4, and 5 show the existing and proposed conditions inundation maps for the 2-, 5-, 10-, 25-, and 100-Yr storms respectively.

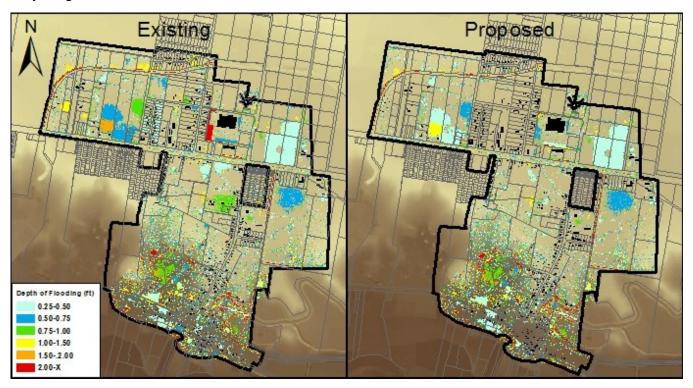
Figure 2: Existing and Proposed Conditions - 5-Yr Storm Inundation Map

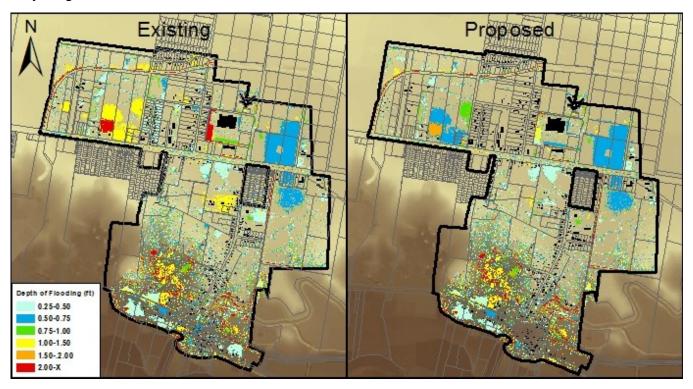
Figure 3: Existing and Proposed Conditions - 10-Yr Storm Inundation Map

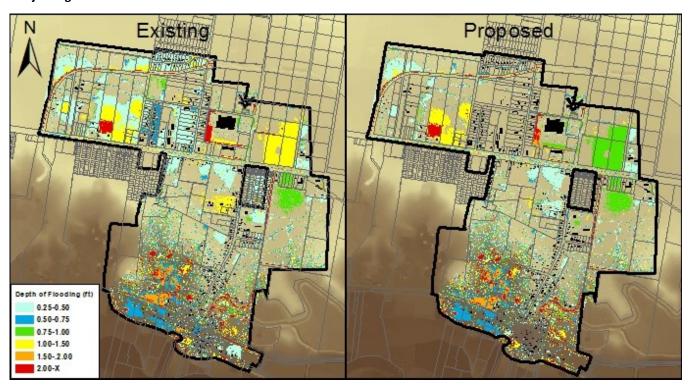
Figure 4: Existing and Proposed Conditions - 25-Yr Storm Inundation Map

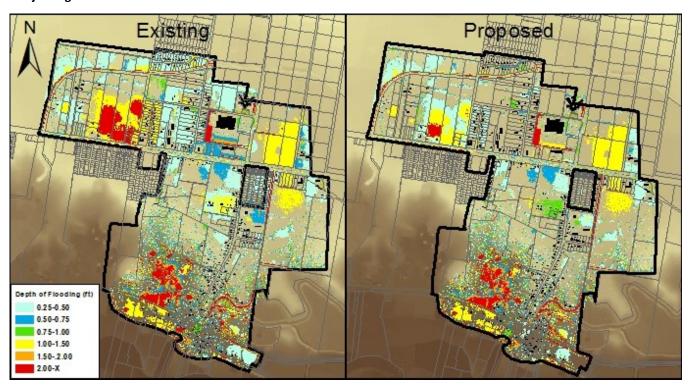
Figure 5: Existing and Proposed Conditions - 100-Yr Storm Inundation Map

1% (100-Year) Flood Recurrence	Pre-Project	Post-Project	Removed
Inundated Structures	92	36	56
Inundated Lots	479	440	39
Inundated Roadway (LF)	6,486	4,375	2,111

- 1. The number of inundated structures are based strictly on finished floor elevations compared to computed water surface elevations.
- 2. The inundation maps above only display flooding depths greater than three inches.
- 3. The number of inundated lots are based strictly on the inundation maps above and therefore do not count as inundated if the depth of flooding is less than three inches.

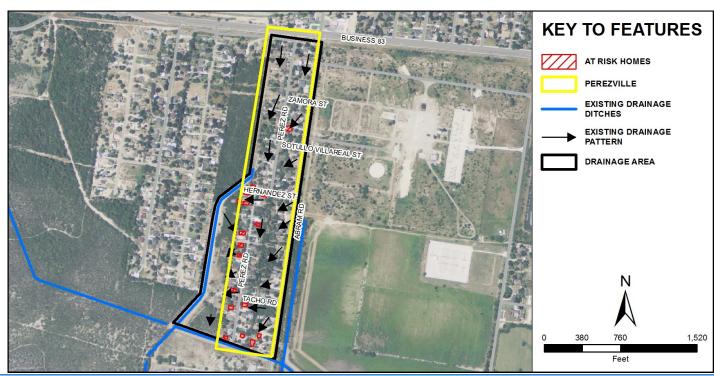
Perezville consists of approximately 49 acres of fully developed residential land. Currently the colonia does not have a drainage system. There are major drainage ditches along the west, east, and south sides of the colonia. The existing drainage pattern indicates runoff flows toward the southwest corner of the colonia. The results of the existing conditions 2D model indicate that there is considerable ponding within the colonia, resulting in structures at high risk of flooding. This may be attributed to low lots or drainage obstructions. Based on LIDAR observations, this colonia may experience flooding from localized events, but should also be evaluated for risk of flooding due to regional storm events that may overflow the existing drainage ditches into the colonia. Figures 1, 2, 3, 4, and 5 illustrate the existing and proposed inundation maps for the 2-, 5-, 10-, 25-, and 100-Year storms respectively. The color coded inundation maps illustrate the depth of flooding as follows: light blue represents a depth of 3 to 6 inches, blue 6 to 9 inches, green 9 to 12 inches, yellow 12 to 18 inches, orange 18 to 24 inches, and red more than 24 inches.

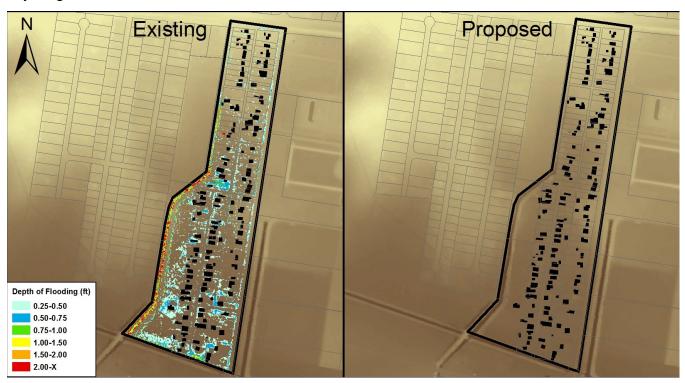
Figure 1: Existing and Proposed Conditions - 2-Yr Storm Inundation Map

50% (2-Year) Flood Recurrence	Pre-Project	Post-Project	Removed
Inundated Structures	3	0	3
Inundated Lots	125	0	125
Inundated Roadway (LF)	51	0	51

The goal of this study was to size the system to be capable of carrying up to the 10-Year storm with no inundation in the colonia. However, some structures lie within low areas of the colonia and still show risk of flooding. When comparing the 6-inch inundation maps for the 25- and 100-Year storms, it is observed that the inundation depths are lower than the existing conditions model, resulting in fewer structures at risk of being flooded once improvements are in place. Figures 1, 2, 3, 4, and 5 show the existing and proposed conditions inundation maps for the 2-, 5-, 10-, 25-, and 100-Yr storms respectively.

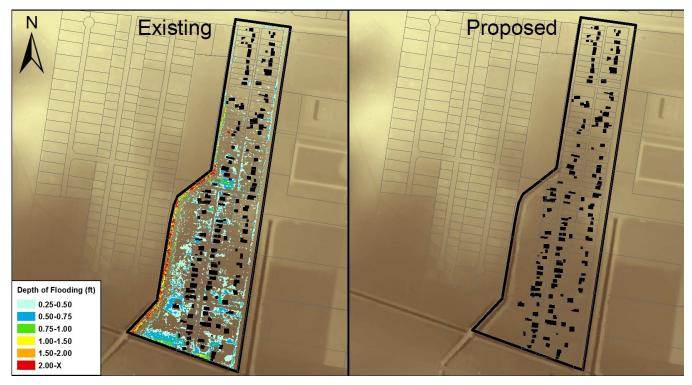
Figure 2: Existing and Proposed Conditions - 5-Yr Storm Inundation Map

20% (5-Year) Flood Recurrence	Pre-Project	Post-Project	Removed
Inundated Structures	8	0	8
Inundated Lots	125	0	125
Inundated Roadway (LF)	80	0	80

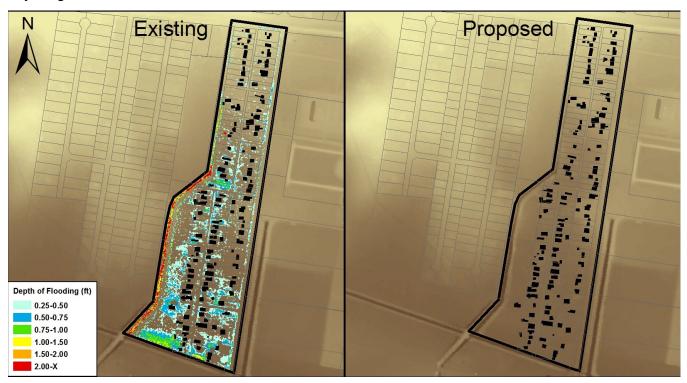
Figure 3: Existing and Proposed Conditions - 10-Yr Storm Inundation Map

10% (10-Year) Flood Recurrence	Pre-Project	Post-Project	Removed
Inundated Structures	9	0	9
Inundated Lots	125	0	125
Inundated Roadway (LF)	87	0	87

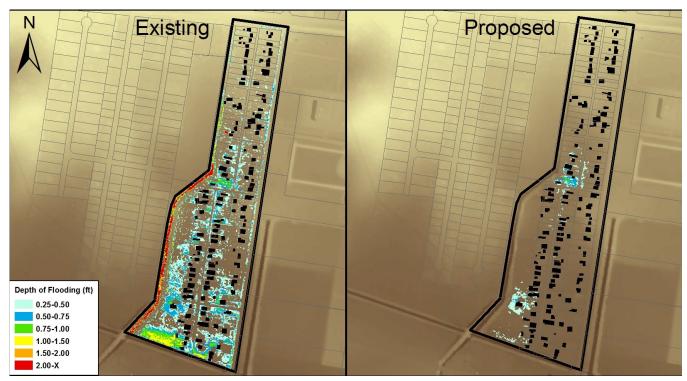
Figure 4: Existing and Proposed Conditions - 25-Yr Storm Inundation Map

4% (25-Year) Flood Recurrence	Pre-Project	Post-Project	Removed
Inundated Structures	12	1	11
Inundated Lots	125	37	88
Inundated Roadway (LF)	129	0	129

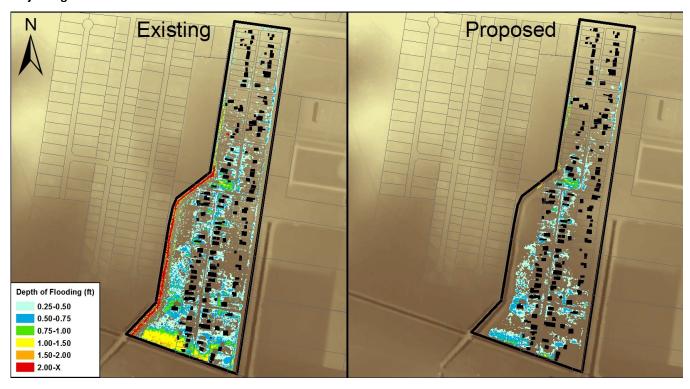
Figure 5: Existing and Proposed Conditions - 100-Yr Storm Inundation Map

1% (100-Year) Flood Recurrence	Pre-Project	Post-Project	Removed
Inundated Structures	17	7	10
Inundated Lots	125	110	15
Inundated Roadway (LF)	431	119	312

- 1. The number of inundated structures are based strictly on finished floor elevations compared to computed water surface elevations.
- 2. The inundation maps above only display flooding depths greater than three inches.
- 3. The number of inundated lots are based strictly on the inundation maps above and therefore do not count as inundated if the depth of flooding is less than three inches.

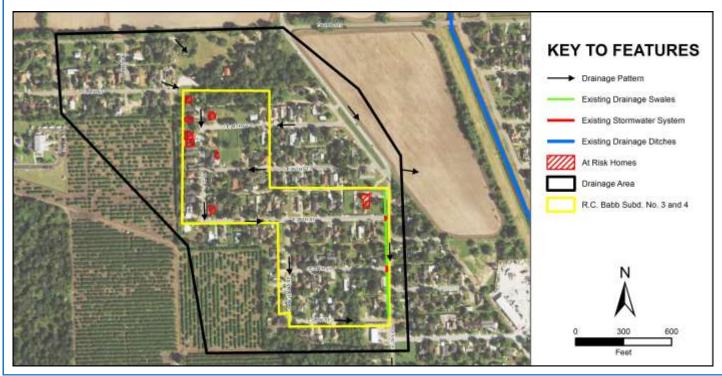
Drainage patterns within this 24-acre colonia are generally to the south and east. The existing drainage system consists of a small stormwater system and roadside swales that are generally undersized and restricted by sediment and vegetation. R.C. Babb Subd. No. 3 and 4 experiences residential lot, street, and structure flooding in nearly every rainfall event. Figures 1-5 illustrate the existing and proposed conditions inundation maps for the 2-, 5-, 10-, 25-, and 100-year storms, respectively. These maps illustrate the depth of flooding as follows: light blue represents a depth of 3 to 6 inches, blue 6 to 9 inches, green 9 to 12 inches, yellow 1 to 2 feet, orange 2 to 3 feet, and red more than 3 feet.

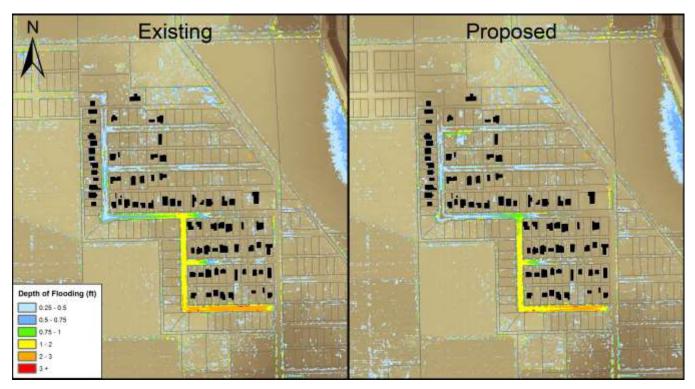
Figure 1: Existing and Proposed Conditions - 2-yr Storm Inundation Map

The goal of this study was to size the system to be capable of carrying up to the 10-Year storm runoff with no inundation in the colonia. However, some structures lie within low areas of the colonia and still show risk of flooding. When comparing the 6-inch inundation map for the 25- and 100-Year storms, it is observed that the inundation depths are lower than the existing conditions model, resulting in fewer structures at risk of being flooded once improvements are in place. Figures 1, 2, 3, 4, and 5 show the existing and proposed conditions inundation maps for the 2-, 5-, 10-, 25-, and 100-Yr storms respectively.

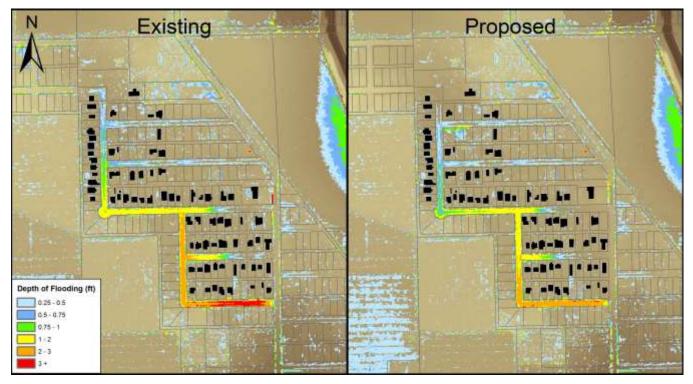
Figure 2: Existing and Proposed Conditions - 5-yr Storm Inundation Map

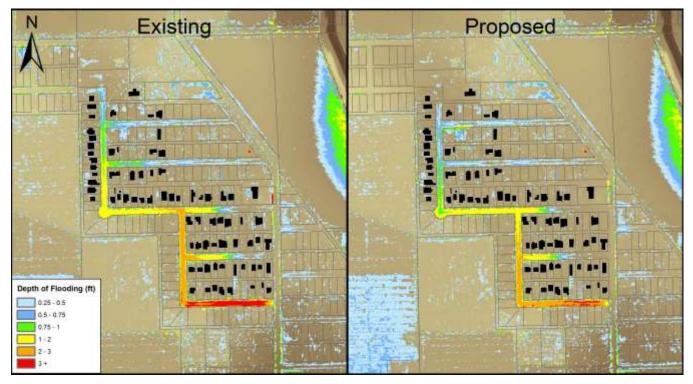
Figure 3: Existing and Proposed Conditions - 10-yr Storm Inundation Map

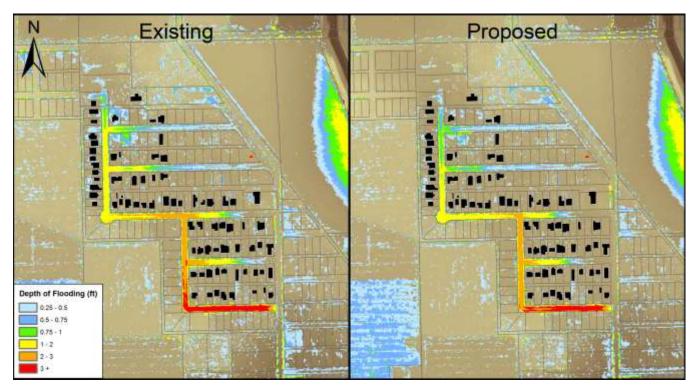
Figure 4: Existing and Proposed Conditions - 25-yr Storm Inundation Map

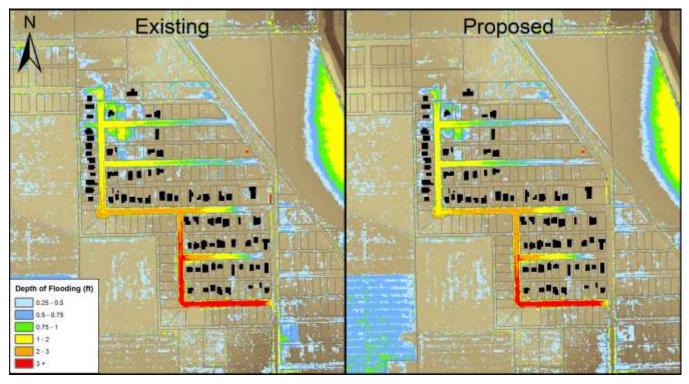
Figure 5: Existing and Proposed Conditions - 100-yr Storm Inundation Map

1% (100-Year)	Pre-Project	Post-Project	Removed
Flood Recurrence			
Inundated Structures	8	3	5
Inundated Lots	104	100	4
Inundated Roadway (LF)	4470	4355	115

- 1. The number of inundated structures are based strictly on finished floor elevations compared to computed water surface elevations.
- 2. The inundation maps above only display flooding depths greater than 3 inches.
- 3. The number of inundated lots are based strictly on the inundation maps above and therefore do not count as inundated if the depth of flooding is less than 3 inches.

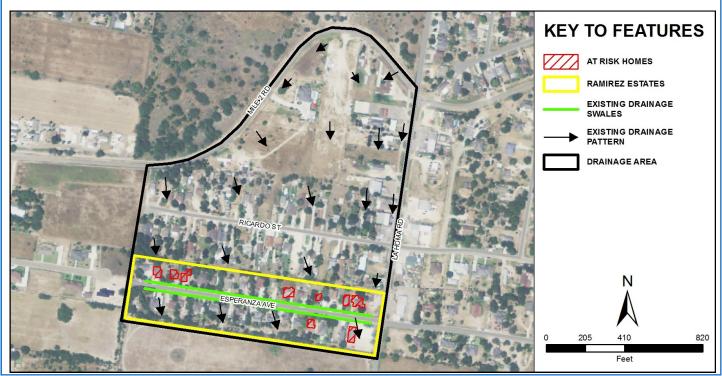
Ramirez Estates consists of approximately 10 acres of fully developed residential land with an offsite drainage area of approximately 31 acres of developed residential land. Part of the offsite drainage area includes the colonia "La Homa Road Subdivision". There are existing swales and culverts along Esperanza Avenue but they do not provide adequate drainage for the colonia. The existing drainage pattern indicates that runoff flows south. The results of the existing conditions 2D model indicate that several structures are at risk of flooding. Figures 1, 2, 3, 4, and 5 illustrate the existing and proposed inundation maps for the 2-, 5-, 10-, 25-, and 100-Year storms respectively. The color coded inundation maps illustrate the depth of flooding as follows: light blue represents a depth of 3 to 6 inches, blue 6 to 9 inches, green 9 to 12 inches, yellow 12 to 18 inches, orange 18 to 24 inches, and red more than 24 inches.

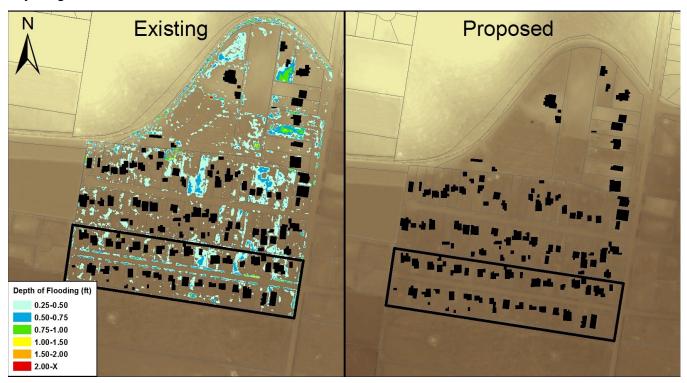
Figure 1: Existing and Proposed Conditions - 2-Yr Storm Inundation Map

50% (2-Year) Flood Recurrence	Pre-Project	Post-Project	Removed
Inundated Structures	1	0	1
Inundated Lots	34	0	34
Inundated Roadway (LF)	0	0	0

The goal of this study was to size the system to be capable of carrying up to the 10-Year storm with no inundation in the colonia. However, some structures lie within low areas of the colonia and still show risk of flooding. When comparing the 6-inch inundation maps for the 25- and 100-Year storms, it is observed that the inundation depths are lower than the existing conditions model, resulting in fewer structures at risk of being flooded once improvements are in place. Figures 1, 2, 3, 4, and 5 show the existing and proposed conditions inundation maps for the 2-, 5-, 10-, 25-, and 100-Yr storms respectively.

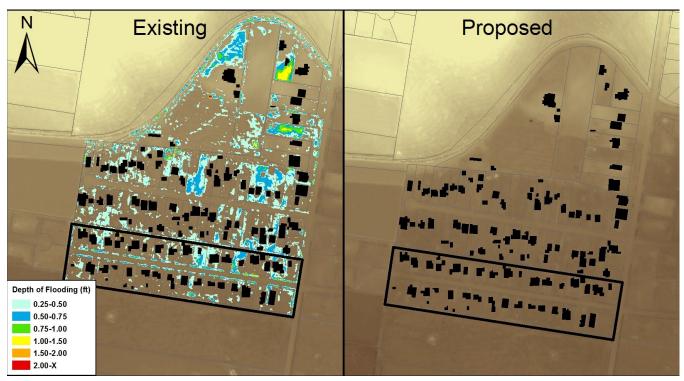
Figure 2: Existing and Proposed Conditions - 5-Yr Storm Inundation Map

20% (5-Year) Flood Recurrence	Pre-Project	Post-Project	Removed
Inundated Structures	1	0	1
Inundated Lots	34	0	34
Inundated Roadway (LF)	0	0	0

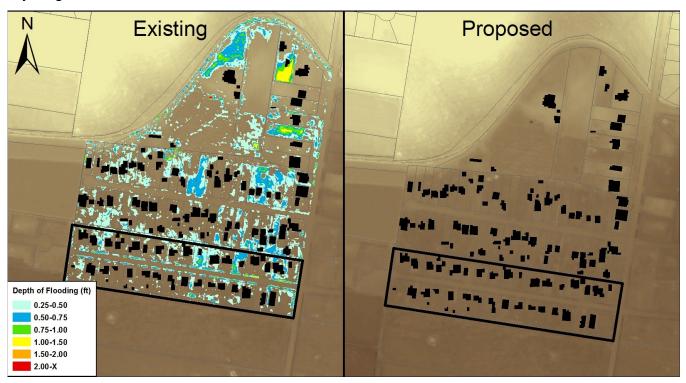
Figure 3: Existing and Proposed Conditions - 10-Yr Storm Inundation Map

10% (10-Year) Flood Recurrence	Pre-Project	Post-Project	Removed
Inundated Structures	6	0	6
Inundated Lots	34	0	34
Inundated Roadway (LF)	0	0	0

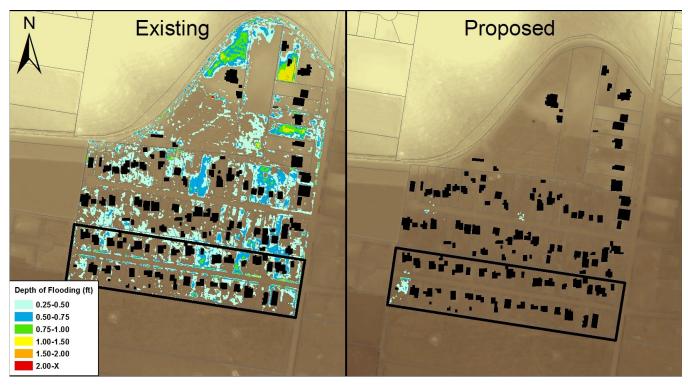
Figure 4: Existing and Proposed Conditions - 25-Yr Storm Inundation Map

4% (25-Year) Flood Recurrence	Pre-Project	Post-Project	Removed
Inundated Structures	7	0	7
Inundated Lots	34	2	32
Inundated Roadway (LF)	0	0	0

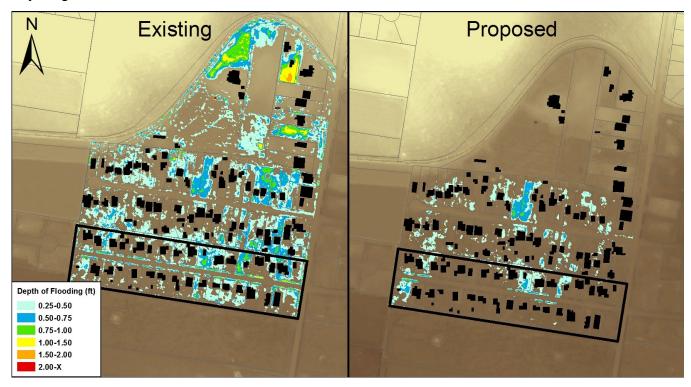
Figure 5: Existing and Proposed Conditions - 100-Yr Storm Inundation Map

1% (100-Year) Flood Recurrence	Pre-Project	Post-Project	Removed
Inundated Structures	9	0	9
Inundated Lots	34	19	15
Inundated Roadway (LF)	0	0	0

- 1. The number of inundated structures are based strictly on finished floor elevations compared to computed water surface elevations.
- 2. The inundation maps above only display flooding depths greater than three inches.
- 3. The number of inundated lots are based strictly on the inundation maps above and therefore do not count as inundated if the depth of flooding is less than three inches.

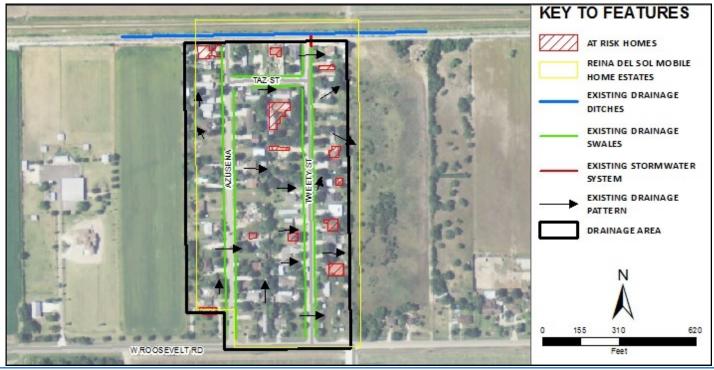
Reina Del Sol Mobile Home Estates consists of approximately 18 acres of fully developed residential land. The existing drainage system consists of swales and culverts that convey runoff toward the north, and outfall into an existing drainage ditch via two culverts. The existing drainage pattern indicates runoff flows toward the east. The existing conditions 2D model results show that several structures are at risk of flooding from a localized storm event. Figures 1, 2, 3, 4, and 5 illustrate the existing and proposed inundation maps for the 2-, 5-, 10-, 25-, and 100-Year storms respectively. The color coded inundation maps illustrate the depth of flooding as follows: light blue represents a depth of 3 to 6 inches, blue 6 to 9 inches, green 9 to 12 inches, yellow 12 to 18 inches, orange 18 to 24 inches, and red more than 24 inches.

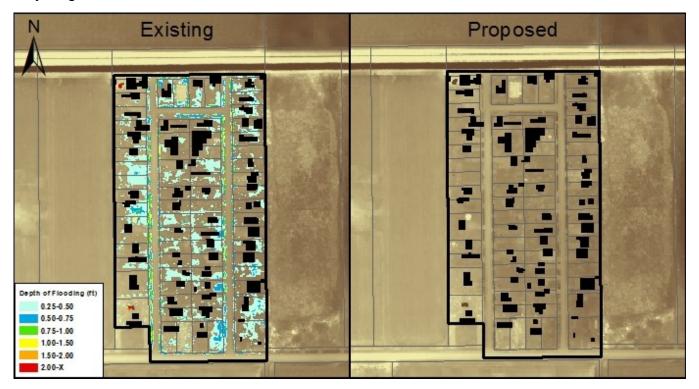
Figure 1: Existing and Proposed Conditions - 2-Yr Storm Inundation Map

The goal of this study was to size the system to be capable of carrying up to the 10-Year storm with no inundation in the colonia. However, some structures lie within low areas of the colonia and still show risk of flooding. When comparing the 6-inch inundation maps for the 25- and 100-Year storms, it is observed that the inundation depths are lower than the existing conditions model, resulting in fewer structures at risk of being flooded once improvements are in place. Figures 1, 2, 3, 4, and 5 show the existing and proposed conditions inundation maps for the 2-, 5-, 10-, 25-, and 100-Yr storms respectively.

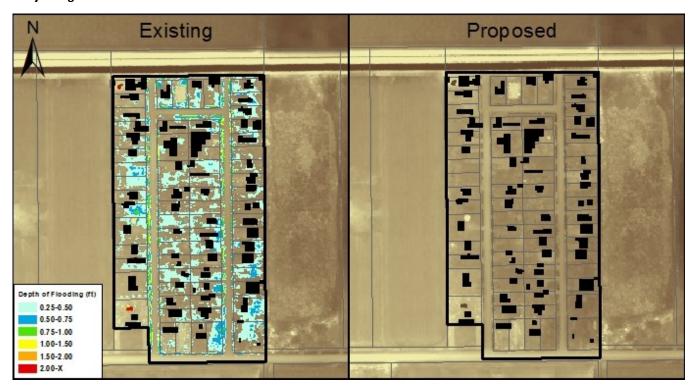
Figure 2: Existing and Proposed Conditions - 5-Yr Storm Inundation Map

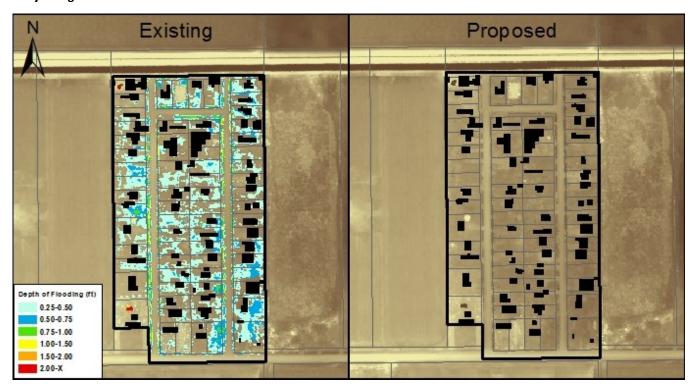
Figure 3: Existing and Proposed Conditions - 10-Yr Storm Inundation Map

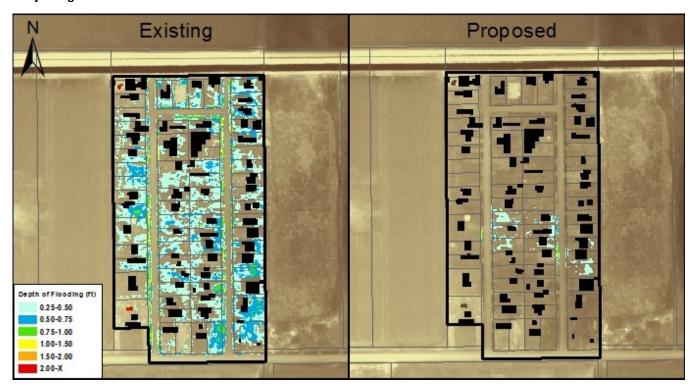
Figure 4: Existing and Proposed Conditions - 25-Yr Storm Inundation Map
