STORMWATER DRAINAGE PLANNING

The Colonias of the Lower Rio Grande Valley (LRGV)

Phase 2 Report

JSW & Associates, Inc. Hazard Mitigation Consultants

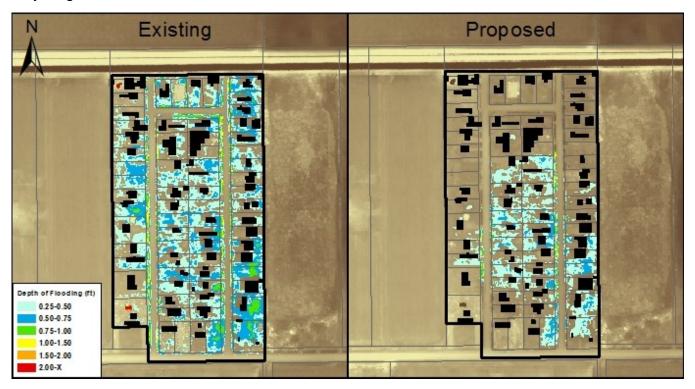
Figure 5: Existing and Proposed Conditions - 100-Yr Storm Inundation Map

1% (100-Year) Flood Recurrence	Pre-Project	Post-Project	Removed
Inundated Structures	13	3	10
Inundated Lots	70	41	29
Inundated Roadway (LF)	0	0	0

- 1. The number of inundated structures are based strictly on finished floor elevations compared to computed water surface elevations.
- 2. The inundation maps above only display flooding depths greater than three inches.
- 3. The number of inundated lots are based strictly on the inundation maps above and therefore do not count as inundated if the depth of flooding is less than three inches.

The goal of this study was to size the system to be capable of carrying up to the 10-Year storm with no inundation in the colonia. However, some structures lie within low areas of the colonia and still show risk of flooding. When comparing the 6-inch inundation maps for the 25- and 100-Year storms, it is observed that the inundation depths are lower than the existing conditions model, resulting in fewer structures at risk of being flooded once improvements are in place. Figures 1, 2, 3, 4, and 5 show the existing and proposed conditions inundation maps for the 2-, 5-, 10-, 25-, and 100-Yr storms respectively.

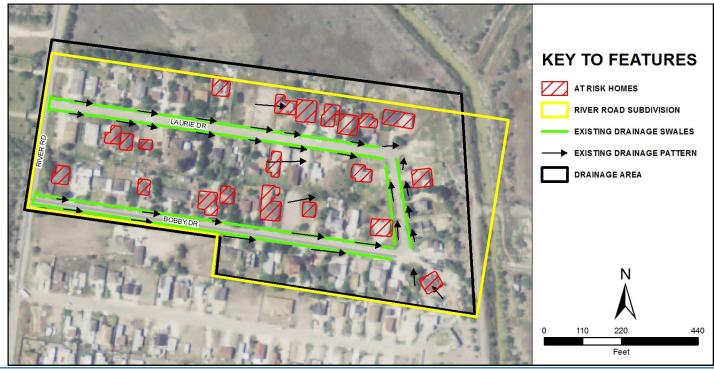
River Road Subdivision consists of approximately 16 acres. Currently the colonia has swales with culverts along Laurie Drive and Bobby Drive, that outfall into an existing ditch along the east side of the colonia. The model results indicate runoff flows toward the northeast quadrant of the colonia. The results are consistent with site visit observations of high-risk flooding areas. Figures 1, 2, 3, 4, and 5 illustrate the existing and proposed inundation maps for the 2-, 5-, 10-, 25-, and 100 -Year storms respectively. The color coded inundation maps illustrate the depth of flooding as follows: light blue represents a depth of 6 to 10 inches, blue 10 to 12 inches, green 12 to 15 inches, yellow 15 to 18 inches, orange 18 to 24 inches and red more than 24 inches.

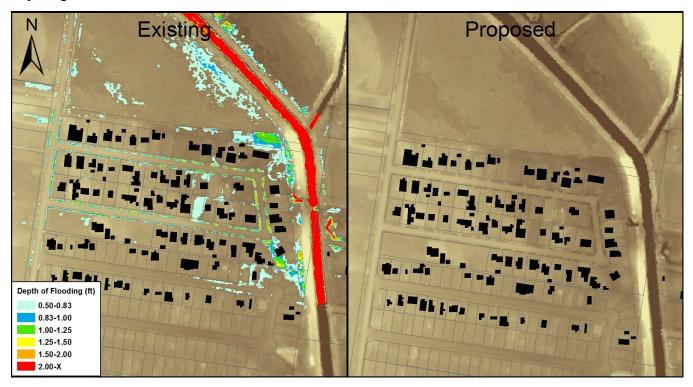
Figure 1: Existing and Proposed Conditions - 2-Yr Storm Inundation Map

50% (2-Year) Flood Recurrence	Pre-Project	Post-Project	Removed
Inundated Structures	2	0	2
Inundated Lots	47	0	47
Inundated Roadway (LF)	0	0	0

The goal of this study was to size the system to be capable of carrying up to the 10-Year storm with no inundation in the colonia. However, some structures lie within low areas of the colonia and still show risk of flooding. When comparing the 6-inch inundation maps for the 25- and 100-Year storms, it is observed that the inundation depths are lower than the existing conditions model, resulting in fewer structures at risk of being flooded once improvements are in place. Figures 1, 2, 3, 4, and 5 show the existing and proposed conditions inundation maps for the 2-, 5-, 10-, 25-, and 100-Yr storms respectively.

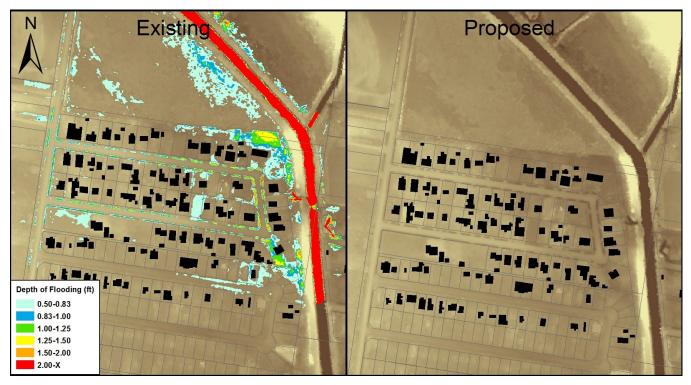
Figure 2: Existing and Proposed Conditions - 5-Yr Storm Inundation Map

20% (5-Year) Flood Recurrence	Pre-Project	Post-Project	Removed
Inundated Structures	2	0	2
Inundated Lots	49	0	49
Inundated Roadway (LF)	0	0	0

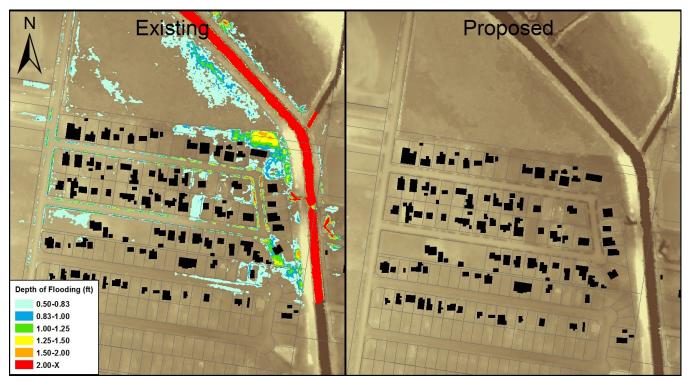
Figure 3: Existing and Proposed Conditions - 10-Yr Storm Inundation Map

10% (10-Year) Flood Recurrence	Pre-Project	Post-Project	Removed
Inundated Structures	2	0	2
Inundated Lots	50	0	50
Inundated Roadway (LF)	0	0	0

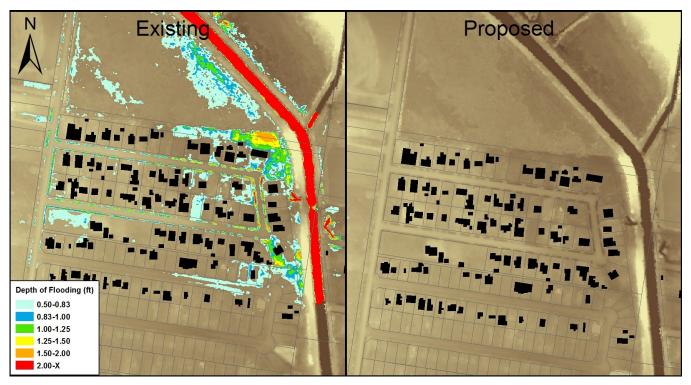
Figure 4: Existing and Proposed Conditions - 25-Yr Storm Inundation Map

4% (25-Year) Flood Recurrence	Pre-Project	Post-Project	Removed
Inundated Structures	2	0	2
Inundated Lots	53	0	53
Inundated Roadway (LF)	0	0	0

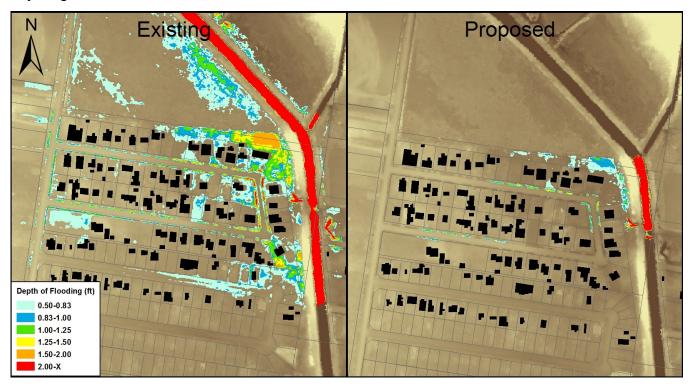
Figure 5: Existing and Proposed Conditions - 100-Yr Storm Inundation Map

1% (100-Year) Flood Recurrence	Pre-Project	Post-Project	Removed
Inundated Structures	5	0	5
Inundated Lots	54	9	45
Inundated Roadway (LF)	0	0	0

- 1. The number of inundated structures are based strictly on finished floor elevations compared to computed water surface elevations.
- 2. The inundation maps above only display flooding depths greater than six inches.
- 3. The number of inundated lots are based strictly on the inundation maps above and therefore do not count as inundated if the depth of flooding is less than six inches.

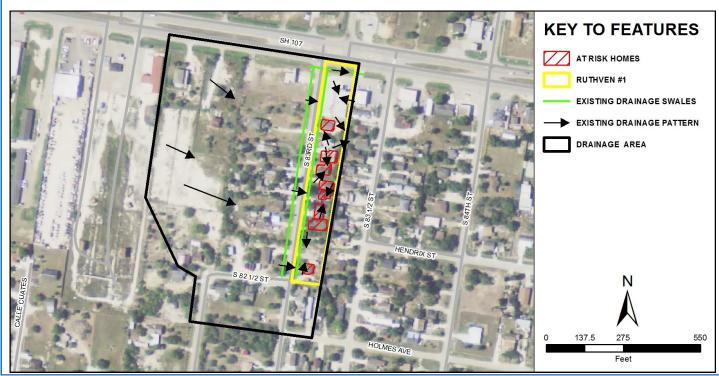
Ruthven #1 consists of approximately 2.2 acres with an offsite drainage basin of approximately 11.9 acres that contributes runoff into the colonia. The colonia currently has a system of swales and culverts that convey runoff toward Highway 107. The model results indicate that some structures within the colonia are at risk of flooding even when subjected to the 10-Year storm and smaller ones. Figures 1, 2, 3, 4, and 5 illustrate the existing and proposed inundation maps for the 2-, 5-, 10 -, 25-, and 100-Year storms respectively. The color coded inundation maps illustrate the depth of flooding as follows: light blue represents a depth of 6 to 10 inches, blue 10 to 12 inches, green 12 to 15 inches, yellow 15 to 22.5 inches, orange 22.5 to 30 inches and red more than 30 inches.

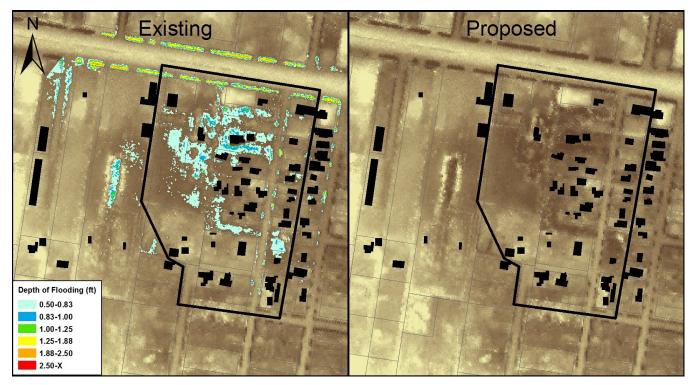
Figure 1: Existing and Proposed Conditions - 2-Yr Storm Inundation Map

50% (2-Year) Flood Recurrence	Pre-Project	Post-Project	Removed
Inundated Structures	1	0	1
Inundated Lots	13	0	13
Inundated Roadway (LF)	0	0	0

The goal of this study was to size the system to be capable of carrying up to the 10-Year storm with no inundation in the colonia. However, some structures lie within low areas of the colonia and still show risk of flooding. When comparing the 6-inch inundation maps for the 25- and 100-Year storms, it is observed that the inundation depths are lower than the existing conditions model, resulting in fewer structures at risk of being flooded once improvements are in place. Figures 1, 2, 3, 4, and 5 show the existing and proposed conditions inundation maps for the 2-, 5-, 10-, 25-, and 100-Yr storms respectively.

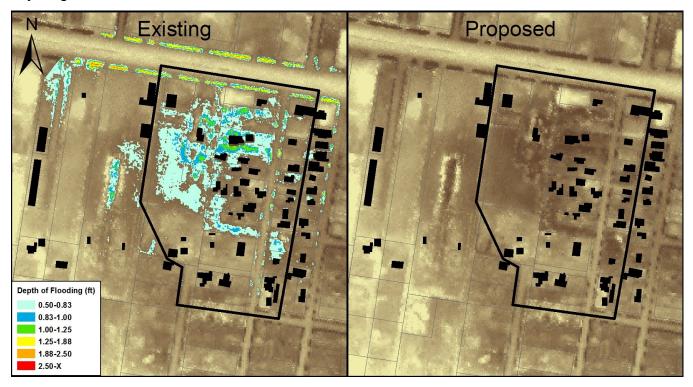
Figure 2: Existing and Proposed Conditions - 5-Yr Storm Inundation Map

20% (5-Year) Flood Recurrence	Pre-Project	Post-Project	Removed
Inundated Structures	1	0	1
Inundated Lots	13	0	13
Inundated Roadway (LF)	0	0	0

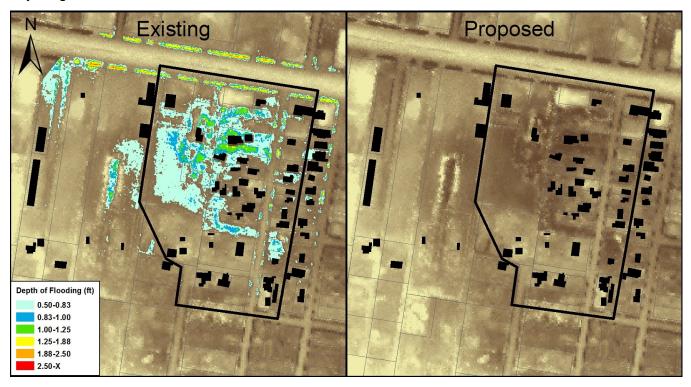
Figure 3: Existing and Proposed Conditions - 10-Yr Storm Inundation Map

10% (10-Year) Flood Recurrence	Pre-Project	Post-Project	Removed
Inundated Structures	1	0	1
Inundated Lots	13	0	13
Inundated Roadway (LF)	0	0	0

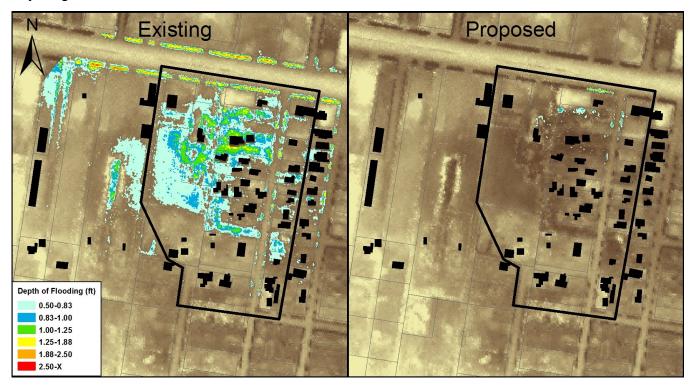
Figure 4: Existing and Proposed Conditions - 25-Yr Storm Inundation Map

4% (25-Year) Flood Recurrence	Pre-Project	Post-Project	Removed
Inundated Structures	2	0	2
Inundated Lots	14	1	13
Inundated Roadway (LF)	0	0	0

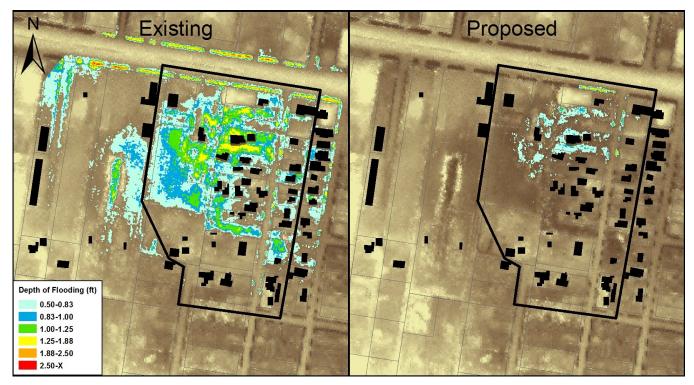
Figure 5: Existing and Proposed Conditions - 100-Yr Storm Inundation Map

1% (100-Year) Flood Recurrence	Pre-Project	Post-Project	Removed
Inundated Structures	2	0	2
Inundated Lots	14	1	13
Inundated Roadway (LF)	0	0	0

- 1. The number of inundated structures are based strictly on finished floor elevations compared to computed water surface elevations.
- 2. The inundation maps above only display flooding depths greater than six inches.
- 3. The number of inundated lots are based strictly on the inundation maps above and therefore do not count as inundated if the depth of flooding is less than six inches.

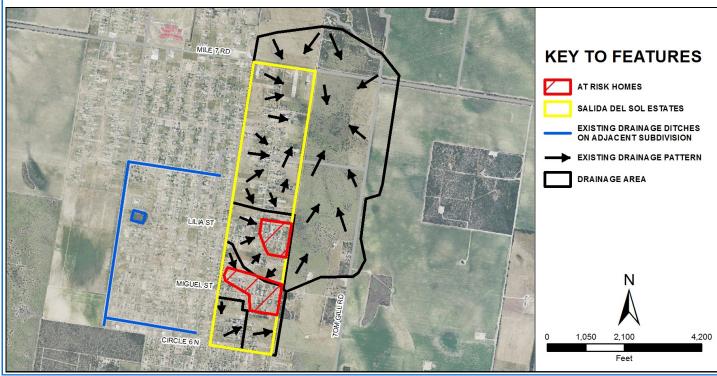
The colonia known as Salida Del Sol Estates consist of approximately 310 acres and the drainage basin that causes the ponding on the northeast corner of the subdivision consists of approximately 667 acres. Some high-risk flooding areas along the southeast end of Miguel Street and the northeast portion of Lilia Street were observed. As runoff travels to low areas it ponds and potentially overflows to other areas of the colonia. The model computed flood depths that are consistent with comments from residents that indicate experience with flooding depths of up to 4-feet. Figures 1, 2, 3, 4, and 5 illustrate the existing and proposed inundation maps of the areas where structures appear to be at risk of flooding for the 2-, 5-, 10-, 25-, and 100-Year storms respectively. The color coded inundation maps illustrate the depth of flooding as follows: light blue represents a depth of 6 to 18 inches, blue 18 to 30 inches, green 30 to 42 inches, yellow 42 to 54 inches, orange 54 to 66 inches and red more than 66 inches.

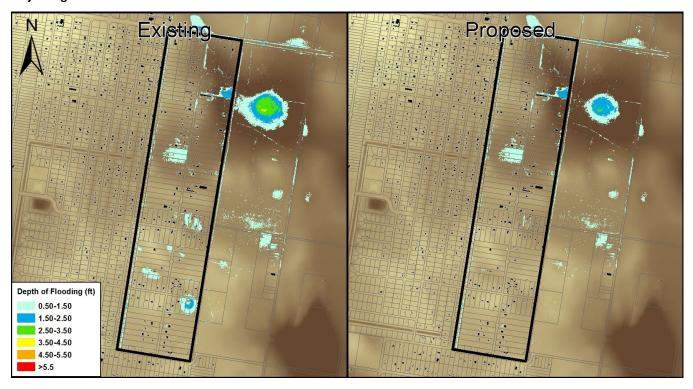
Figure 1: Existing and Proposed Conditions - 2-Yr Storm Inundation Map

50% (2-Year) Flood Recurrence	Pre-Project	Post-Project	Removed
Inundated Structures	1	0	1
Inundated Lots	178	144	34
Inundated Roadway (LF)	215	215	0

The goal of this study was to size the system to be capable of carrying up to the 10-Year storm with no inundation in the colonia. However, some structures lie within low areas of the colonia and still show risk of flooding. When comparing the 6-inch inundation maps for the 25- and 100-Year storms, it is observed that the inundation depths are lower than the existing conditions model, resulting in fewer structures at risk of being flooded once improvements are in place. Figures 1, 2, 3, 4, and 5 show the existing and proposed conditions inundation maps for the 2-, 5-, 10-, 25-, and 100-Yr storms respectively.

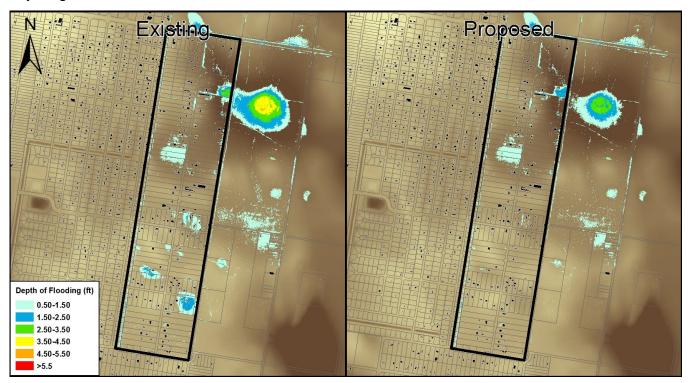
Figure 2: Existing and Proposed Conditions - 5-Yr Storm Inundation Map

20% (5-Year) Flood Recurrence	Pre-Project	Post-Project	Removed
Inundated Structures	2	0	2
Inundated Lots	187	149	38
Inundated Roadway (LF)	434	215	219

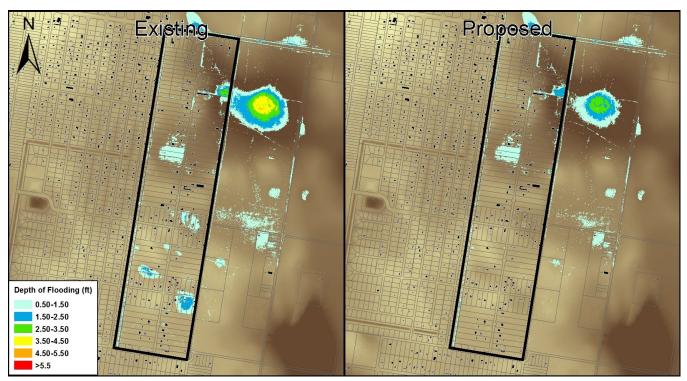
Figure 3: Existing and Proposed Conditions - 10-Yr Storm Inundation Map

10% (10-Year) Flood Recurrence	Pre-Project	Post-Project	Removed
Inundated Structures	2	0	2
Inundated Lots	188	152	36
Inundated Roadway (LF)	436	215	221

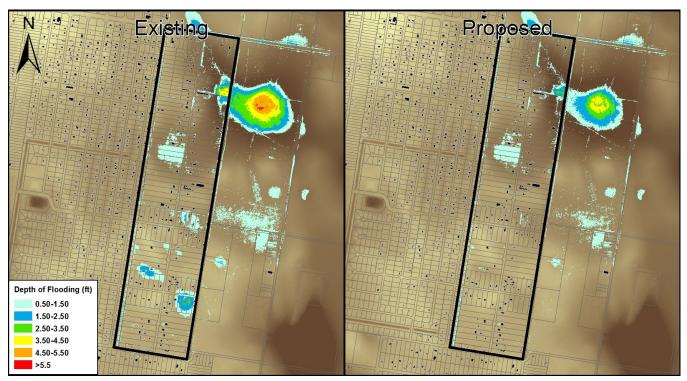
Figure 4: Existing and Proposed Conditions - 25-Yr Storm Inundation Map

4% (25-Year) Flood Recurrence	Pre-Project	Post-Project	Removed
Inundated Structures	3	0	3
Inundated Lots	189	153	36
Inundated Roadway (LF)	530	218	312

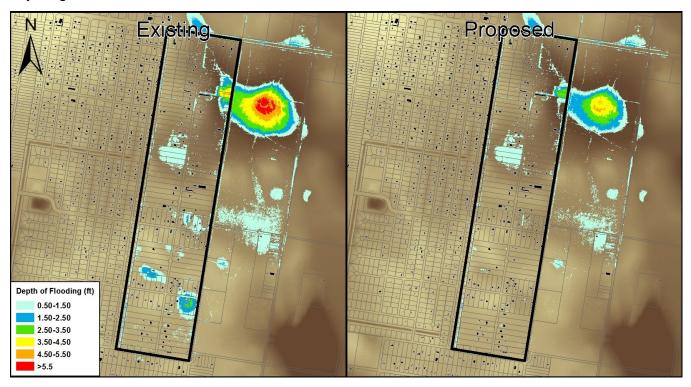
Figure 5: Existing and Proposed Conditions - 100-Yr Storm Inundation Map

50% (2-Year) Flood Recurrence	Pre-Project	Post-Project	Removed
Inundated Structures	5	0	5
Inundated Lots	189	155	34
Inundated Roadway (LF)	745	220	525

- 1. The number of inundated structures are based strictly on finished floor elevations compared to computed water surface elevations.
- 2. The inundation maps above only display flooding depths greater than six inches.
- 3. The number of inundated lots are based strictly on the inundation maps above and therefore do not count as inundated if the depth of flooding is less than six inches.

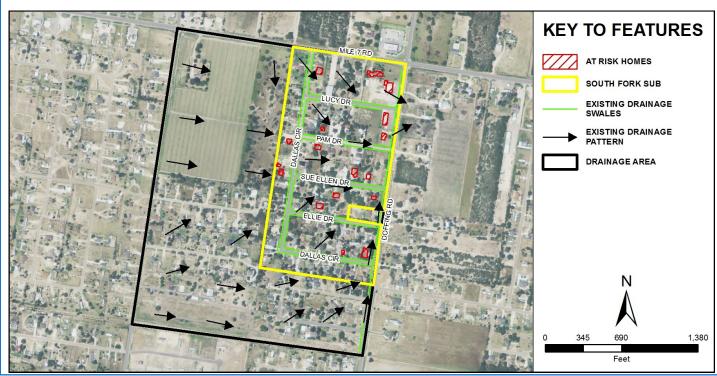
South Fork Subdivision consist of approximately 47 acres of fully developed residential land with an offsite drainage area of approximately 82 acres of developed residential land and agricultural land. The existing swales are very small, shallow, and eroded, therefore they do not provide adequate drainage; additionally, not all driveways have culverts to allow flow throughout the colonia. The existing drainage pattern indicates runoff flows toward the east. The results of the existing conditions 2D model indicate that there is considerable ponding within the colonia, resulting in several structures at high risk of flooding. This may be attributed to low lots or drainage obstructions. Figures 1, 2, 3, 4, and 5 illustrate the existing and proposed inundation maps for the 2-, 5-, 10-, 25-, and 100-Year storms respectively. The color coded inundation maps illustrate the depth of flooding as follows: light blue represents a depth of 3 to 6 inches, blue 6 to 9 inches, green 9 to 12 inches, yellow 12 to 18 inches, orange 18 to 24 inches, and red more than 24 inches.

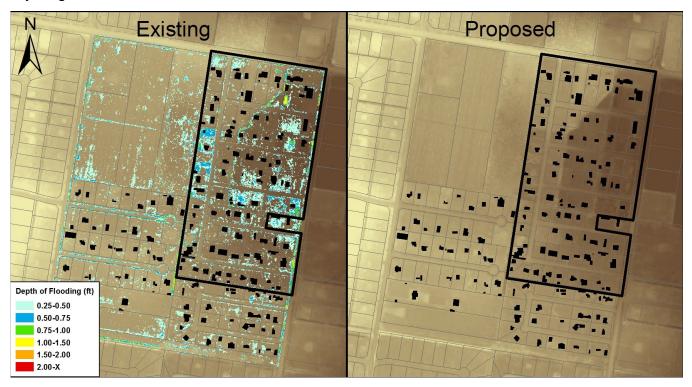
Figure 1: Existing and Proposed Conditions - 2-Yr Storm Inundation Map

50% (2-Year) Flood Recurrence	Pre-Project	Post-Project	Removed
Inundated Structures	3	0	3
Inundated Lots	86	0	86
Inundated Roadway (LF)	41	0	41

The goal of this study was to size the system to be capable of carrying up to the 10-Year storm with no inundation in the colonia. However, some structures lie within low areas of the colonia and still show risk of flooding. When comparing the 6-inch inundation maps for the 25- and 100-Year storms, it is observed that the inundation depths are lower than the existing conditions model, resulting in fewer structures at risk of being flooded once improvements are in place. Figures 1, 2, 3, 4, and 5 show the existing and proposed conditions inundation maps for the 2-, 5-, 10-, 25-, and 100-Yr storms respectively.

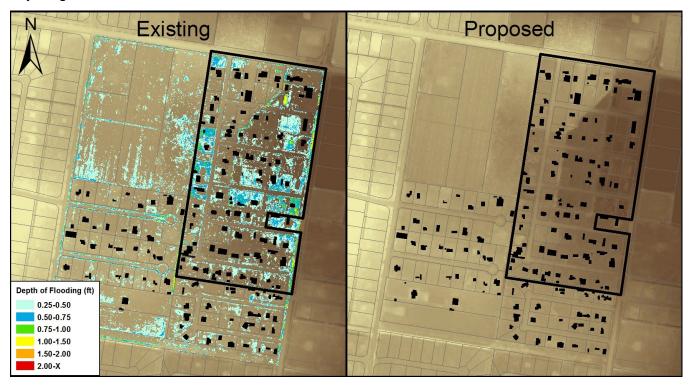
Figure 2: Existing and Proposed Conditions - 5-Yr Storm Inundation Map

20% (5-Year) Flood Recurrence	Pre-Project	Post-Project	Removed
Inundated Structures	7	0	7
Inundated Lots	86	0	86
Inundated Roadway (LF)	129	0	129

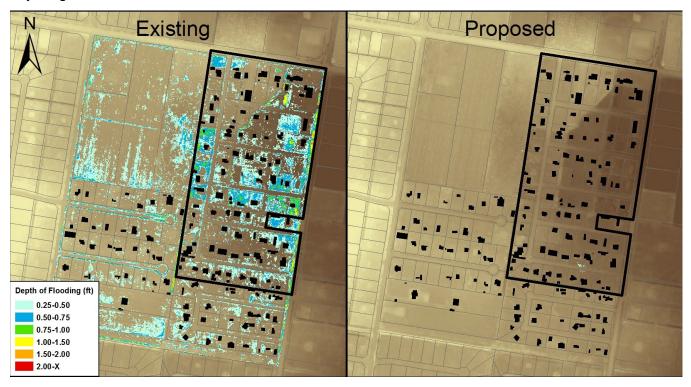
Figure 3: Existing and Proposed Conditions - 10-Yr Storm Inundation Map

10% (10-Year) Flood Recurrence	Pre-Project	Post-Project	Removed
Inundated Structures	8	0	8
Inundated Lots	86	3	83
Inundated Roadway (LF)	177	0	177

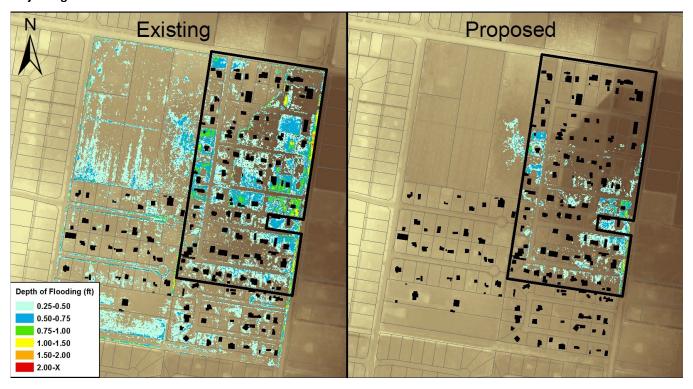
Figure 4: Existing and Proposed Conditions - 25-Yr Storm Inundation Map

4% (25-Year) Flood Recurrence	Pre-Project	Post-Project	Removed
Inundated Structures	13	3	10
Inundated Lots	86	56	30
Inundated Roadway (LF)	276	71	205

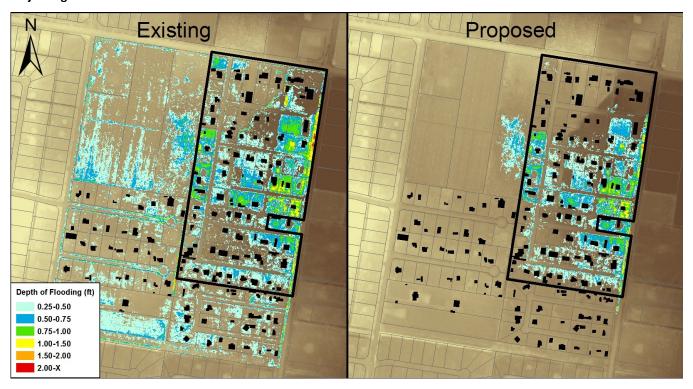
Figure 5: Existing and Proposed Conditions - 100-Yr Storm Inundation Map

1% (100-Year) Flood Recurrence	Pre-Project	Post-Project	Removed
Inundated Structures	17	10	7
Inundated Lots	86	71	15
Inundated Roadway (LF)	1348	202	1146

- 1. The number of inundated structures are based strictly on finished floor elevations compared to computed water surface elevations.
- 2. The inundation maps above only display flooding depths greater than three inches.
- 3. The number of inundated lots are based strictly on the inundation maps above and therefore do not count as inundated if the depth of flooding is less than three inches.

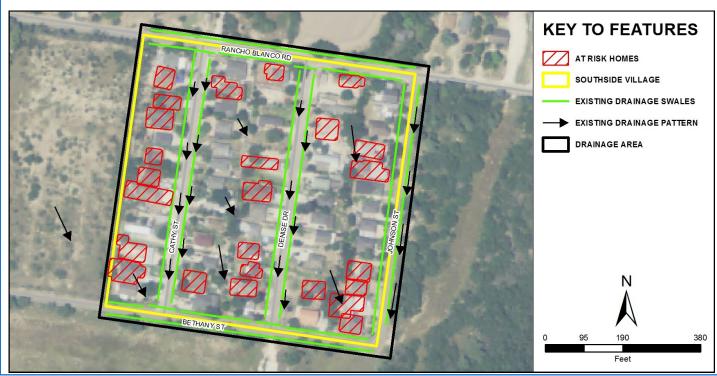
Southside Village consists of approximately 10.3 acres and currently does not have a drainage system. Culverts were observed at each intersection of Bethany Street and seemingly drain south toward an empty field. The model results indicate that there are high-risk flooding areas throughout the colonia. Figures 1, 2, 3, 4, and 5 illustrate the existing and proposed inundation maps for the 2-, 5-, 10-, 25-, and 100-Year storms respectively. The color coded inundation maps illustrate the depth of flooding as follows: light blue represents a depth of 4 to 6 inches, blue 6 to 7.5 inches, green 7.5 to 9 inches, yellow 9 to 11 inches, orange 11 to 28 inches and red more than 28 inches.

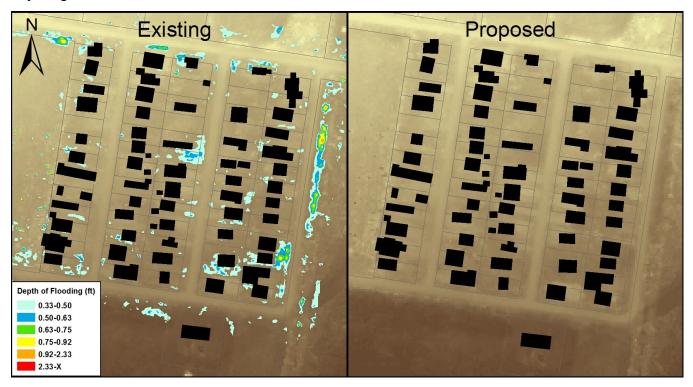
Figure 1: Existing and Proposed Conditions - 2-Yr Storm Inundation Map

50% (2-Year) Flood Recurrence	Pre-Project	Post-Project	Removed
Inundated Structures	6	2	4
Inundated Lots	56	0	56
Inundated Roadway (LF)	0	0	0

The goal of this study was to size the system to be capable of carrying up to the 10-Year storm with no inundation in the colonia. However, some structures lie within low areas of the colonia and still show risk of flooding. When comparing the 6-inch inundation maps for the 25- and 100-Year storms, it is observed that the inundation depths are lower than the existing conditions model, resulting in fewer structures at risk of being flooded once improvements are in place. Figures 1, 2, 3, 4, and 5 show the existing and proposed conditions inundation maps for the 2-, 5-, 10-, 25-, and 100-Yr storms respectively.

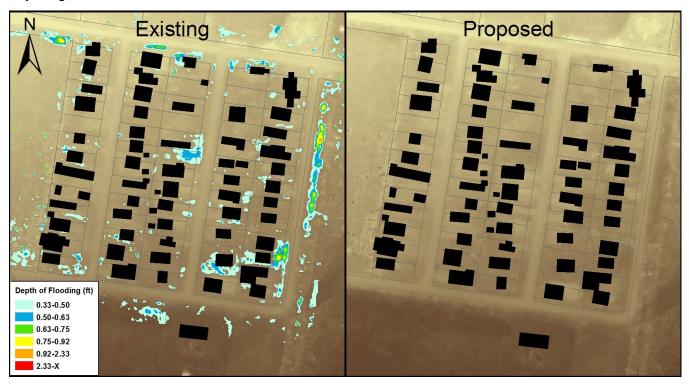
Figure 2: Existing and Proposed Conditions - 5-Yr Storm Inundation Map

20% (5-Year) Flood Recurrence	Pre-Project	Post-Project	Removed
Inundated Structures	8	2	6
Inundated Lots	58	0	58
Inundated Roadway (LF)	0	0	0

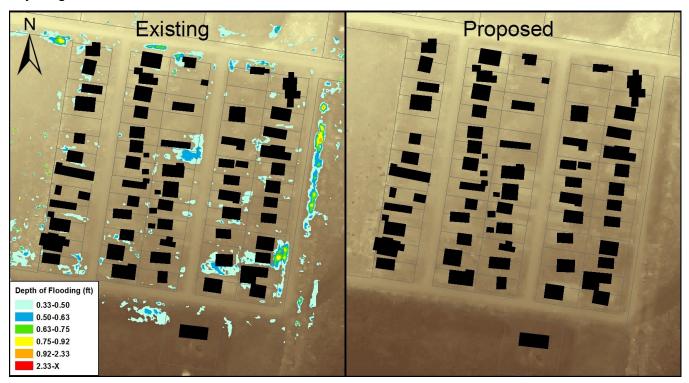
Figure 3: Existing and Proposed Conditions - 10-Yr Storm Inundation Map

10% (10-Year) Flood Recurrence	Pre-Project	Post-Project	Removed
Inundated Structures	8	2	6
Inundated Lots	58	0	58
Inundated Roadway (LF)	0	0	0

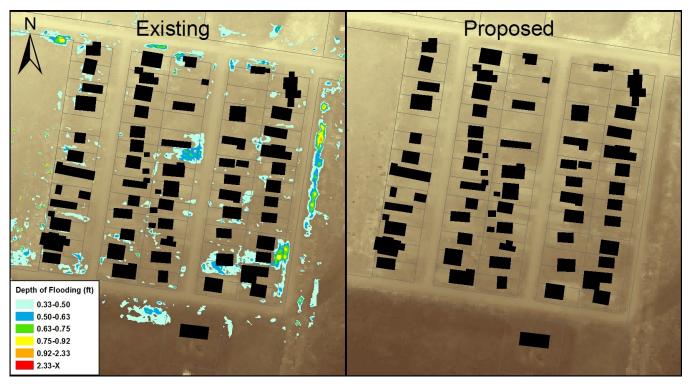
Figure 4: Existing and Proposed Conditions - 25-Yr Storm Inundation Map

4% (25-Year) Flood Recurrence	Pre-Project	Post-Project	Removed
Inundated Structures	8	2	6
Inundated Lots	62	0	62
Inundated Roadway (LF)	0	0	0

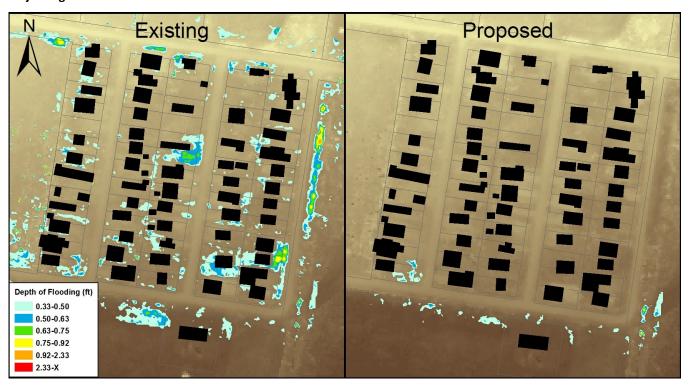
Figure 5: Existing and Proposed Conditions - 100-Yr Storm Inundation Map

1% (100-Year) Flood Recurrence	Pre-Project	Post-Project	Removed
Inundated Structures	8	2	6
Inundated Lots	64	2	62
Inundated Roadway (LF)	0	0	0

- 1. The number of inundated structures are based strictly on finished floor elevations compared to computed water surface elevations.
- 2. The inundation maps above only display flooding depths greater than four inches.
- 3. The number of inundated lots are based strictly on the inundation maps above and therefore do not count as inundated if the depth of flooding is less than four inches.

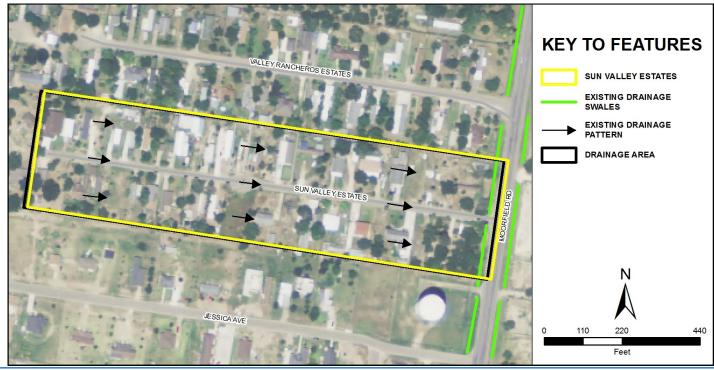
Sun Valley Estates consists of approximately 10 acres of fully developed residential land. Currently the colonia does not have a drainage system and runoff flows toward the east. The model results indicate that the properties along the center of the colonia are at risk of flooding, mostly due to the lots being low or having drainage obstructions. The majority of homes in this colonia are elevated mobile homes and may not be affected by ponding on low lots. Based on the model results and estimated finish floor elevations for the structures it was determined that no structure is at high risk of flooding from a localized storm event. It was also found that the northeast properties may experience risk of flooding if the swales on Moorfield Road become blocked. Figures 1, 2, 3, 4, and 5 illustrate the existing and proposed inundation maps for the 2-, 5-, 10-, 25-, and 100-Year storms respectively. The color coded inundation maps illustrate the depth of flooding as follows: light blue represents a depth of 3 to 4.5 inches, blue 4.5 to 6 inches, green 6 to 9 inches, yellow 9 to 12 inches, orange 12 to 17 inches, and red more than 17inches.

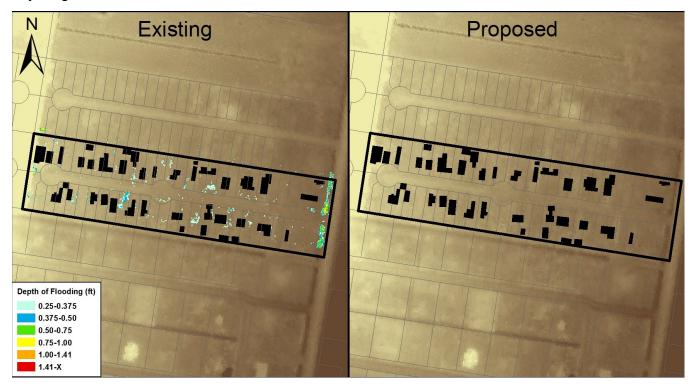
Figure 1: Existing and Proposed Conditions - 2-Yr Storm Inundation Map

50% (2-Year) Flood Recurrence	Pre-Project	Post-Project	Removed
Inundated Structures	0	0	0
Inundated Lots	51	0	51
Inundated Roadway (LF)	0	0	0

The goal of this study was to size the system to be capable of carrying up to the 10-Year storm with no inundation in the colonia. However, some structures lie within low areas of the colonia and still show risk of flooding. When comparing the 6-inch inundation maps for the 25- and 100-Year storms, it is observed that the inundation depths are lower than the existing conditions model, resulting in less overall ponding and the street is at lower risk of being flooded once improvements are in place. Figures 1, 2, 3, 4, and 5 show the existing and proposed conditions inundation maps for the 2-, 5-, 10-, 25-, and 100-Yr storms respectively.

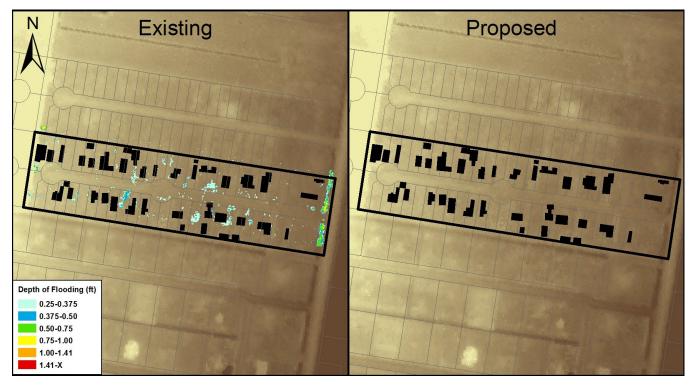
Figure 2: Existing and Proposed Conditions - 5-Yr Storm Inundation Map

20% (5-Year) Flood Recurrence	Pre-Project	Post-Project	Removed
Inundated Structures	0	0	0
Inundated Lots	52	0	52
Inundated Roadway (LF)	0	0	0

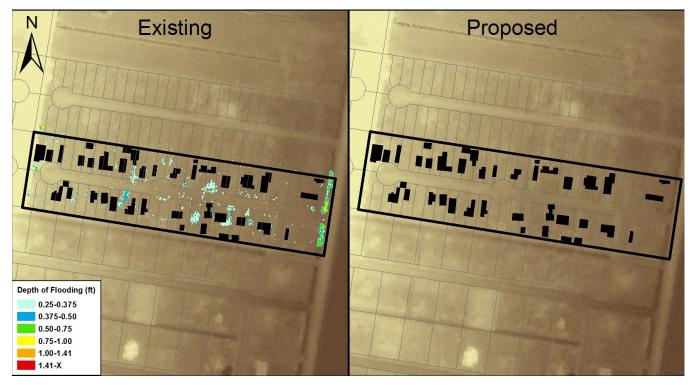
Figure 3: Existing and Proposed Conditions - 10-Yr Storm Inundation Map

10% (10-Year) Flood Recurrence	Pre-Project	Post-Project	Removed
Inundated Structures	0	0	0
Inundated Lots	52	0	52
Inundated Roadway (LF)	0	0	0

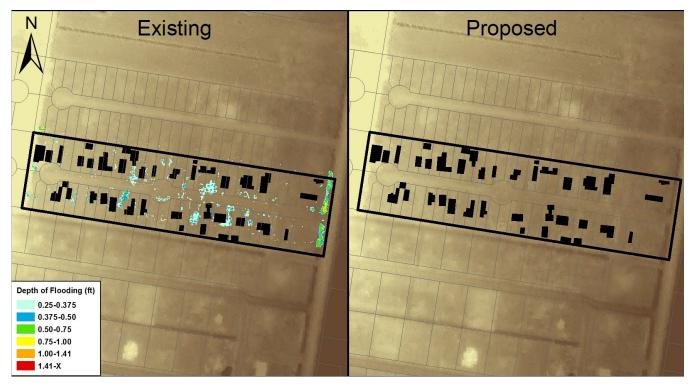
Figure 4: Existing and Proposed Conditions - 25-Yr Storm Inundation Map

4% (25-Year) Flood Recurrence	Pre-Project	Post-Project	Removed
Inundated Structures	0	0	0
Inundated Lots	52	0	52
Inundated Roadway (LF)	0	0	0

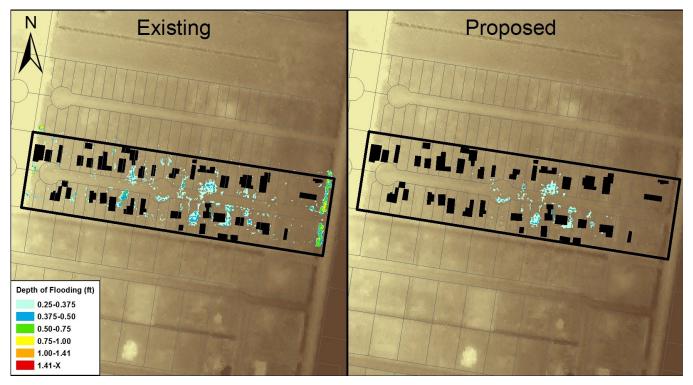
Figure 5: Existing and Proposed Conditions - 100-Yr Storm Inundation Map

1% (100-Year) Flood Recurrence	Pre-Project	Post-Project	Removed
Inundated Structures	0	0	0
Inundated Lots	52	25	29
Inundated Roadway (LF)	18	0	18

- 1. The number of inundated structures are based strictly on finished floor elevations compared to computed water surface elevations.
- 2. The inundation maps above only display flooding depths greater than three inches.
- 3. The number of inundated lots are based strictly on the inundation maps above and therefore do not count as inundated if the depth of flooding is less than three inches.

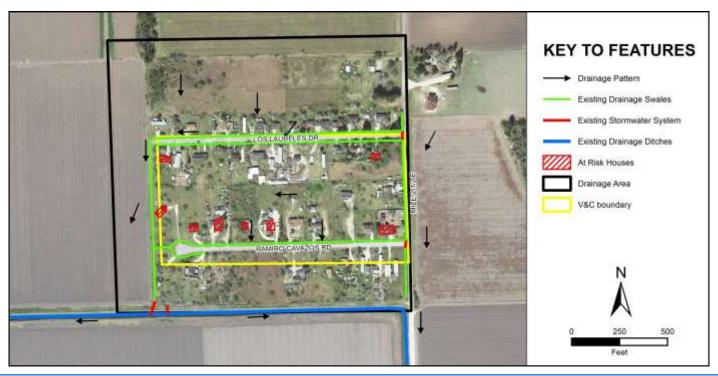
Drainage patterns within this 20-acre colonia are generally to the south and west. The existing drainage system consists of a small stormwater system and roadside swales that are generally undersized and restricted by sediment and vegetation. V&C experiences residential lot, street, and structure flooding in nearly every rainfall event. Figures 1-5 illustrate the existing and proposed conditions inundation maps for the 2-, 5-, 10-, 25-, and 100-year storms, respectively. These maps illustrate the depth of flooding as follows: light blue represents a depth of 3 to 6 inches, blue 6 to 9 inches, green 9 to 12 inches, yellow 1 to 2 feet, orange 2 to 3 feet, and red more than 3 feet.

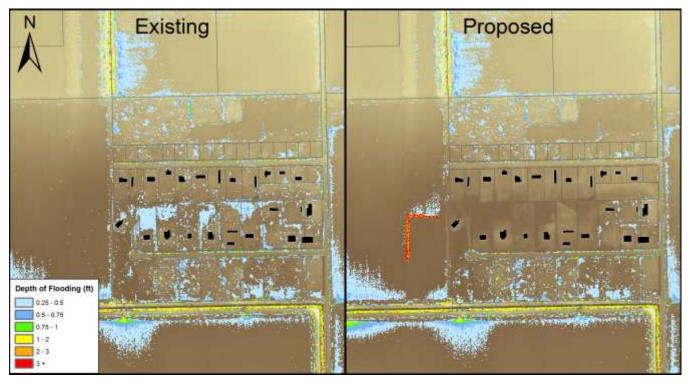
Figure 1: Existing and Proposed Conditions - 2-yr Storm Inundation Map

The goal of this study was to size the system to be capable of carrying up to the 10-Year storm runoff with no inundation in the colonia. However, some structures lie within low areas of the colonia and still show risk of flooding. When comparing the 6-inch inundation map for the 25- and 100-Year storms, it is observed that the inundation depths are lower than the existing conditions model, resulting in fewer structures at risk of being flooded once improvements are in place. Figures 1, 2, 3, 4, and 5 show the existing and proposed conditions inundation maps for the 2-, 5-, 10-, 25-, and 100-Yr storms respectively.

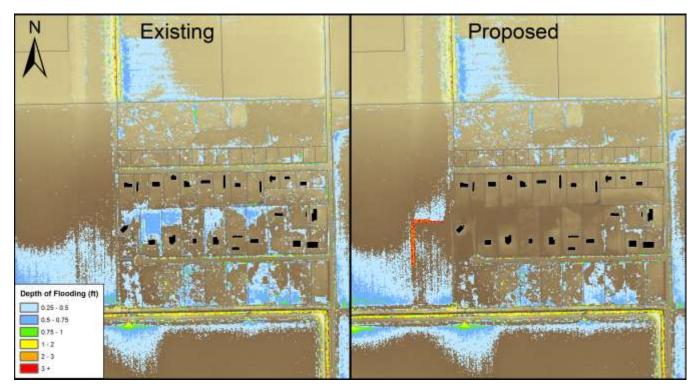
Figure 2: Existing and Proposed Conditions - 5-yr Storm Inundation Map

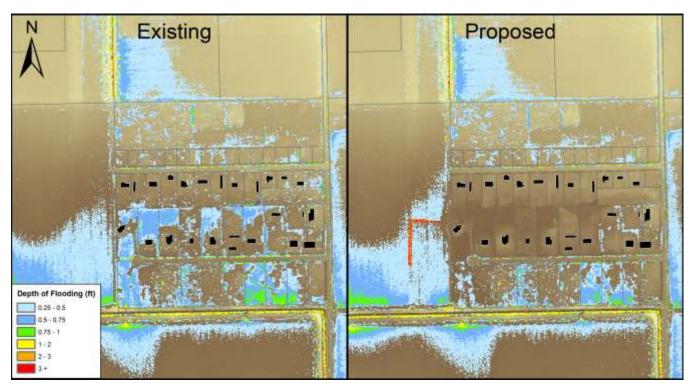
Figure 3: Existing and Proposed Conditions - 10-yr Storm Inundation Map

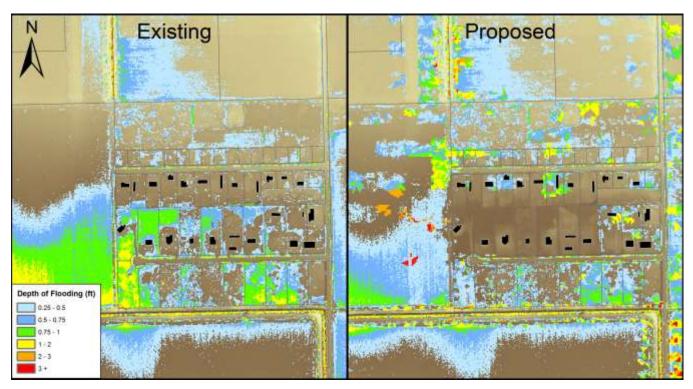
Figure 4: Existing and Proposed Conditions - 25-yr Storm Inundation Map

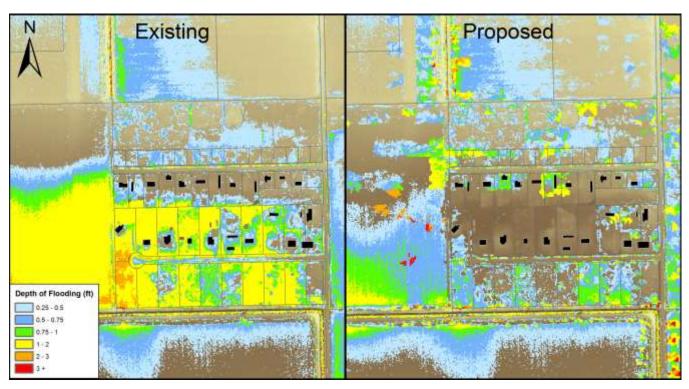
Figure 5: Existing and Proposed Conditions - 100-yr Storm Inundation Map

1% (100-Year) Flood Recurrence	Pre-Project	Post-Project	Removed
Inundated Structures	8	0	8
Inundated Lots	24	1	23
Inundated Roadway (LF)	980	85	895

- 1. The number of inundated structures are based strictly on finished floor elevations compared to computed water surface elevations.
- 2. The inundation maps above only display flooding depths greater than 3 inches.
- 3. The number of inundated lots are based strictly on the inundation maps above and therefore do not count as inundated if the depth of flooding is less than 3 inches.

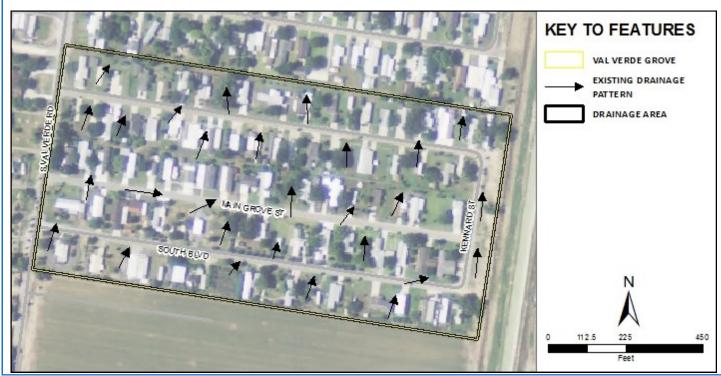
Val Verde Grove consists of approximately 19.6 acres of fully developed residential land. The colonia currently does not have a drainage system. The existing drainage pattern indicates runoff flows toward the north. Based on the existing conditions 2D model results and estimated finished floor elevations for the structures, it was determined that no structure is at high risk of flooding from a localized storm event. Figures 1, 2, 3, 4, and 5 illustrate the existing and proposed inundation maps for the 2-, 5-, 10-, 25-, and 100-Year storms respectively. The color coded inundation maps illustrate the depth of flooding as follows: light blue represents a depth of 3 to 6 inches, blue 6 to 9 inches, green 9 to 12 inches, yellow 12 to 18 inches, orange 18 to 24 inches, and red more than 24 inches.

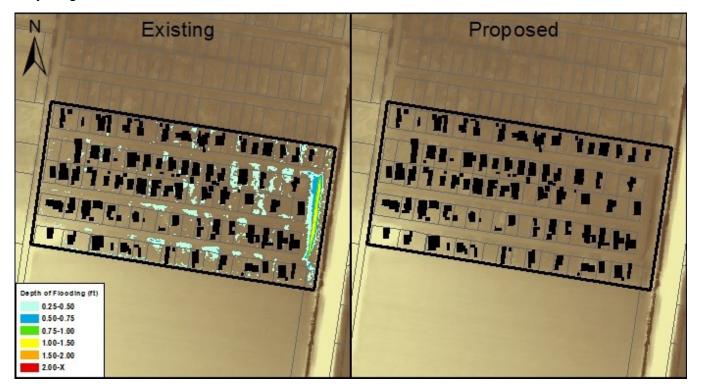
Figure 1: Existing and Proposed Conditions - 2-Yr Storm Inundation Map

The goal of this study was to size the system to be capable of carrying up to the 10-Year storm with no inundation in the colonia. However, some structures lie within low areas of the colonia and still show risk of flooding. When comparing the 6-inch inundation maps for the 25- and 100-Year storms, it is observed that the inundation depths are lower than the existing conditions model, resulting in less overall ponding and the street is at lower risk of being flooded once improvements are in place. Figures 1, 2, 3, 4, and 5 show the existing and proposed conditions inundation maps for the 2-, 5-, 10-, 25-, and 100-Yr storms respectively.

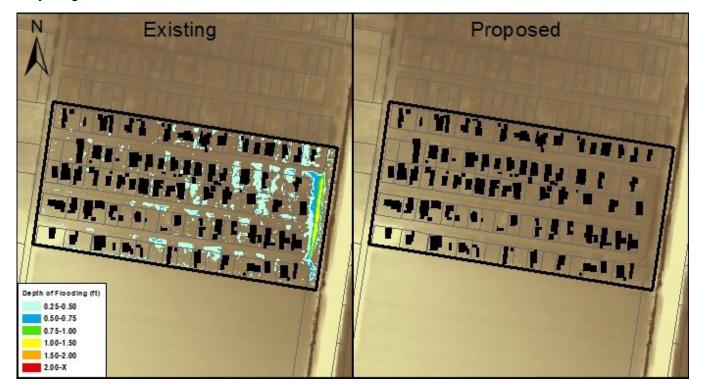
Figure 2: Existing and Proposed Conditions - 5-Yr Storm Inundation Map

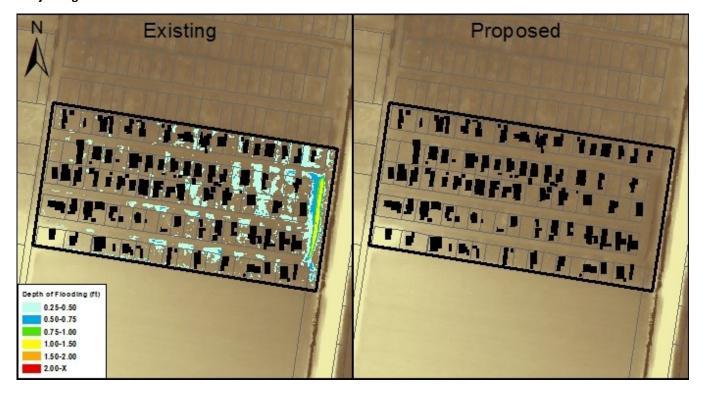
Figure 3: Existing and Proposed Conditions - 10-Yr Storm Inundation Map

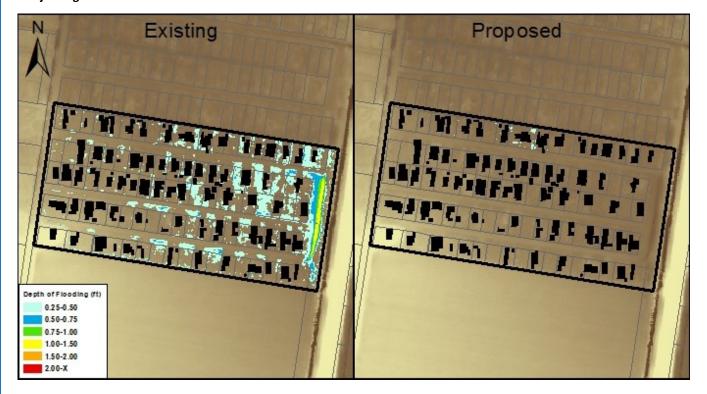
Figure 4: Existing and Proposed Conditions - 25-Yr Storm Inundation Map

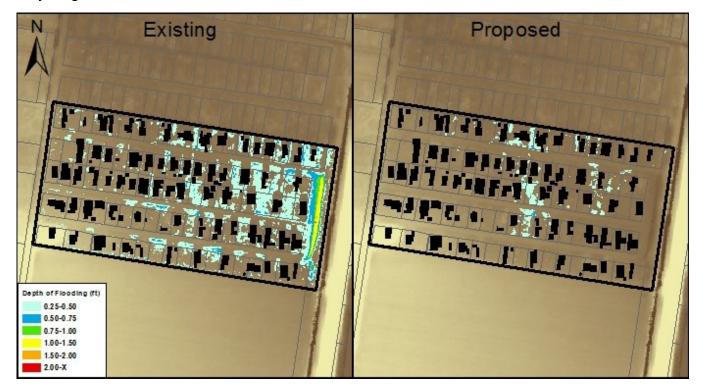
Figure 5: Existing and Proposed Conditions - 100-Yr Storm Inundation Map

1% (100-Year) Flood Recurrence	Pre-Project	Post-Project	Removed
Inundated Structures	0	0	0
Inundated Lots	85	33	52
Inundated Roadway (LF)	0	0	0

- 1. The number of inundated structures are based strictly on finished floor elevations compared to computed water surface elevations.
- 2. The inundation maps above only display flooding depths greater than three inches.
- 3. The number of inundated lots are based strictly on the inundation maps above and therefore do not count as inundated if the depth of flooding is less than three inches.

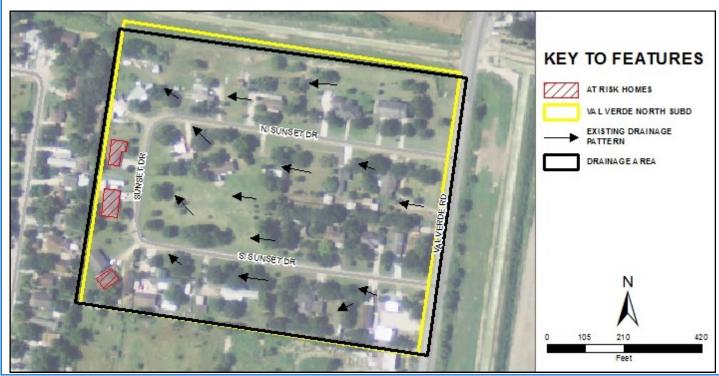
Val Verde North Subd. consists of approximately 17 acres of fully developed residential land. The colonia currently does not have a drainage system. The existing drainage pattern indicates runoff flows toward the west. Based on the existing conditions 2D model results, structures along the west side of the colonia appear to be at risk of flooding. Figures 1, 2, 3, 4, and 5 illustrate the existing and proposed inundation maps for the 2-, 5-, 10-, 25-, and 100-Year storms respectively. The color coded inundation maps illustrate the depth of flooding as follows: light blue represents a depth of 3 to 6 inches, blue 6 to 9 inches, green 9 to 12 inches, yellow 12 to 18 inches, orange 18 to 24 inches, and red more than 24 inches.

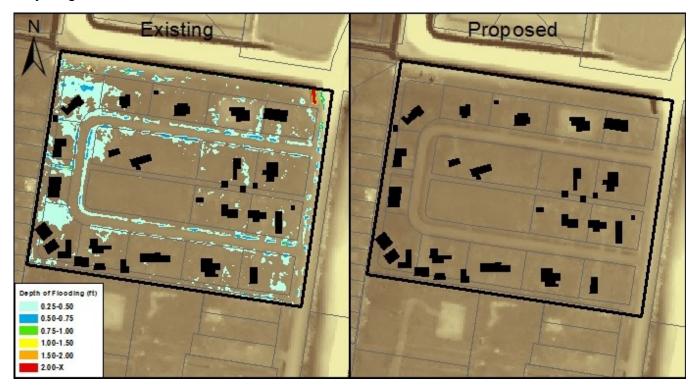
Figure 1: Existing and Proposed Conditions - 2-Yr Storm Inundation Map

The goal of this study was to size the system to be capable of carrying up to the 10-Year storm with no inundation in the colonia. However, some structures lie within low areas of the colonia and still show risk of flooding. When comparing the 6-inch inundation maps for the 25- and 100-Year storms, it is observed that the inundation depths are lower than the existing conditions model, resulting in fewer structures at risk of being flooded once improvements are in place. Figures 1, 2, 3, 4, and 5 show the existing and proposed conditions inundation maps for the 2-, 5-, 10-, 25-, and 100-Yr storms respectively.

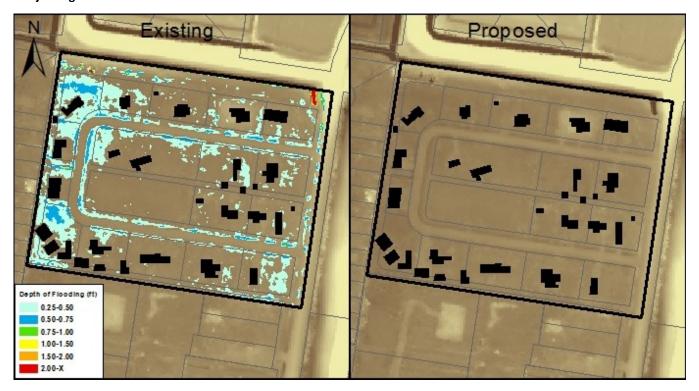
Figure 2: Existing and Proposed Conditions - 5-Yr Storm Inundation Map

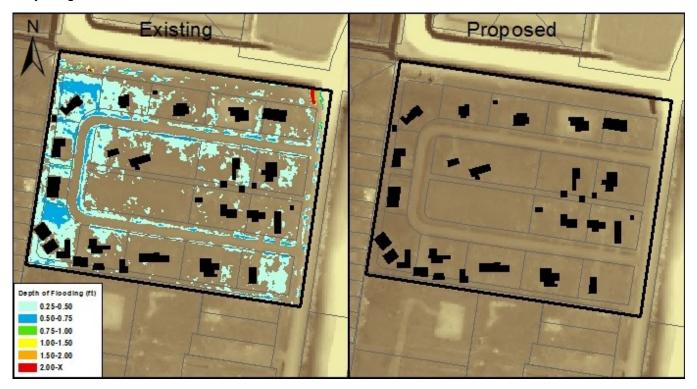
Figure 3: Existing and Proposed Conditions - 10-Yr Storm Inundation Map

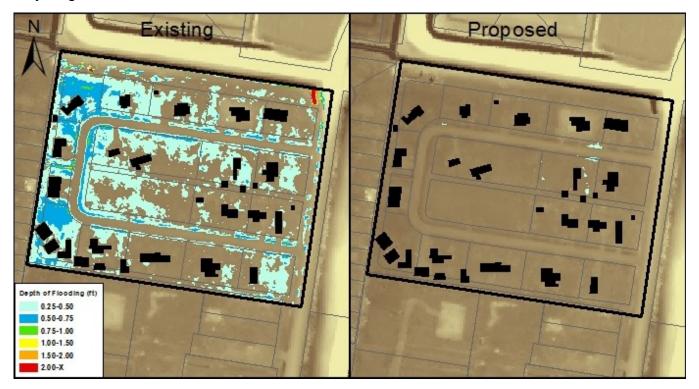
Figure 4: Existing and Proposed Conditions - 25-Yr Storm Inundation Map

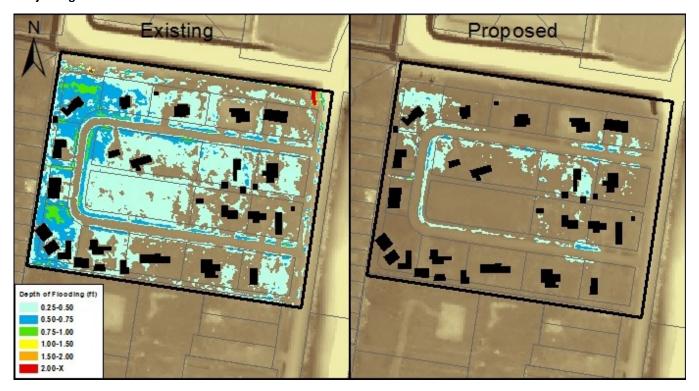
Figure 5: Existing and Proposed Conditions - 100-Yr Storm Inundation Map

1% (100-Year) Flood Recurrence	Pre-Project	Post-Project	Removed
Inundated Structures	3	0	3
Inundated Lots	18	14	4
Inundated Roadway (LF)	0	0	0

- 1. The number of inundated structures are based strictly on finished floor elevations compared to computed water surface elevations.
- 2. The inundation maps above only display flooding depths greater than three inches.
- 3. The number of inundated lots are based strictly on the inundation maps above and therefore do not count as inundated if the depth of flooding is less than three inches.
