STORMWATER DRAINAGE PLANNING

The Colonias of the Lower Rio Grande Valley (LRGV)

Phase 2 Report

JSW & Associates, Inc. Hazard Mitigation Consultants

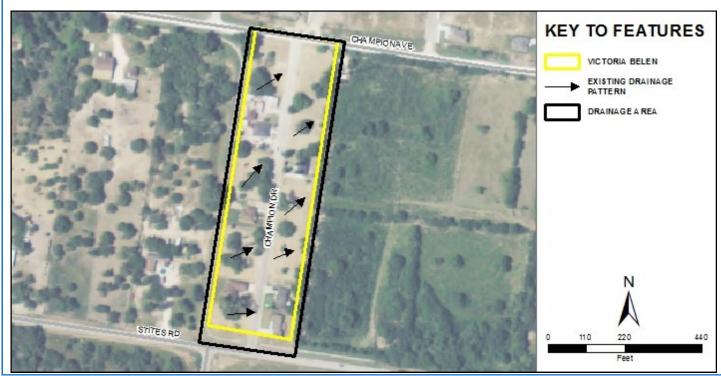
Victoria Belen consists of approximately 6 acres of partially developed residential land. The colonia currently does not have a drainage system. There is an existing abandoned irrigation canal that runs parallel to Champion Dr. along the west side of the colonia. It turns east along the north side of Stites Rd and runs for approximately 470 feet. The existing drainage pattern seems to indicate runoff flows toward the northeast. Based on the existing conditions 2D model results and estimated finished floor elevations for the structures, it was determined that no structure is at high risk of flooding from a localized storm event. Figures 1, 2, 3, 4, and 5 illustrate the existing and proposed inundation maps for the 2-, 5-, 10-, 25-, and 100-Year storms respectively. The color coded inundation maps illustrate the depth of flooding as follows: light blue represents a depth of 3 to 6 inches, blue 6 to 9 inches, green 9 to 12 inches, yellow 12 to 18 inches, orange 18 to 24 inches, and red more than 24 inches.

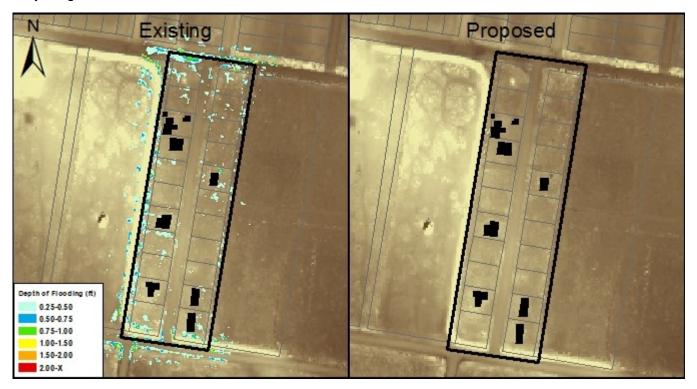
Figure 1: Existing and Proposed Conditions - 2-Yr Storm Inundation Map

The goal of this study was to size the system to be capable of carrying up to the 10-Year storm with no inundation in the colonia. However, some structures lie within low areas of the colonia and still show risk of flooding. When comparing the 6-inch inundation maps for the 25- and 100-Year storms, it is observed that the inundation depths are lower than the existing conditions model, resulting in less overall ponding and the street is at lower risk of being flooded once improvements are in place. Figures 1, 2, 3, 4, and 5 show the existing and proposed conditions inundation maps for the 2-, 5-, 10-, 25-, and 100-Yr storms respectively.

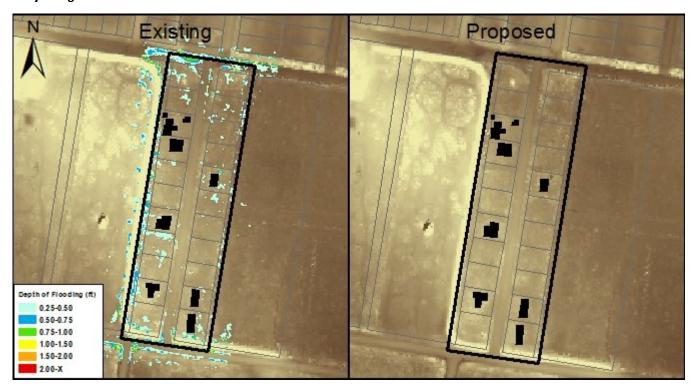
Figure 2: Existing and Proposed Conditions - 5-Yr Storm Inundation Map

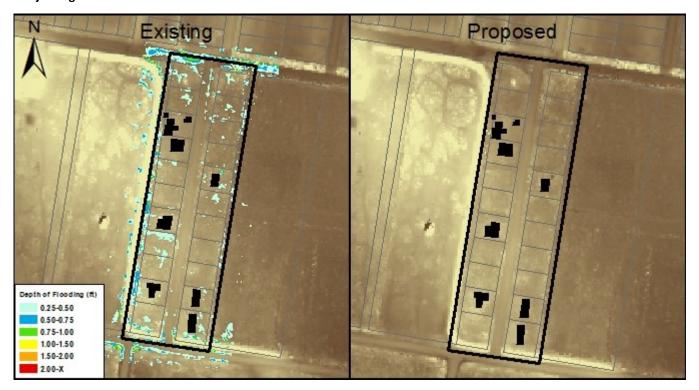
Figure 3: Existing and Proposed Conditions - 10-Yr Storm Inundation Map

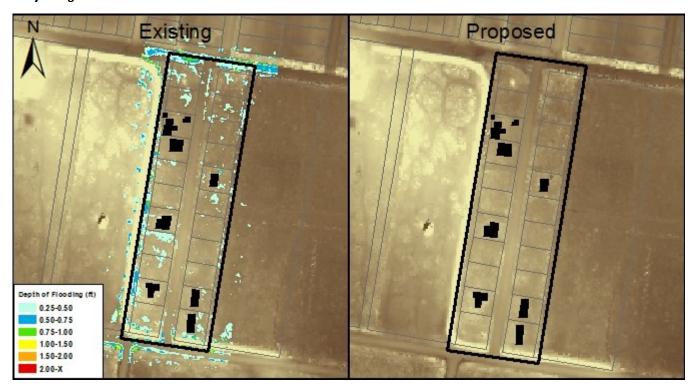
Figure 4: Existing and Proposed Conditions - 25-Yr Storm Inundation Map

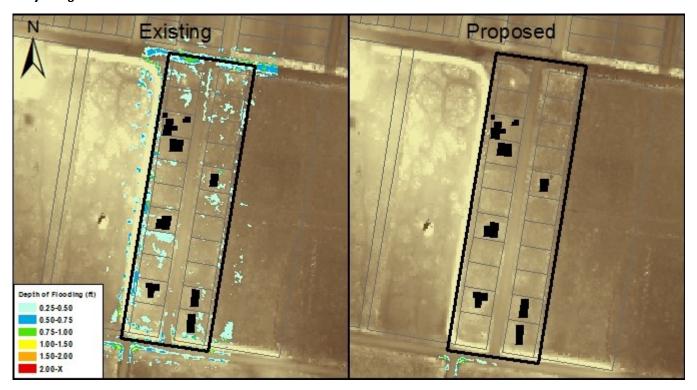
Figure 5: Existing and Proposed Conditions - 100-Yr Storm Inundation Map

1% (100-Year) Flood Recurrence	Pre-Project	Post-Project	Removed
Inundated Structures	0	0	0
Inundated Lots	22	0	22
Inundated Roadway (LF)	399	0	399

- 1. The number of inundated structures are based strictly on finished floor elevations compared to computed water surface elevations.
- 2. The inundation maps above only display flooding depths greater than three inches.
- 3. The number of inundated lots are based strictly on the inundation maps above and therefore do not count as inundated if the depth of flooding is less than three inches.

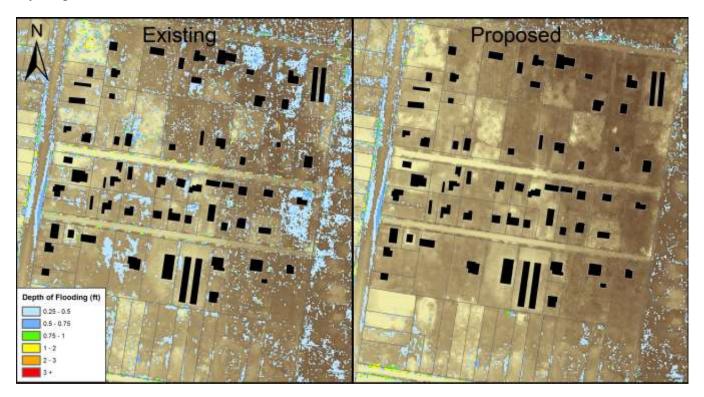
Figure 1: Existing and Proposed Conditions - 2-yr Storm Inundation Map

The goal of this study was to size the system to be capable of carrying up to the 10-Year storm runoff with no inundation in the colonia. However, some structures lie within low areas of the colonia and still show risk of flooding. When comparing the 6-inch inundation map for the 25- and 100-Year storms, it is observed that the inundation depths are lower than the existing conditions model, resulting in fewer structures at risk of being flooded once improvements are in place. Figures 1, 2, 3, 4, and 5 show the existing and proposed conditions inundation maps for the 2-, 5-, 10-, 25-, and 100-Yr storms respectively.

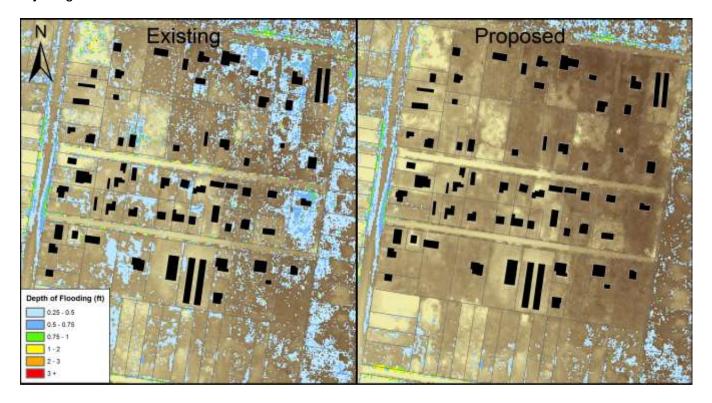
Figure 2: Existing and Proposed Conditions - 5-yr Storm Inundation Map

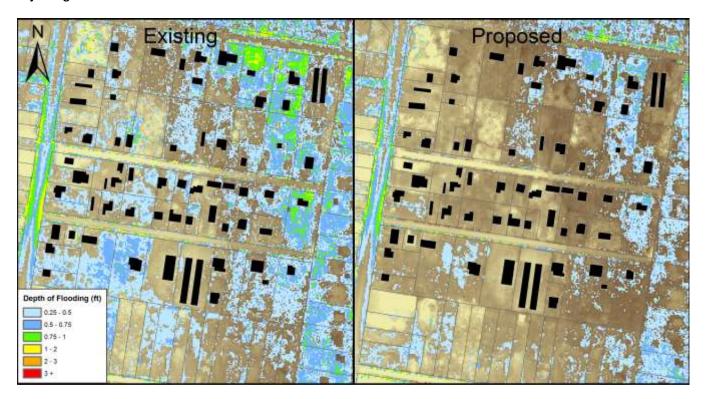
Figure 5: Existing and Proposed Conditions - 100-yr Storm Inundation Map

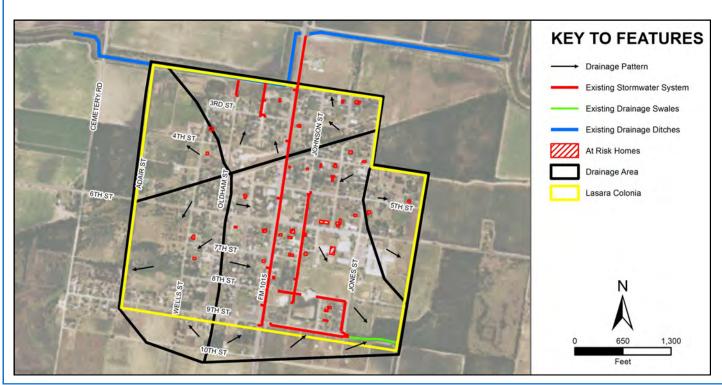
Drainage patterns within this 275-acre colonia are generally from the two high points on the east and west sides of the colonia to the low-lying area along FM 1015 bisecting the area north to south. The existing drainage system includes an underground stormwater system along FM 1015 as well as two smaller underground systems in the northwest corner of the colonia. These systems currently discharge to the regional ditch north of the colonia. At the time of this analysis, a county drainage improvement project has been partially constructed in the southeastern portion of the colonia; however, construction plans were not available. High-risk areas include low-lying areas along FM 1015 and other areas throughout the colonia where the drainage infrastructure is undersized or non-existent. Figures 1-5 illustrate the existing and proposed conditions inundation maps for the 2-, 5-, 10-, 25-, and 100-year storms, respectively. These maps illustrate the depth of flooding as follows: light blue represents a depth of 6 to 9 inches, blue 9 to 12 inches, green 1 to 1.5 feet, yellow 1.5 to 2 feet, orange 2 to 3 feet, and red more than 3 feet.

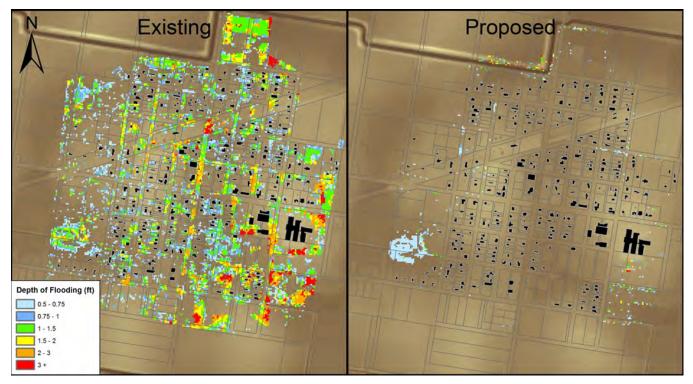
Figure 1: Existing and Proposed Conditions - 2-yr Storm Inundation Map

The goal of this study was to size the system to be capable of carrying up to the 10-Year storm runoff with no inundation in the colonia. However, some structures lie within low areas of the colonia and still show risk of flooding. When comparing the 6-inch inundation map for the 25- and 100-Year storms, it is observed that the inundation depths are lower than the existing conditions model, resulting in fewer structures at risk of being flooded once improvements are in place. Figures 1, 2, 3, 4, and 5 show the existing and proposed conditions inundation maps for the 2-, 5-, 10-, 25-, and 100-Yr storms respectively.

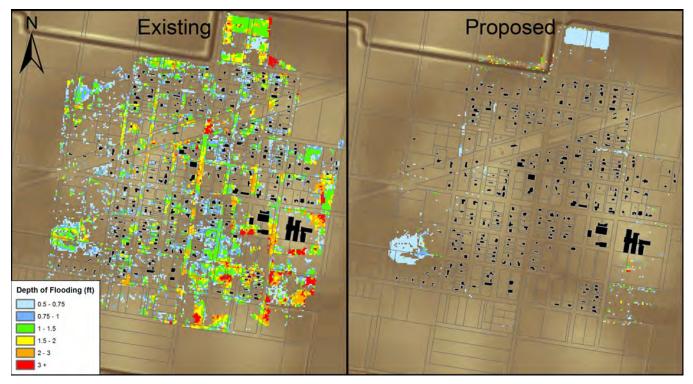
Figure 2: Existing and Proposed Conditions - 5-yr Storm Inundation Map

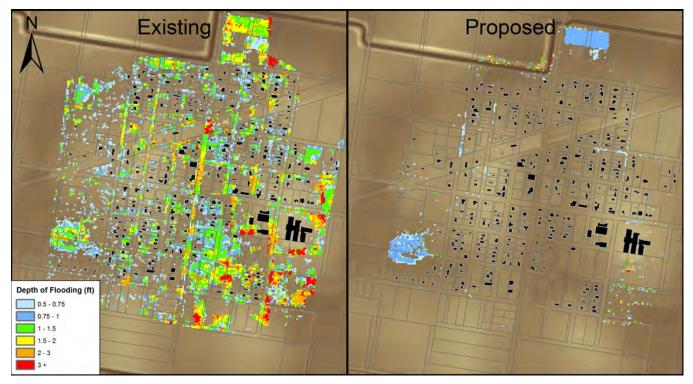
Figure 3: Existing and Proposed Conditions - 10-yr Storm Inundation Map

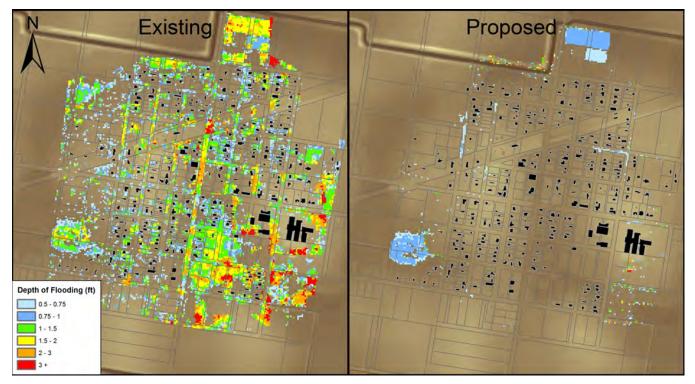
Figure 4: Existing and Proposed Conditions - 25-yr Storm Inundation Map

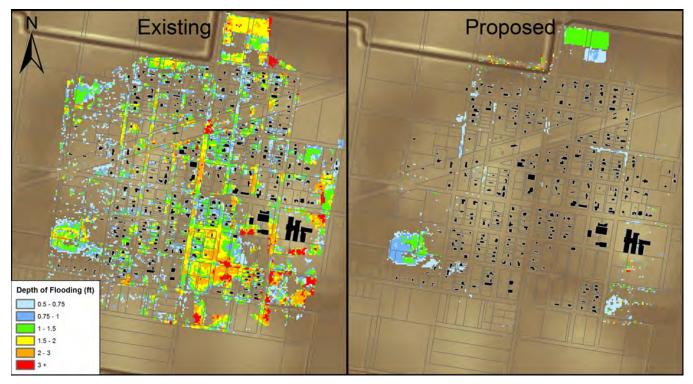
Figure 5: Existing and Proposed Conditions - 100-yr Storm Inundation Map

1% (100-Year)	Pre-Project	Post-Project	Removed
Flood Recurrence	The Project	r ost r roject	Removed
Inundated Structures	36	24	12
Inundated Lots	860	59	801
Inundated Roadway (LF)	21135	2065	19070

- 1. The number of inundated structures are based strictly on finished floor elevations compared to computed water surface elevations.
- 2. The inundation maps above only display flooding depths greater than 6 inches.
- 3. The number of inundated lots are based strictly on the inundation maps above and therefore do not count as inundated if the depth of flooding is less than 6 inches.

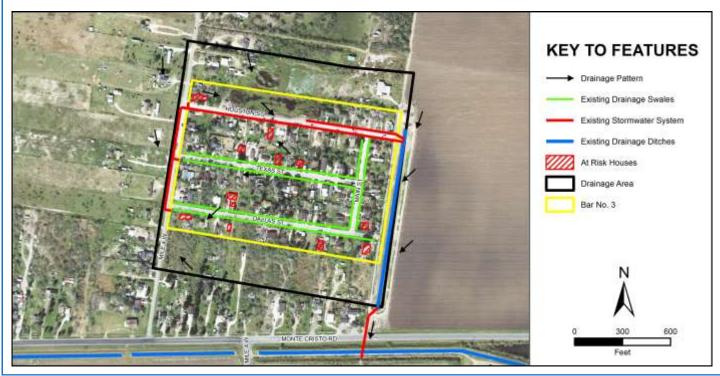
Drainage patterns within this 29-acre colonia are generally to the south and west. The existing drainage system consists of a small stormwater system and roadside swales that are generally undersized and restricted by sediment and vegetation. Bar No. 3 experiences residential lot, street, and structure flooding in nearly every rainfall event. Figures 1-5 illustrate the existing and proposed conditions inundation maps for the 2-, 5-, 10-, 25-, and 100-year storms, respectively. These maps illustrate the depth of flooding as follows: light blue represents a depth of 3 to 6 inches, blue 6 to 9 inches, green 9 to 12 inches, yellow 1 to 2 feet, orange 2 to 3 feet, and red more than 3 feet.

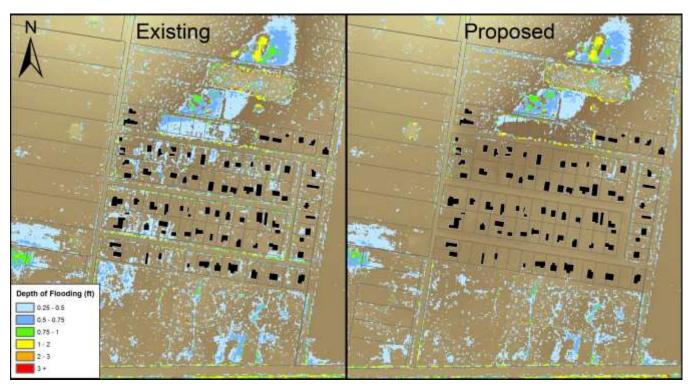
Figure 1: Existing and Proposed Conditions - 2-yr Storm Inundation Map

The goal of this study was to size the system to be capable of carrying up to the 10-Year storm runoff with no inundation in the colonia. However, some structures lie within low areas of the colonia and still show risk of flooding. When comparing the 6-inch inundation map for the 25- and 100-Year storms, it is observed that the inundation depths are lower than the existing conditions model, resulting in fewer structures at risk of being flooded once improvements are in place. Figures 1, 2, 3, 4, and 5 show the existing and proposed conditions inundation maps for the 2-, 5-, 10-, 25-, and 100-Yr storms respectively.

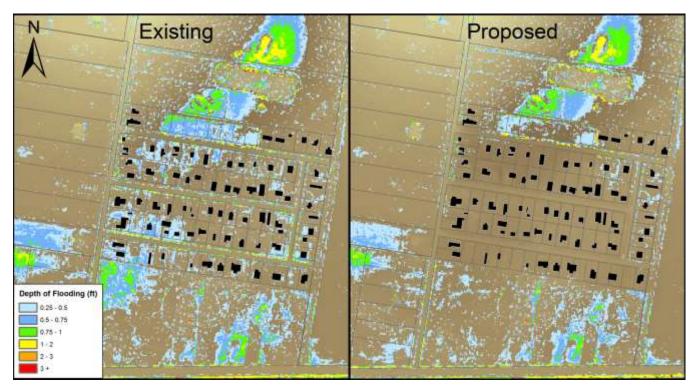
Figure 2: Existing and Proposed Conditions - 5-yr Storm Inundation Map

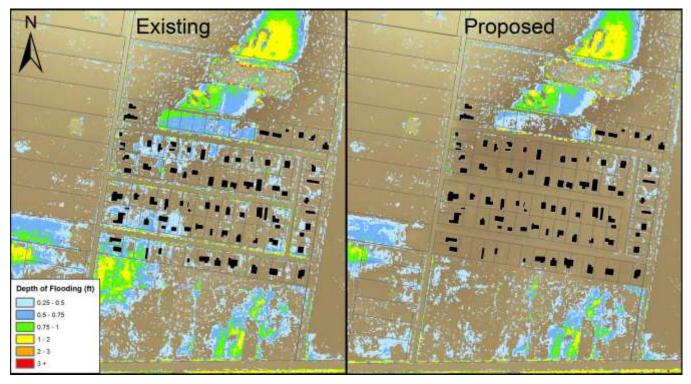
Figure 3: Existing and Proposed Conditions - 10-yr Storm Inundation Map

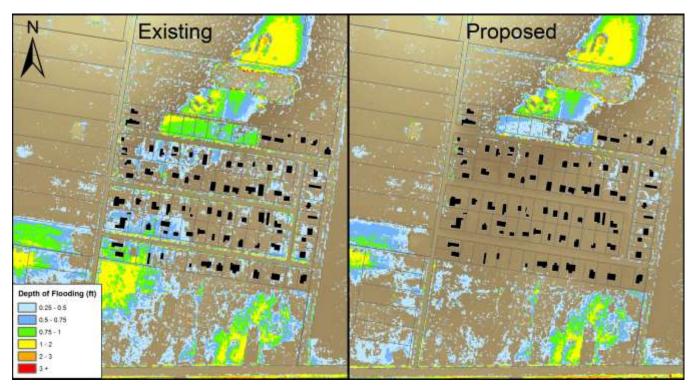
Figure 4: Existing and Proposed Conditions - 25-yr Storm Inundation Map

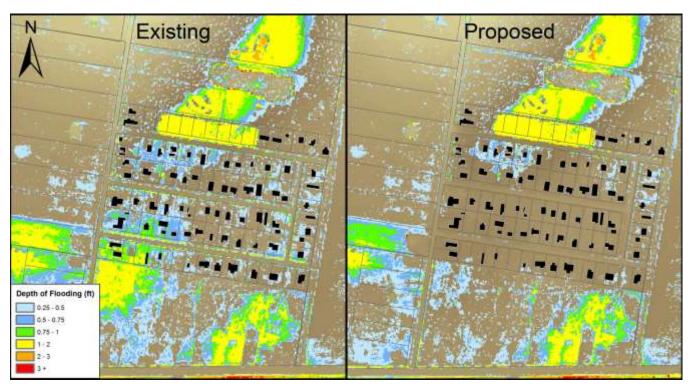
Figure 5: Existing and Proposed Conditions - 100-yr Storm Inundation Map

1% (100-Year) Flood Recurrence	Pre-Project	Post-Project	Removed
Inundated Structures	12	1	11
Inundated Lots	96	61	35
Inundated Roadway (LF)	17	0	17

- 1. The number of inundated structures are based strictly on finished floor elevations compared to computed water surface elevations.
- 2. The inundation maps above only display flooding depths greater than 3 inches.
- 3. The number of inundated lots are based strictly on the inundation maps above and therefore do not count as inundated if the depth of flooding is less than 3 inches.

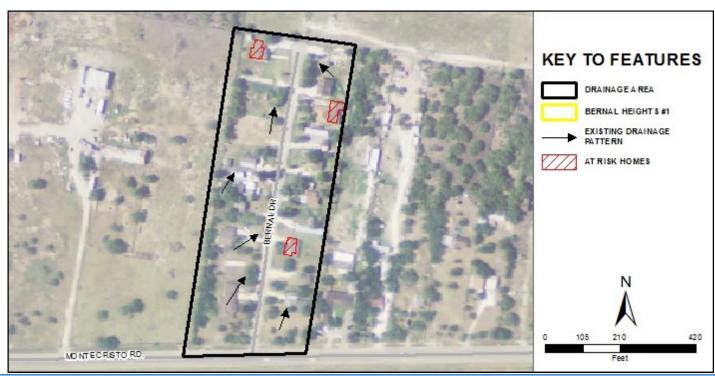
Bernal Heights #1 consists of approximately 7 acres of fully developed residential land. The existing drainage system consist of culverts and swales along Bernal Drive. The swales appear to convey stormwater toward the north, however there isn't an outfall. Monte Cristo Road also has swales along the north side of the roadway. The existing drainage pattern indicates runoff flows toward the northeast. Based on the existing conditions 2D model results, structures along the east and north sides of the colonia appear to be at risk of flooding. Figures 1, 2, 3, 4, and 5 illustrate the existing and proposed inundation maps for the 2-, 5-, 10-, 25-, and 100-Year storms respectively. The color coded inundation maps illustrate the depth of flooding as follows: light blue represents a depth of 3 to 6 inches, blue 6 to 9 inches, green 9 to 12 inches, yellow 12 to 18 inches, orange 18 to 24 inches, and red more than 24 inches.

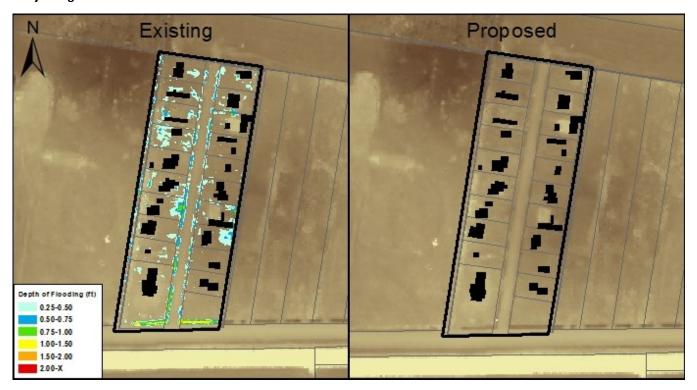
Figure 1: Existing and Proposed Conditions - 2-Yr Storm Inundation Map

The goal of this study was to size the system to be capable of carrying up to the 10-Year storm with no inundation in the colonia. However, some structures lie within low areas of the colonia and still show risk of flooding. When comparing the 6-inch inundation maps for the 25- and 100-Year storms, it is observed that the inundation depths are lower than the existing conditions model, resulting in fewer structures at risk of being flooded once improvements are in place. Figures 1, 2, 3, 4, and 5 show the existing and proposed conditions inundation maps for the 2-, 5-, 10-, 25-, and 100-Yr storms respectively.

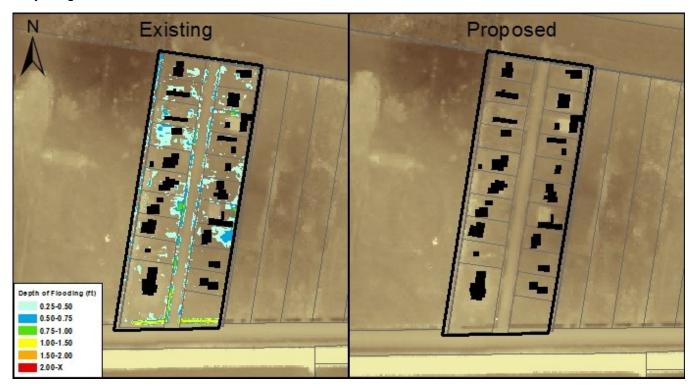
Figure 2: Existing and Proposed Conditions - 5-Yr Storm Inundation Map

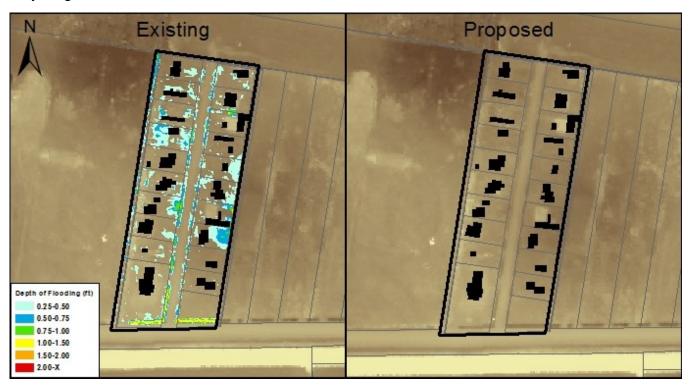
Figure 3: Existing and Proposed Conditions - 10-Yr Storm Inundation Map

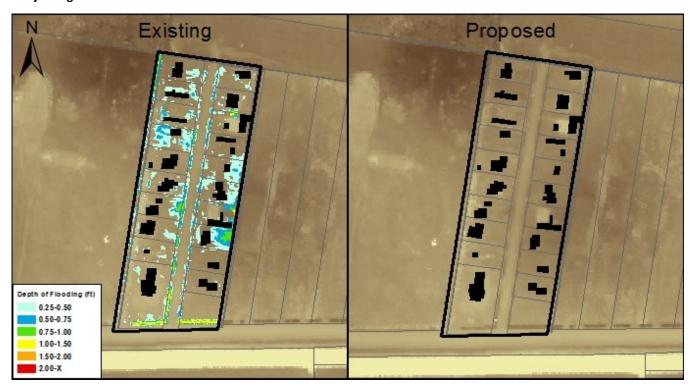
Figure 4: Existing and Proposed Conditions - 25-Yr Storm Inundation Map

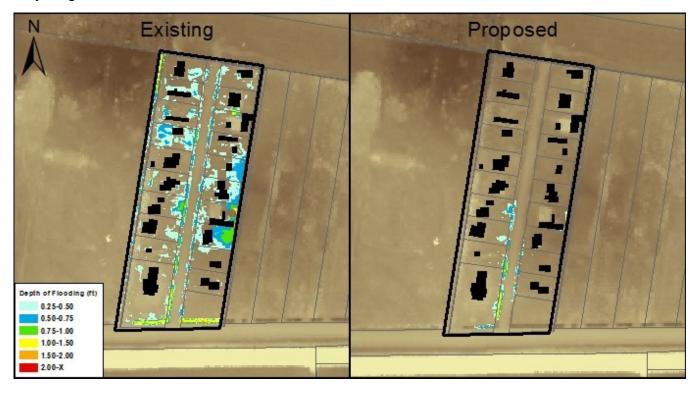
Figure 5: Existing and Proposed Conditions - 100-Yr Storm Inundation Map

1% (100-Year) Flood Recurrence	Pre-Project	Post-Project	Removed
Inundated Structures	3	0	3
Inundated Lots	21	9	12
Inundated Roadway (LF)	0	0	0

- 1. The number of inundated structures are based strictly on finished floor elevations compared to computed water surface elevations.
- 2. The inundation maps above only display flooding depths greater than three inches.
- 3. The number of inundated lots are based strictly on the inundation maps above and therefore do not count as inundated if the depth of flooding is less than three inches.

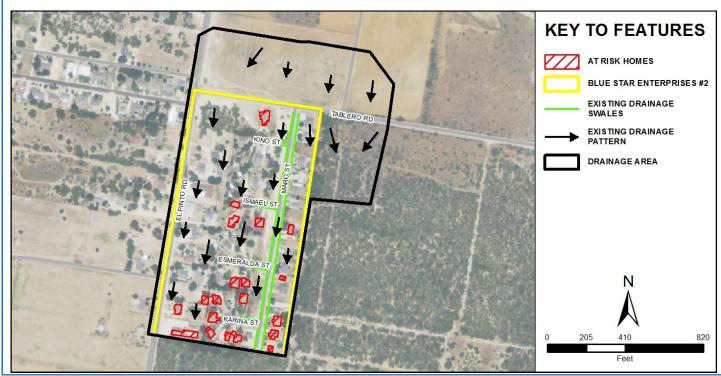
Blue Star Enterprises #2 consists of approximately 20 acres of fully developed residential land with an offsite drainage area of approximately 12 acres of agricultural land. Currently there are swales and culverts along the streets within the colonia; However, the swales do not have an outlet and therefore do not provide adequate drainage for the colonia. The existing drainage pattern indicates runoff flows toward the south end of the colonia. Structures located along the southern portion of the colonia are at risk of flooding. Figures 1, 2, 3, 4, and 5 illustrate the existing and proposed inundation maps for the 2-, 5-, 10-, 25-, and 100-Year storms respectively. The color coded inundation maps illustrate the depth of flooding as follows: light blue represents a depth of 3 to 6 inches, blue 6 to 9 inches, green 9 to 12 inches, yellow 12 to 18 inches, orange 18 to 24 inches, and red more than 24 inches.

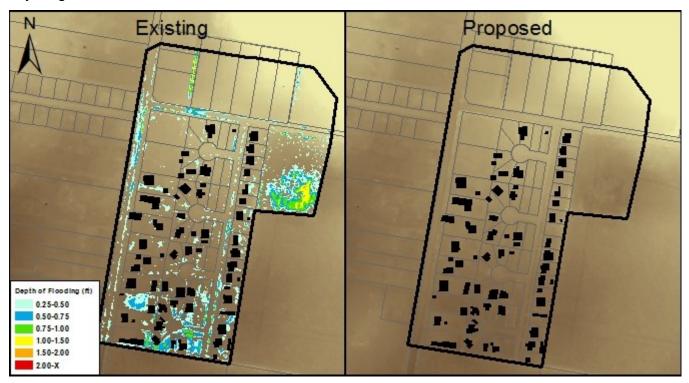
Figure 1: Existing and Proposed Conditions - 2-Yr Storm Inundation Map

50% (2-Year) Flood Recurrence	Pre-Project	Post-Project	Removed
Inundated Structures	3	0	3
Inundated Lots	67	0	67
Inundated Roadway (LF)	279	0	279

The goal of this study was to size the system to be capable of carrying up to the 10-Year storm with no inundation in the colonia. However, some structures lie within low areas of the colonia and still show risk of flooding. When comparing the 6-inch inundation maps for the 25- and 100-Year storms, it is observed that the inundation depths are lower than the existing conditions model, resulting in fewer structures at risk of being flooded once improvements are in place. Figures 1, 2, 3, 4, and 5 show the existing and proposed conditions inundation maps for the 2-, 5-, 10-, 25-, and 100-Yr storms respectively.

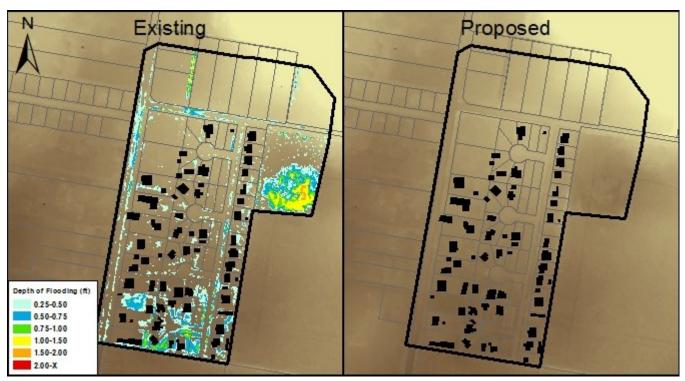
Figure 2: Existing and Proposed Conditions - 5-Yr Storm Inundation Map

25% (5-Year) Flood Recurrence	Pre-Project	Post-Project	Removed
Inundated Structures	7	0	7
Inundated Lots	67	0	67
Inundated Roadway (LF)	403	0	403

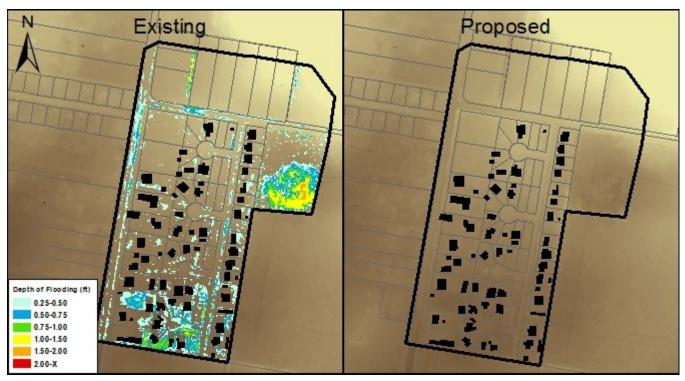
Figure 3: Existing and Proposed Conditions - 10-Yr Storm Inundation Map

10% (10-Year) Flood Recurrence	Pre-Project	Post-Project	Removed
Inundated Structures	8	0	8
Inundated Lots	67	0	67
Inundated Roadway (LF)	430	0	430

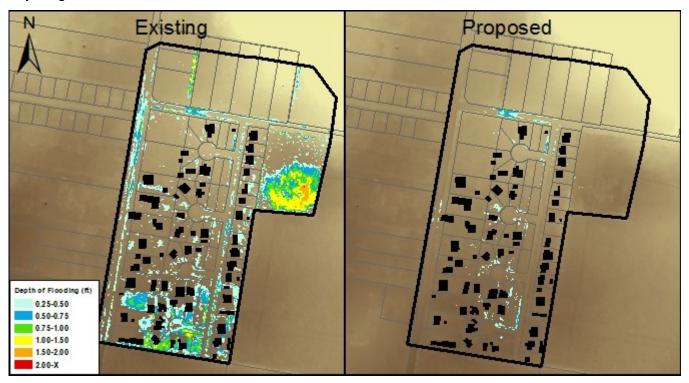
Figure 4: Existing and Proposed Conditions - 25-Yr Storm Inundation Map

4% (25-Year) Flood Recurrence	Pre-Project	Post-Project	Removed
Inundated Structures	9	0	9
Inundated Lots	67	38	29
Inundated Roadway (LF)	508	95	413

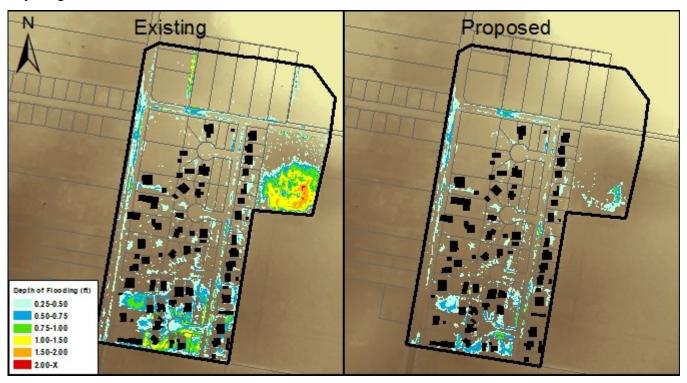
Figure 5: Existing and Proposed Conditions - 100-Yr Storm Inundation Map

1% (100-Year) Flood Recurrence	Pre-Project	Post-Project	Removed
Inundated Structures	15	3	12
Inundated Lots	67	59	8
Inundated Roadway (LF)	645	444	201

- 1. The number of inundated structures are based strictly on finished floor elevations compared to computed water surface elevations.
- 2. The inundation maps above only display flooding depths greater than three inches.
- 3. The number of inundated lots are based strictly on the inundation maps above and therefore do not count as inundated if the depth of flooding is less than three inches.

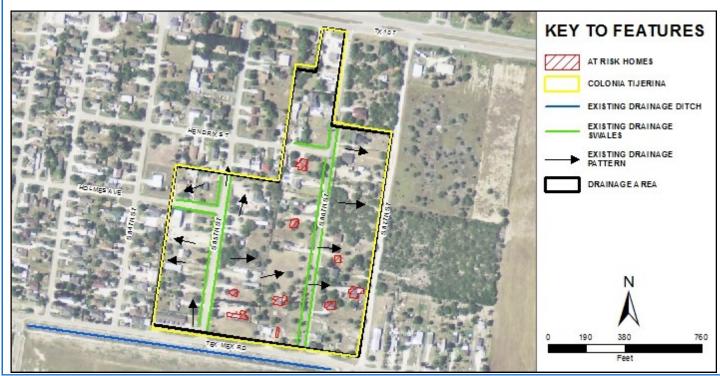
Colonia Tijerina consists of approximately 24.3 acres of fully developed residential land. The existing drainage system consists of swales and culvers that appear to outfall into an existing drainage ditch. The existing drainage pattern indicates runoff flows toward the east and west. Based on the existing conditions 2D model results several structures are at risk of flooding from a localized storm event. Figures 1, 2, 3, 4, and 5 illustrate the existing and proposed inundation maps for the 2-, 5-, 10-, 25-, and 100-Year storms respectively. The color coded inundation maps illustrate the depth of flooding as follows: light blue represents a depth of 3 to 6 inches, blue 6 to 9 inches, green 9 to 12 inches, yellow 12 to 18 inches, orange 18 to 24 inches, and red more than 24 inches.

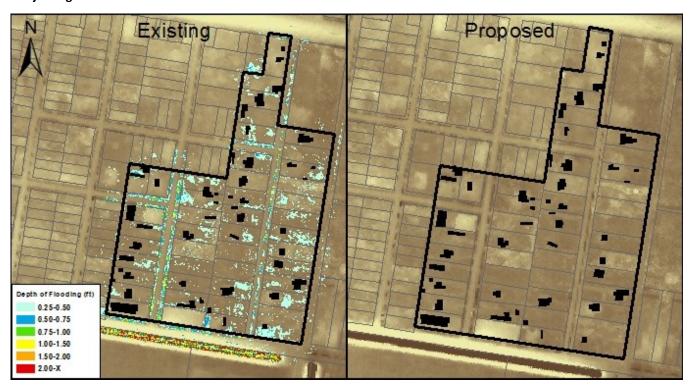
Figure 1: Existing and Proposed Conditions - 2-Yr Storm Inundation Map

The goal of this study was to size the system to be capable of carrying up to the 10-Year storm with no inundation in the colonia. However, some structures lie within low areas of the colonia and still show risk of flooding. When comparing the 6-inch inundation maps for the 25- and 100-Year storms, it is observed that the inundation depths are lower than the existing conditions model, resulting in fewer structures at risk of being flooded once improvements are in place. Figures 1, 2, 3, 4, and 5 show the existing and proposed conditions inundation maps for the 2-, 5-, 10-, 25-, and 100-Yr storms respectively.

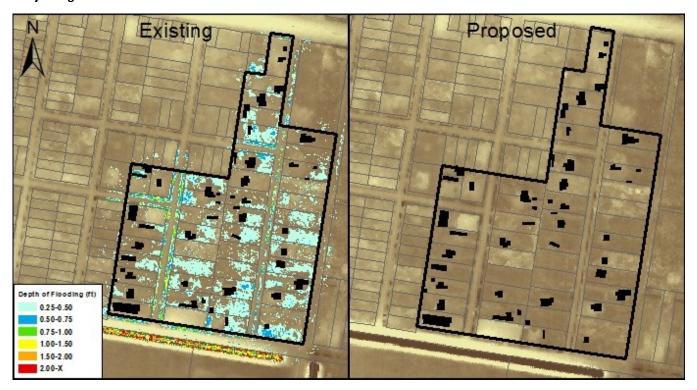
Figure 2: Existing and Proposed Conditions - 5-Yr Storm Inundation Map

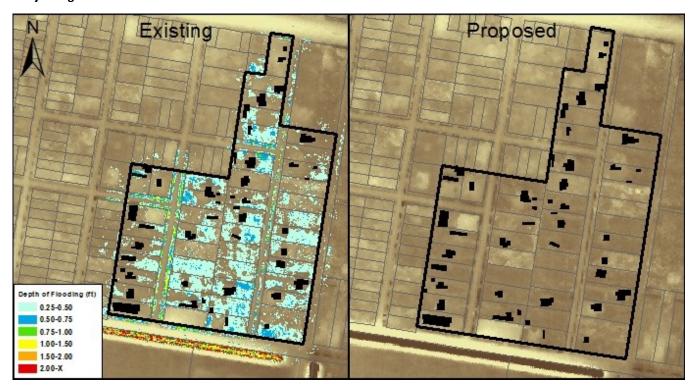
Figure 3: Existing and Proposed Conditions - 10-Yr Storm Inundation Map

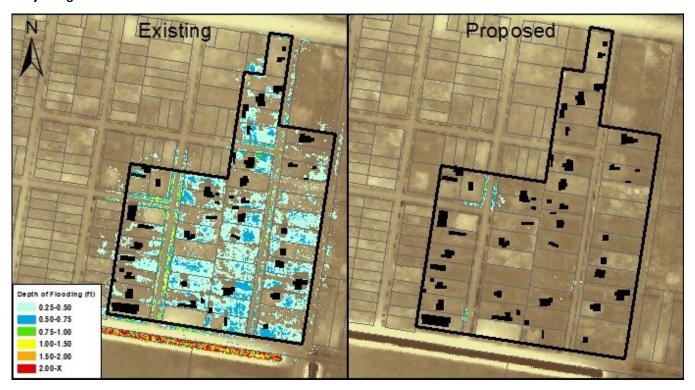
Figure 4: Existing and Proposed Conditions - 25-Yr Storm Inundation Map

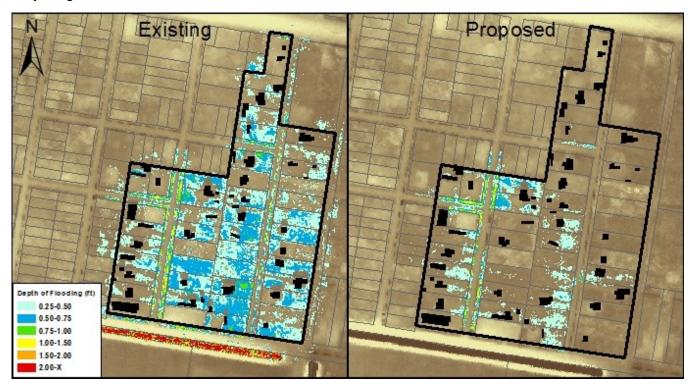
Figure 5: Existing and Proposed Conditions - 100-Yr Storm Inundation Map

1% (100-Year) Flood Recurrence	Pre-Project	Post-Project	Removed
Inundated Structures	9	0	9
Inundated Lots	45	26	19
Inundated Roadway (LF)	58	58	0

- 1. The number of inundated structures are based strictly on finished floor elevations compared to computed water surface elevations.
- 2. The inundation maps above only display flooding depths greater than three inches.
- 3. The number of inundated lots are based strictly on the inundation maps above and therefore do not count as inundated if the depth of flooding is less than three inches.

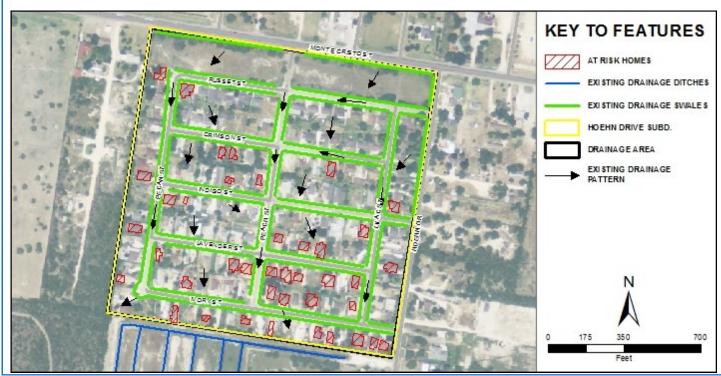
Hoehn Drive Subd. consists of approximately 39.8 acres of fully developed residential land. The existing drainage system consists of swales and culverts that drain south to an existing detention pond, via two 30-inch diameter pipes. The detention pond is drained by a stormwater pump station. The existing drainage pattern indicates runoff flows toward Peach Street then south. Based on the existing conditions 2D model results several structures are at risk of flooding from a localized storm event. However, since half of the colonia is under the 100-Yr floodplain, it should be evaluated for risk of flooding due to regional storm events. Figures 1, 2, 3, 4, and 5 illustrate the existing and proposed inundation maps for the 2-, 5-, 10-, 25-, and 100-Year storms respectively. The color coded inundation maps illustrate the depth of flooding as follows: light blue represents a depth of 3 to 6 inches, blue 6 to 9 inches, green 9 to 12 inches, yellow 12 to 18 inches, orange 18 to 24 inches, and red more than 24 inches.

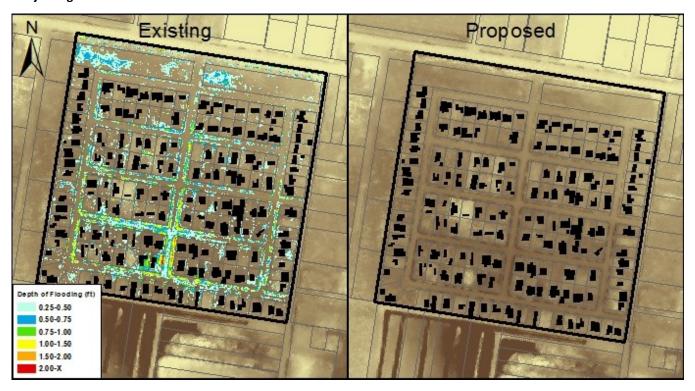
Figure 1: Existing and Proposed Conditions - 2-Yr Storm Inundation Map

The goal of this study was to size the system to be capable of carrying up to the 10-Year storm with no inundation in the colonia. However, some structures lie within low areas of the colonia and still show risk of flooding. When comparing the 6-inch inundation maps for the 25- and 100-Year storms, it is observed that the inundation depths are lower than the existing conditions model, resulting in fewer structures at risk of being flooded once improvements are in place. Figures 1, 2, 3, 4, and 5 show the existing and proposed conditions inundation maps for the 2-, 5-, 10-, 25-, and 100-Yr storms respectively.

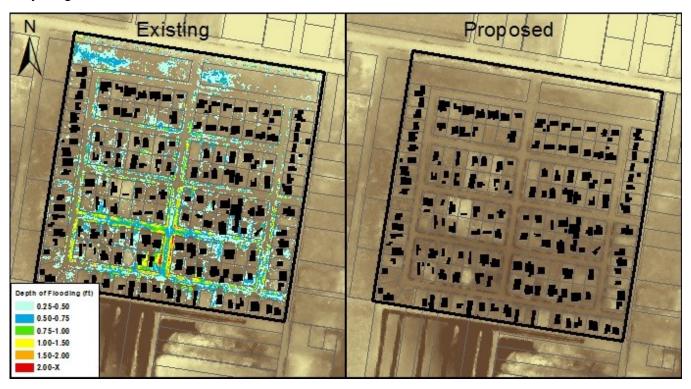
Figure 2: Existing and Proposed Conditions - 5-Yr Storm Inundation Map

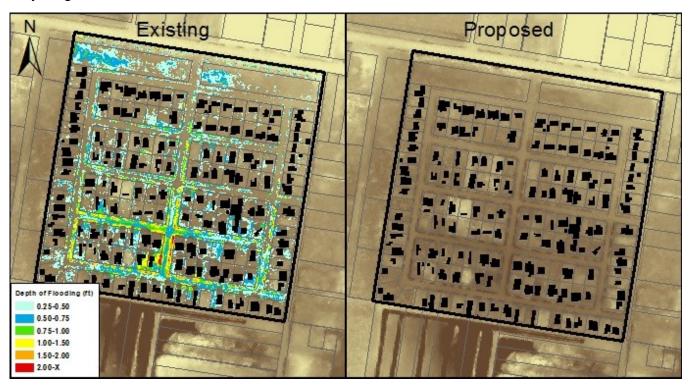
Figure 3: Existing and Proposed Conditions - 10-Yr Storm Inundation Map

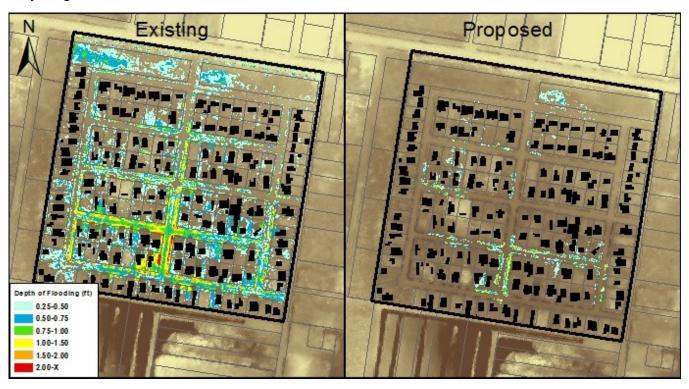
Figure 4: Existing and Proposed Conditions - 25-Yr Storm Inundation Map

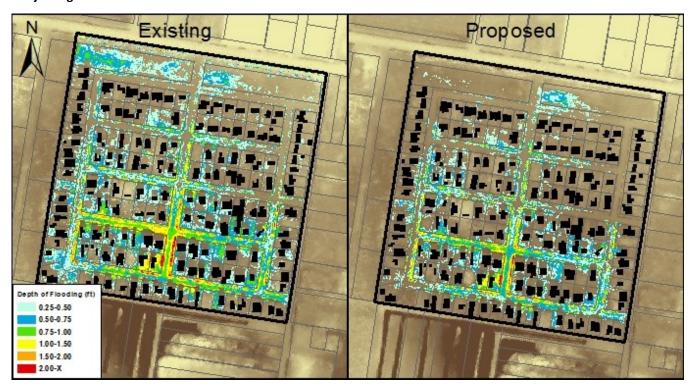
Figure 5: Existing and Proposed Conditions - 100-Yr Storm Inundation Map

1% (100-Year) Flood Recurrence	Pre-Project	Post-Project	Removed
Inundated Structures	43	30	13
Inundated Lots	166	137	29
Inundated Roadway (LF)	4,000	2721	1,279

- 1. The number of inundated structures are based strictly on finished floor elevations compared to computed water surface elevations.
- 2. The inundation maps above only display flooding depths greater than three inches.
- 3. The number of inundated lots are based strictly on the inundation maps above and therefore do not count as inundated if the depth of flooding is less than three inches.

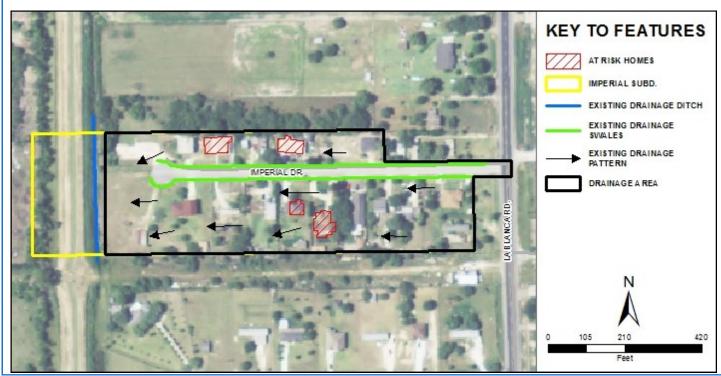
Imperial Subd. consists of approximately 7 acres of fully developed residential land. Imperial Drive has swales and culvers along both north and south sides; and existing outlet was not observed. The existing drainage pattern indicates runoff flows toward the west. Based on the existing conditions 2D model results, structures on both the north and south sides of Imperial Drive appear to be at risk of flooding. Figures 1, 2, 3, 4, and 5 illustrate the existing and proposed inundation maps for the 2-, 5-, 10-, 25-, and 100-Year storms respectively. The color coded inundation maps illustrate the depth of flooding as follows: light blue represents a depth of 3 to 6 inches, blue 6 to 9 inches, green 9 to 12 inches, yellow 12 to 18 inches, orange 18 to 24 inches, and red more than 24 inches.

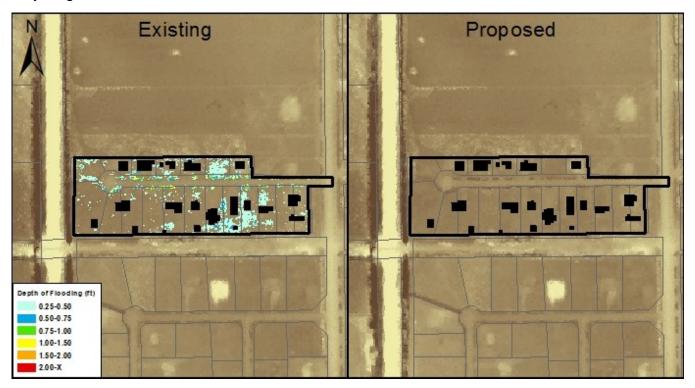
Figure 1: Existing and Proposed Conditions - 2-Yr Storm Inundation Map

The goal of this study was to size the system to be capable of carrying up to the 10-Year storm with no inundation in the colonia. However, some structures lie within low areas of the colonia and still show risk of flooding. When comparing the 6-inch inundation maps for the 25- and 100-Year storms, it is observed that the inundation depths are lower than the existing conditions model, resulting in fewer structures at risk of being flooded once improvements are in place. Figures 1, 2, 3, 4, and 5 show the existing and proposed conditions inundation maps for the 2-, 5-, 10-, 25-, and 100-Yr storms respectively.

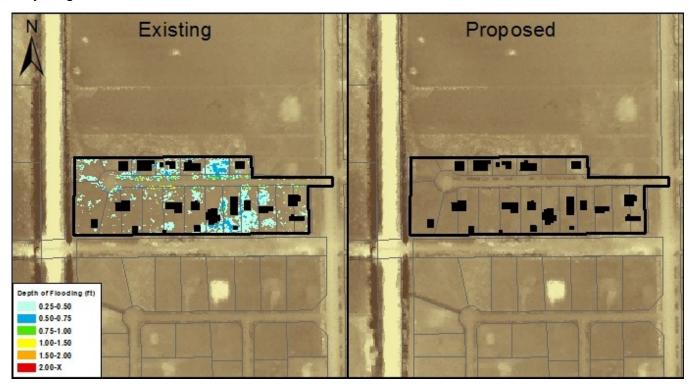
Figure 2: Existing and Proposed Conditions - 5-Yr Storm Inundation Map

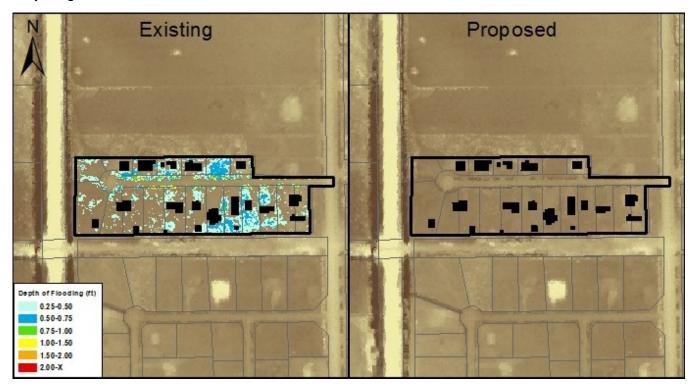
Figure 3: Existing and Proposed Conditions - 10-Yr Storm Inundation Map

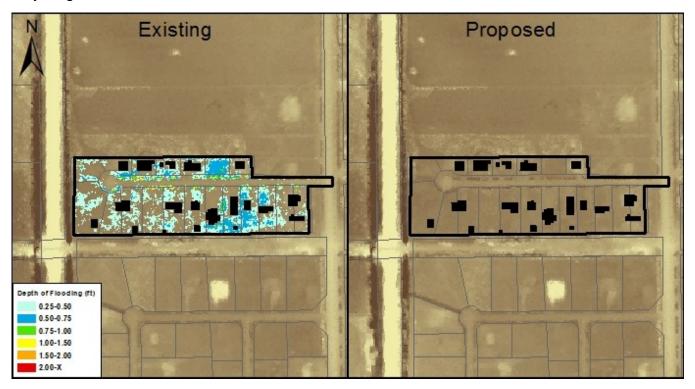
Figure 4: Existing and Proposed Conditions - 25-Yr Storm Inundation Map

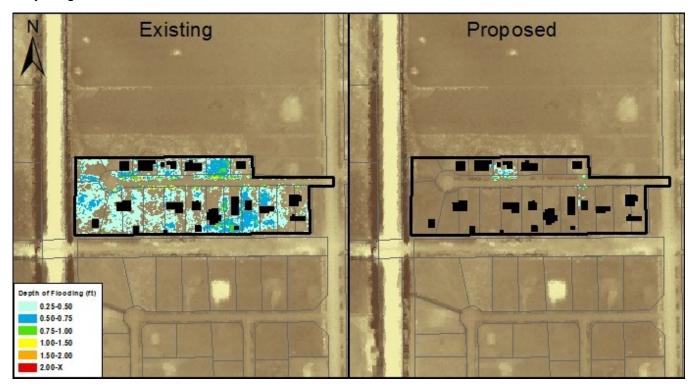
Figure 5: Existing and Proposed Conditions - 100-Yr Storm Inundation Map

1% (100-Year) Flood Recurrence	Pre-Project	Post-Project	Removed
Inundated Structures	4	0	4
Inundated Lots	19	4	15
Inundated Roadway (LF)	0	0	0

- 1. The number of inundated structures are based strictly on finished floor elevations compared to computed water surface elevations.
- 2. The inundation maps above only display flooding depths greater than three inches.
- 3. The number of inundated lots are based strictly on the inundation maps above and therefore do not count as inundated if the depth of flooding is less than three inches.

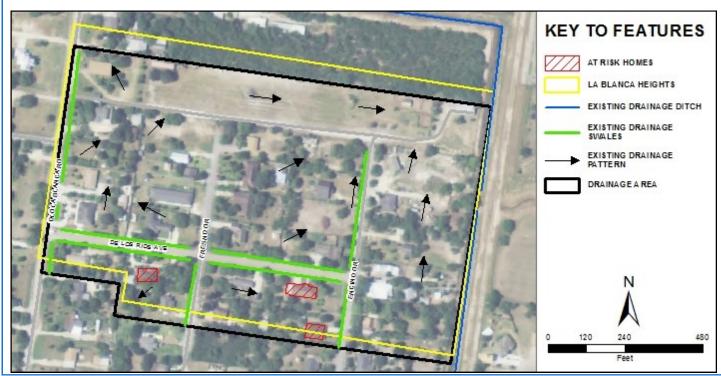
La Blanca Heights consists of approximately 23.6 acres of fully developed residential land. The existing drainage system consists of swales and culvers with no apparent outfall. The existing drainage pattern indicates runoff flows toward the northeast. Based on the existing conditions 2D model results several structures are at risk of flooding from a localized storm event. Figures 1, 2, 3, 4, and 5 illustrate the existing and proposed inundation maps for the 2-, 5-, 10-, 25-, and 100-Year storms respectively. The color coded inundation maps illustrate the depth of flooding as follows: light blue represents a depth of 3 to 6 inches, blue 6 to 9 inches, green 9 to 12 inches, yellow 12 to 18 inches, orange 18 to 24 inches, and red more than 24 inches.

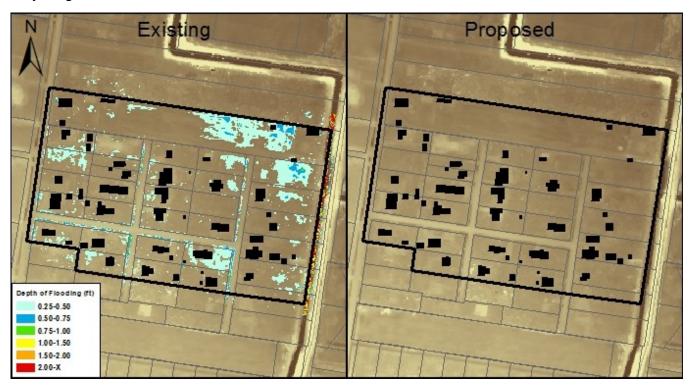
Figure 1: Existing and Proposed Conditions - 2-Yr Storm Inundation Map

The goal of this study was to size the system to be capable of carrying up to the 10-Year storm with no inundation in the colonia. However, some structures lie within low areas of the colonia and still show risk of flooding. When comparing the 6-inch inundation maps for the 25- and 100-Year storms, it is observed that the inundation depths are lower than the existing conditions model, resulting in fewer structures at risk of being flooded once improvements are in place. Figures 1, 2, 3, 4, and 5 show the existing and proposed conditions inundation maps for the 2-, 5-, 10-, 25-, and 100-Yr storms respectively.

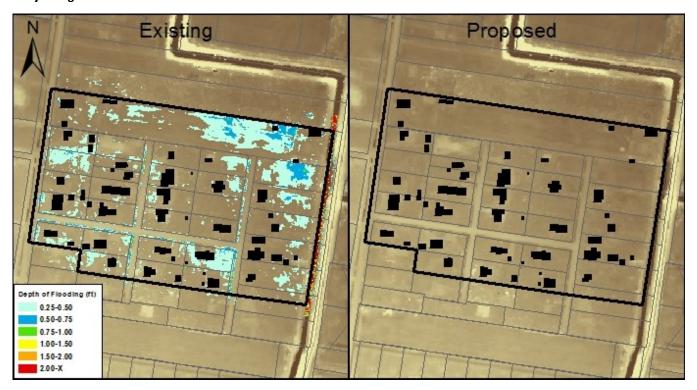
Figure 2: Existing and Proposed Conditions - 5-Yr Storm Inundation Map

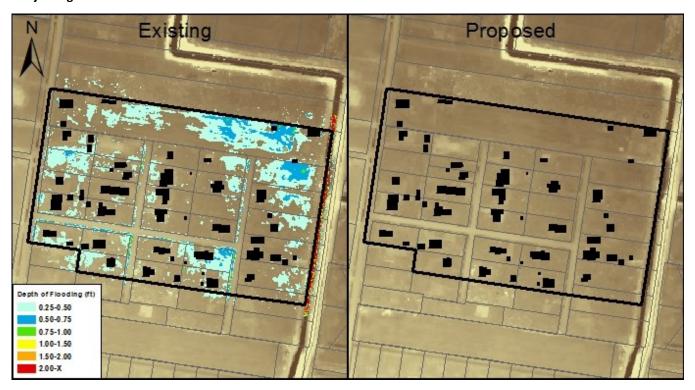
Figure 3: Existing and Proposed Conditions - 10-Yr Storm Inundation Map

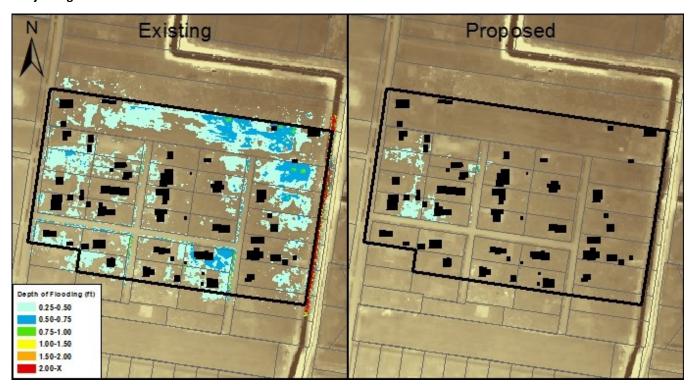
Figure 4: Existing and Proposed Conditions - 25-Yr Storm Inundation Map

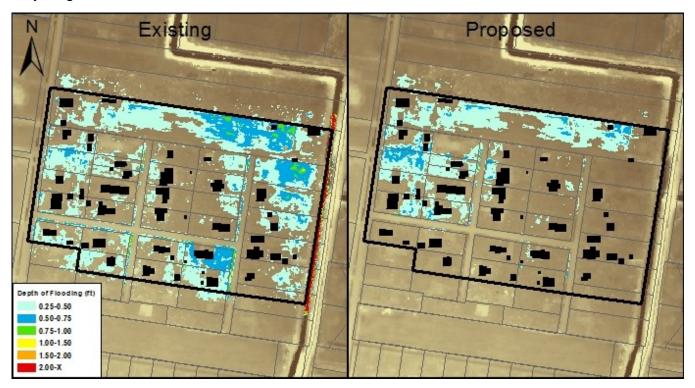
Figure 5: Existing and Proposed Conditions - 100-Yr Storm Inundation Map

1% (100-Year) Flood Recurrence	Pre-Project	Post-Project	Removed
Inundated Structures	9	0	9
Inundated Lots	31	22	9
Inundated Roadway (LF)	0	0	0

- 1. The number of inundated structures are based strictly on finished floor elevations compared to computed water surface elevations.
- 2. The inundation maps above only display flooding depths greater than three inches.
- 3. The number of inundated lots are based strictly on the inundation maps above and therefore do not count as inundated if the depth of flooding is less than three inches.

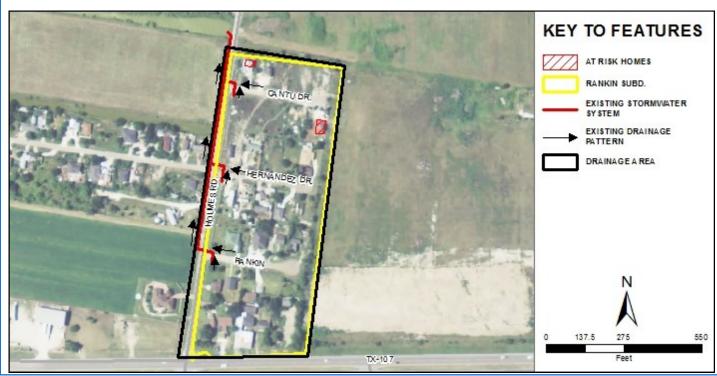
Rankin Subd. consists of approximately 10.6 acres of fully developed residential land. The existing drainage system consists of curb and gutter along the streets with an underground drainage system. From LIDAR observations it appears runoff flows toward the north. The existing conditions 2D model results indicate that structures at the north end of the colonia appear to be at risk of flooding. The model conditions were ran with a worst case scenario of a full drainage ditch at the outfall. Figures 1, 2, 3, 4, and 5 illustrate the existing and proposed inundation maps for the 2-, 5-, 10-, 25-, and 100-Year storms respectively. The color coded inundation maps illustrate the depth of flooding as follows: light blue represents a depth of 3 to 6 inches, blue 6 to 9 inches, green 9 to 12 inches, yellow 12 to 18 inches, orange 18 to 24 inches, and red more than 24 inches.
