STORMWATER DRAINAGE PLANNING

The Colonias of the Lower Rio Grande Valley (LRGV)

Phase 2 Report

JSW & Associates, Inc. Hazard Mitigation Consultants

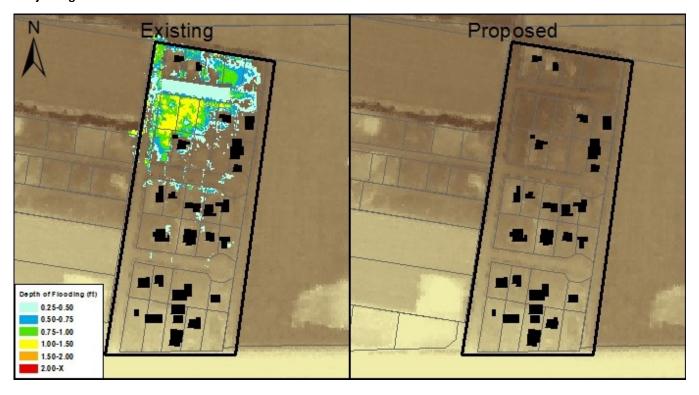
Figure 1: Existing and Proposed Conditions - 2-Yr Storm Inundation Map

The goal of this study was to size the system to be capable of carrying up to the 10-Year storm with no inundation in the colonia. However, some structures lie within low areas of the colonia and still show risk of flooding. When comparing the 6-inch inundation maps for the 25- and 100-Year storms, it is observed that the inundation depths are lower than the existing conditions model, resulting in fewer structures at risk of being flooded once improvements are in place. Figures 1, 2, 3, 4, and 5 show the existing and proposed conditions inundation maps for the 2-, 5-, 10-, 25-, and 100-Yr storms respectively.

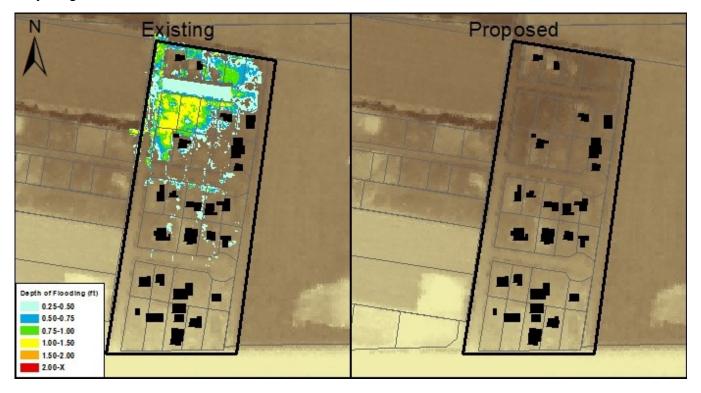
Figure 2: Existing and Proposed Conditions - 5-Yr Storm Inundation Map

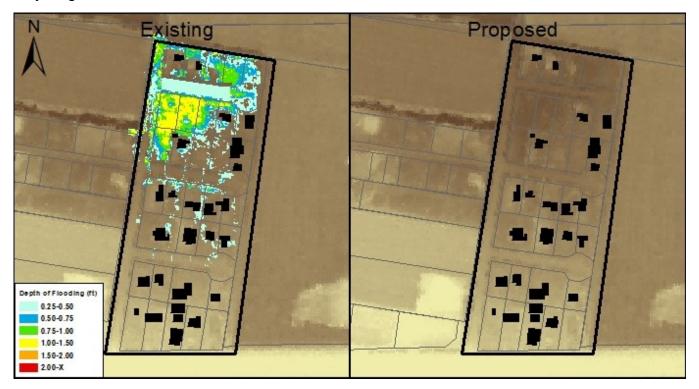
Figure 3: Existing and Proposed Conditions - 10-Yr Storm Inundation Map

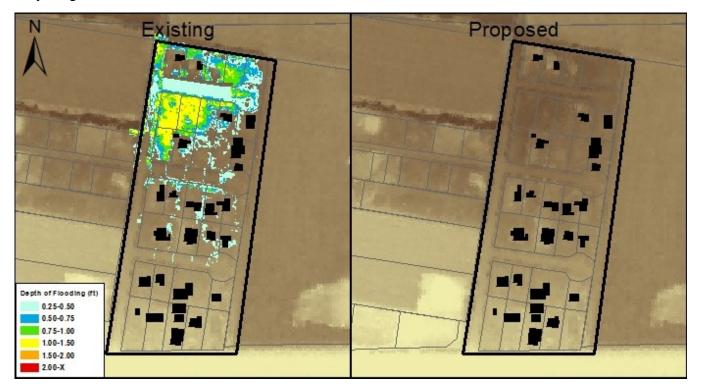
Figure 4: Existing and Proposed Conditions - 25-Yr Storm Inundation Map

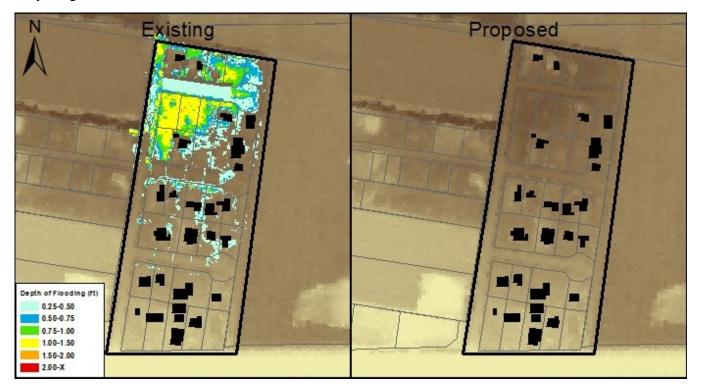
Figure 5: Existing and Proposed Conditions - 100-Yr Storm Inundation Map

1% (100-Year) Flood Recurrence	Pre-Project	Post-Project	Removed
Inundated Structures	2	0	2
Inundated Lots	27	0	27
Inundated Roadway (LF)	675	0	675

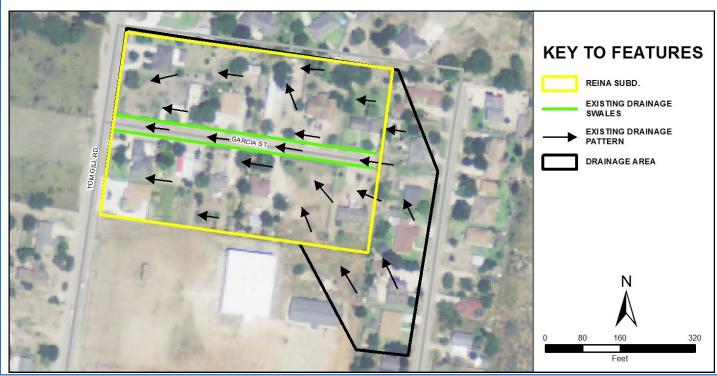
Reina Subd. consists of approximately 5.2 acres of fully developed residential land with an offsite drainage area of approximately 1.8 acres of fully developed residential land. Currently the colonia only appears to have roadside swales that are too shallow and eroded to provide adequate drainage. The existing drainage pattern indicates runoff flows west toward Tom Gill Road. Based on the existing conditions 2D model results and estimated finished floor elevations for the structures, it was determined that no structure is at high risk of flooding from a localized storm event. Figures 1, 2, 3, 4, and 5 illustrate the existing and proposed inundation maps for the 2-, 5-, 10-, 25-, and 100-Year storms respectively. The color coded inundation maps illustrate the depth of flooding as follows: light blue represents a depth of 3 to 6 inches, blue 6 to 9 inches, green 9 to 12 inches, yellow 12 to 18 inches, orange 18 to 24 inches, and red more than 24 inches.

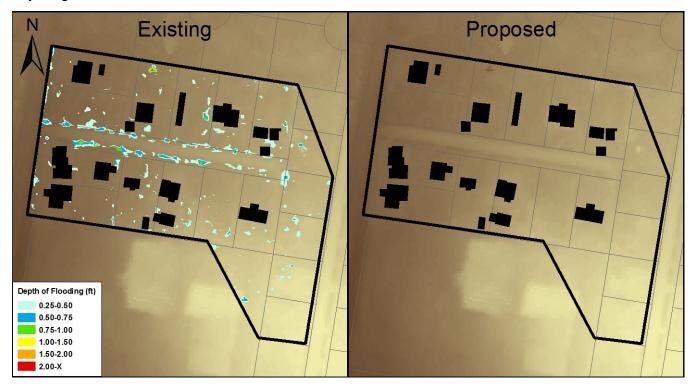
Figure 1: Existing and Proposed Conditions - 2-Yr Storm Inundation Map

50% (2-Year) Flood Recurrence	Pre-Project	Post-Project	Removed
Inundated Structures	0	0	0
Inundated Lots	12	0	12
Inundated Roadway (LF)	0	0	0

The goal of this study was to size the system to be capable of carrying up to the 10-Year storm with no inundation in the colonia. However, some structures lie within low areas of the colonia and still show risk of flooding. When comparing the 6-inch inundation maps for the 25- and 100-Year storms, it is observed that the inundation depths are lower than the existing conditions model, resulting in less overall ponding and the street is at lower risk of being flooded once improvements are in place. Figures 1, 2, 3, 4, and 5 show the existing and proposed conditions inundation maps for the 2-, 5-, 10-, 25-, and 100-Yr storms respectively.

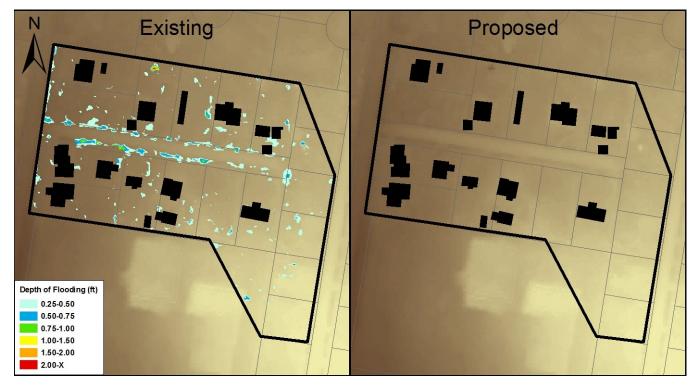
Figure 2: Existing and Proposed Conditions - 5-Yr Storm Inundation Map

20% (5-Year) Flood Recurrence	Pre-Project	Post-Project	Removed
Inundated Structures	0	0	0
Inundated Lots	12	0	12
Inundated Roadway (LF)	0	0	0

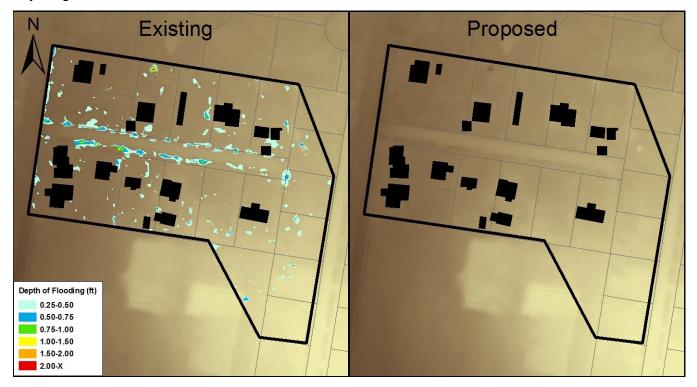
Figure 3: Existing and Proposed Conditions - 10-Yr Storm Inundation Map

10% (10-Year) Flood Recurrence	Pre-Project	Post-Project	Removed
Inundated Structures	0	0	0
Inundated Lots	12	0	12
Inundated Roadway (LF)	0	0	0

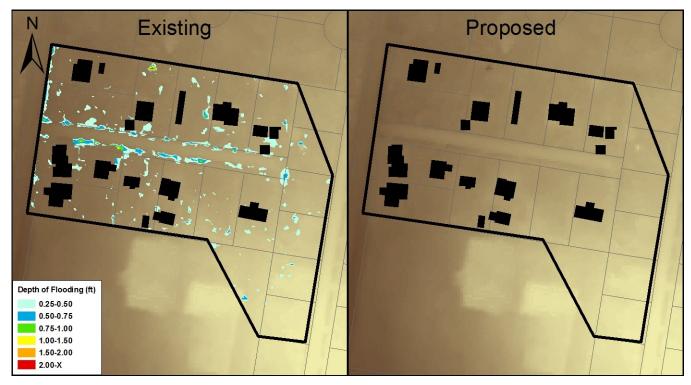
Figure 4: Existing and Proposed Conditions - 25-Yr Storm Inundation Map

4% (25-Year) Flood Recurrence	Pre-Project	Post-Project	Removed
Inundated Structures	0	0	0
Inundated Lots	12	0	12
Inundated Roadway (LF)	0	0	0

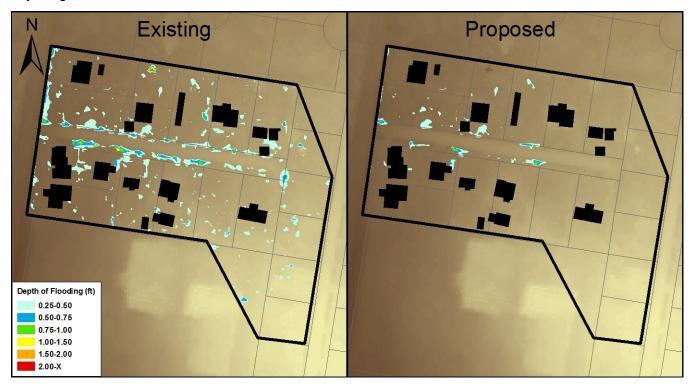
Figure 5: Existing and Proposed Conditions - 100-Yr Storm Inundation Map

1% (100-Year) Flood Recurrence	Pre-Project	Post-Project	Removed
Inundated Structures	0	0	0
Inundated Lots	12	6	6
Inundated Roadway (LF)	0	0	0

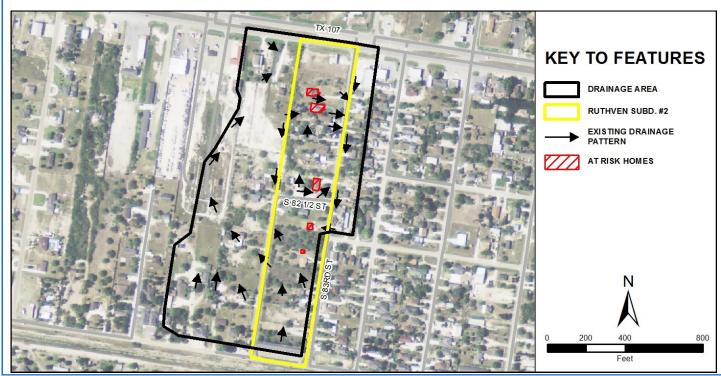
Ruthven Subd. #2 consists of approximately 11 acres of fully developed residential land with an offsite drainage area of approximately 16 acres of fully developed residential land. The existing drainage system consist of culverts and swales, however most of the swales and culverts are partially or completely filled. The existing drainage pattern indicates runoff flows northwest through the south portion of the colonia and back east at the north end of the colonia. Based on the existing conditions 2D model results, structures along the north side of the colonia appear to be at risk of flooding. It should be noted that providing drainage improvements to this colonia would also benefit Ruthven #1, however the benefit to cost ratio was only calculated for this colonia. A regional design approach should be evaluated for these two colonias. Figures 1, 2, 3, 4, and 5 illustrate the existing and proposed inundation maps for the 2-, 5-, 10-, 25-, and 100-Year storms respectively. The color coded inundation maps illustrate the depth of flooding as follows: light blue represents a depth of 3 to 6 inches, blue 6 to 9 inches, green 9 to 12 inches, yellow 12 to 18 inches, orange 18 to 24 inches, and red more than 24 inches.

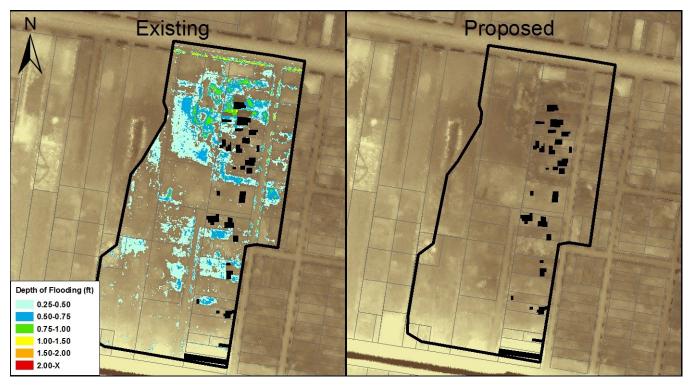
Figure 1: Existing and Proposed Conditions - 2-Yr Storm Inundation Map

50% (2-Year) Flood Recurrence	Pre-Project	Post-Project	Removed
Inundated Structures	2	0	2
Inundated Lots	26	0	26
Inundated Roadway (LF)	0	0	0

The goal of this study was to size the system to be capable of carrying up to the 10-Year storm with no inundation in the colonia. However, some structures lie within low areas of the colonia and still show risk of flooding. When comparing the 6-inch inundation maps for the 25- and 100-Year storms, it is observed that the inundation depths are lower than the existing conditions model, resulting in fewer structures at risk of being flooded once improvements are in place. Figures 1, 2, 3, 4, and 5 show the existing and proposed conditions inundation maps for the 2-, 5-, 10-, 25-, and 100-Yr storms respectively.

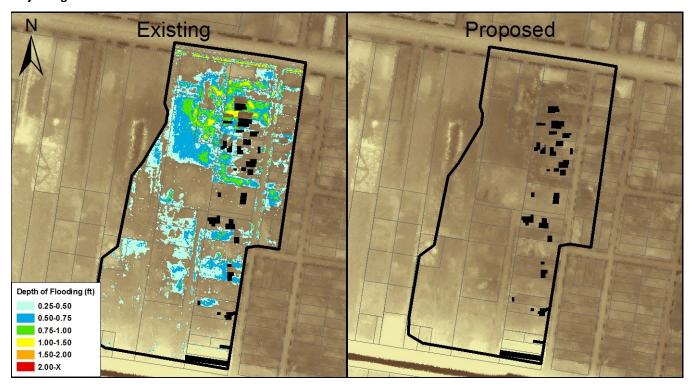
Figure 2: Existing and Proposed Conditions - 5-Yr Storm Inundation Map

20% (5-Year) Flood Recurrence	Pre-Project	Post-Project	Removed
Inundated Structures	3	0	3
Inundated Lots	26	0	26
Inundated Roadway (LF)	10	0	10

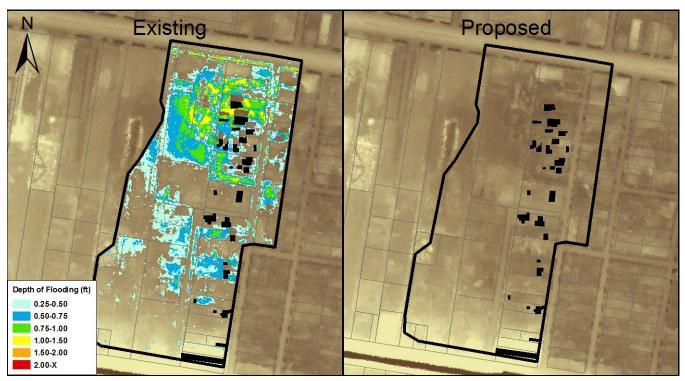
Figure 3: Existing and Proposed Conditions - 10-Yr Storm Inundation Map

10% (10-Year) Flood Recurrence	Pre-Project	Post-Project	Removed
Inundated Structures	4	0	4
Inundated Lots	26	0	26
Inundated Roadway (LF)	92	0	92

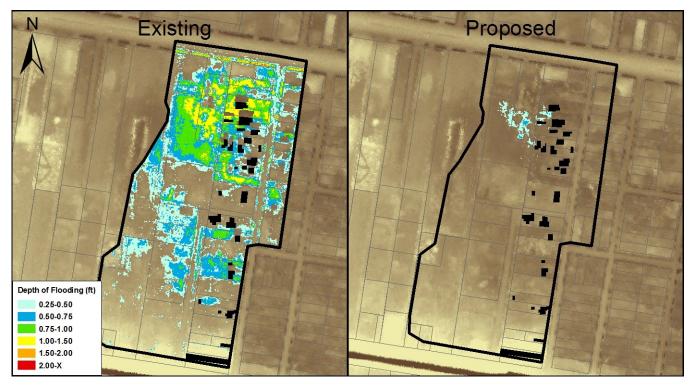
Figure 4: Existing and Proposed Conditions - 25-Yr Storm Inundation Map

4% (25-Year) Flood Recurrence	Pre-Project	Post-Project	Removed
Inundated Structures	4	0	4
Inundated Lots	26	6	20
Inundated Roadway (LF)	270	0	270

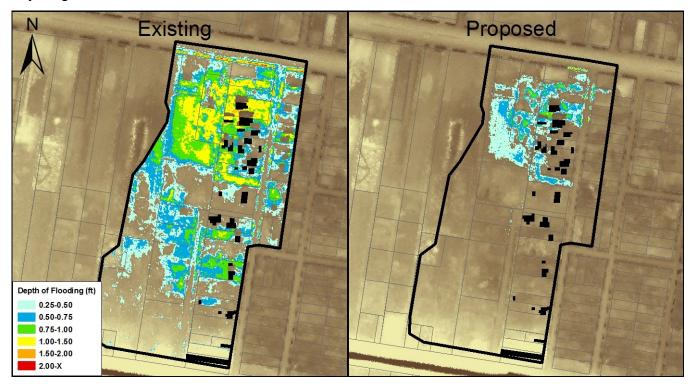
Figure 5: Existing and Proposed Conditions - 100-Yr Storm Inundation Map

1% (100-Year) Flood Recurrence	Pre-Project	Post-Project	Removed
Inundated Structures	5	2	3
Inundated Lots	26	12	14
Inundated Roadway (LF)	334	0	334

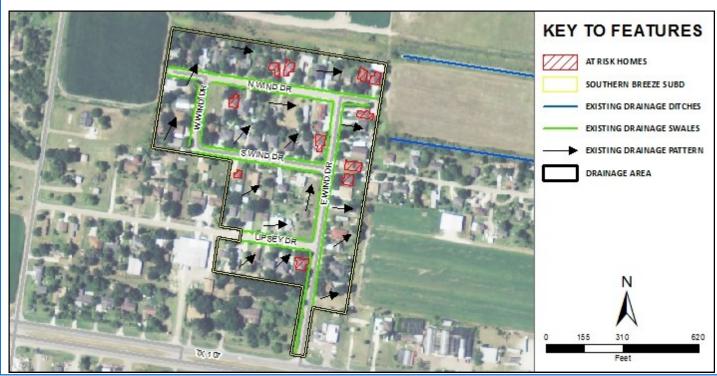
Southern Breeze Subd. consists of approximately 16 acres of fully developed residential land. The existing drainage system consists of swales and culvers that do not appear to have an outfall. The existing drainage pattern indicates runoff flows toward the northeast corner of the colonia. The existing conditions 2D model results indicate some structures are at risk of flooding from a localized storm event. Based on LIDAR observations, this colonia may experience flooding from localized events, but should also be evaluated for risk of flooding due to regional storm events. Figures 1, 2, 3, 4, and 5 illustrate the existing and proposed inundation maps for the 2-, 5-, 10-, 25-, and 100-Year storms respectively. The color coded inundation maps illustrate the depth of flooding as follows: light blue represents a depth of 3 to 6 inches, blue 6 to 9 inches, green 9 to 12 inches, yellow 12 to 18 inches, orange 18 to 24 inches, and red more than 24 inches.

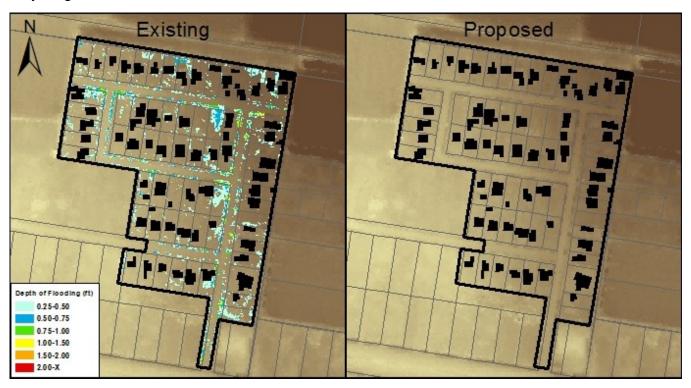
Figure 1: Existing and Proposed Conditions - 2-Yr Storm Inundation Map

The goal of this study was to size the system to be capable of carrying up to the 10-Year storm with no inundation in the colonia. However, some structures lie within low areas of the colonia and still show risk of flooding. When comparing the 6-inch inundation maps for the 25- and 100-Year storms, it is observed that the inundation depths are lower than the existing conditions model, resulting in fewer structures at risk of being flooded once improvements are in place. Figures 1, 2, 3, 4, and 5 show the existing and proposed conditions inundation maps for the 2-, 5-, 10-, 25-, and 100-Yr storms respectively.

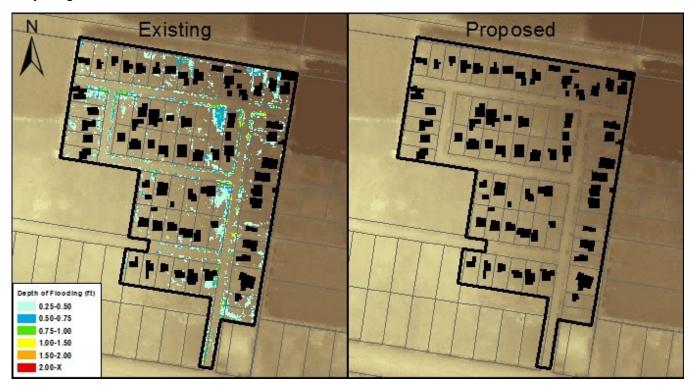
Figure 2: Existing and Proposed Conditions - 5-Yr Storm Inundation Map

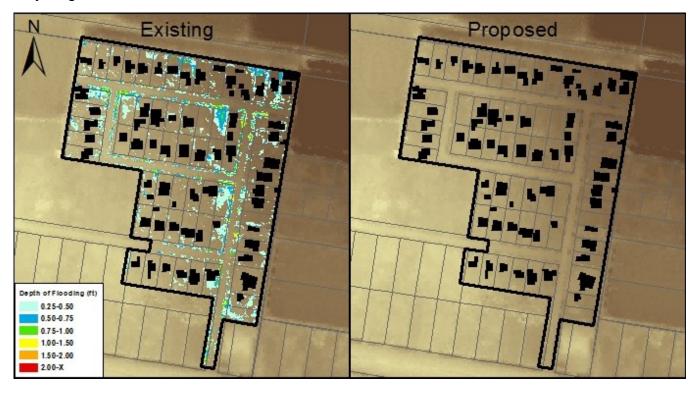
Figure 3: Existing and Proposed Conditions - 10-Yr Storm Inundation Map

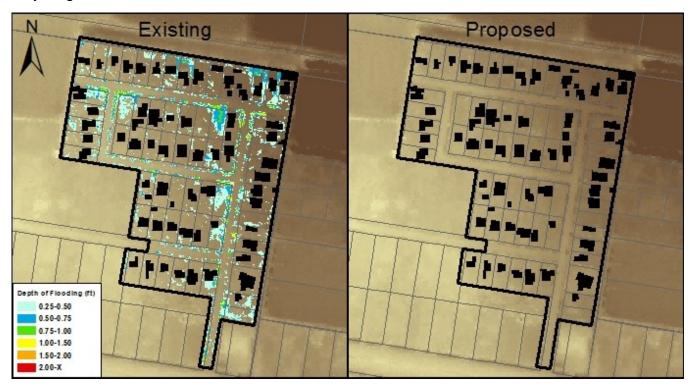
Figure 4: Existing and Proposed Conditions - 25-Yr Storm Inundation Map

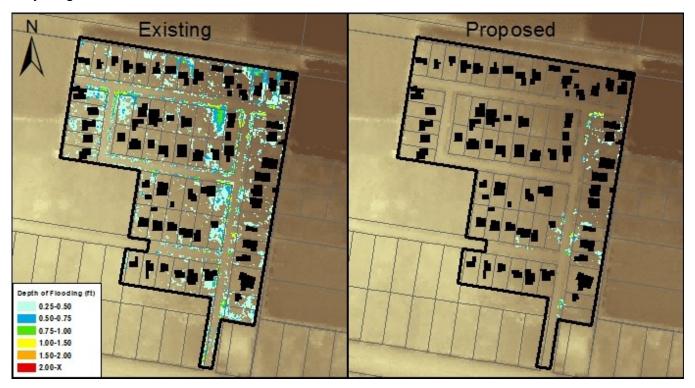
Figure 5: Existing and Proposed Conditions - 100-Yr Storm Inundation Map

1% (100-Year) Flood Recurrence	Pre-Project	Post-Project	Removed
Inundated Structures	13	4	9
Inundated Lots	68	16	52
Inundated Roadway (LF)	0	0	0

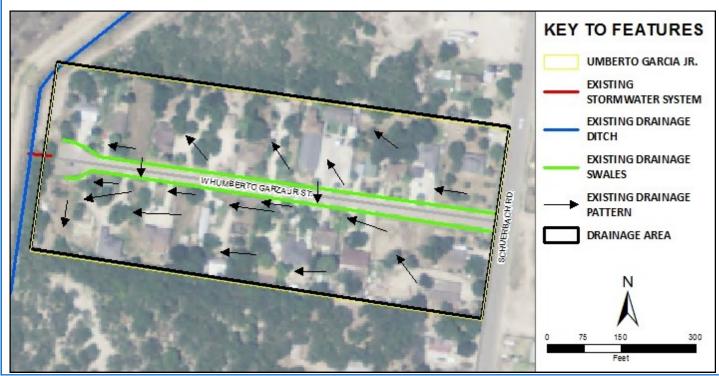
Umberto Garcia Jr. Subd. consists of approximately 8 acres of fully developed residential land. The existing drainage system consists of swales and culverts that outfall into an existing drainage ditch via a 36-inch diameter pipe at the west end of the colonia. The existing drainage pattern indicates runoff flows toward the west. Based on the existing conditions 2D model results and estimated finished floor elevations for the structures, it was determined that no structure is at high risk of flooding from a localized storm event. However, this colonia should also be evaluated for risk of flooding due to regional storm events. Figures 1, 2, 3, 4, and 5 illustrate the existing and proposed inundation maps for the 2-, 5-, 10-, 25-, and 100-Year storms respectively. The color coded inundation maps illustrate the depth of flooding as follows: light blue represents a depth of 3 to 6 inches, blue 6 to 9 inches, green 9 to 12 inches, yellow 12 to 18 inches, orange 18 to 24 inches, and red more than 24 inches.

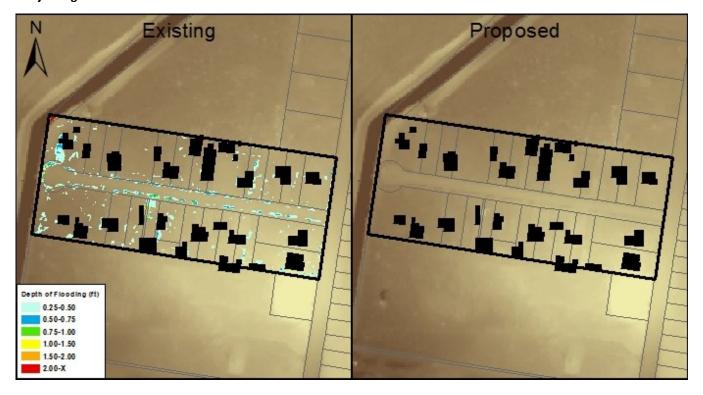
Figure 1: Existing and Proposed Conditions - 2-Yr Storm Inundation Map

The goal of this study was to size the system to be capable of carrying up to the 10-Year storm with no inundation in the colonia. However, some structures lie within low areas of the colonia and still show risk of flooding. When comparing the 6-inch inundation maps for the 25- and 100-Year storms, it is observed that the inundation depths are lower than the existing conditions model, resulting in less overall ponding and the street is at lower risk of being flooded once improvements are in place. Figures 1, 2, 3, 4, and 5 show the existing and proposed conditions inundation maps for the 2-, 5-, 10-, 25-, and 100-Yr storms respectively.

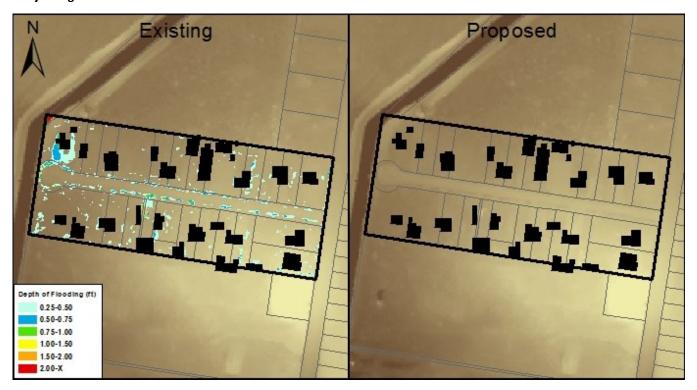
Figure 2: Existing and Proposed Conditions - 5-Yr Storm Inundation Map

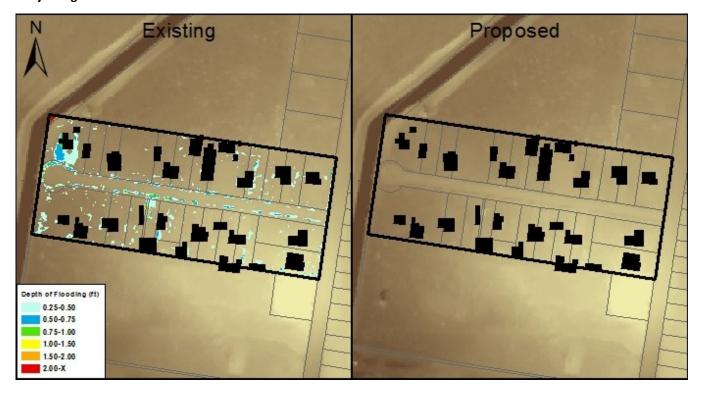
Figure 3: Existing and Proposed Conditions - 10-Yr Storm Inundation Map

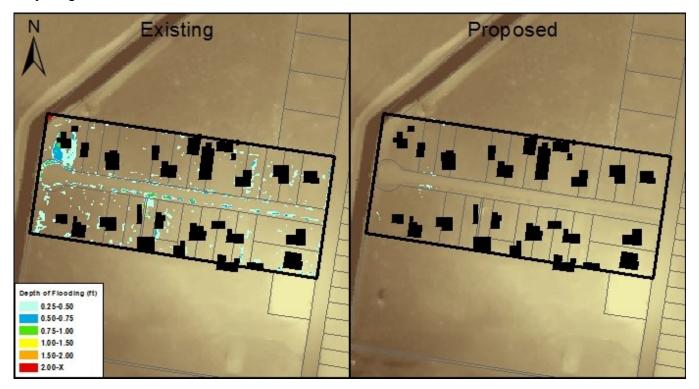
Figure 4: Existing and Proposed Conditions - 25-Yr Storm Inundation Map

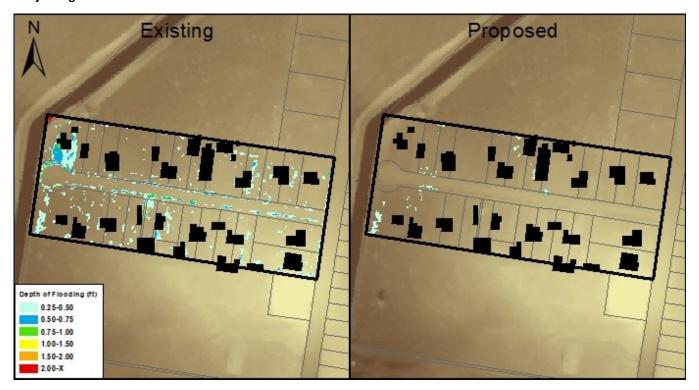
Figure 5: Existing and Proposed Conditions - 100-Yr Storm Inundation Map

1% (100-Year) Flood Recurrence	Pre-Project	Post-Project	Removed
Inundated Structures	0	0	0
Inundated Lots	23	8	15
Inundated Roadway (LF)	0	0	0

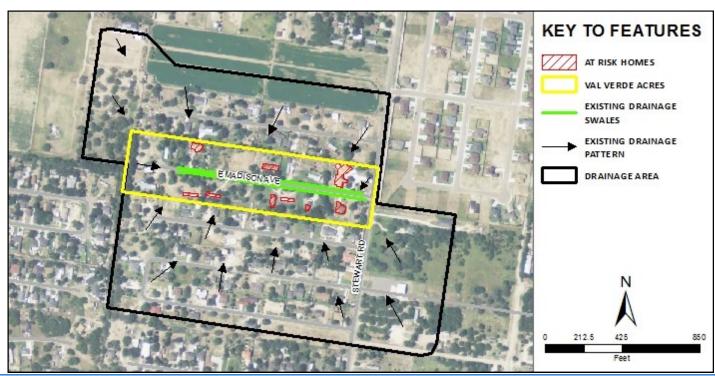
Val Verde Acres consists of approximately 10.5 acres of fully developed residential land with an offsite drainage area of approximately 45 acres of fully developed residential land. The existing drainage system consists of swales and culverts with no outfall. The existing drainage pattern indicates runoff flows toward the center of Val Verde Acres. Based on the existing conditions 2D model results several structures are at risk of flooding. Based on LIDAR observations, this colonia may experience flooding from localized events, but should also be evaluated for risk of flooding due to regional storm events. Figures 1, 2, 3, 4, and 5 illustrate the existing and proposed inundation maps for the 2-, 5-, 10-, 25-, and 100-Year storms respectively. The color coded inundation maps illustrate the depth of flooding as follows: light blue represents a depth of 3 to 6 inches, blue 6 to 9 inches, green 9 to 12 inches, yellow 12 to 18 inches, orange 18 to 24 inches, and red more than 24 inches.

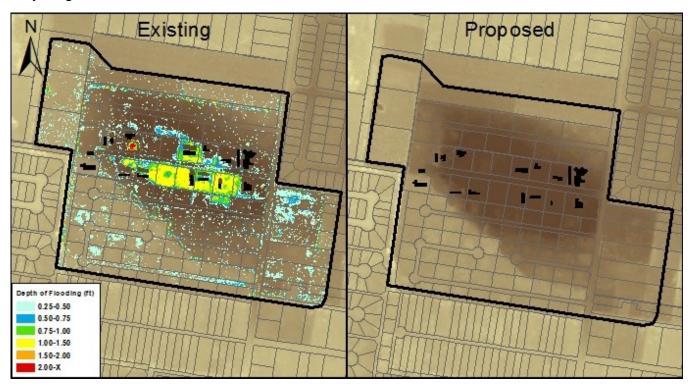
Figure 1: Existing and Proposed Conditions - 2-Yr Storm Inundation Map

The goal of this study was to size the system to be capable of carrying up to the 10-Year storm with no inundation in the colonia. However, some structures lie within low areas of the colonia and still show risk of flooding. When comparing the 6-inch inundation maps for the 25- and 100-Year storms, it is observed that the inundation depths are lower than the existing conditions model, resulting in fewer structures at risk of being flooded once improvements are in place. Figures 1, 2, 3, 4, and 5 show the existing and proposed conditions inundation maps for the 2-, 5-, 10-, 25-, and 100-Yr storms respectively.

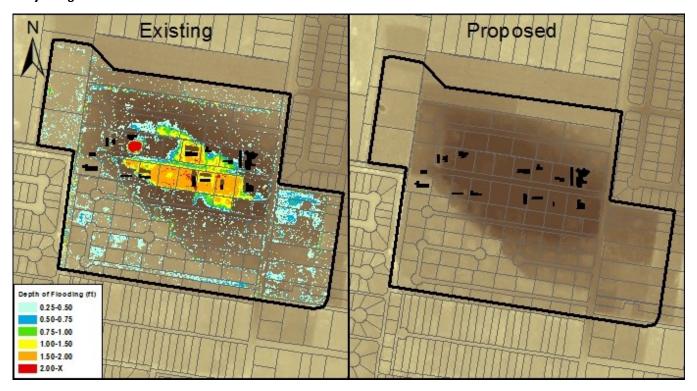
Figure 2: Existing and Proposed Conditions - 5-Yr Storm Inundation Map

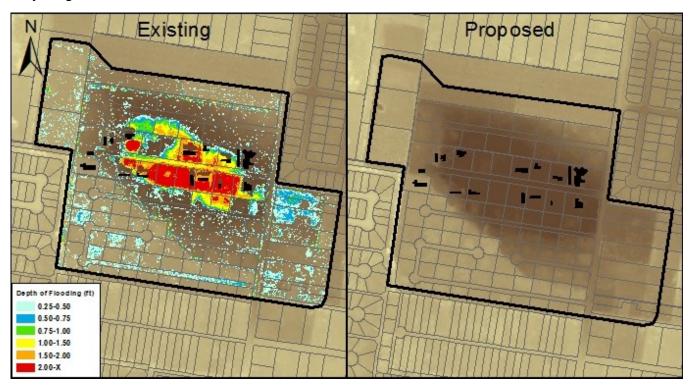
Figure 3: Existing and Proposed Conditions - 10-Yr Storm Inundation Map

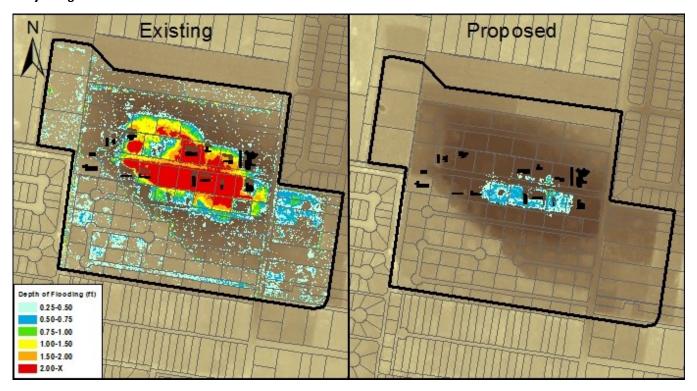
Figure 4: Existing and Proposed Conditions - 25-Yr Storm Inundation Map

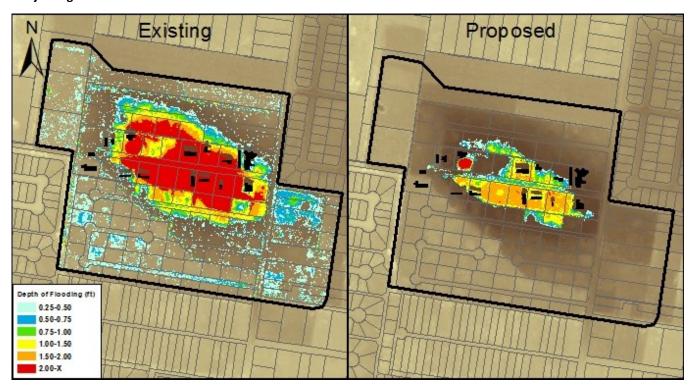
Figure 5: Existing and Proposed Conditions - 100-Yr Storm Inundation Map

1% (100-Year) Flood Recurrence	Pre-Project	Post-Project	Removed
Inundated Structures	10	2	8
Inundated Lots	17	16	1
Inundated Roadway (LF)	1,077	688	389

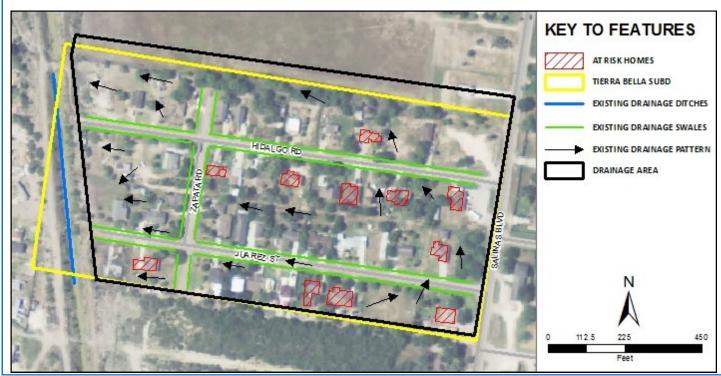
Tierra Bella Subd. consists of approximately 19.5 acres of fully developed residential land. The existing drainage system consists of swales and culvers that outfall into an existing drainage ditch. The existing drainage pattern indicates runoff flows toward the west. Based on the existing conditions 2D model results several structures are at risk of flooding from a localized storm event. Figures 1, 2, 3, 4, and 5 illustrate the existing and proposed inundation maps for the 2-, 5-, 10-, 25-, and 100-Year storms respectively. The color coded inundation maps illustrate the depth of flooding as follows: light blue represents a depth of 3 to 6 inches, blue 6 to 9 inches, green 9 to 12 inches, yellow 12 to 18 inches, orange 18 to 24 inches, and red more than 24 inches.

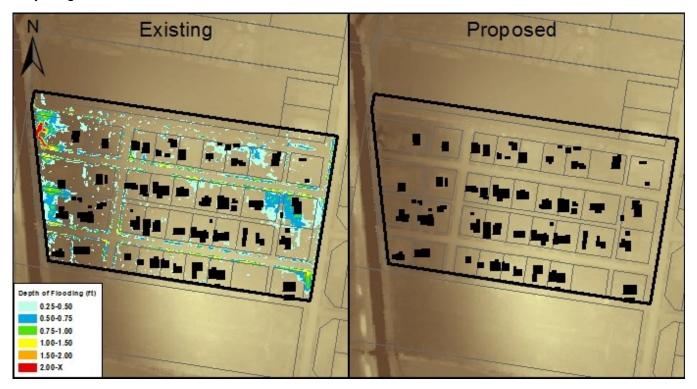
Figure 1: Existing and Proposed Conditions - 2-Yr Storm Inundation Map

The goal of this study was to size the system to be capable of carrying up to the 10-Year storm with no inundation in the colonia. However, some structures lie within low areas of the colonia and still show risk of flooding. When comparing the 6-inch inundation maps for the 25- and 100-Year storms, it is observed that the inundation depths are lower than the existing conditions model, resulting in fewer structures at risk of being flooded once improvements are in place. Figures 1, 2, 3, 4, and 5 show the existing and proposed conditions inundation maps for the 2-, 5-, 10-, 25-, and 100-Yr storms respectively.

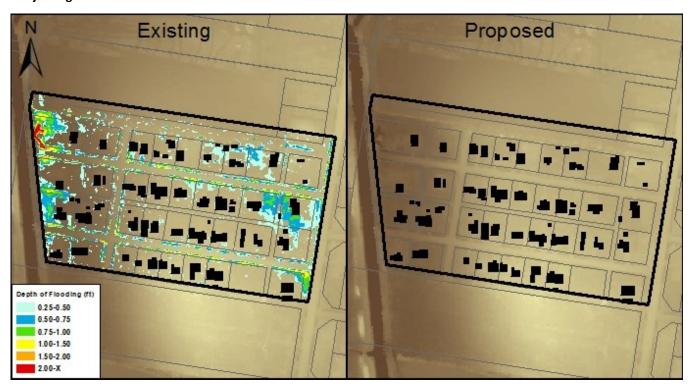
Figure 2: Existing and Proposed Conditions - 5-Yr Storm Inundation Map

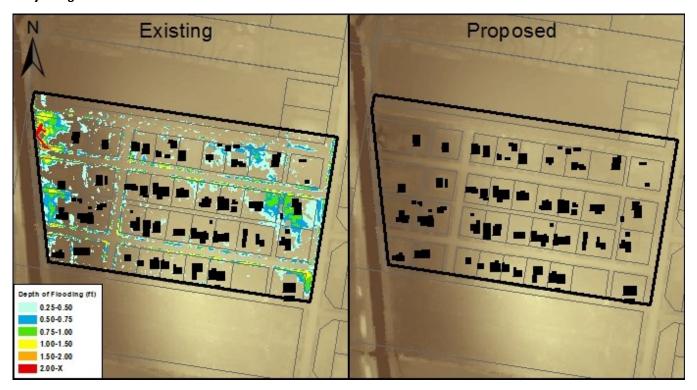
Figure 3: Existing and Proposed Conditions - 10-Yr Storm Inundation Map

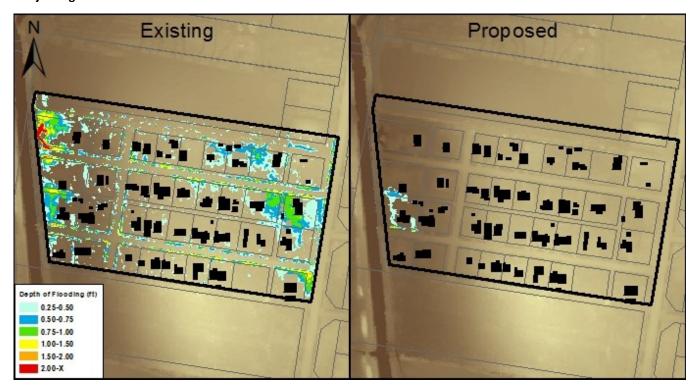
Figure 4: Existing and Proposed Conditions - 25-Yr Storm Inundation Map

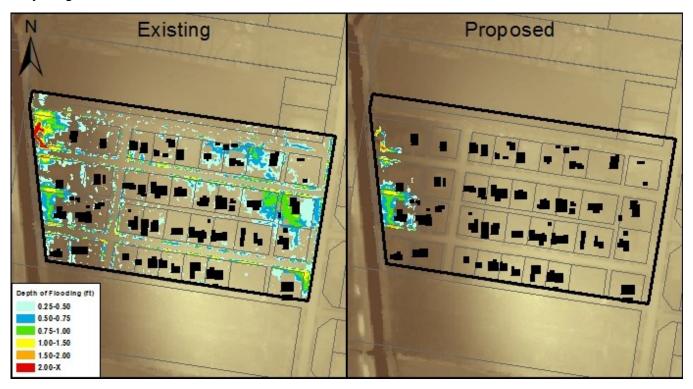
Figure 5: Existing and Proposed Conditions - 100-Yr Storm Inundation Map

1% (100-Year) Flood Recurrence	Pre-Project	Post-Project	Removed
Inundated Structures	11	0	11
Inundated Lots	36	3	33
Inundated Roadway (LF)	0	0	0

- 1. The number of inundated structures are based strictly on finished floor elevations compared to computed water surface elevations.
- 2. The inundation maps above only display flooding depths greater than three inches.
- 3. The number of inundated lots are based strictly on the inundation maps above and therefore do not count as inundated if the depth of flooding is less than three inches.

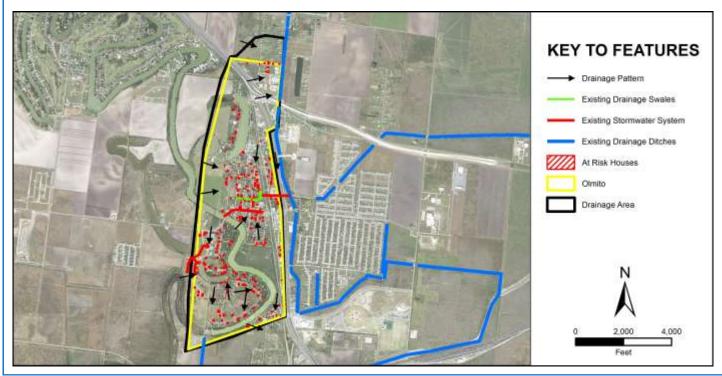
Drainage patterns within this 802-acre colonia are generally to the south and east. The existing drainage system consists of a small stormwater system and roadside swales that are generally undersized and restricted by sediment and vegetation. Olmito experiences residential lot, street, and structure flooding in nearly every rainfall event. Figures 1-5 illustrate the existing and proposed conditions inundation maps for the 2-, 5-, 10-, 25-, and 100-year storms, respectively. These maps illustrate the depth of flooding as follows: light blue represents a depth of 6 to 9 inches, blue 9 to 12 inches, green 1 to 1.5 feet, yellow 1.5 to 2 feet, orange 2 to 3 feet, and red more than 3 feet.

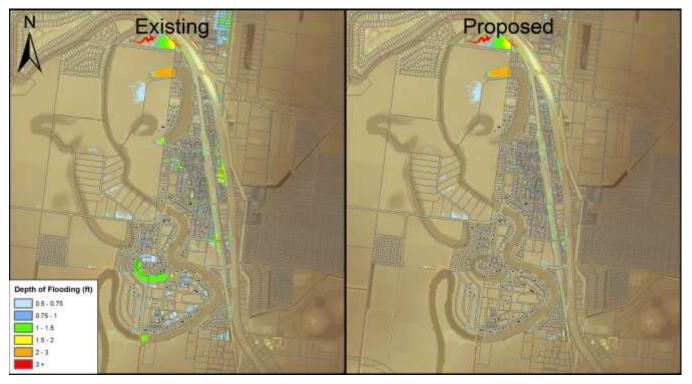
Figure 1: Existing and Proposed Conditions - 2-yr Storm Inundation Map

The goal of this study was to size the system to be capable of carrying up to the 10-Year storm runoff with no inundation in the colonia. However, some structures lie within low areas of the colonia and still show risk of flooding. When comparing the 6-inch inundation map for the 25- and 100-Year storms, it is observed that the inundation depths are lower than the existing conditions model, resulting in fewer structures at risk of being flooded once improvements are in place. Figures 1, 2, 3, 4, and 5 show the existing and proposed conditions inundation maps for the 2-, 5-, 10-, 25-, and 100-Yr storms respectively.

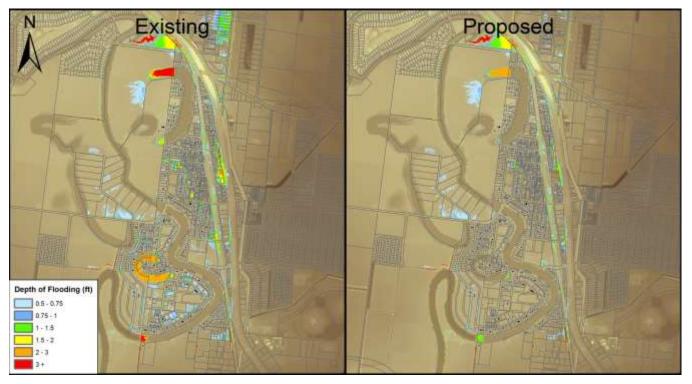
Figure 2: Existing and Proposed Conditions - 5-yr Storm Inundation Map

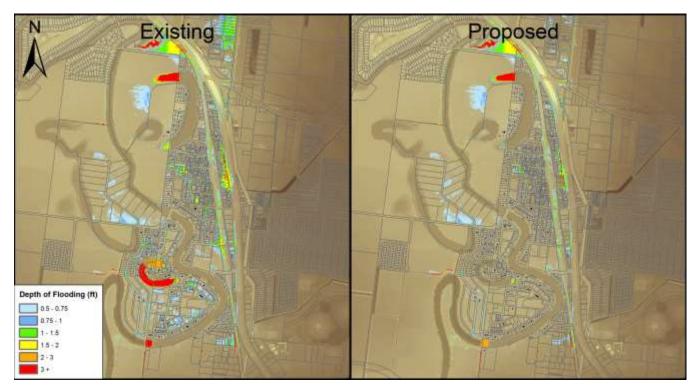
Figure 3: Existing and Proposed Conditions - 10-yr Storm Inundation Map

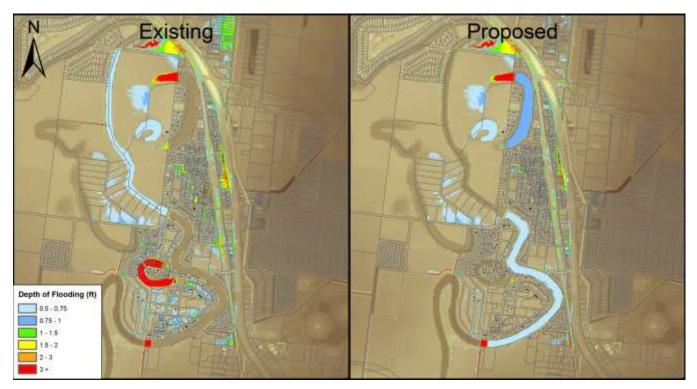
Figure 4: Existing and Proposed Conditions - 25-yr Storm Inundation Map

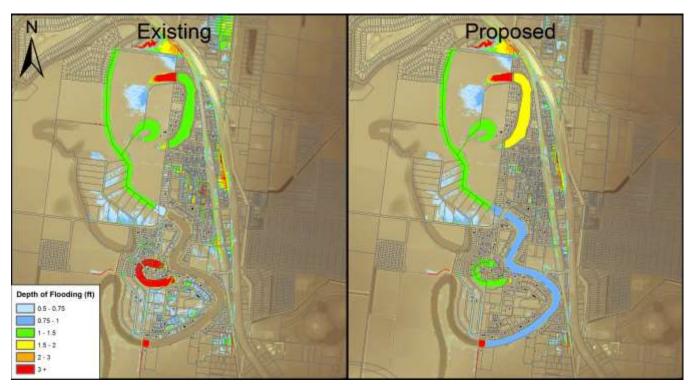
Figure 5: Existing and Proposed Conditions - 100-yr Storm Inundation Map

1% (100-Year)	Pre-Project	Post-Project	Removed
Flood Recurrence			
Inundated Structures	192	66	126
Inundated Lots	1162	881	281
Inundated Roadway (LF)	12620	2690	9930

- 1. The number of inundated structures are based strictly on finished floor elevations compared to computed water surface elevations.
- 2. The inundation maps above only display flooding depths greater than 6 inches.
- 3. The number of inundated lots are based strictly on the inundation maps above and therefore do not count as inundated if the depth of flooding is less than 6 inches.

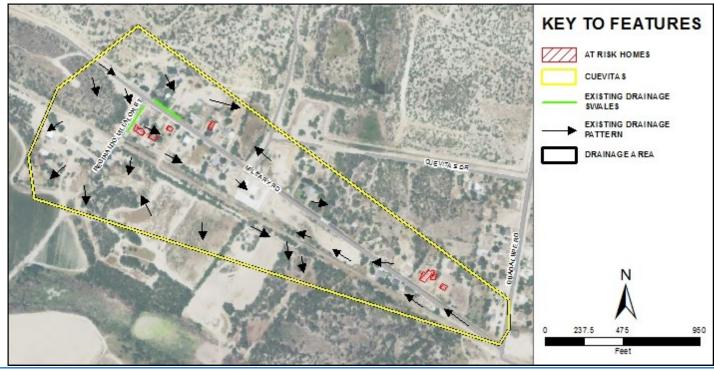
Cuevitas consists of approximately 53.2 acres of fully developed residential land. The existing drainage system consists of only some roadside swales. The existing drainage pattern indicates runoff flows east and west toward some low areas in the colonia. Based on LIDAR observations, this colonia may experience flooding from localized events, but should also be evaluated for risk of flooding due to regional storm events. Figures 1, 2, 3, 4, and 5 illustrate the existing and proposed inundation maps for the 2-, 5-, 10-, 25-, and 100-Year storms respectively. The color coded inundation maps illustrate the depth of flooding as follows: light blue represents a depth of 3 to 6 inches, blue 6 to 9 inches, green 9 to 12 inches, yellow 12 to 18 inches, orange 18 to 24 inches, and red more than 24 inches.

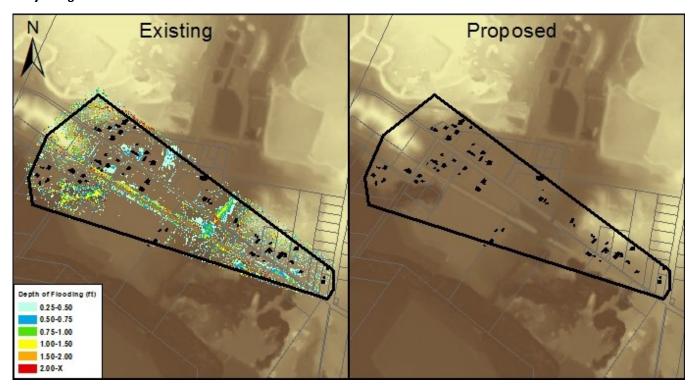
Figure 1: Existing and Proposed Conditions - 2-Yr Storm Inundation Map

The goal of this study was to size the system to be capable of carrying up to the 10-Year storm with no inundation in the colonia. However, some structures lie within low areas of the colonia and still show risk of flooding. When comparing the 6-inch inundation maps for the 25- and 100-Year storms, it is observed that the inundation depths are lower than the existing conditions model, resulting in fewer structures at risk of being flooded once improvements are in place. Figures 1, 2, 3, 4, and 5 show the existing and proposed conditions inundation maps for the 2-, 5-, 10-, 25-, and 100-Yr storms respectively.

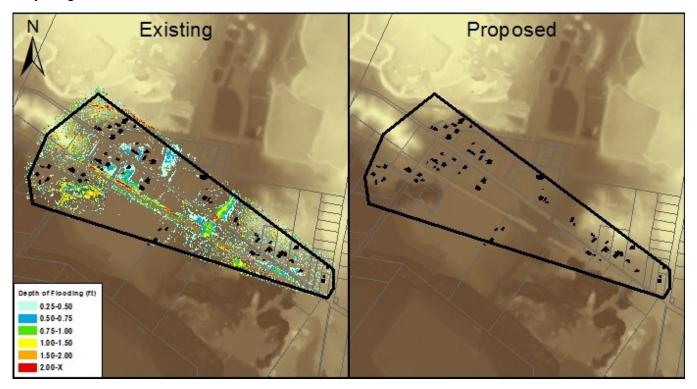
Figure 2: Existing and Proposed Conditions - 5-Yr Storm Inundation Map

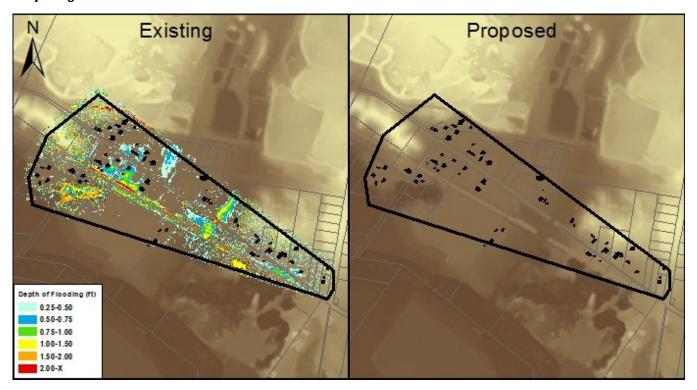
Figure 3: Existing and Proposed Conditions - 10-Yr Storm Inundation Map

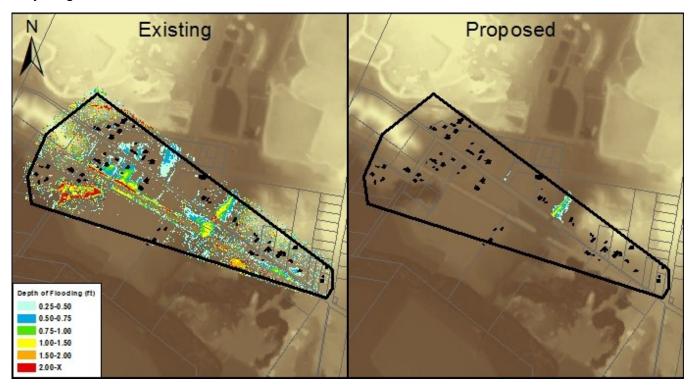
Figure 4: Existing and Proposed Conditions - 25-Yr Storm Inundation Map

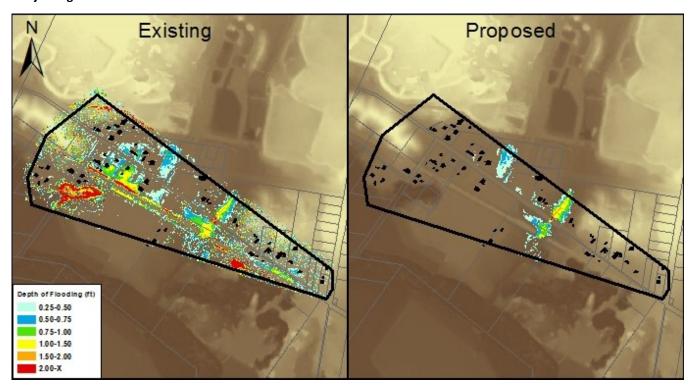
Figure 5: Existing and Proposed Conditions - 100-Yr Storm Inundation Map

1% (100-Year) Flood Recurrence	Pre-Project	Post-Project	Removed
Inundated Structures	8	0	8
Inundated Lots	49	11	38
Inundated Roadway (LF)	273	25	248

- 1. The number of inundated structures are based strictly on finished floor elevations compared to computed water surface elevations.
- 2. The inundation maps above only display flooding depths greater than three inches.
- 3. The number of inundated lots are based strictly on the inundation maps above and therefore do not count as inundated if the depth of flooding is less than three inches.

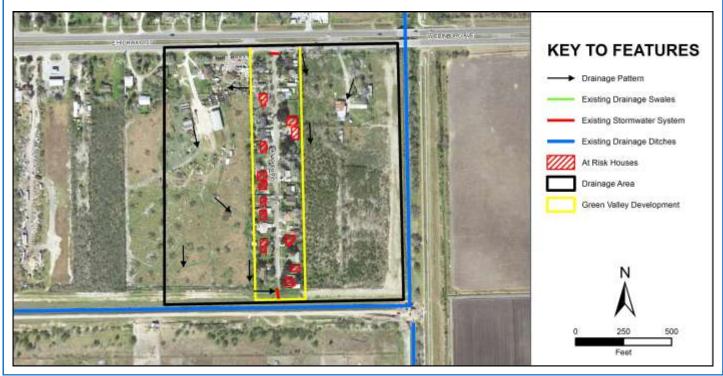
Drainage patterns within this 8-acre colonia are generally to the south. The existing drainage system consists of a small stormwater system and roadside swales that are generally undersized and restricted by sediment and vegetation. Green Valley Development experiences residential lot, street, and structure flooding in nearly every rainfall event. Figures 1-5 illustrate the existing and proposed conditions inundation maps for the 2-, 5-, 10-, 25-, and 100-year storms, respectively. These maps illustrate the depth of flooding as follows: light blue represents a depth of 3 to 6 inches, blue 6 to 9 inches, green 9 to 12 inches, yellow 1 to 2 feet, orange 2 to 3 feet, and red more than 3 feet.

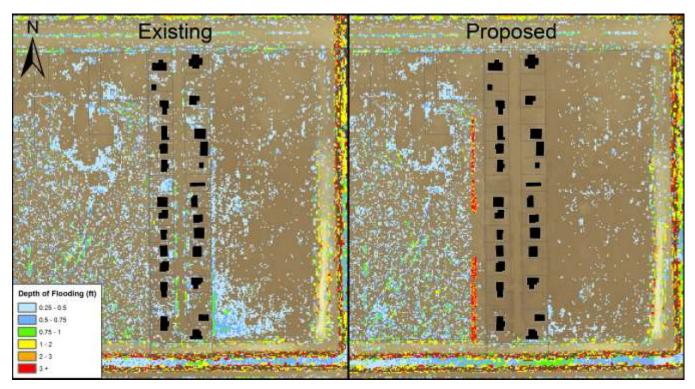
Figure 1: Existing and Proposed Conditions - 2-yr Storm Inundation Map

The goal of this study was to size the system to be capable of carrying up to the 10-Year storm runoff with no inundation in the colonia. However, some structures lie within low areas of the colonia and still show risk of flooding. When comparing the 6-inch inundation map for the 25- and 100-Year storms, it is observed that the inundation depths are lower than the existing conditions model, resulting in fewer structures at risk of being flooded once improvements are in place. Figures 1, 2, 3, 4, and 5 show the existing and proposed conditions inundation maps for the 2-, 5-, 10-, 25-, and 100-Yr storms respectively.

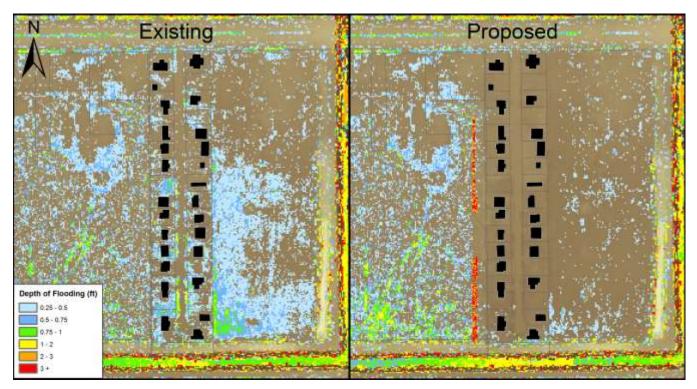
Figure 2: Existing and Proposed Conditions - 5-yr Storm Inundation Map

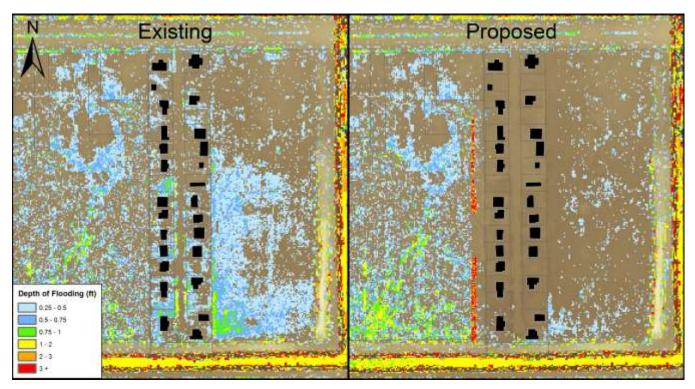
Figure 3: Existing and Proposed Conditions - 10-yr Storm Inundation Map

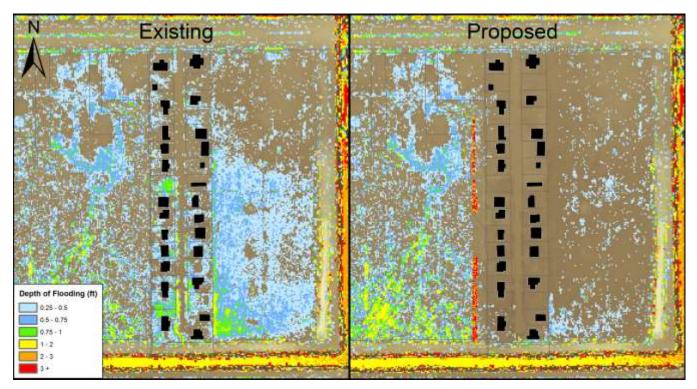
Figure 4: Existing and Proposed Conditions - 25-yr Storm Inundation Map

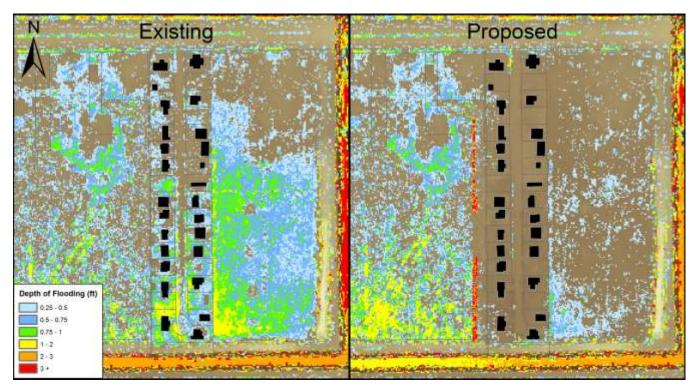
Figure 5: Existing and Proposed Conditions - 100-yr Storm Inundation Map

1% (100-Year) Flood Recurrence	Pre-Project	Post-Project	Removed
Inundated Structures	12	0	12
Inundated Lots	35	23	12
Inundated Roadway (LF)	115	25	90

- 1. The number of inundated structures are based strictly on finished floor elevations compared to computed water surface elevations.
- 2. The inundation maps above only display flooding depths greater than 3 inches.
- 3. The number of inundated lots are based strictly on the inundation maps above and therefore do not count as inundated if the depth of flooding is less than 3 inches.
