A REPORT ON MODEL SPILLWAY STUDIES

Prepared under the direction of Ivan M. Stout,  
Chief Engineer, State Board of Water Engineers,  
in cooperation with Dr. Walter L. Moore,  
The Department of Civil Engineering at The University of Texas.

COMMENTS ON MODEL  
STUDIES FOR THE HICKS AND  
PURE OIL COMPANY DAMS  
AND SPILLWAYS

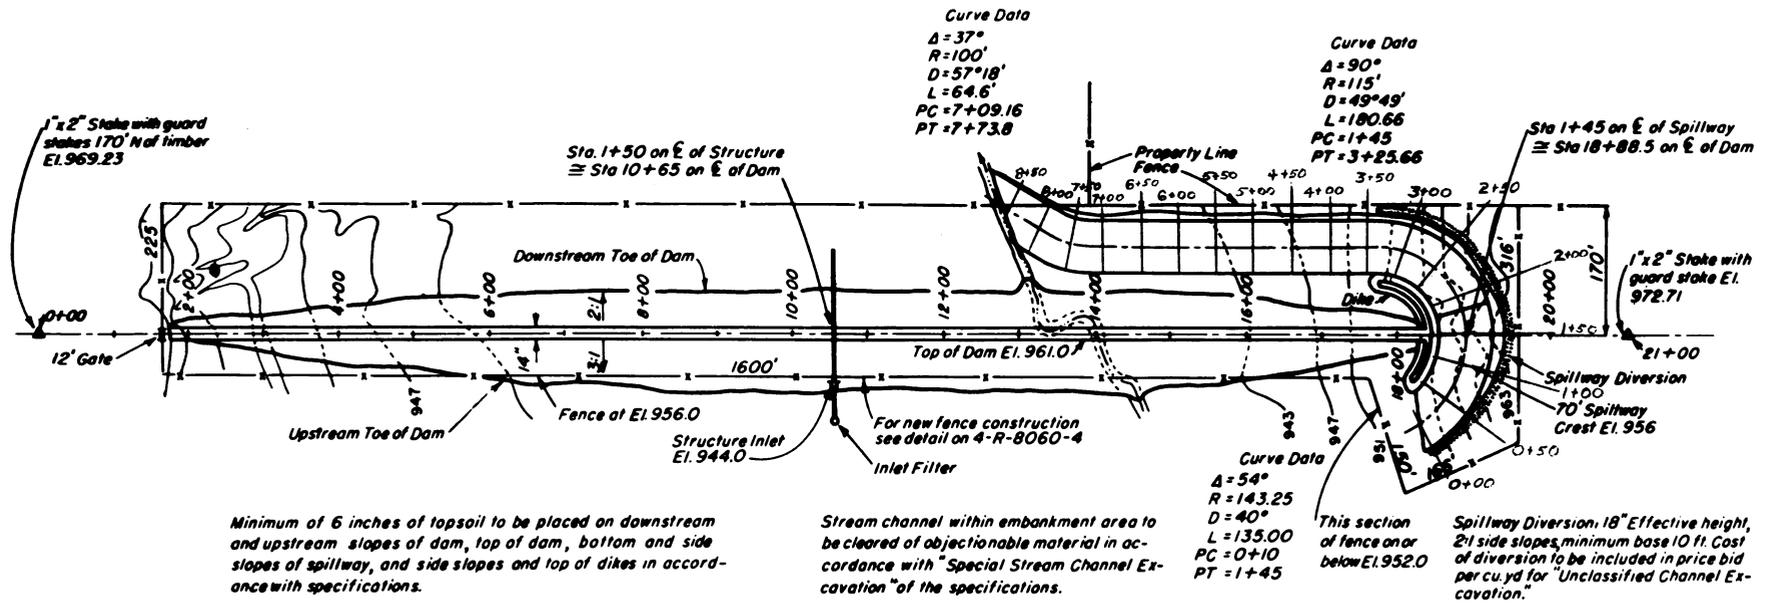
Dwg. 1

**PLAN OF EMBANKMENT & SPILLWAY**

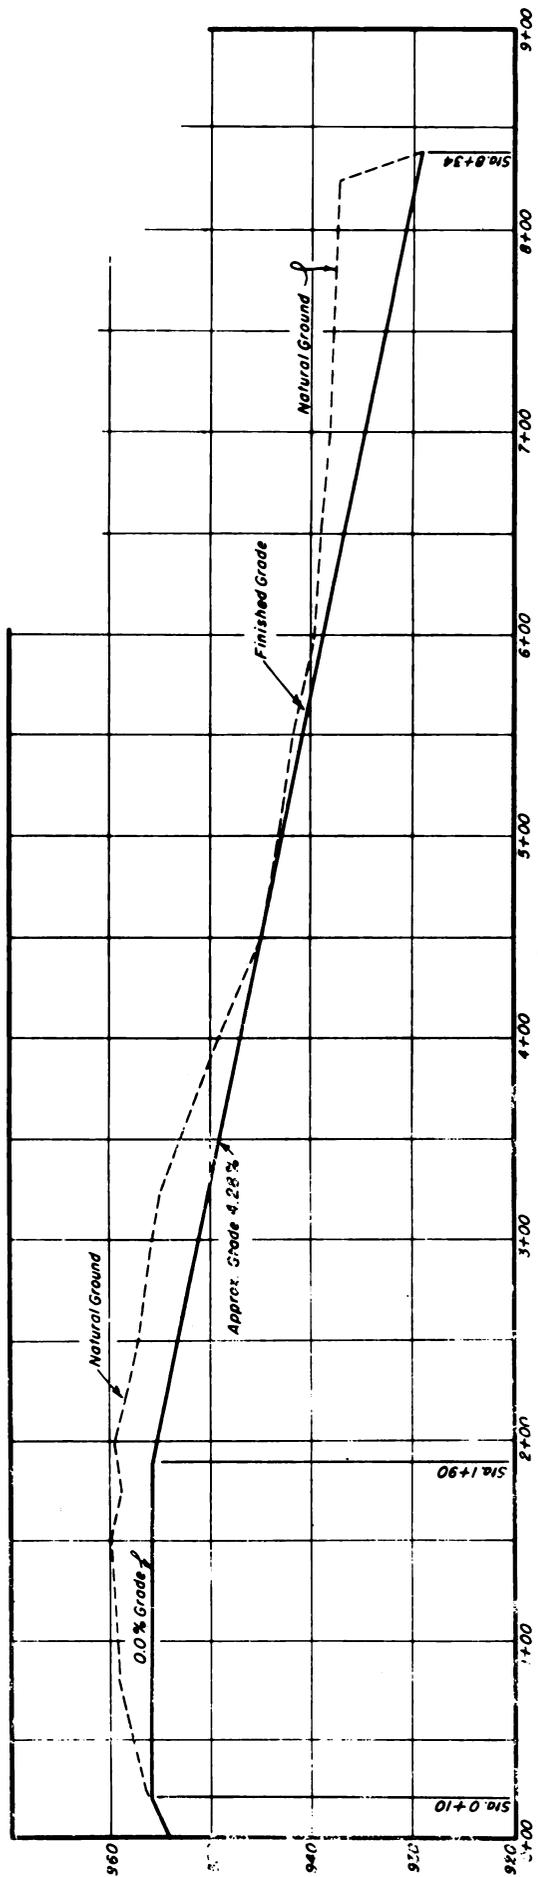
DWG. 3.

**PROFILE OF C OF SPILLWAY**

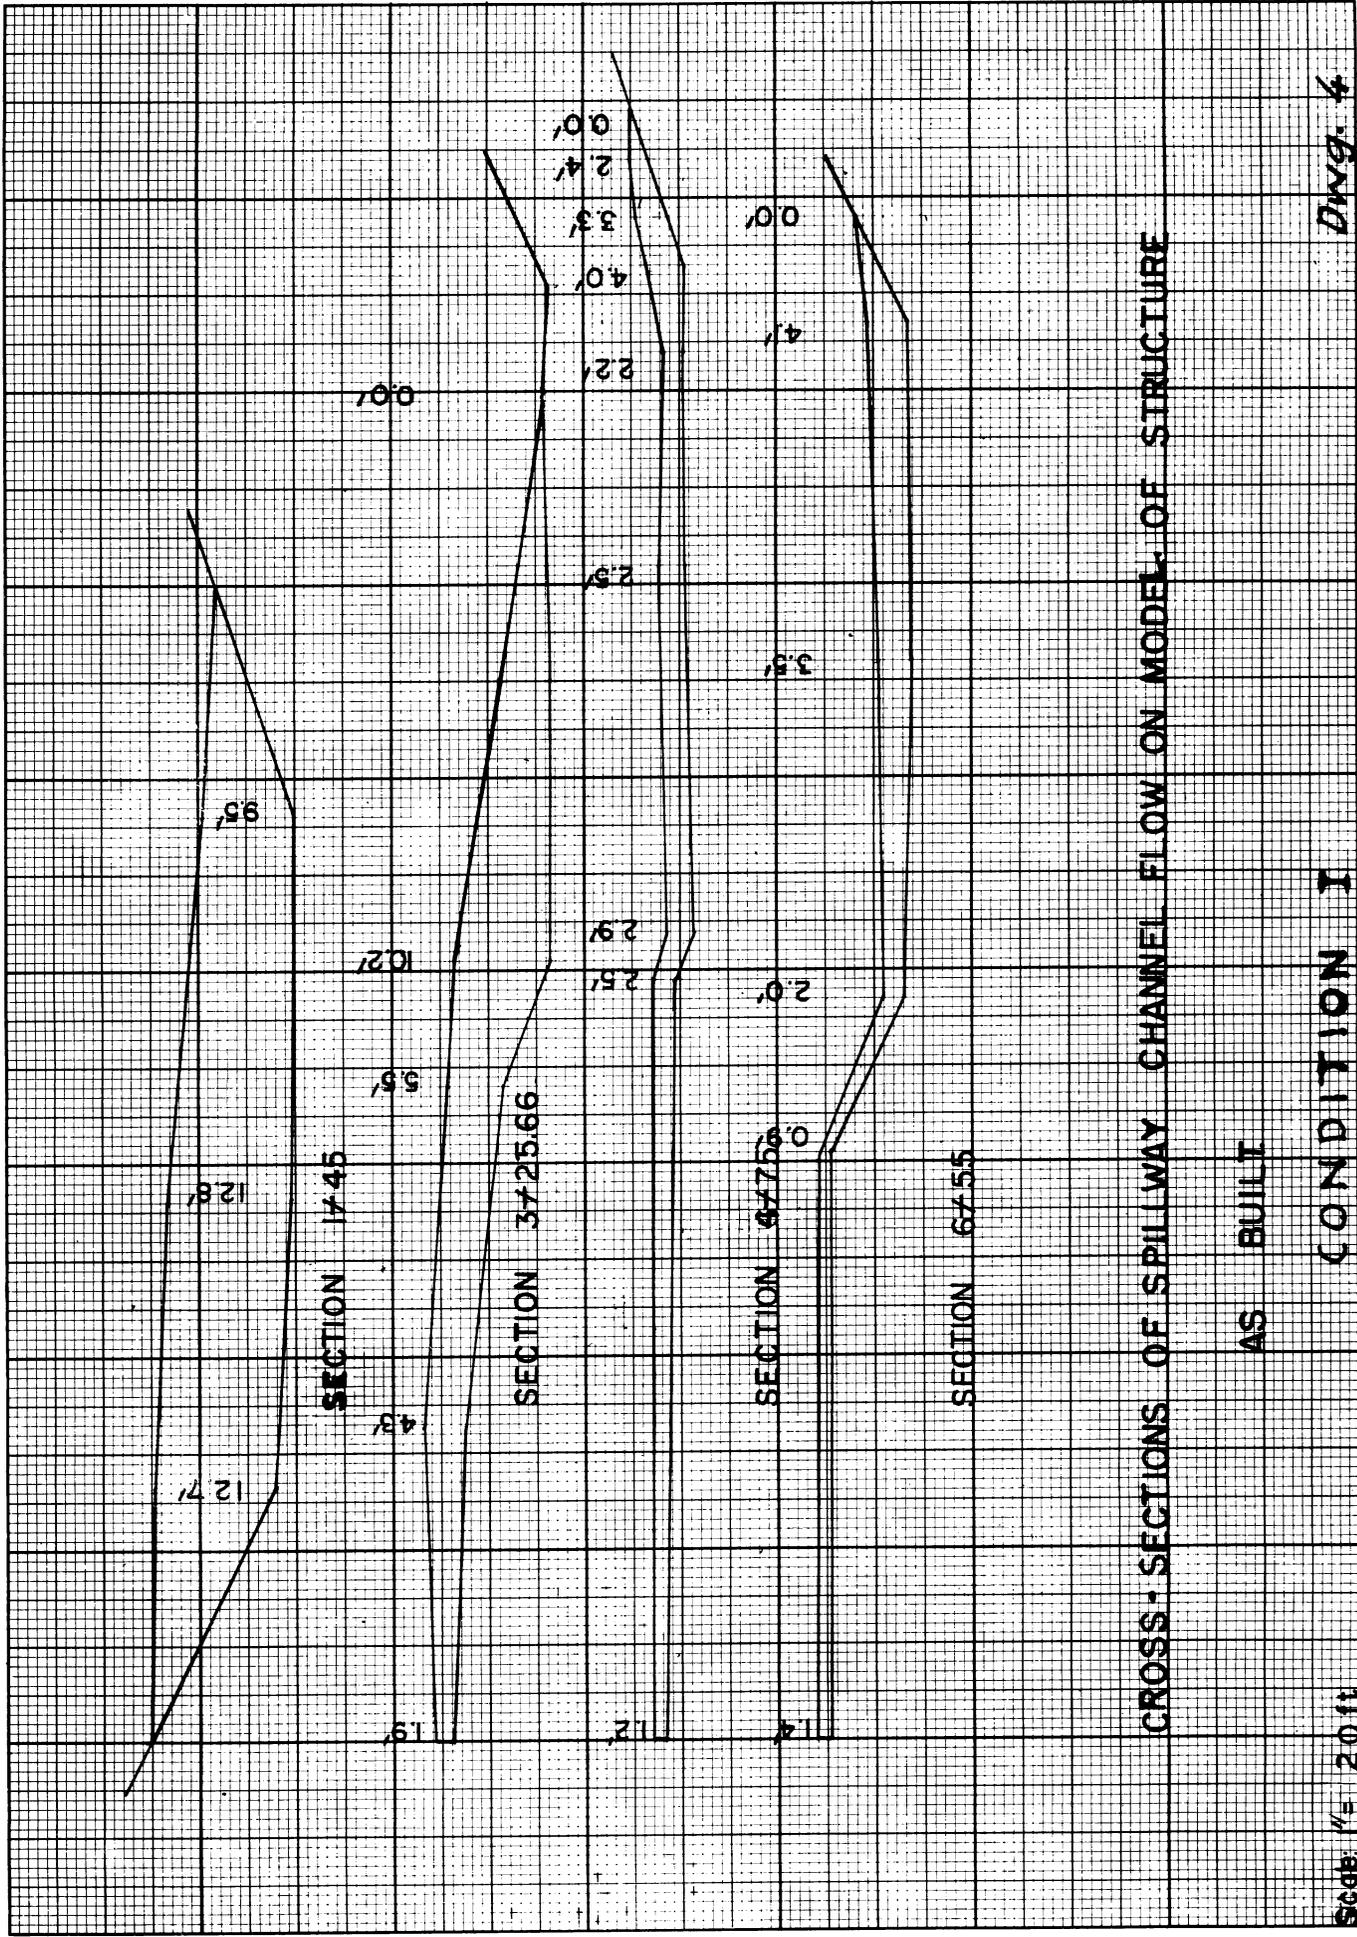
Dwg. 4

CROSS-SECTIONS OF SPILLWAY CHANNEL FLOW ON MODEL OF STRUCTURE

AS BUILT

CONDITION I

Scale 1/8" = 2.0 ft

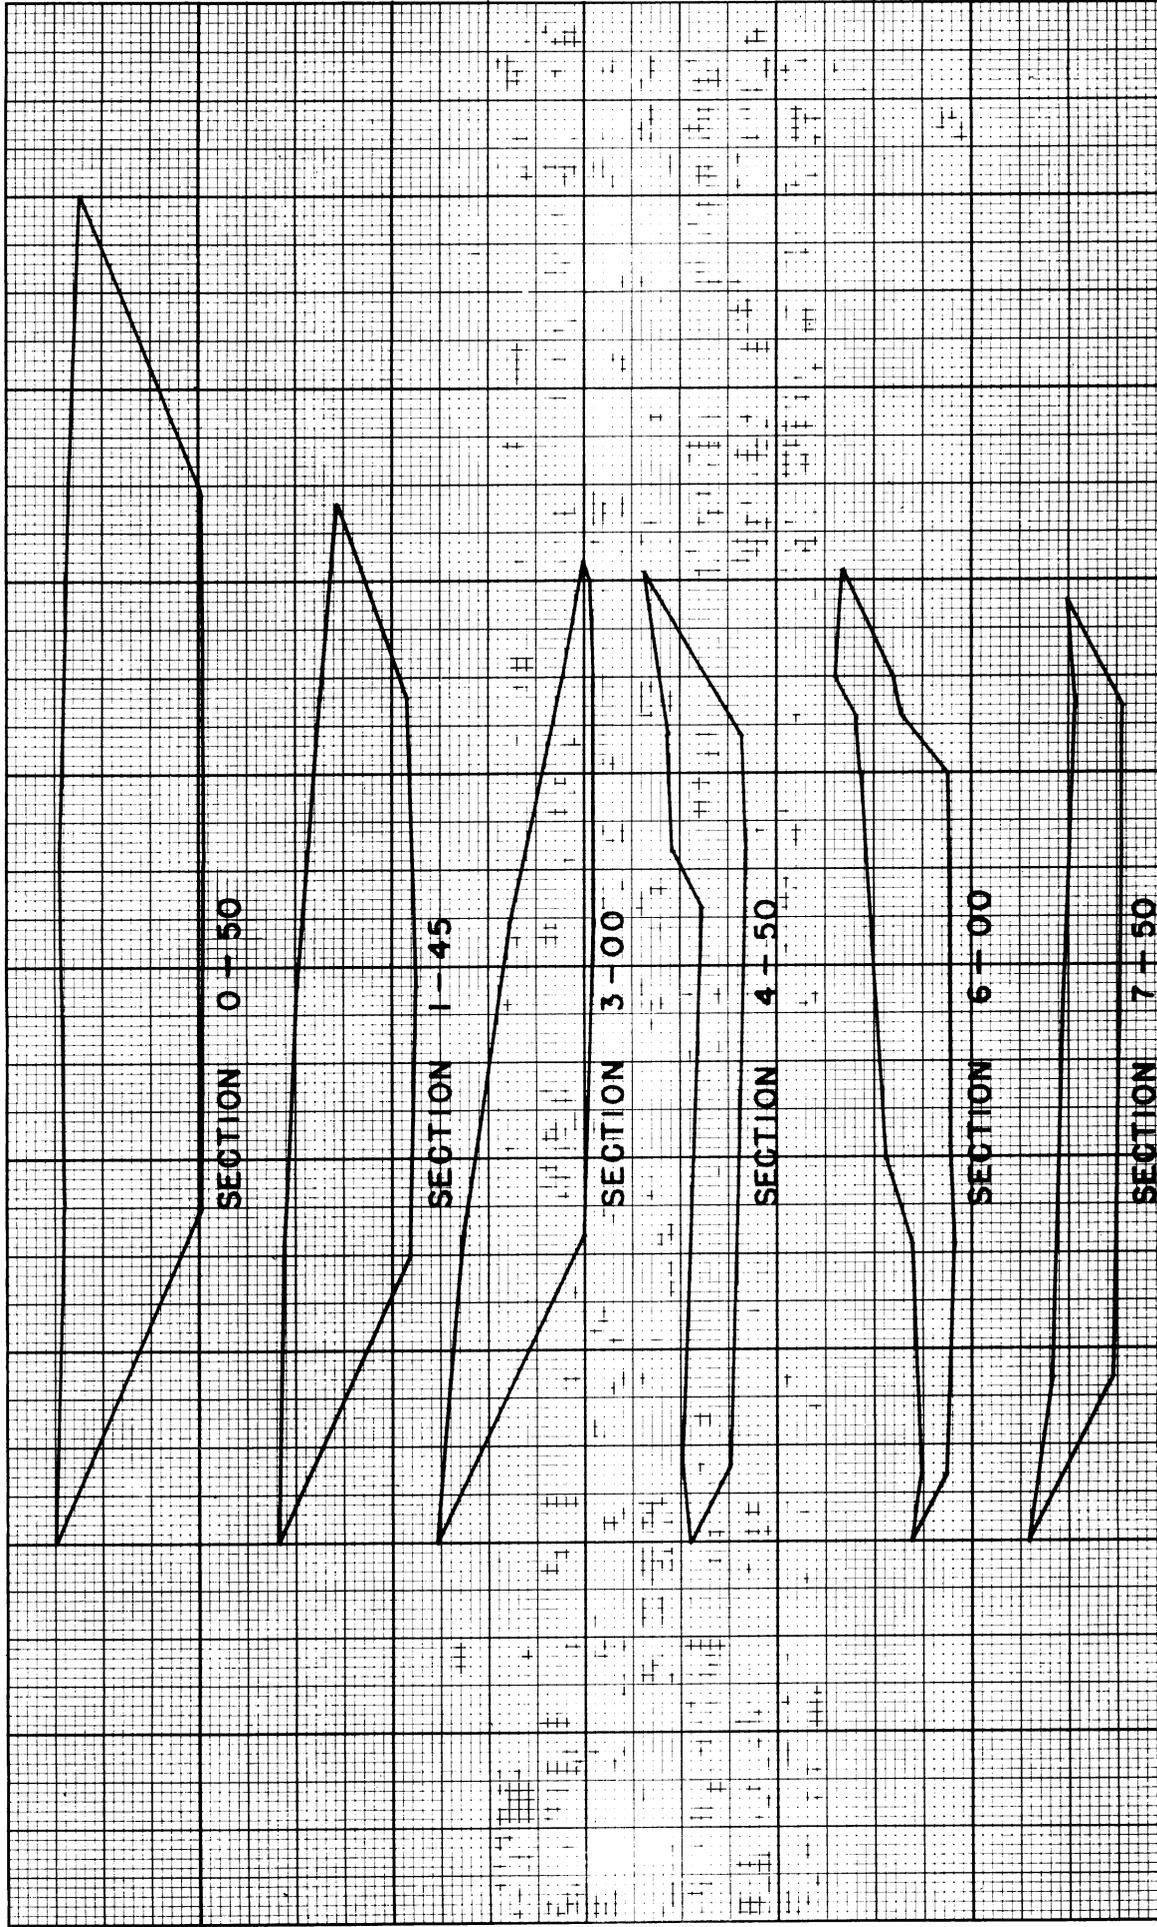
Drwg. 8.

CONDITION IV

Scale: 1" = 20 ft.

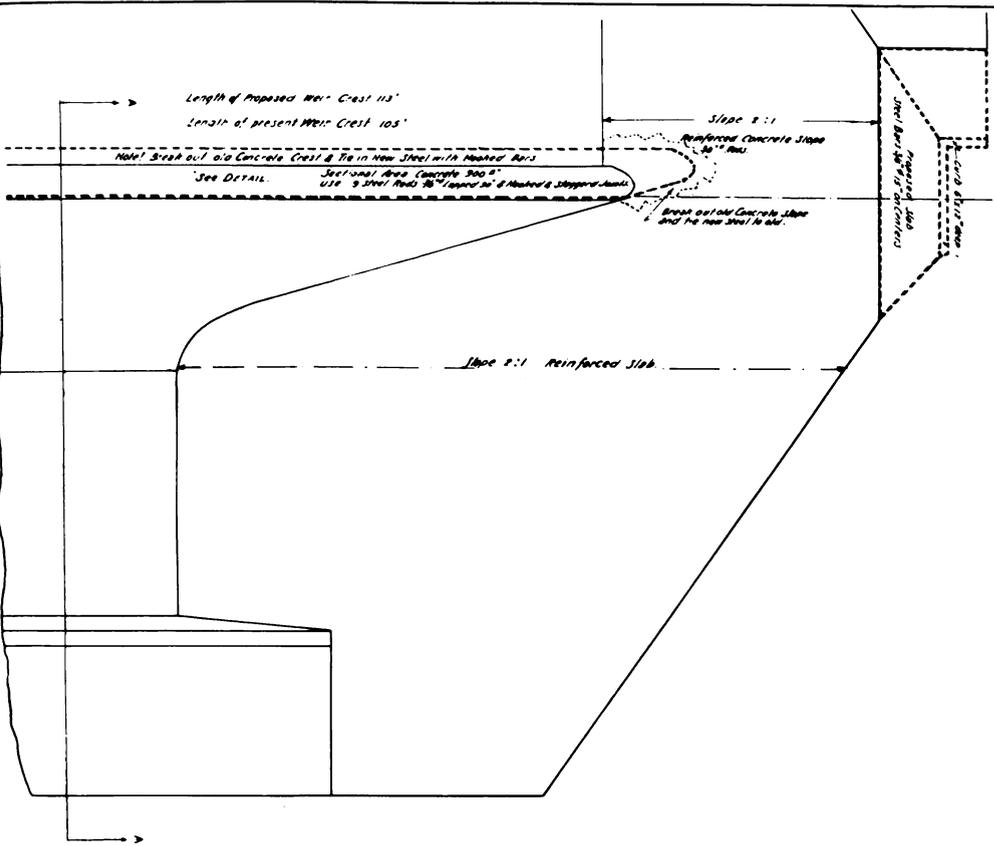
HALF PLAN 1" = 4.0'

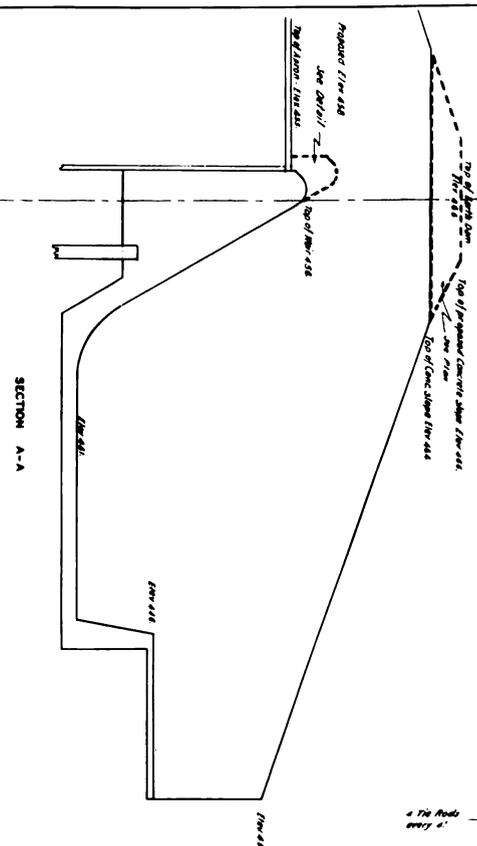
SECTION A-A

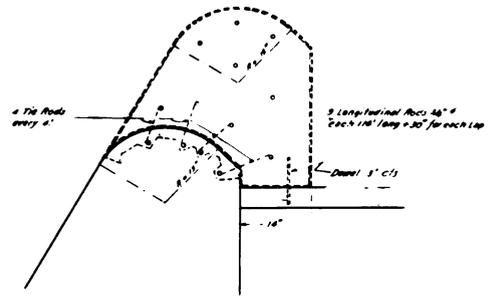
DETAIL SECTION OF PROPOSED WEIR CREST. SCALE: 1" = 1'

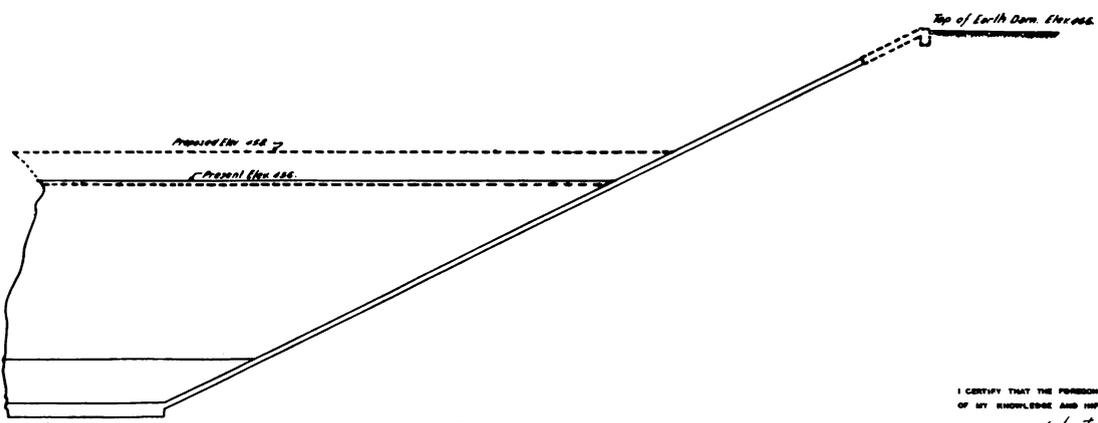
HALF LONGITUDINAL SECTION SCALE: 1" = 4.0'

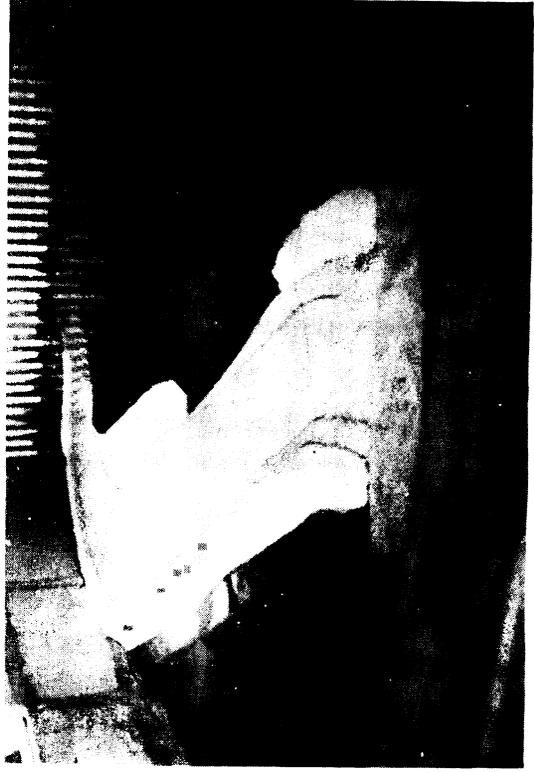
III-a.

III-b.

III-c.

Model with outer levee, super-elevation and slightly improved entrance

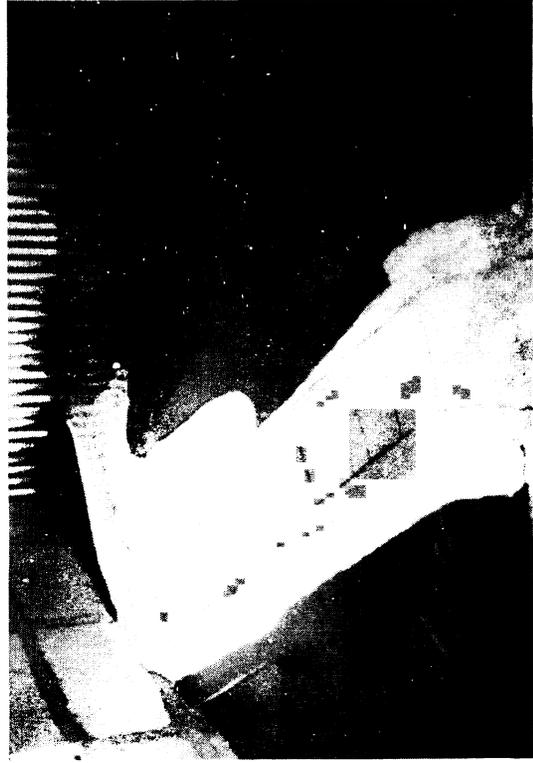
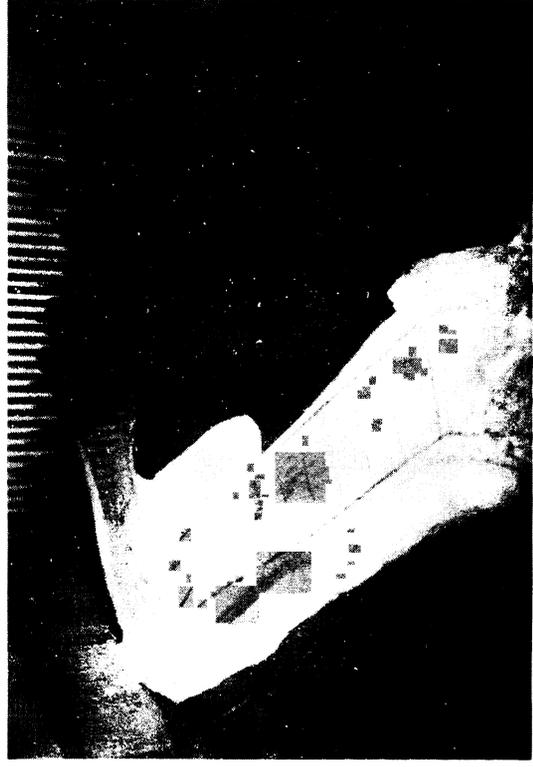
IV-a. Die pattern shows bottom currents

IV-b. Die pattern shows bottom currents

IV-c. Drops of die show surface current  
Model with outer levee, no superelevation but with greatly improved entrance

IV-d. Drops of die show surface current  
Model with outer levee, no superelevation but with greatly improved entrance

For Condition IV, where no superelevation is used, but the entrance was

widened more than for III, thickening of the flow on the outside of the curves is noted, but the flow appears to be more uniform than for II, which was for a similar condition, but without widening of the inlet.

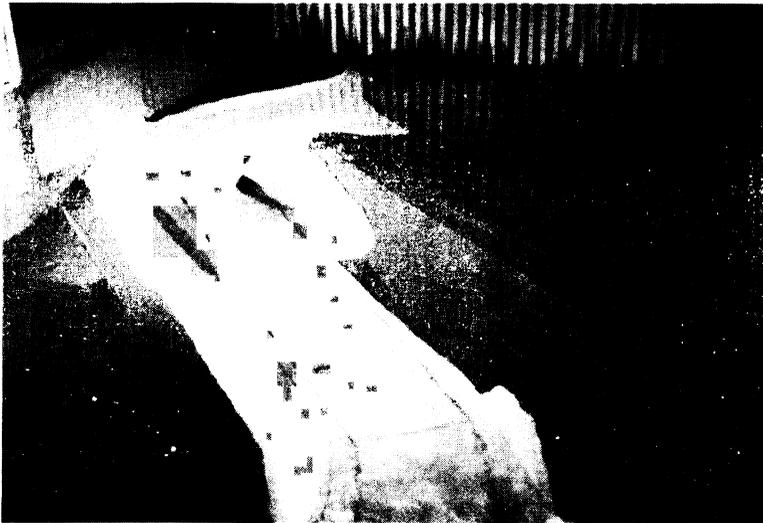
IV-e. Dark spot die shows area where spillway is nearly dry.
