CITY OF VALERA  
COLEMAN COUNTY, TEXAS  
INVESTIGATION OF GROUND-WATER CONTAMINATION

By  
H. D. Holloway, Geologist  
Ground Water Division

Texas Water Commission  
November 1962

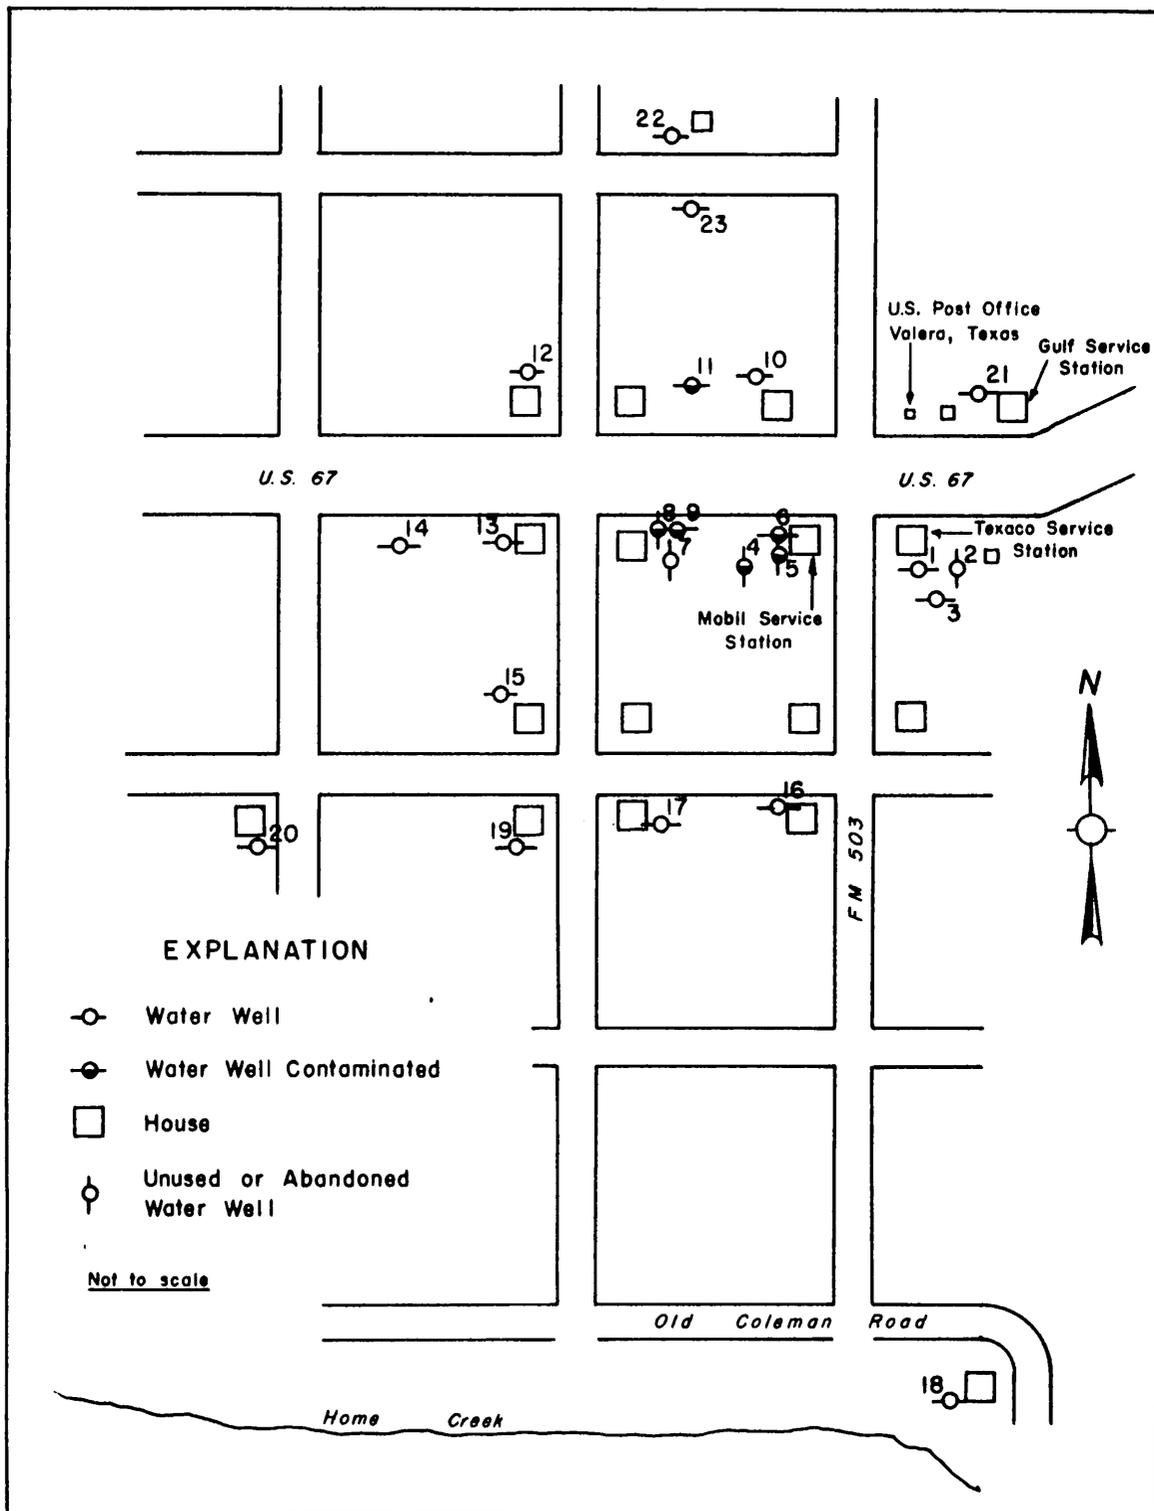
FIGURE I.- Map showing location of water wells in area of investigation, Valera, Texas

A field investigation of the problem was made in the period from July 30 through August 3, 1962. During the course of this investigation, 22 water wells were inventoried in the immediate area, and 14 water samples were collected from water wells for chemical analysis. Pressure tests on gasoline storage tanks at two service stations were witnessed and gas-detection tests were made in 9 water wells in an attempt to determine the areal extent of contamination.
