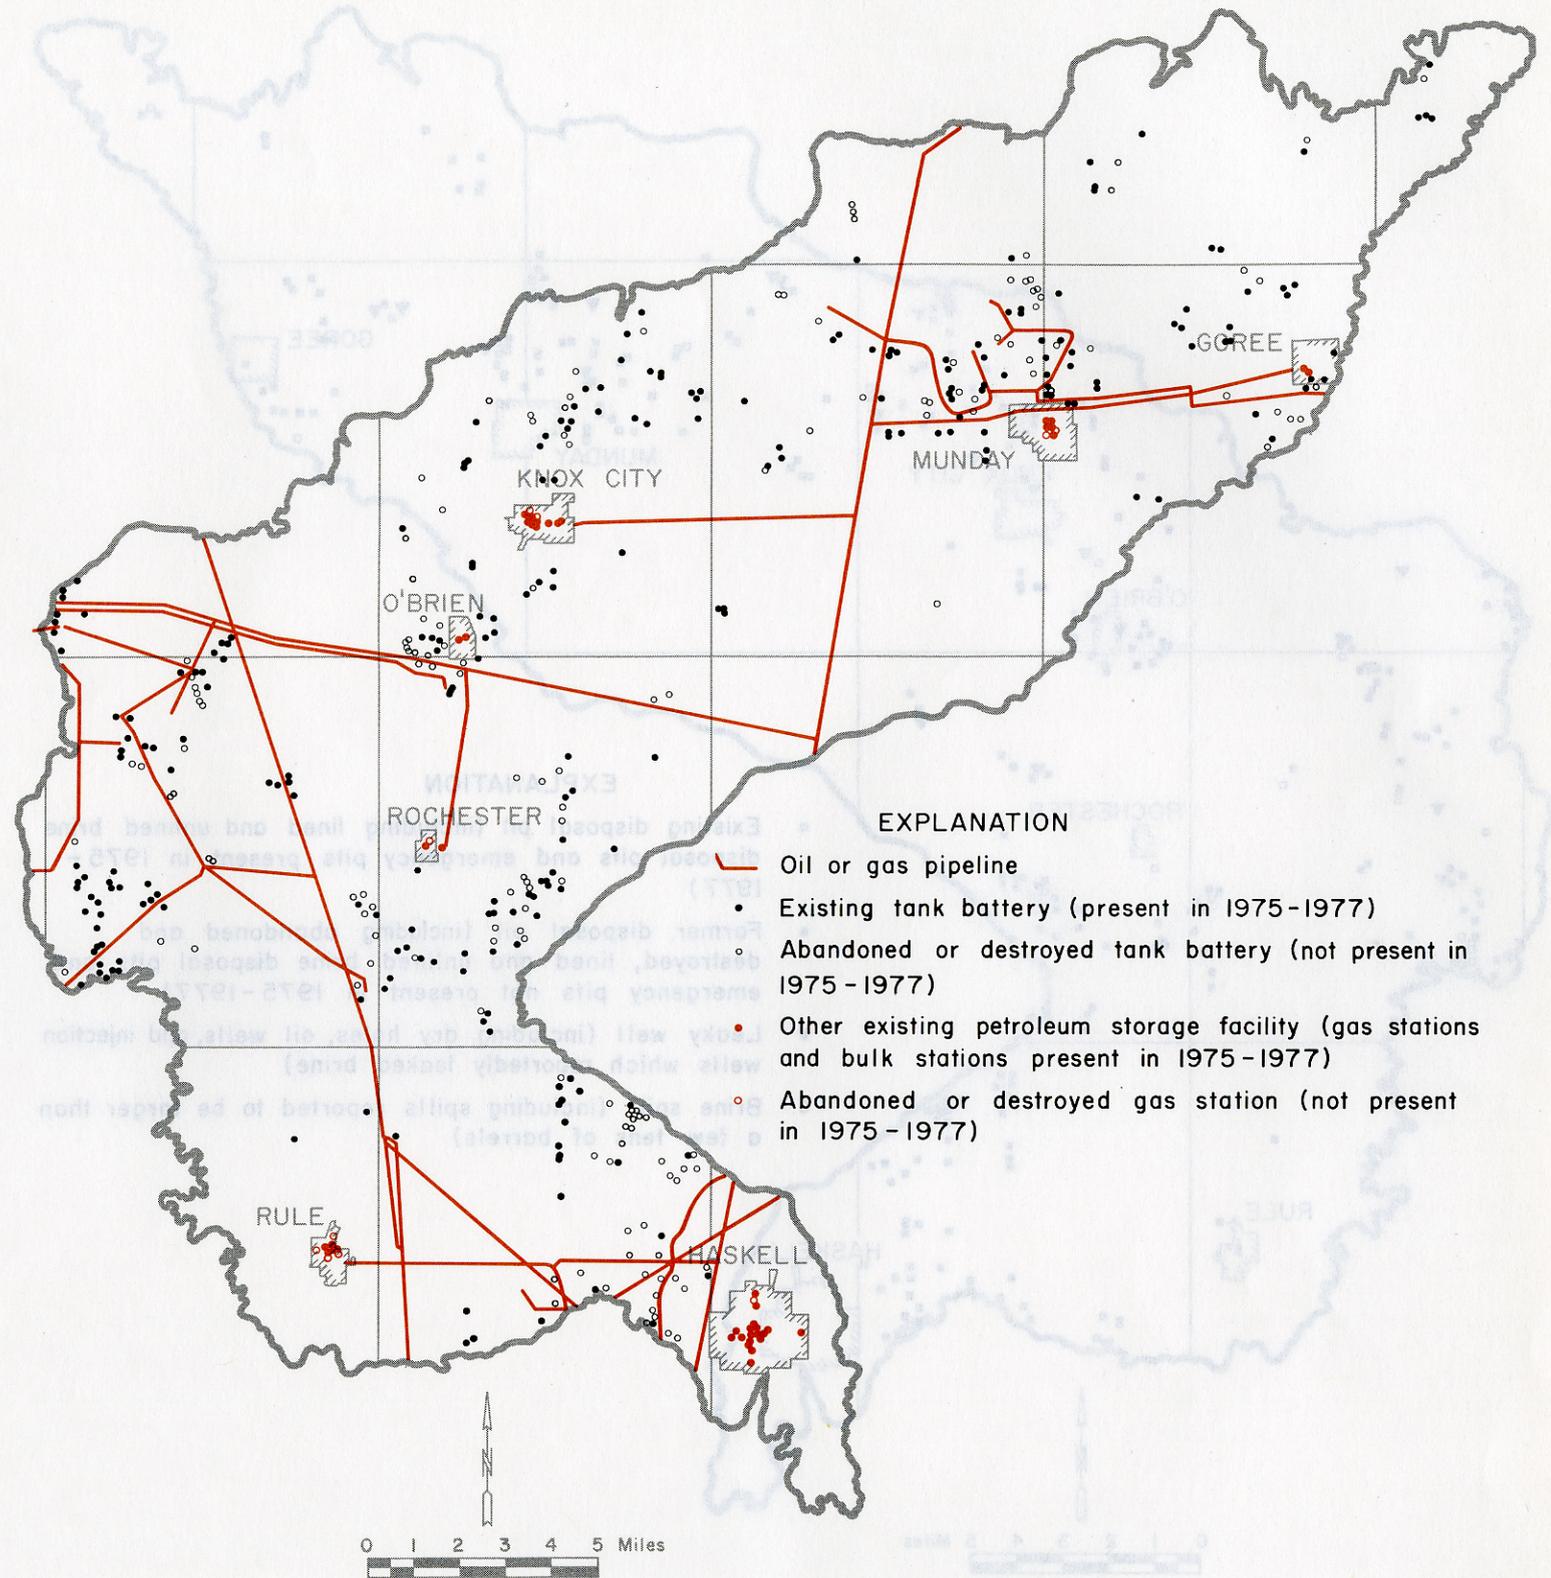
Figure 48. Locations of Pipelines, Tank Batteries, and Other Petroleum Facilities
