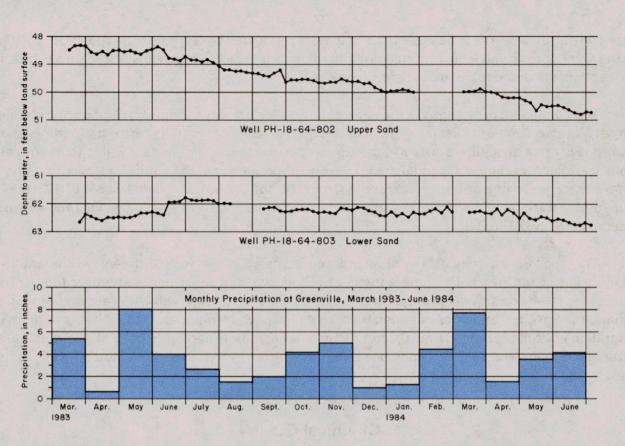
Figure 11.—Hydrographs of Water Levels in Wells Completed in Upper and Lower Nacatoch Sand Units and Monthly Precipitation at Greenville, Texas, March 1983-June 1984

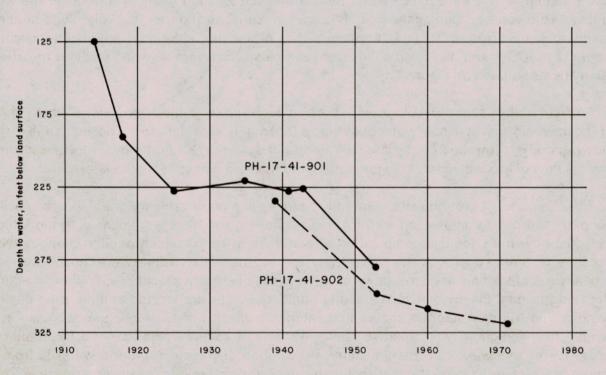
Figure 12.—Hydrographs of Two Public Supply Wells in Commerce, Texas
