El Paso County Stormwater Master Plan

August 2010

URS Corporation
Austin, TX, Albuquerque, NM

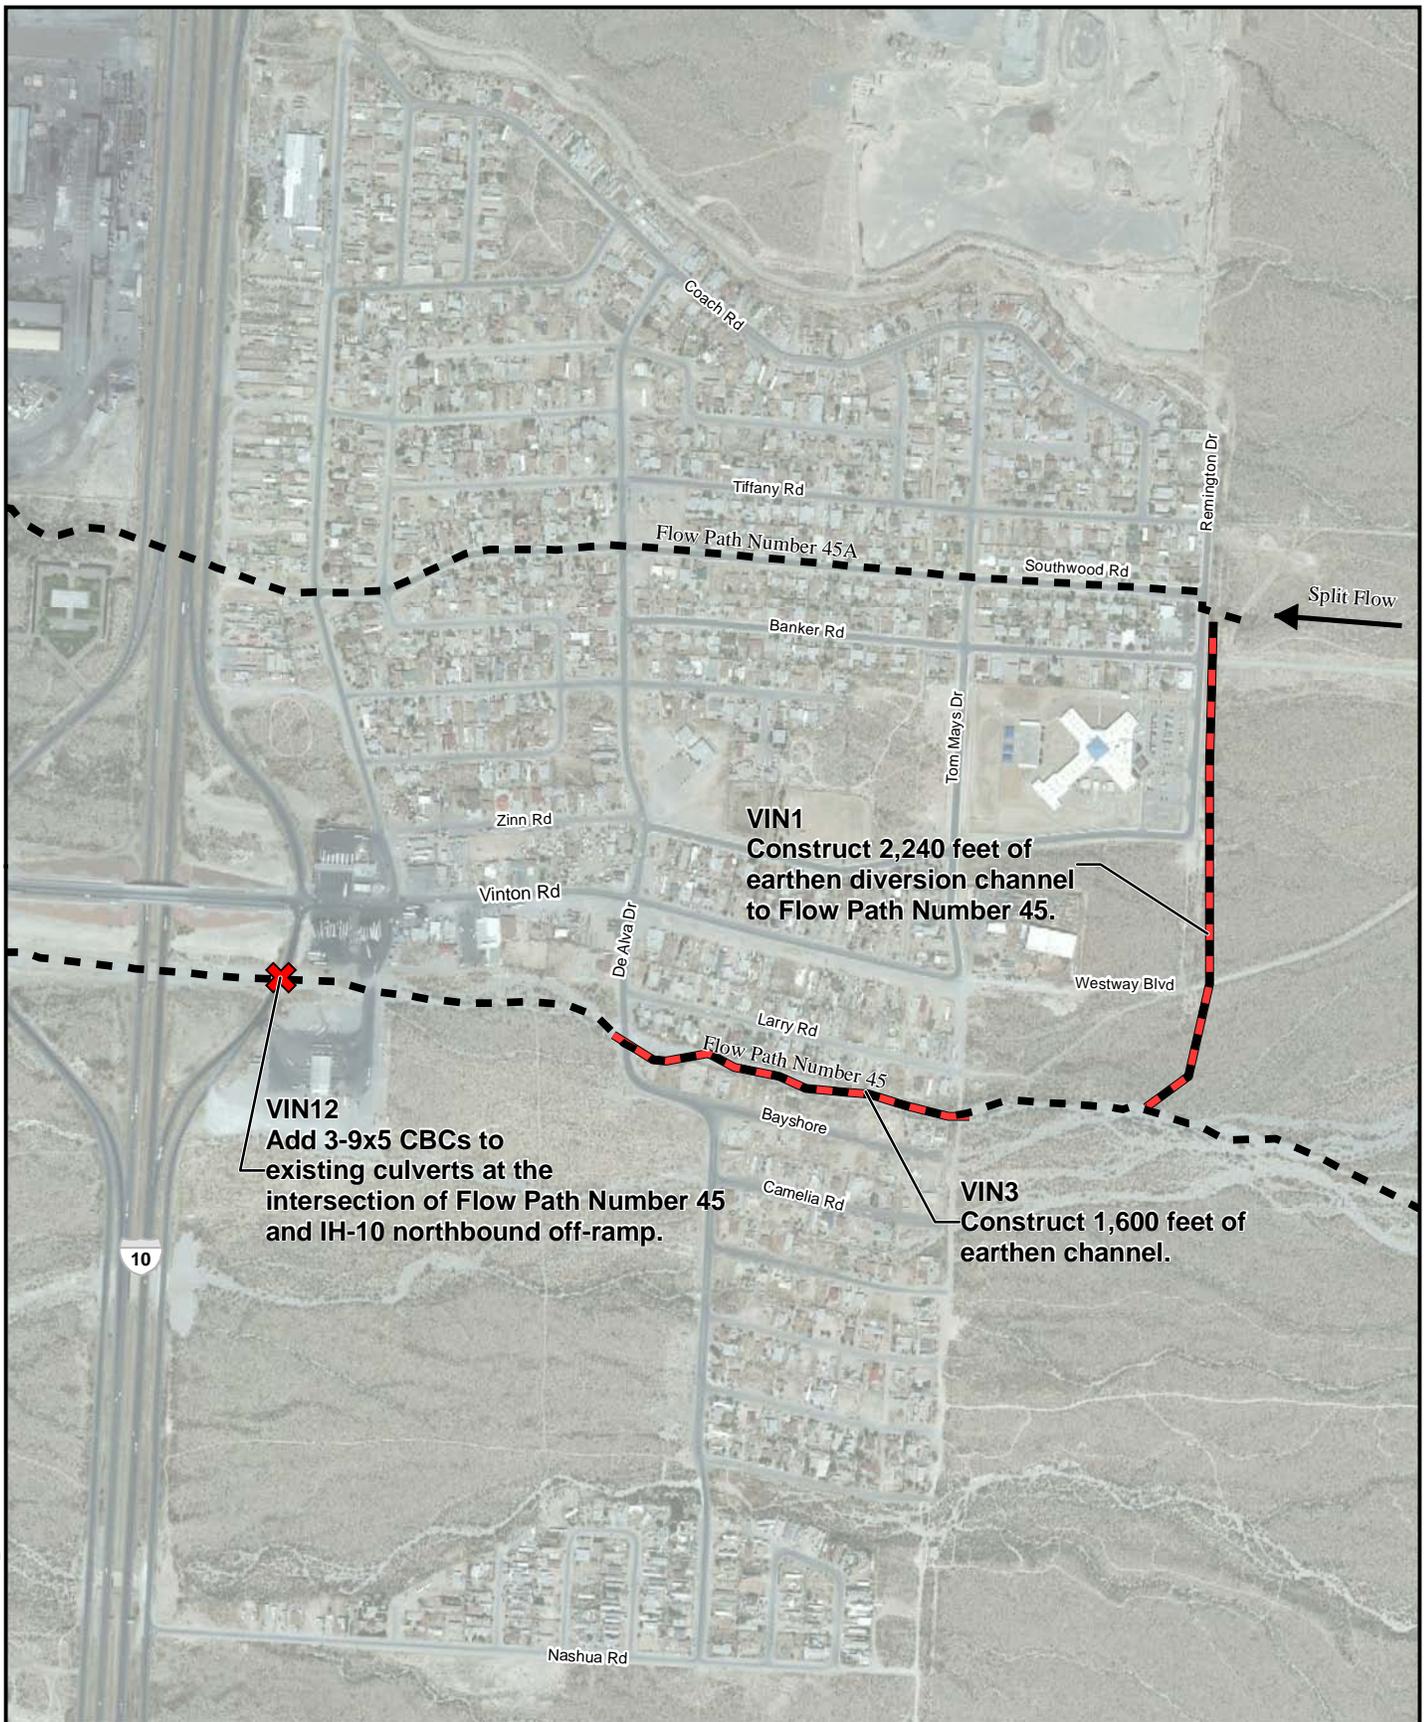
Figure 6-1

VIN1
Construct 2,240 feet of earthen diversion channel to Flow Path Number 45.

VIN12
Add 3-9x5 CBCs to existing culverts at the intersection of Flow Path Number 45 and IH-10 northbound off-ramp.

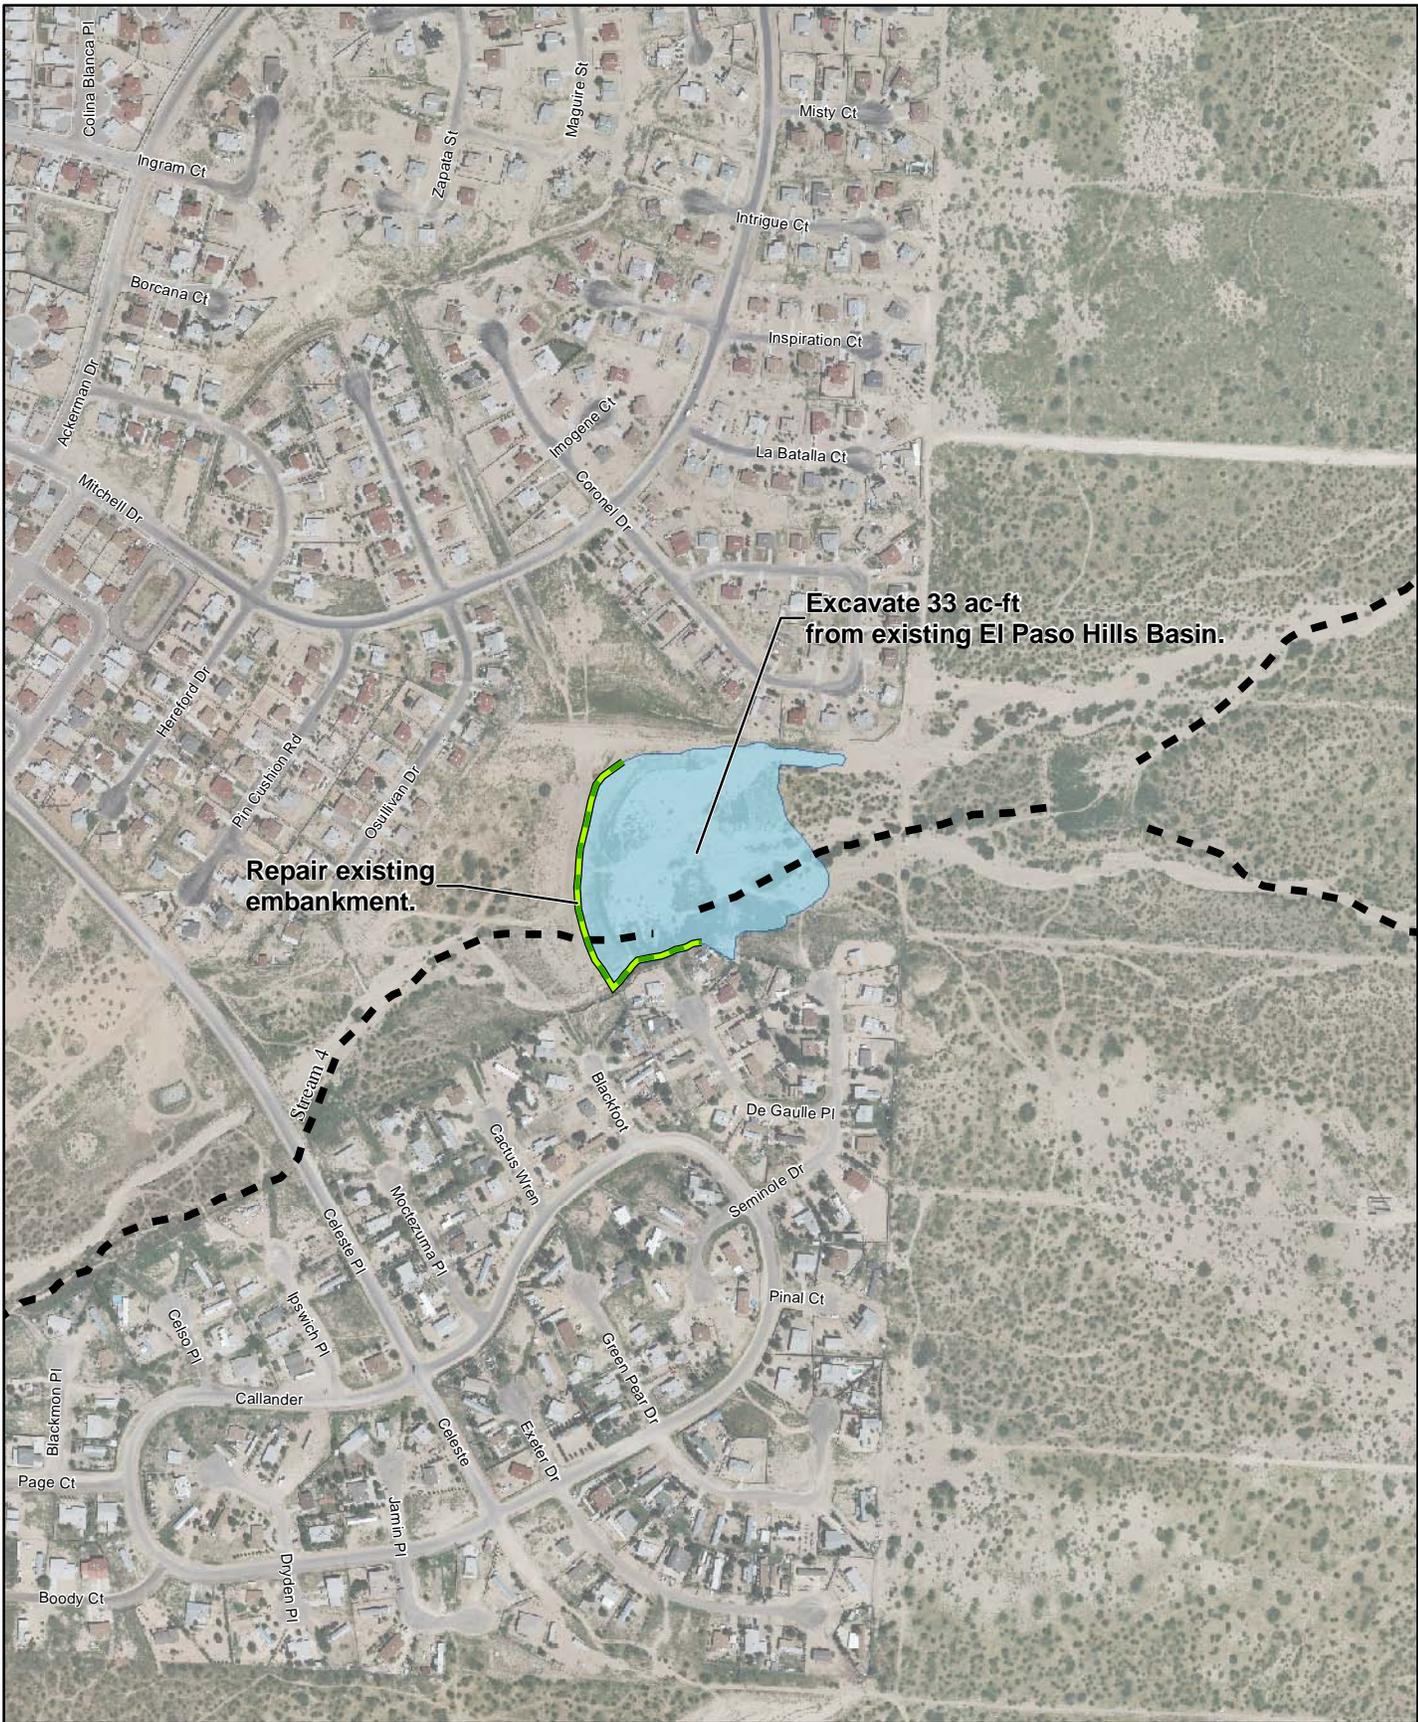
Excavate 33 ac-ft from existing El Paso Hills Basin.

Repair existing embankment.

The basin in El Paso Hills currently has a failed embankment and is not functioning properly. According to El Paso County staff, a portion of the embankment failed in a 2004 storm event. Per a 2009 site visit, this failure has not been repaired. The basin had been providing some benefit prior to its failure by controlling flows in Stream 4, but is providing minimal benefit in its current state.

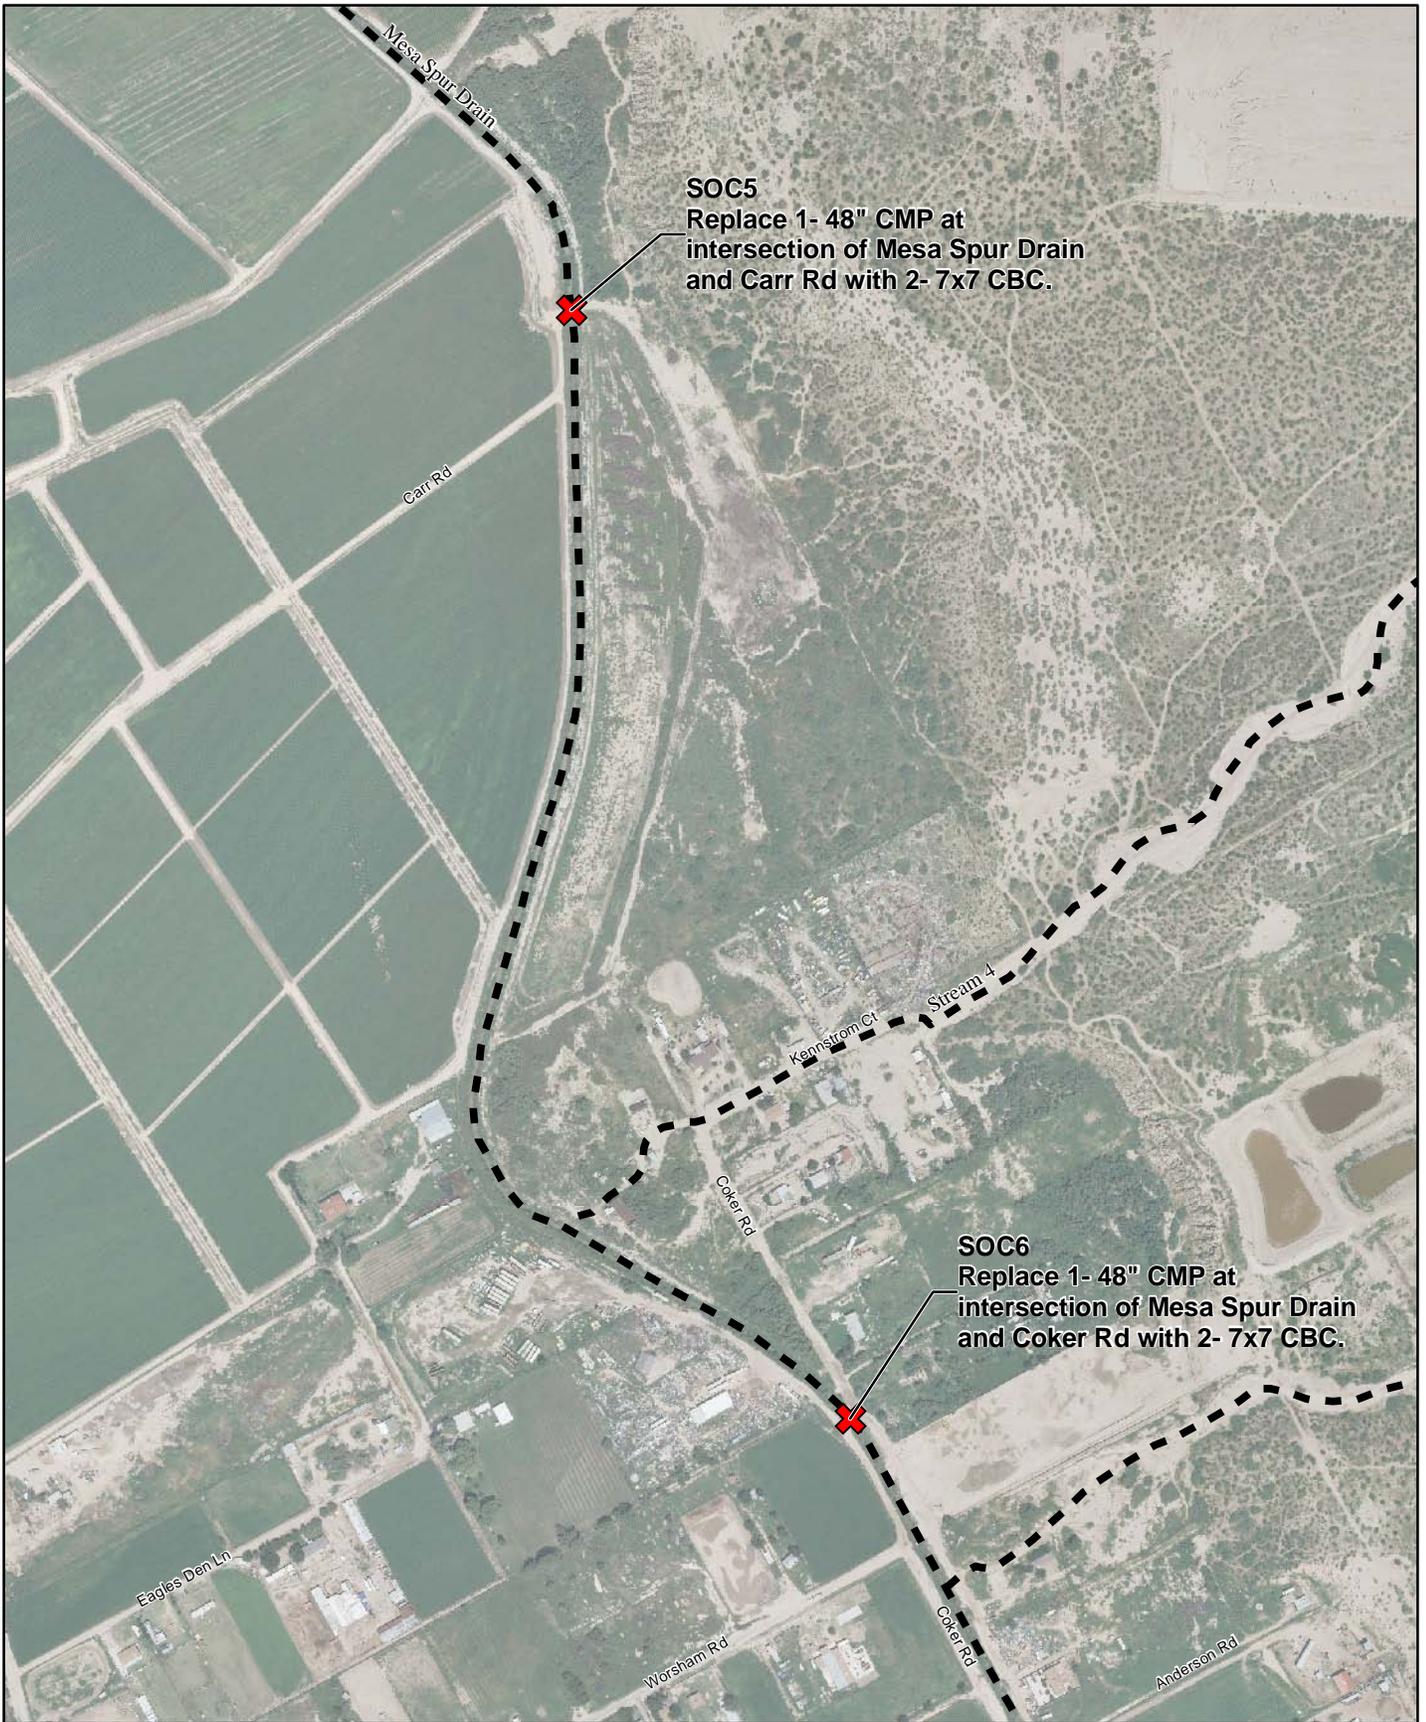
Figure 6-15

SOC5
 Replace 1- 48" CMP at
 intersection of Mesa Spur Drain
 and Carr Rd with 2- 7x7 CBC.

SOC6
 Replace 1- 48" CMP at
 intersection of Mesa Spur Drain
 and Coker Rd with 2- 7x7 CBC.

Although the crossing (one 48-inch CMP) at the intersection of the Mesa Spur Drain and Carr Road was not reported to have capacity problems, based on inspection and hydraulic analysis, the culvert does not have capacity greater than or equal to that of the channel. If the Mesa Spur Drain was flowing bank-fill, this crossing would restrict the capacity of the channel and potentially cause flooding of the agricultural lands adjacent to the channel.

Although the crossing (one 48-inch CMP) at the intersection of the Mesa Spur Drain and Coker Road was not reported to have capacity problems, based on inspection and hydraulic analysis, the culvert does not have capacity greater than or equal to that of the channel. If the Mesa Spur Drain was flowing bank-fill, this crossing would restrict the capacity of the channel and potentially cause flooding of the residential and agricultural lands adjacent to the channel.

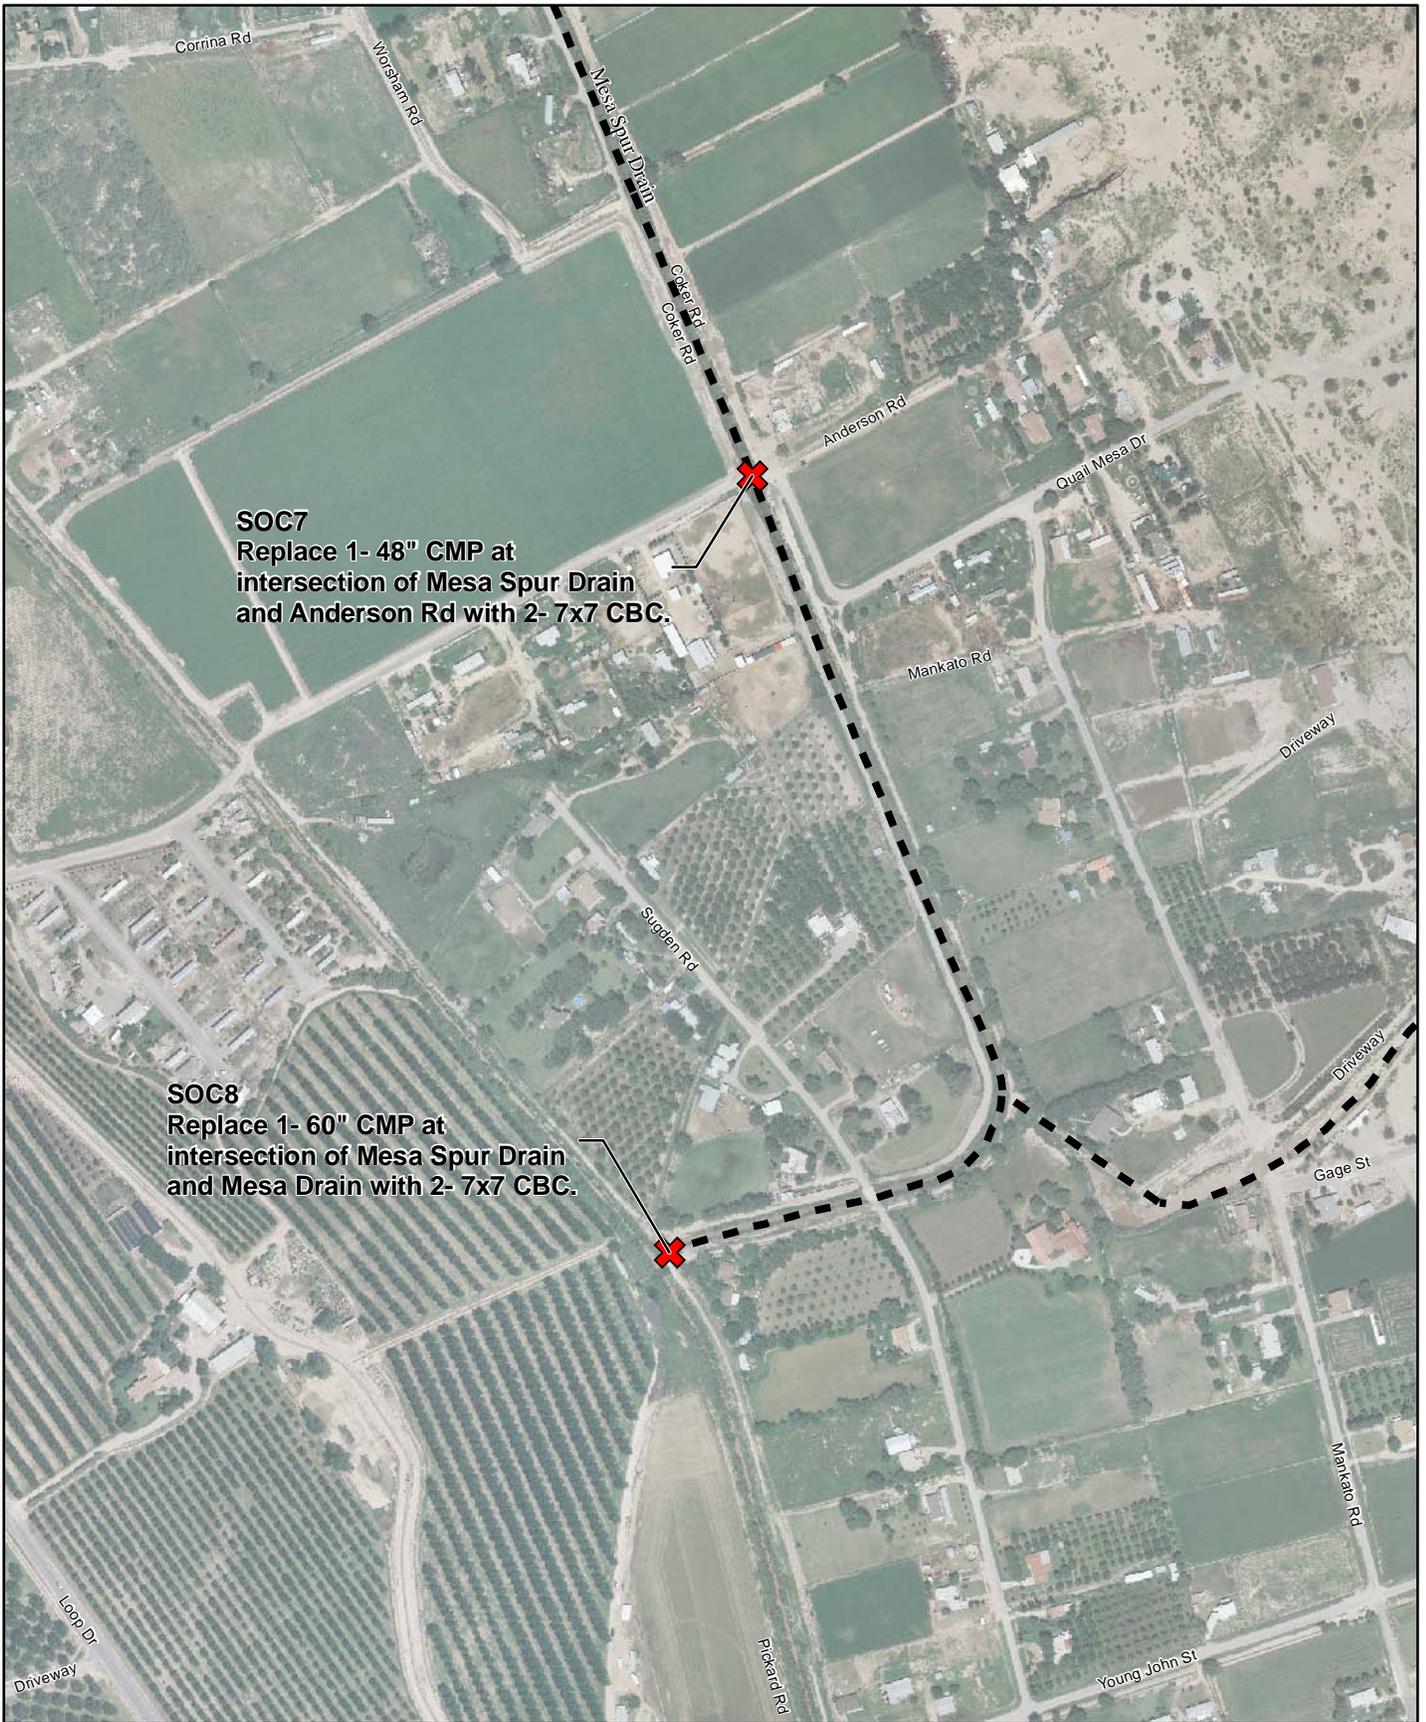
SOC7
 Replace 1- 48" CMP at
 intersection of Mesa Spur Drain
 and Anderson Rd with 2- 7x7 CBC.

SOC8
 Replace 1- 60" CMP at
 intersection of Mesa Spur Drain
 and Mesa Drain with 2- 7x7 CBC.

Although the crossing (one 48-inch CMP) at the intersection of the Mesa Spur Drain and Anderson Road was not reported to have capacity problems, based on inspection and hydraulic analysis, the culvert does not have capacity greater than or equal to that of the channel. If the Mesa Spur Drain was flowing bank-fill, this crossing would restrict the capacity of the channel and potentially cause flooding of the residential and agricultural lands adjacent to the channel.

Although the crossing (one 60-inch CMP) at the intersection of the Mesa Spur Drain and Mesa Drain was not reported to have capacity problems, based on inspection and hydraulic analysis it appears that the culvert does not have capacity greater than or equal to that of the channel. If the Mesa Spur Drain was flowing bank-fill, this crossing would restrict the capacity of the channel and potentially cause flooding of the residential and agricultural lands adjacent to the channel.
