**DECLINE OF SUBMERGED VEGETATION IN THE GALVESTON BAY SYSTEM:  
CHRONOLOGY AND RELATIONSHIPS TO PHYSICAL PROCESSES**

**Warren M. Pulich and William A. White**

**Prepared as part of a Cooperative Agreement  
between the  
Texas Parks and Wildlife Department  
and  
Bureau of Economic Geology**

**Bureau of Economic Geology  
W. L. Fisher, Director  
The University of Texas at Austin  
Austin, Texas 78713**

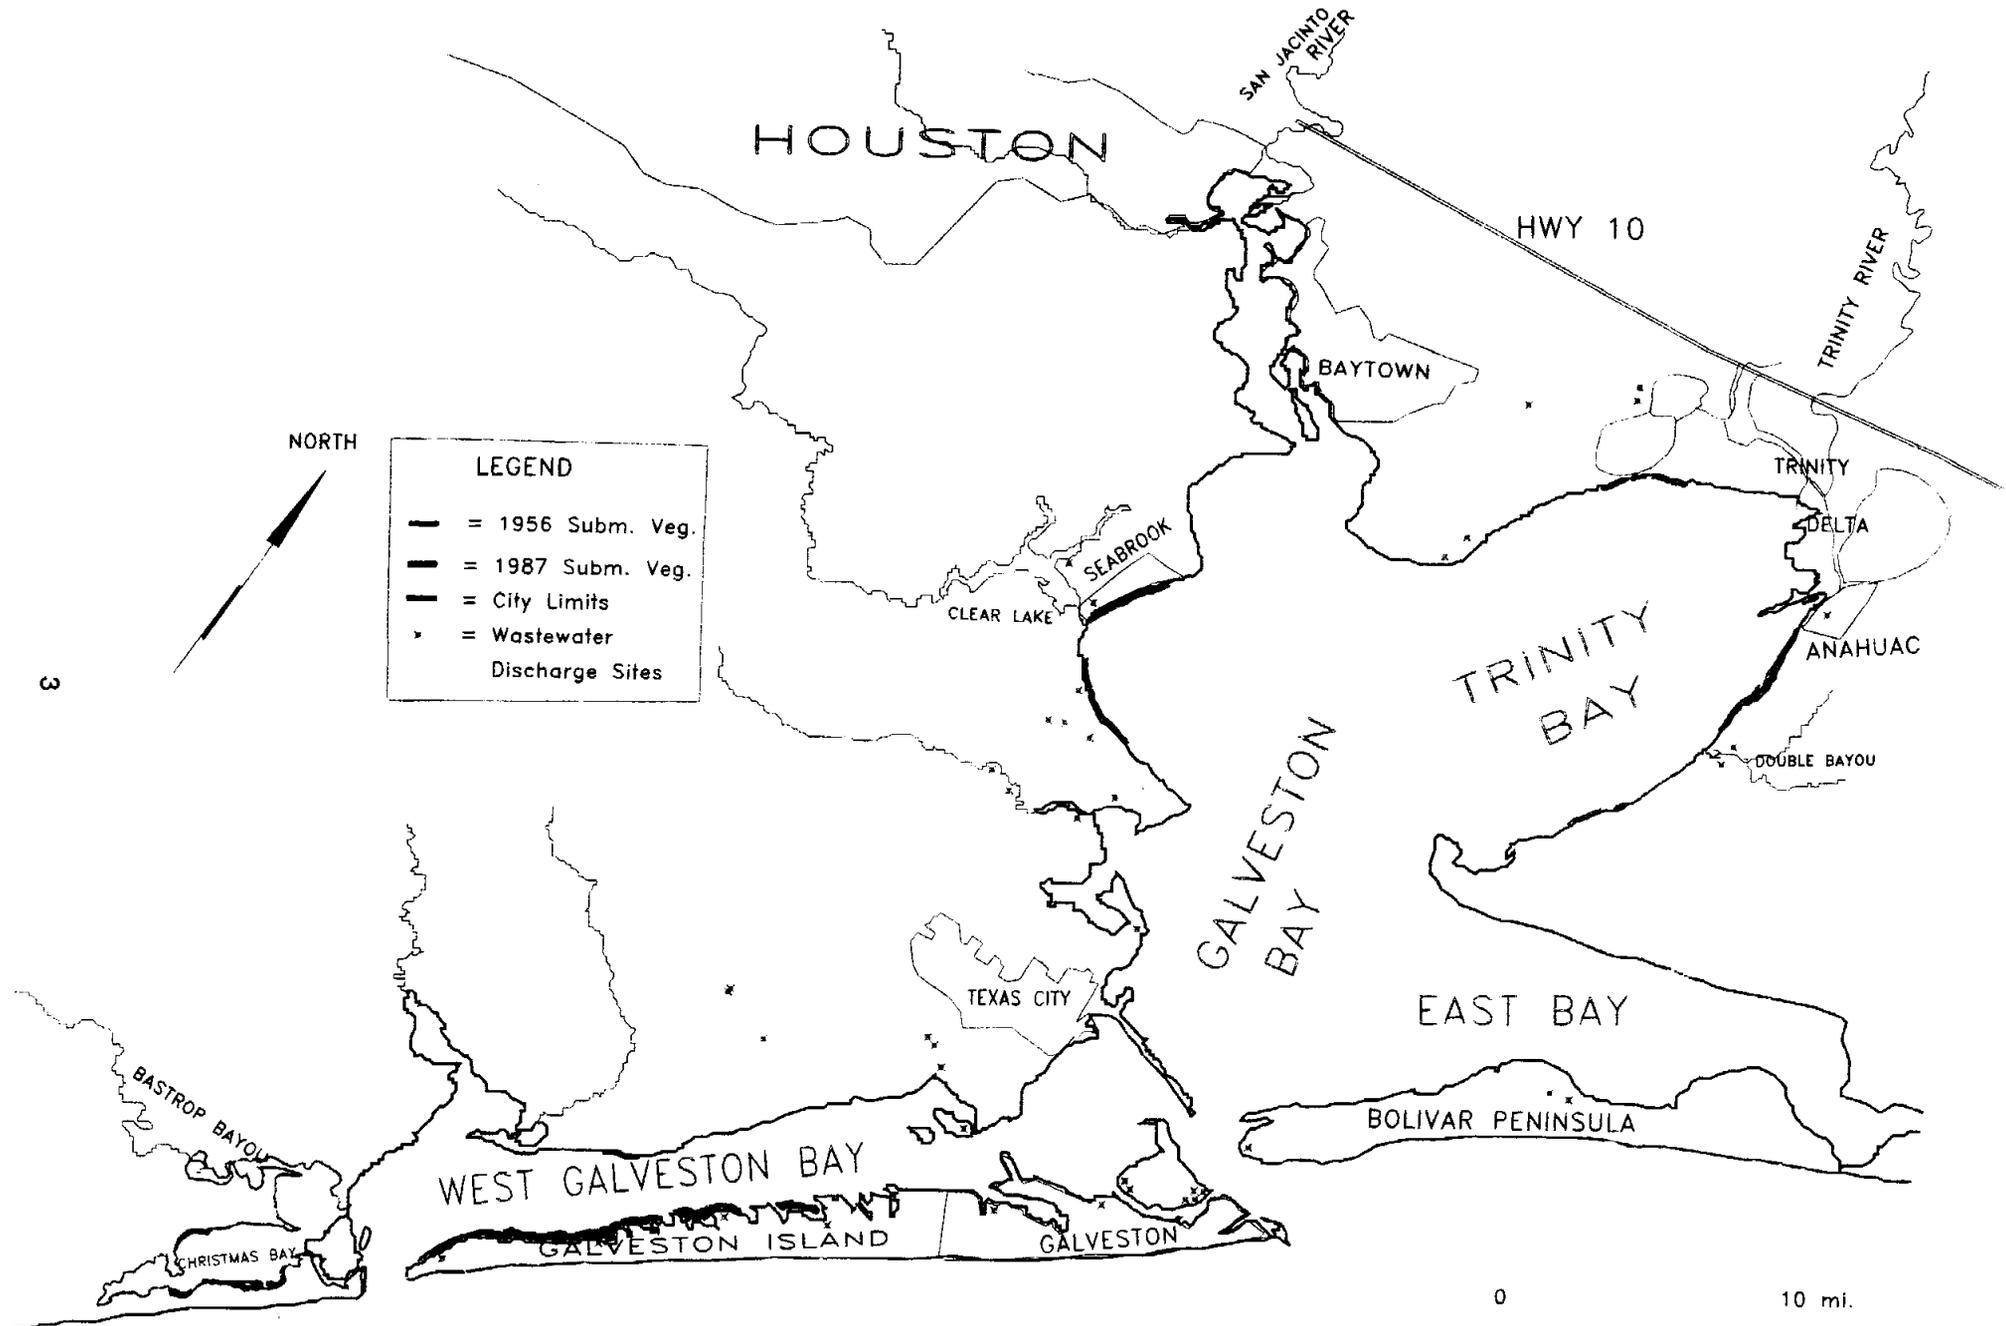
Figure 1. Map of the Galveston Bay system comparing 1956 and 1987 locations of submerged vegetation. Wastewater discharge sites compiled from 1988 records in Texas Water Commission permits section.

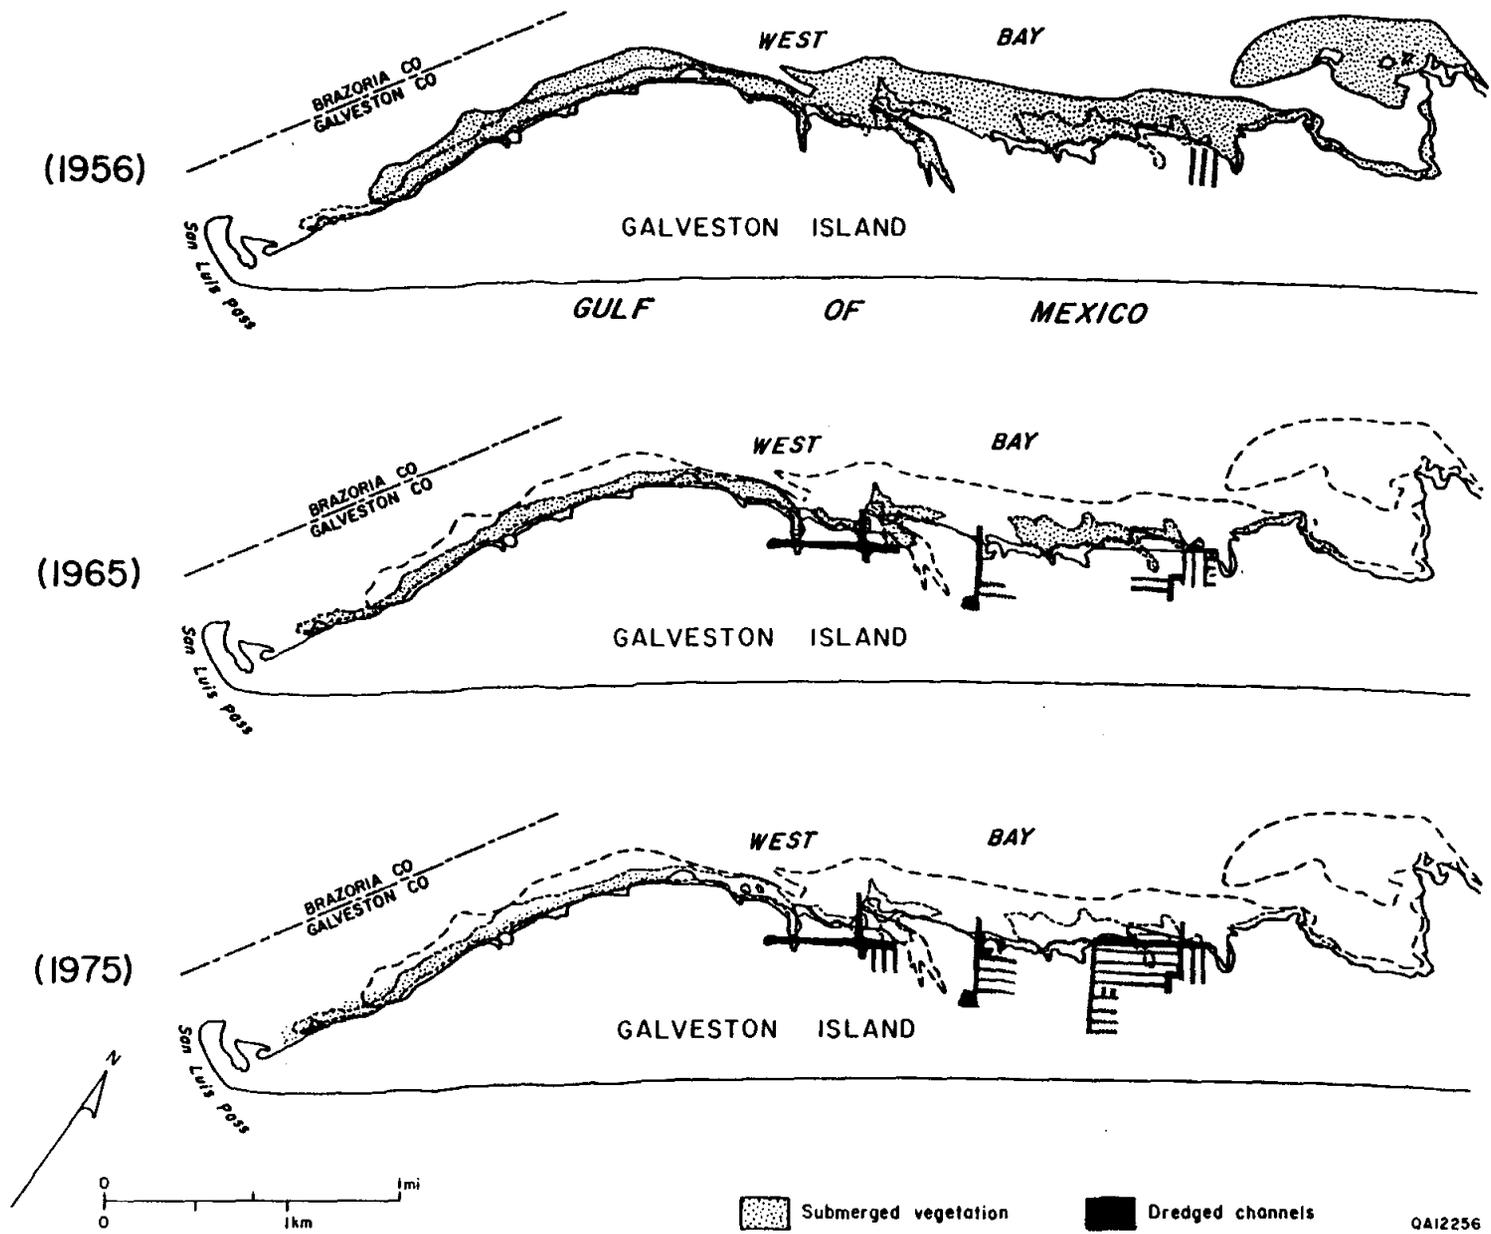
Figure 2. Historical changes in the distribution of seagrass and dredged channels along the western half of Galveston Island, West Bay.

Analysis of aerial photographs from 1956, 1965, 1975, and 1987 substantiates the progression of seagrass loss for Lower West Bay (Fig. 2). Reports by West (1973), Gilmore and Trent (1974) and area scientists (Sammy Ray, Texas A&M University at Galveston; Kirk Strawn, Texas A&M University; Roger Zimmerman, National Marine Fisheries Service, Galveston; personnel

communication) further corroborate the occurrence and decline of Halodule from the West Bay area. After a dramatic decrease in seagrasses from approximately 1,100 to 300 acres between 1956 and 1965, the remainder of the reduction appears to have occurred gradually (Fig. 2).

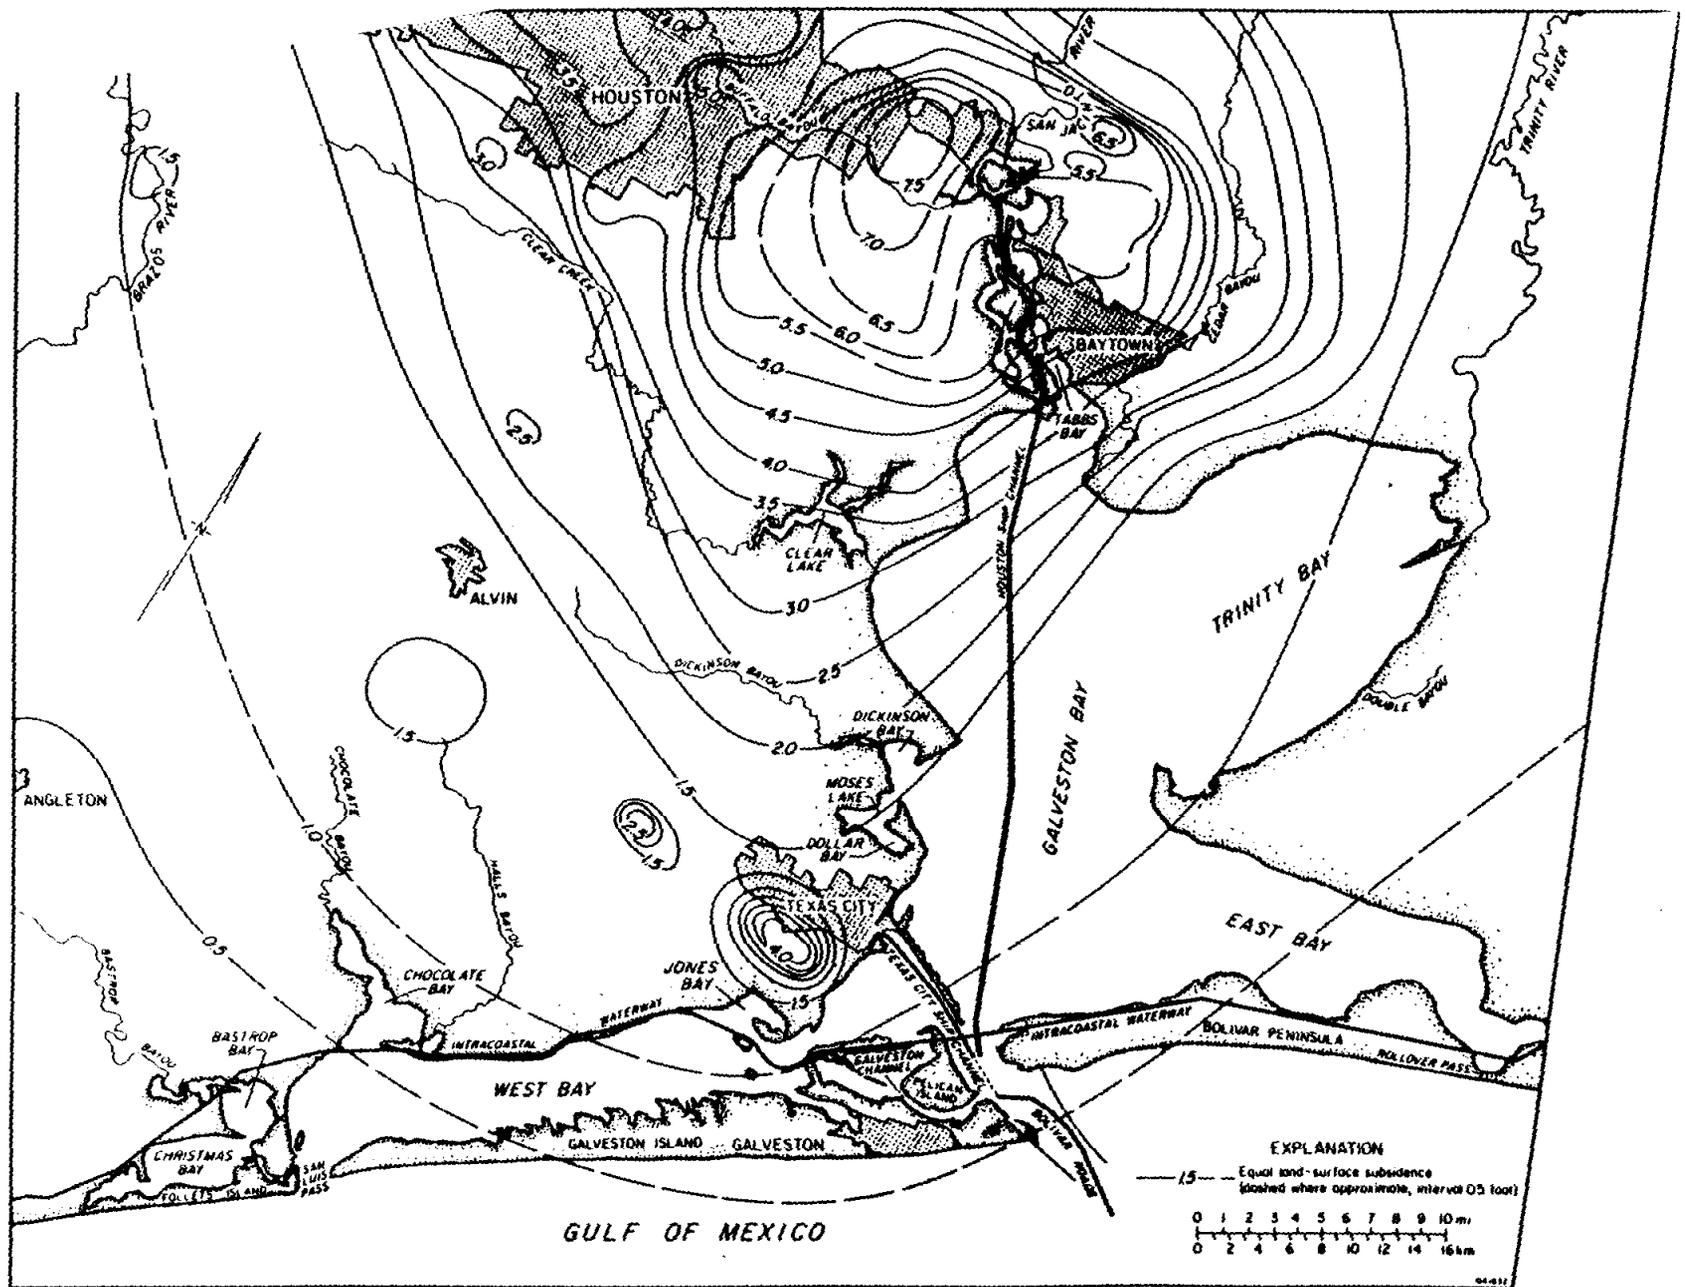
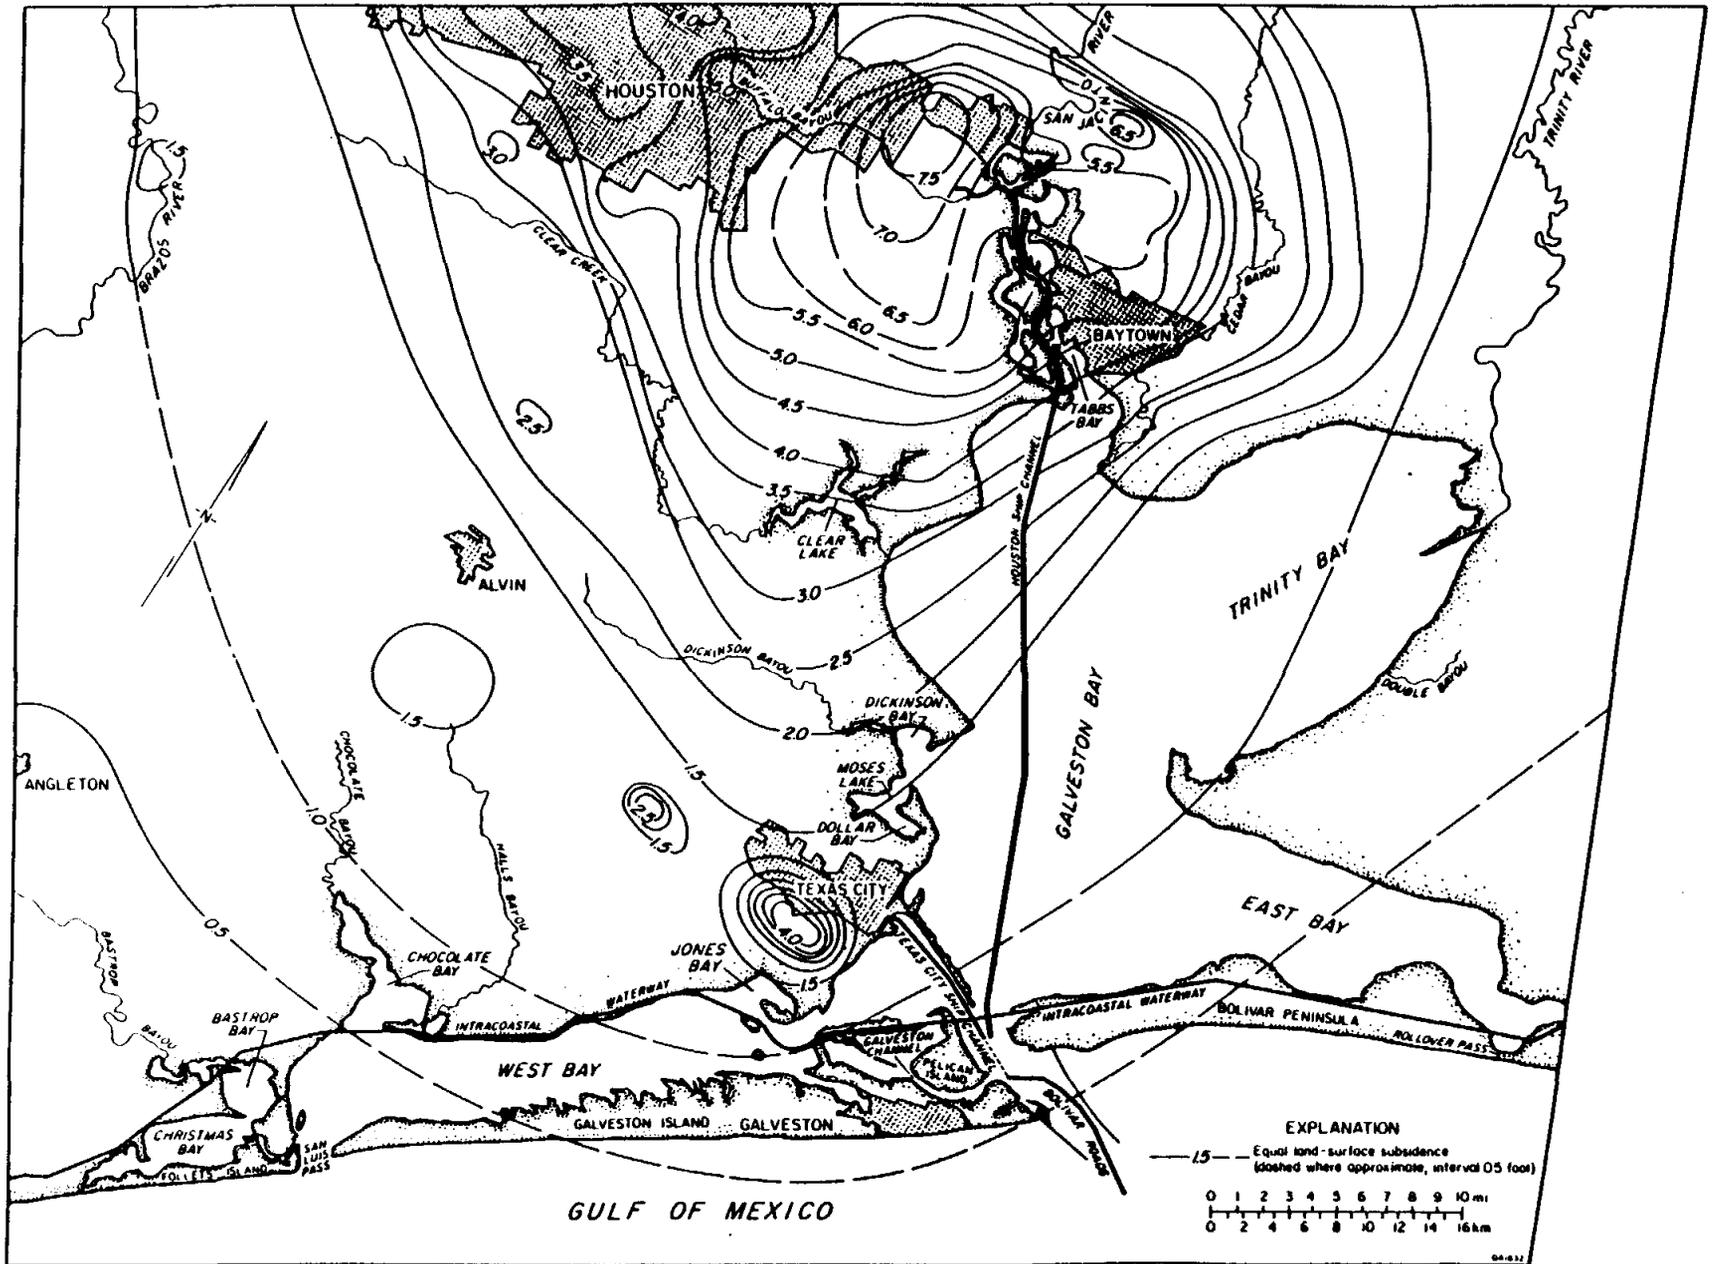
Figure 3. Land-surface subsidence in the Houston-Galveston area, 1943-1973. (From Gabrysch and Bonnet, 1975.)

The SV area affected most by subsidence is on the west side of Galveston Bay near Seabrook (Fig. 3). Historical trends in subsidence in the Seabrook area indicate that rates increased after 1943 and reached a maximum of about 6 cm/yr for the period 1964-1973 (Fig. 4). Subsidence in the Seabrook area between 1943 and 1973 was approximately 0.9 m, and from 1943 to 1978 it exceeded 1.2 m (Gabrysch, 1984). Water depths near shore possibly increased by as much as 30 to 60 cm between 1968 and 1977 (Morton and McGowen, 1980). The amount of subsidence in other SV areas is considerably lower than in the Seabrook area, ranging from less than 0.5 m in upper Trinity Bay to less than 0.4 m in West Bay and 0.2 m in Christmas Bay for the period 1943 to 1973 (Fig. 3). In the eastern part of Trinity Bay and in the southwest part of West Bay, subsidence during the period 1943 to 1978 was less than 0.3 m (Gabrysch, 1984).

The significance of sea-level rise in the 1960's and 1970's due to subsidence was examined by reviewing Figure 3. For the most part, high subsidence rates occurred only along the mainland side of Upper West Bay. However, the north end of Galveston Island showed a moderate decrease in elevation since 1943 (Fig. 3). It appears that subsidence was not a significant factor in the loss of sub-

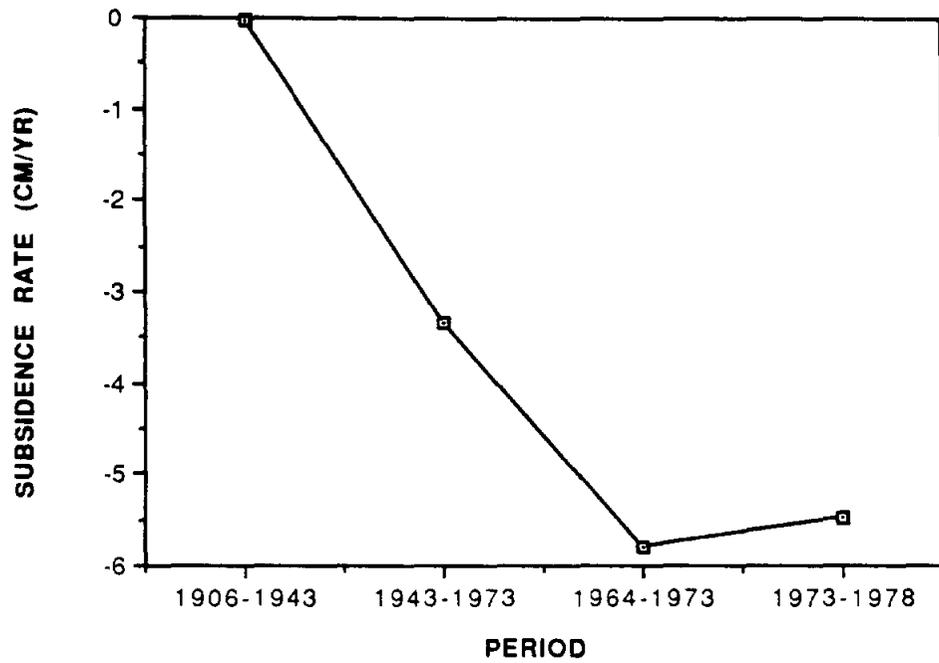
Figure 4. Subsidence rates along the Galveston Bay margin in the Seabrook area. (Based on data from Gabrysch and Bonnet, 1975, and Gabrysch 1984.)

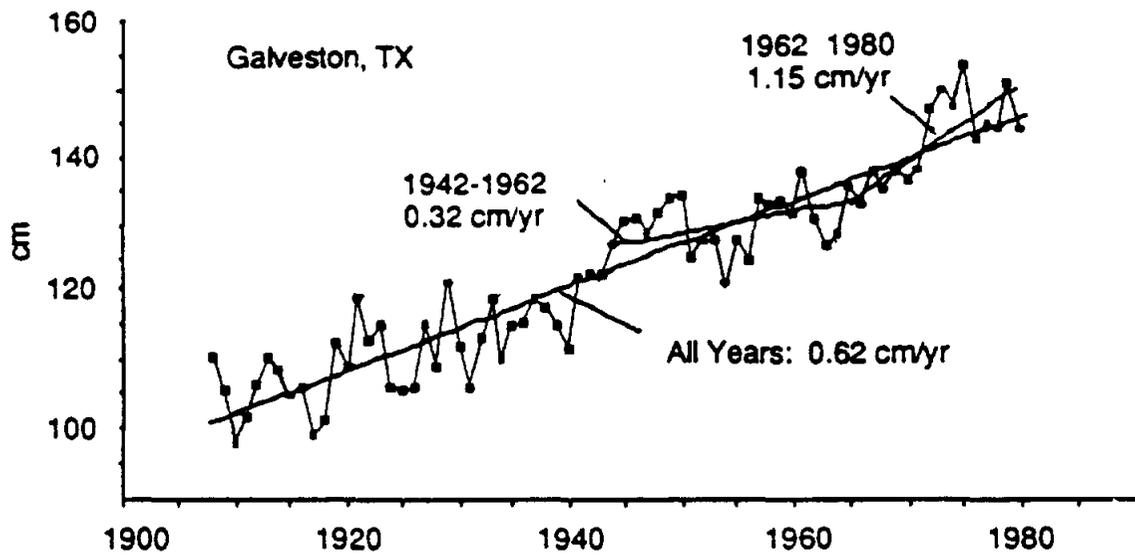
Figure 5. Annual changes in water level based on tide gauge records at Galveston (Pier 21), with variations in rates of rise indicated for different periods. (Modified from Turner, 1987.)

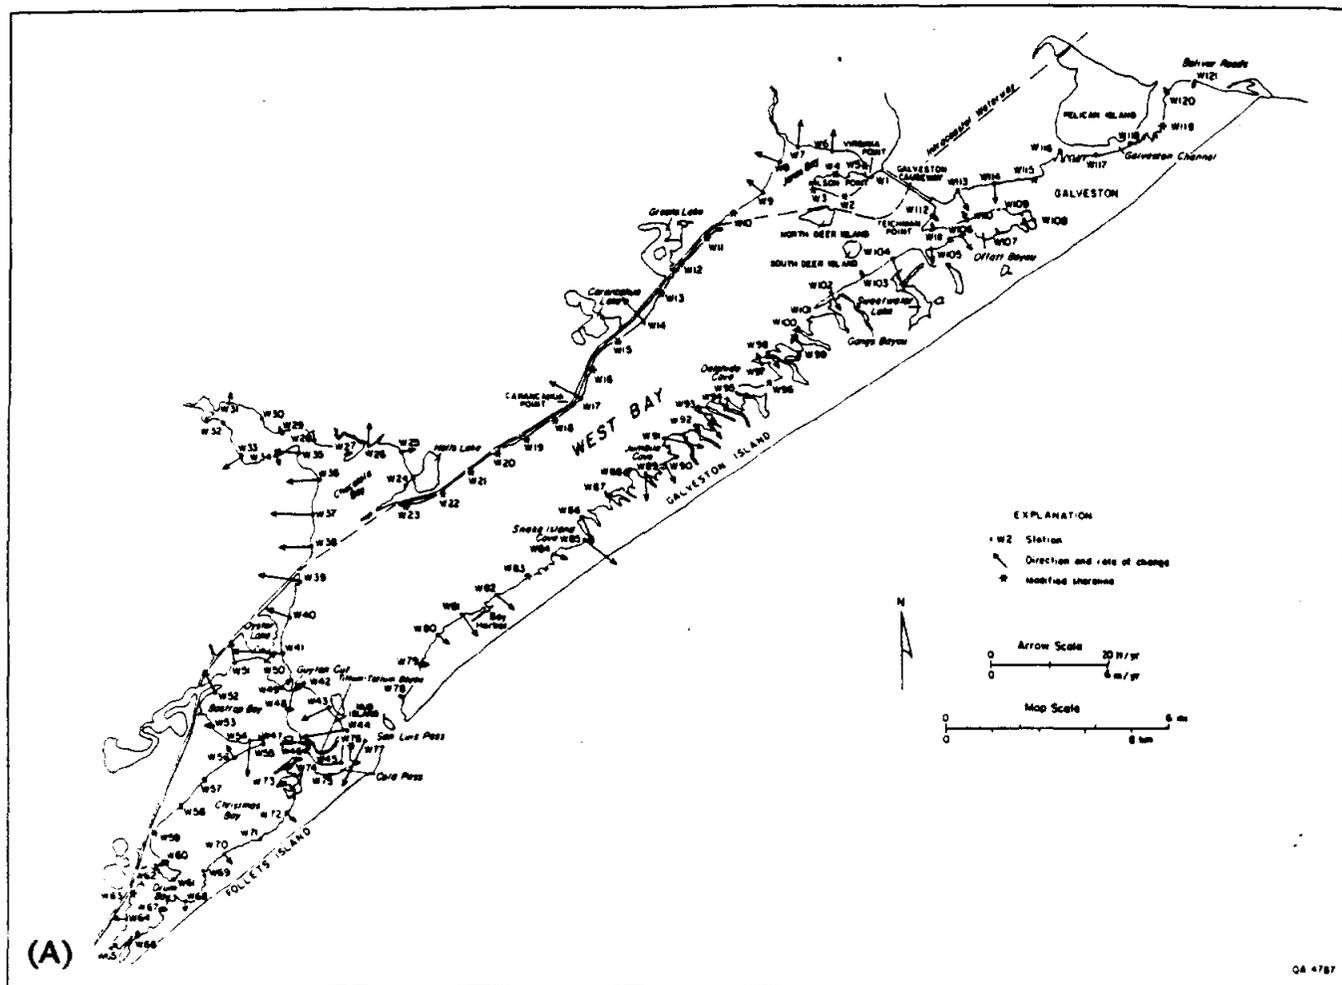
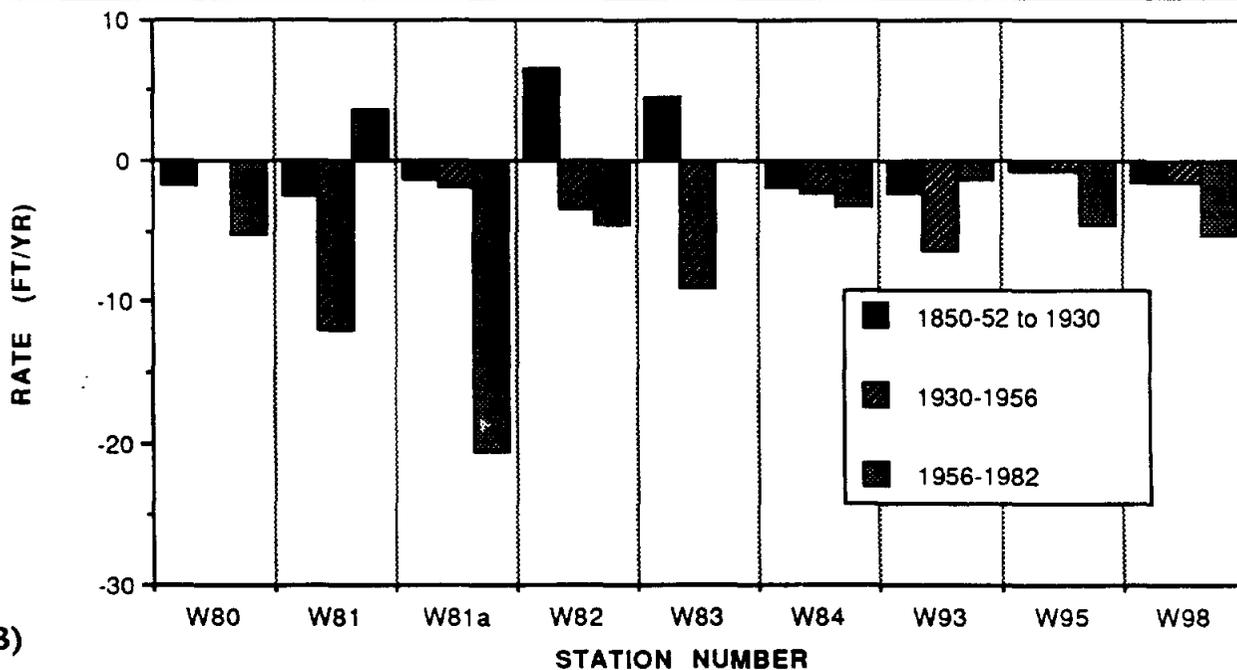
Figure 6. Bay shoreline changes along Galveston Island during specified periods. (A) Station location map and rates of shoreline change along West Bay, 1930 to 1982 (From Paine and Morton, 1986) and (B) rates of shoreline change for specified periods (From unpublished BEG data).

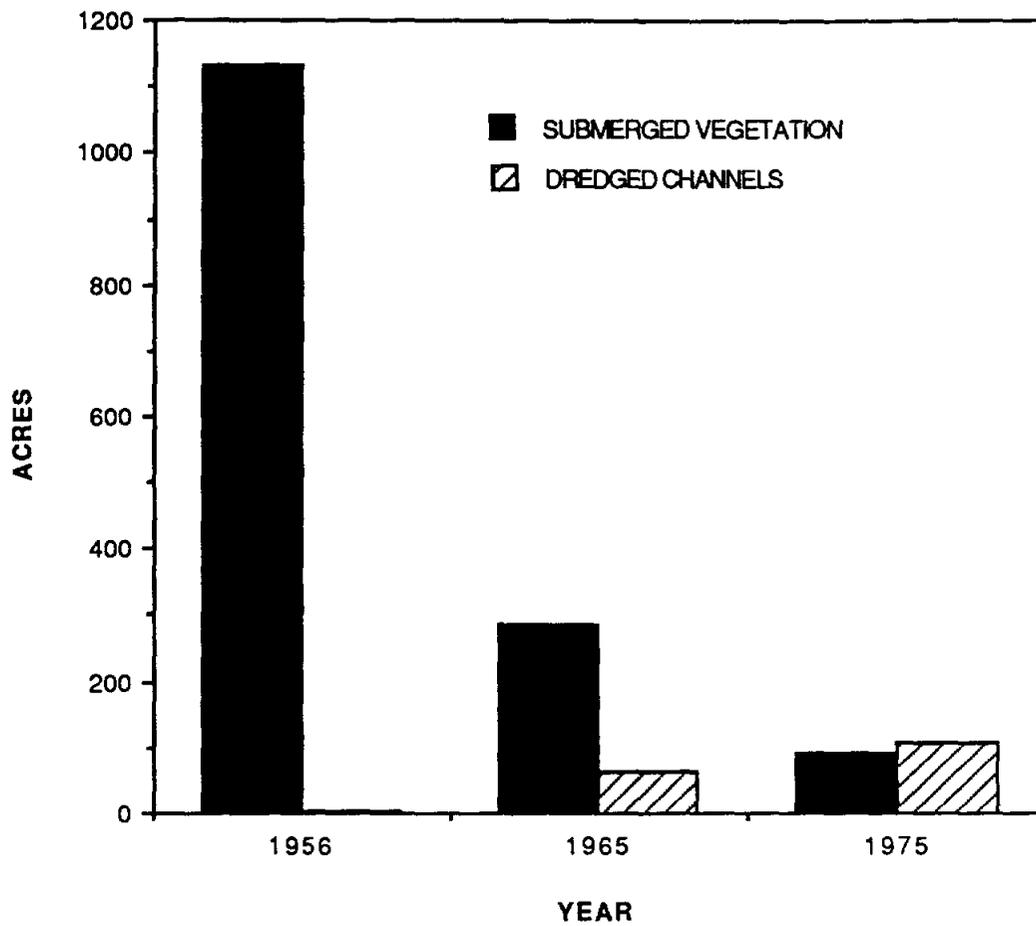
Figure 7. Changes in areas of submerged vegetation and dredged channels along the western half of Galveston Island, West Bay, 1956-1975.

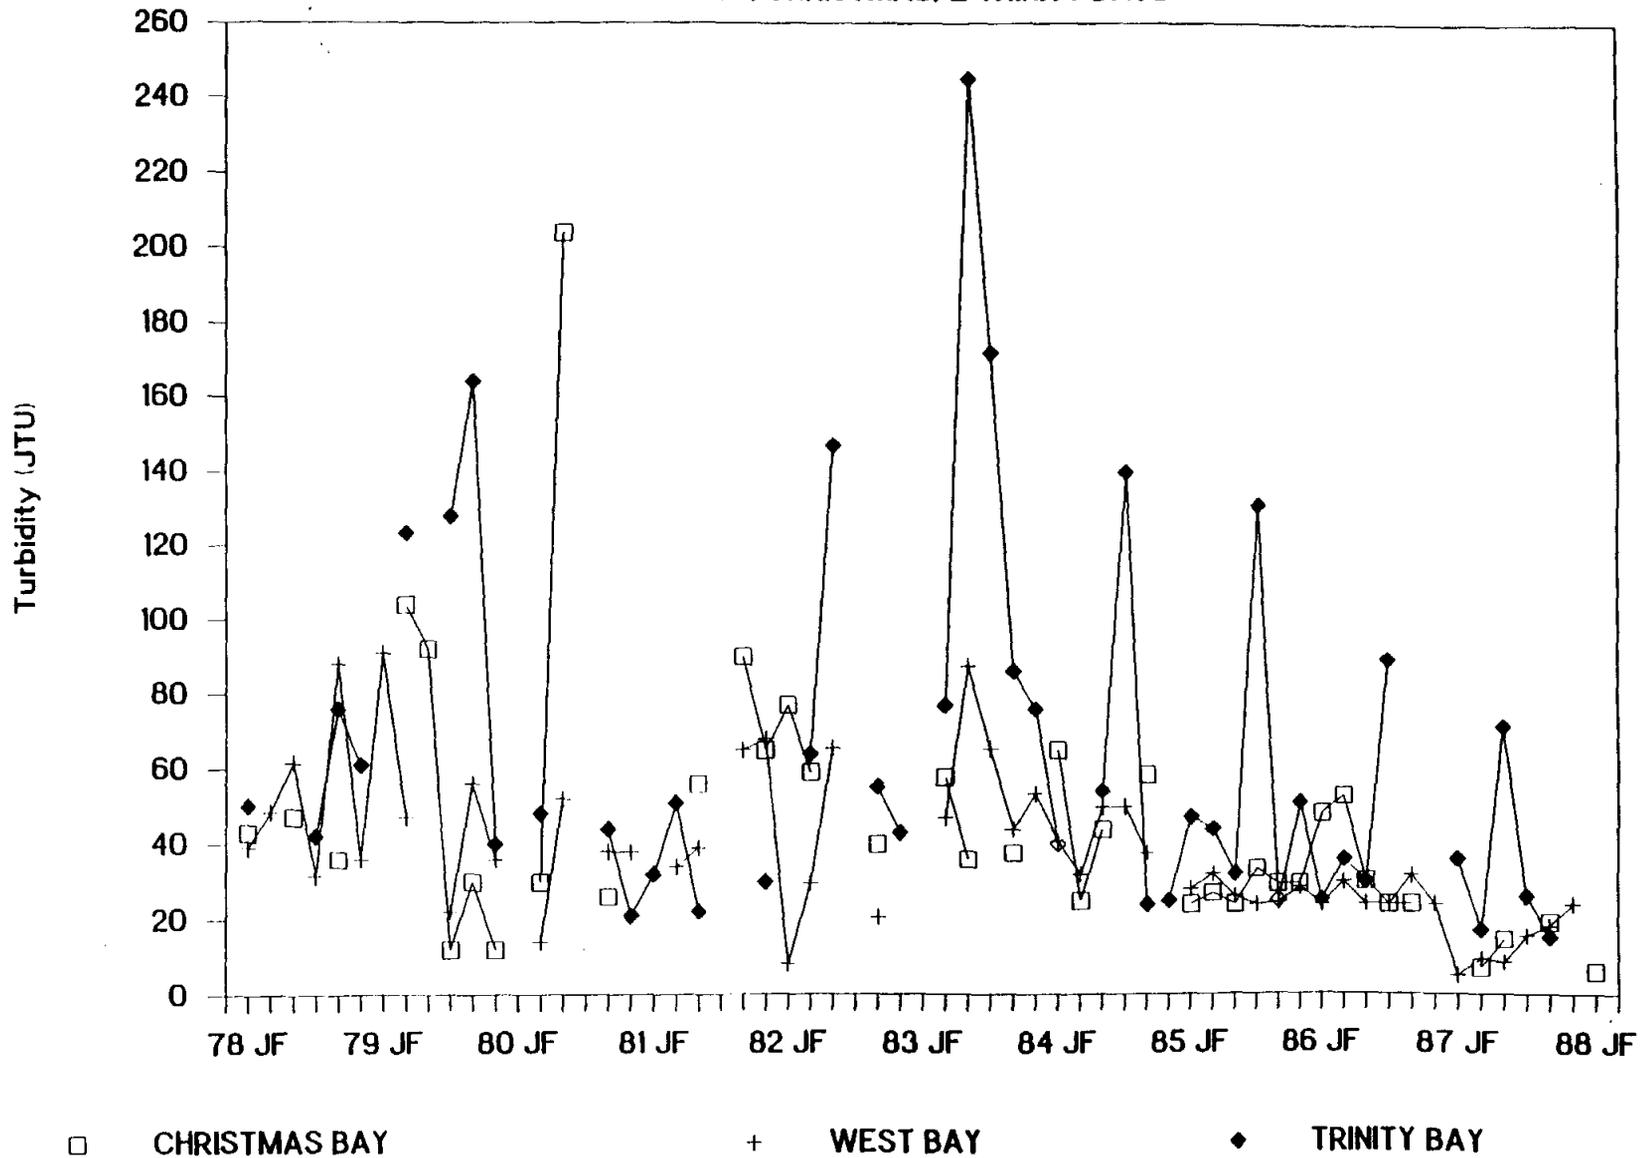
Figure 8. Mean turbidities in areas of submerged vegetation in Christmas, West, and Trinity Bays.

West Bay and Christmas Bay water were not appreciably different at this time. When bimonthly means were compared (Fig. 8), the two areas showed essentially similar turbidity regimes over this ten year period. The current SV sites on the east shore of Trinity Bay also serve as controls for the lower bay turbidity regimes. Although these areas experience higher turbidities than the lower bay areas, due to freshwater inflows from the Trinity River, Ruppia still grows well at this higher turbidity level.

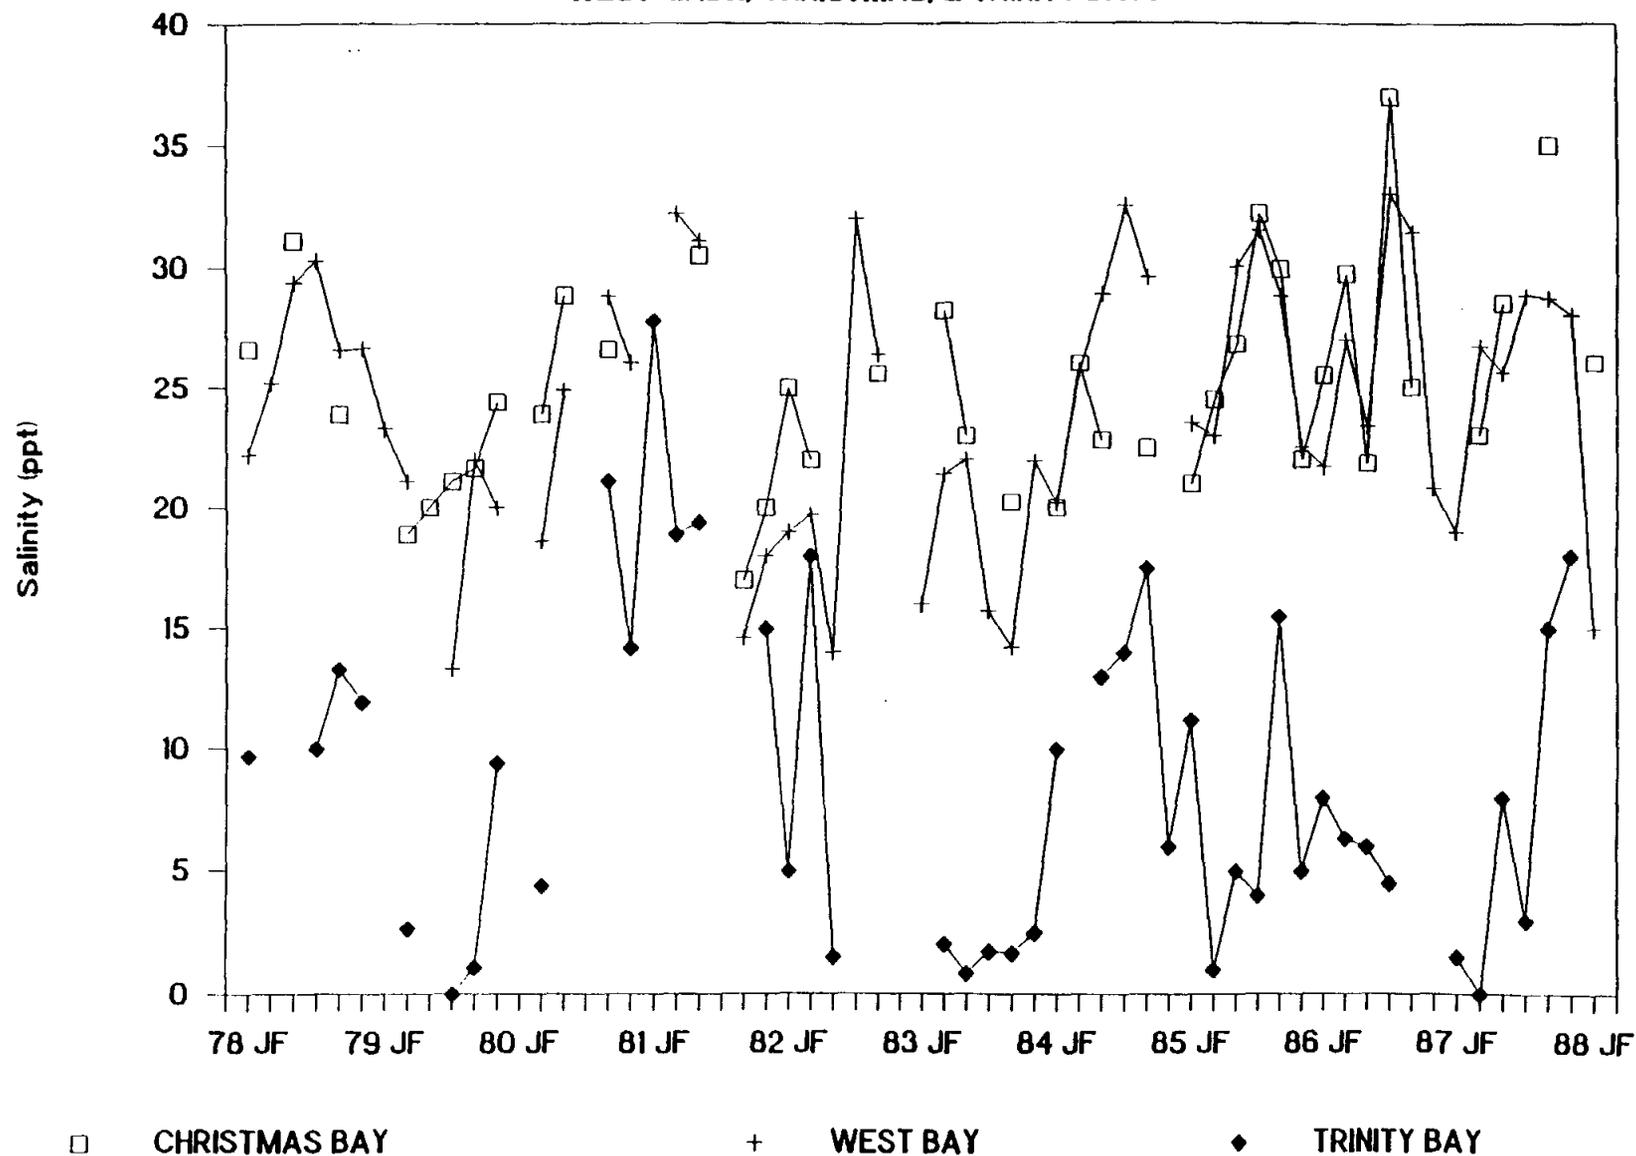
Figure 9. Mean salinities in areas of submerged vegetation in Christmas, West, and Trinity Bays.

Mean salinities in West, Christmas, and Trinity Bays are compared in Figure 9. There is no evidence to suggest that salinity regimes have contributed to a decline in SV areas. Salinities in Christmas Bay, where seagrasses are relatively abundant, are similar to salinities in West Bay where seagrasses have disappeared.
