SANDY CREEK/LAKE TRAVIS NPS WATER QUALITY STUDY

FINAL REPORT

LOWER COLORADO RIVER AUTHORITY

TEXAS WATER DEVELOPMENT BOARD GRANT #92-483-335

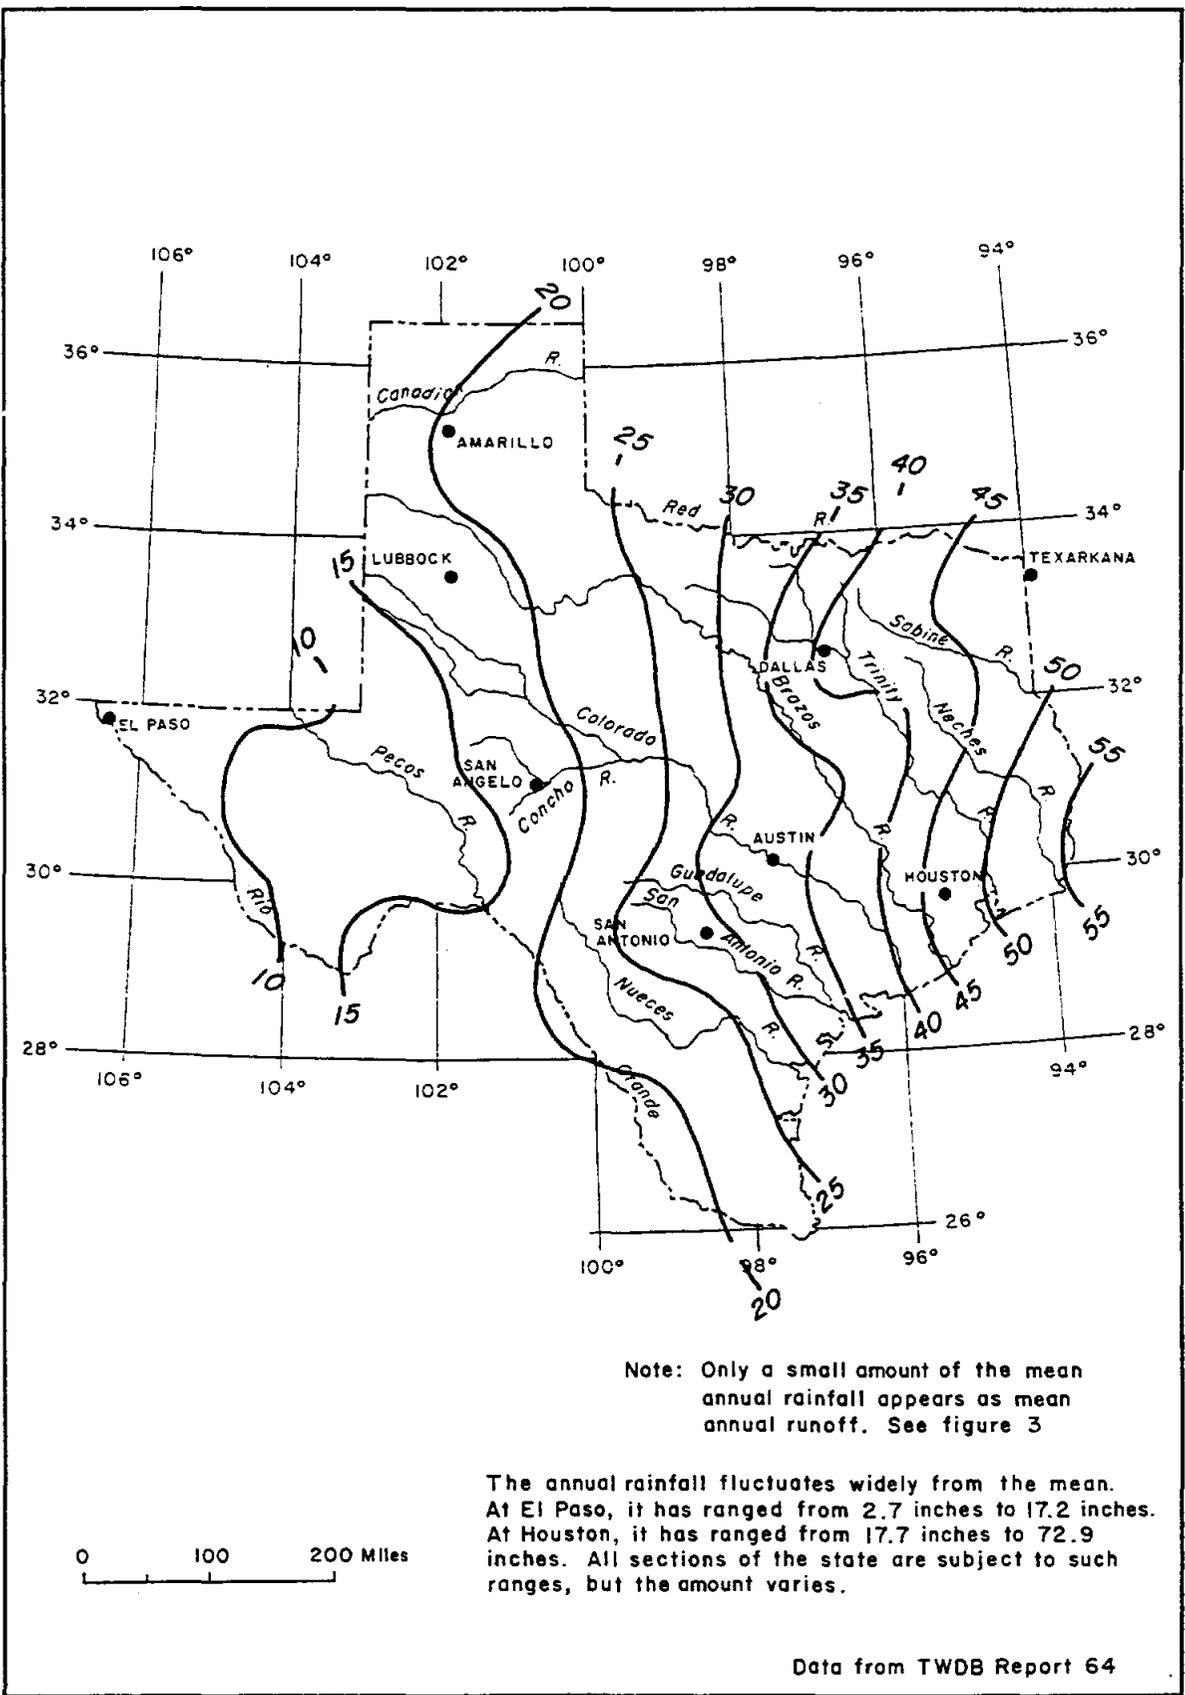
Figure 2

FIGURE 2.- Mean annual rainfall, in inches, 1940 - 65

The Austin area receives about 33 inches of precipitation per year, as shown in Figure 2. The average amount of annual runoff in Austin is about 3 inches per year, as shown in Figure 3. The difference between rainfall and runoff is attributable to evaporation, infiltration and transpiration by plants. Dependent on antecedent moisture conditions, at least one-half to one inches of rain must fall before runoff occurs.

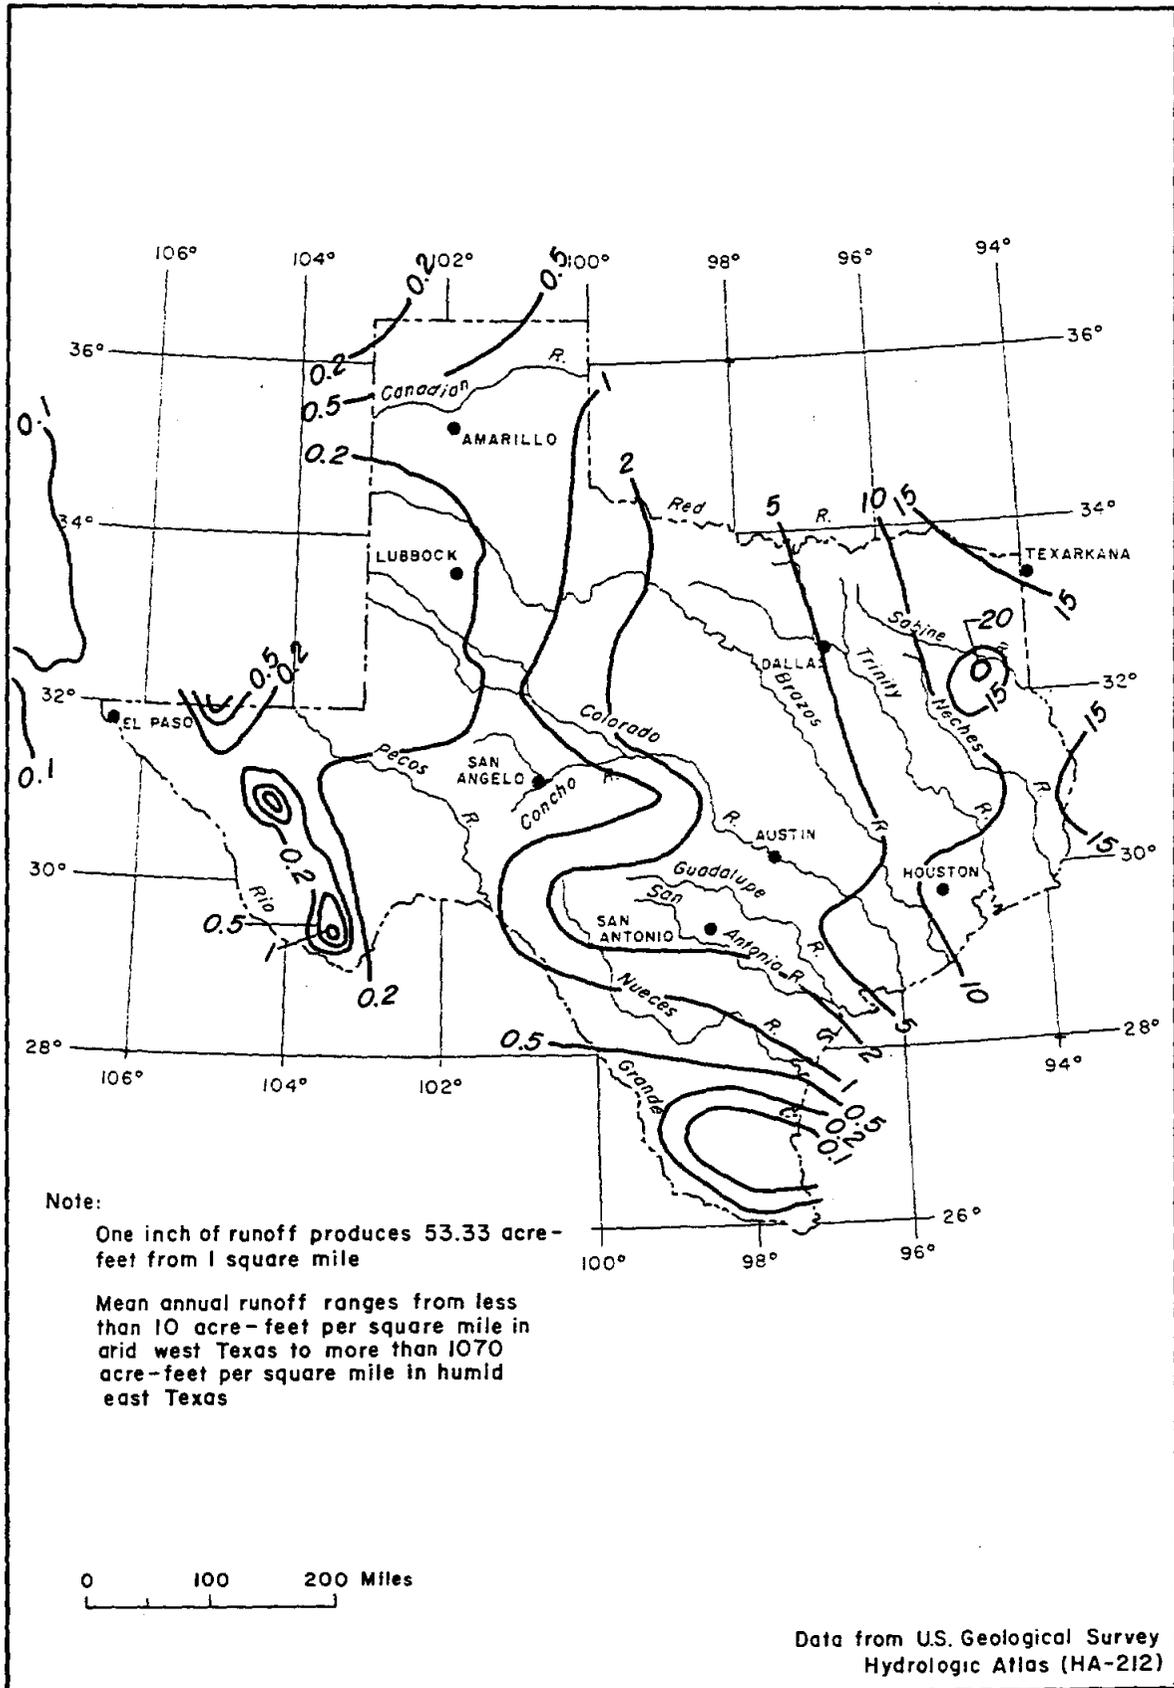
Figure 3

FIGURE 3.-Mean annual runoff, in inches

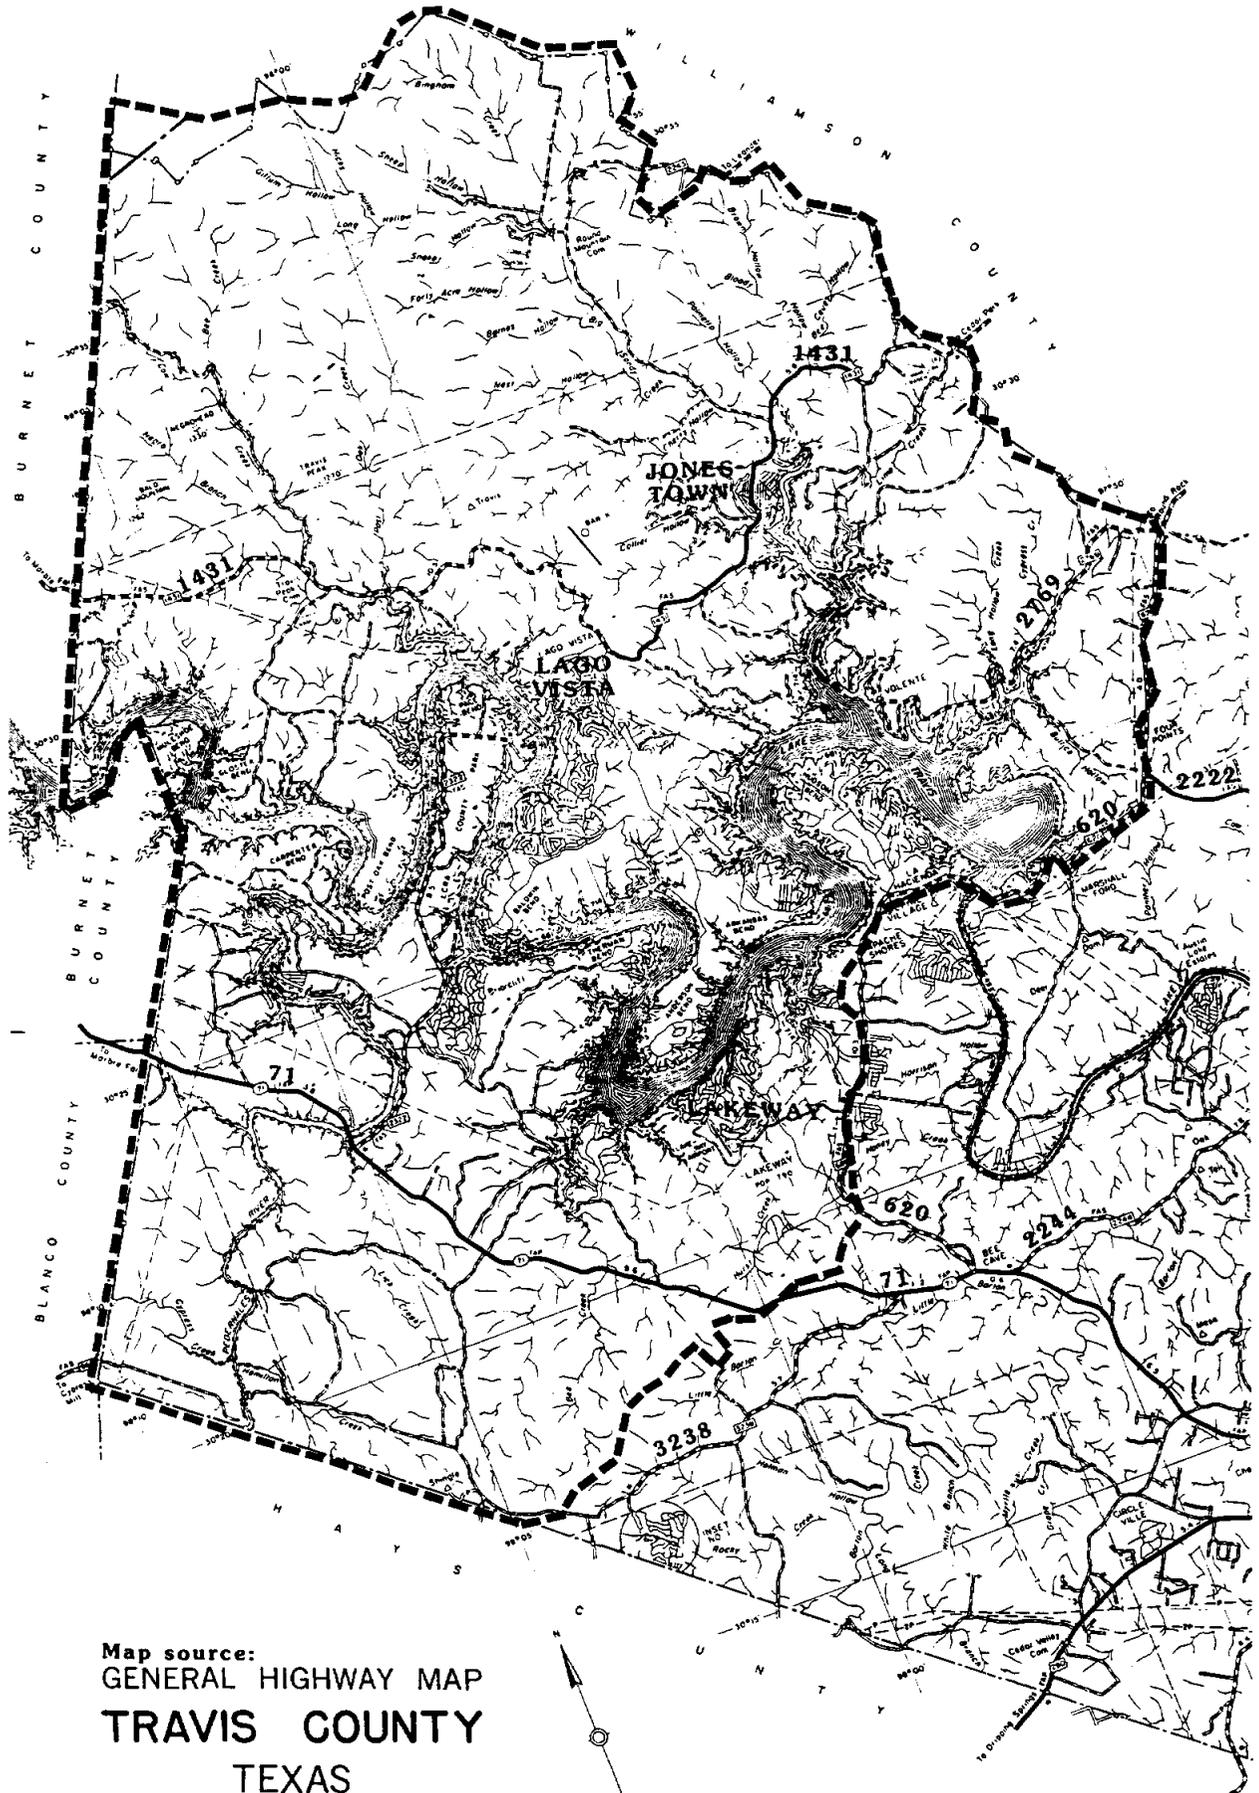
Figure 4

AREA SUBJECT TO
LCRA NONPOINT
SOURCE POLLUTION
CONTROL ORDINANCE

Most of the runoff in the Austin area results from short-term, high intensity storm events. Development of the watershed has a directly effect on rates and amounts of runoff, especially creation of impervious cover such as roads and buildings. Higher rates of runoff generally correspond to higher rates of erosion and pollutant loading of streams and reservoirs. The Lake Travis Non-Point Source Pollution Control ordinance is intended to address these concerns. The area subject to the ordinance is shown in Figure 4.

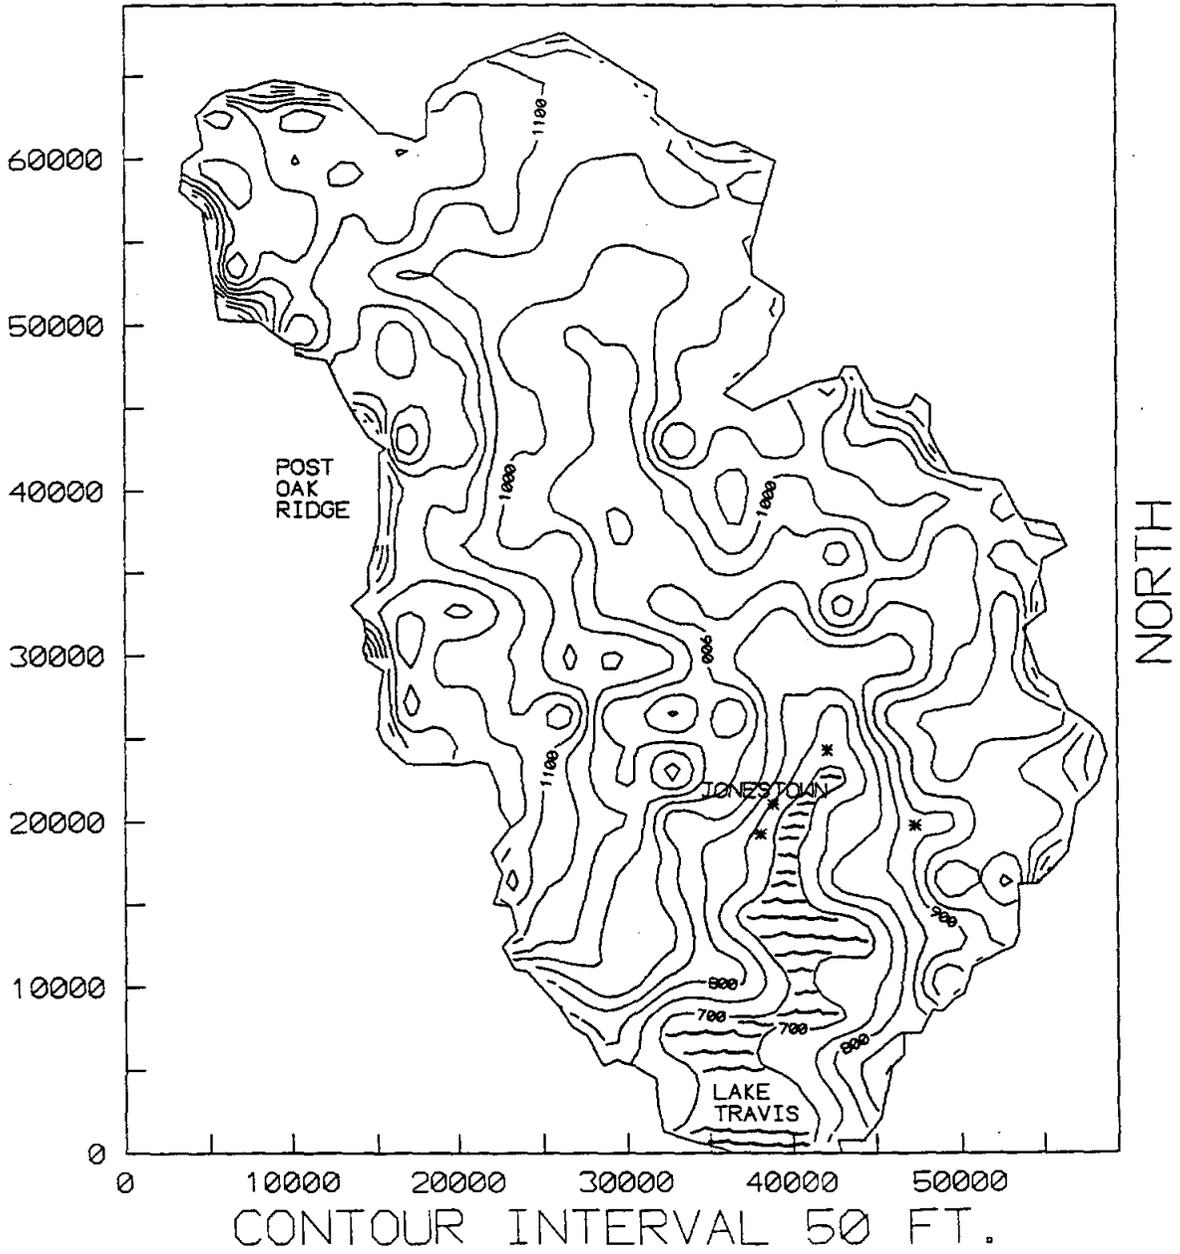
SANDY CREEK ARM OF LAKE TRAVIS

Erosive rates of runoff and relatively high stream gradients have created a landscape characterized by steep hills and valleys. The topography of the study area is terraced, caused by layering of hard and soft beds of the Glen Rose limestone formation. Stream patterns in the study area are mostly controlled by the resistance of underlying limestone formations to erosion. Sharp bends in creeks occur where streams have encountered resistant bedrock. Almost no alluvial or floodplain deposits exist in the steep ravines. The ravines drain into canyons, the most prominent of which is the canyon of the Colorado River which has been inundated by Lake Travis.

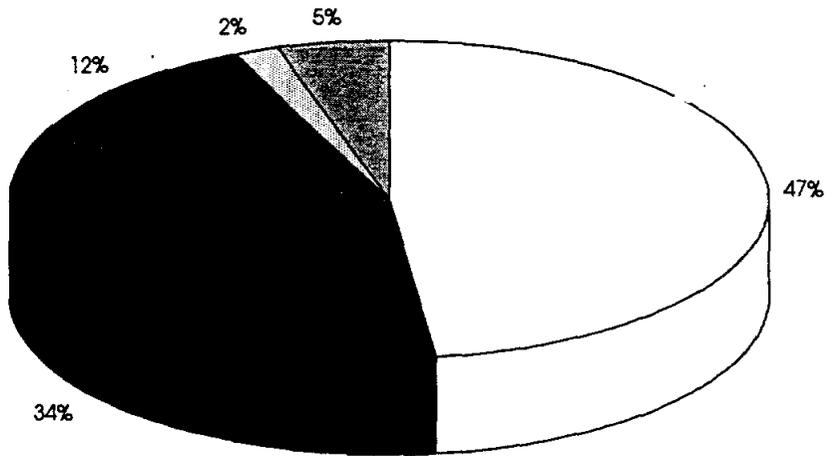
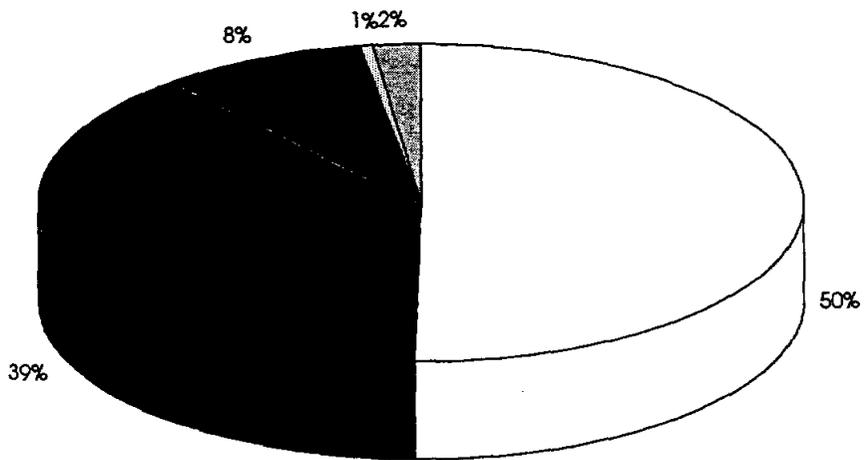
Figure 7

Lake Travis Land Use

Sandy Creek Land Use

The watershed of Lake Travis and the subwatershed of Sandy Creek are both mostly rangeland, consisting of 50% pasture, 39% woodland, 8% urban, 2% industry and 1% other land uses. The area receives about 33 inches of precipitation per year, and yields about 3 inches of runoff per year. The remainder is lost to evaporation, infiltration and transpiration by plants. Most of the runoff occurs from storm events.

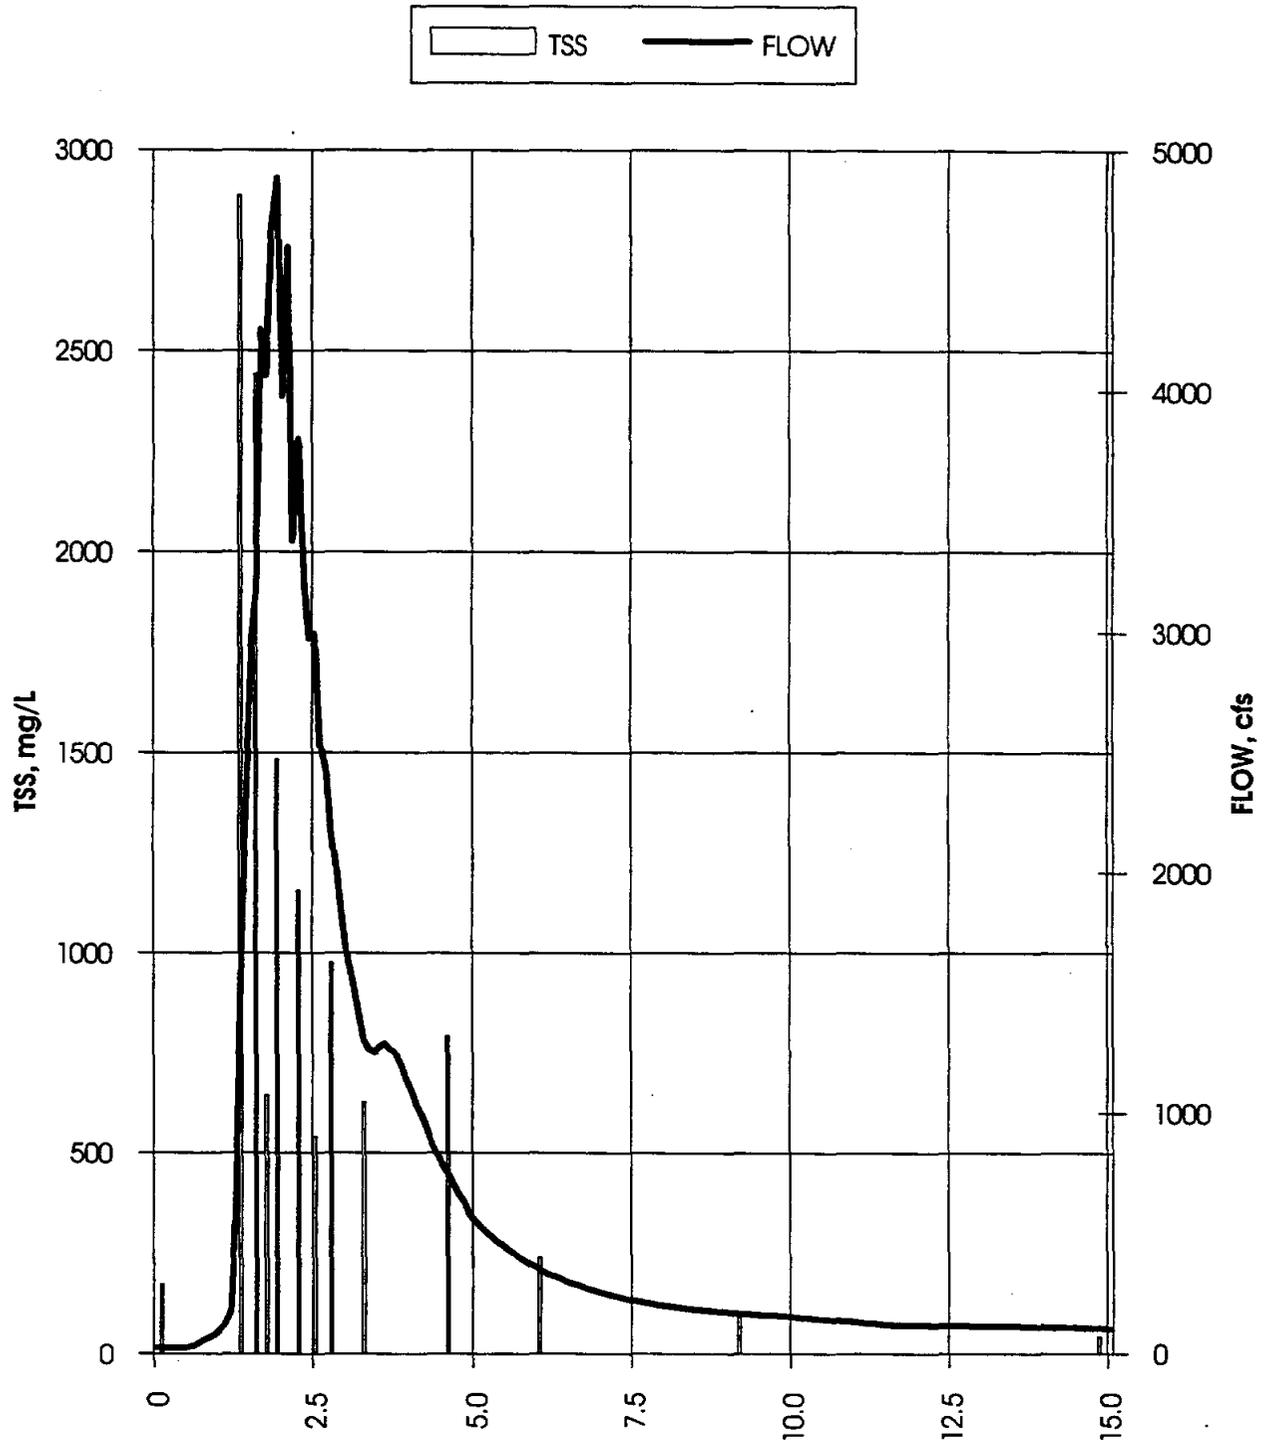
Figure 8

SANDY CREEK 6/21/93 STORM

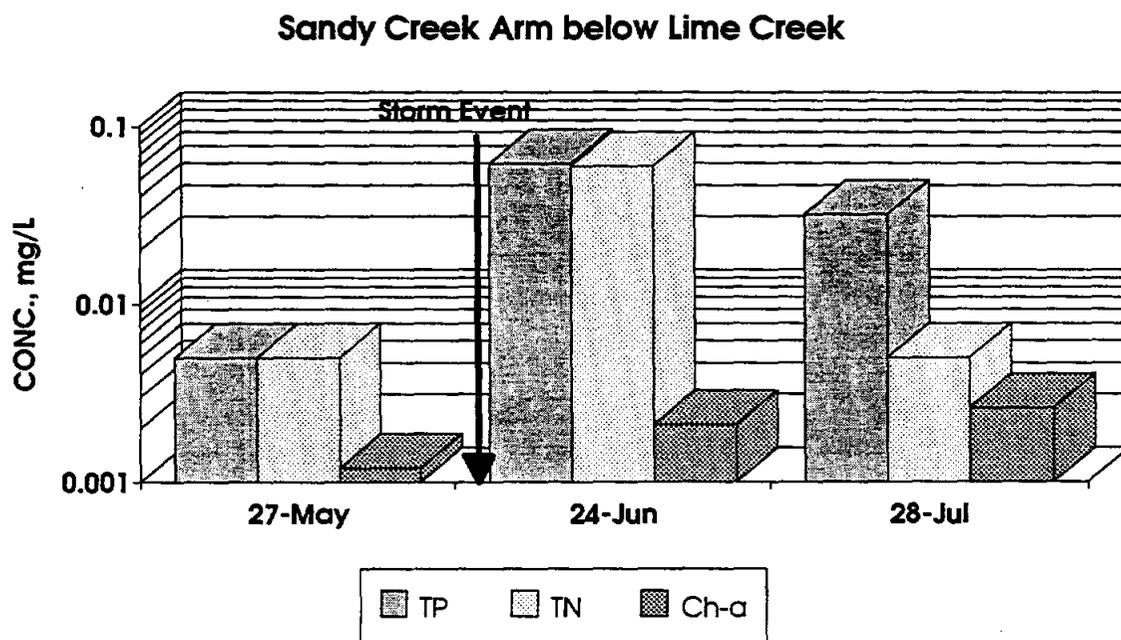
Figure 9

By July 28 however, available nitrogen was back to non-detectable levels, and phosphorus went from a high concentration of 0.062 to a low of 0.031 mg/L in Sandy Creek Arm. From June 24 to July 28 (period of no rain after the storm), Chlorophyll-a levels went from an average of 0.0017 to as high as 0.0080 mg/L. Ch-a showed a consistent trend higher at sites progressively upstream. The data indicate that nutrient loading from the storm event caused increased productivity. Moreover, nitrogen was consumed at a faster rate than phosphorus, which was still at near-eutrophic levels when all available nitrogen was used up. These trends are shown in Figure 9.

The most dramatic effect on water quality of the lake from the June 21 storm came from nutrient loading. At the five lake sampling sites between May 27 and June 24, available nitrogen (ammonia-N plus nitrate-N) went from non-detectable levels (<0.010) to an average of 0.045 mg/L. Phosphorus went up by a factor of 2 or more to 0.062 mg/L. After the storm, total P at all five sites was greater than the EPA criteria for eutrophic conditions of 0.025 mg/L (EPA, 1986), and was equal to or greater than 0.040 mg/L at three out of five sites.

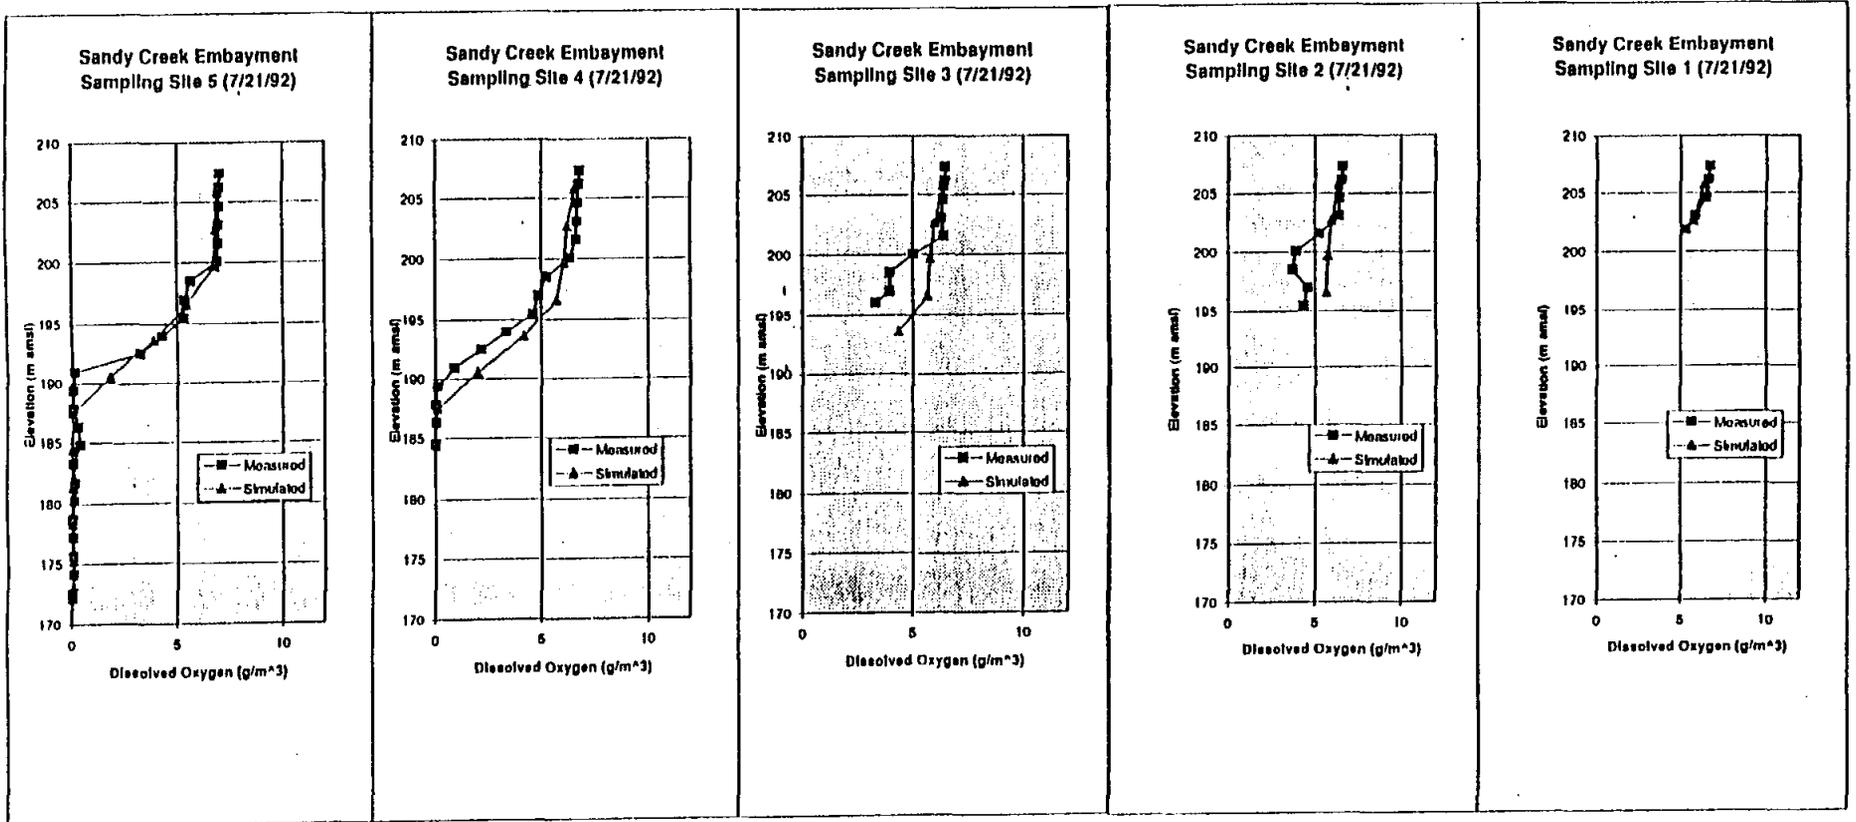
Figure 12 shows a series of vertical profile plots of measured versus simulated values for dissolved oxygen at the five sampling locations in Sandy Creek embayment for July 21, 1992. The DO profile shows close agreement between simulated and observed values on this date with the presence of a thermocline clearly indicated. By this time in the computation, the model simulation has been continuously computing for more than two months of simulation time. The dissolved oxygen profile, using an expanded set of interacting model parameters similarly shows adequate agreement between simulated and observed values, generally within about one g/m^3 (mg/l) of DO. These DO simulations appear to follow the processes observed and lead to anoxic conditions below depths of about 20 feet in Sandy Creek embayment. Similarly, the TDS profiles show close agreement. For each of the computed constituent profiles, results are somewhat poorer in shallow water.

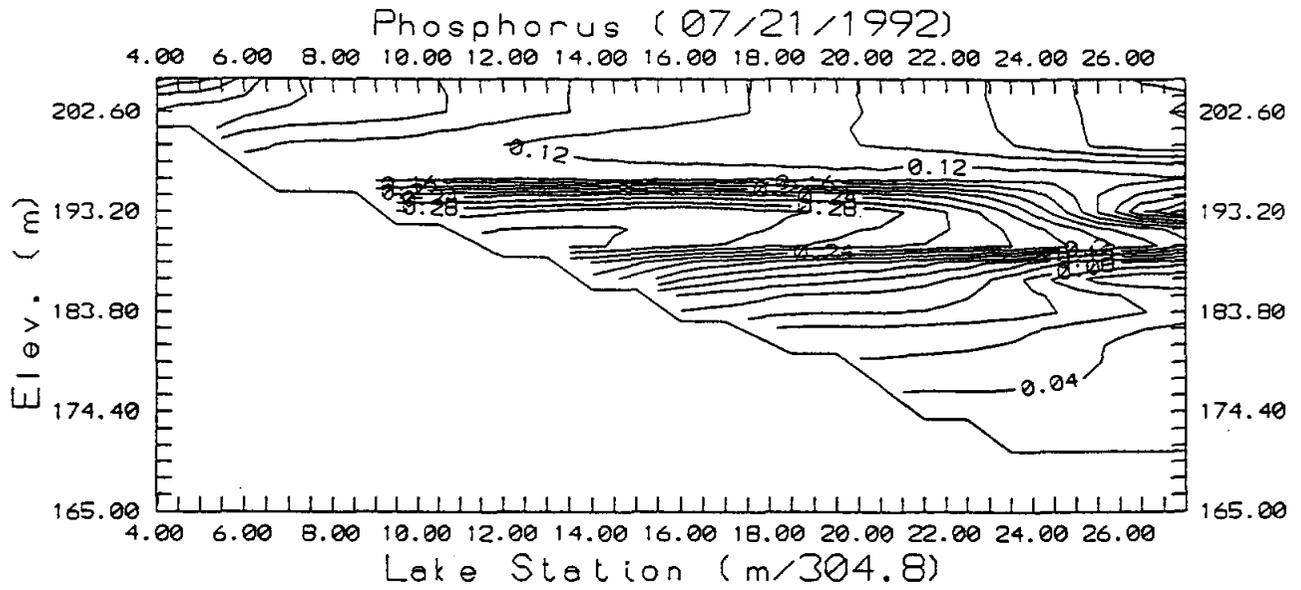
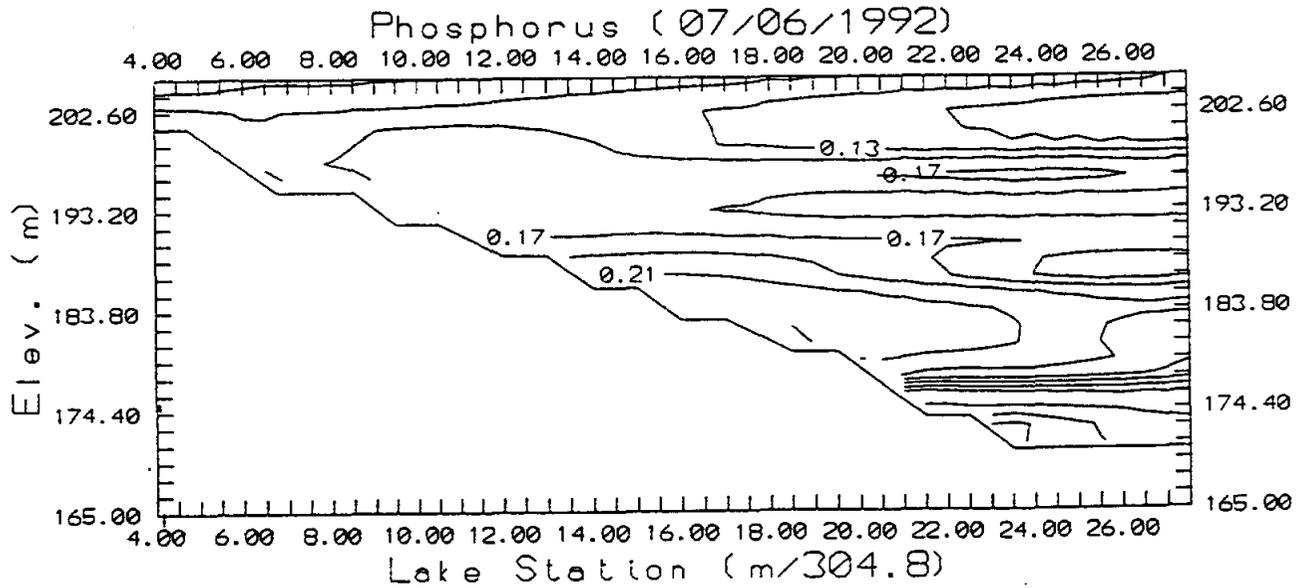
Figure 13 shows x-z plane contour plots with computed results for phosphorus only, for July 6 and 21, 1992. Recall that measured vertical profile data are available only at five stations and only for temperature, TDS, and dissolved oxygen for the full profile. Hence, full comparison with measured data is not possible. However, in general, the x-z plane contour plots and the vertical (simulated versus observed) plots for the two summer days appear to provide reasonable results based on the model assumptions and the data supplied for use. The results shown are only representative of typical CE-QUAL-W2 simulations for a summer time period (stratified condition).

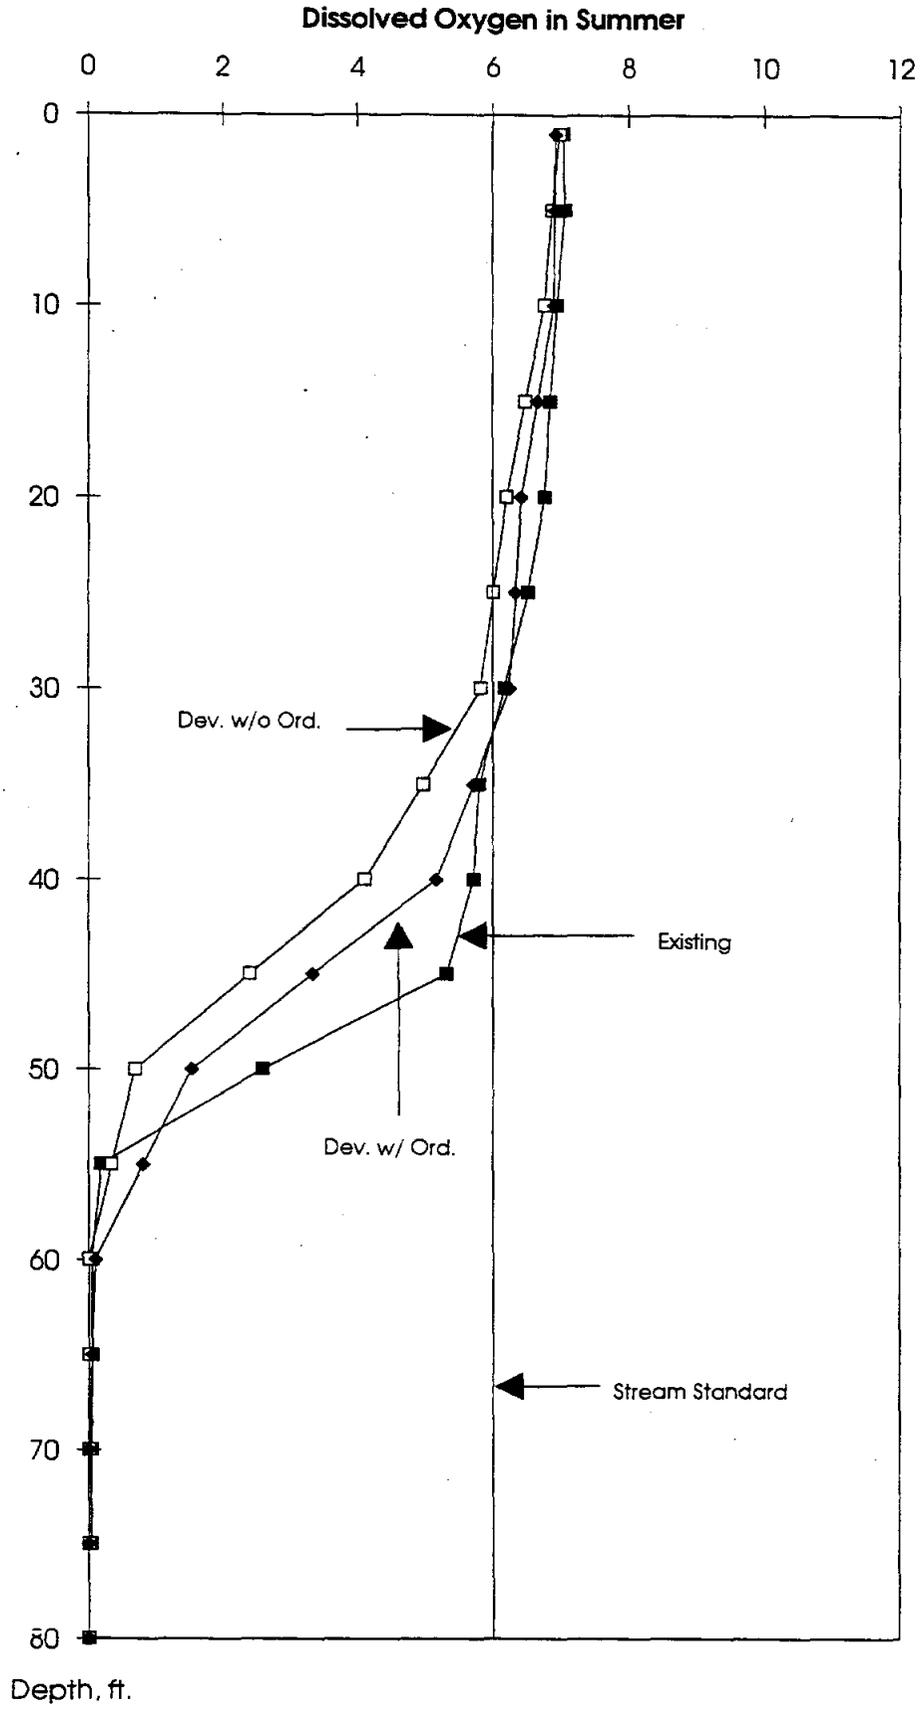
Figure 14 shows the effect of the ordinance on dissolved oxygen in summer. The stream standard for Lake Travis of 6.0 mg/L is shown as a vertical line. Increased nutrient loading and resultant algal growth and decay in Scenario 2 and 3 has the effect of reducing the concentration of dissolved oxygen. However, reductions in pollutant loading required by the ordinance has a consistently beneficial effect on DO. At a depth of 40 feet, DO is approximately 1 mg/L higher with the ordinance in place. In the epilimnetic zone above 40 feet, the TNRCC stream standard is maintained.

Seasonal scenarios were modeled using data from August 17, 1992 for summer conditions and March 25, 1993 for winter conditions. The results are shown in Table 2 and Figures 14 and 15. The table displays dissolved oxygen values at the Lime Creek lake sampling site, as measured values compared to Scenario 2 (fully developed w/o ordinance and Scenario 3 (fully developed w/ ordinance in place). The figures show these data plotted for summer and winter conditions.
